Final Report

May 1, 2015

# Franklin Hill / Irishtown Bend

## Stabilization and Restoration

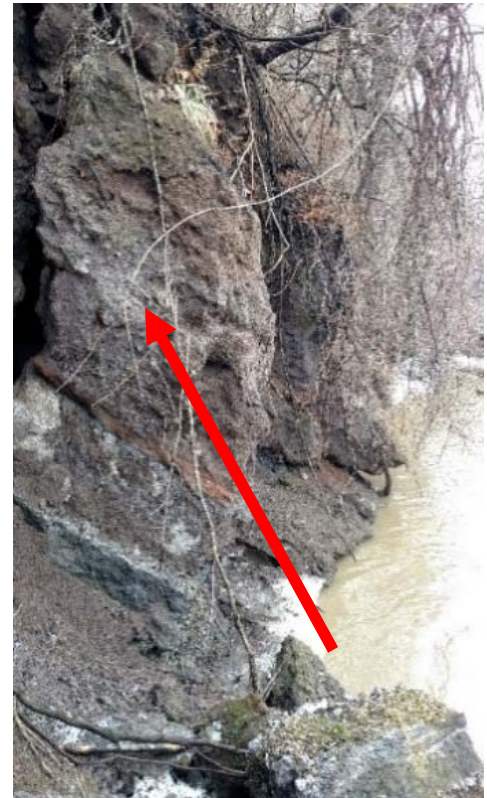
Visual observation along the toe of the river identified soil block failures up to heights of 15' and tension cracks developing along the top of the riverbank as shown in Figures 5 and 6. The tension cracks will further grow as they collect water and expand under freeze and thaw cycles. The river bank failures that are occurring at the top of the slope, as shown in Figures 5 and 6, are reducing the stability of the hillside from the river's edge up to Franklin Avenue. This type of large mass soil failure at the river's edge and at the toe of the slope is further described in Appendix A and is known as a Retrogressive Slide Development. If efficient action is not implemented, the stability of the slope can be further jeopardized. Soil block failures such as shown in Figure 5 can interfere with ship traffic.

Figure 5: Soil Block Failure

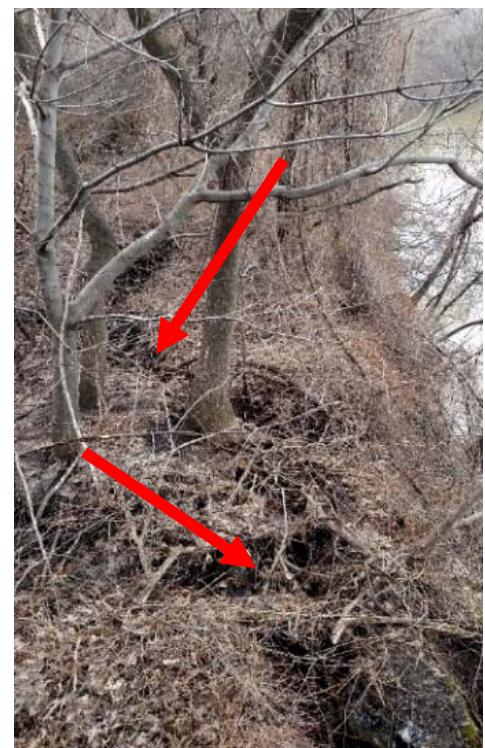
Figure 6: Tension Crack

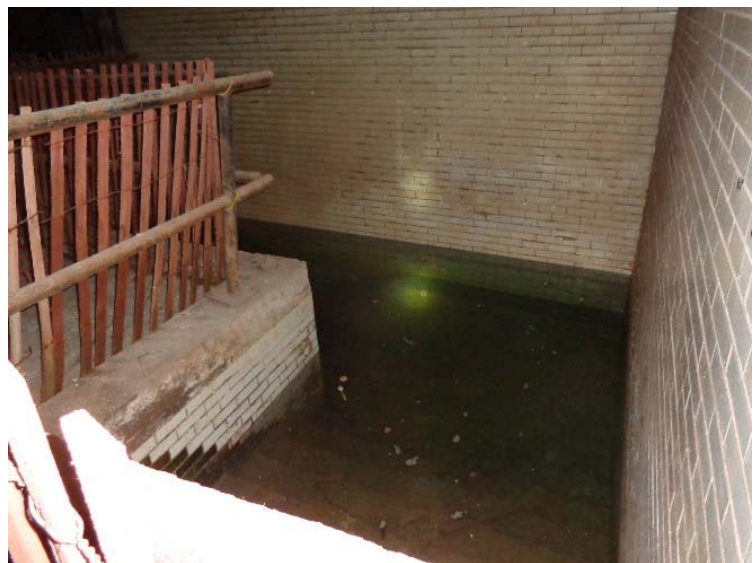
It was observed during the site inspection that the West Station pedestrian bypass tunnel was flooded with water (see Figure 7). Observations of water entering the tunnel were noted in the late 1980’s by Cuyahoga Bridge Inspectors. It is unlikely that the tunnel would have been constructed below the groundwater elevation without means of dewatering, since the primary purpose of the tunnel was to allow subway passengers to safely cross under the railroad tracks to access the restrooms.

Figure 7: Bypass Tunnel Flooded with Water

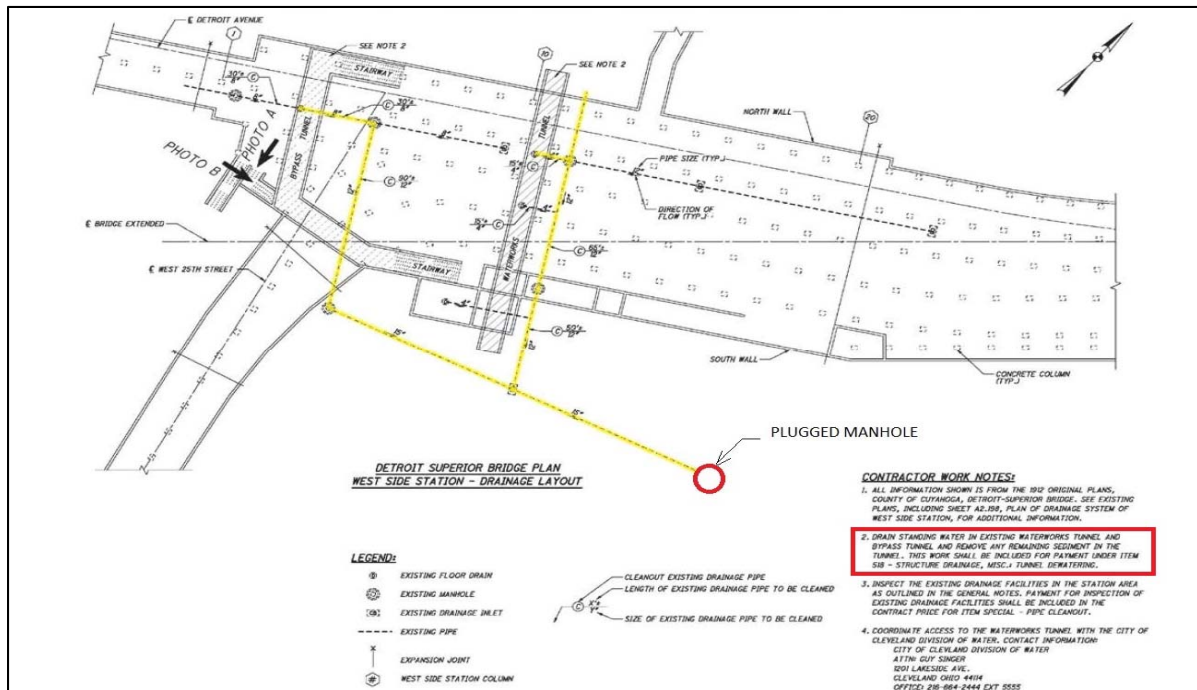
Figure 11: 2014 Project Plan Sheet from CUY-6-14.56

Figure 11 is from the recent construction project, CUY-6-14.56 PID No. 77040, which is primarily a concrete rehabilitation of the Detroit-Superior Avenue Bridge. The highlighted conduits for each tunnel system are connected at a drainage structure that flows to a manhole that should outlet to the Cuyahoga River. However, that manhole is partially plugged and does not allow drainage of the tunnel systems. The plugged manhole (which is shown in Figures 11 and 14) is approximately 40' deep and has 20' of standing water in it. An attempt was made to dewater the manhole in conjunction with the contractor dewatering of the pedestrian bypass tunnel, per Item 2 in the highlighted construction work notes in Figure 11. The water in the manhole was lowered by 8' in one week of pumping and the contractor was able to partially dewater the pedestrian tunnel. However, complete dewatering of either structure was never achieved.

**Figure 11, Contractor Work Note 2:** Drain standing water in existing waterworks tunnel and bypass tunnel and remove any remaining sediment in the tunnel. This work shall be included for payment under Item 518 – Structure Drainage, Misc., Tunnel Dewatering.

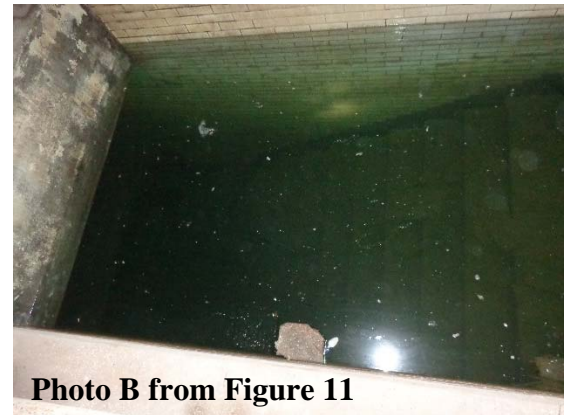
Photo B from Figure 11

The contractor hired by ODOT for CUY-6-14.56 also made an attempt at dewatering the tunnel but could only reduce the water elevation by approximately 2'-4'. A section view of the tunnel is shown in Figure 13. ODOT decided to abandon the operation and cease the work associated with draining and inspecting these tunnel systems. Inspection of the waterworks tunnel could not be performed for this phase because access was blocked and flooded with high pressure water.

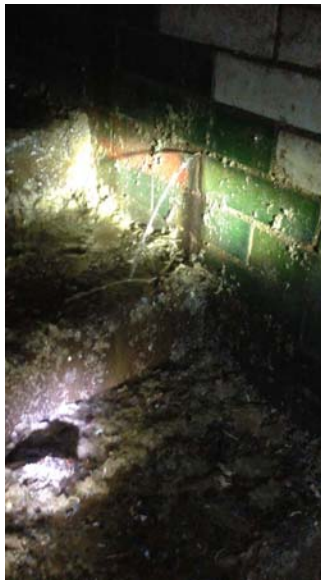
Figure 12: Water Penetrating through Walls

The fact that the tunnels have a combined drainage system that share an outlet that is partially plugged allows water to back up into the tunnel systems. Therefore, the tunnels serve as large holding reservoirs allowing water to slowly discharge through the partially plugged manhole.

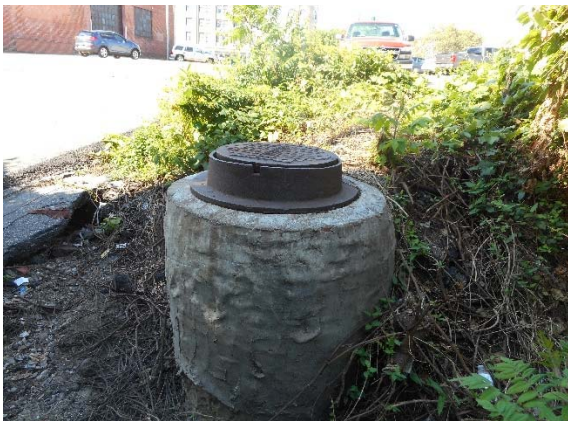
An attempt to dewater the partially plugged manhole that is connected to the tunnel system was made between May 5, 2014 and May 9, 2014. The depth of water in this manhole during the time of inspections was consistently 20' and the bottom of the manhole is approximately 40' deep. The process of dewatering the manhole with a trash pump was ceased because of the lack of advancement to lower the water by more than 8'. Subsequently, a 4,000 Gallon VAC-Truck was mobilized to the site to try to dewater and clean the debris and sediment from the bottom of the manhole. After two days of operations and three full disposals of water and sediment, the operation was halted because of lack of progress to dewater the structure. Therefore, the condition assessment of the storm conduits draining into this system from the tunnels could not be made.

Figure 14: Partially Plugged Manhole as shown in Figure 11

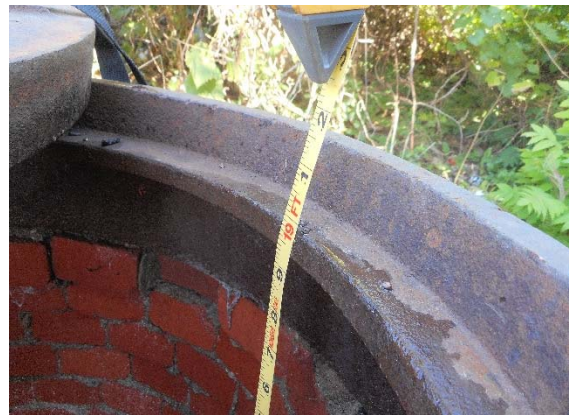
Figure 15: Water Depth in Partially Plugged Manhole

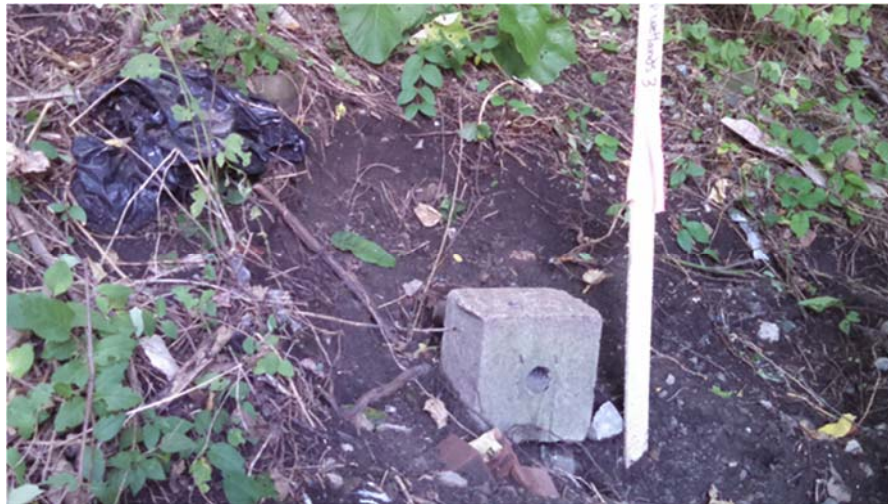
Figure 16: Horizontal 2" Diameter Drain Pipes Installed in 1966

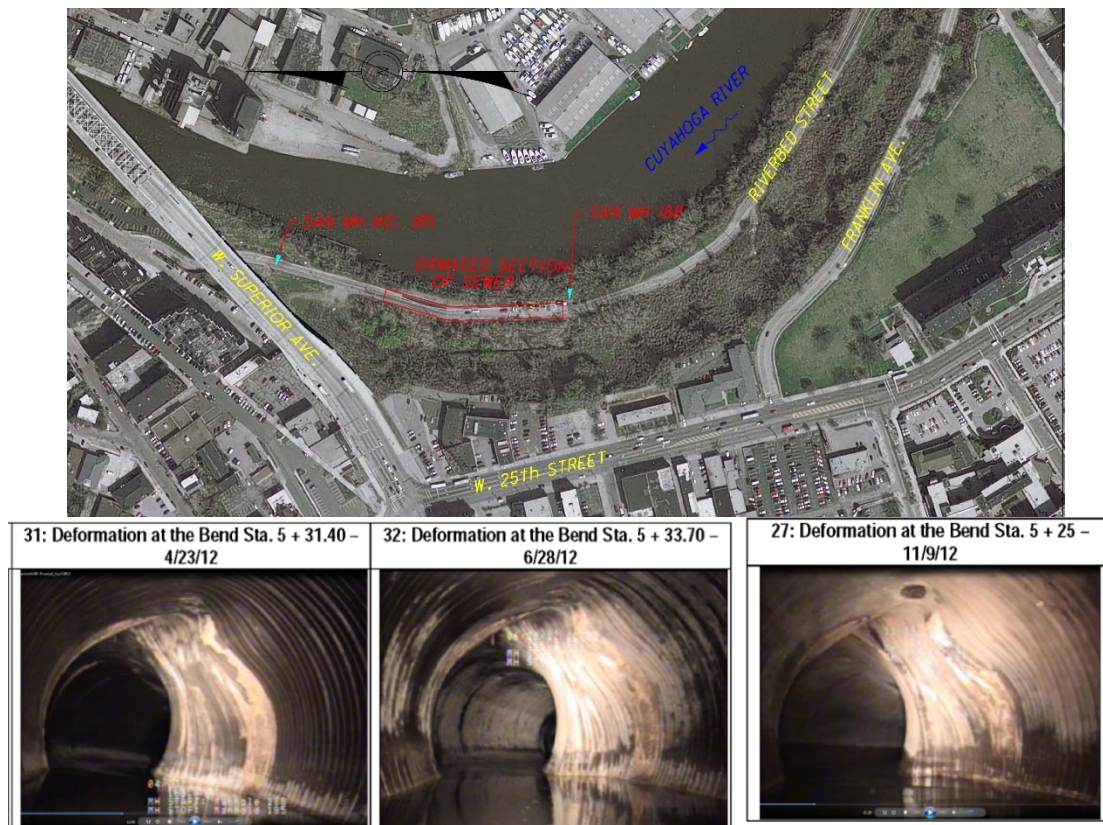
The Northeast Ohio Regional Sewer District (NEORS) maintains a 60” brick sanitary sewer known as the Westerly Low Level Interceptor (WLLI) through the project limits of the site. The alignment closely follows Riverbed Street and the depth of cover varies from 30’ - 40’. The flow is from south to north toward the Division Avenue Pump Station that carries the sewage to the Westerly Wastewater Treatment Plant. The condition of the sanitary line was compromised in two local slips along Riverbed Street in January and August of 2006. An emergency repair project was conducted in 2007 that installed a 42” and 50” spiral wound grouted sleeve between Sanitary Manholes 185 and 190. Also, a 12” to 16” bypass system was installed in case of future failures along Riverbed Street. NEORS routinely monitors this section of sewer with video inspections conducted approximately every six months. Review of the video indicates that the lining has deformed between the 2012 and 2013 inspections. It appears that the section under most distress is the section highlighted in Figure 17, with maximum deformation of the lining occurring in the horizontal deflection of the alignment.

Figure 17: Section of Sanitary Line Under Most Distress

The remaining length of the sewer appears to be stable and functioning as designed. The section between Manholes 185 and 188 is approximately 700' and could be replaced in conjunction with the installation of the bulkhead system. There would be advantages to combining the construction of the tieback system with the required excavation to expose and replace the damaged section of the sanitary line. In essence, the sheet piling designed for the bulkhead deadman system could function as a shoring system so that conventional trench boxes could be used for replacement of the line as shown in Figure 22. The bypass system already in place could be used to divert flow during the replacement process. The approach and design would require close coordination with NEORS staff. Coordinating efforts to repair the WLLI with stabilizing the hillside will reduce total cost and time necessary for global improvement to the site.

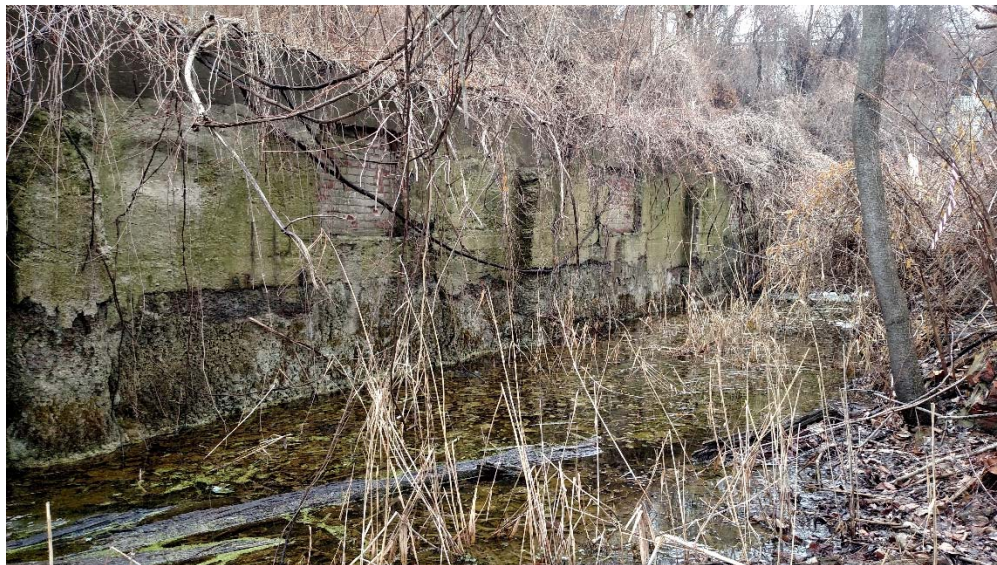
Figure 20: Lederer Building Foundation (Trapping Water)
