**VOLUME I
RATING REPORT SUMMARY
FOR THE 2011 IN-DEPTH INSPECTION**

MAIN AVENUE BRIDGE

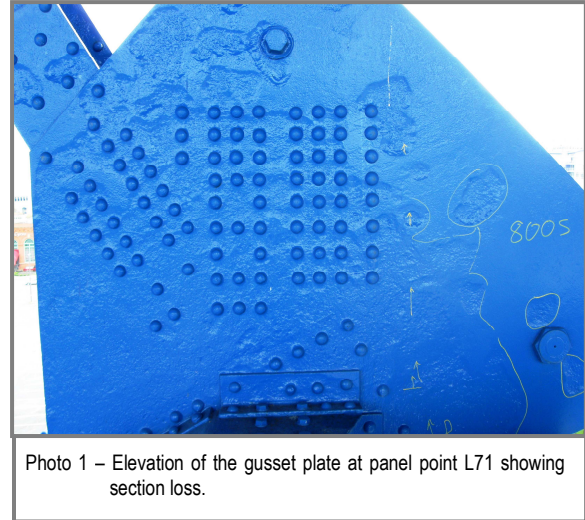
Photo 1 – Elevation of the gusset plate at panel point L71 showing section loss.

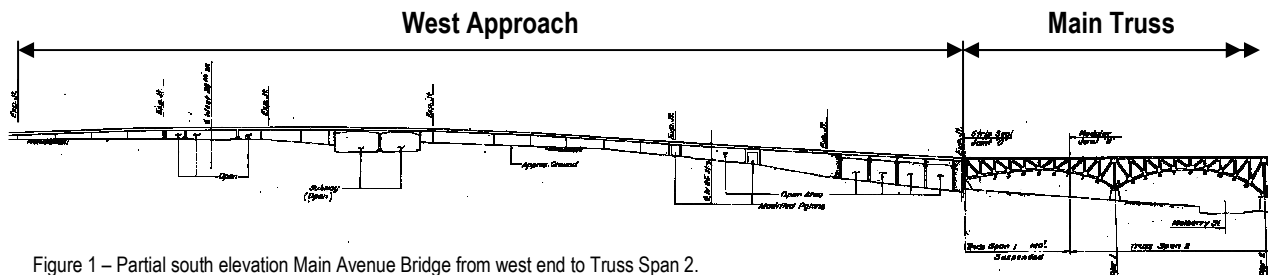
Figure 1 – Partial south elevation Main Avenue Bridge from west end to Truss Span 2.

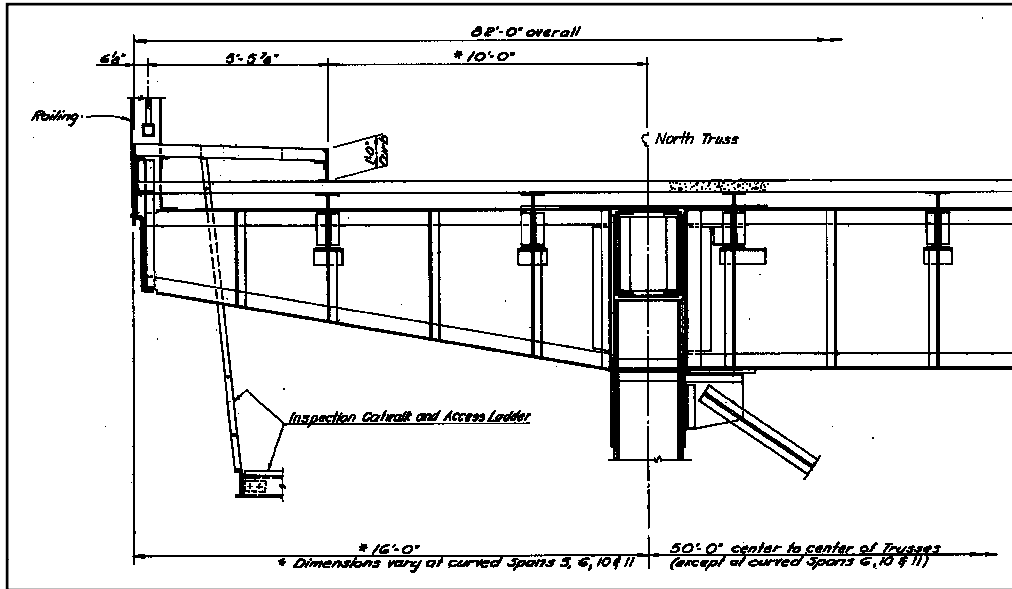
Figure 9 – Cross Section of the original configuration of Main Avenue Bridge with 82'-0" out to out bridge deck and 6'-0" sidewalks.

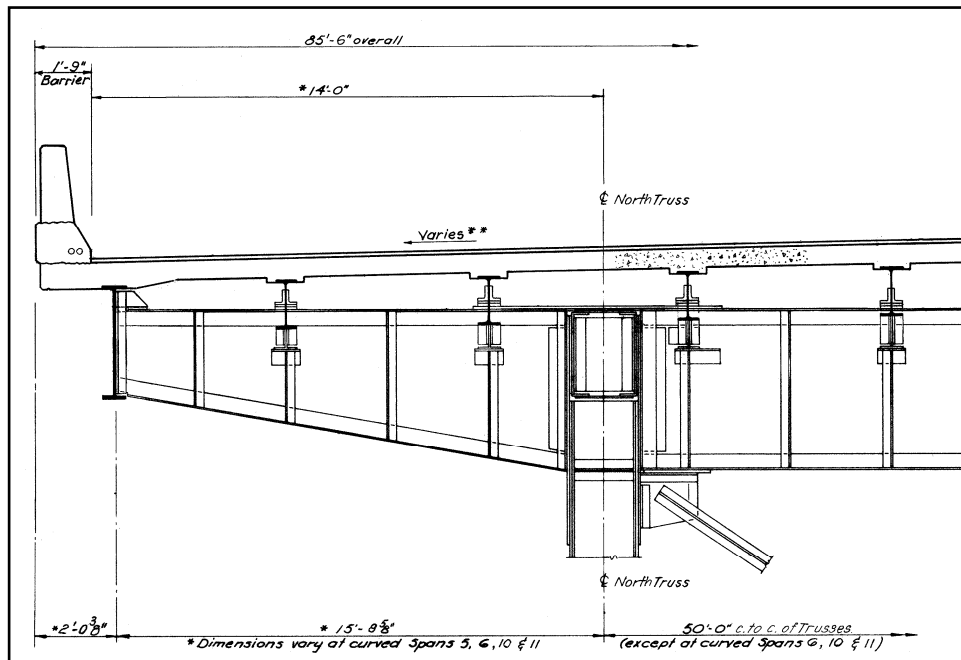
Figure 10 – Cross Section of the existing configuration of Main Avenue Bridge with 85'-6" out to out bridge deck.

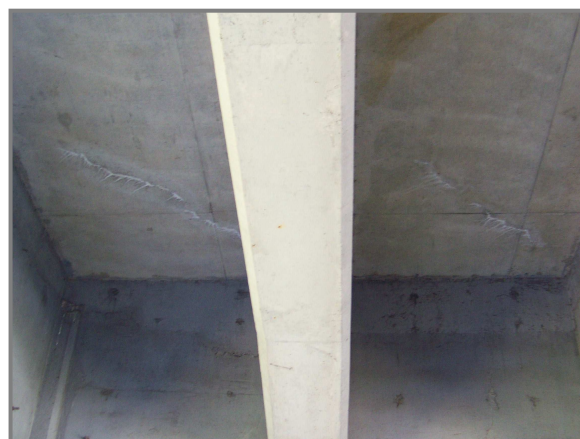
Photo 2 – Minor diagonal cracking in Bays 2 and 3 at the extreme east end of Section P.

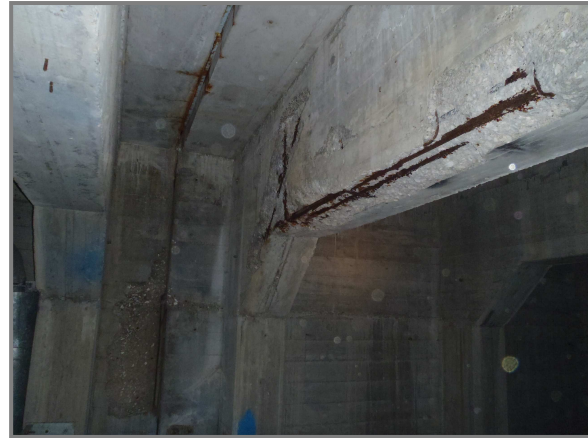
Photo 3 – The west face of Bent 21 in Section D of the west approach exhibits a large spalled area with exposed reinforcement.

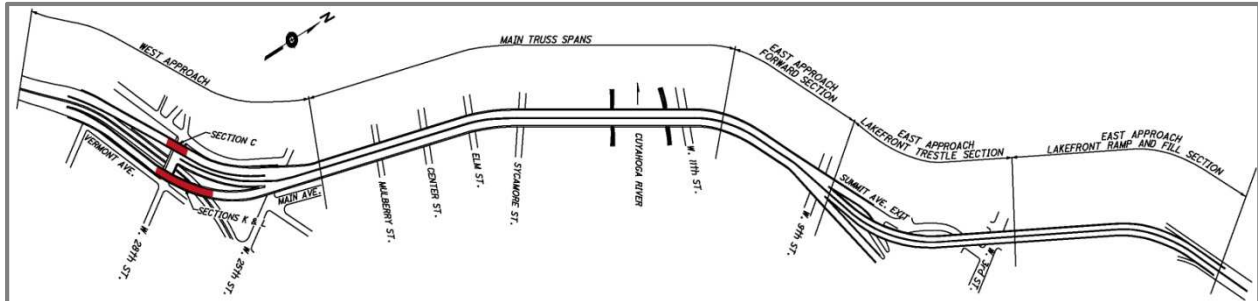
Figure 13 – Location of Sections K, L, and C

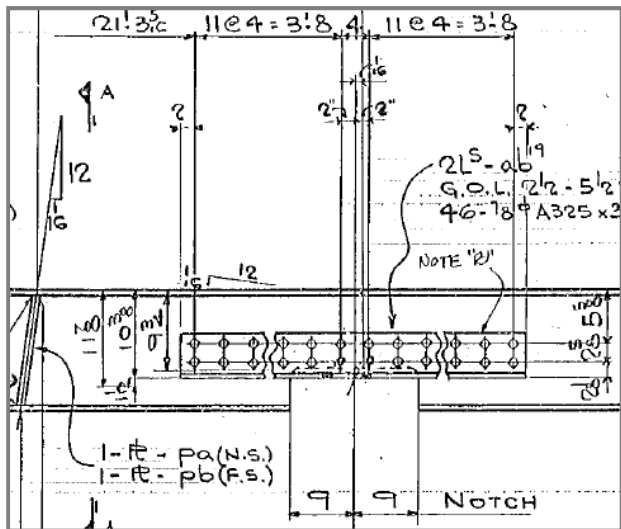
Figure 14 – Typical coped stringer shop drawing detail

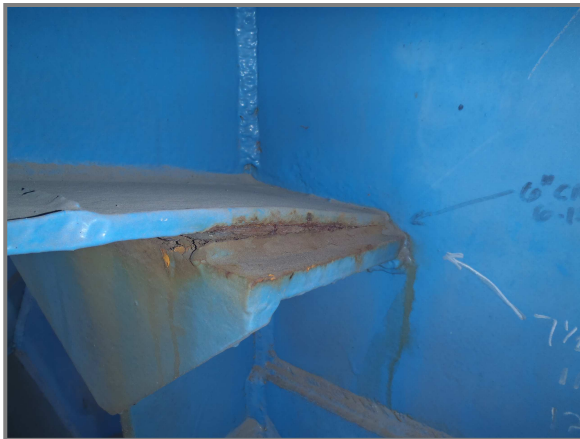
Photo 6 – Cracked weld between the seat and south bracket at Column K2 in Section K.

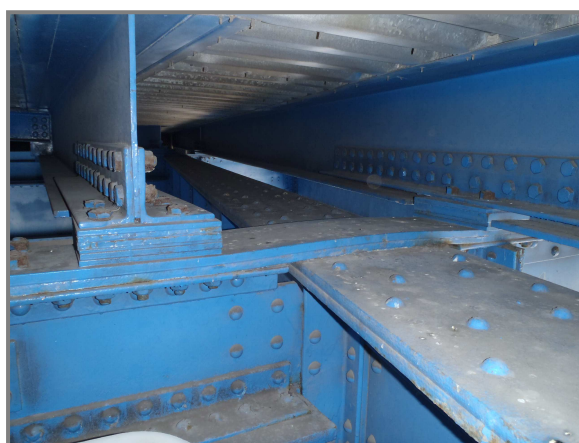
Photo 7 – Typical framing in Section N, stringers supported floorbeams that are framed into girders.

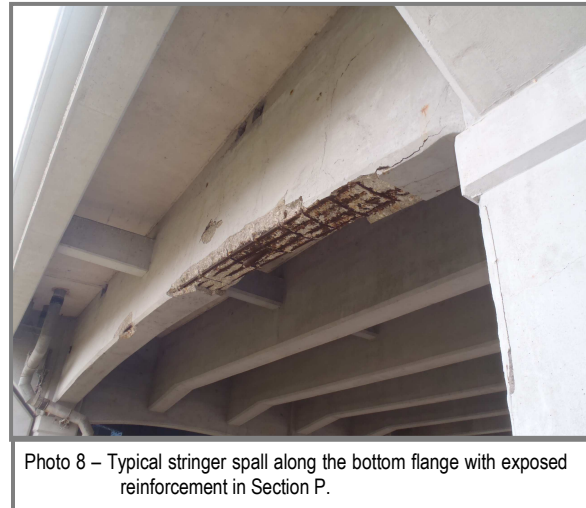
Photo 8 – Typical stringer spall along the bottom flange with exposed reinforcement in Section P.

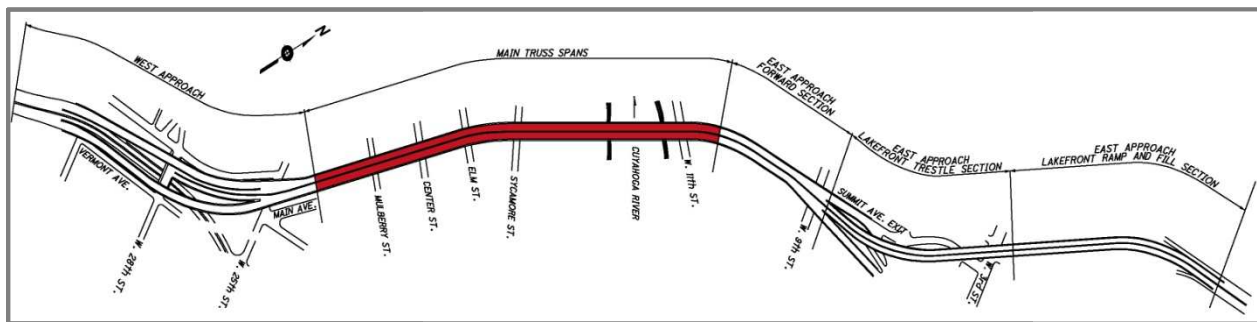
Figure 19 – Location of Main Truss Spans

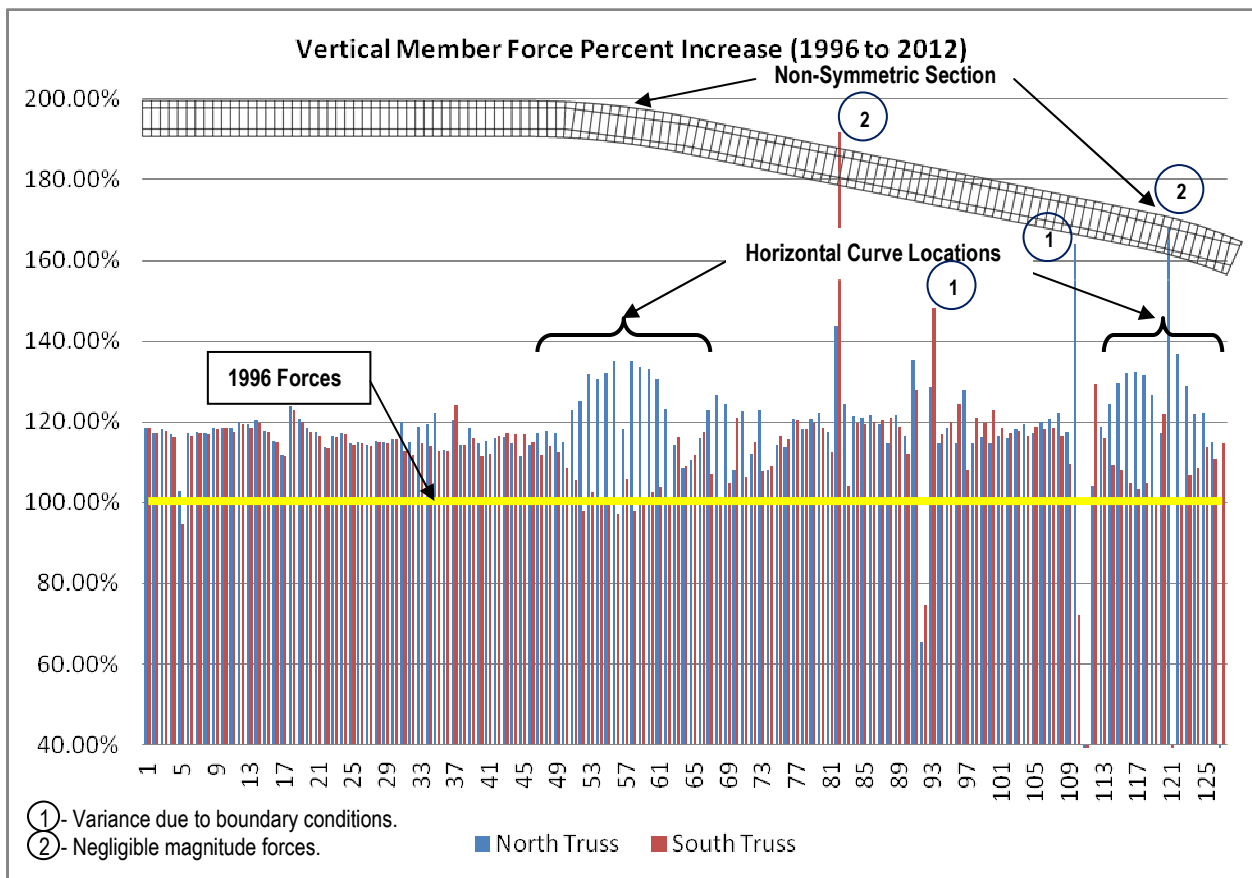
Chart 1 - Variance between 2012 and 1996 vertical member forces. Note divergence of percentages at roadway bend points.

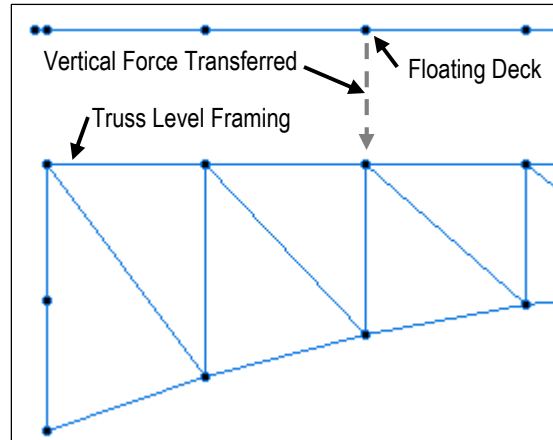
Figure 22: Floating Deck and Truss Elevation

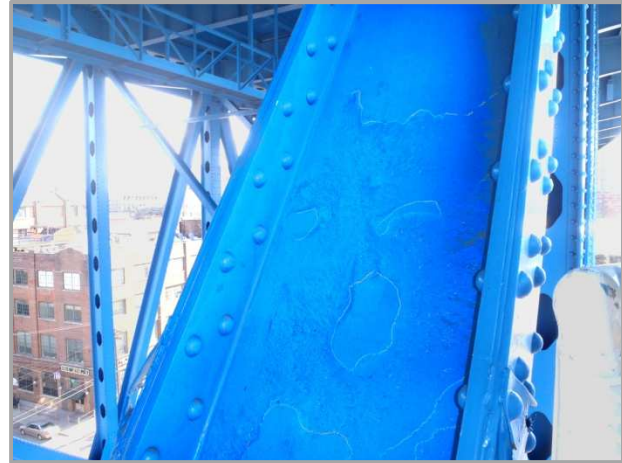
Photo 9– Member U52-L53 of the north truss with heavy web section loss.

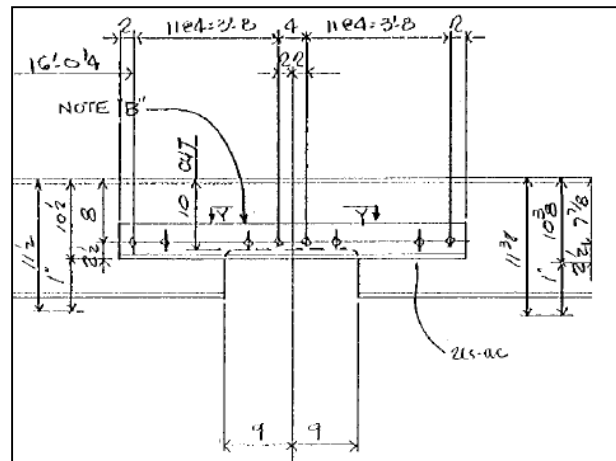
Figure 23– Typical coped stringer detail over floorbeam connection (Unit 3 Span 6 Stringer 14 shown).

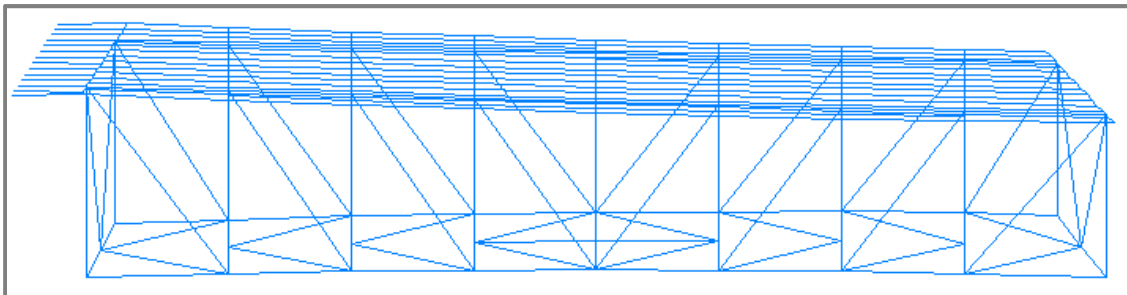
Figure 25 – South Elevation of Span 11 STAAD model

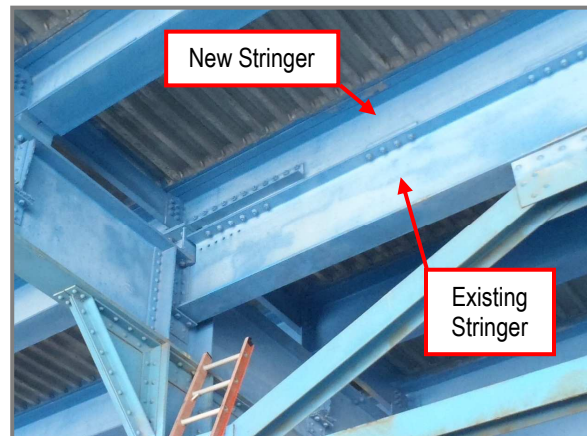
Photo 11 – Forward Section showing t-shaped stringer added in rehabilitation on top of existing stringer.

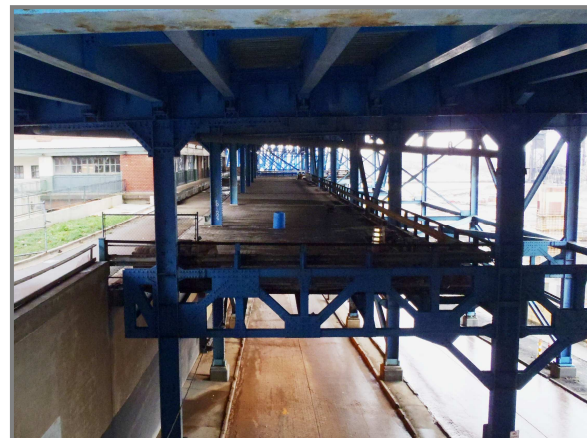
Photo 12 – Lower level deck in the East Approach – Forward Section (looking west)

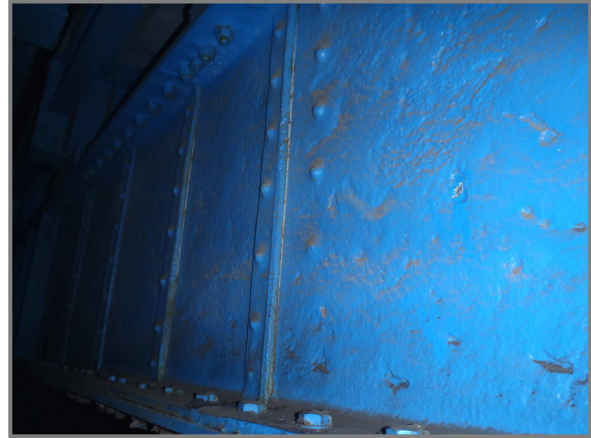
Photo 13 – Typical pitting of the east face of Floorbeam 14 at mid-beam. Note the removal of vertical stiffener legs in this area.

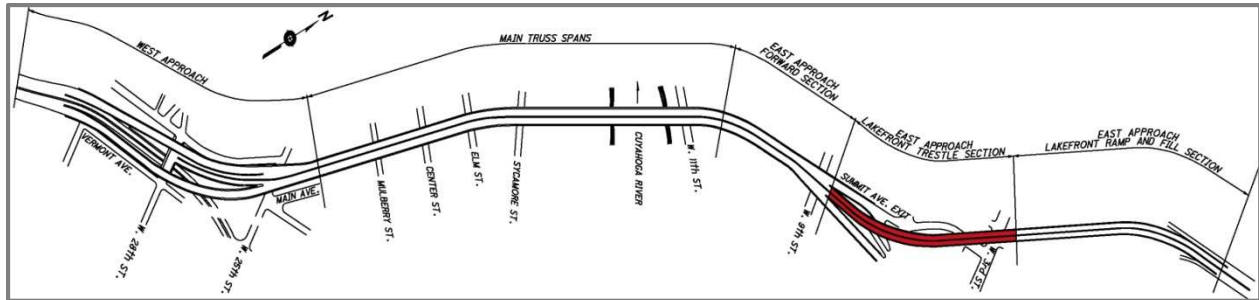
Figure 26 – Location of East Approach – Lakefront Trestle Section

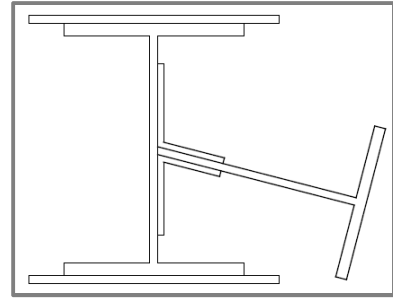
Figure 28 – Typical column cross section for Bents 24 and 25 (East Approach – Lakefront Trestle)

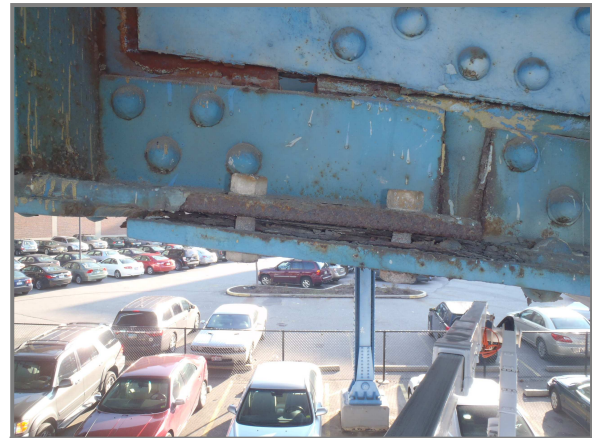
Photo 14 – Pack rust between South Girder bottom flange and wind shear plate at Bent 29. Note bolts have backed off nuts.

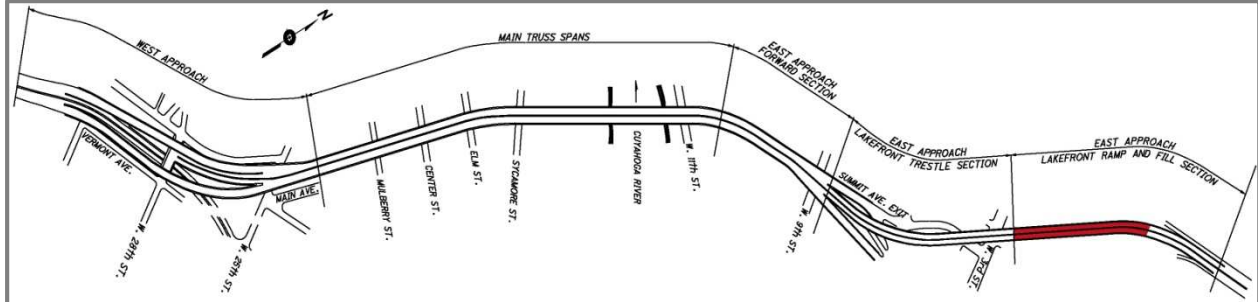
Figure 29 – Location of East Approach – Lakefront Ramp Section

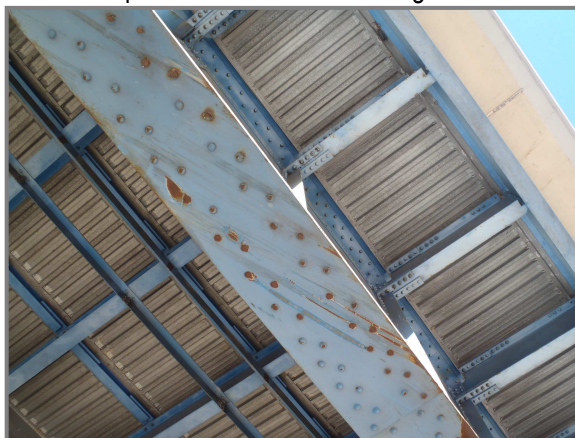
Photo 16 – Impact to the South Girder in the Lakefront Ramp. Note scraping and rivet heads sheared off.

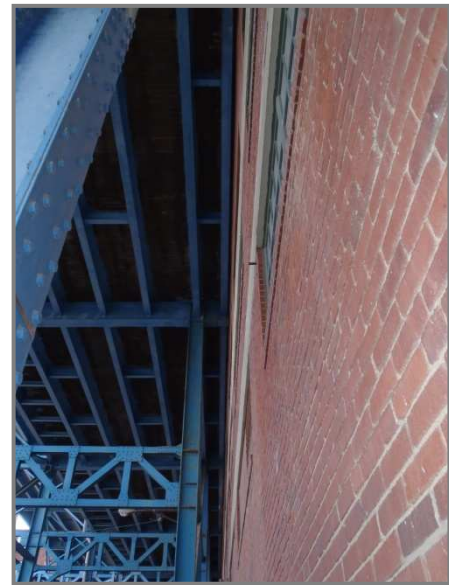
Photo 17 – On Main Avenue, looking up and east at apartment building and lower deck of Forward Section.

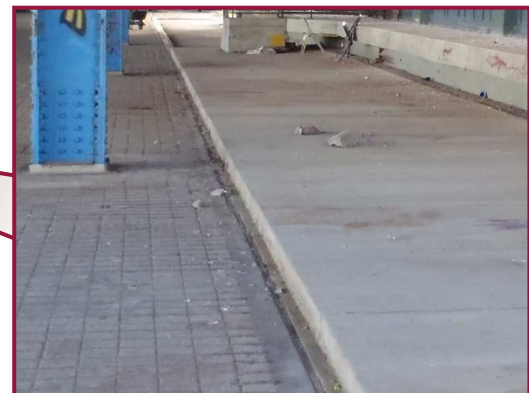
- Item 2:** The drainage system throughout the entire structure is generally in poor condition. The open trough drainage system on the truss spans allows water to spill onto adjacent truss members. Leaking joints, misaligned/broken pipes, and clogged pipes throughout all the sections are contributing to advanced section loss to members in those areas. It is recommended that the deteriorated members and open trough drainage components be replaced with a closed drainage system. Since complete joint replacement is not practical for this phase the joints should be sealed with Wabo HSeal or EMSeal.

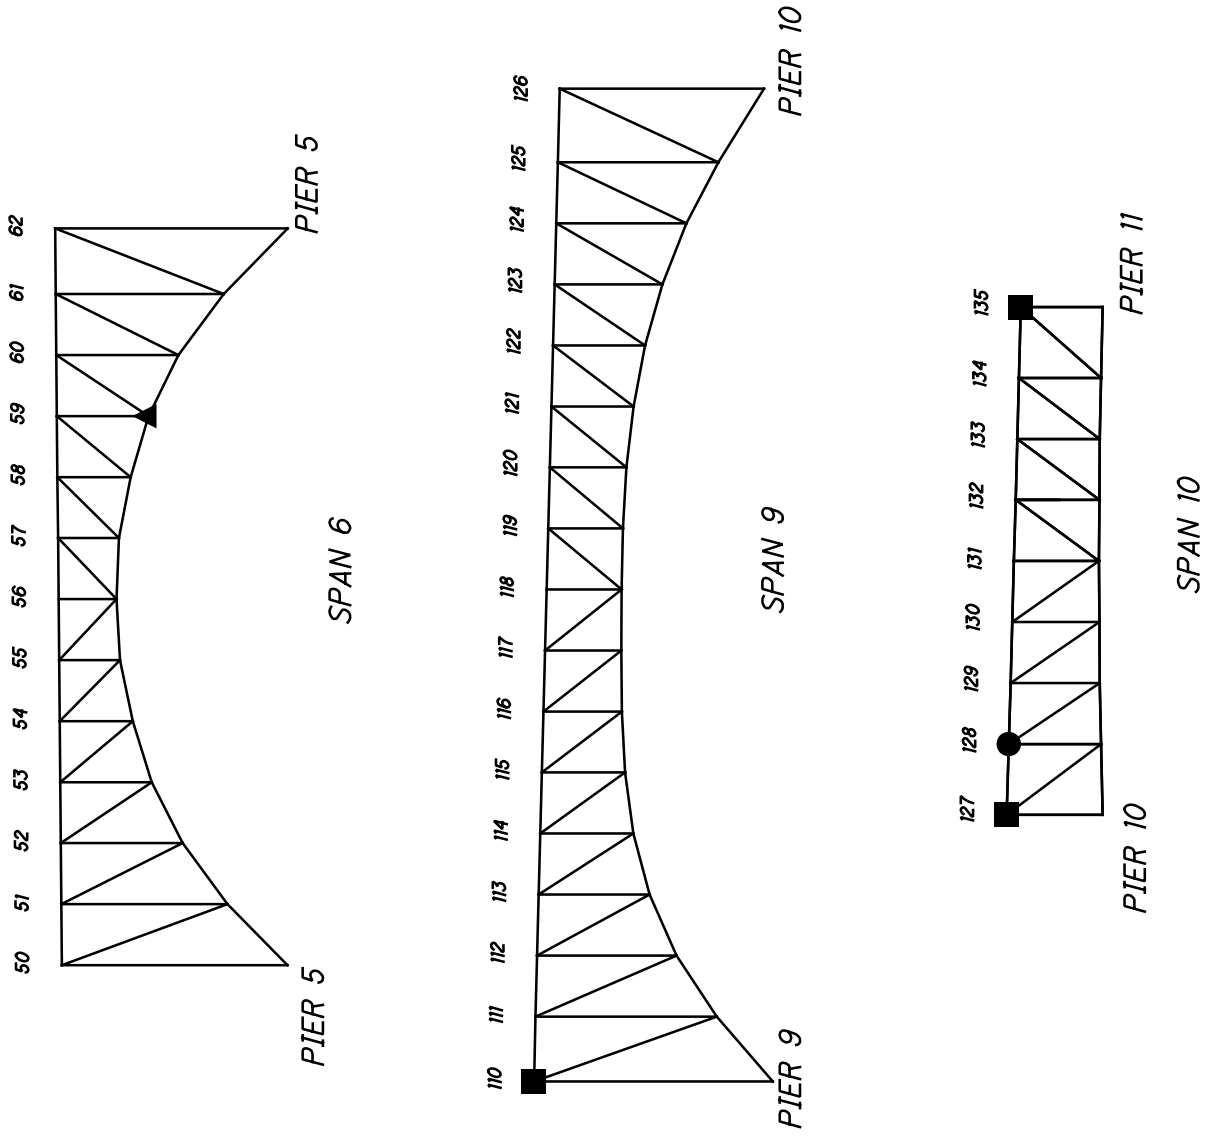
FIGURE C1
GUSSET PLATE LOCATIONS WITH OHIO
LEGAL LOAD RATING LESS THAN 1.10
(TRUSS SOUTH ELEVATION)
