**Physical Condition Report for
CUY-002-1441
SFN 1800035
Main Avenue Bridge over the Cuyahoga River
2021 Routine and Fracture Critical Inspection**

Prepared for:

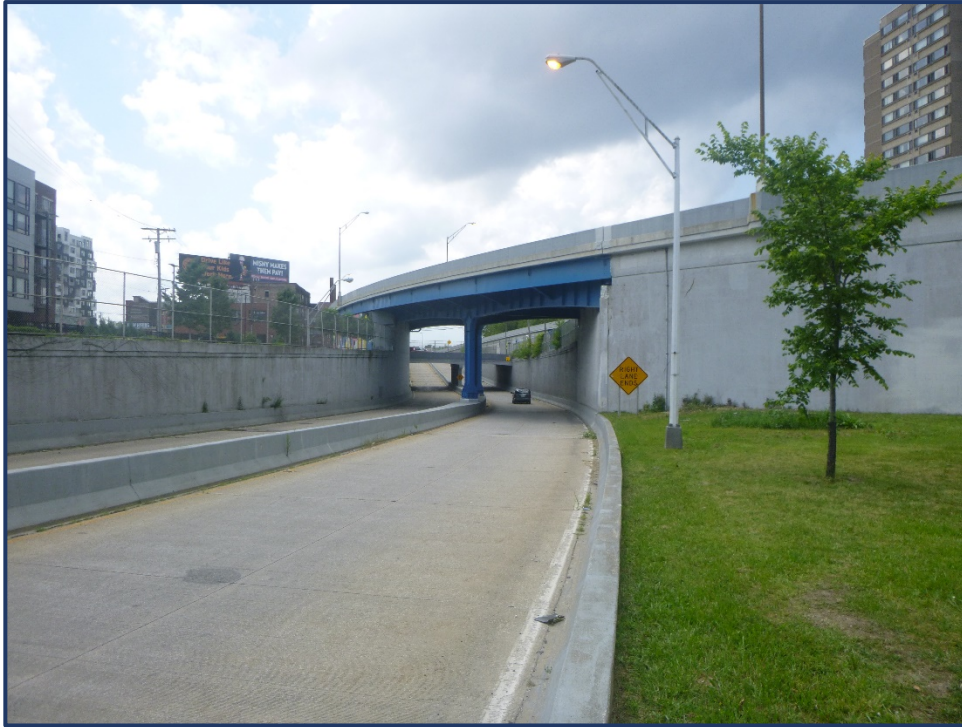
West 28th Street Overpass Looking West

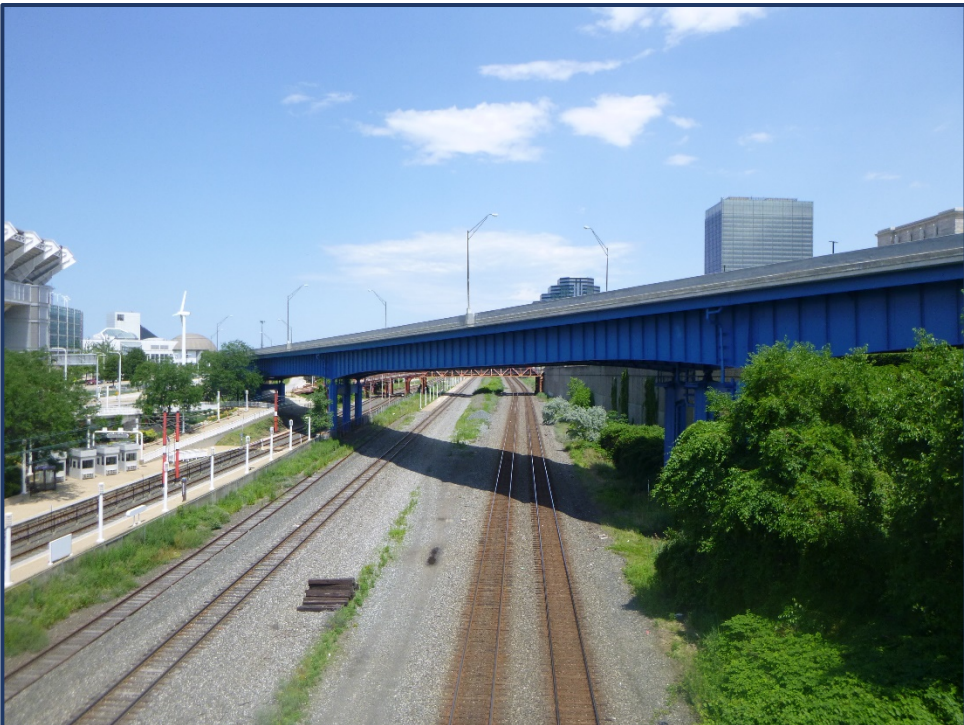
Unit V Lakefront Ramp Over CSX and NS Railroad Tracks Looking East

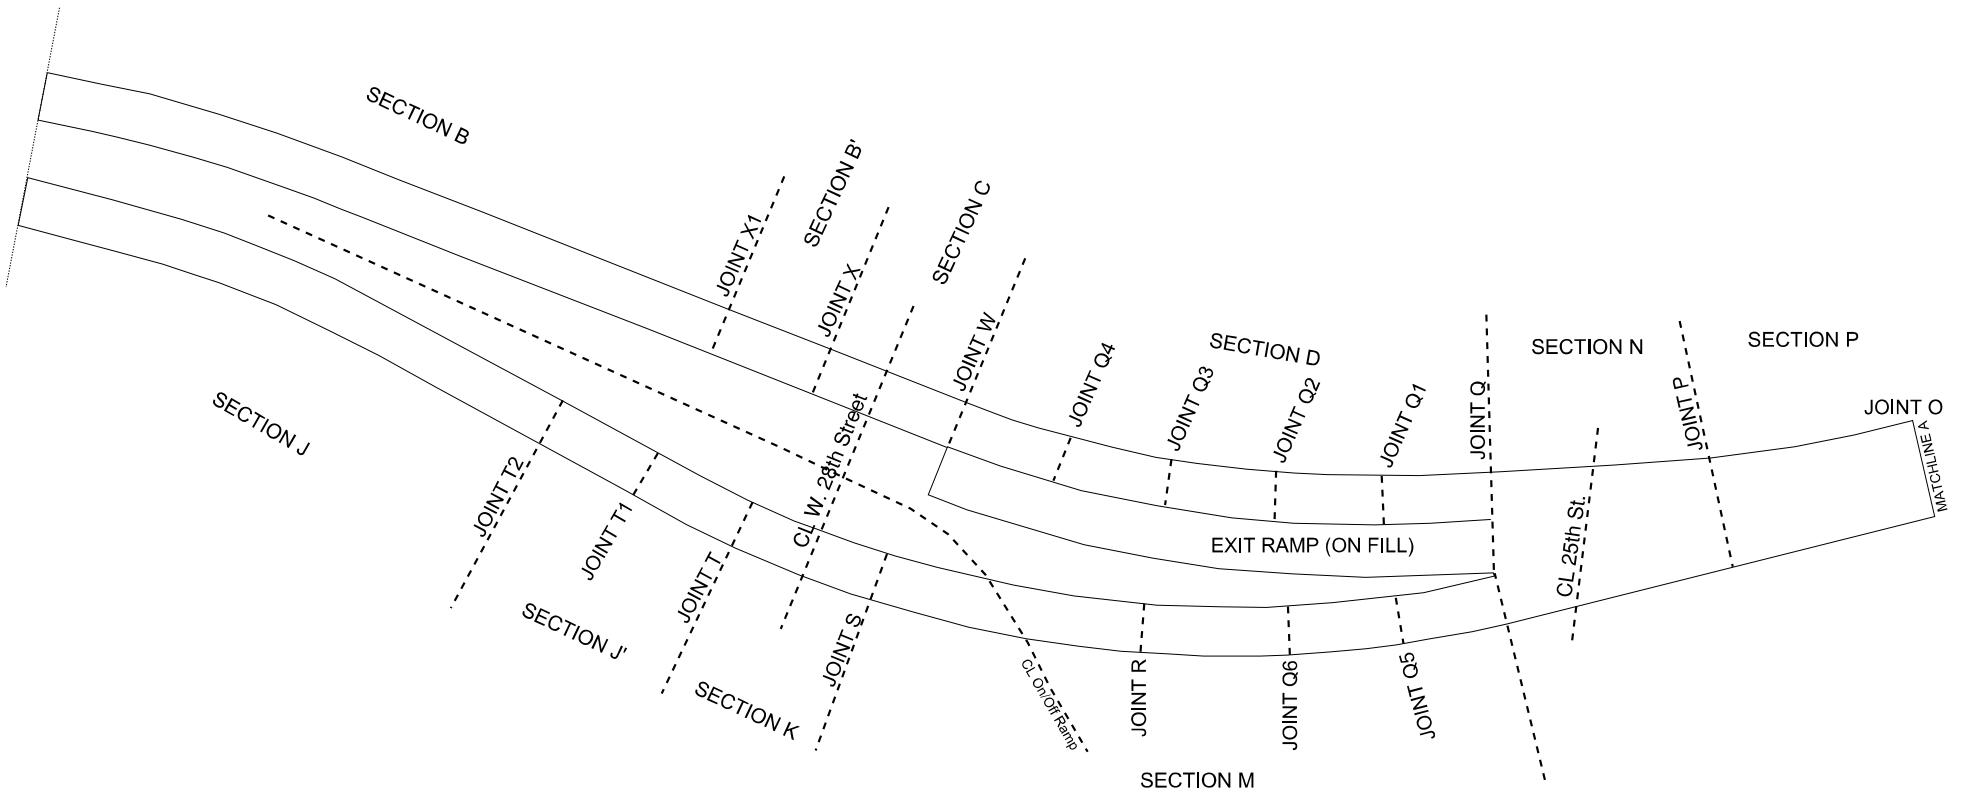
PLAN: WEST APPROACH - UNIT I

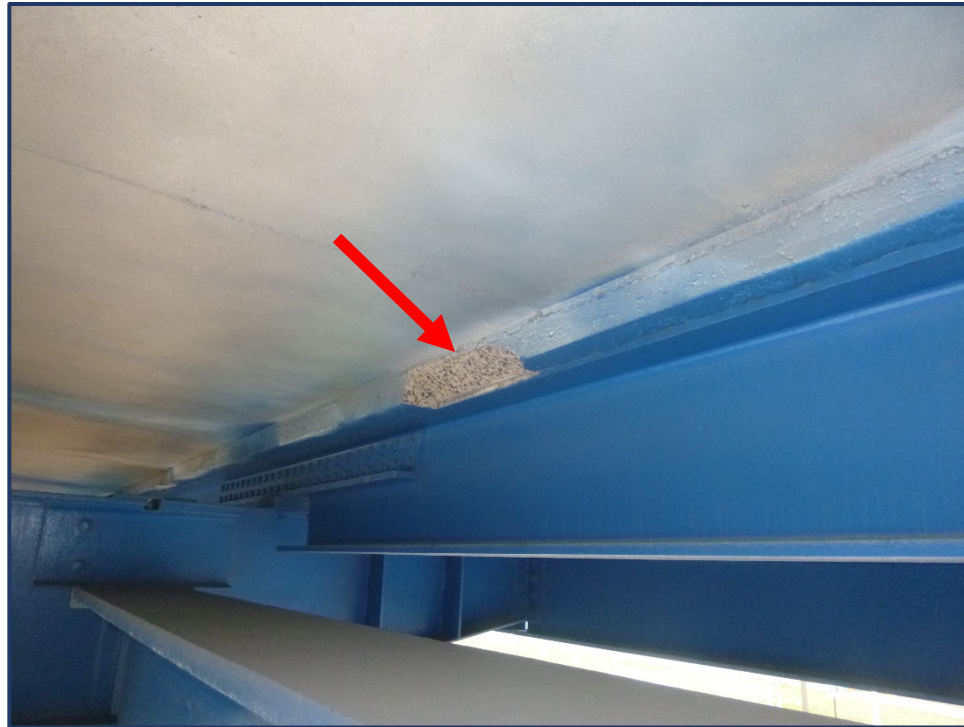
Photo 12-1 – Scattered Haunch Spalling in Unit I

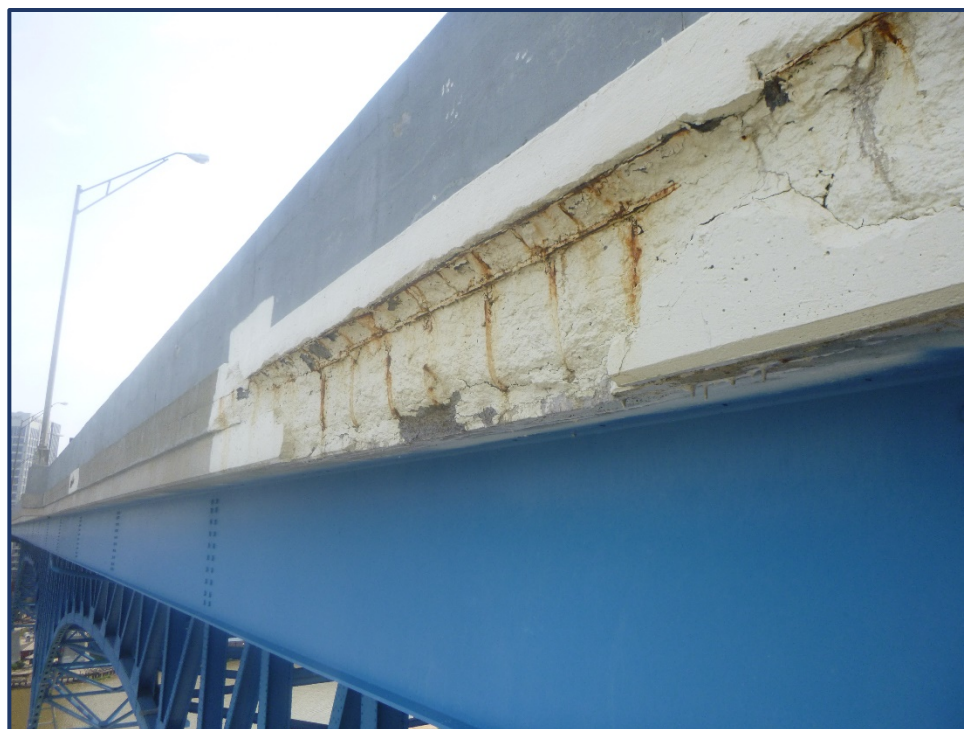
Photo 12-2 – Deck Edge Spalling and Delamination in Unit II

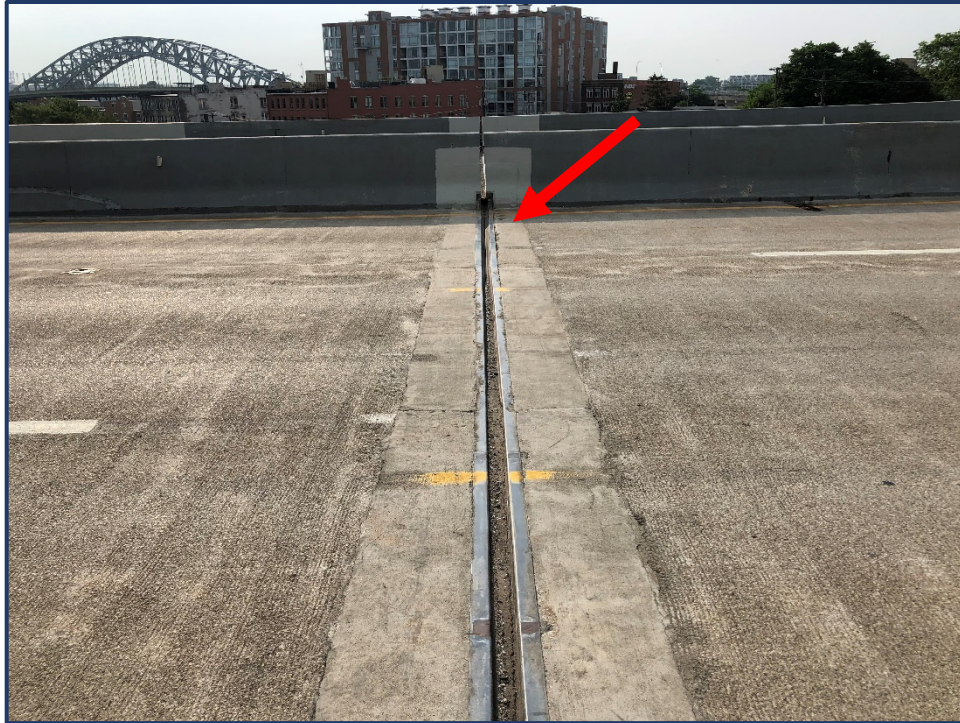
Photo 300-1 – Joint O Loose Joint Armor and Spalled Header

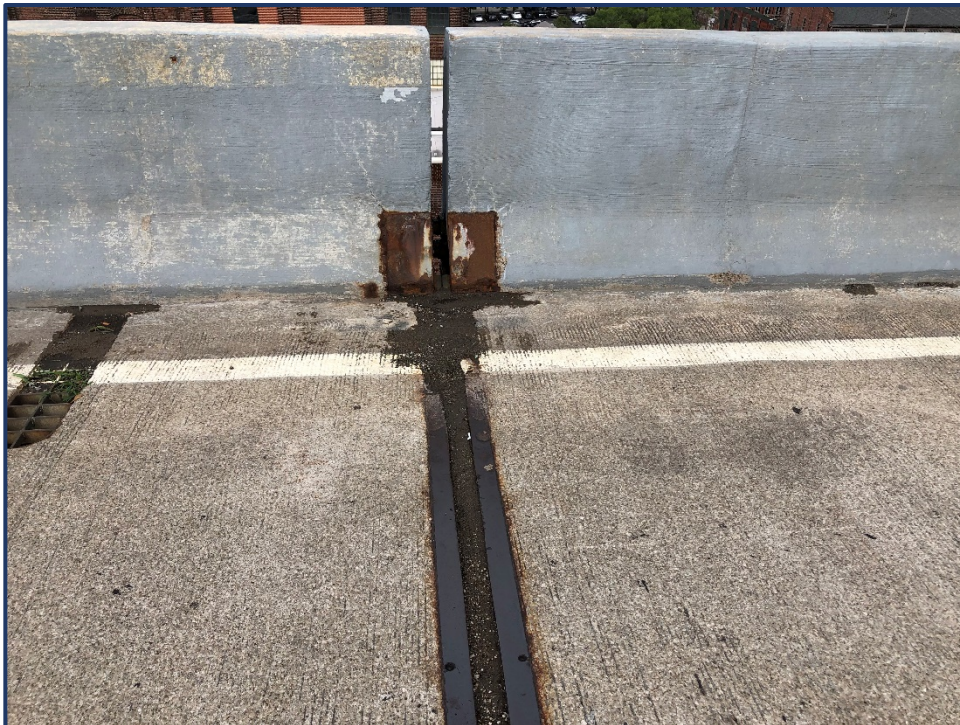
Photo 300-2 – Unit II, Span 4/5 Joint L1, Typical Rusting and Debris Impaction in Joint

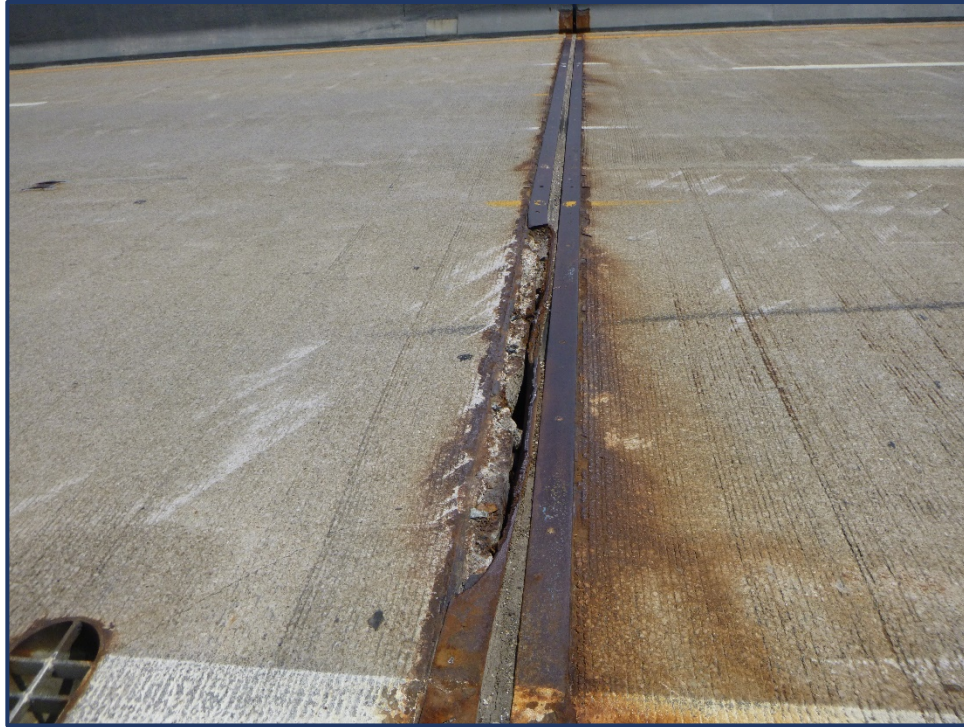
Photo 302-1 – Unit I, Joint X, 10-ft Section of Broken Retainer in Westbound Lane 3

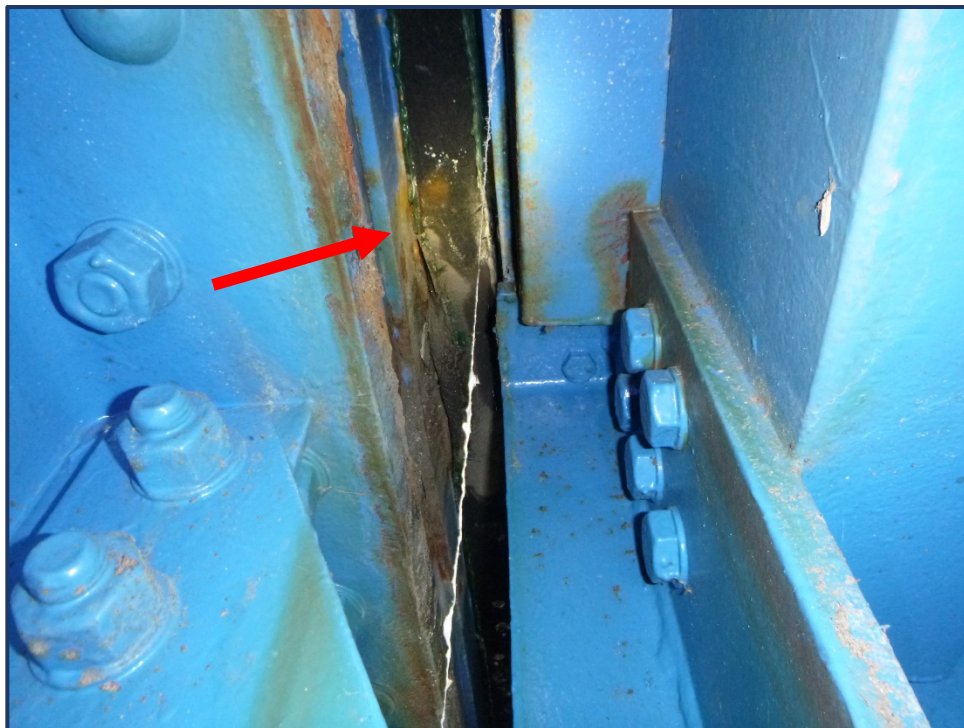
Photo 302-2 – Unit IV, Joint B4, Section of Compression Joint Seal Dislodged from Retainer, Eastbound Lane 1

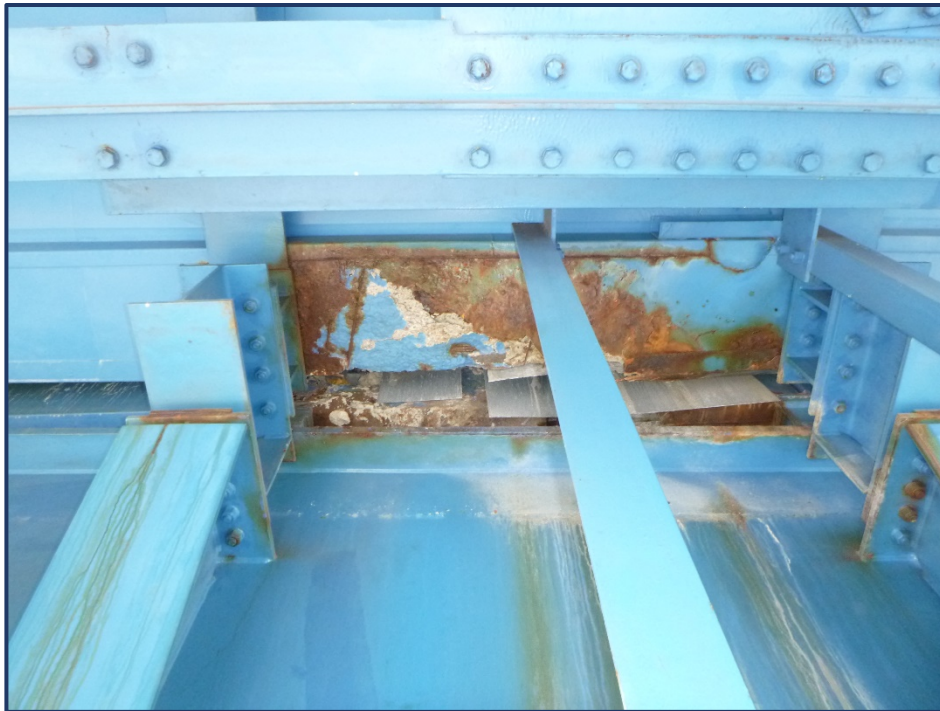
Photo 303-1 – Unit II, Joint L Header Spalled and Delaminated Concrete

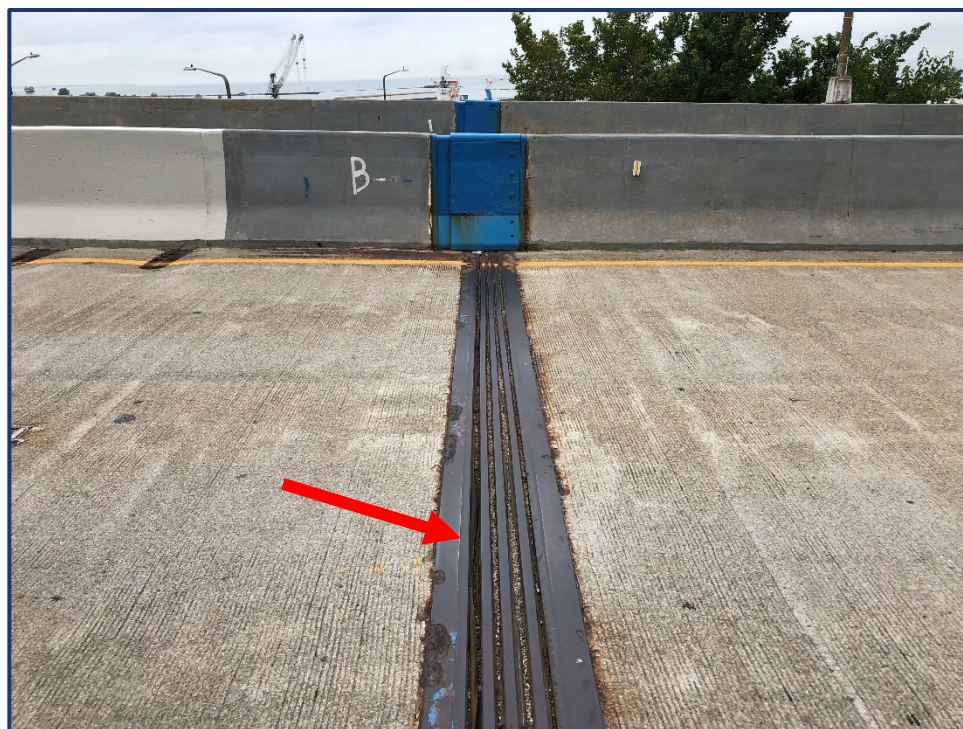
Photo 303-2 – Unit V, Joint B, Areas of Minor Seal Tearing

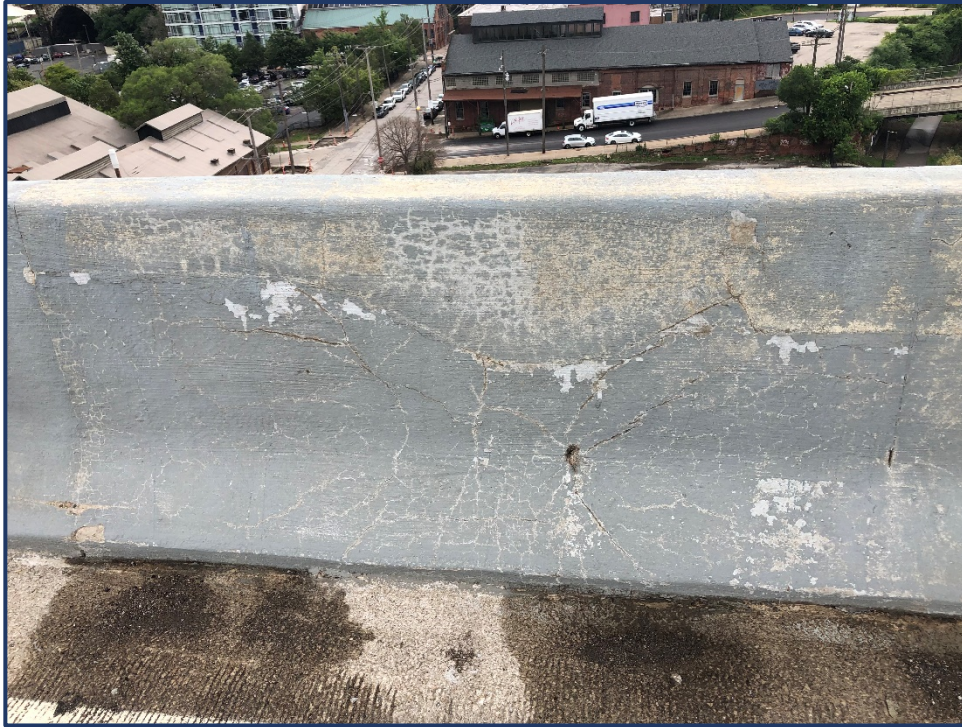
Photo 331-1 – Typical Area of Cracking, Parapet Interior Face

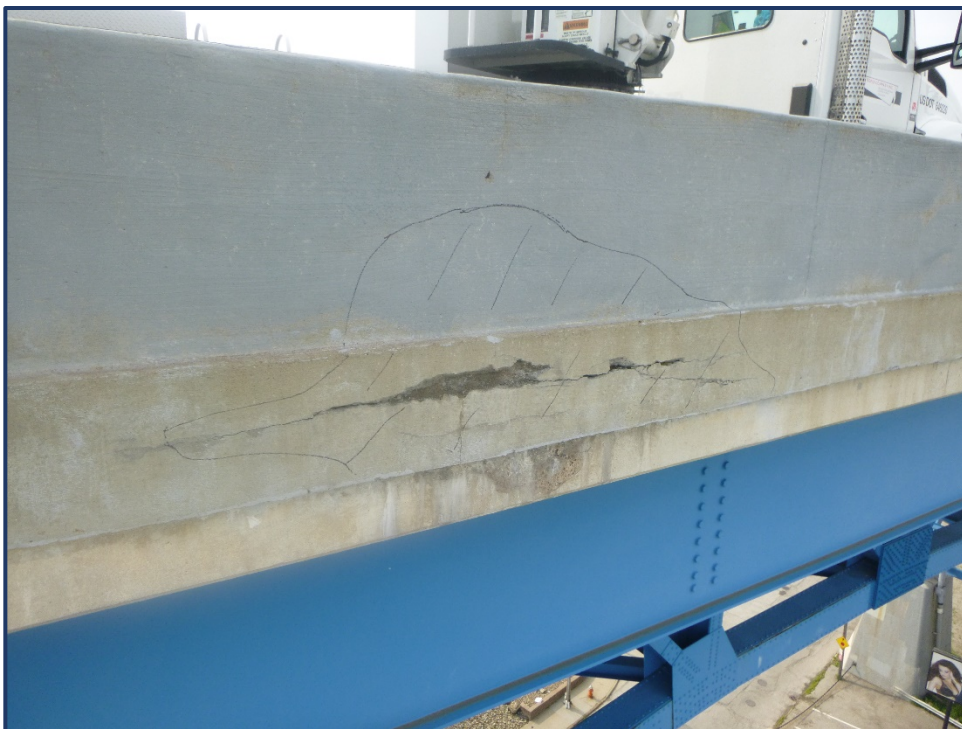
Photo 331-2 – Typical Area of Delamination & Spalling, Parapet Exterior Face

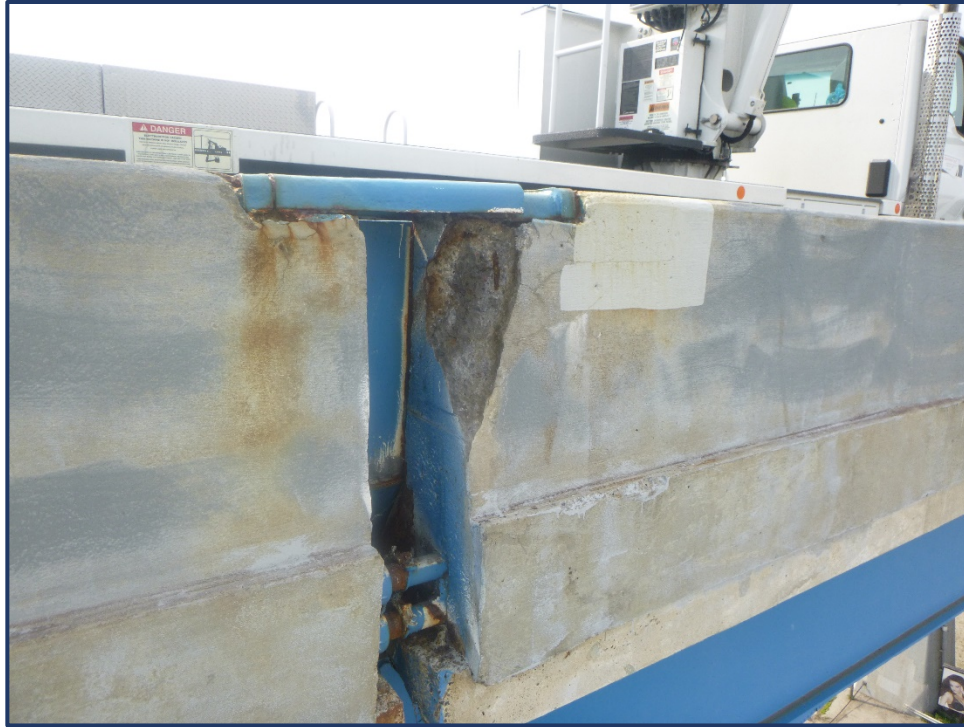
Photo 331-1 – Area of Parapet Spalling at Deck Joint.

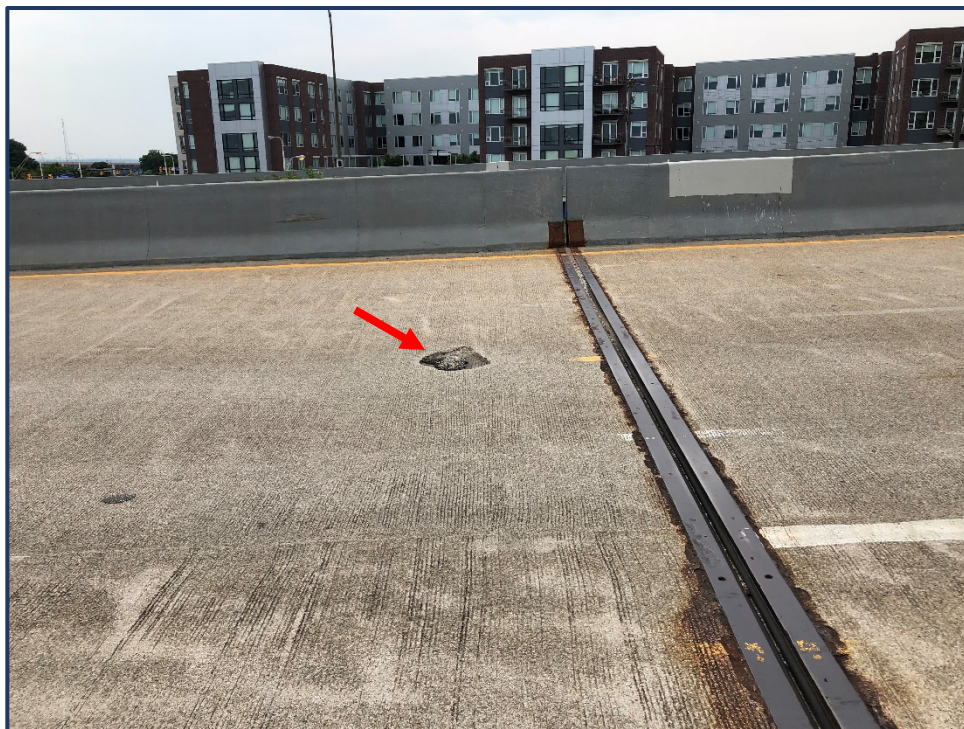
Photo 510-1 – Scattered Shell Spalling with Asphalt Patching in Wearing Surface

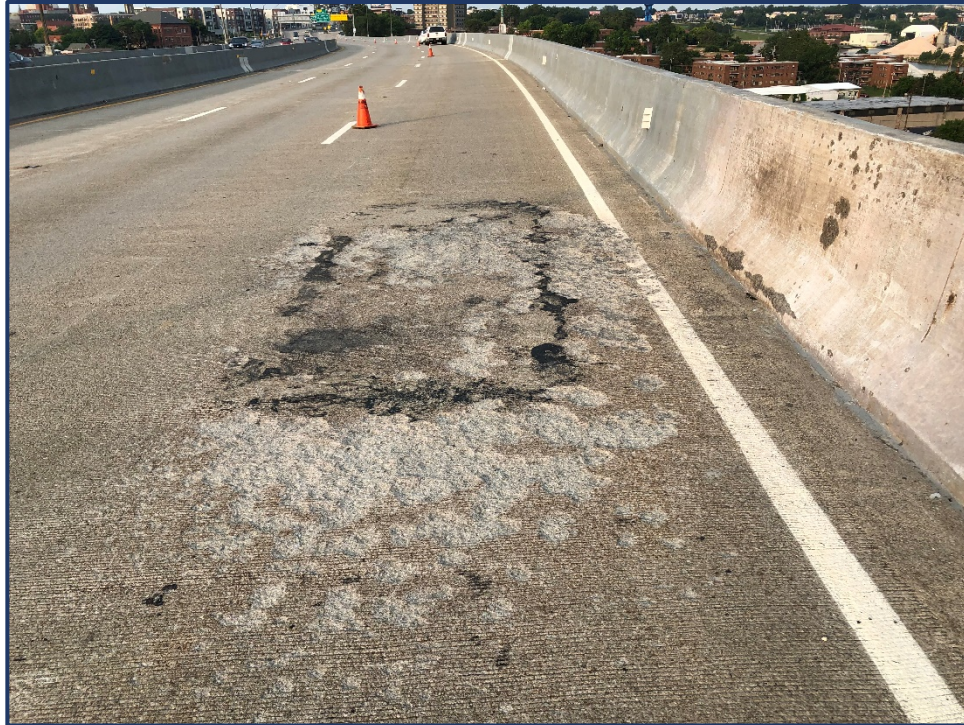
Photo 510-2 – Unit II, Span 6, Area of Shallow Spalling and Burn Marks in Westbound Lane 3

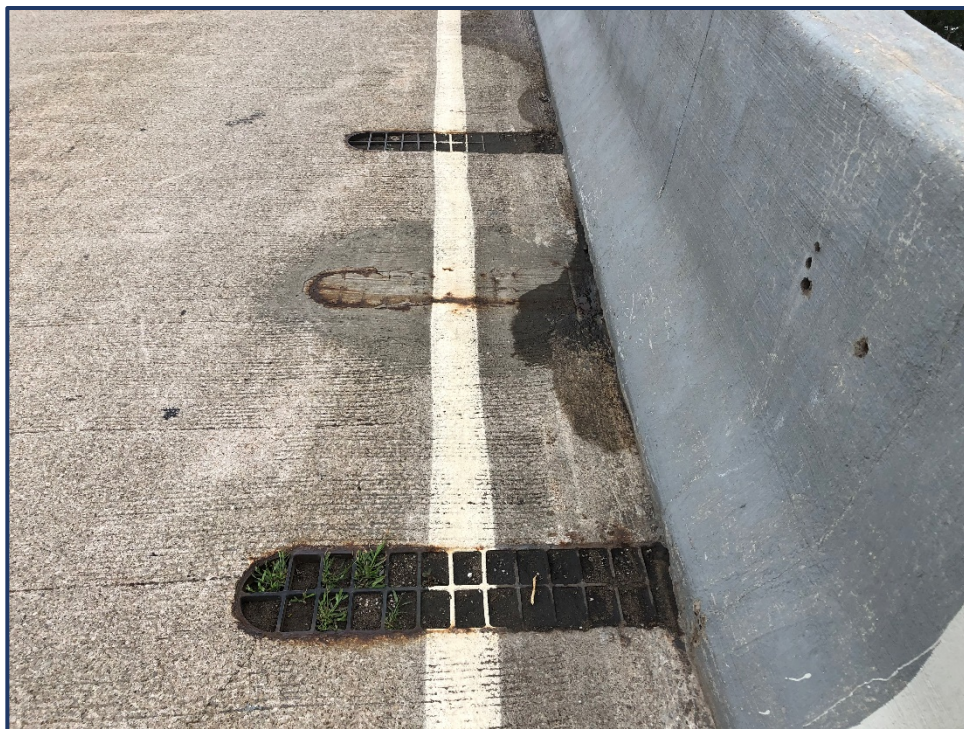
Photo 815-1 – Typical Clogged Scupper Inlets

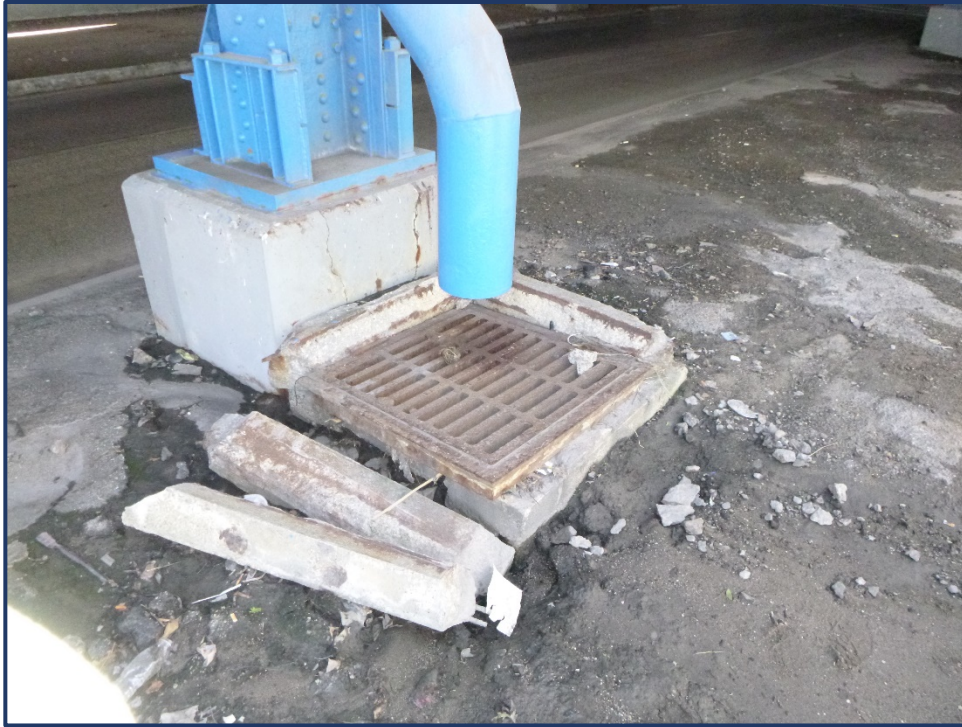
Photo 815-2 – Unit IV, Bent 15 Catch Basin, Heavy Spalling of Frame and Shifting Grate

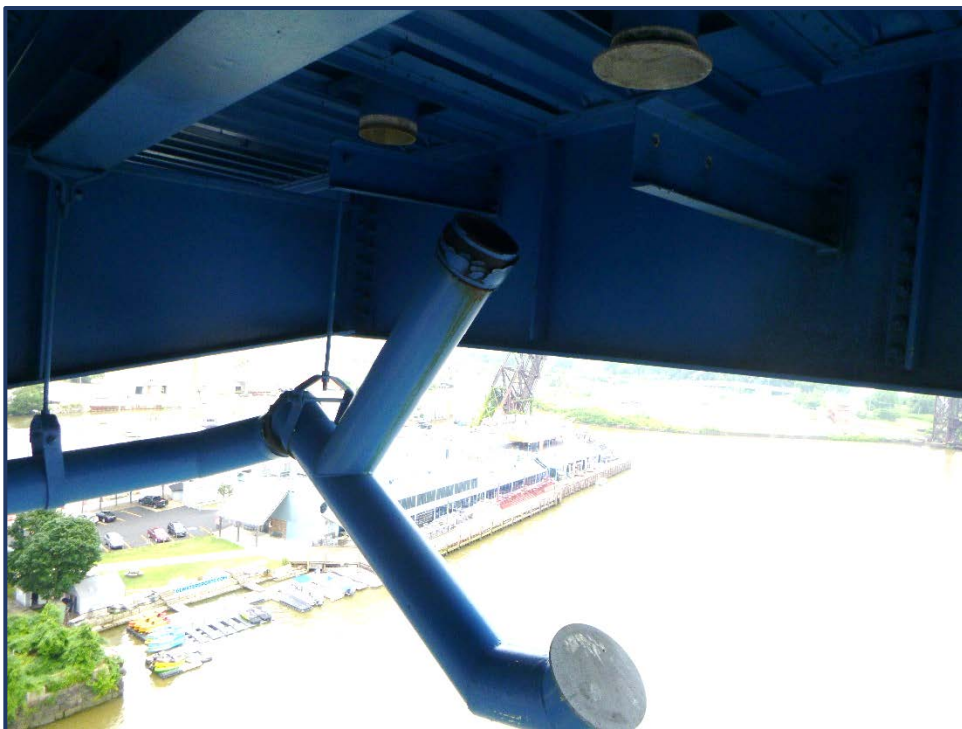
Photo 815-3 – Unit II, Span 9, North Side Scupper Downspout Disconnected

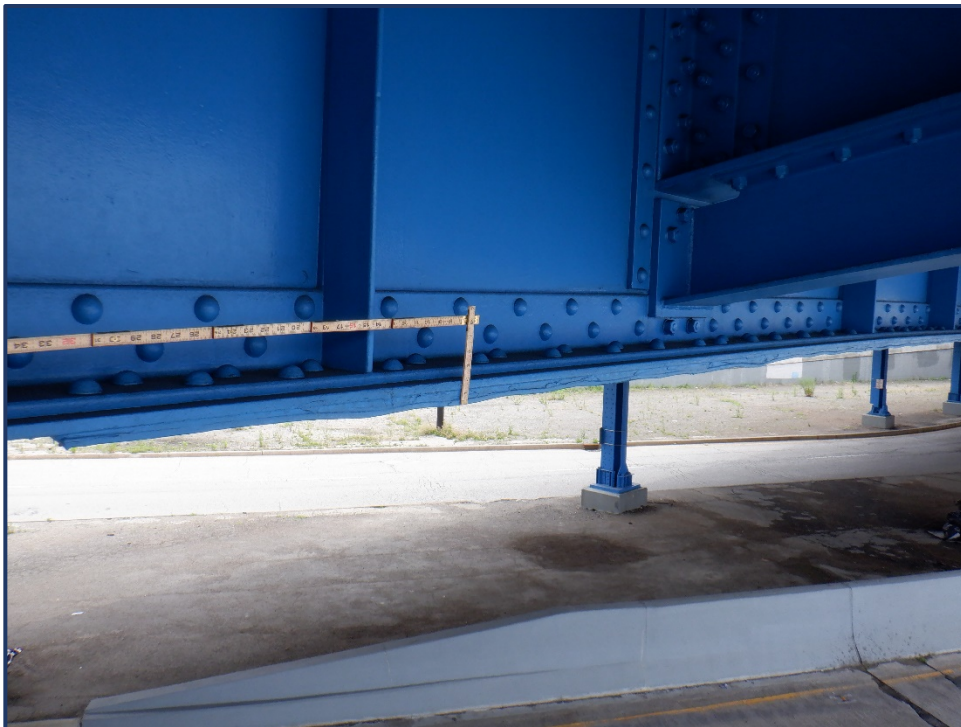
Photo 107-2 – Unit IV Girders, Typical Bottom Flange Pack Rust up to 1”

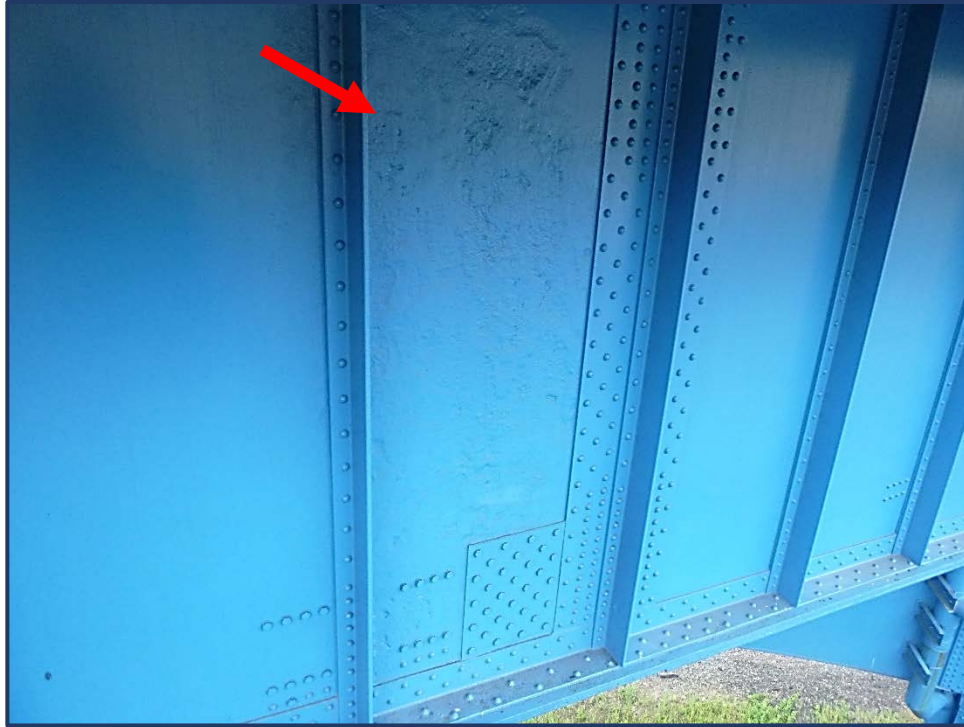
Photo 107-3 – Unit V, South Girder, ¼" Painted over Section Loss on Web

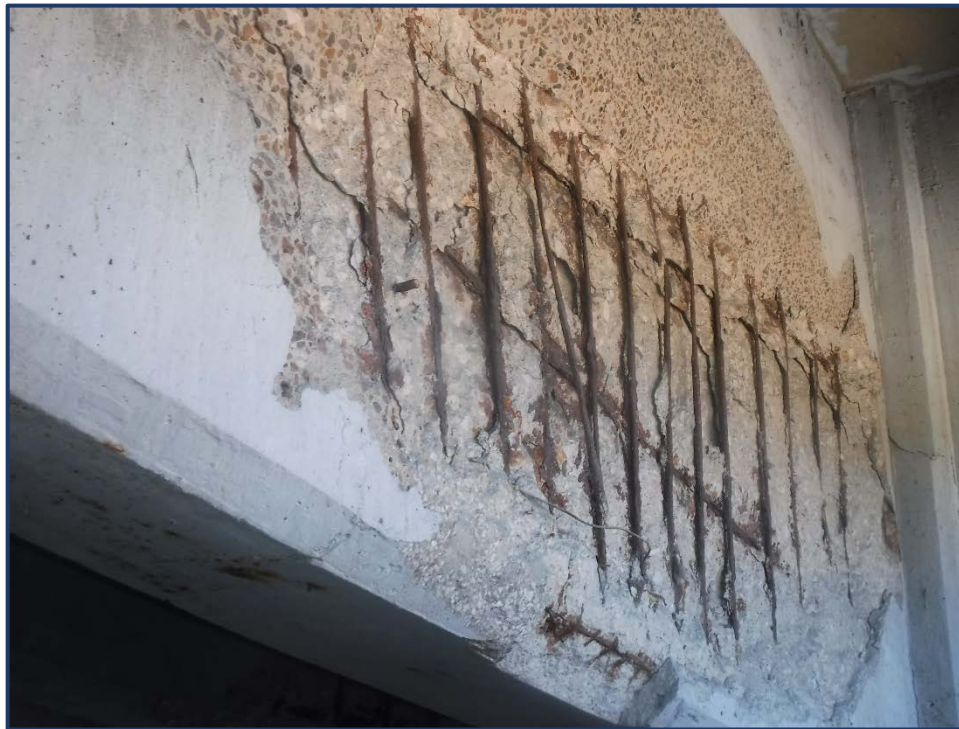
Photo 116-3 – Span 13, Active Corrosion on Maintenance Deck Stringers

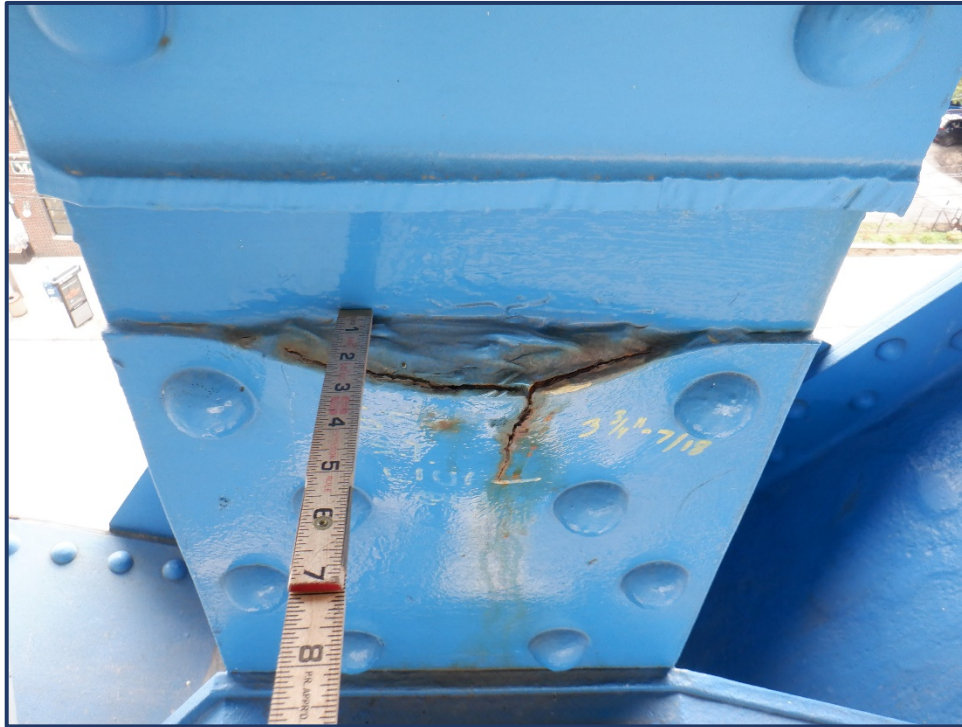
Photo 120-1 – Span 5, South Truss, Section Loss and Distortion due to Pack Rust at L1-U1 Fill Plate

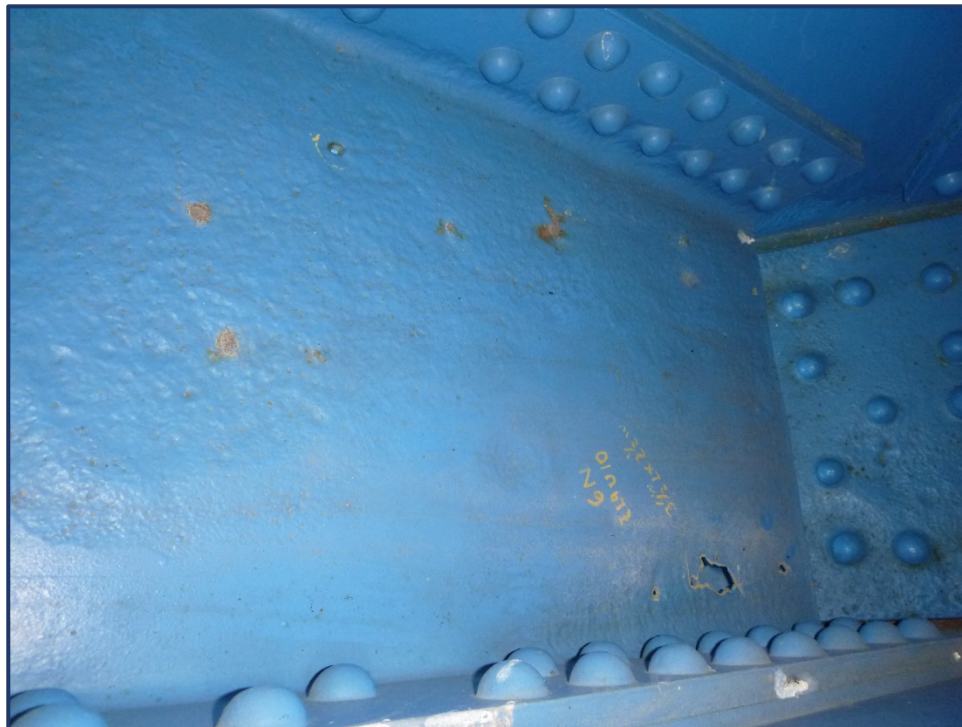
Photo 120-2 – Span 6, North Truss, Painted over Pitting and Corrosion Holes in Web of L9-U10 at L9

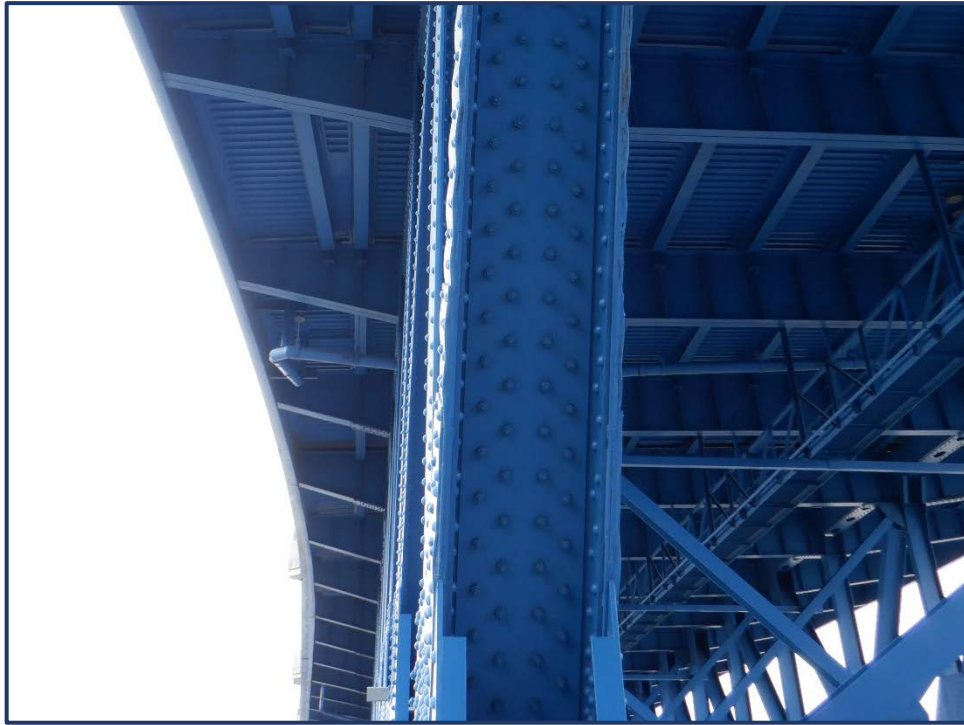
Photo 120-3 – Typical Distortion of Diagonal Flange Plates due to Sealed Pack Rust

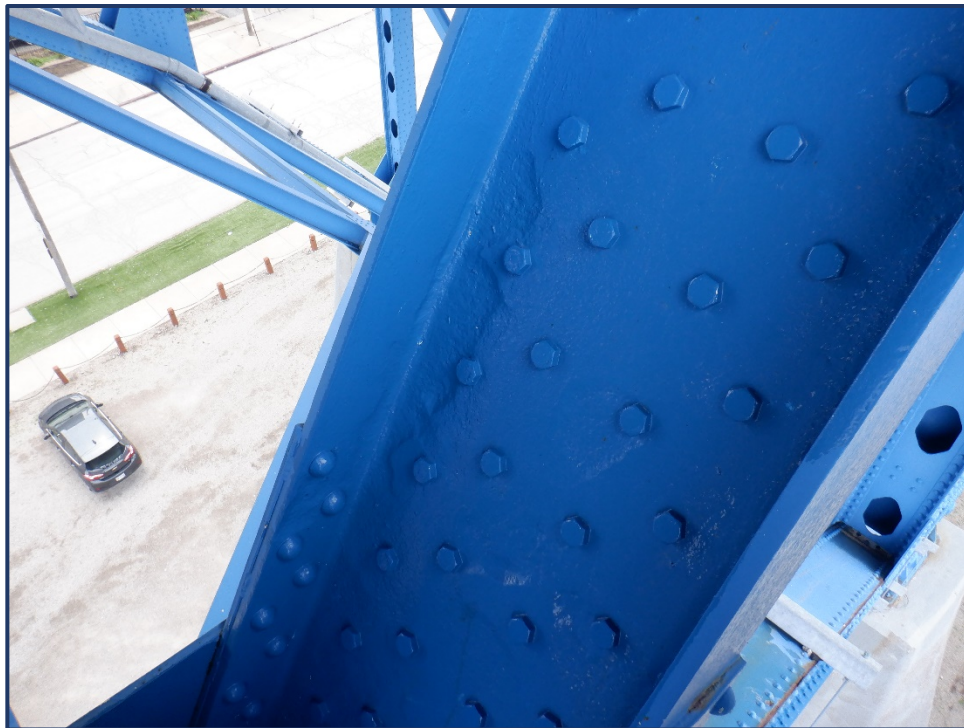
Photo 120-4 – Area of Painted over Section Loss on Diagonal with Retrofit Plate on Back Side

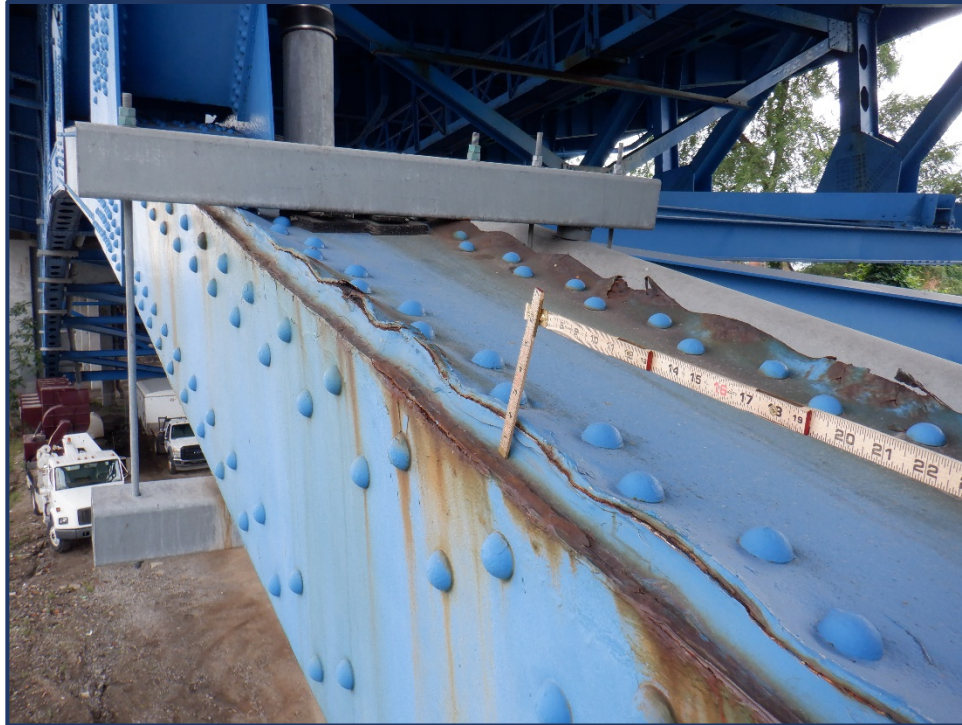
Photo 120-7 – Span 1, South Truss, L8-L9, Distortion of Top Flange Plate due to Pack Rust

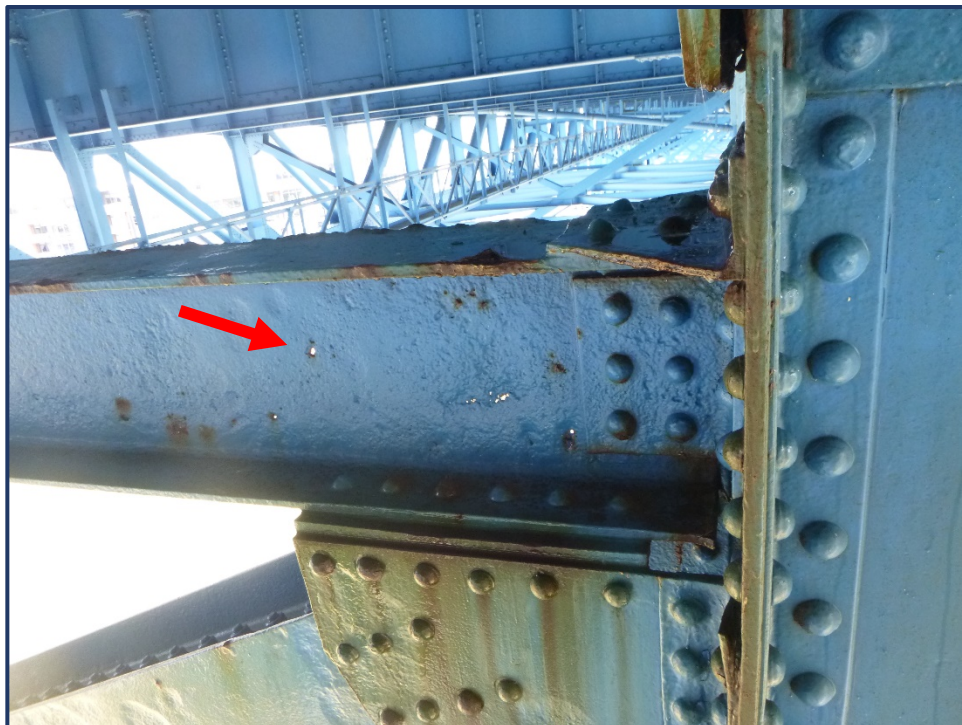
Photo 120-8 – Typical Painted over Section Loss with Perforations in Sway Bracing

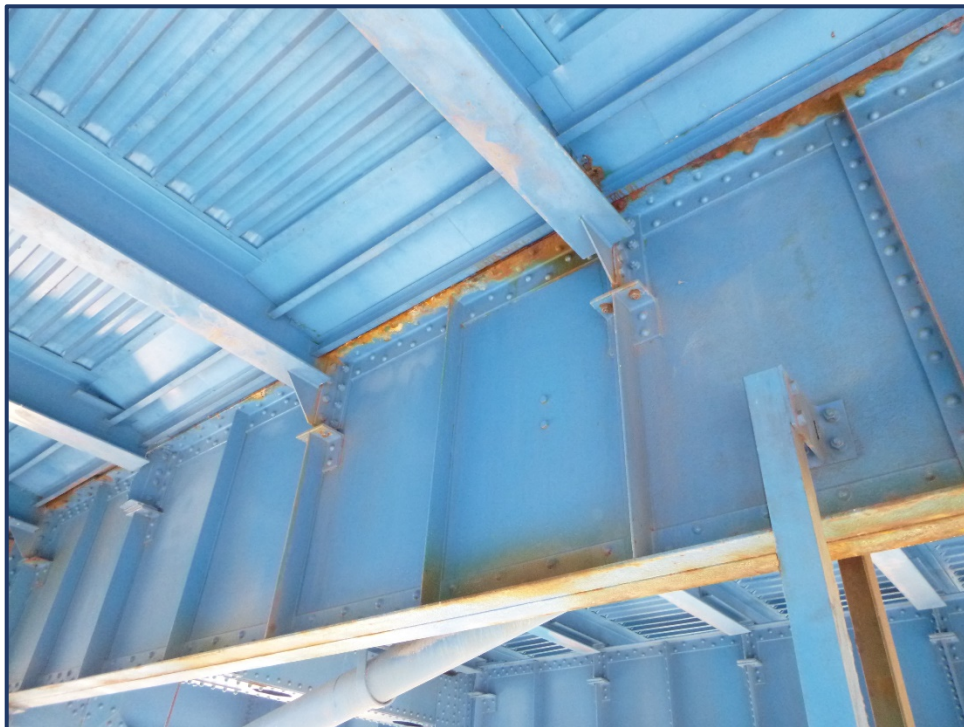
Photo 152-2 – Unit II, Span 2, FB 16, Active Surface Corrosion due to Deck Drainage

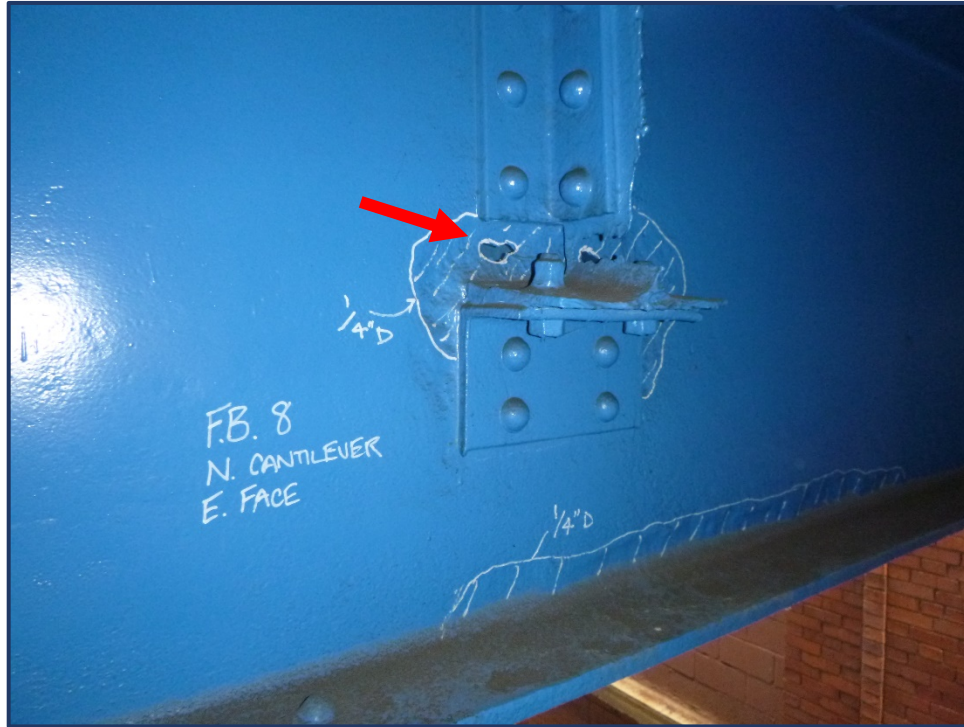
Photo 152-3 – Unit III, FB 8, Areas of Painted over Section Loss and Corrosion Holes at Abandoned Stringer Connection

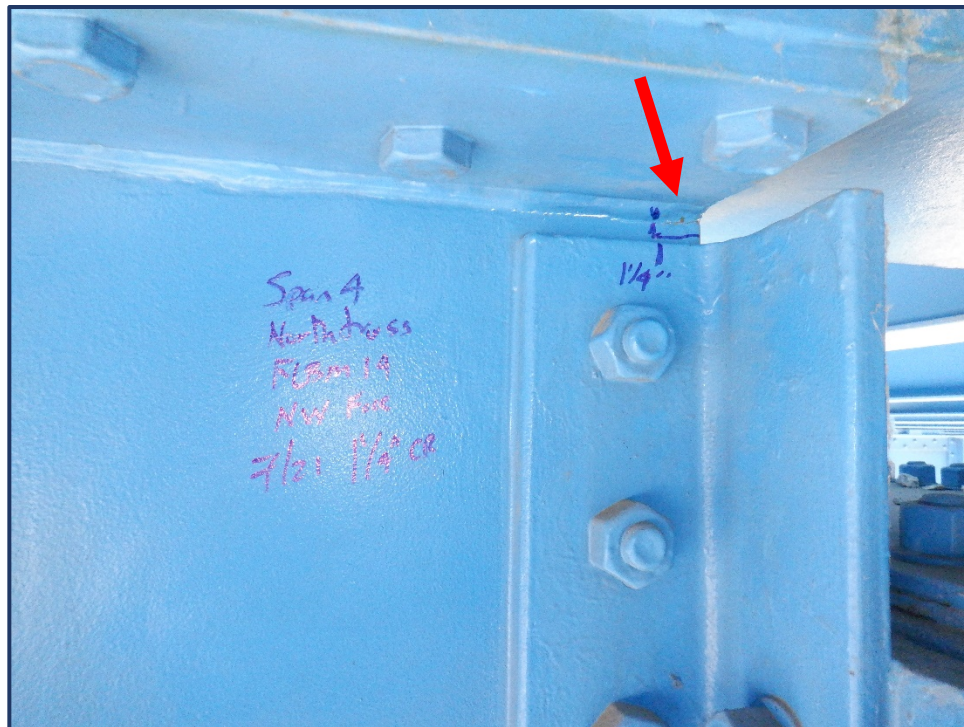
Photo 152-4 – Unit II, Span 4, FB 14 at North Truss, New Crack in Top Flange Cope
