**Physical Condition Report for
CUY-002-1441
SFN 1800035
Main Avenue Bridge over the Cuyahoga River
2021 Routine and Fracture Critical Inspection**

Prepared for:

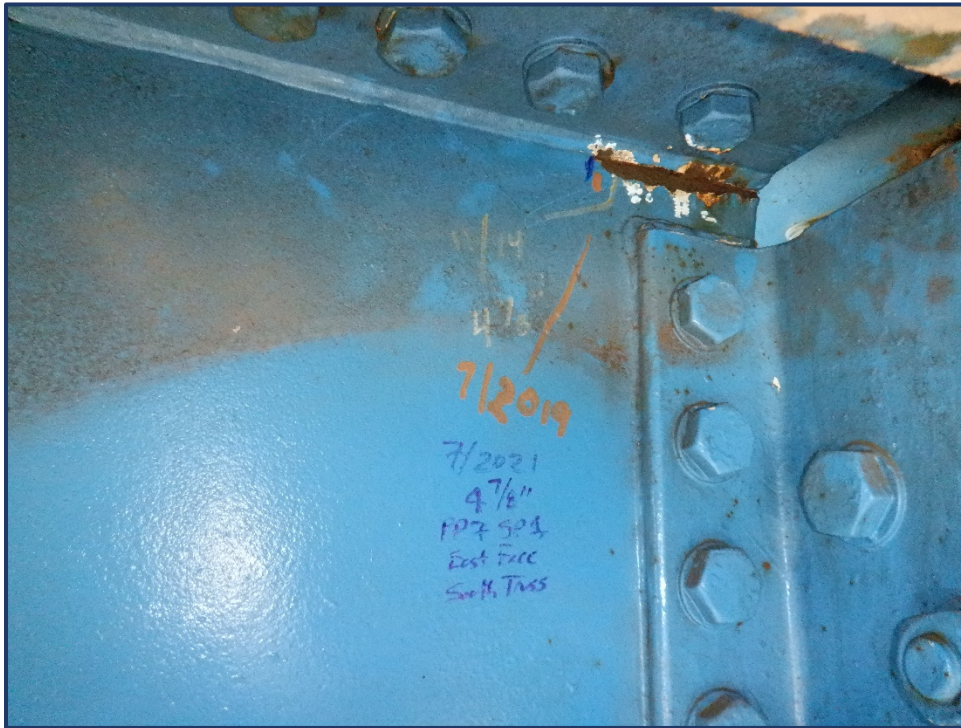
Photo 152-5 – Unit II, Span 1, FB 7 at South Truss, Crack in Top Flange Cope Exhibiting Slow Growth

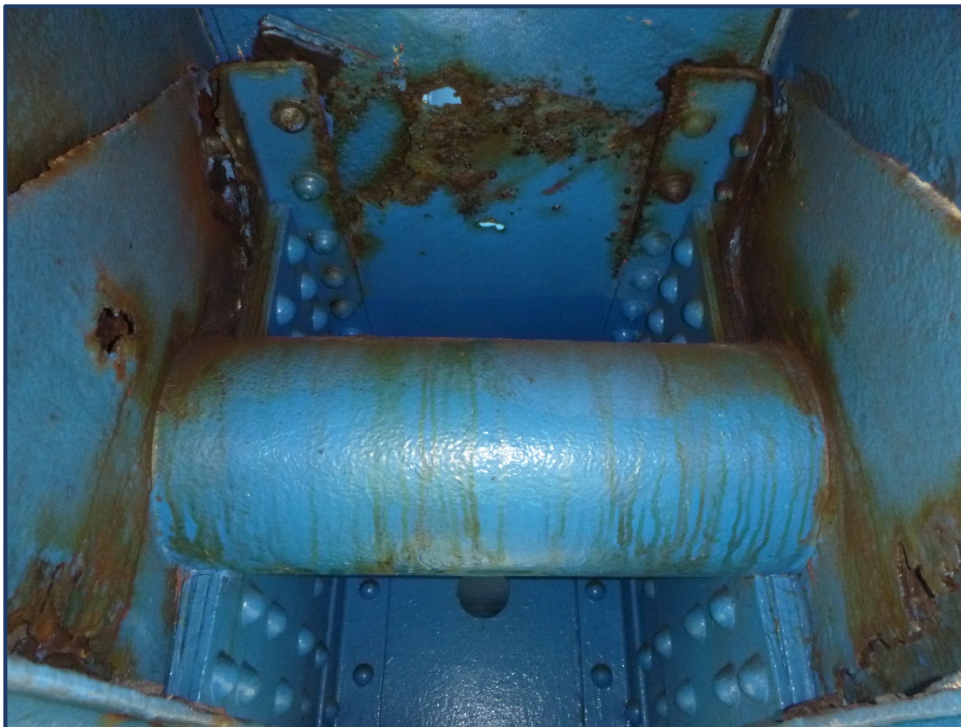
Photo 161-1 – Unit II, Span 9, North Truss, Painted over Pitting on Pin with Rust Staining

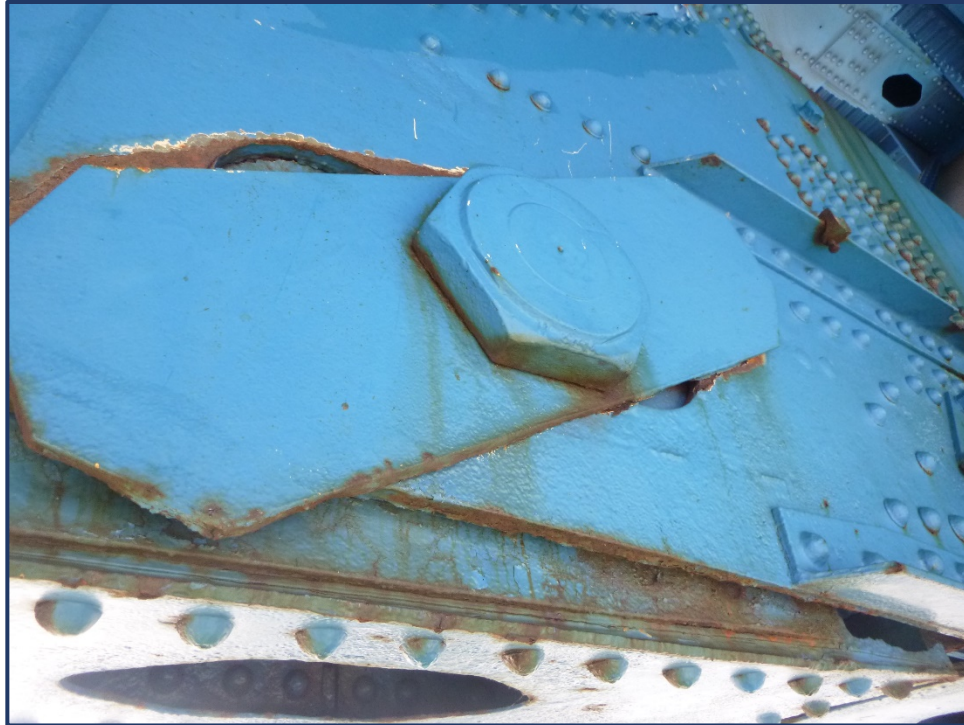
Photo 161-2 – Unit II, Span 9, South Truss, Rotated Pin Plate at L0

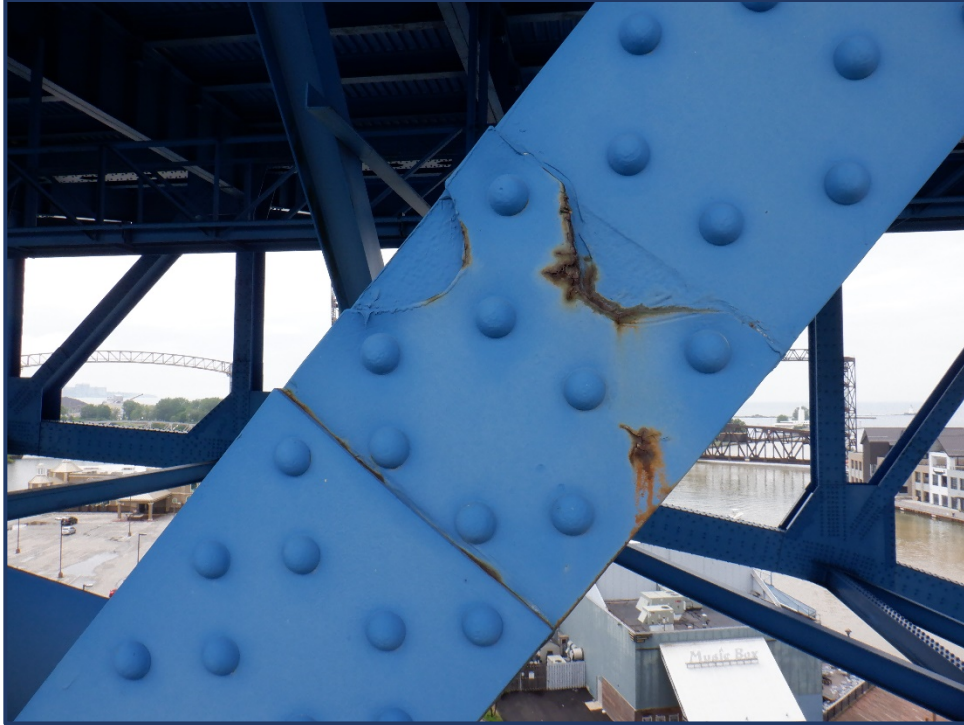
Photo 162-3 – Unit II, Span 8, South Truss, Corrosion Complete Section Loss In Fill Plate

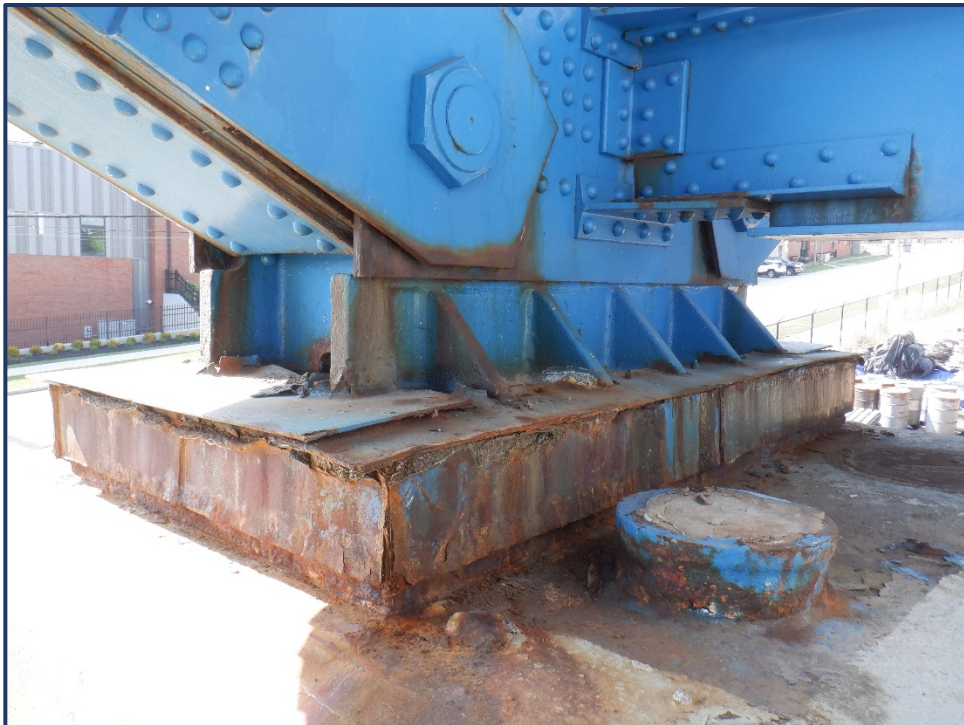
Photo 311-1 – Unit II, Pier 1, South Truss Bearing, Layered Corrosion

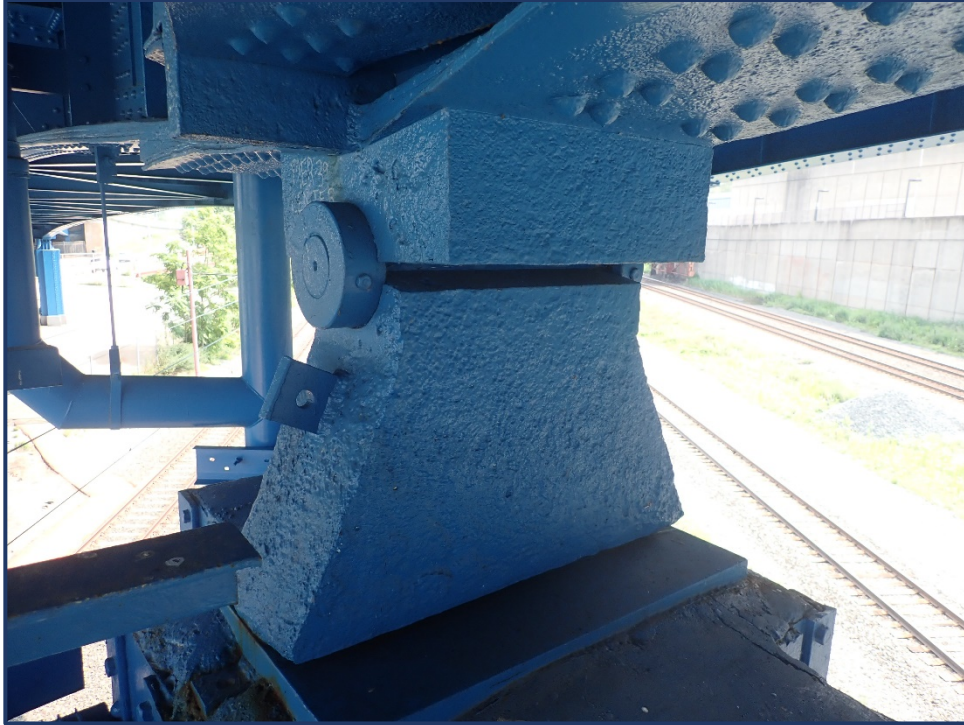
Photo 311-1 – Unit V, Pier 39, North Bearing, Painted Over Pitting

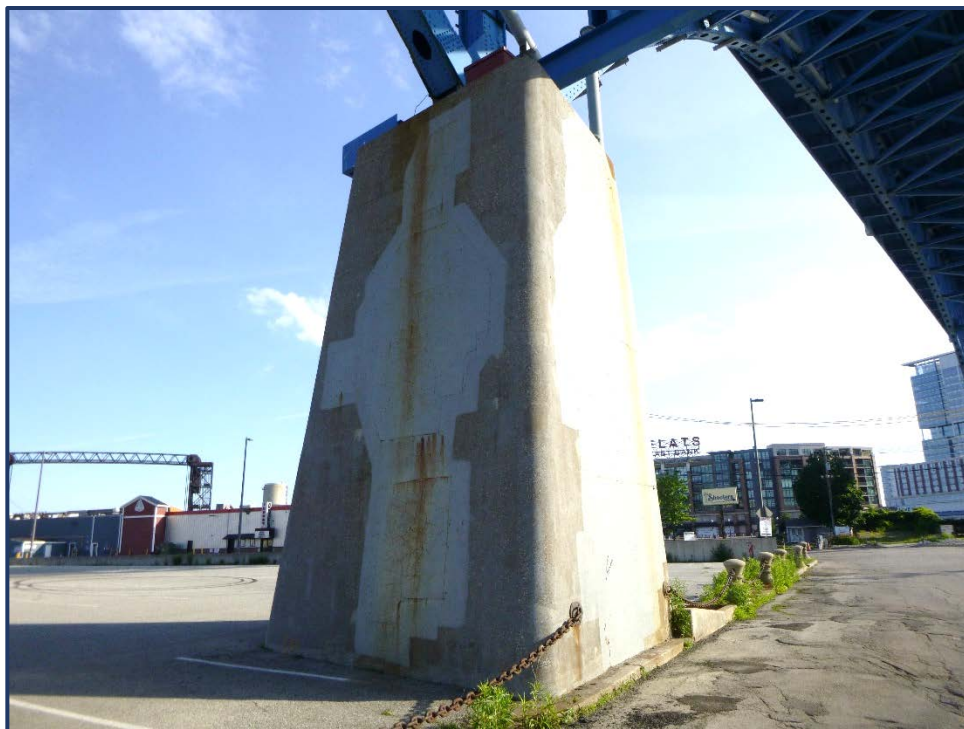
Photo 205-2 –Unit II, Pier 7 North, Patching and Rust Staining

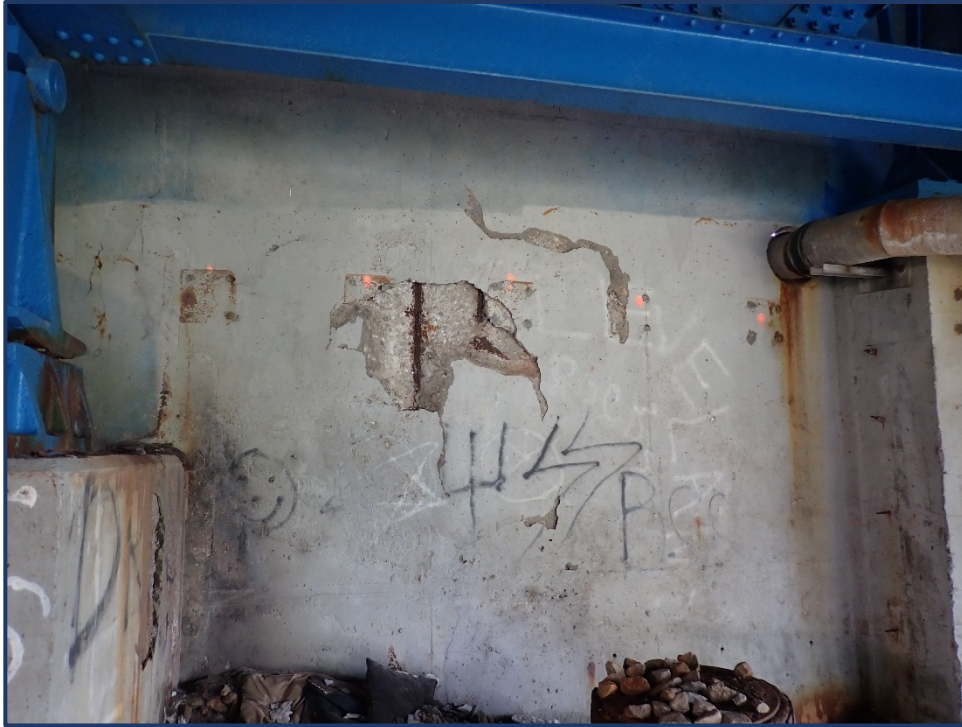
Photo 210-1 – Pier 37, East Face, Delamination and Spalling of Pier Wall

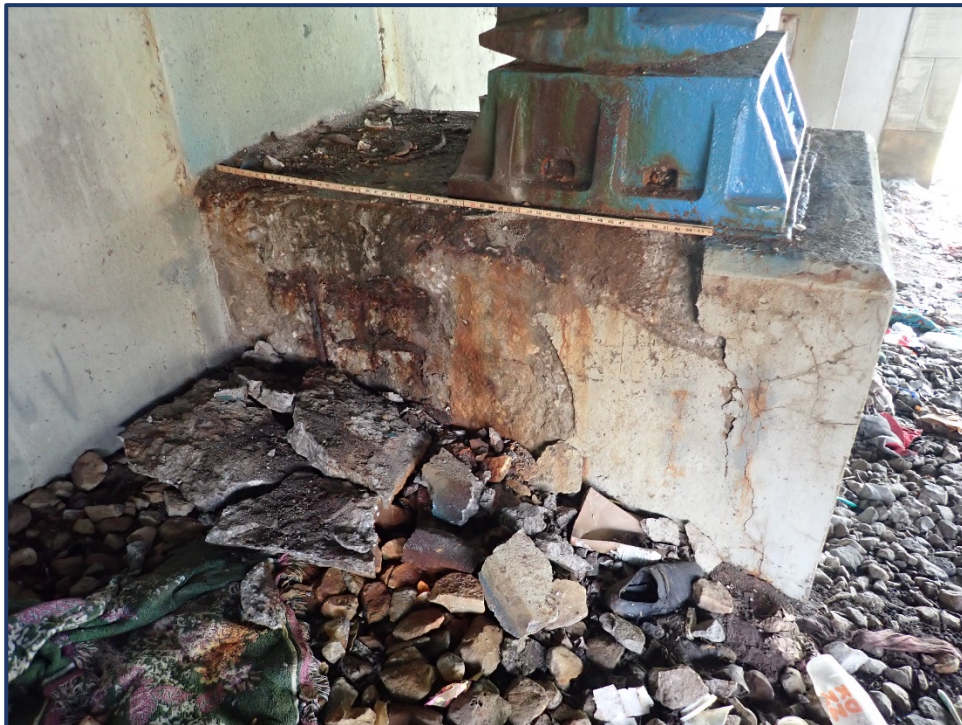
Photo 210-2 – Pier 37, Span 38 South Bearing Pedestal Spalling with Exposed Reinforcing

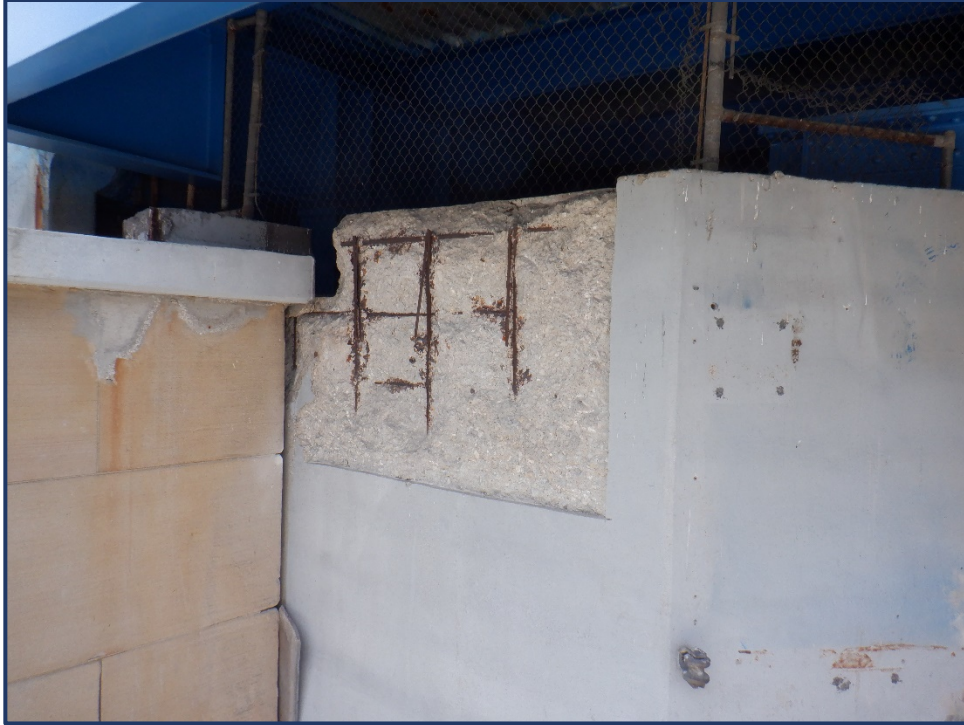
Photo MW-1 – Pier 37, Unit I, Section N, Spalling of Mask Wall at South Fascia

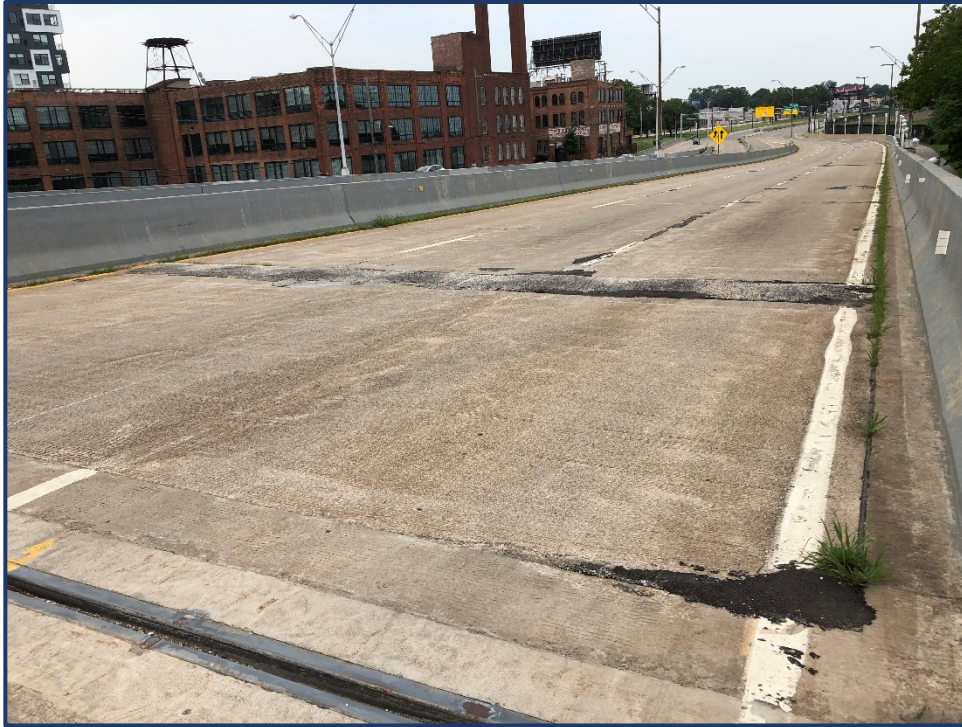
Photo 321-1 – West Approach Slab, Westbound, Areas of Patching and Heaving of Asphalt Joint

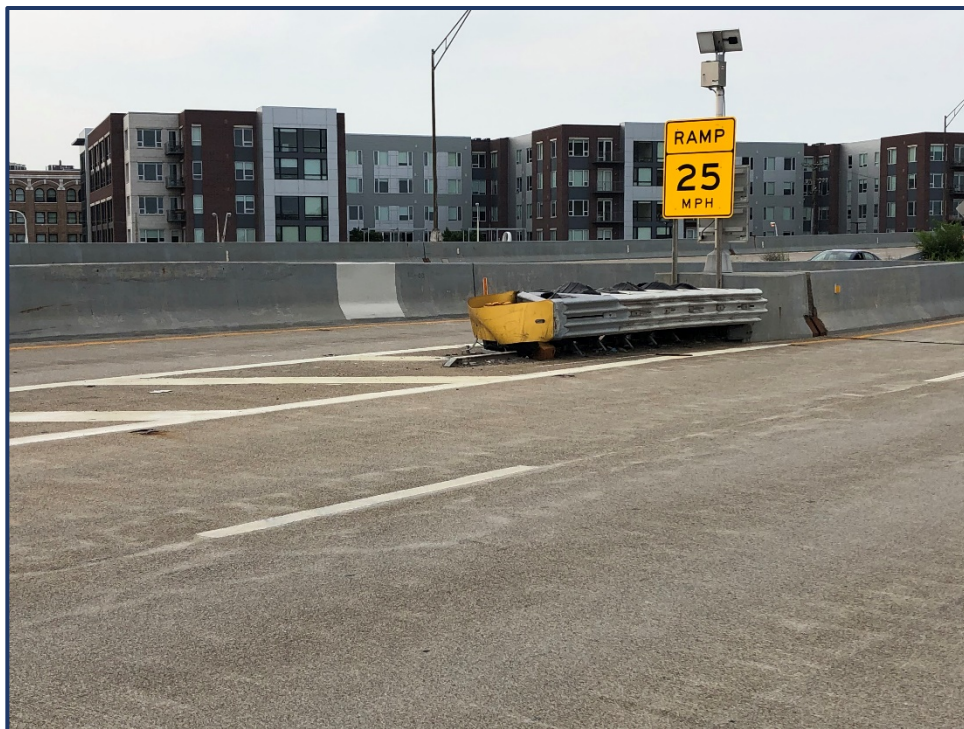
Photo APR-2 – Westbound Exist to W. 28th St., Heavily Damaged Impact Attenuator

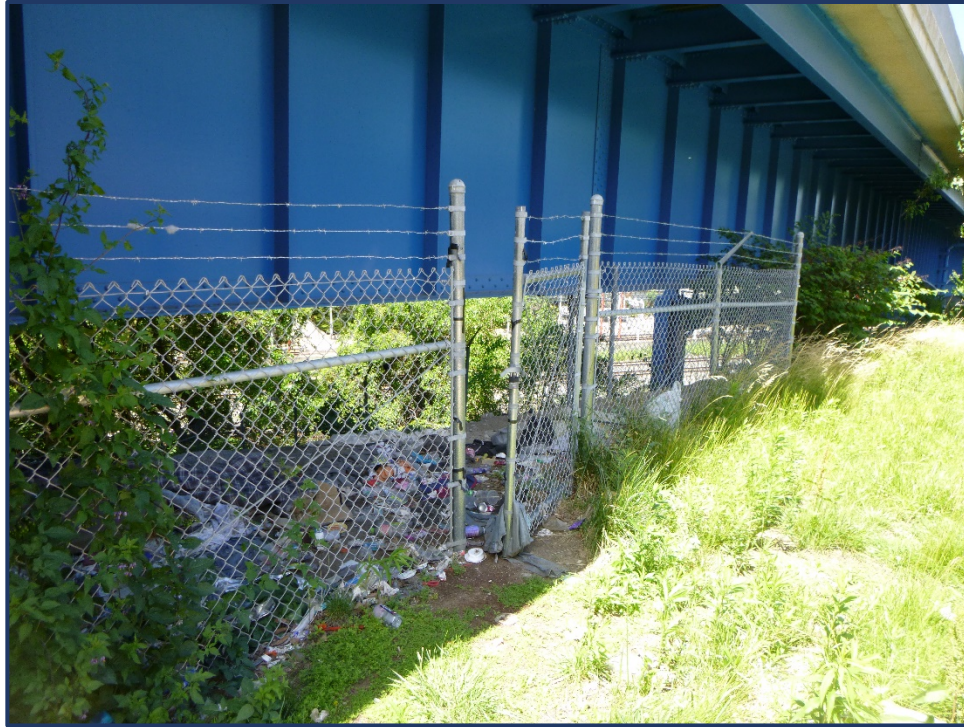
Photo APR-3 – Unit V, South Side of Pier 37, Open Vandal Fence Gate

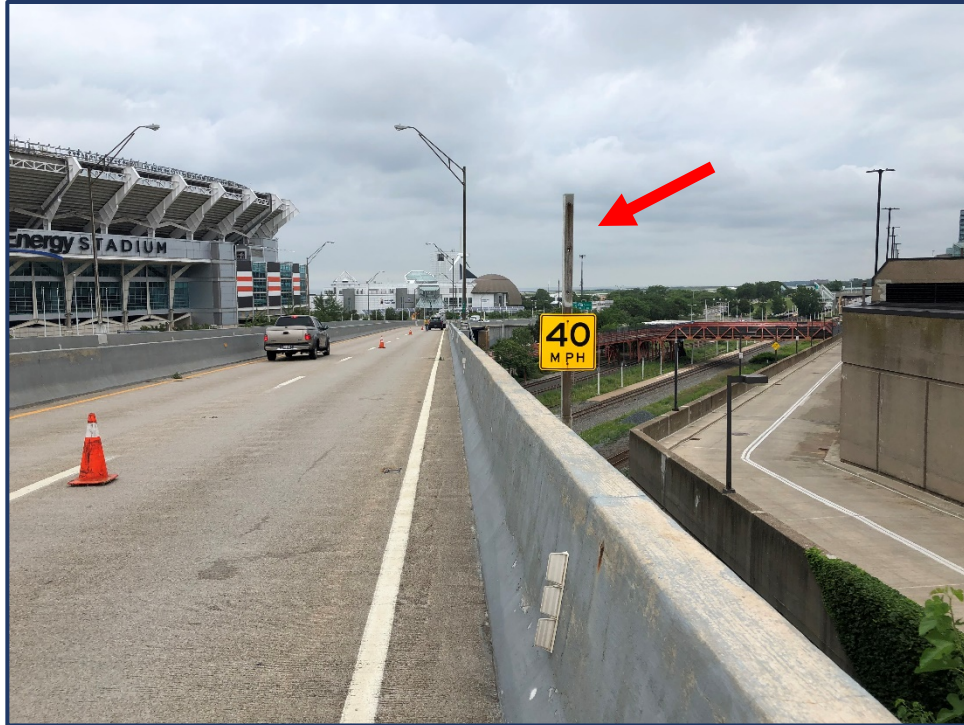
Photo SIG-1 – Unit V, Eastbound, Missing Sign on Right Parapet

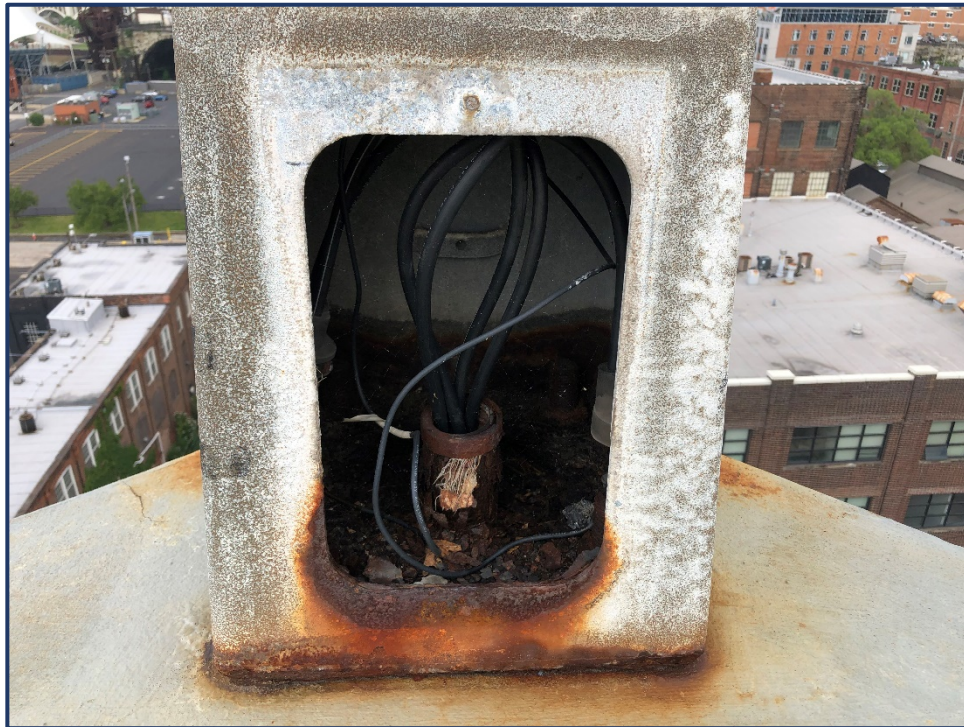
Photo LI-1 – Typical missing utility cover at light pole, Span 5 over Elm Street

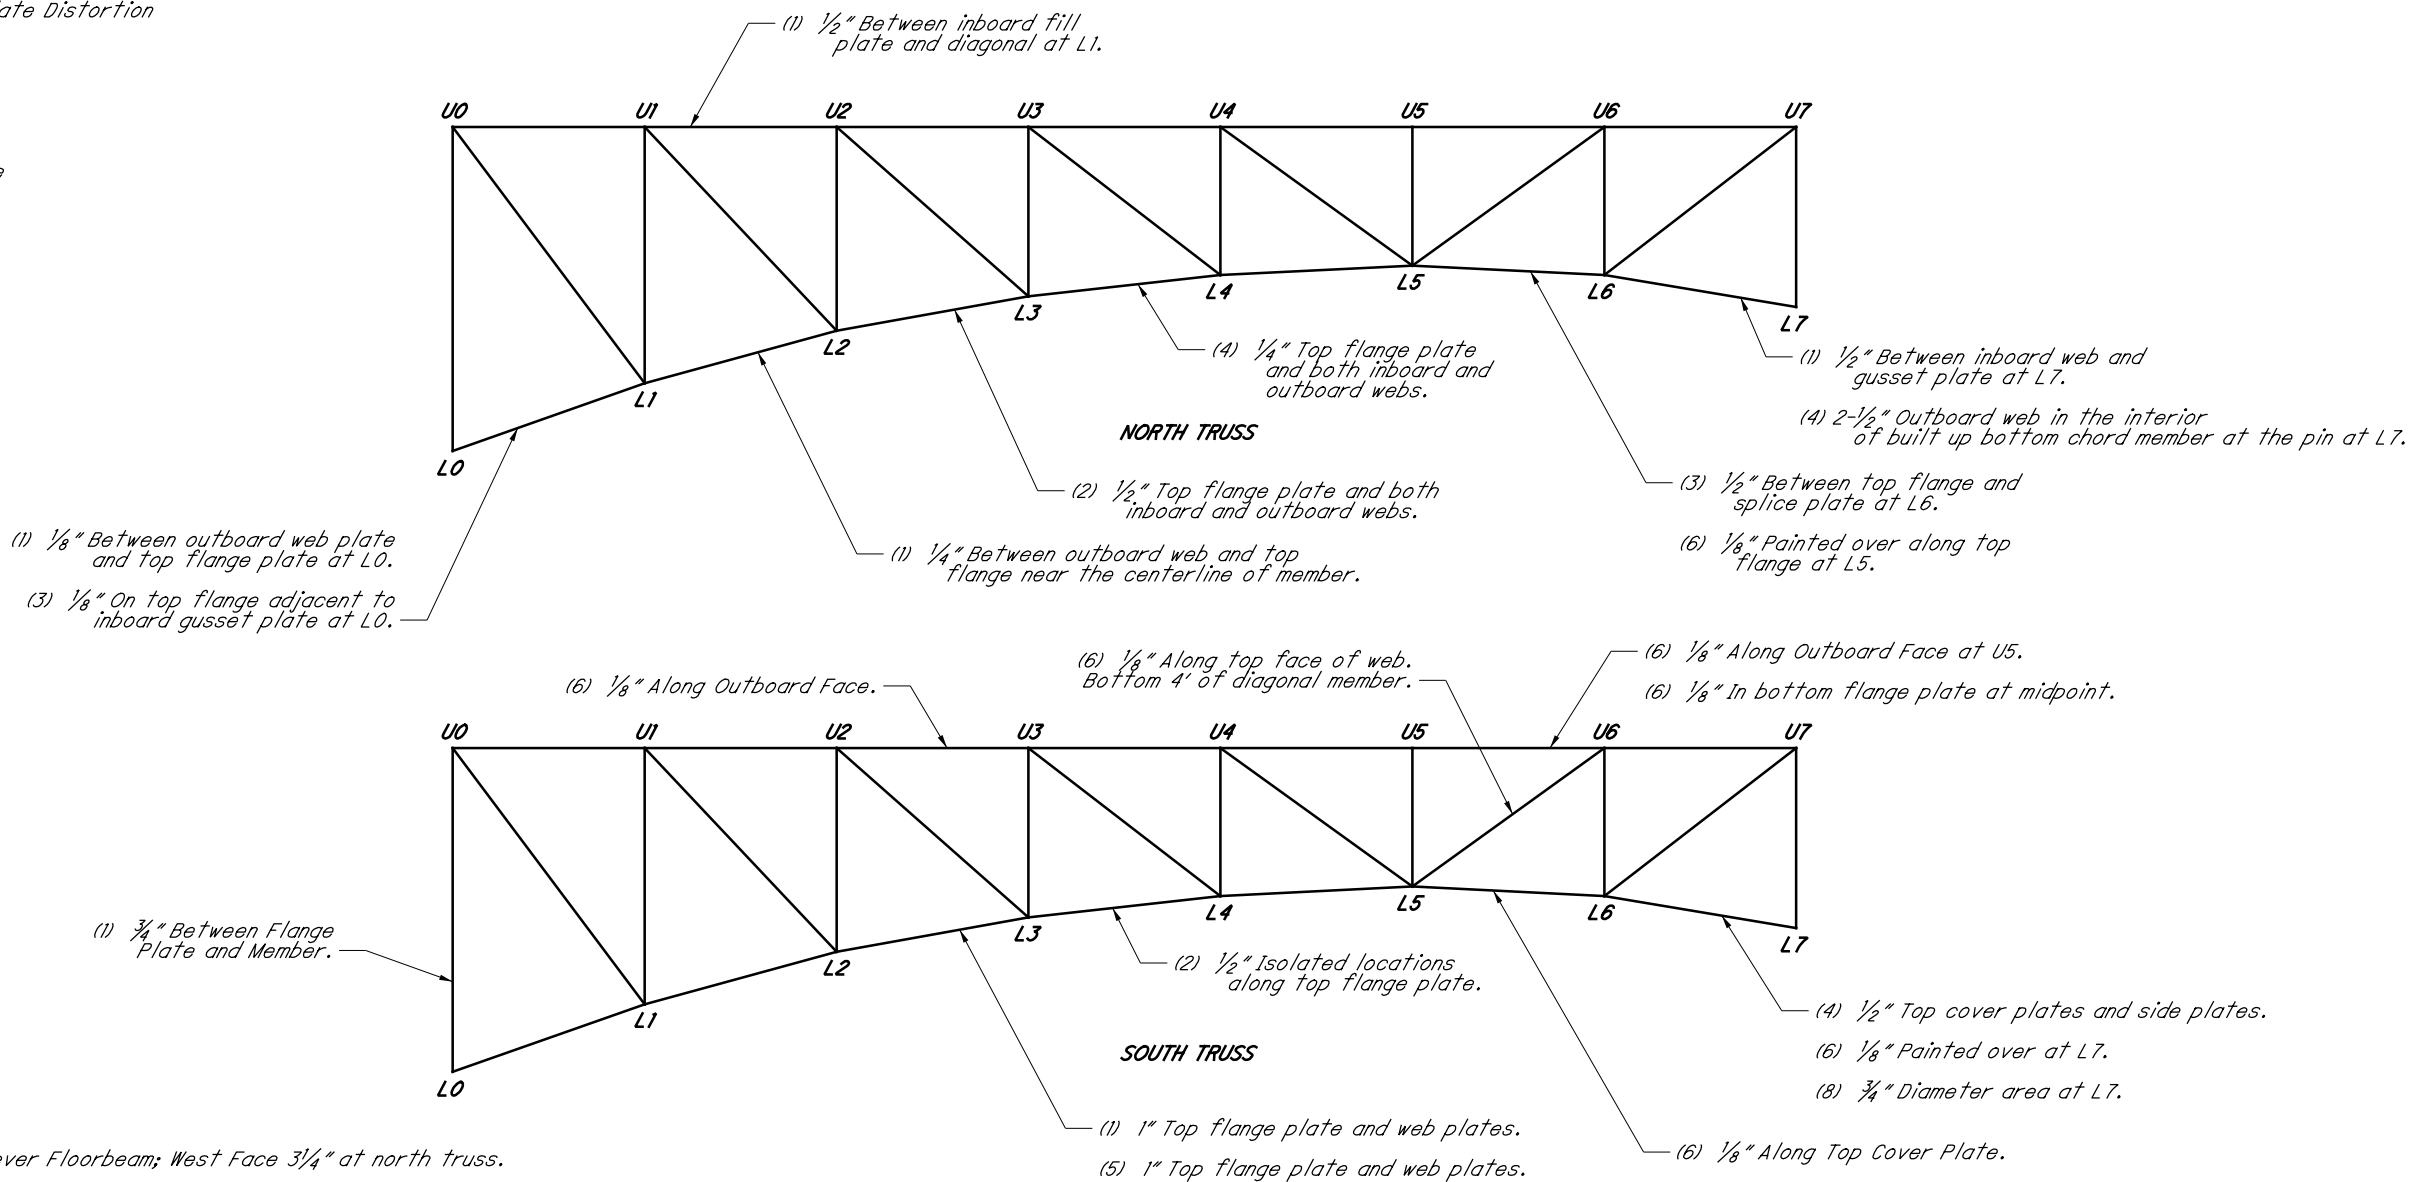
Floorbeam Deficiencies:

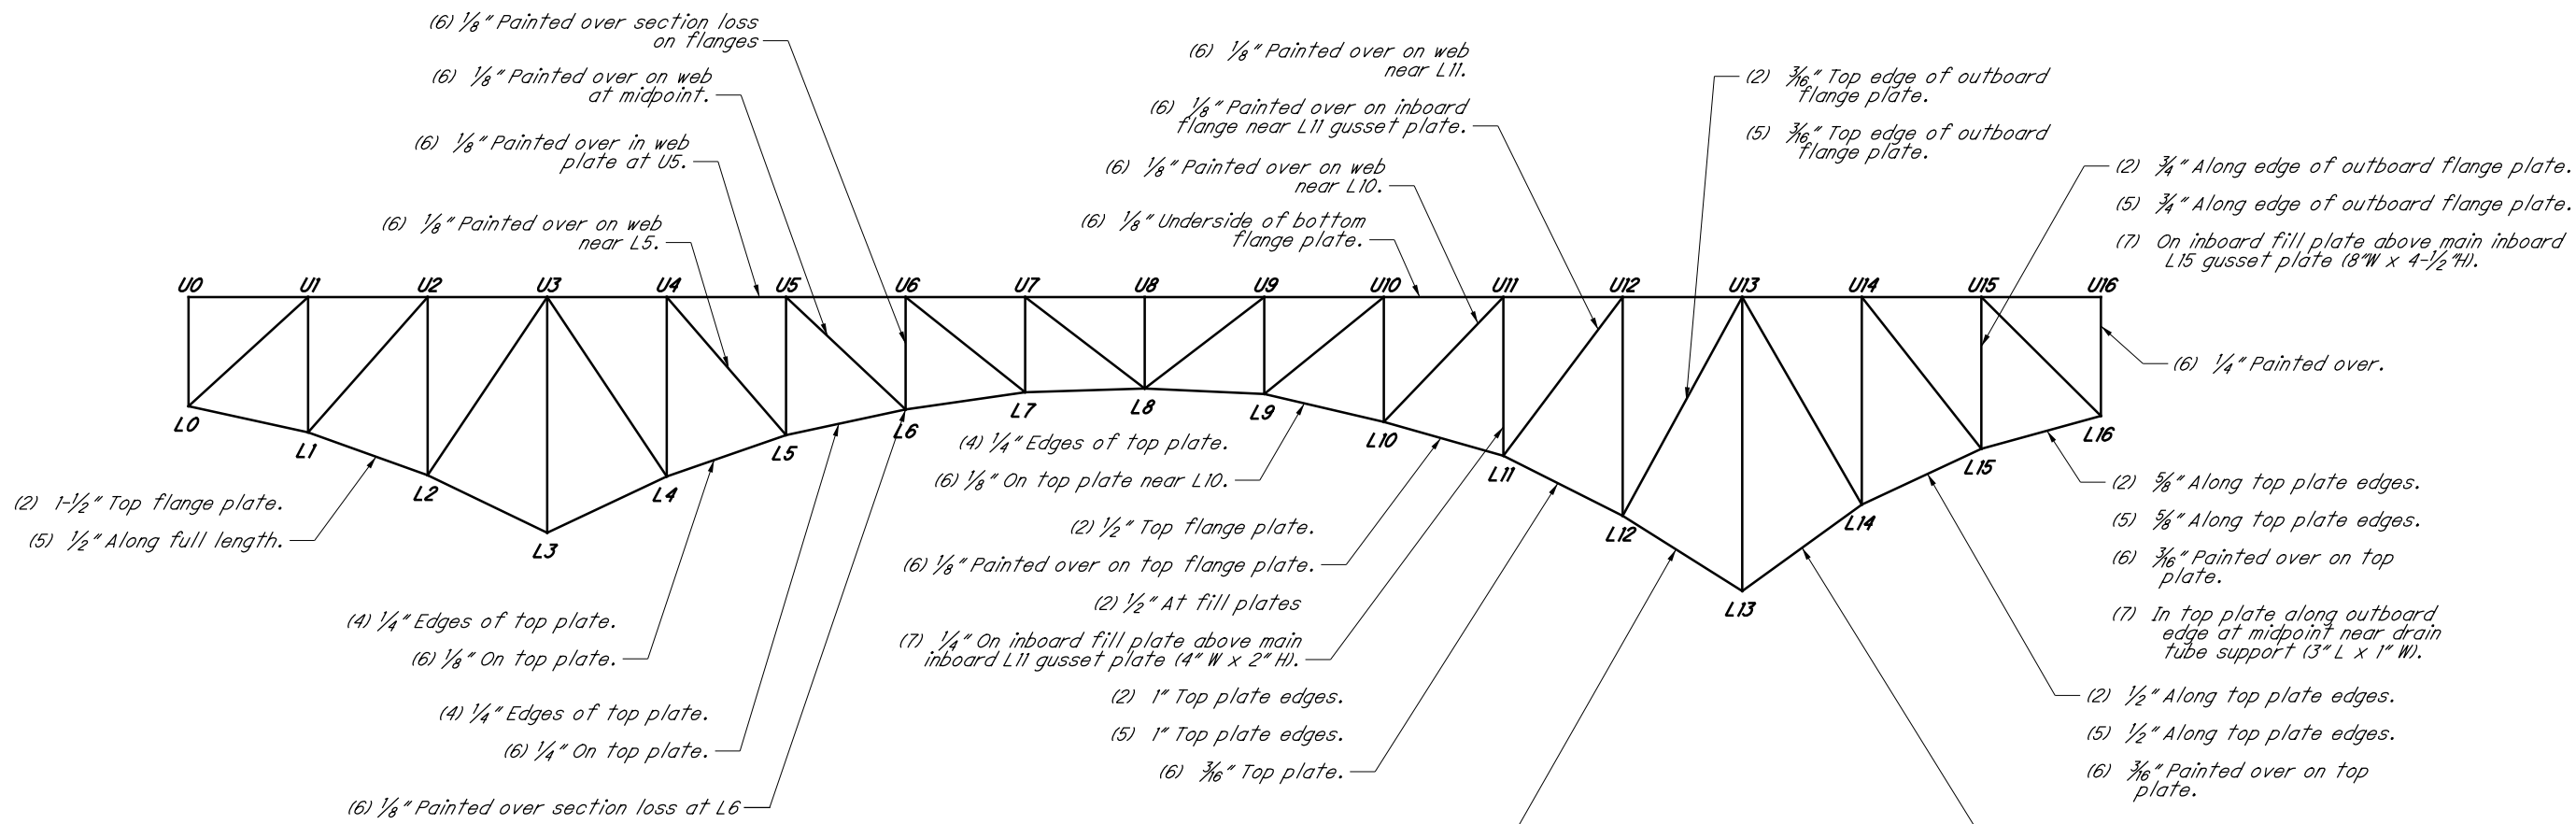
J:\000T\09534_VAR-D12_Inspection\Inspection\CUY-2-14-41_Main_Ave_1800035\2021\Inspection\CAD\CUY_2-14-41_Truss_Span_Configurations.dgn_Span 2 - North 11/30/2021 10:21:07 AM Justin-r

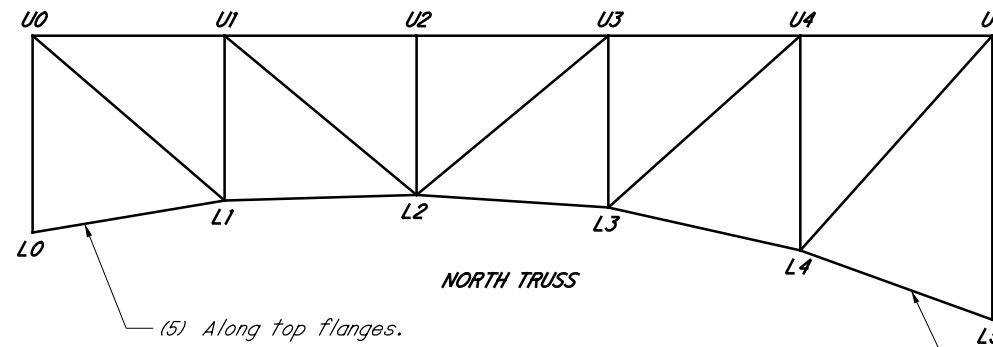
(5) Along top flanges.

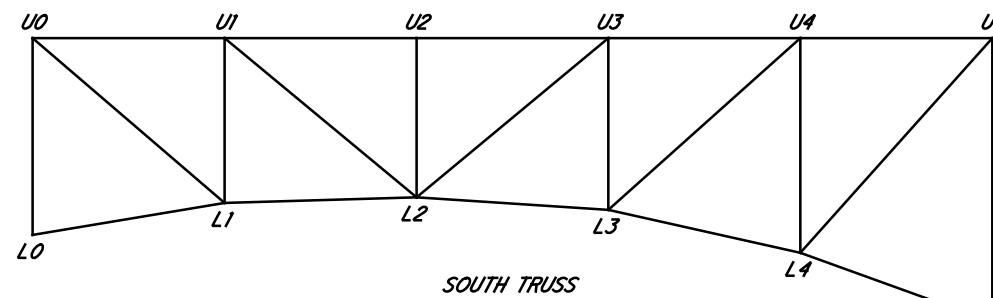
(6) 1/4" Painted over along 50% of the top flange.

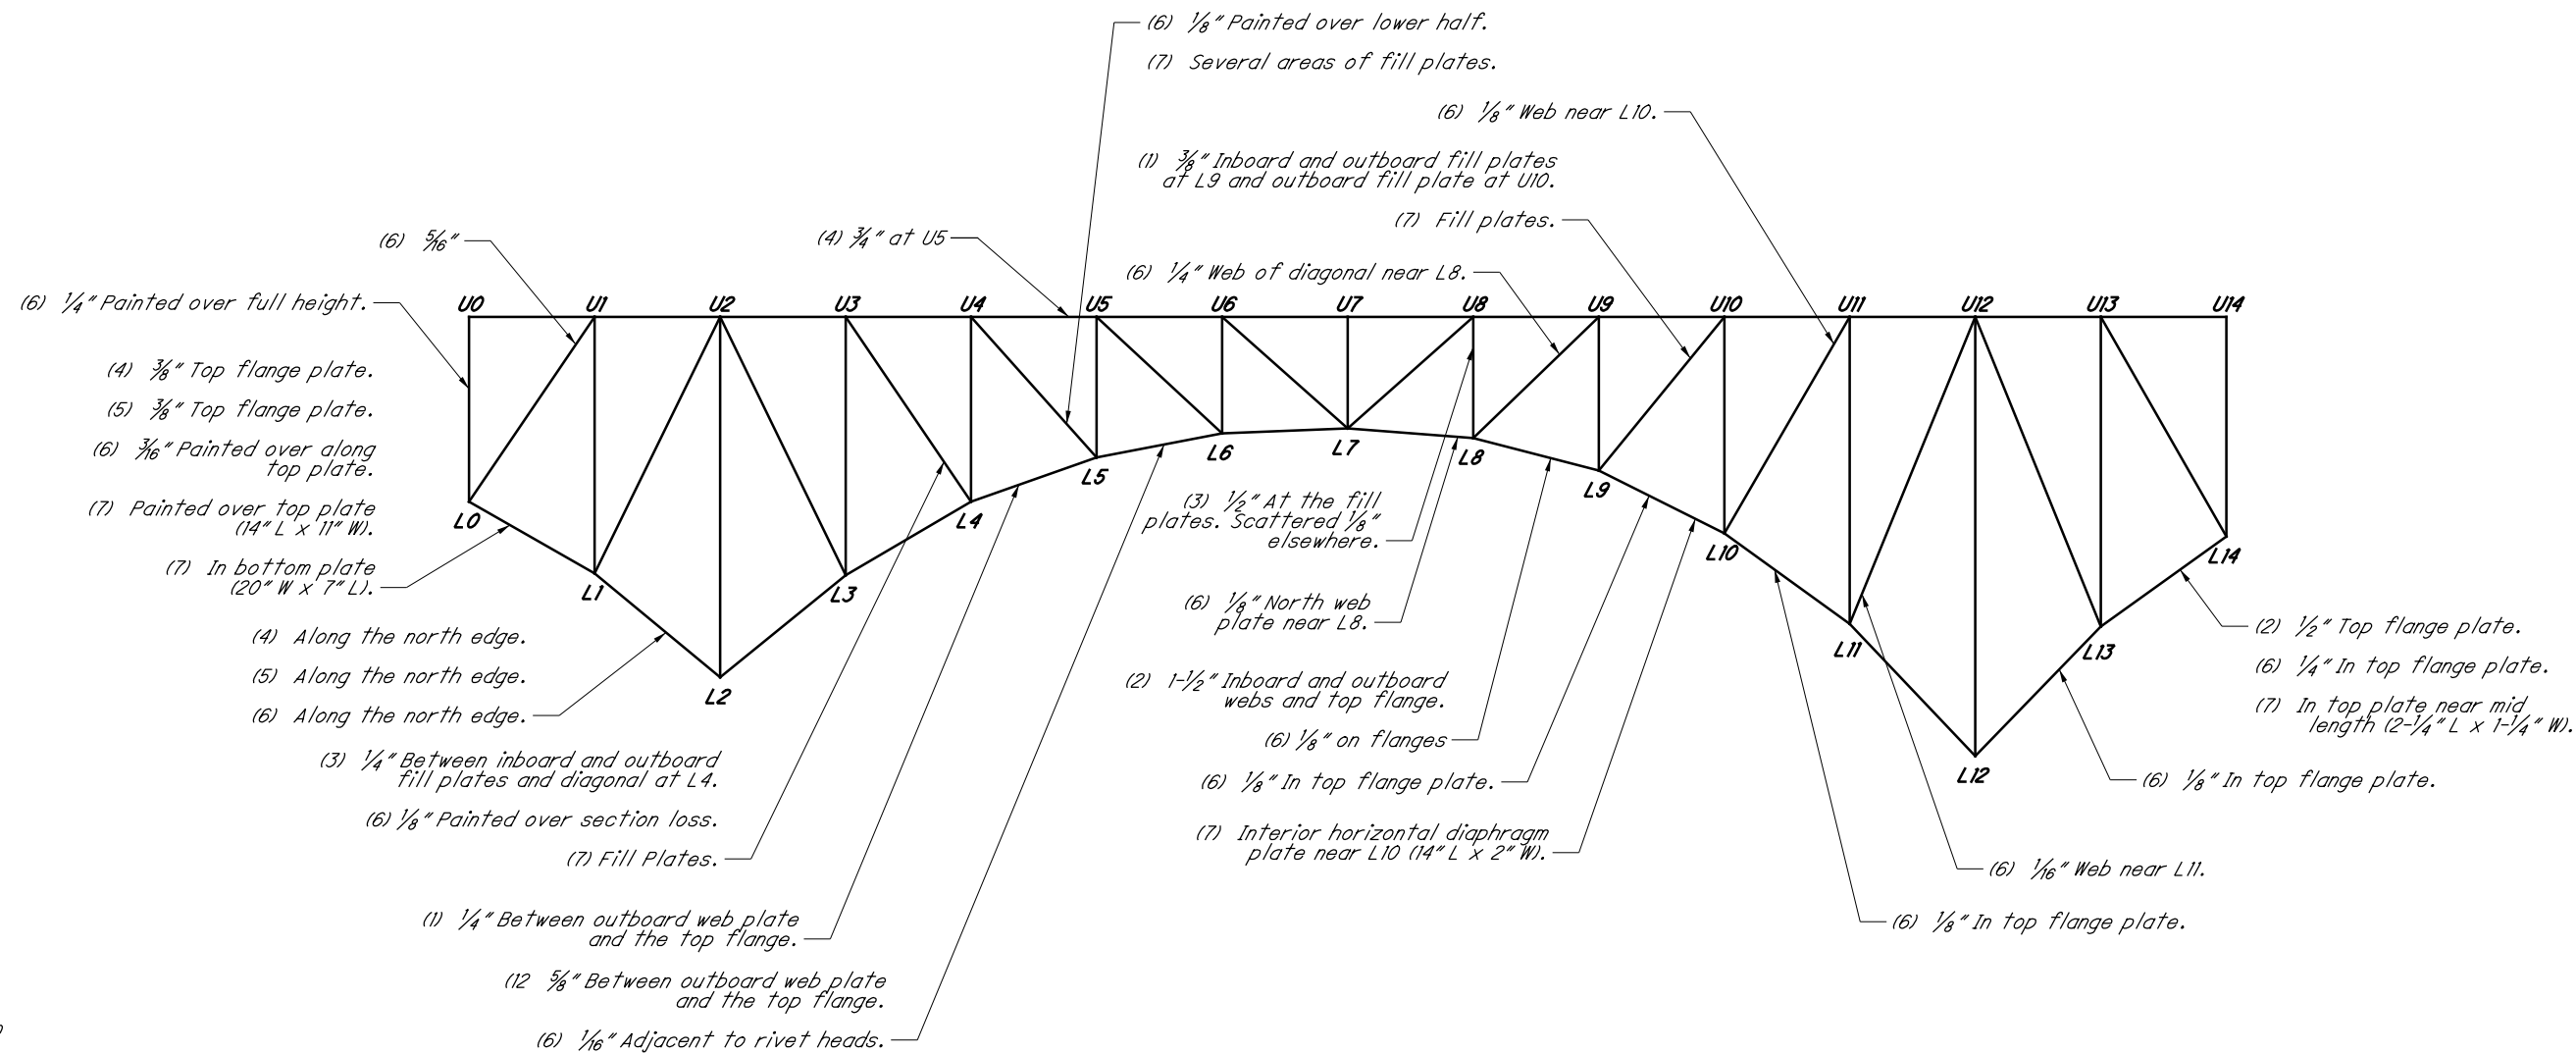
J:\OD0T\109534_VAR-D12_Inspections\Inspection\CUY-2-14.41_Main_Ave_1800035\2021\Inspection\CAD\CUY_2-14.41_Truss_Span_4 - North_11/30/2021 10:21:09 AM_Justin-r

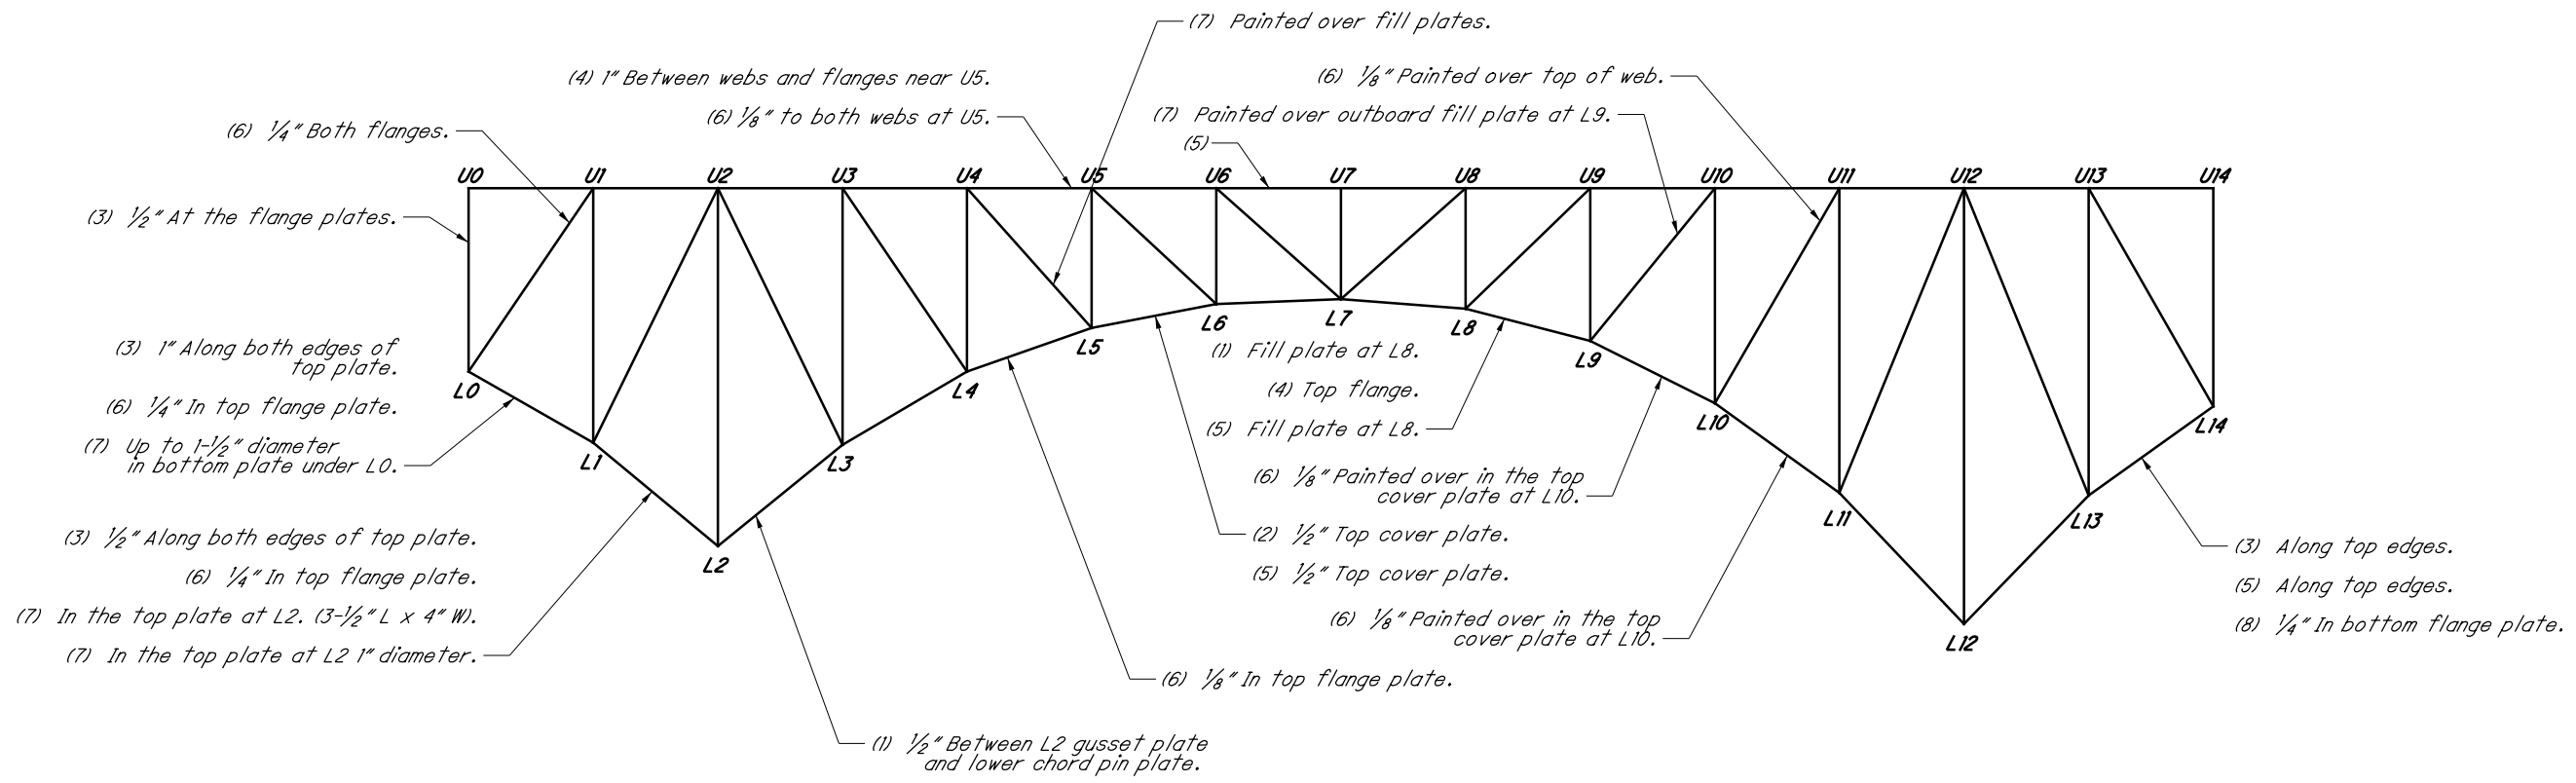
J:\ODOT\109534_VAR-D12_Inspection\CUY-2-14-41_Main_Ave_1800035\2021\Inspection\CAD\CUY_2-14-41_Truss_Span_Configurations.dgn_Span 4 - South 11/30/2021 10:21:09 AM Justin-r
