**Physical Condition Report for
CUY-002-1441
SFN 1800035
Main Avenue Bridge over the Cuyahoga River
2021 Routine and Fracture Critical Inspection**

Prepared for:

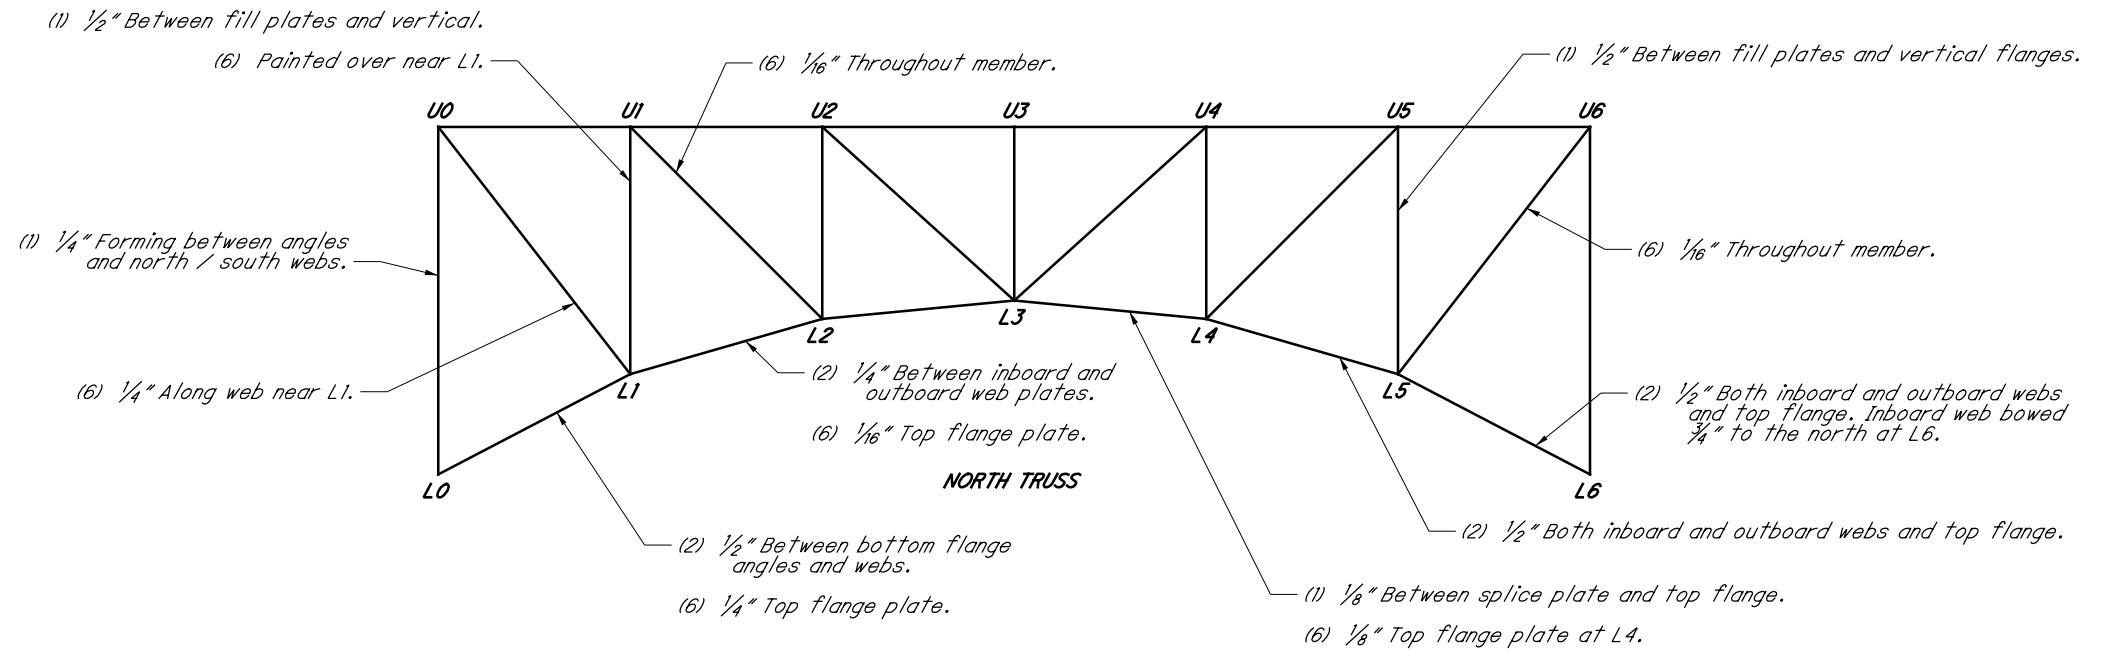
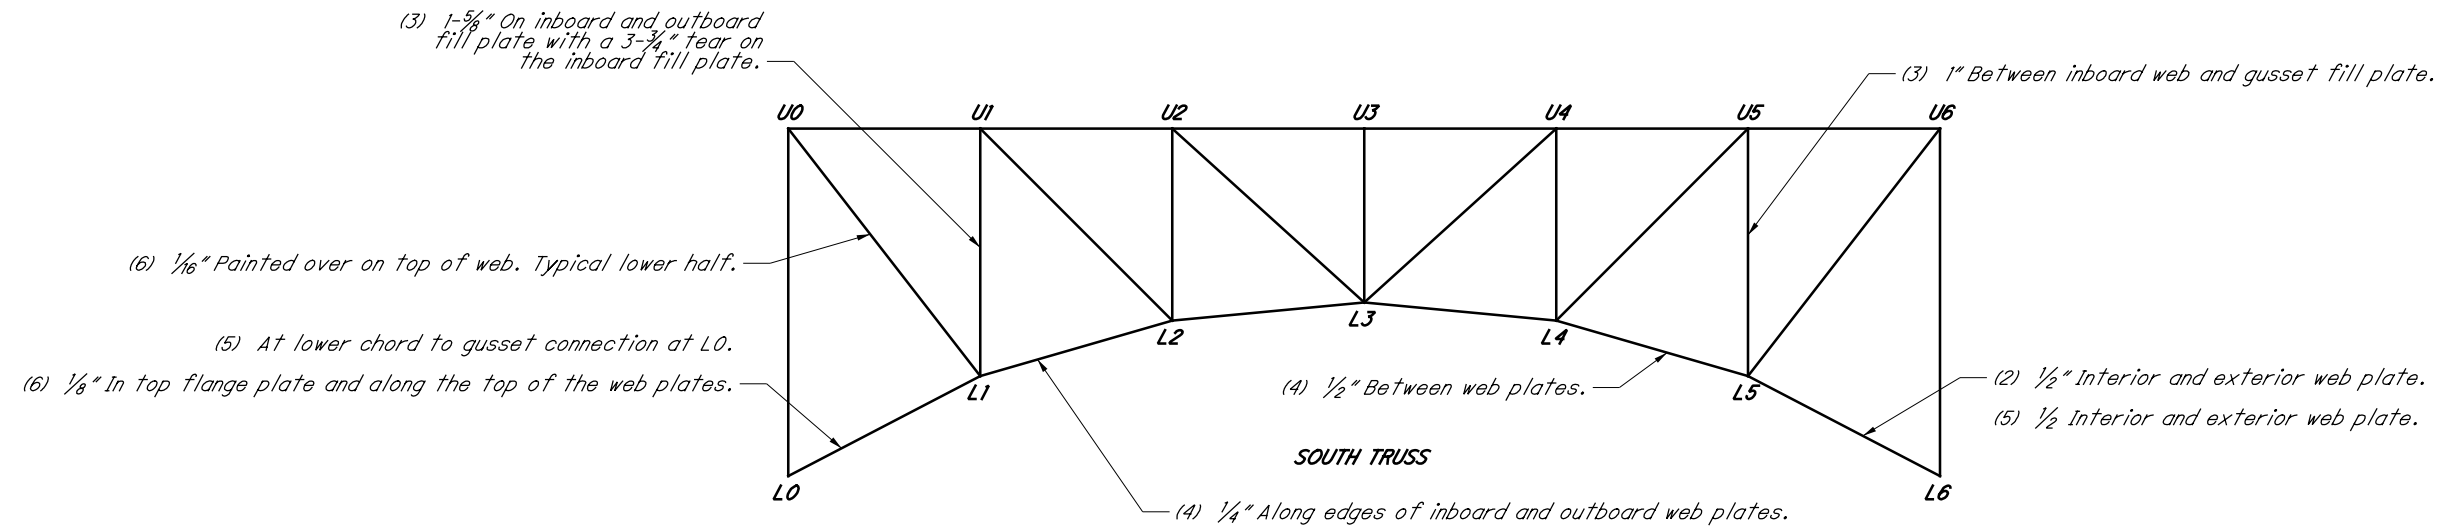
South Truss Gusset Plate Deficiencies:

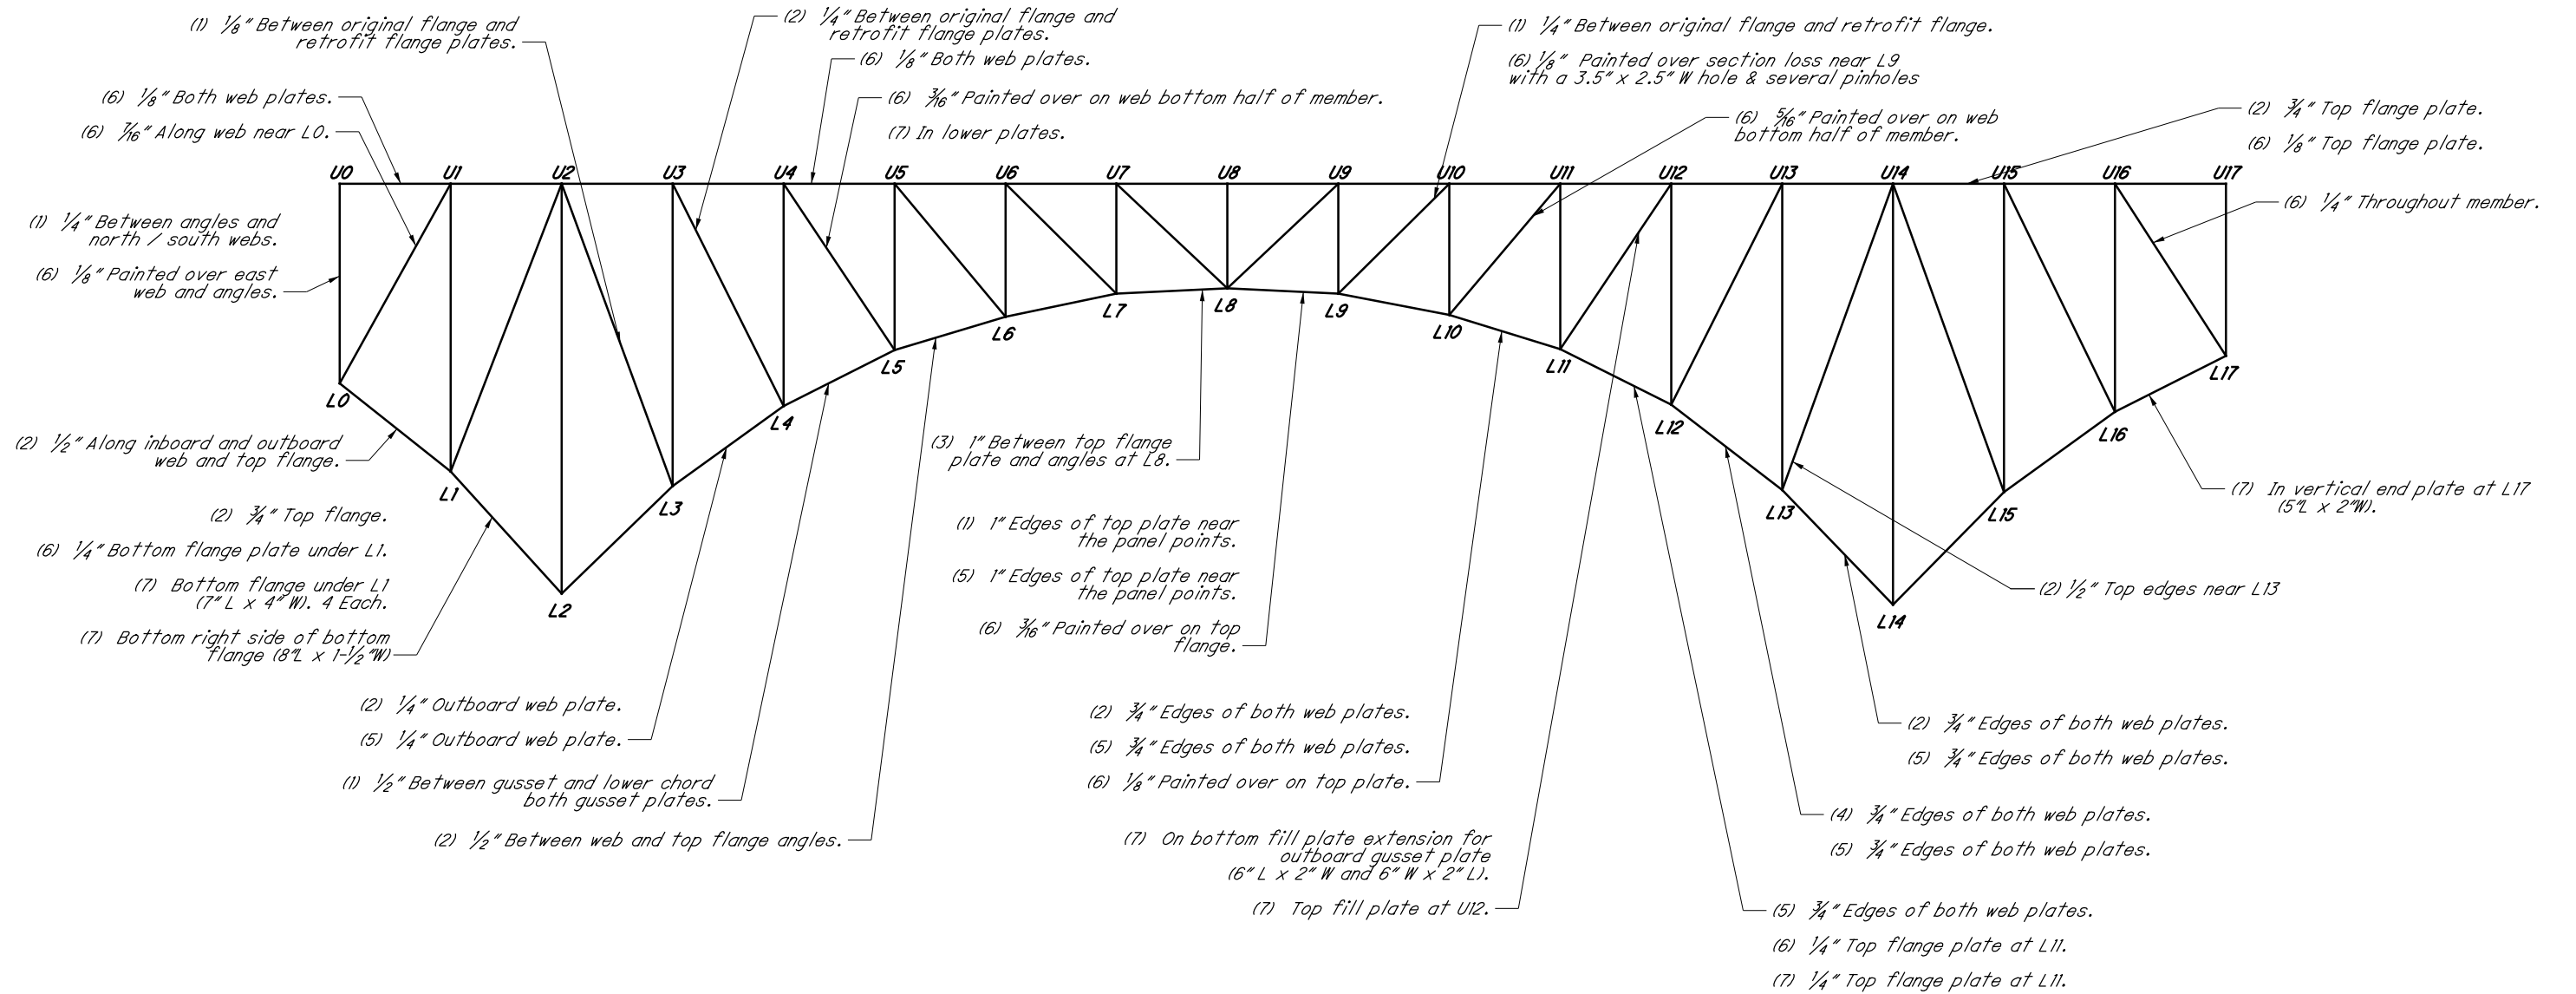
Floorbeam Deficiencies:

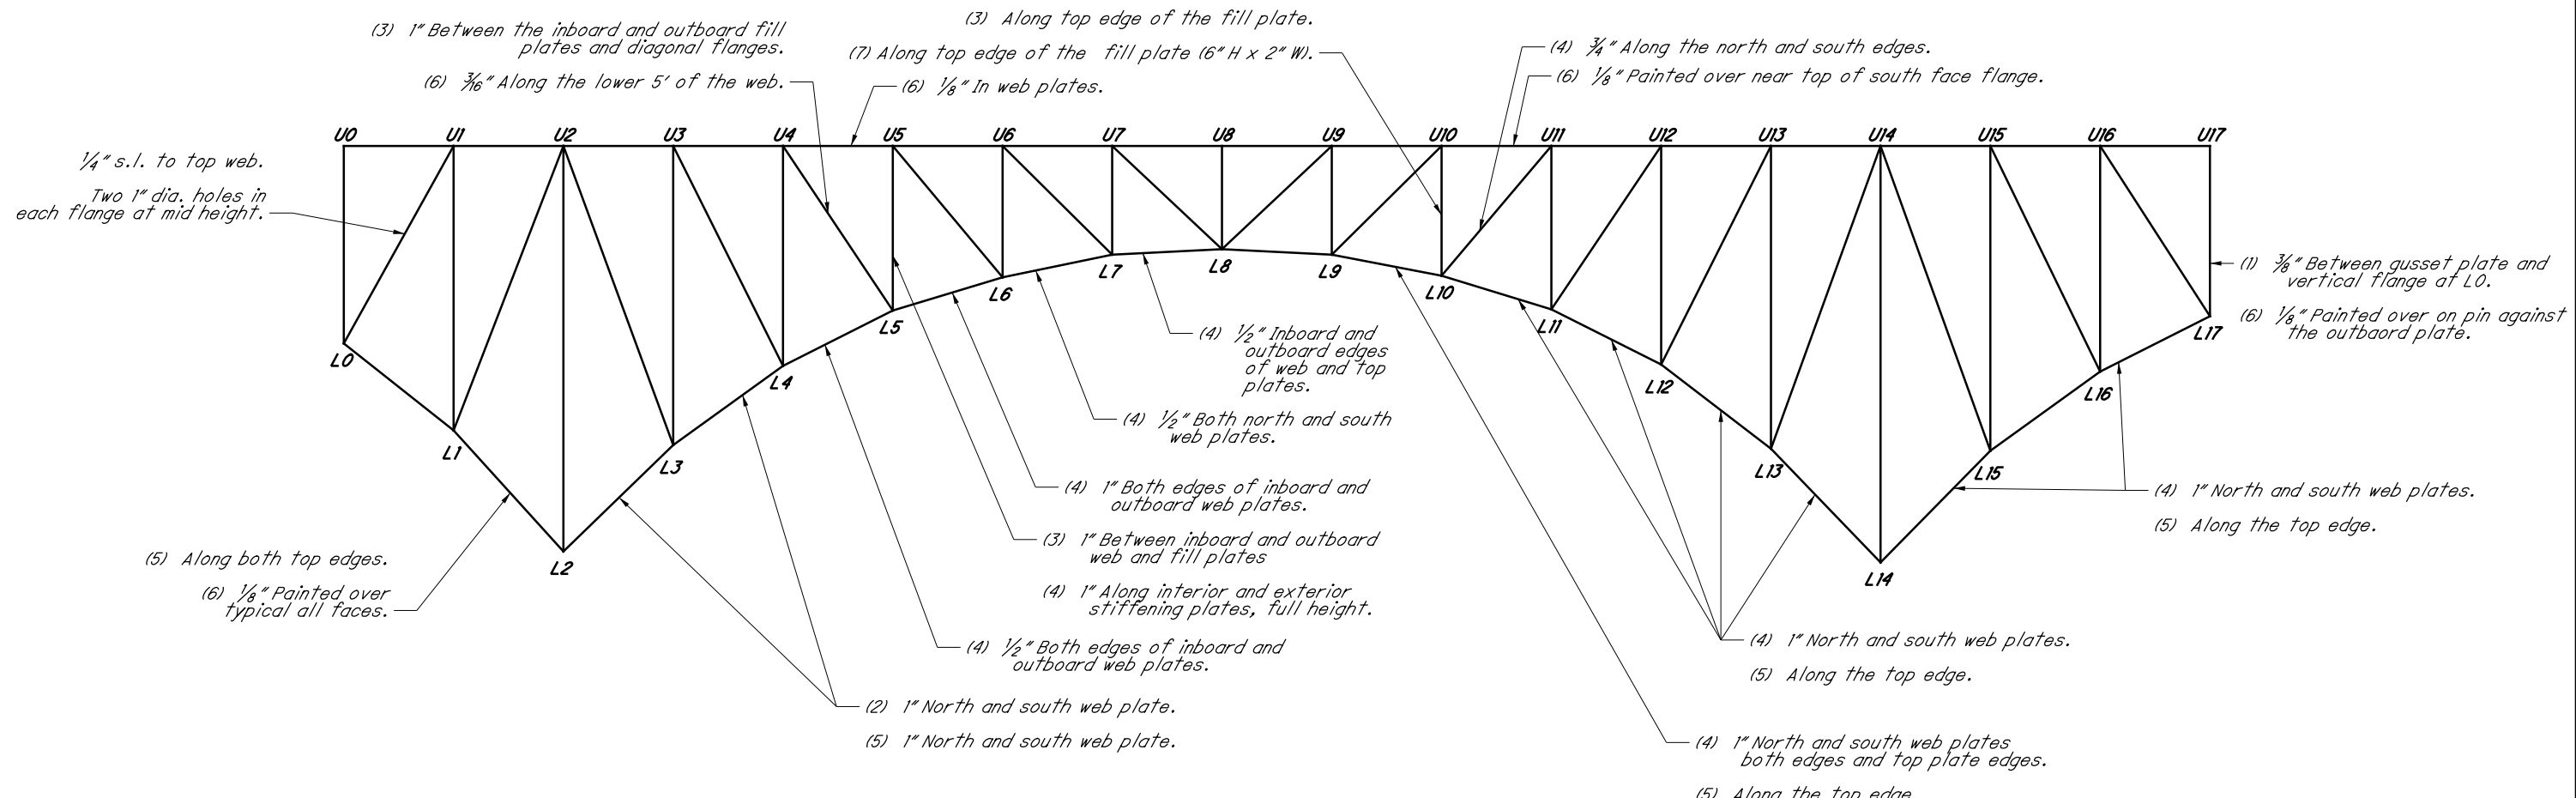
South Truss Gusset Plate Deficiencies:

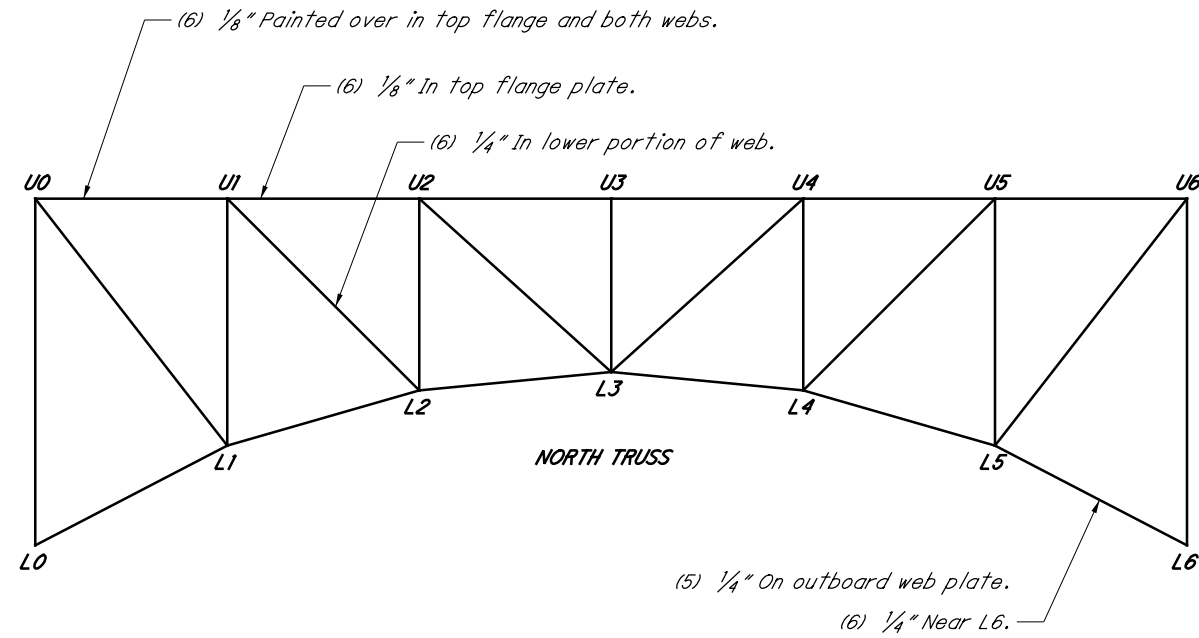
North Truss Gusset Plate Deficiencies:

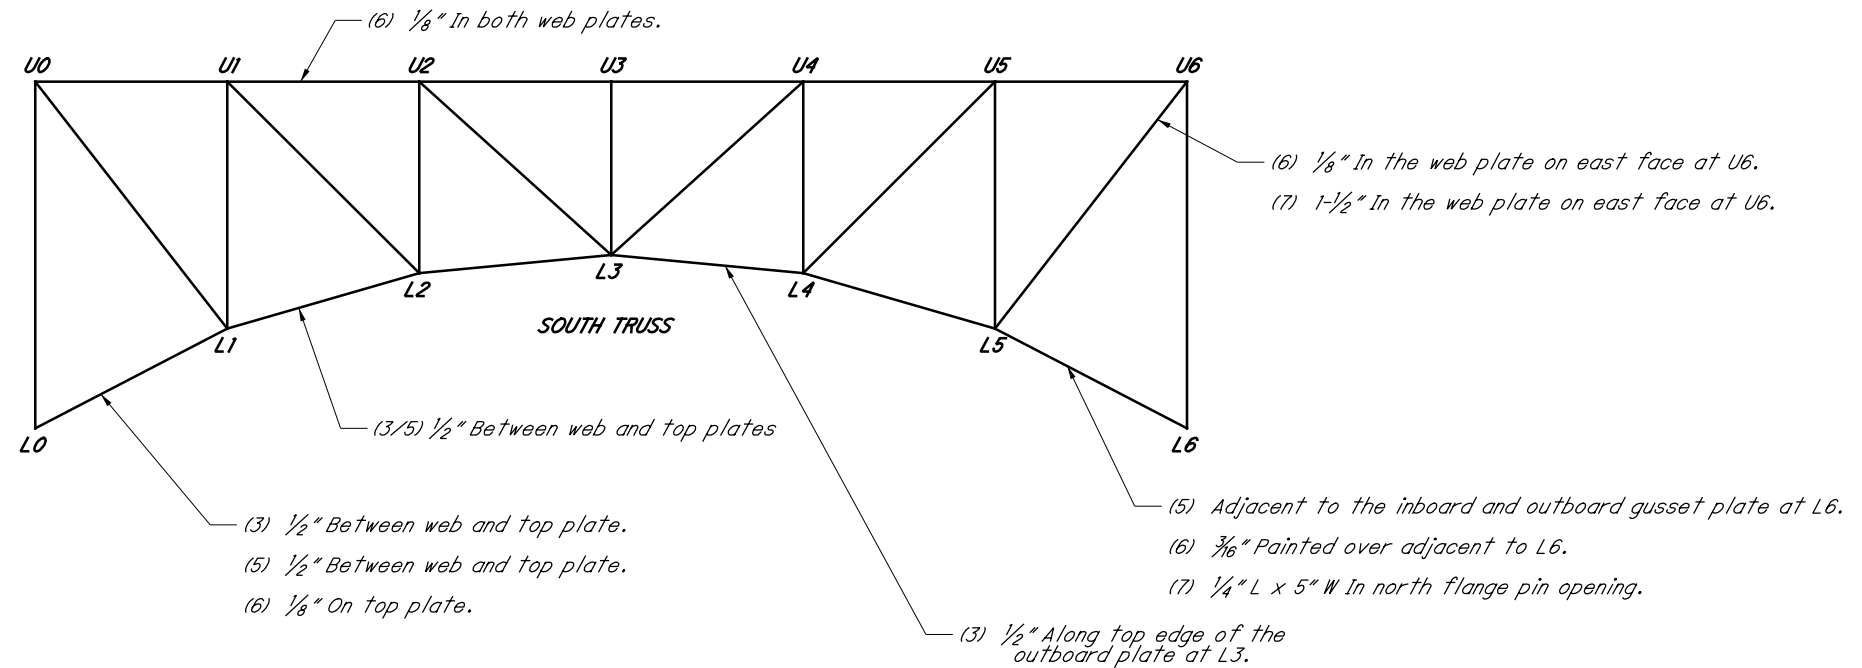
Floorbeam Deficiencies:

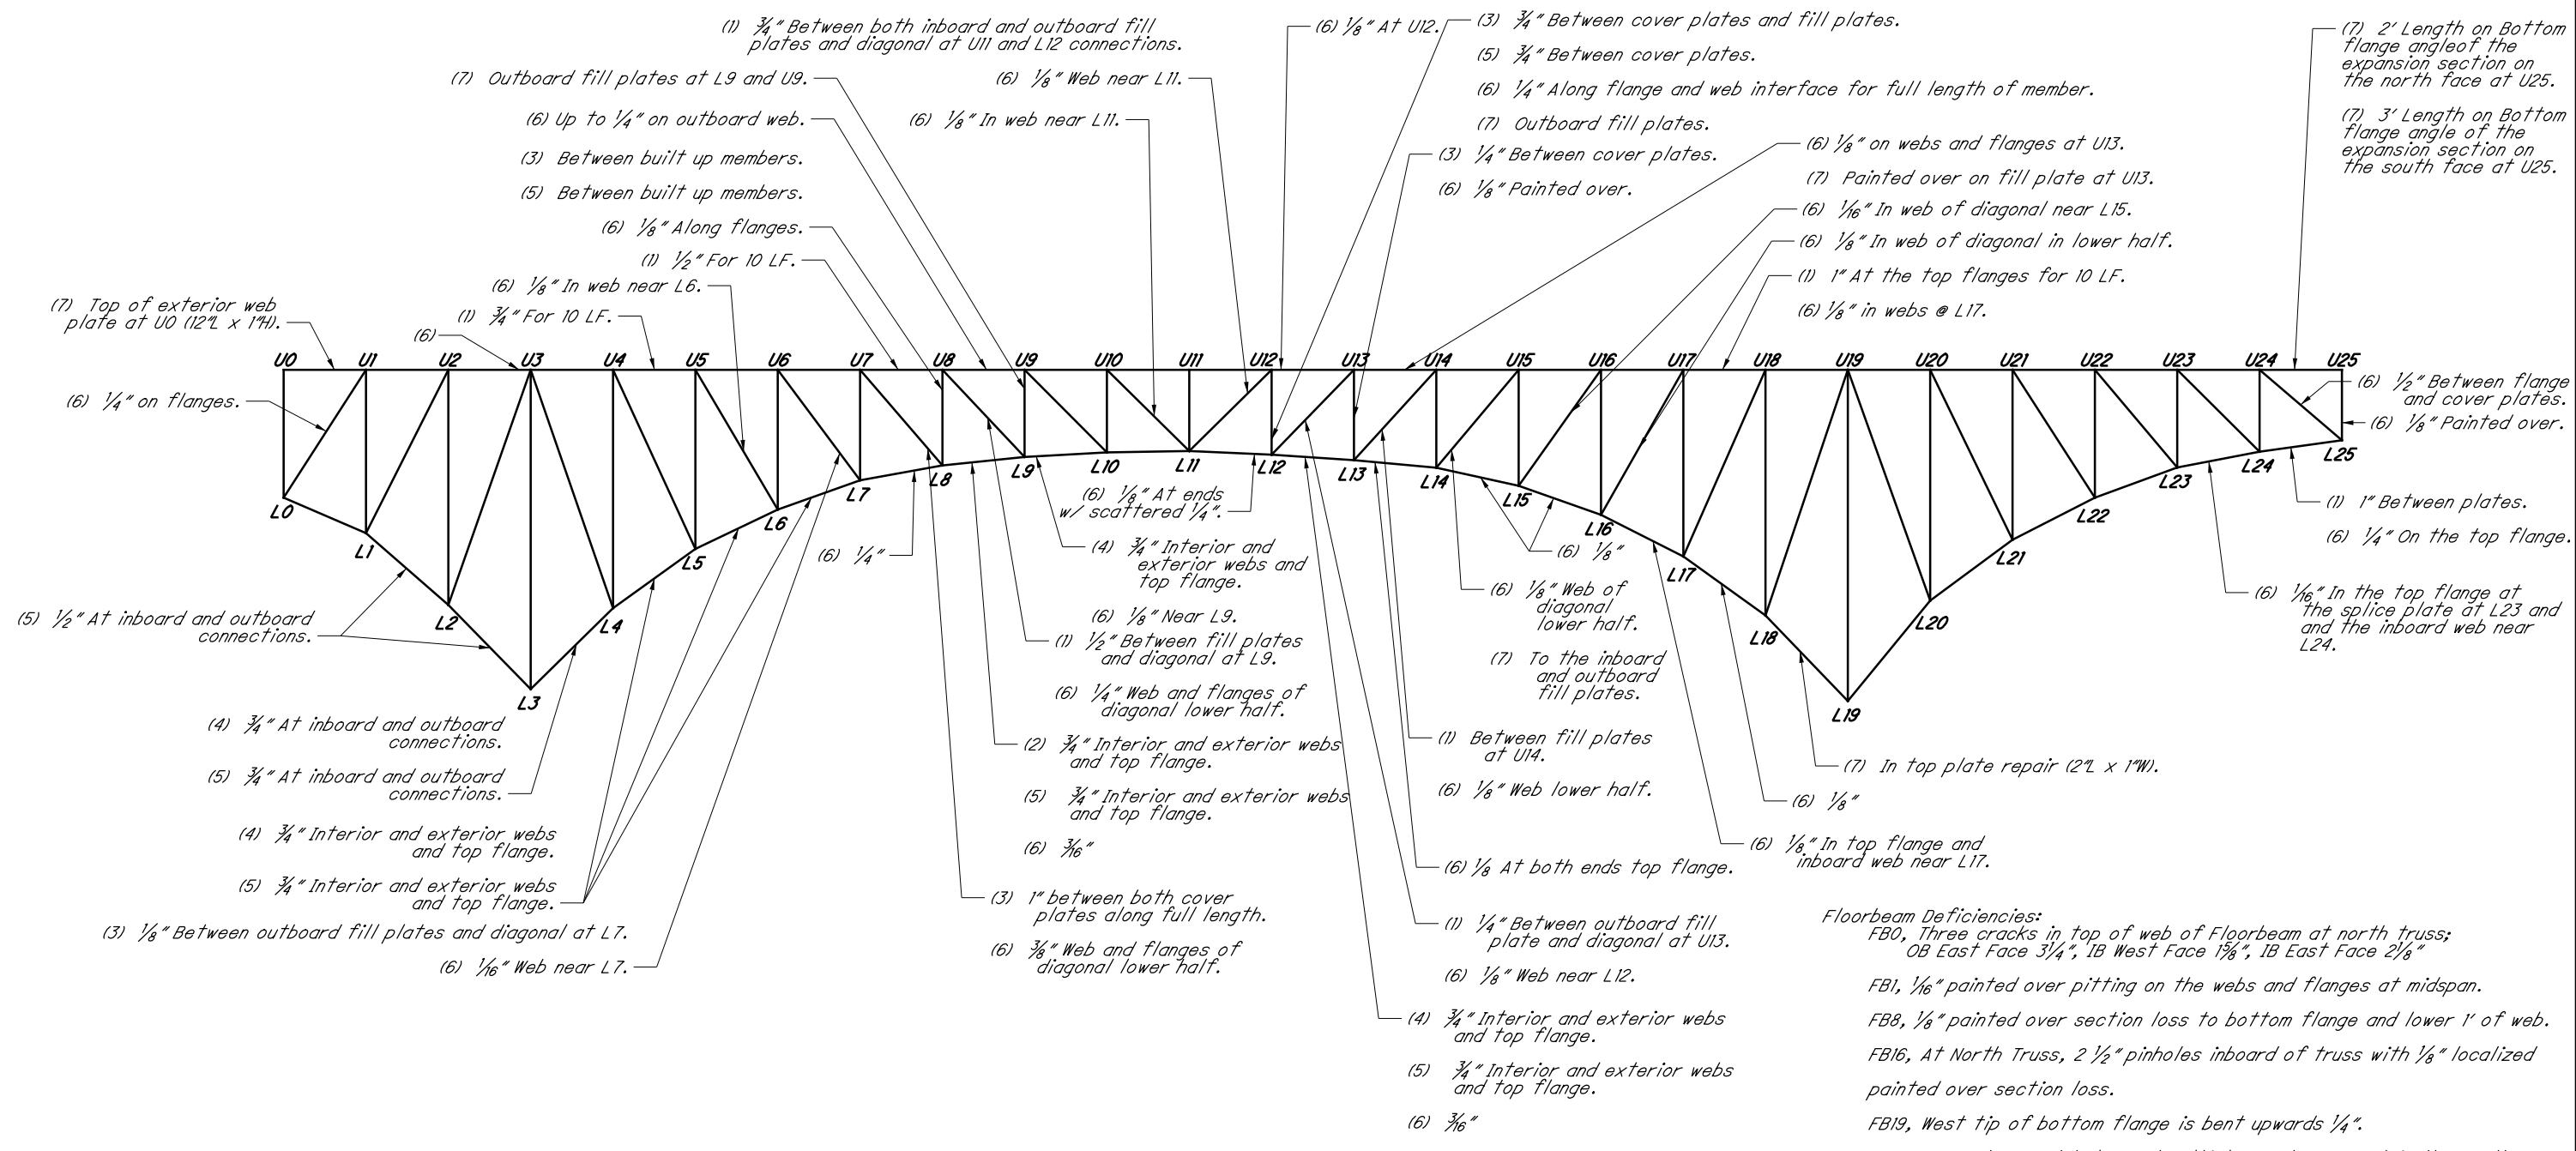
Floorbeam Deficiencies:
 FB0, Three cracks in top of web of Floorbeam at north truss; OB East Face 3/4", IB West Face 1/8", IB East Face 2/8"
 FB1, 1/16" painted over pitting on the webs and flanges at midspan.
 FB8, 1/8" painted over section loss to bottom flange and lower 1' of web.
 FB16, At North Truss, 2 1/2" pinholes inboard of truss with 1/8" localized painted over section loss.
 FB19, West tip of bottom flange is bent upwards 1/4".
 FB25, 6 crack arrest holes and multiple cracks present in the North cantilever at the Stringer 6 bracket.

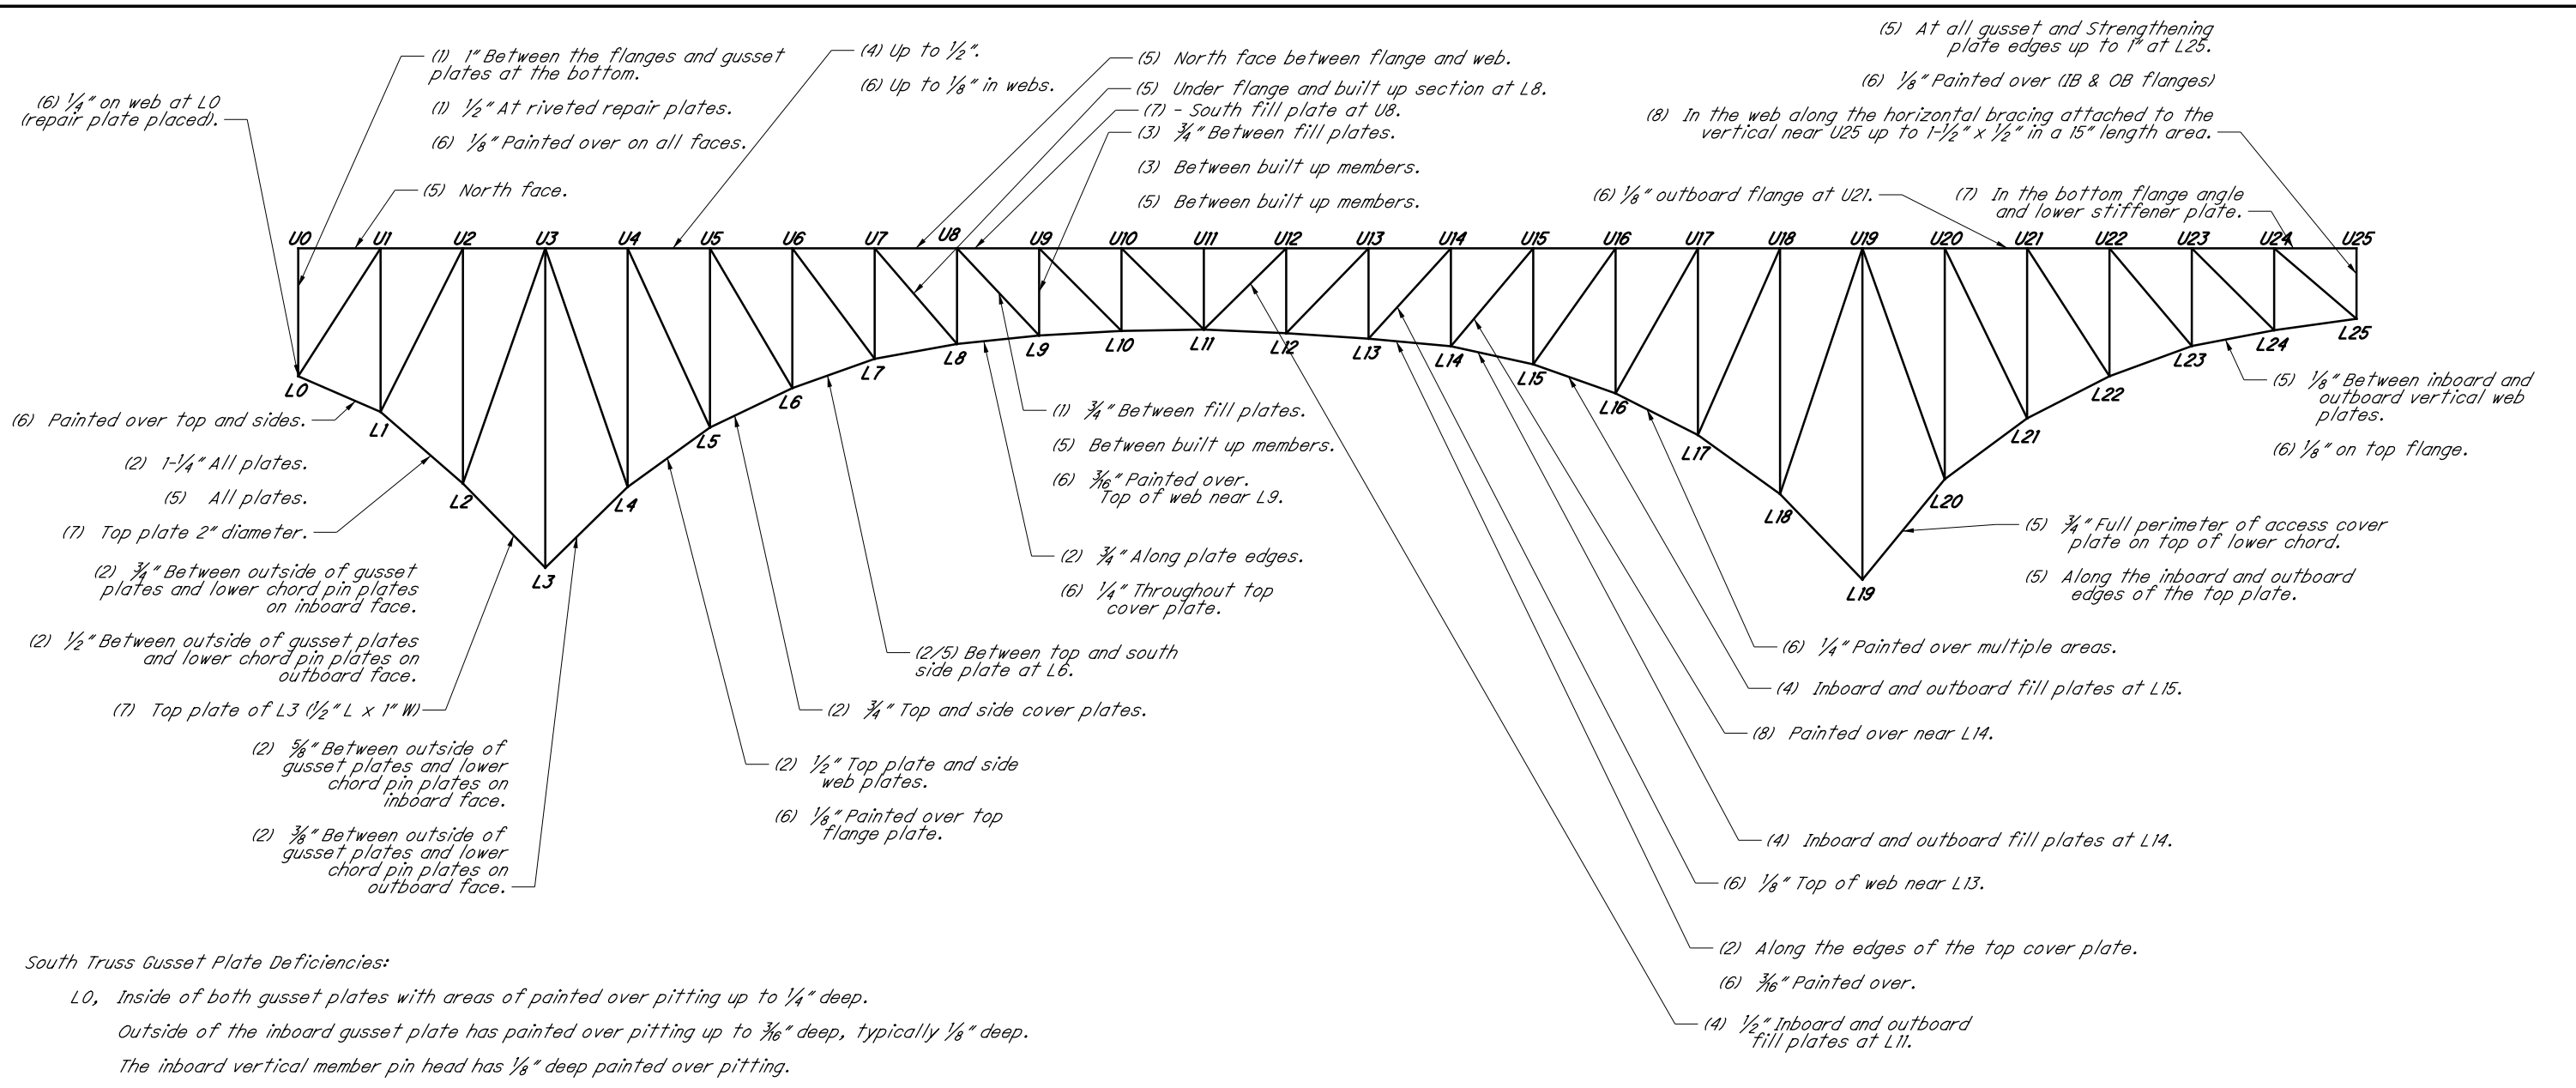
South Truss Gusset Plate Deficiencies:

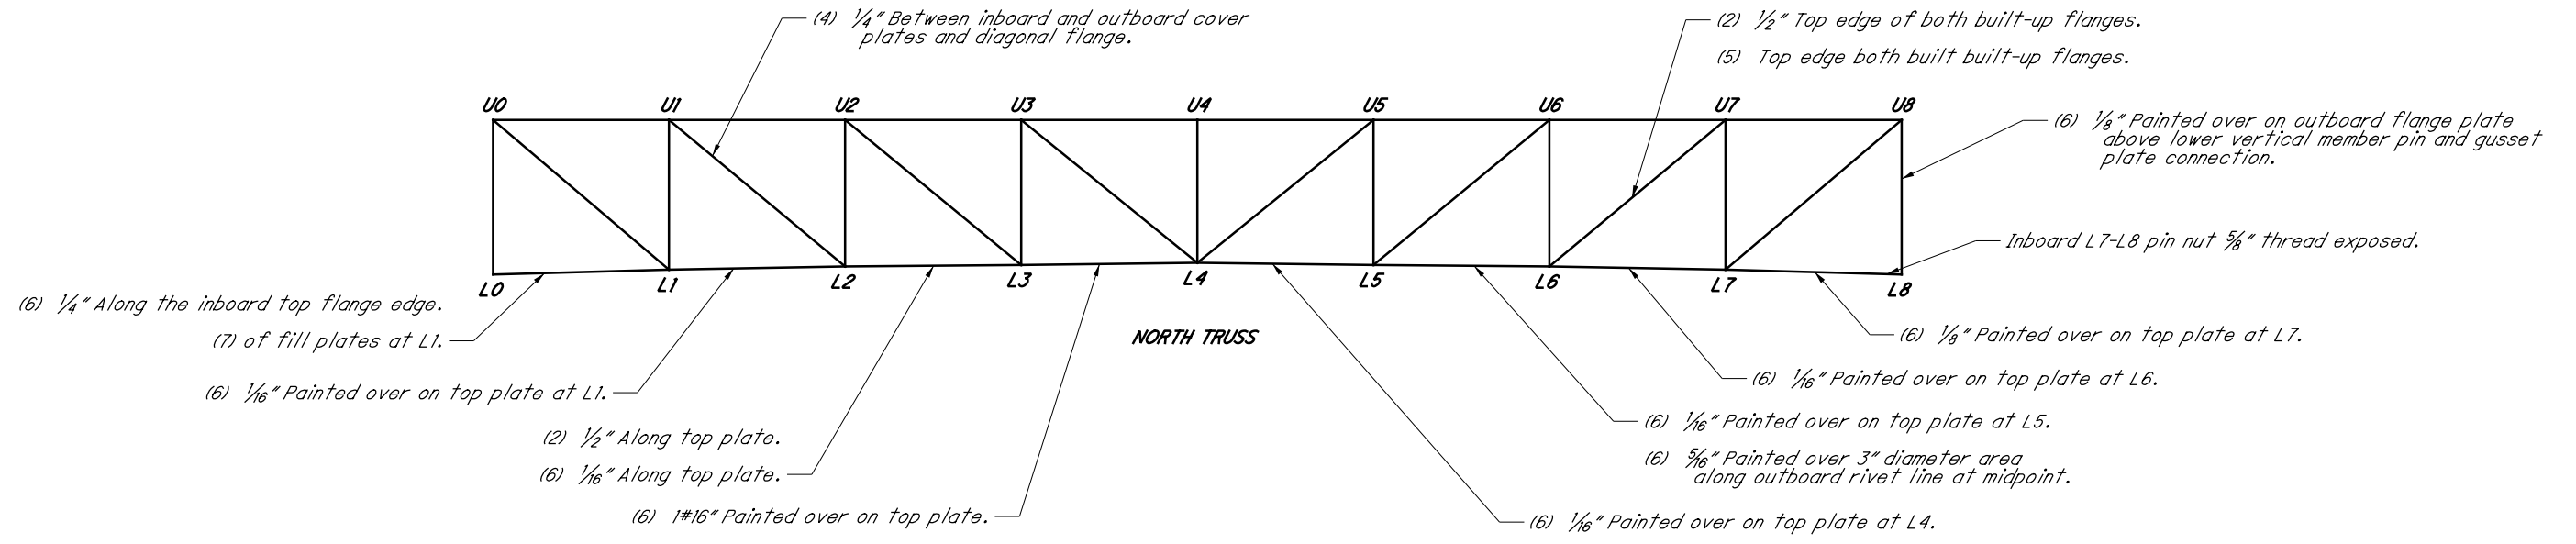
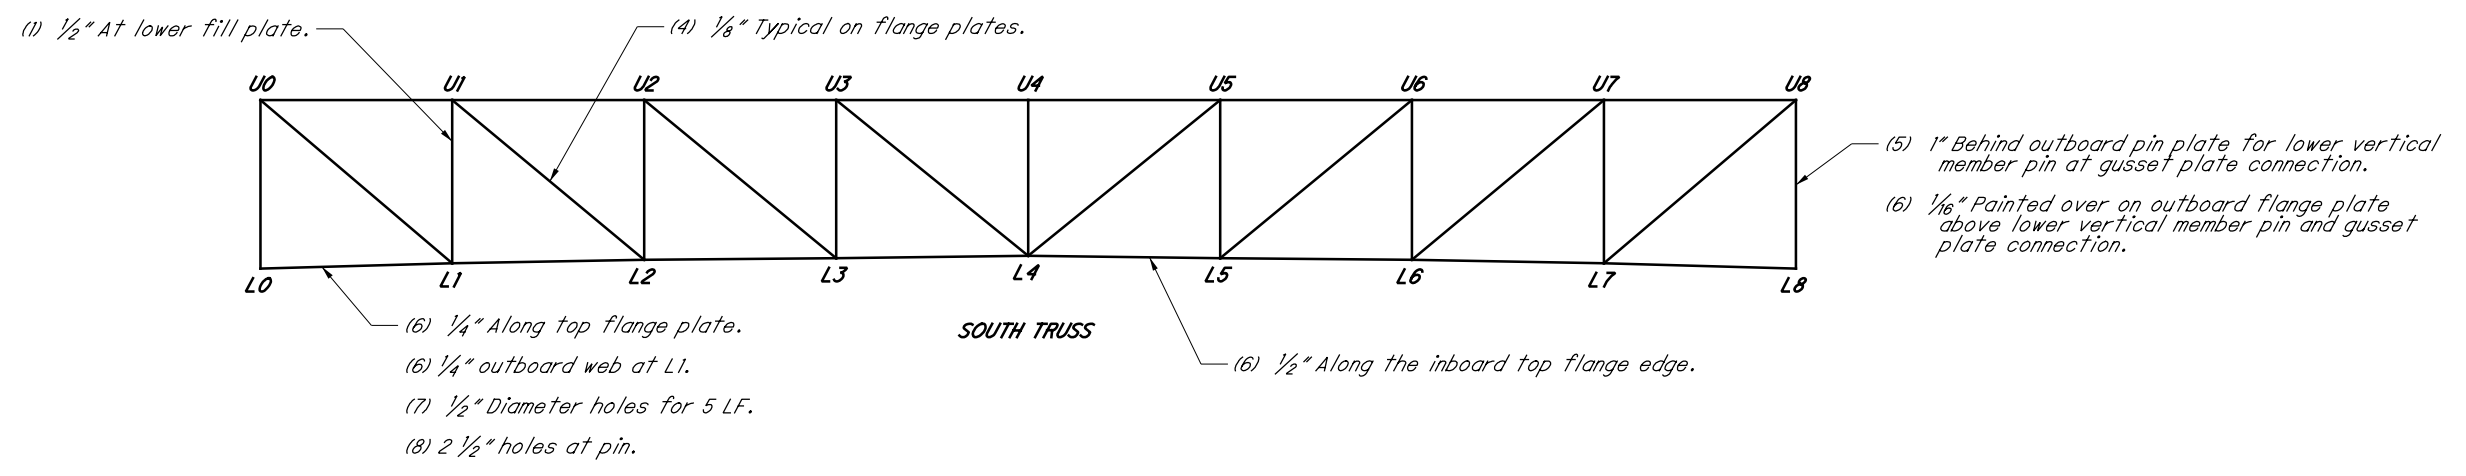
North Truss Gusset Plate Deficiencies:

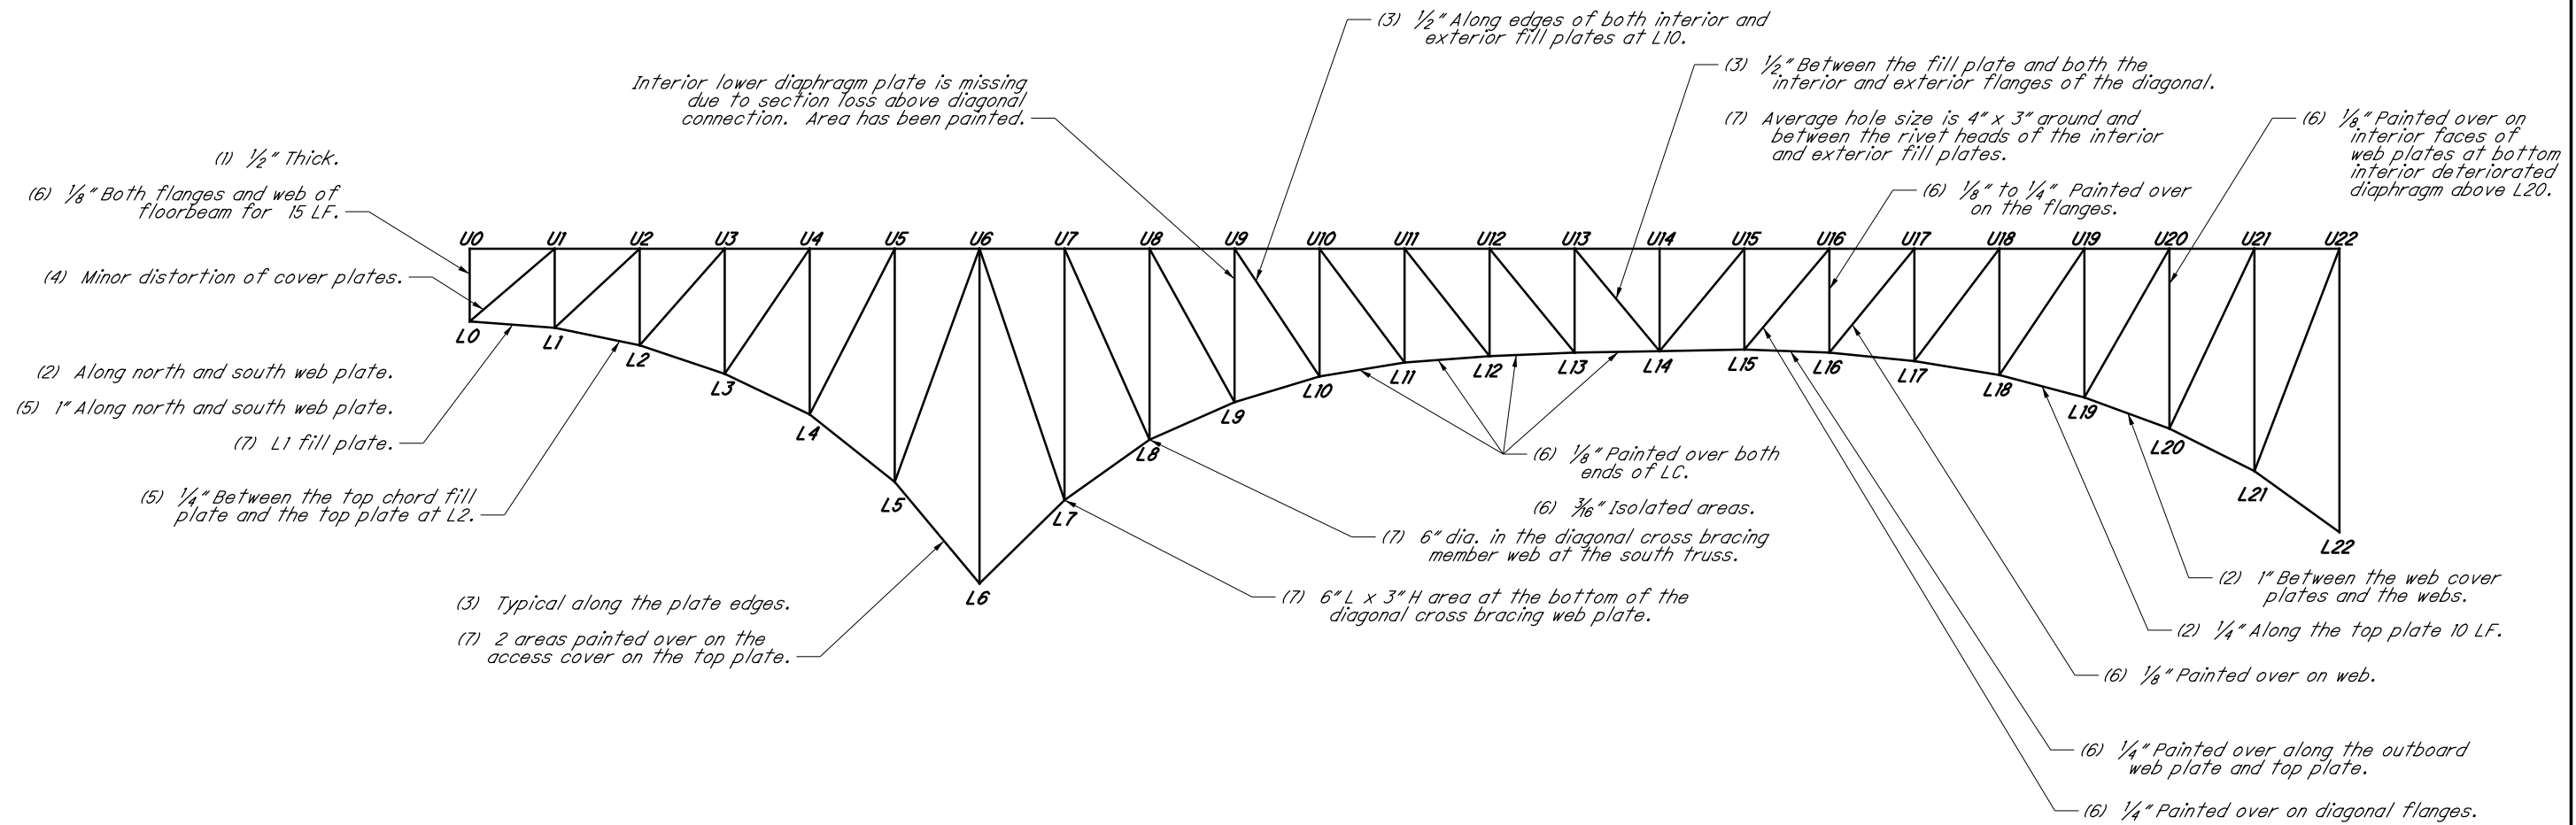
Floorbeam Deficiencies:

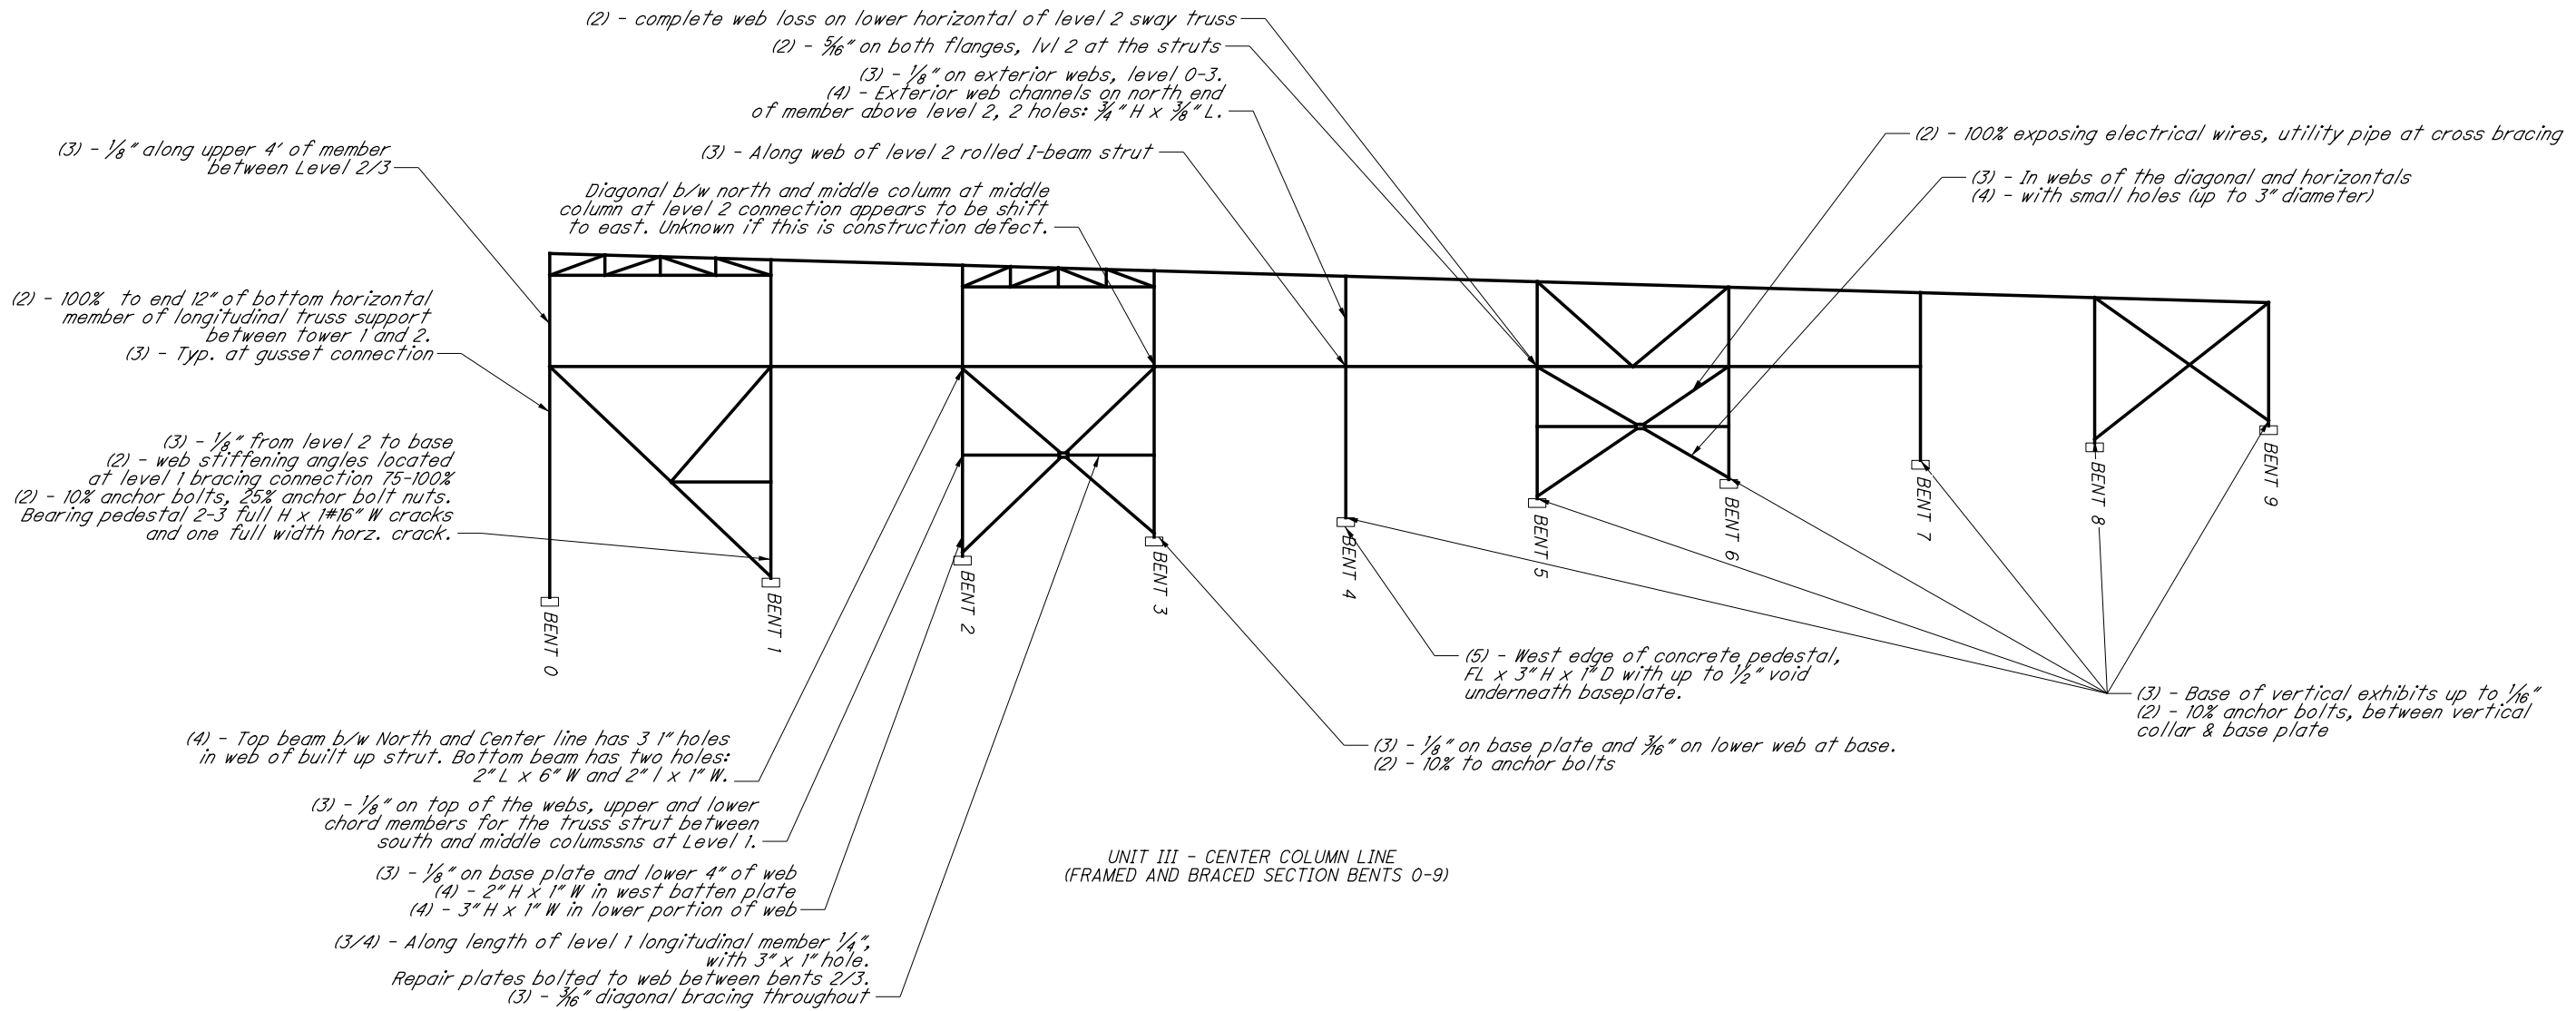
UNIT III - CENTER COLUMN LINE
(FRAMED AND BRACED SECTION BENTS 0-9)
