**Physical Condition Report for
CUY-002-1441
SFN 1800035
Main Avenue Bridge over the Cuyahoga River
2021 Routine and Fracture Critical Inspection**

Prepared for:

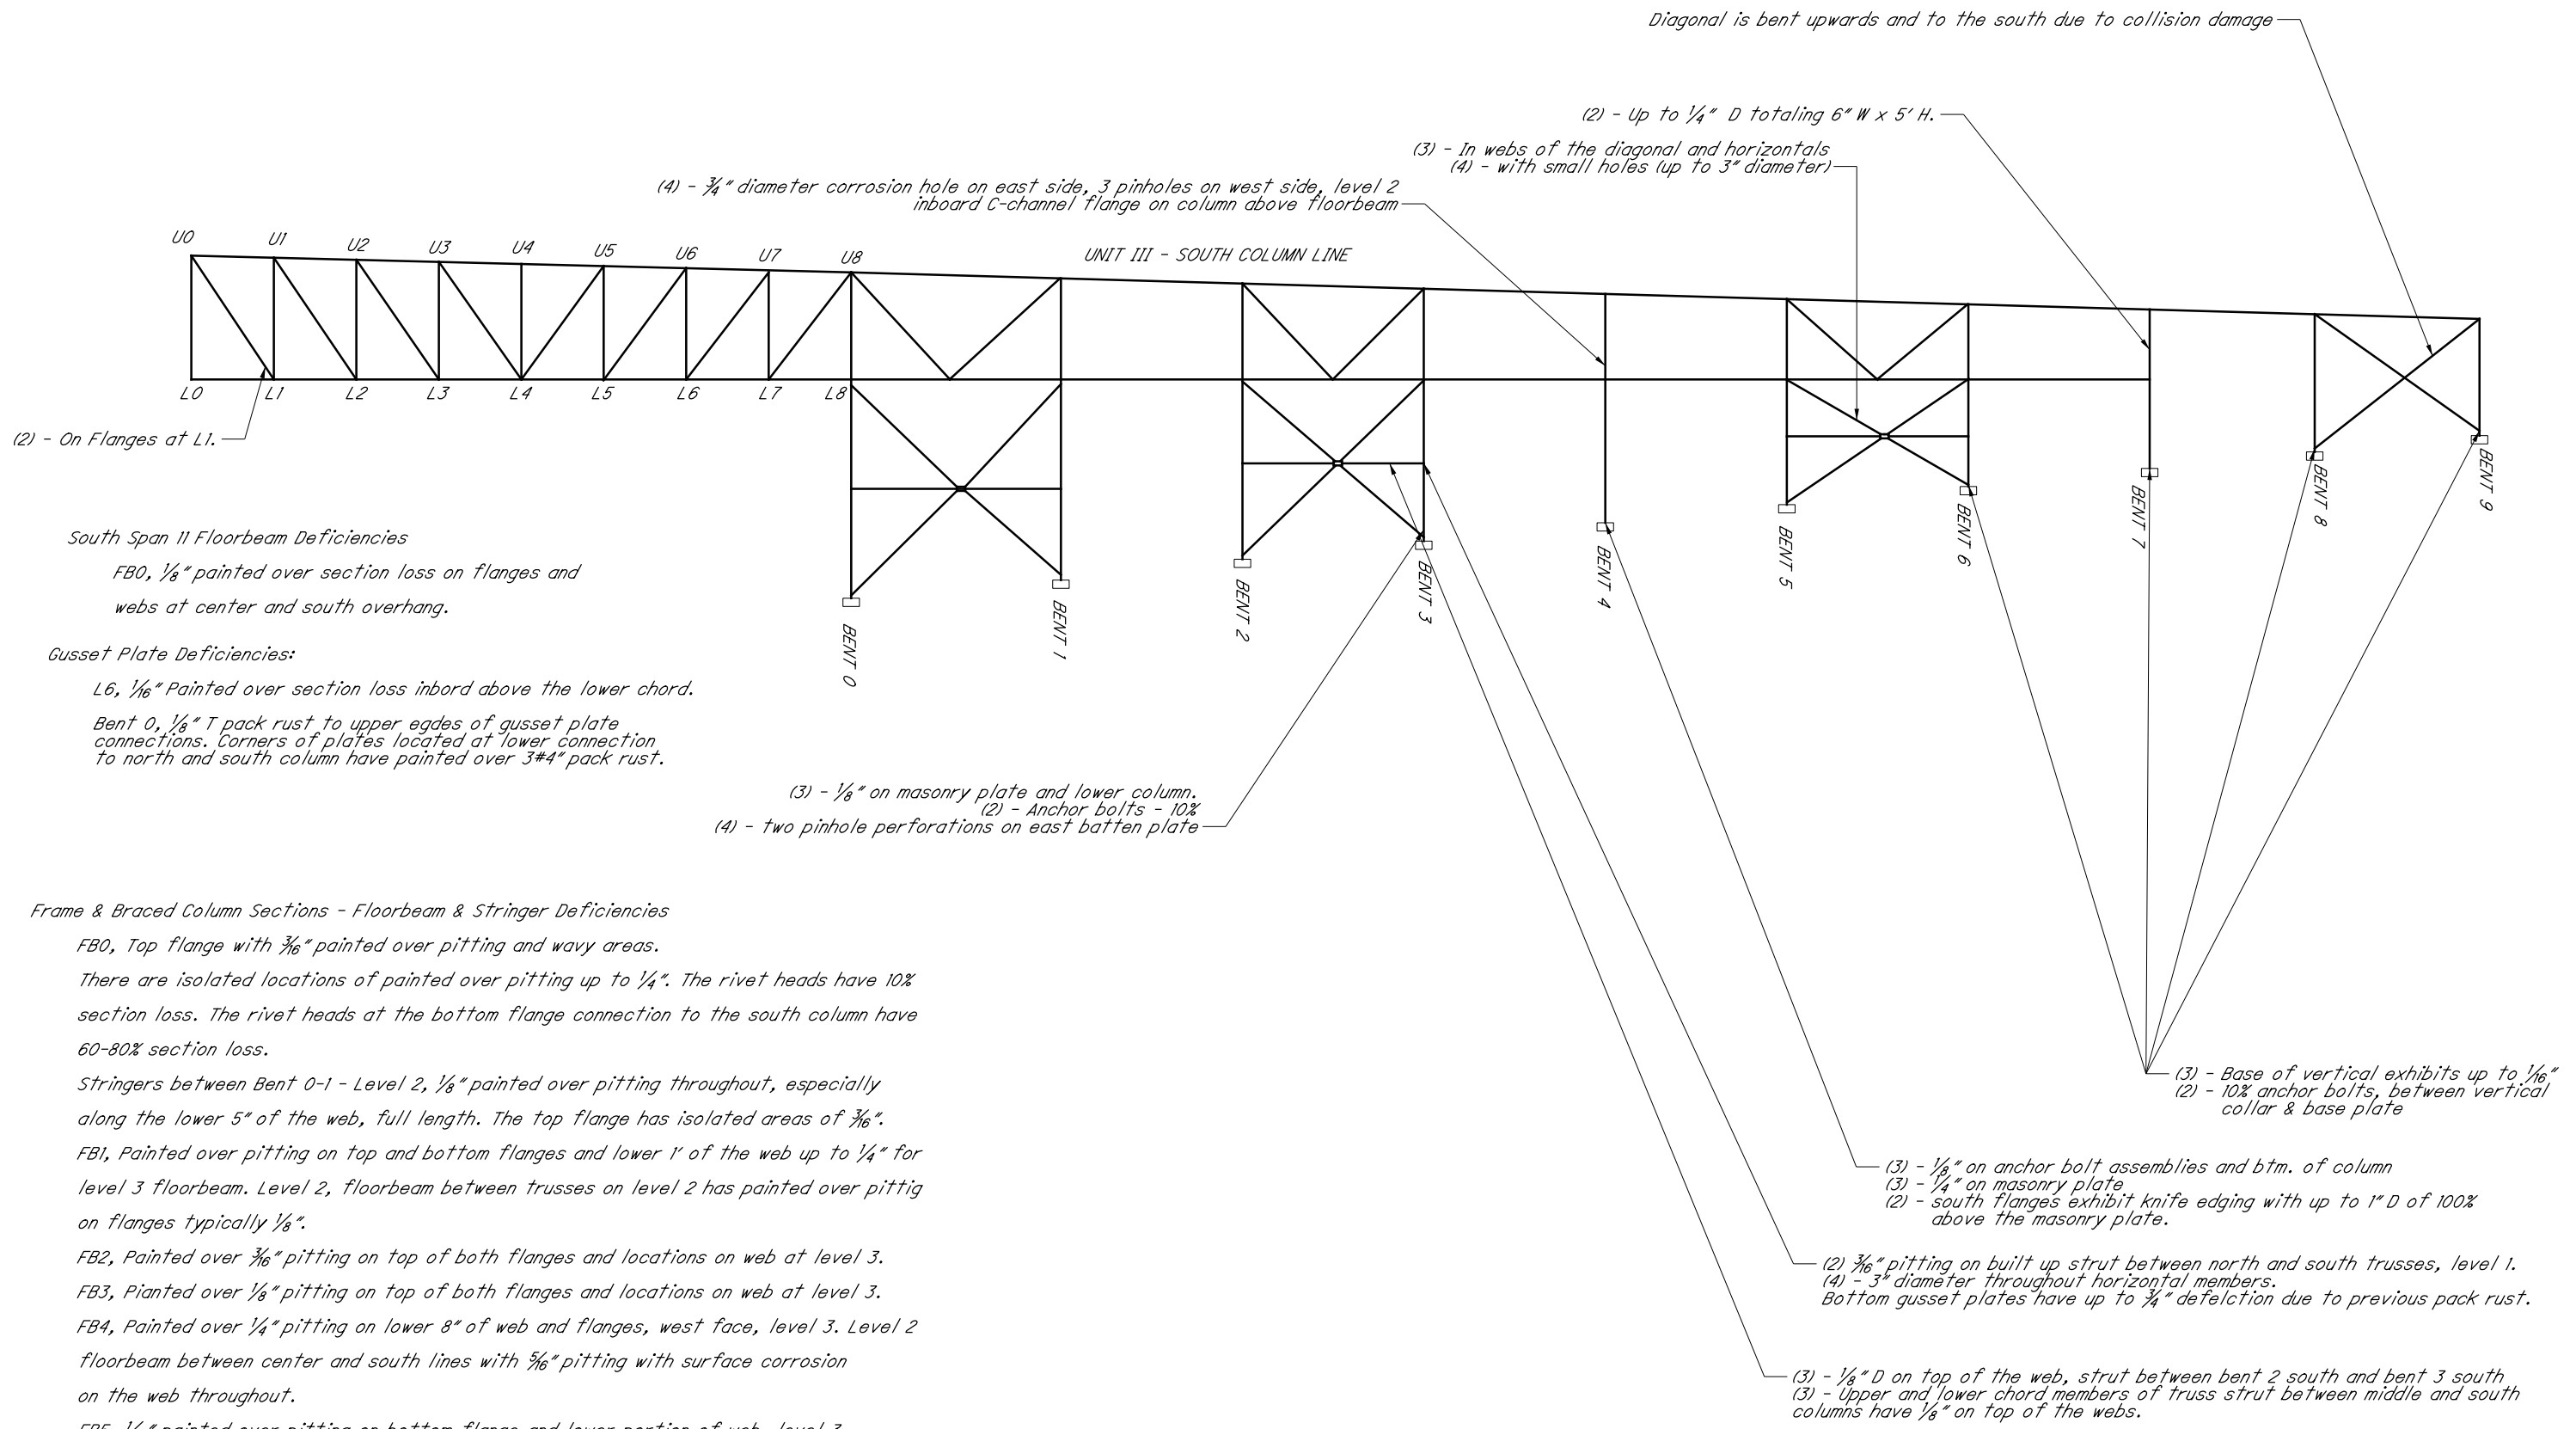
- LEGEND**
- 1 - Painted Over Pack Rust
 - 2 - Painted Over Section Loss
 - 3 - Painted Over Pitting
 - 4 - Corrosion Hole(s)
