**Physical Condition Report for
CUY-002-1441
SFN 1800035
Main Avenue Bridge over the Cuyahoga River
2020 Routine Inspection**

Prepared for:

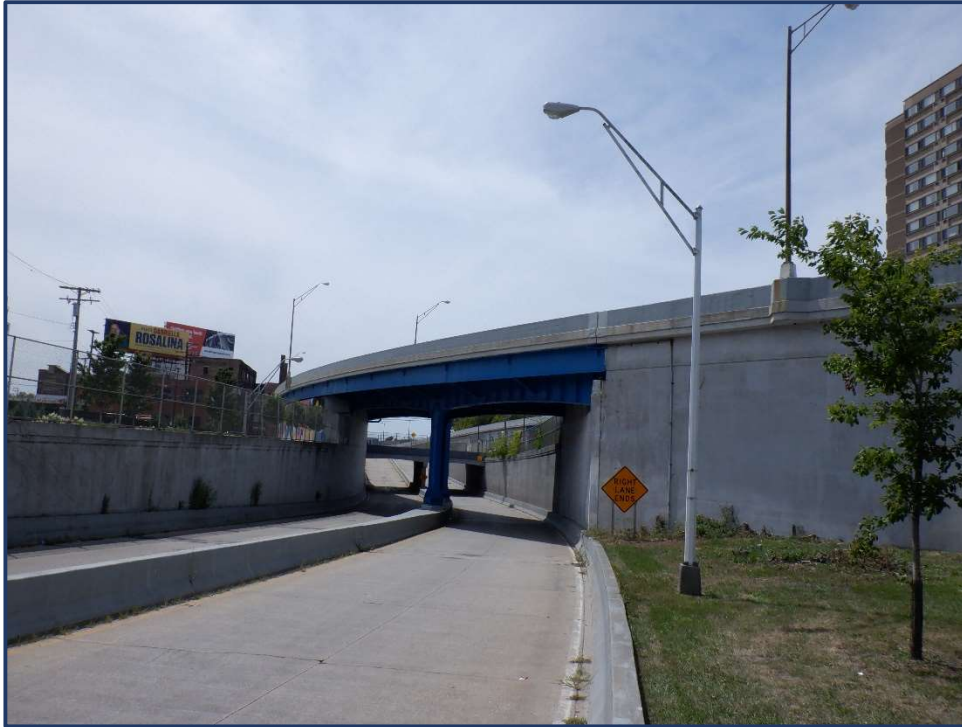
West 28th Street Overpass Looking West

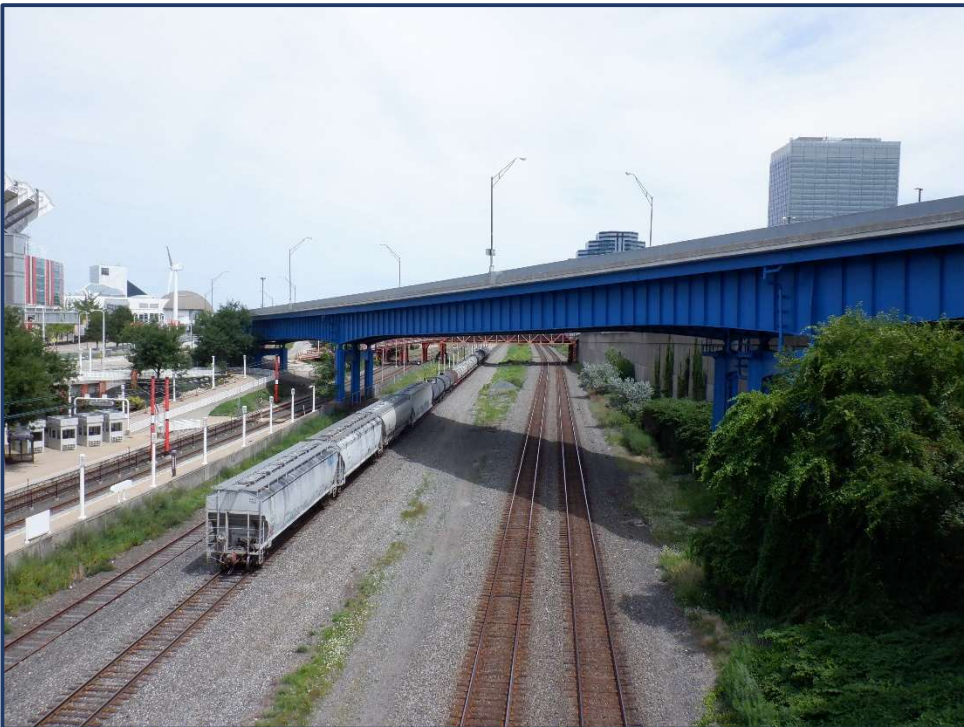
Unit V Lakefront Ramp Over CSX and NS Railroad Tracks Looking East

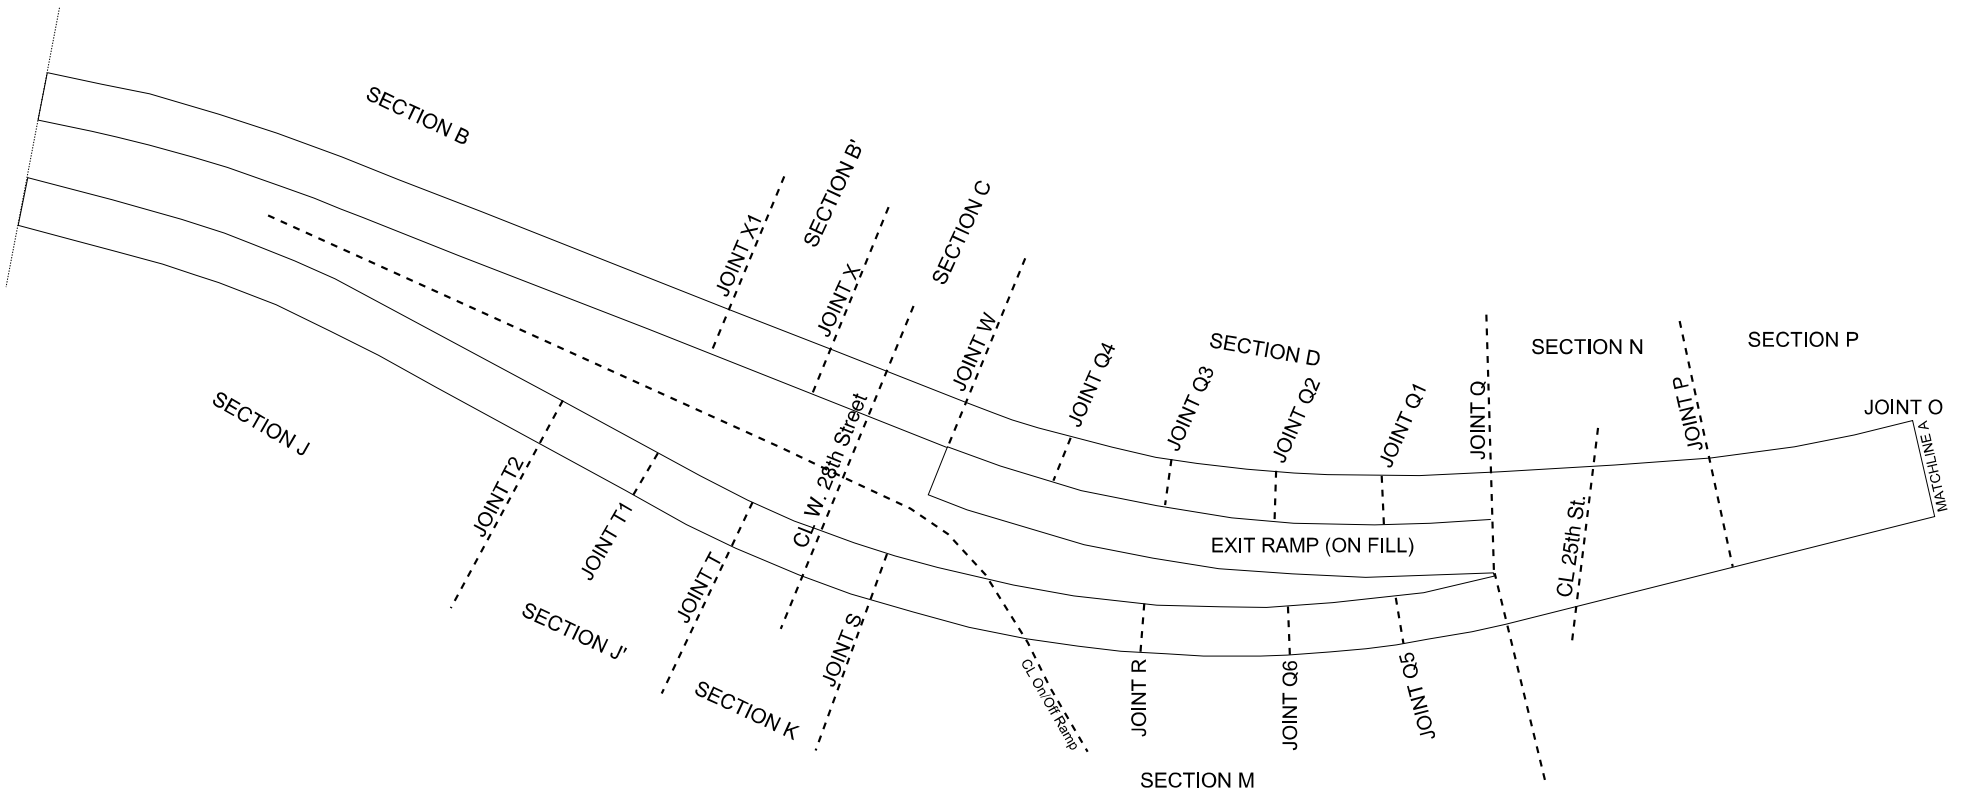
PLAN: WEST APPROACH - UNIT I

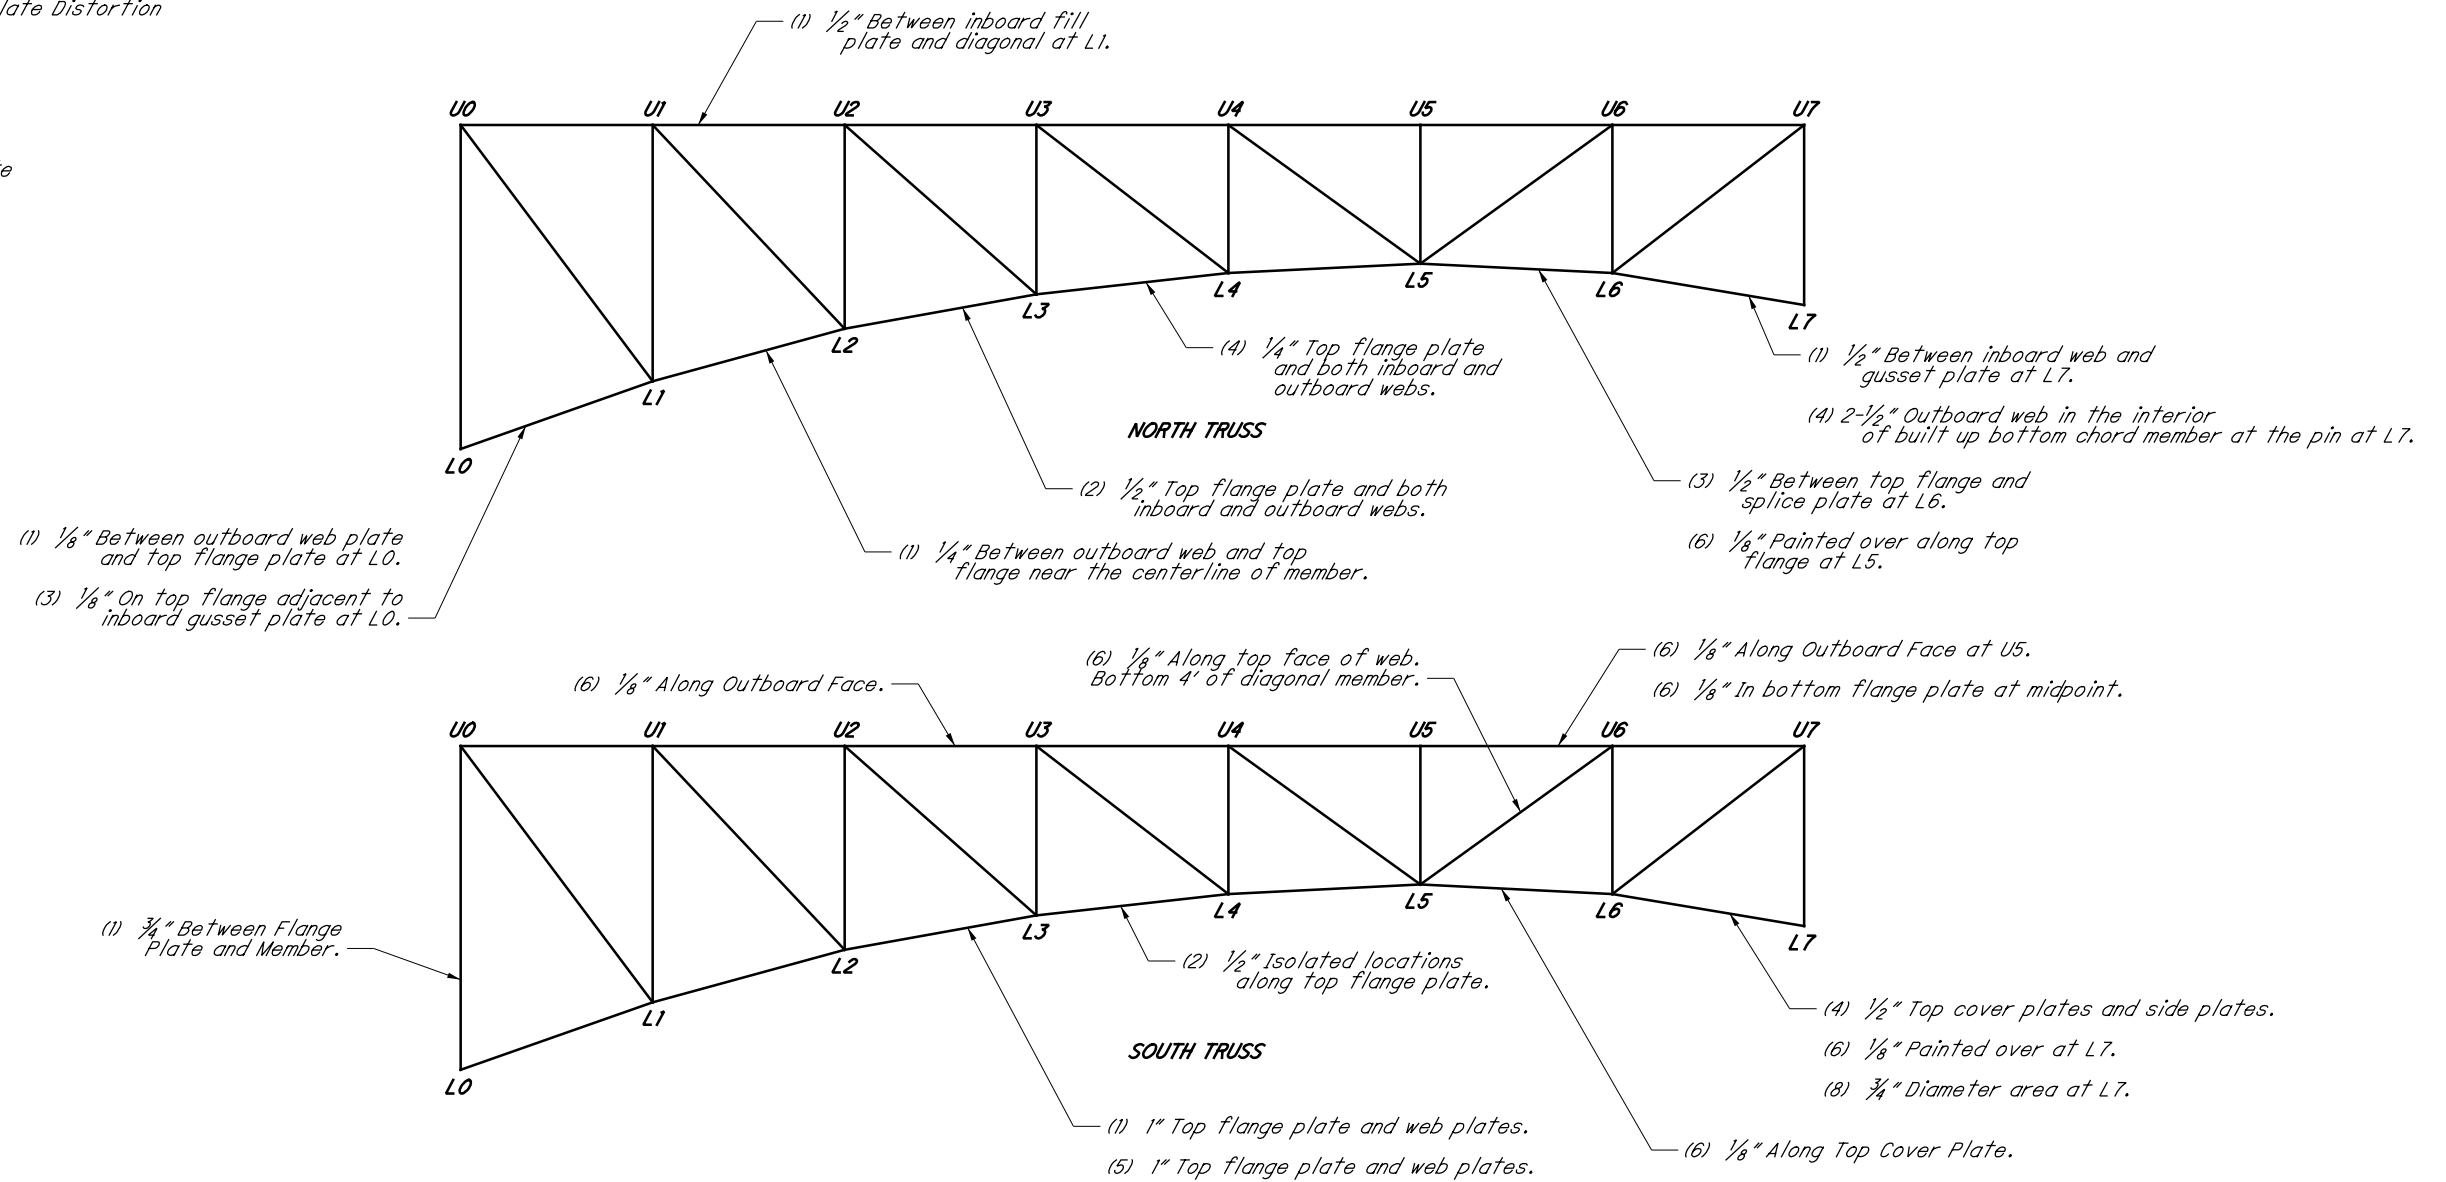
Floorbeam Deficiencies:

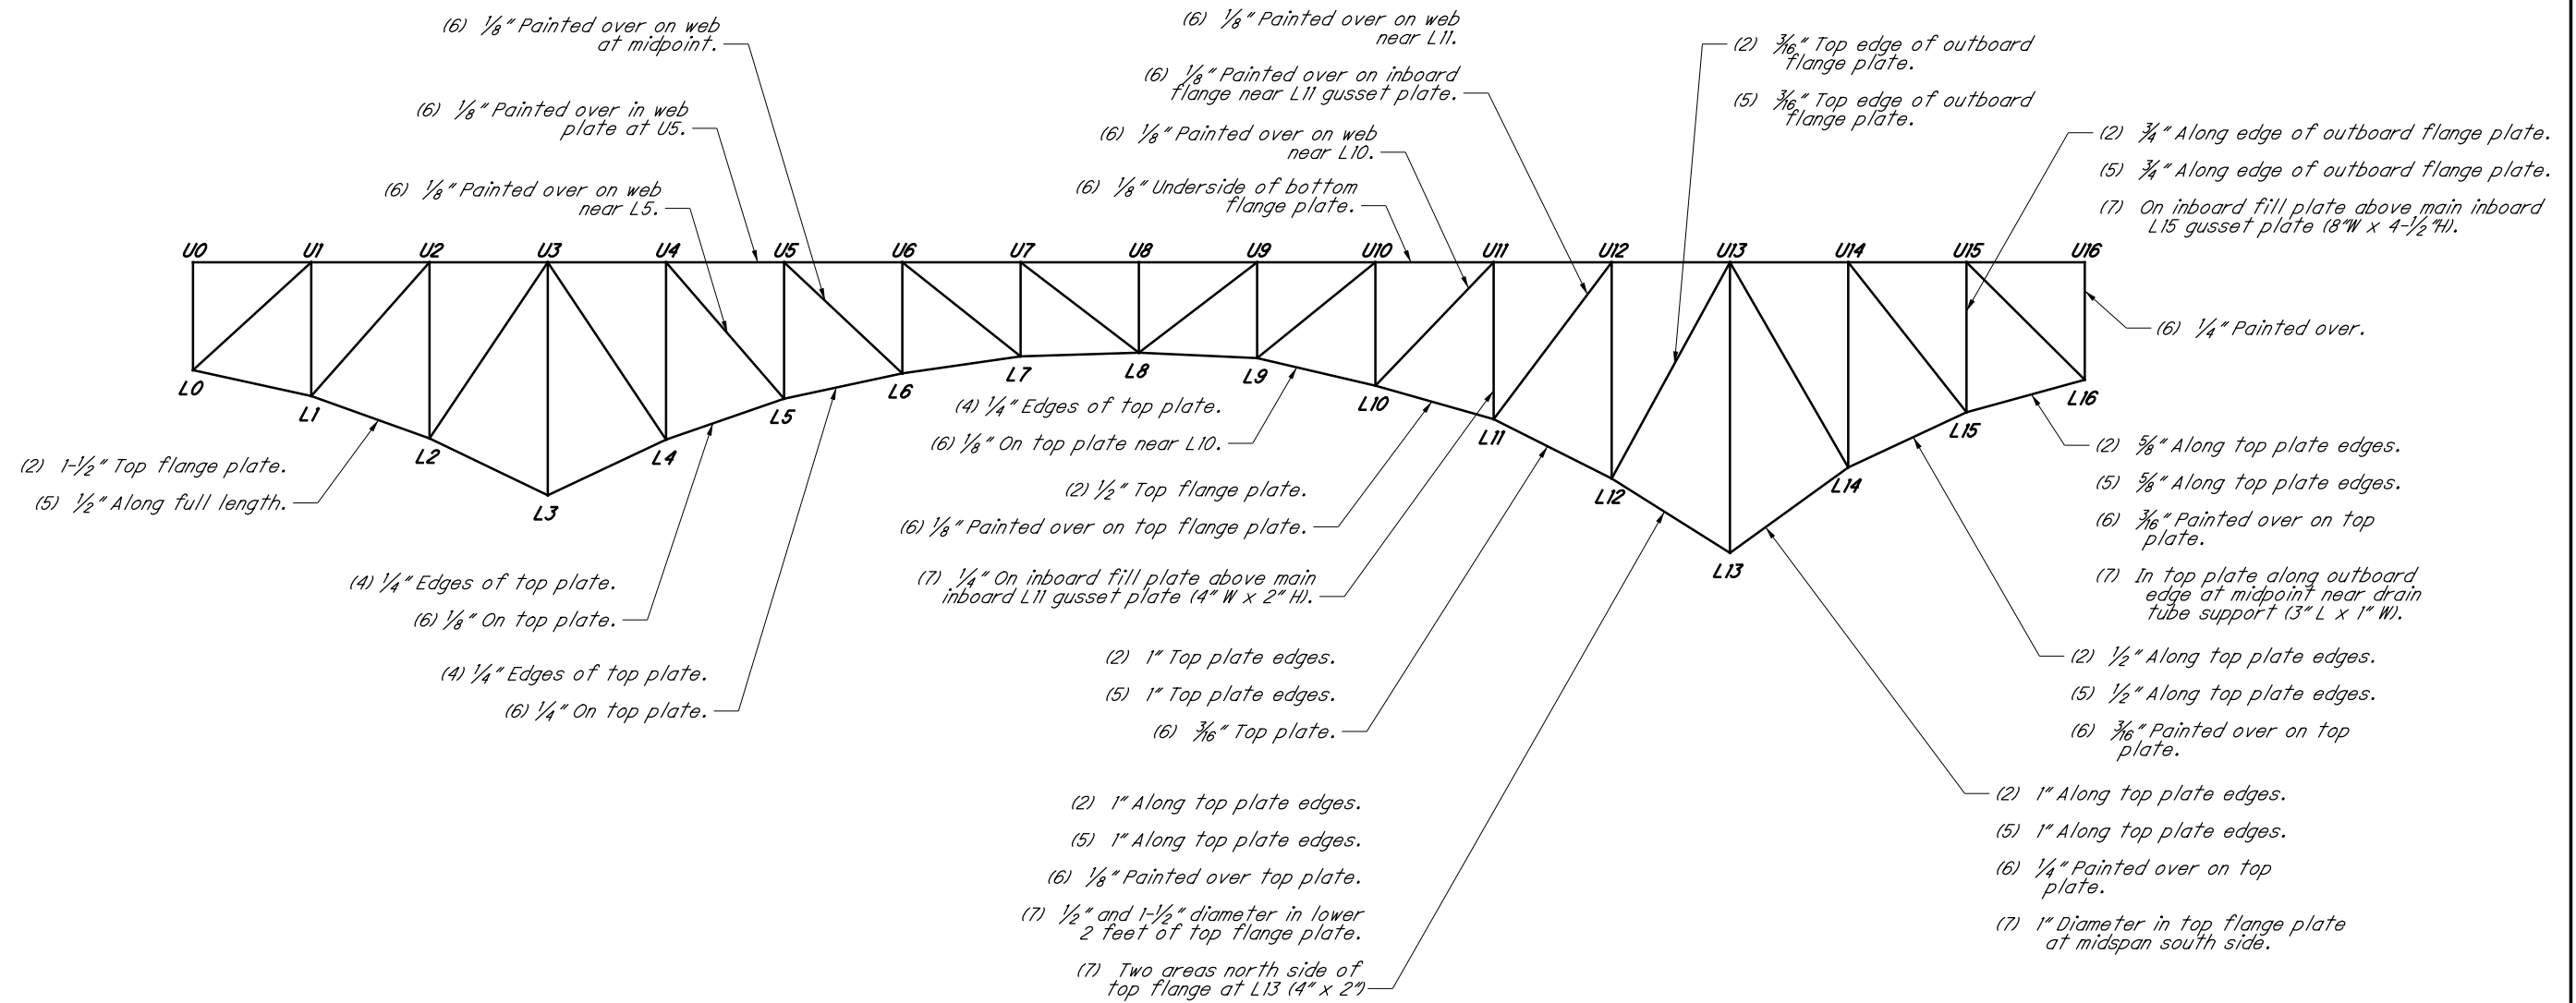
MAIN AVENUE OVER CUYAHOGA RIVER BRIDGE NO. CUY-2-14.41	
NOT TO SCALE			TRUSS ELEVATION - SPAN 1	PAGE B-1

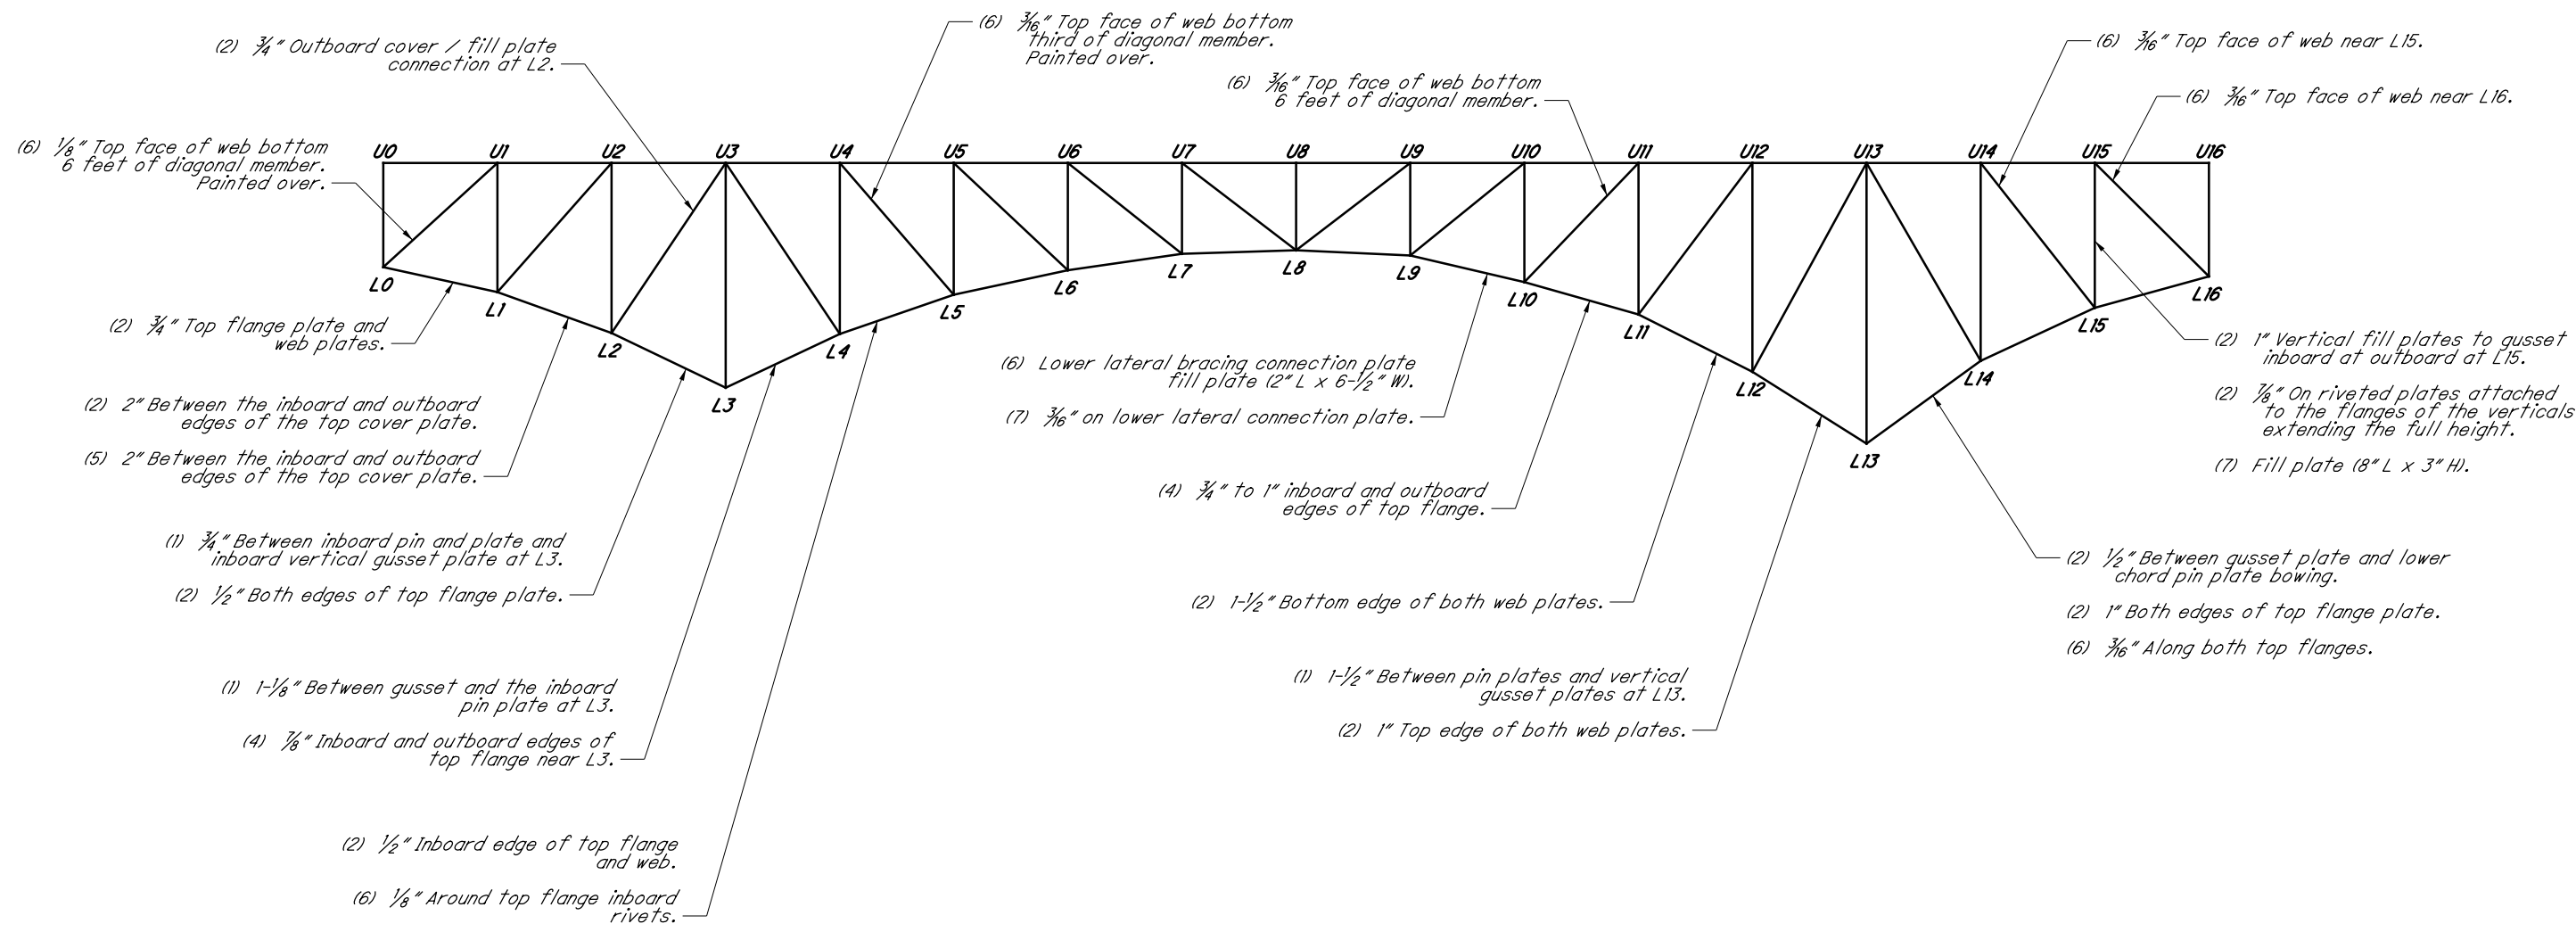
South Truss Gusset Plate Deficiencies:

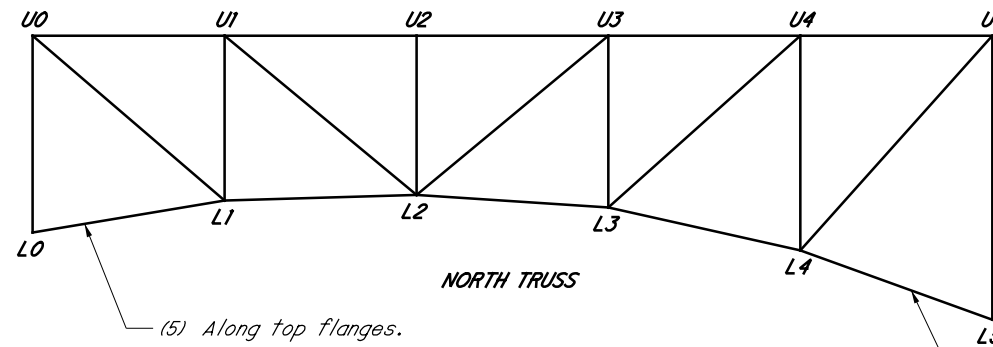
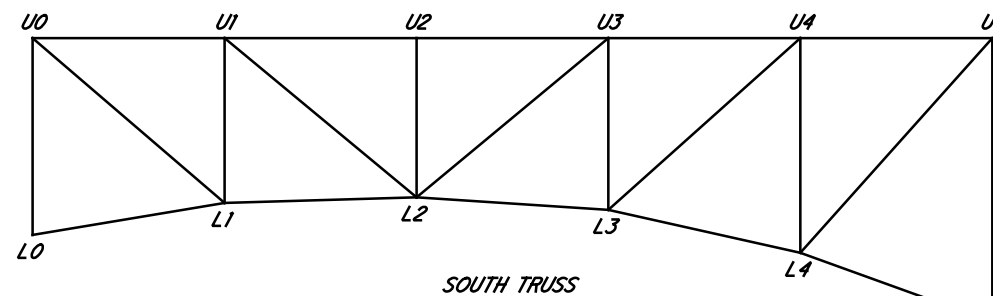
South Truss Gusset Plate Deficiencies:

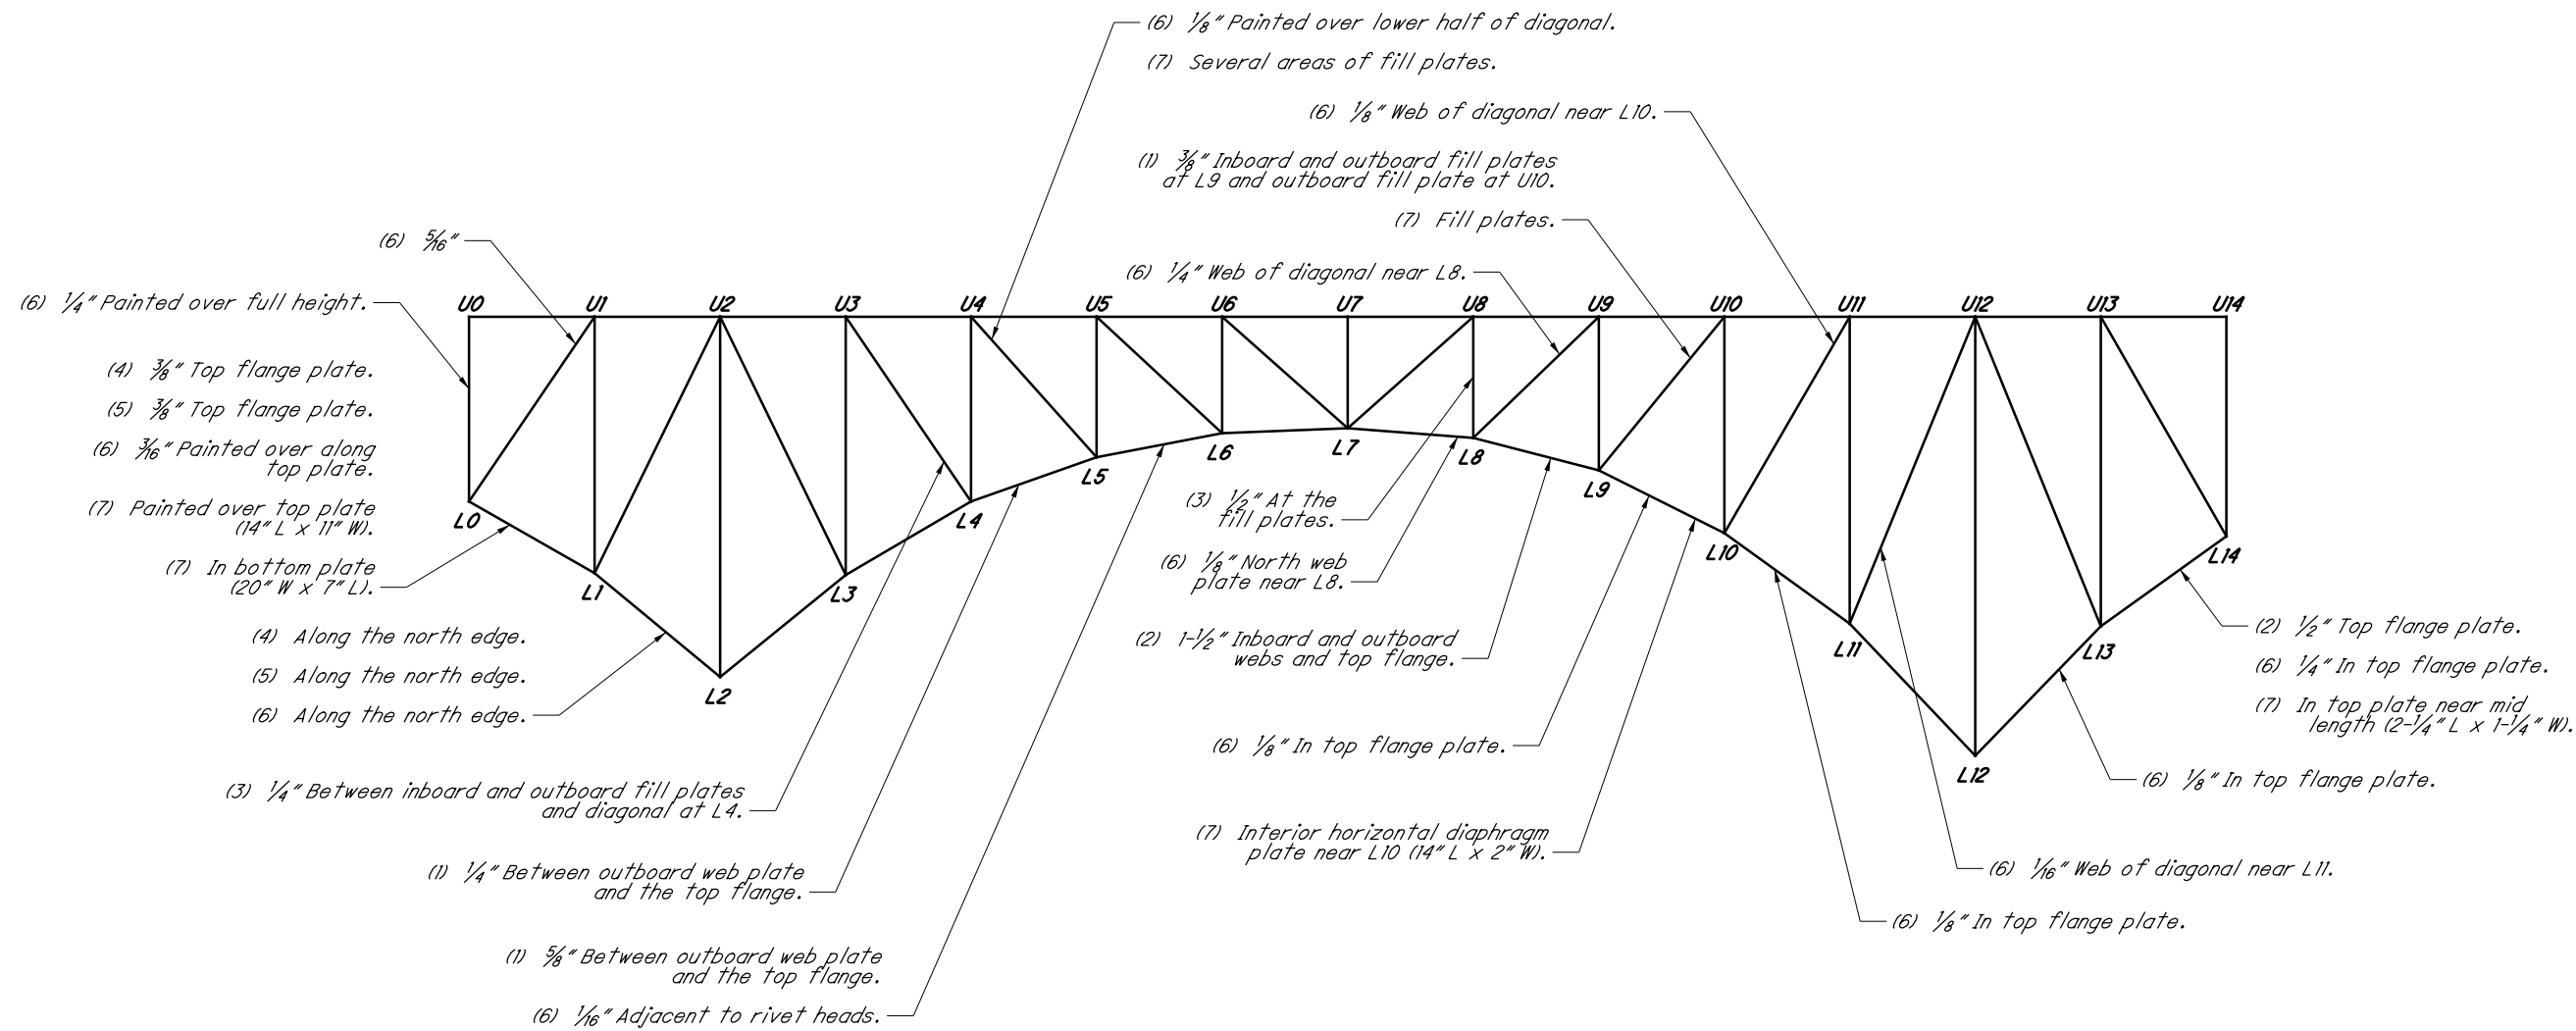
PATRICK ENGINEERING	MAIN AVENUE OVER CUYAHOGA RIVER BRIDGE NO. CUY-2-14.41	
NOT TO SCALE			TRUSS ELEVATION - SPAN 3	PAGE B-3

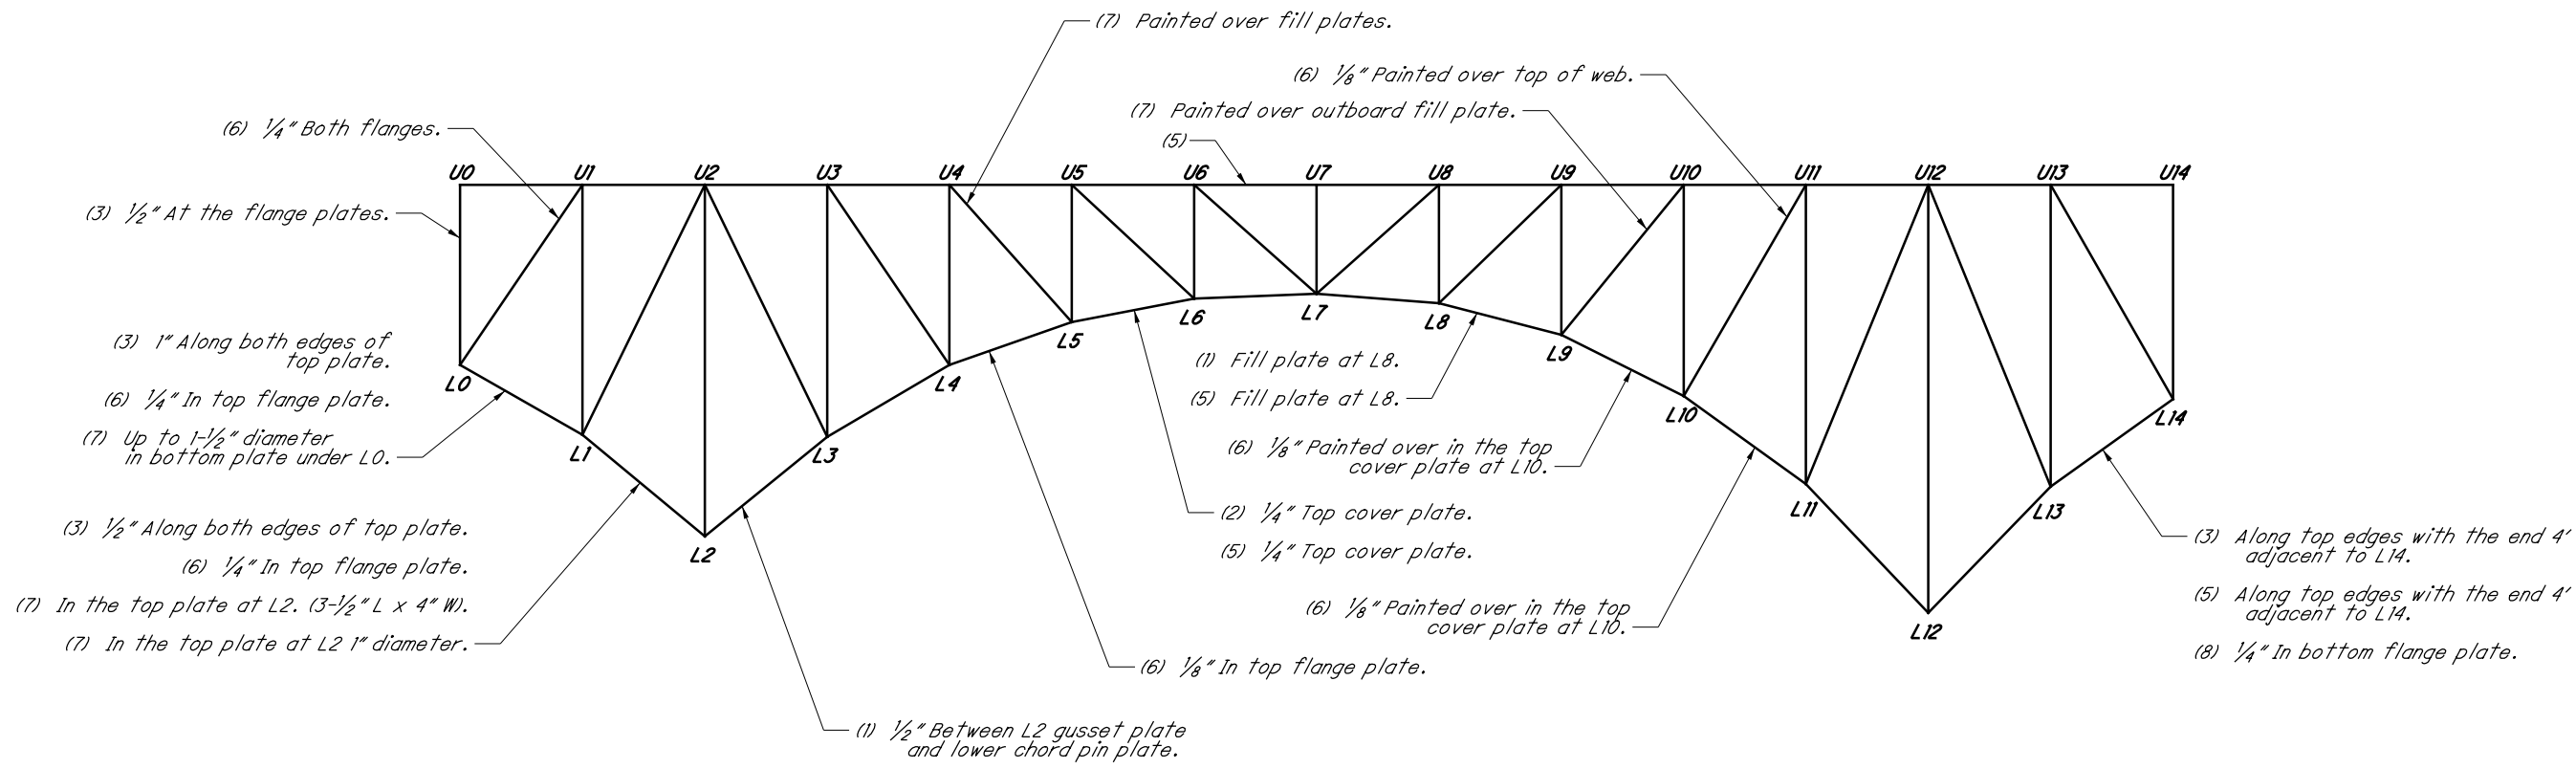
MAIN AVENUE OVER CUYAHOGA RIVER BRIDGE NO. CUY-2-14.41	
NOT TO SCALE			TRUSS ELEVATION - SPAN 4 NORTH	PAGE B-4

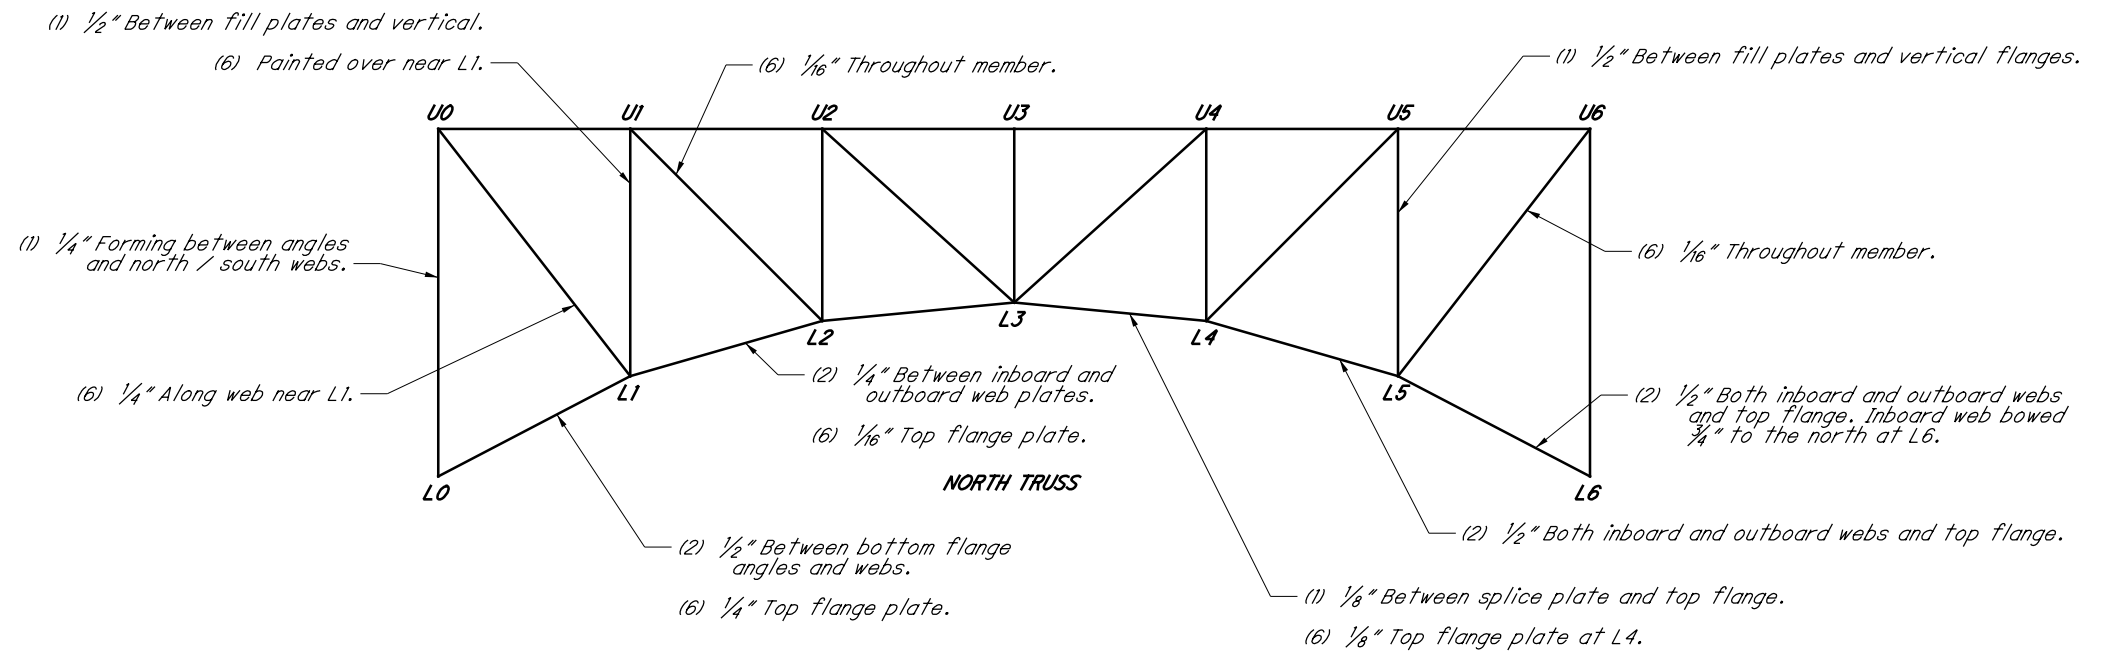
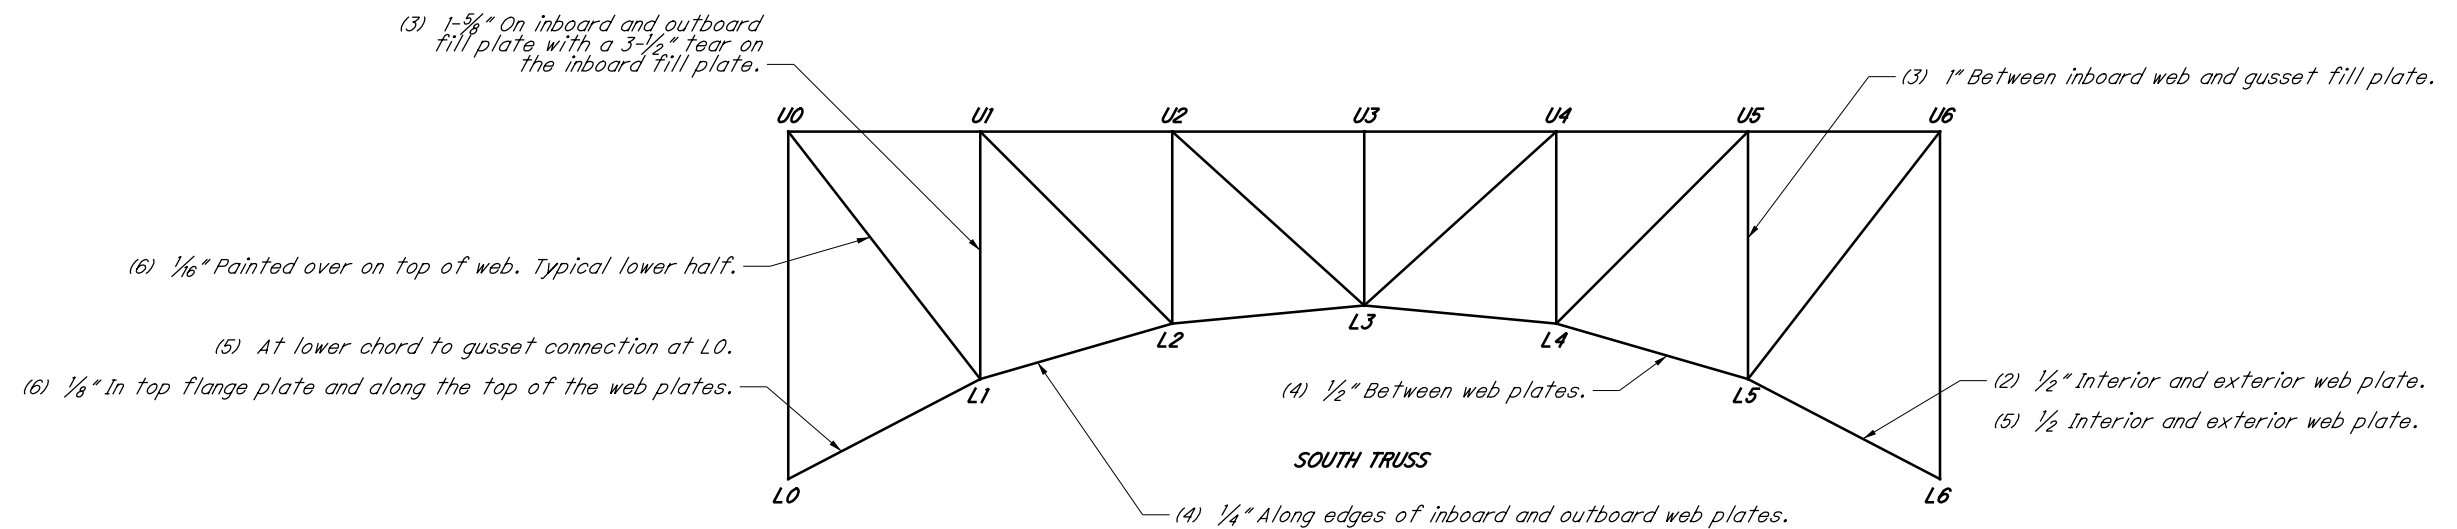
South Truss Gusset Plate Deficiencies:

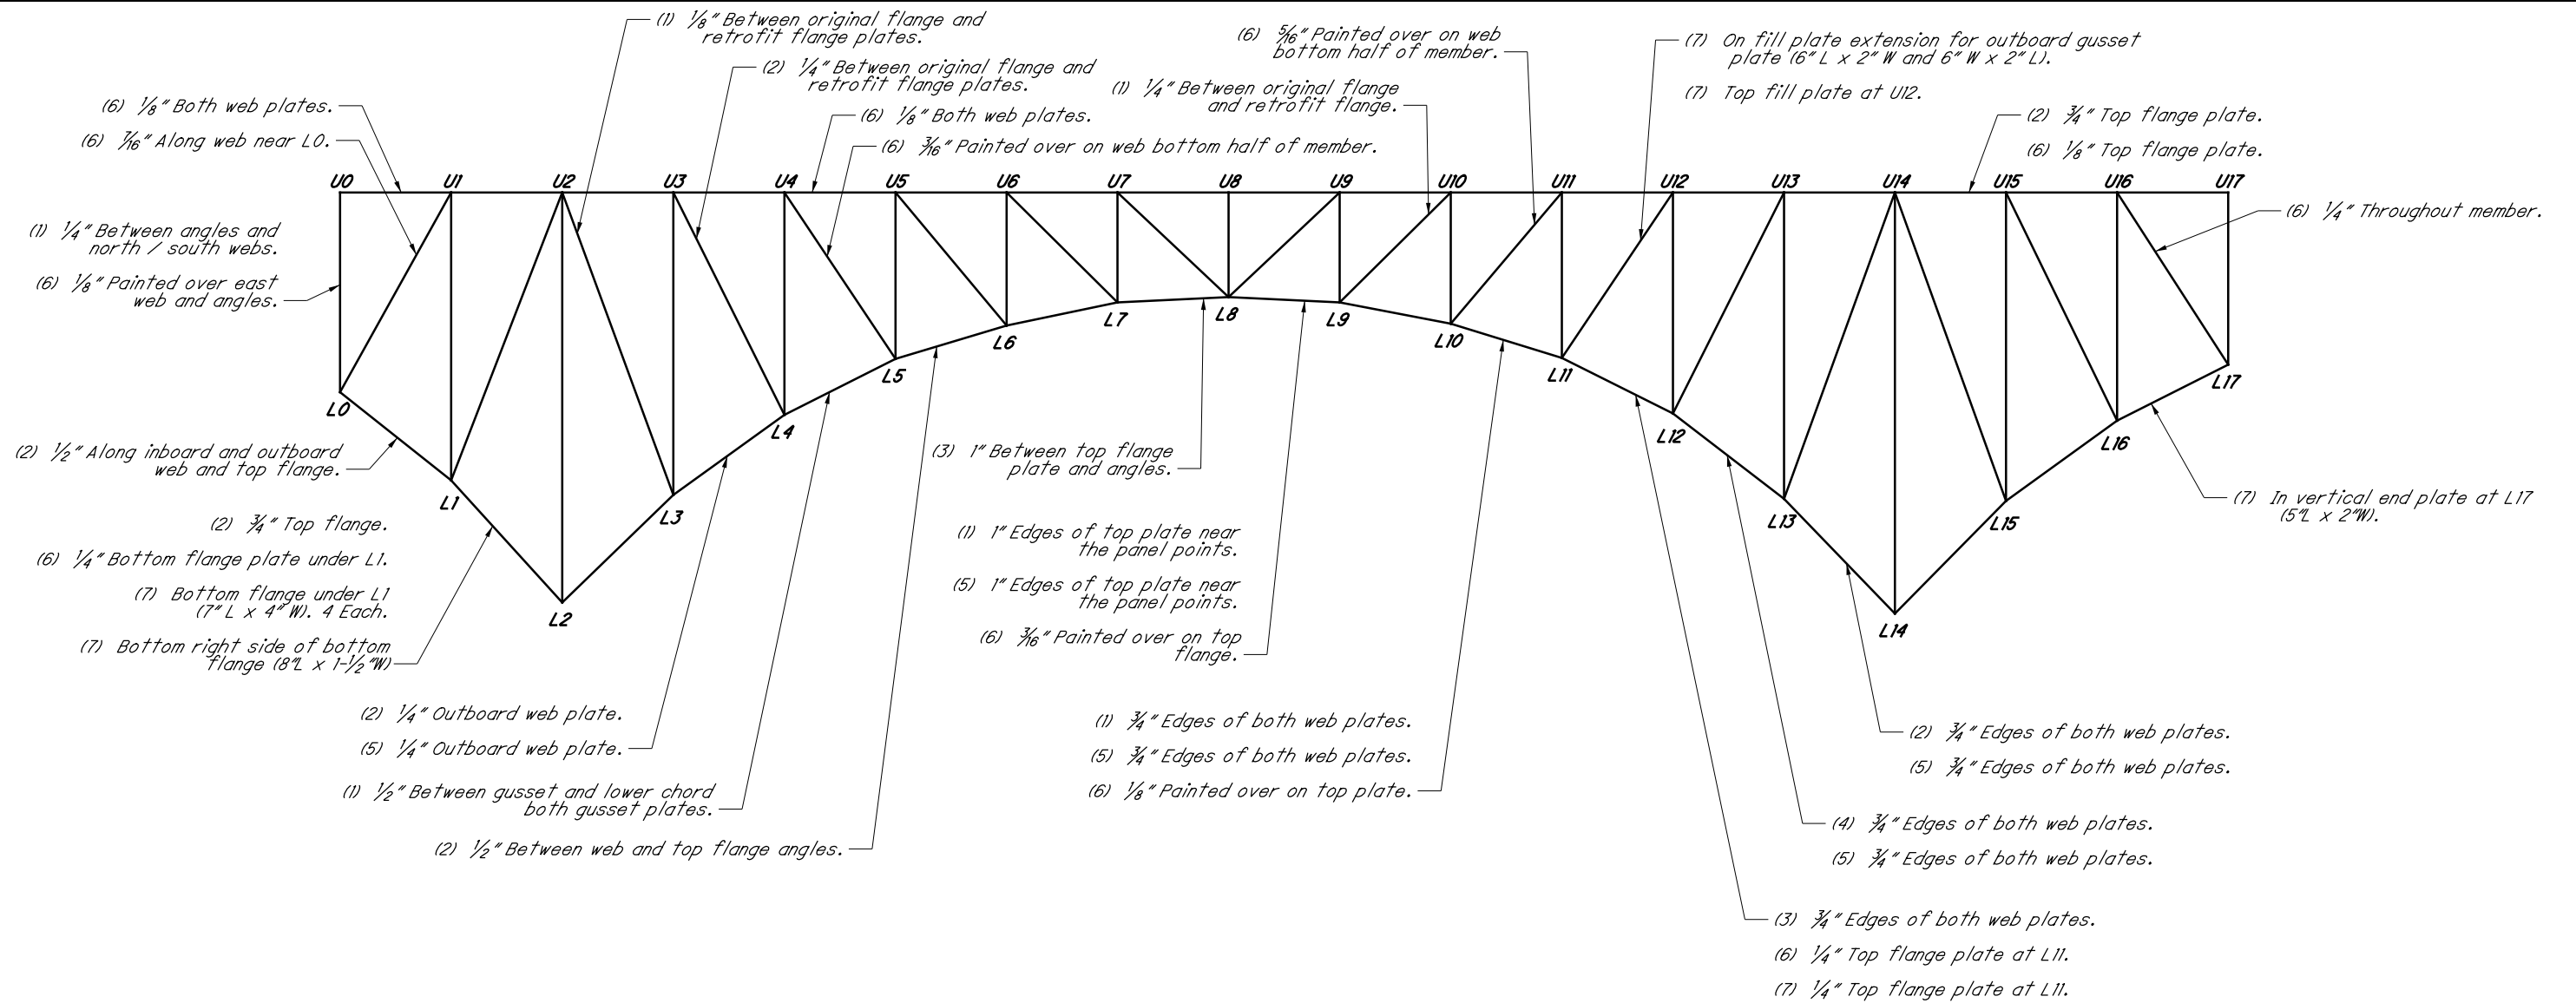
Floorbeam Deficiencies:
