**Physical Condition Report for
CUY-002-1441
SFN 1800035
Main Avenue Bridge over the Cuyahoga River
2020 Routine Inspection**

Prepared for:

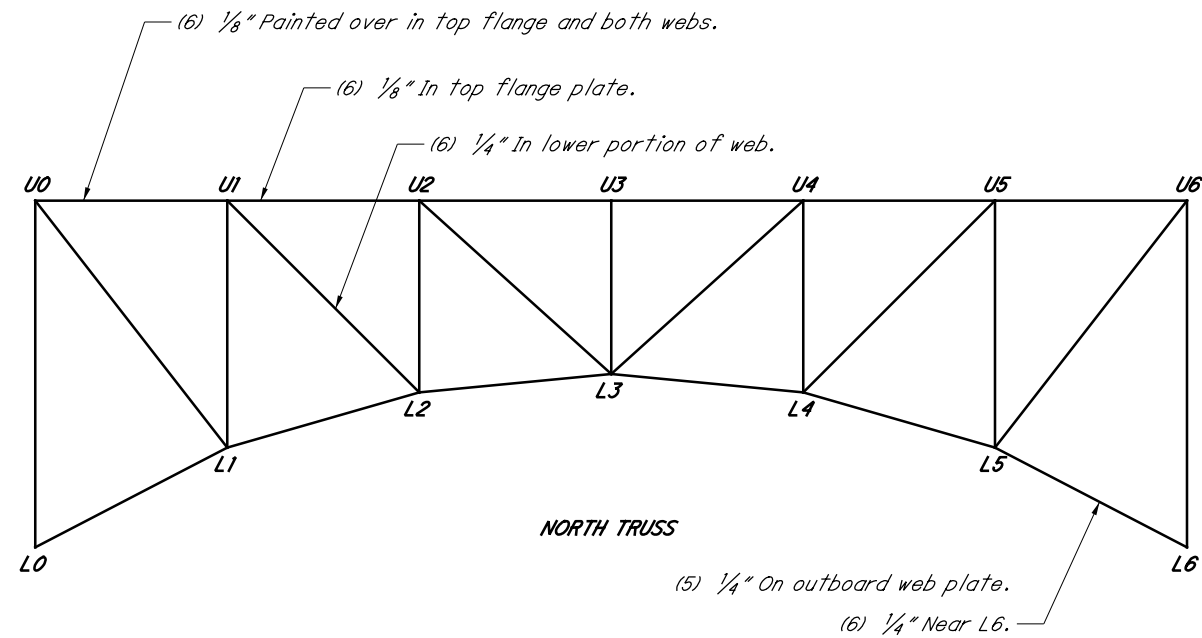
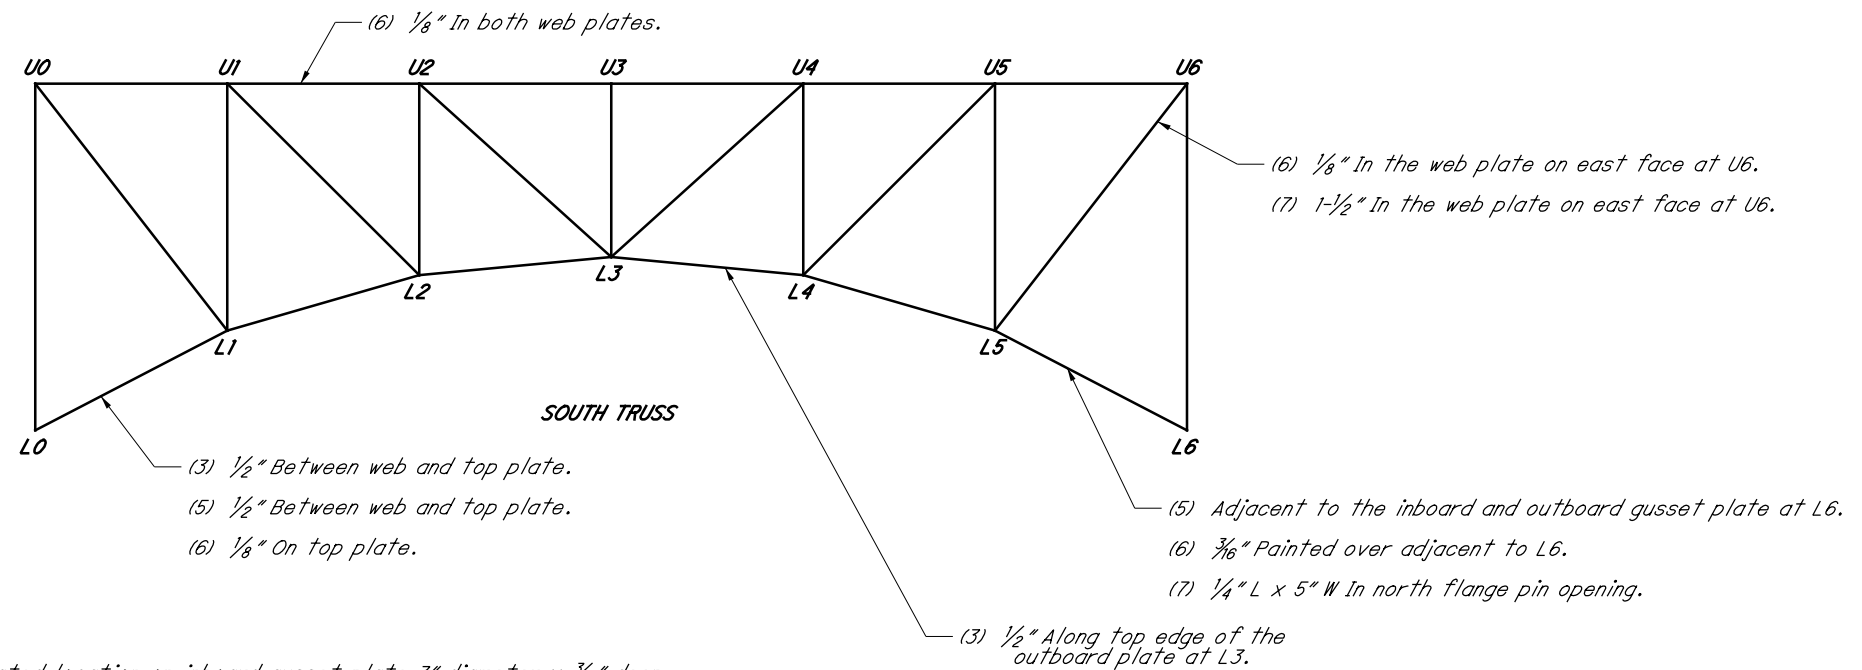
South Truss Gusset Plate Deficiencies:

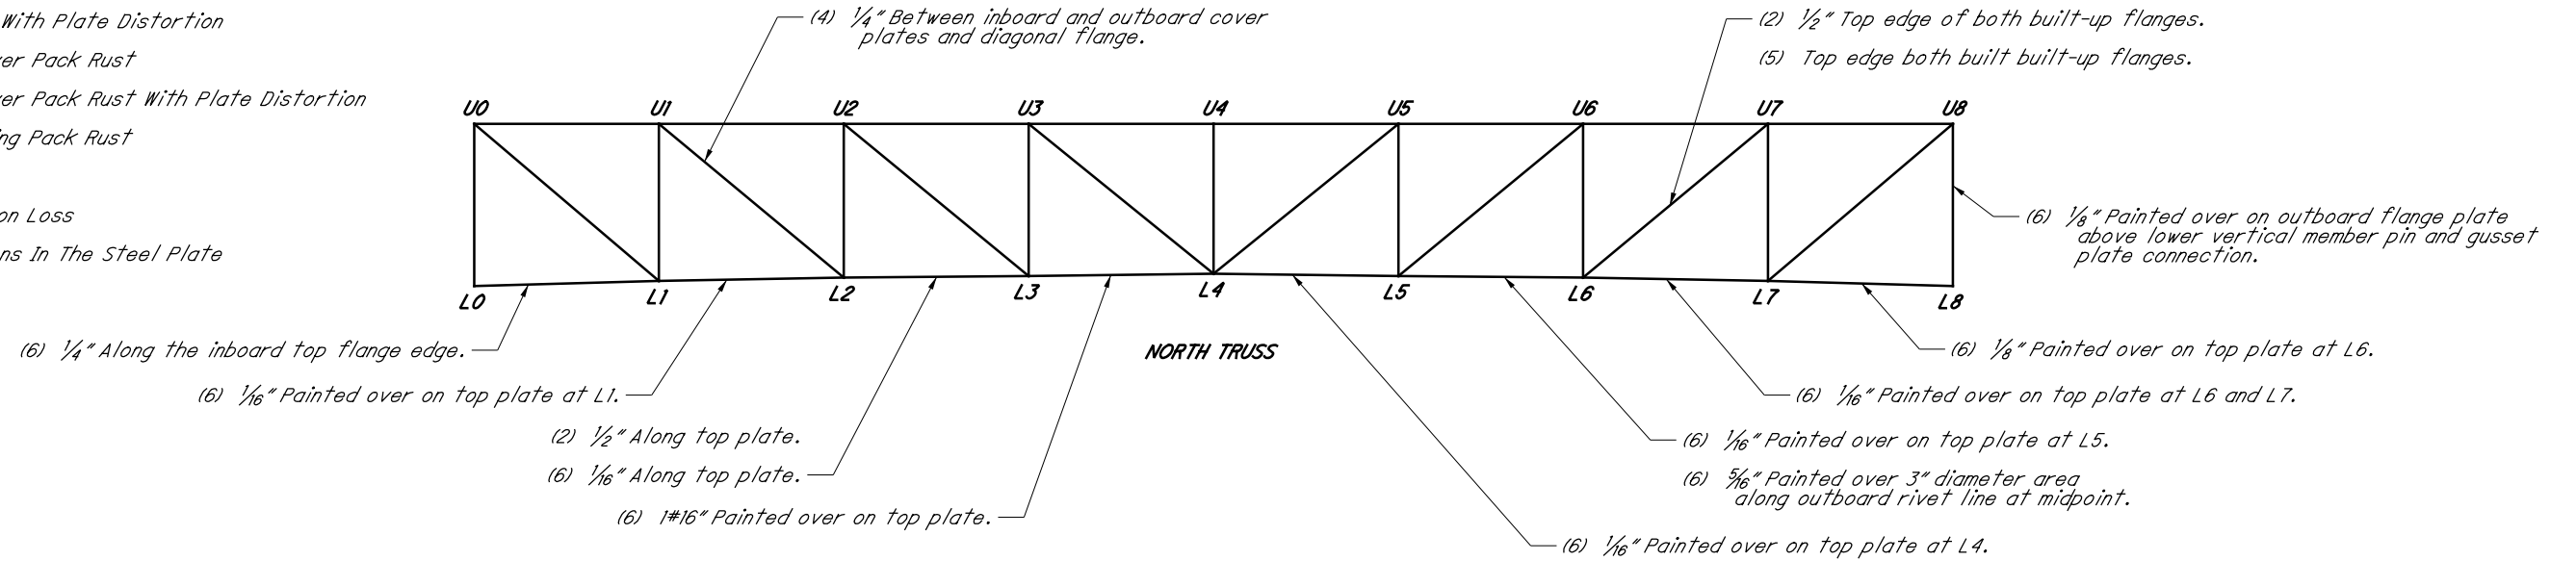
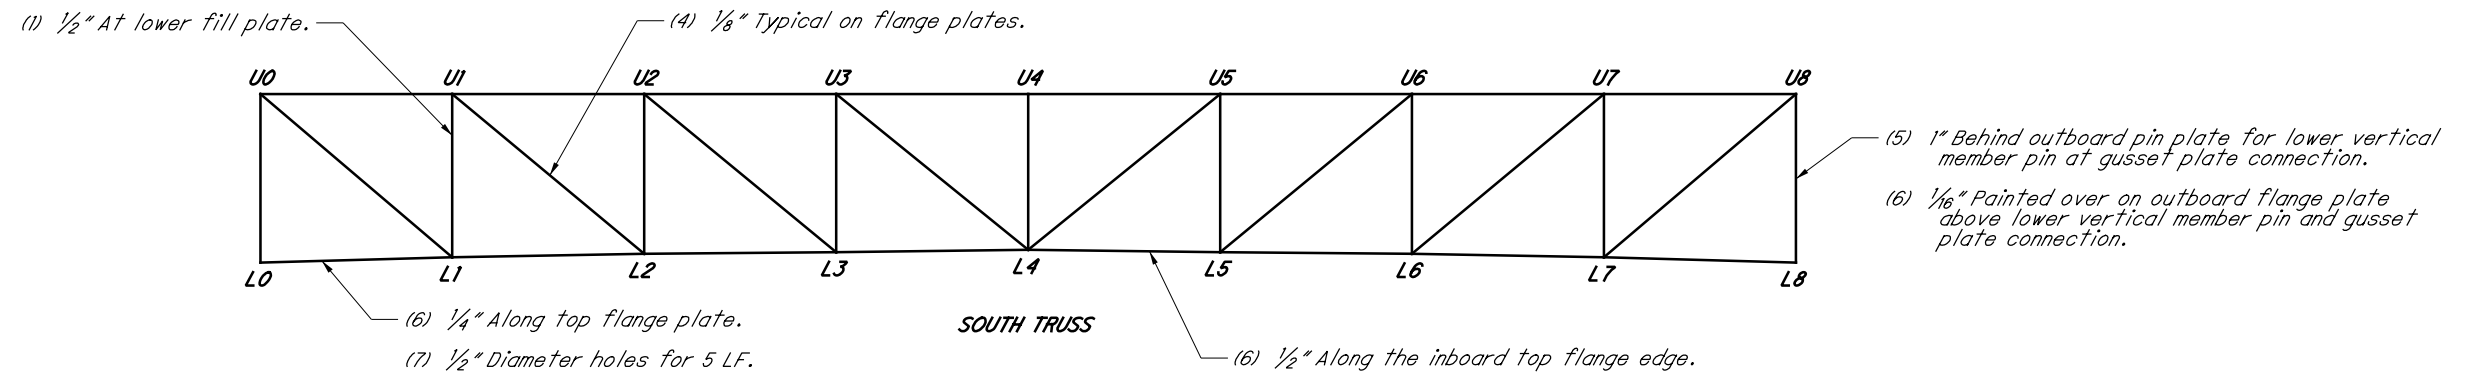
Floorbeam Deficiencies:

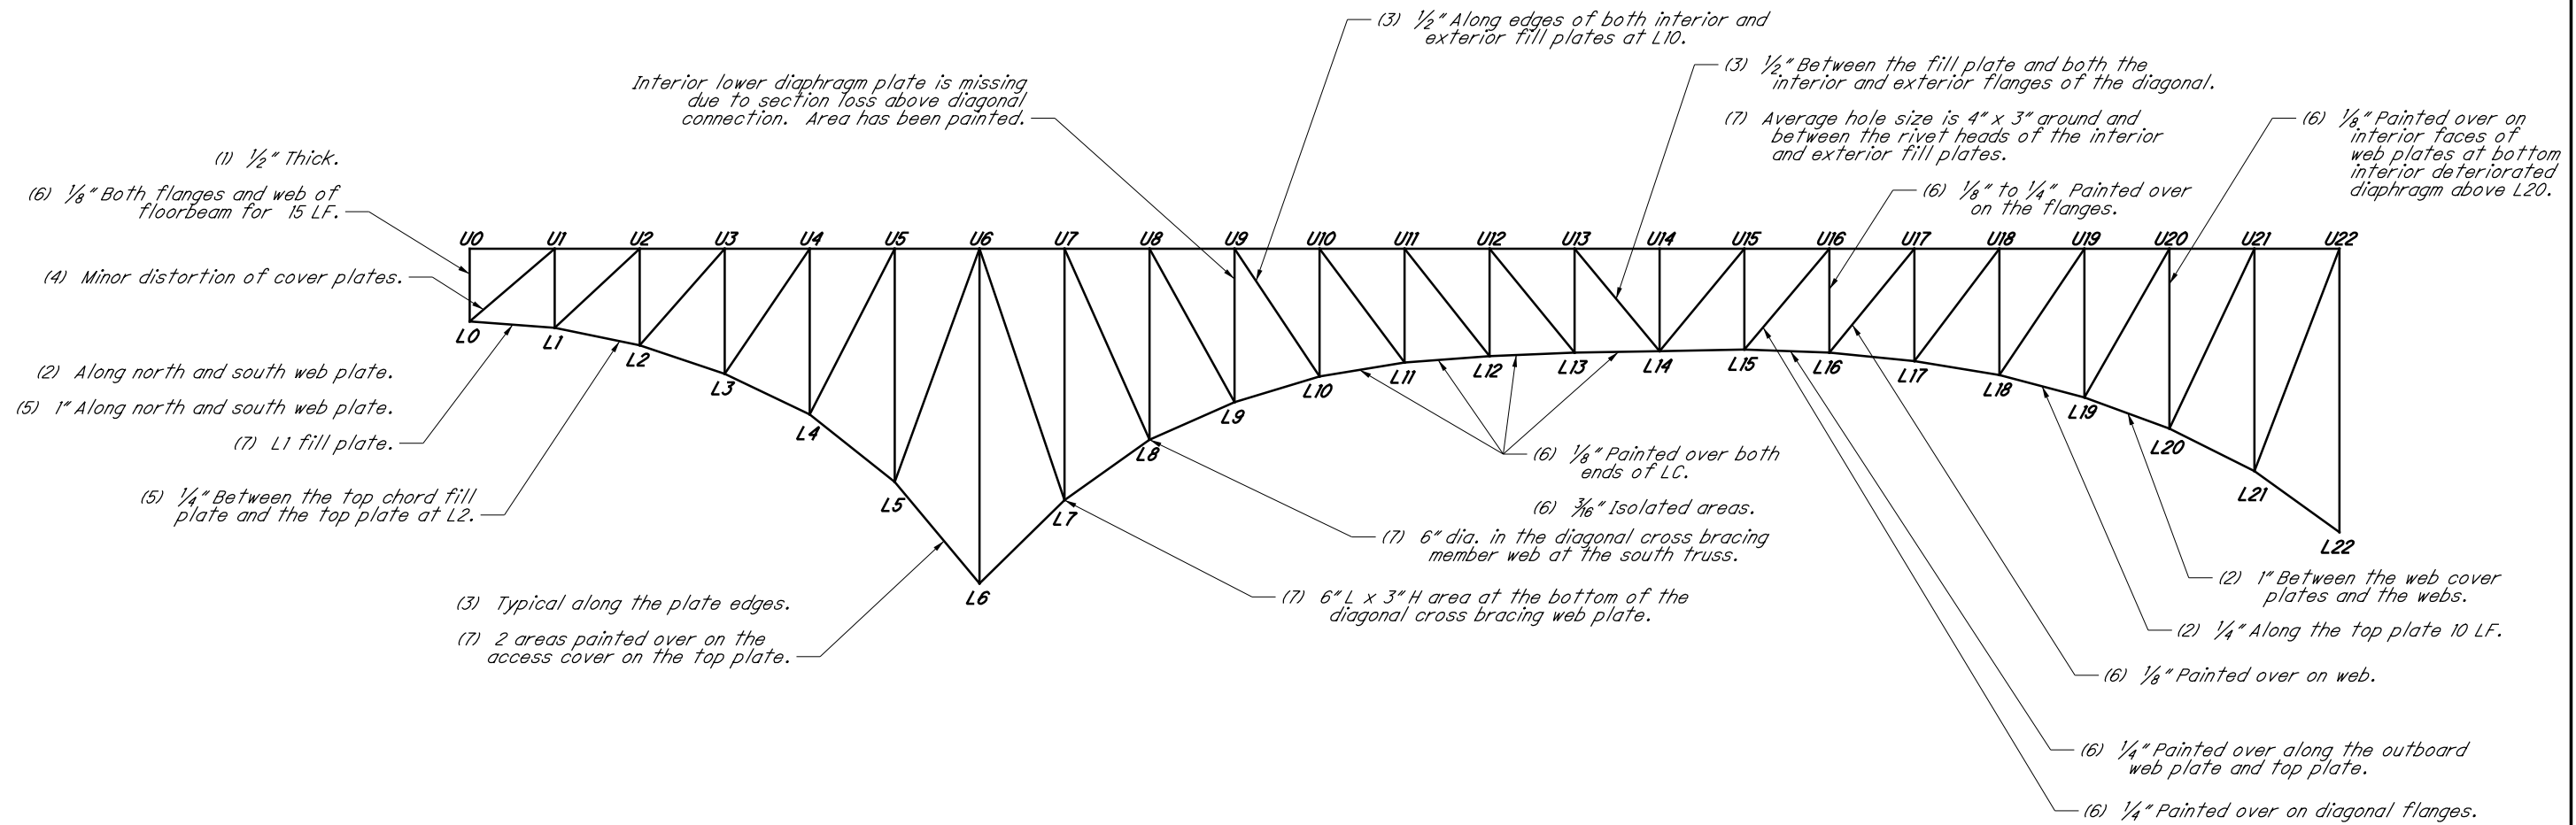
Floorbeam Deficiencies:

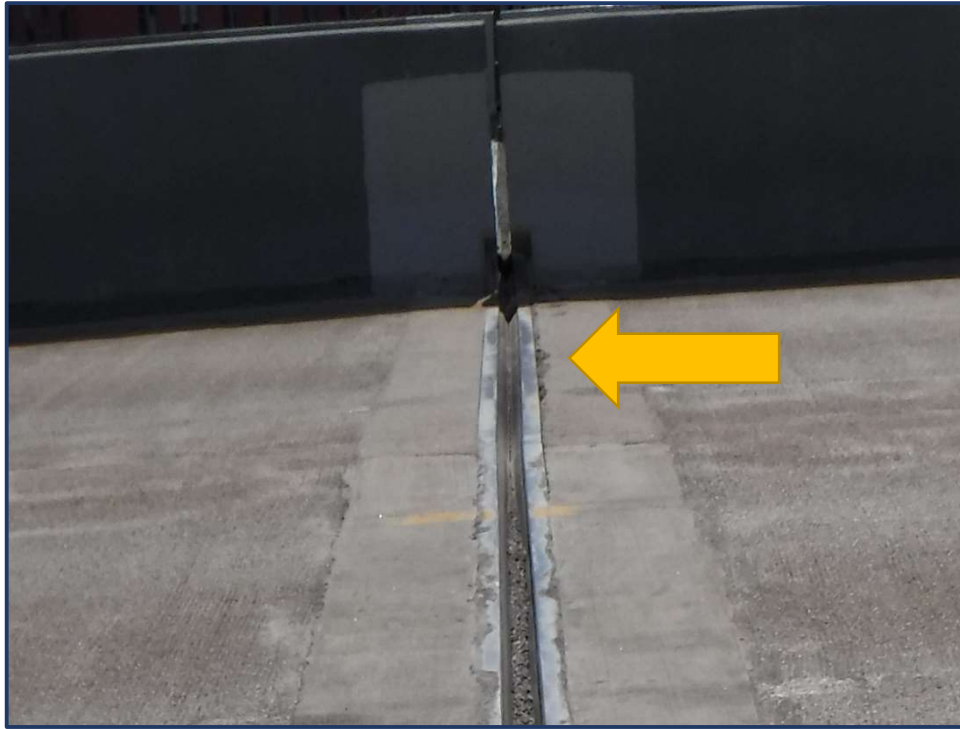
Photo 1 – Joint O Loose Joint Armor and Spalled Header

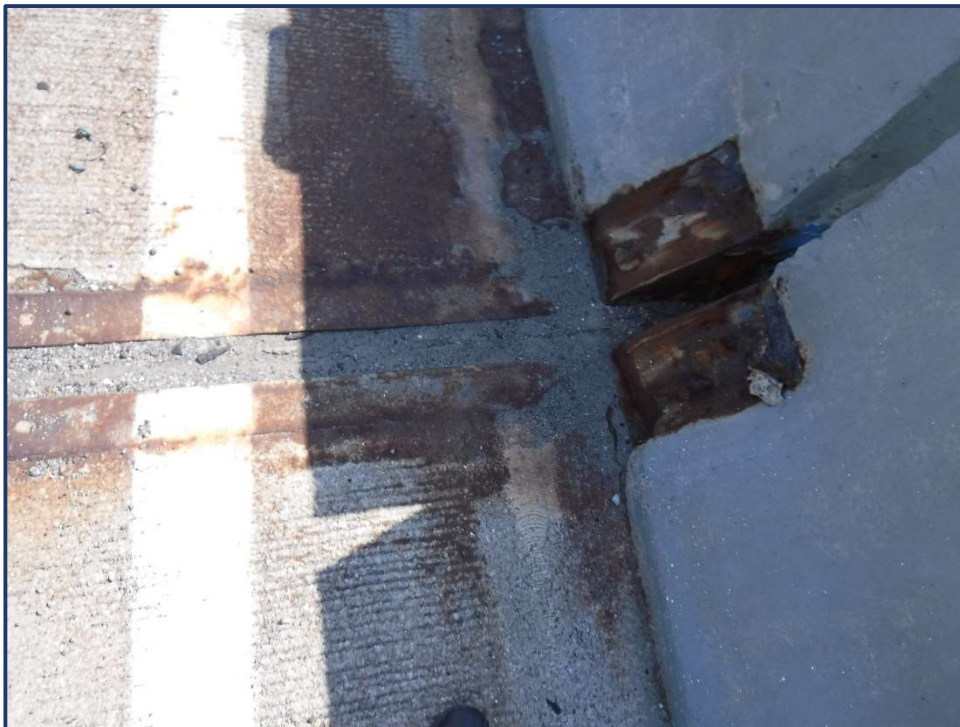
Photo 2 – Span J' Joint T Typical Rusting and Debris Impaction in Joints

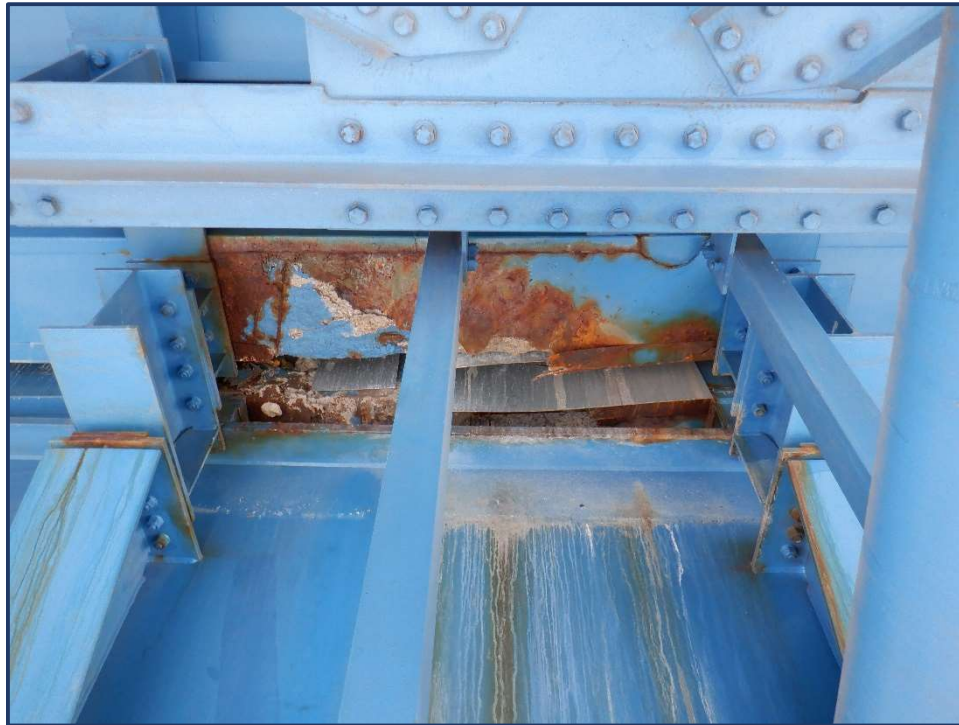
Photo 3 – Joint L Header Spalled and Delaminated Concrete

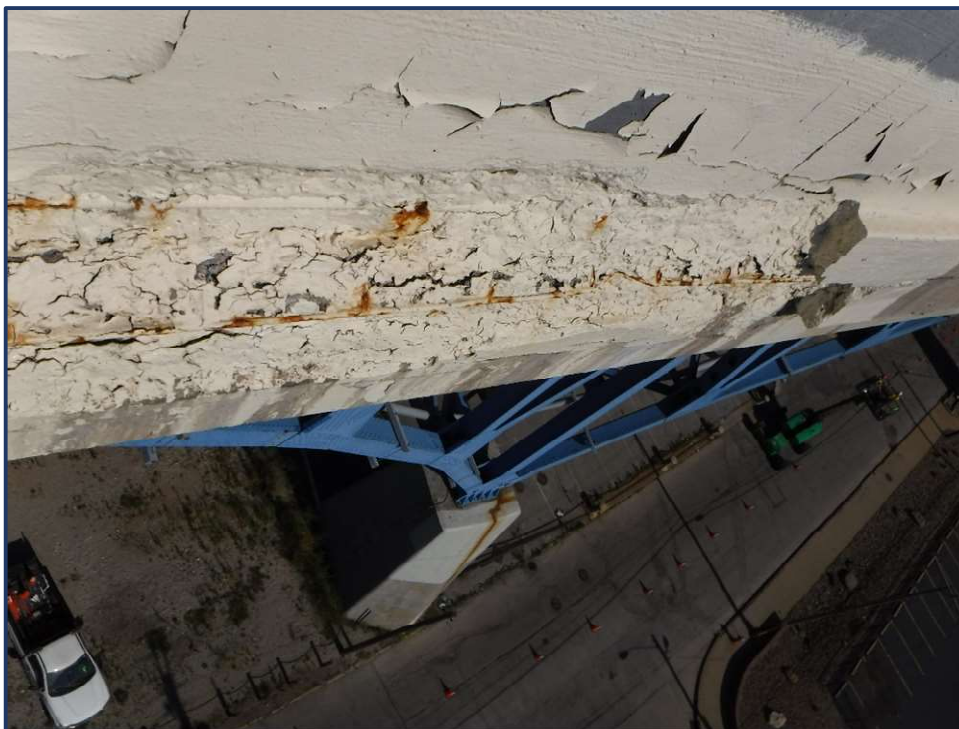
Photo 4 – Typical sealed spalls in exterior of parapet with corroded reinforcing South fascia west of Joint KC1 in Span 6 shown

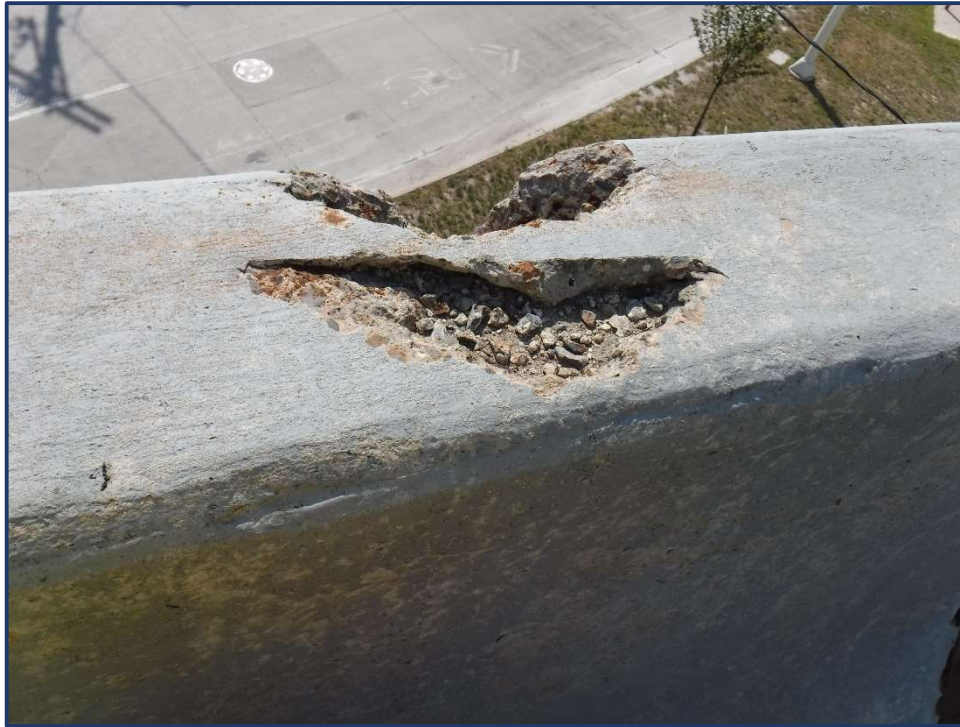
Photo 5 – Spalled parapet in Section N near Joint Q

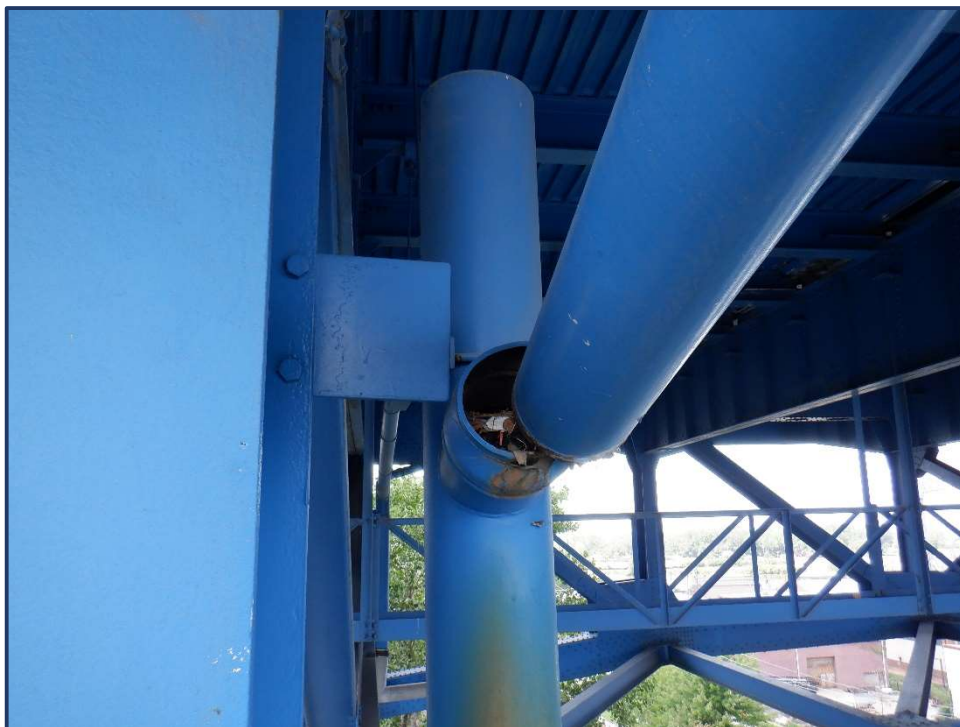
Photo 6 – Broken Downspout at South Truss L6U6 in Span 2

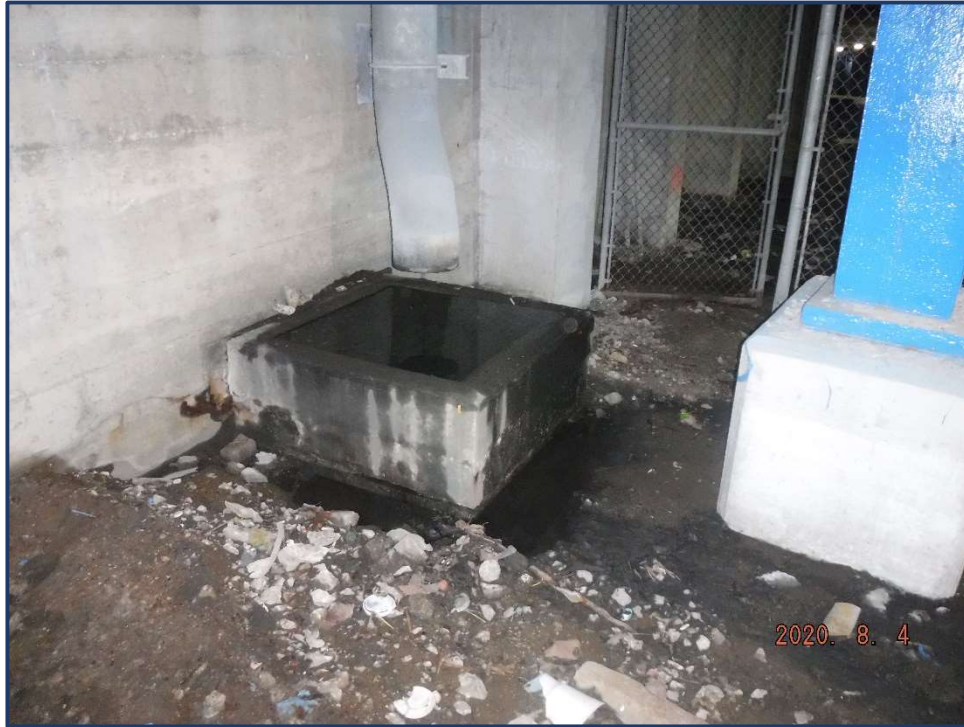
Photo 7 – Clogged catch basin at Joint R in Unit 1

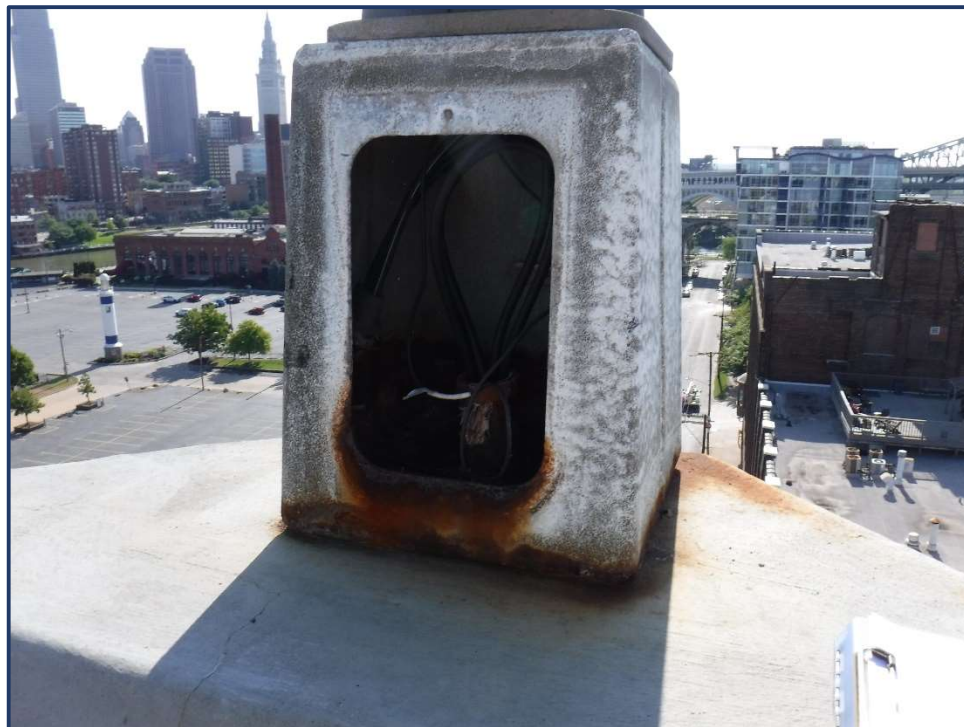
Photo 8 – Typical missing utility cover at light pole, Span 5 over Elm Street

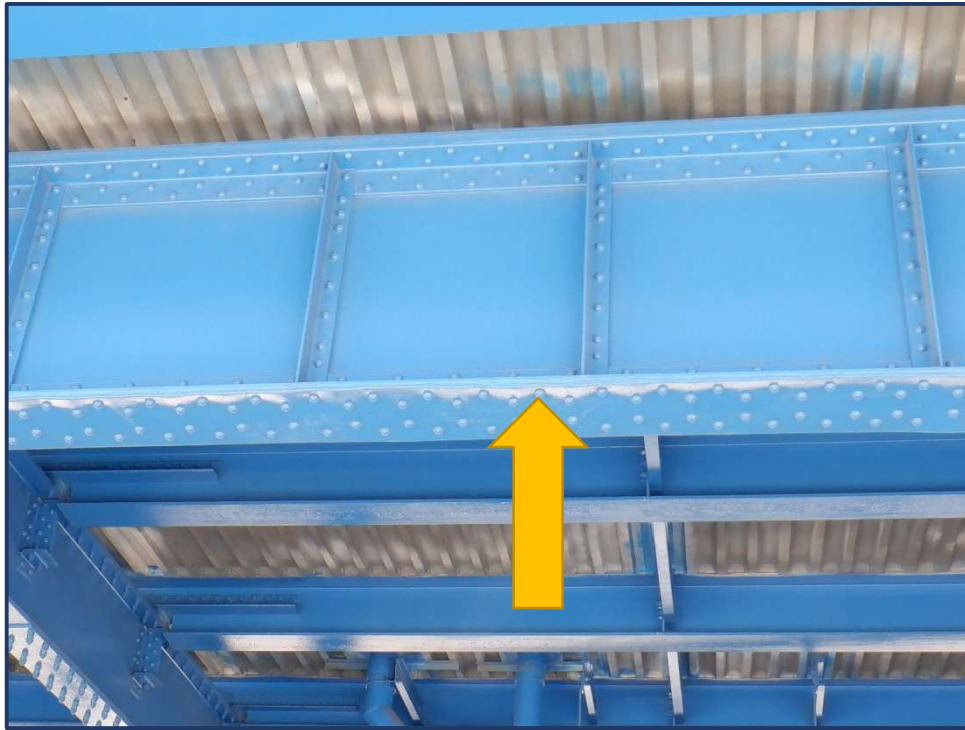
*Photo 9 – 1" thick pack rust between bottom flange cover plate and flange.
North girder over Lakeside Avenue shown*

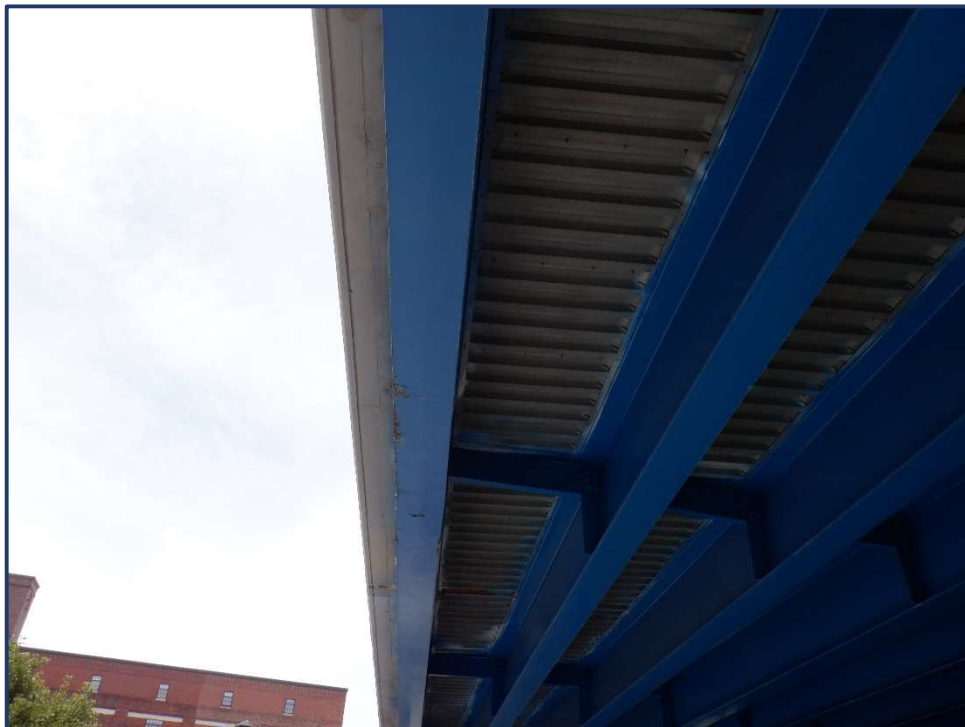
*Photo 10 – South fascia beam over W. 9th Street impact damage and impact
scrapes on bottom flange*

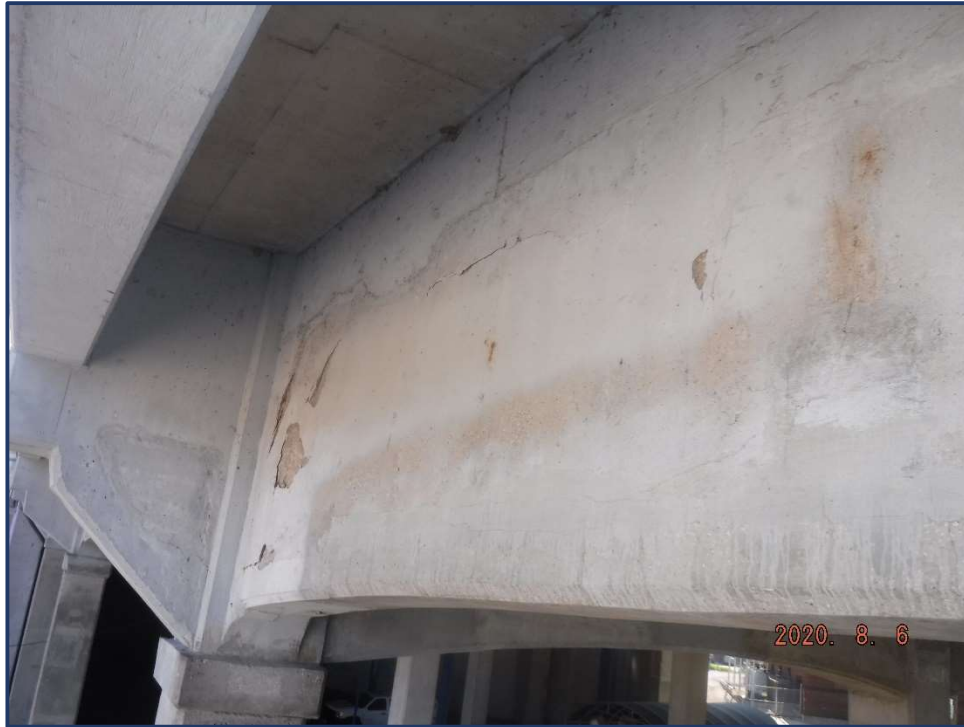
Photo 11 – 12' long x 4' high delaminated area in Girder 15 in Section P

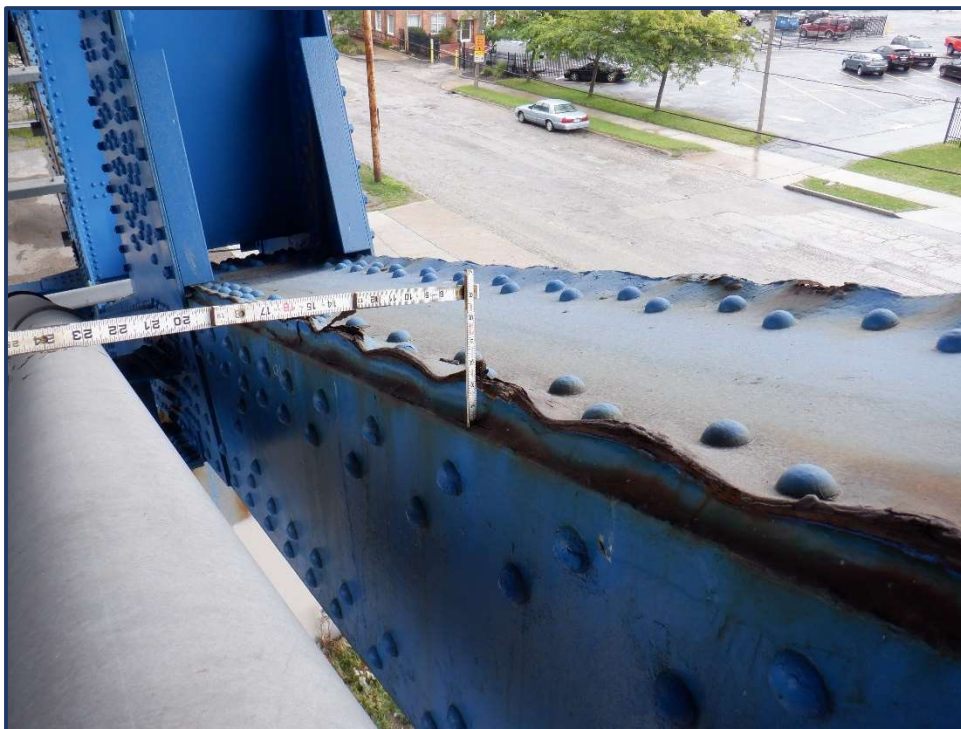
Photo 12 – Pack Rust Induced Distortion in Lower Chord L1L2, Span 2, South Truss

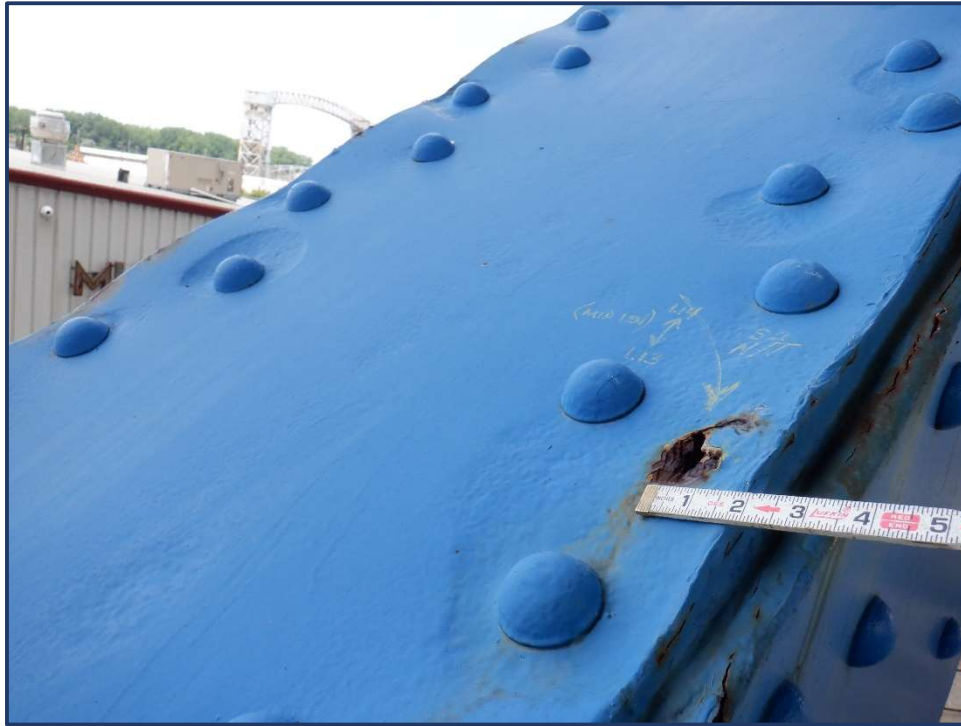
Photo 13 – 1" Diameter Corrosion Hole, L13L14, Span 2, North Truss

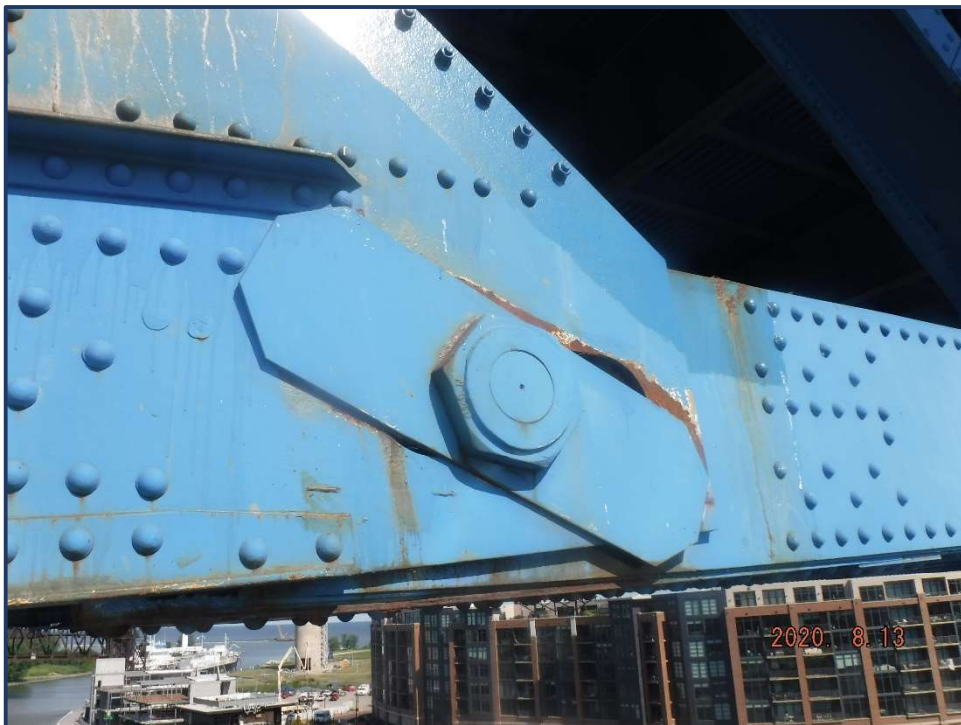
Photo 14 – Pin plate rotated, L0L1, Span 9, South Truss

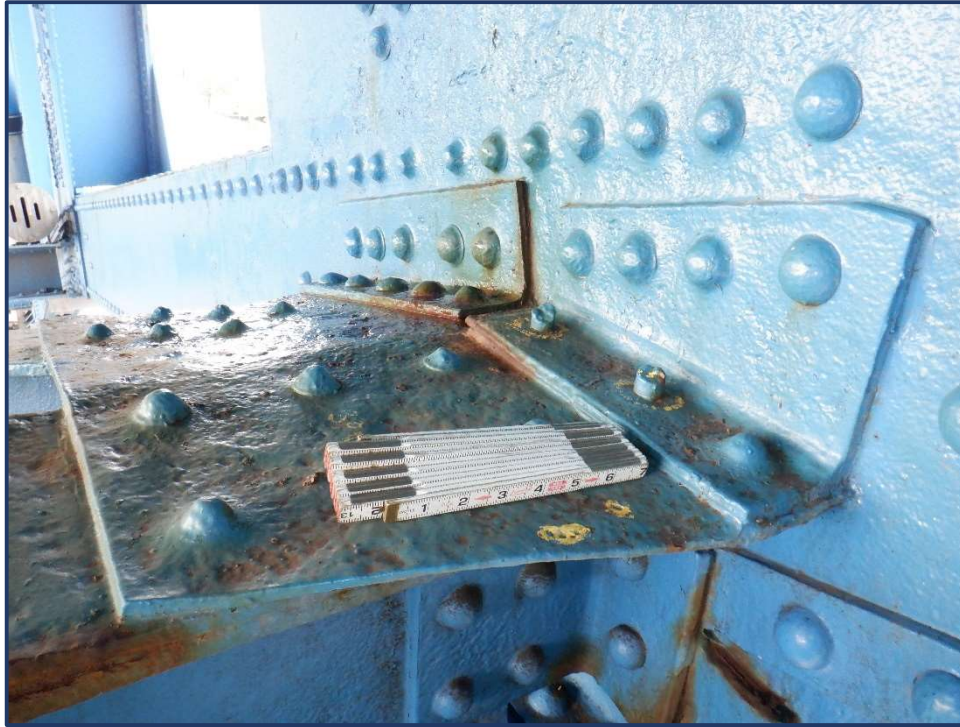
Photo 17 – Lower Lateral Bracing Gusset Defects, L7, Span 1, South Truss

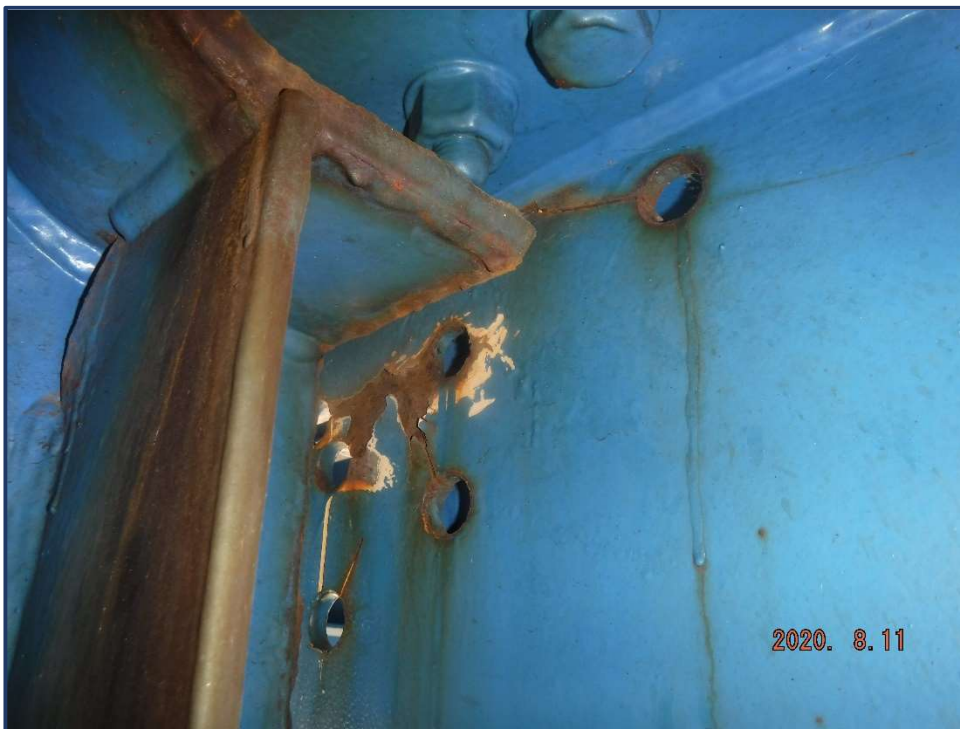
Photo 18 – Span 8, Floorbeam 25 Fatigue Cracks with Arrest Holes

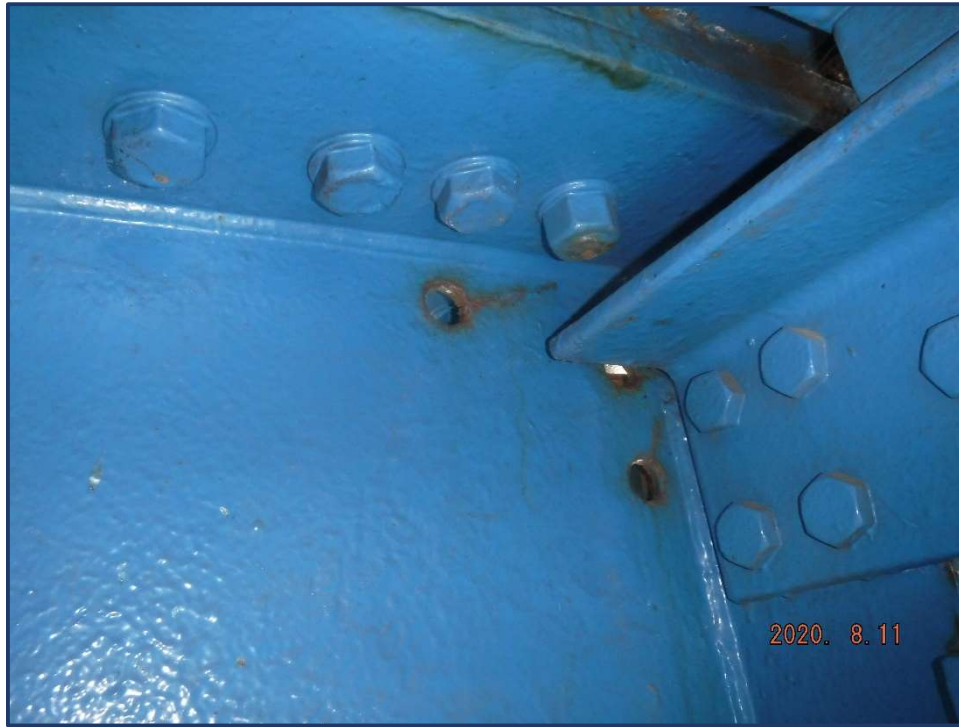
Photo 19 – Span 8, Floorbeam 25 North Cantilever Arrested Fatigue Cracks

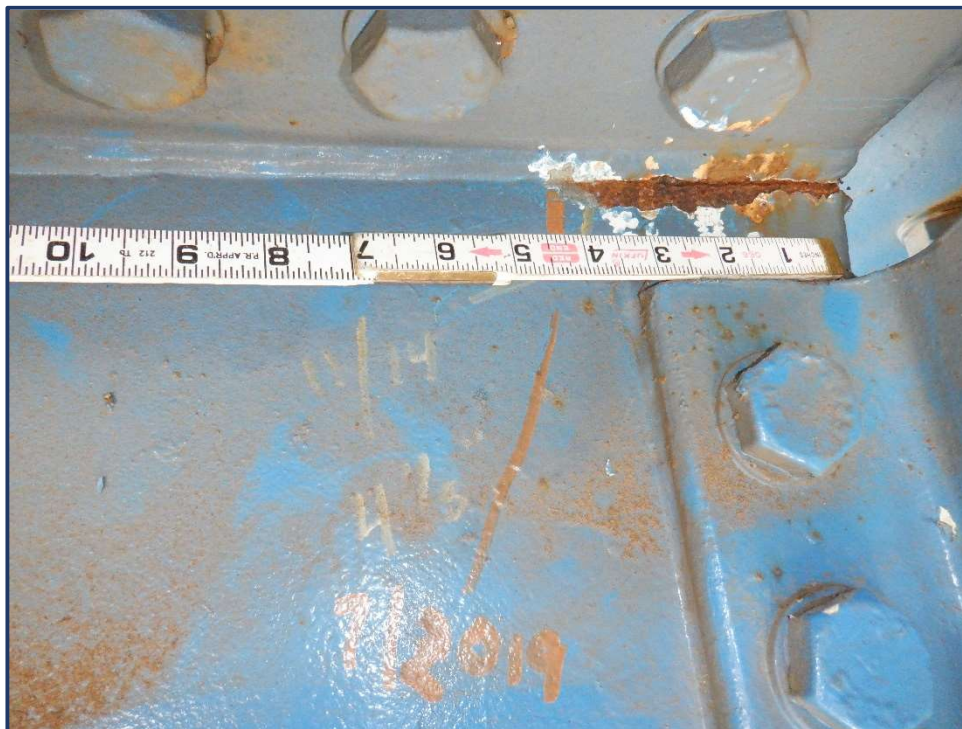
Photo 20 – Span 1, FLBM 7 South Cantilever 5½” Long Crack at Top Flange

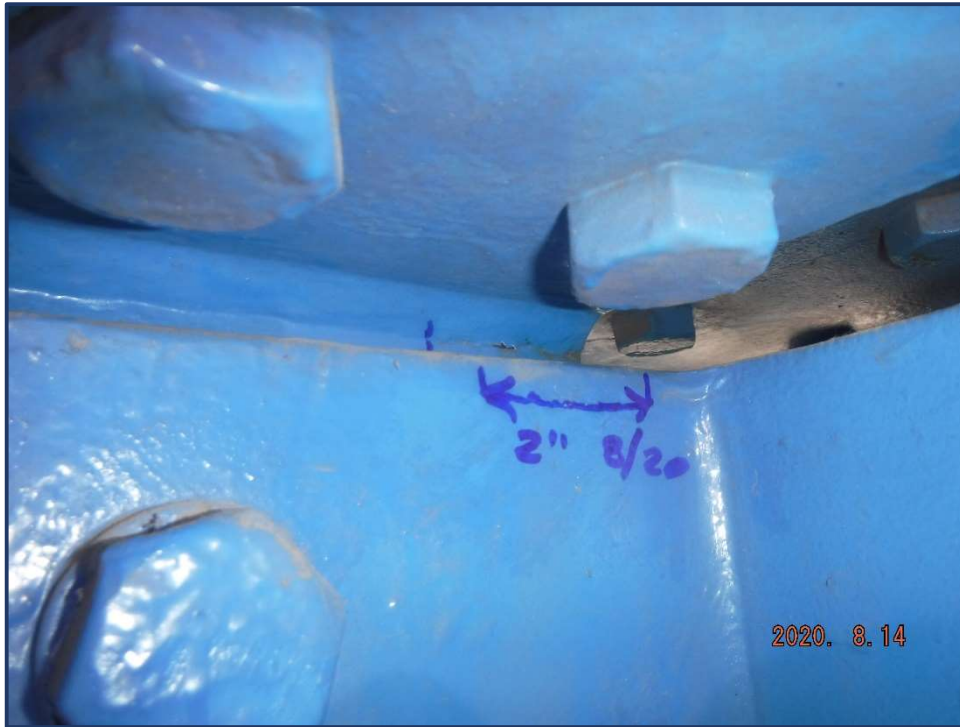
Photo 21 – 2" long crack in east face of top cope of Floorbeam 0 in Span 6

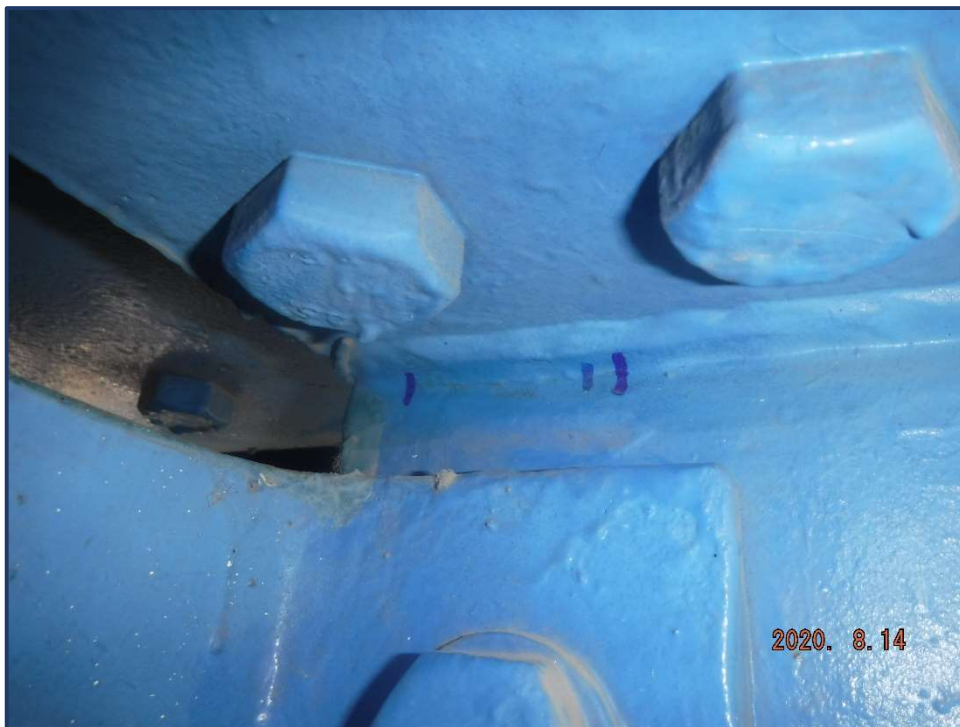
Photo 22 – 2 1/8" long crack in west face of top cope of Floorbeam 0 in Span 6

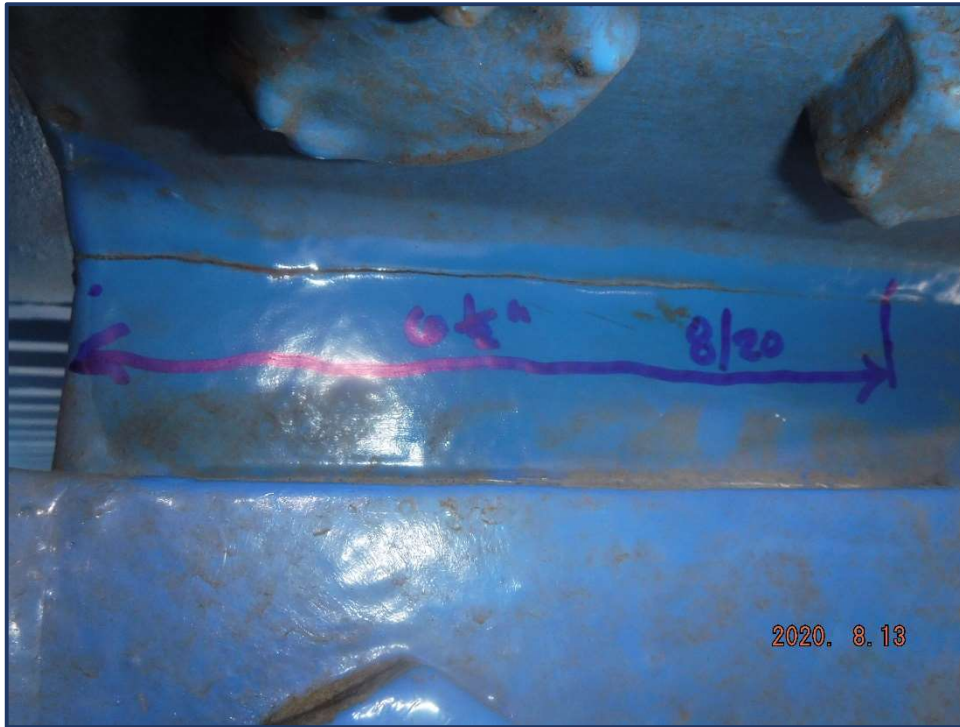
Photo 23 – 6½” long crack in east face top cope of Floorbeam 22 in Span 10

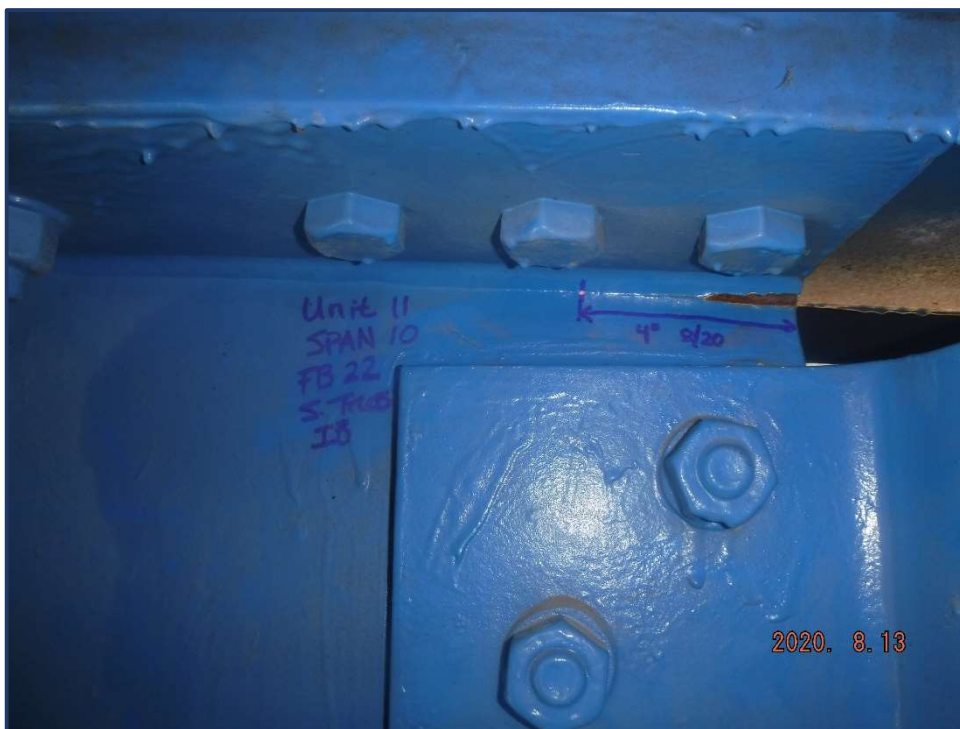
Photo 24 – 4” long crack in east face top cope of Floorbeam 22 in Span 10

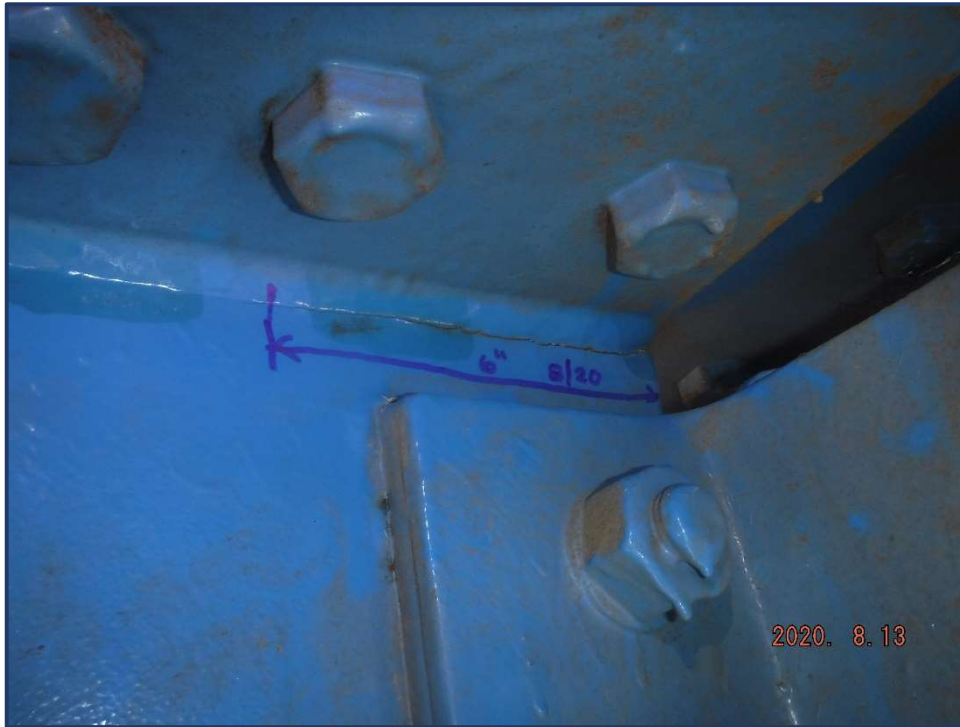
Photo 25 – 6" long crack east face outboard top cope of FLBM 22 in Span 10
