**Physical Condition Report for
CUY-002-1441
SFN 1800035
Main Avenue Bridge over the Cuyahoga River
2020 Routine Inspection**

Prepared for:

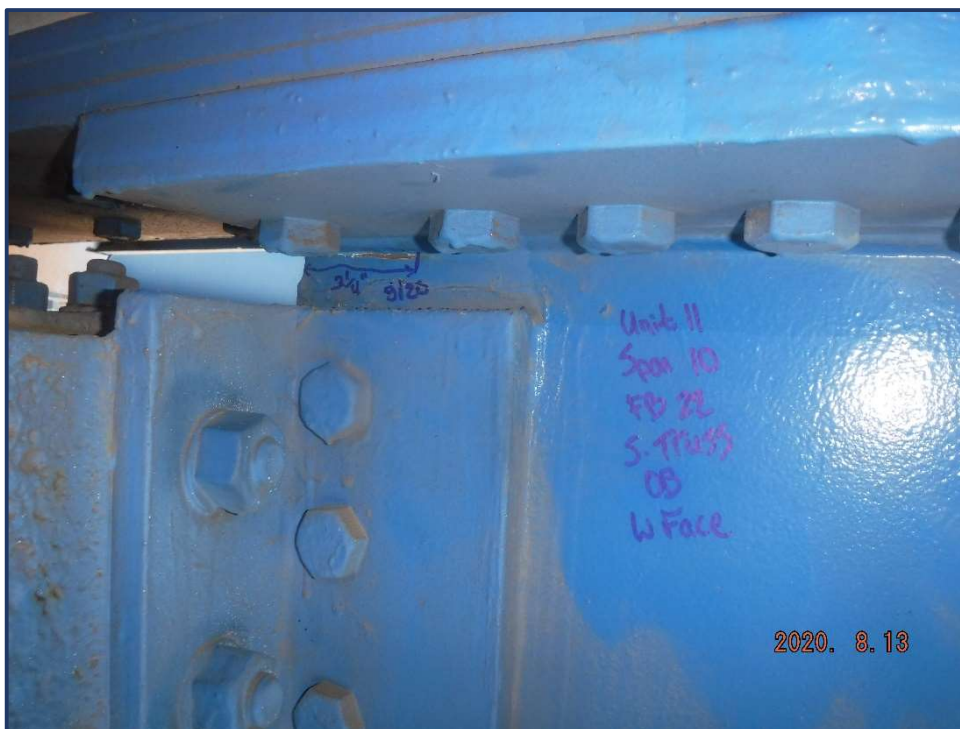
Photo 26 – 3/4" long crack west face outboard top cope of FLBM 22 Span 10

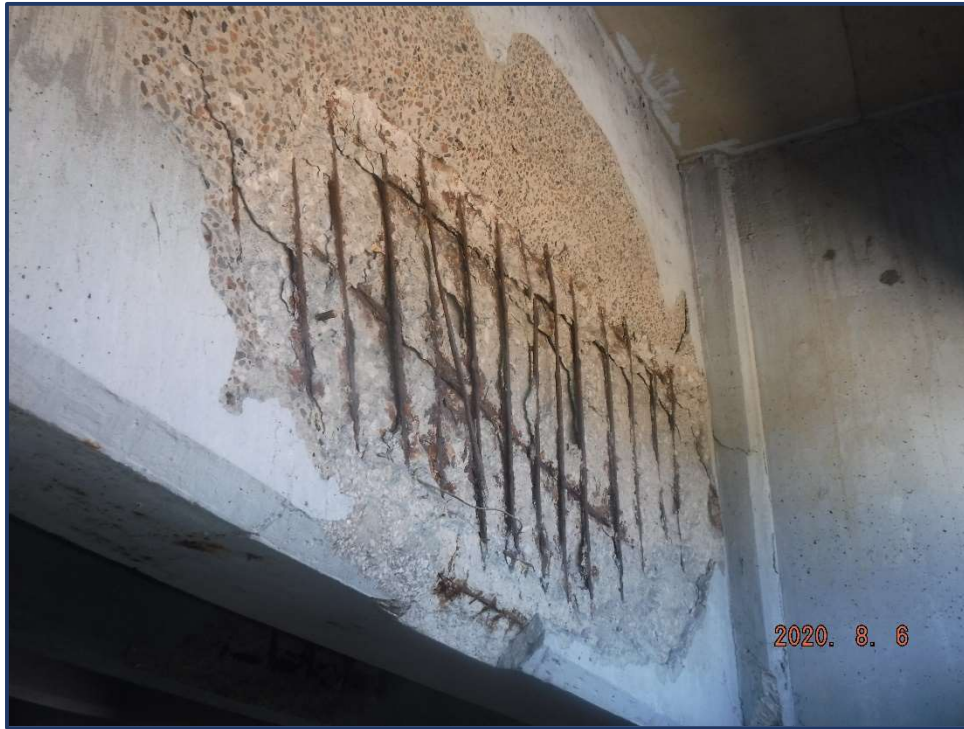
Photo 27 – 7' long x 4' high x 3" deep spall with exposed rebar with 100% section log, Floorbeam 0 west cantilever, south face, Section P,

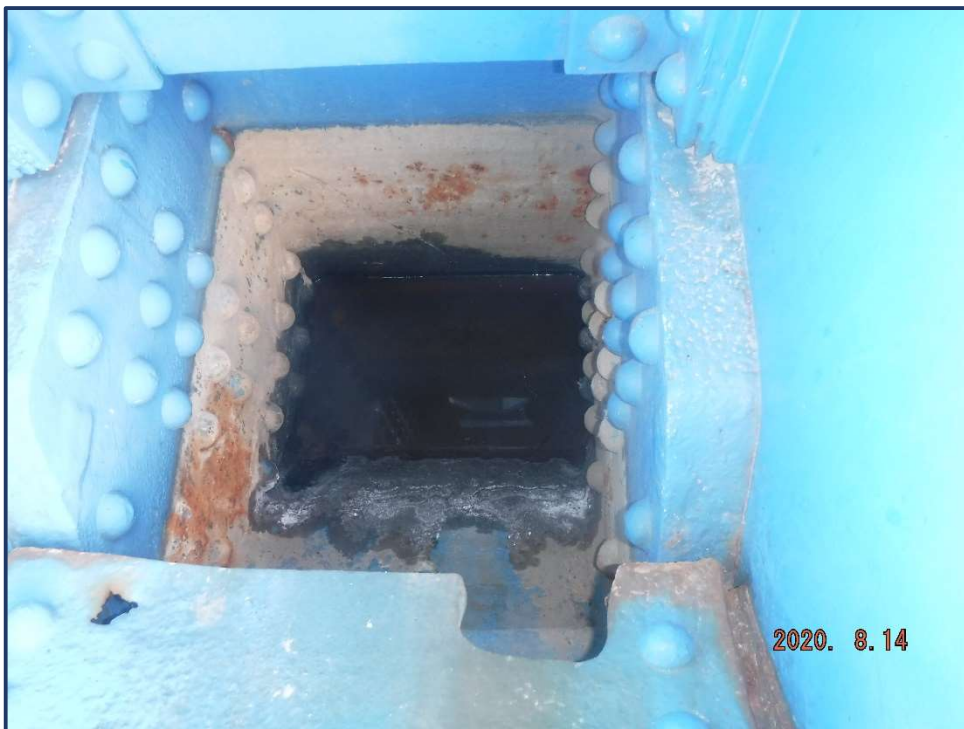
Photo 28 – Bearing assembly full of water, L1L2, Span 4, South Truss

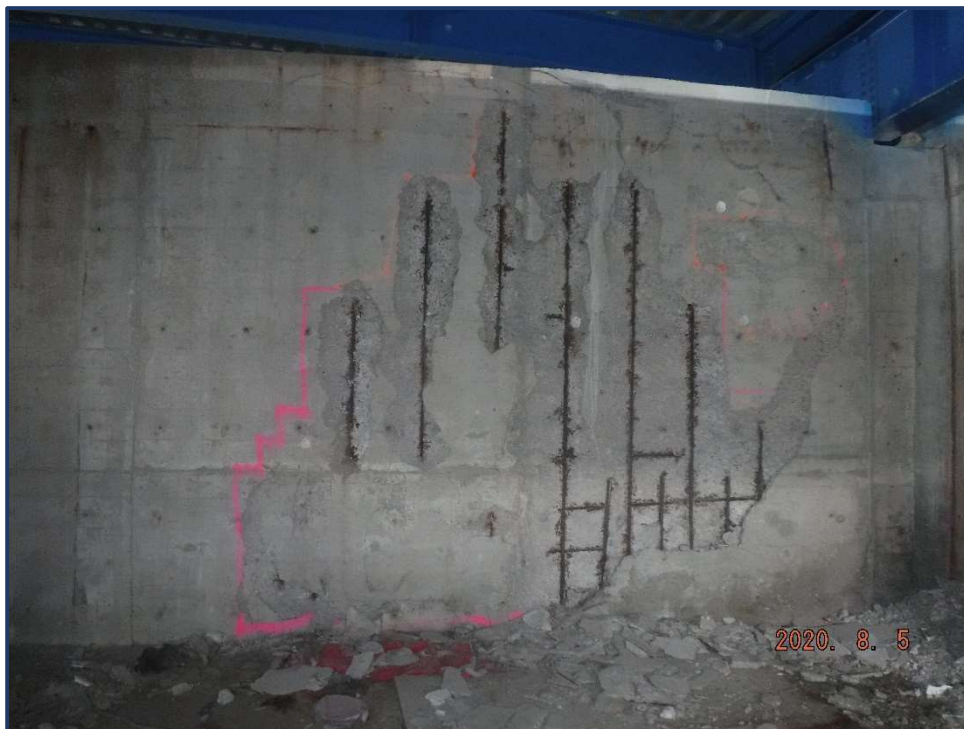
Photo 32 – Spall with exposed rebar in north wall of south vault at W. 9th Street
