**Physical Condition Report for  
CUY-002-1441  
SFN 1800035  
Main Avenue Bridge over the Cuyahoga River  
2022 Routine Inspection**

**Prepared for:**

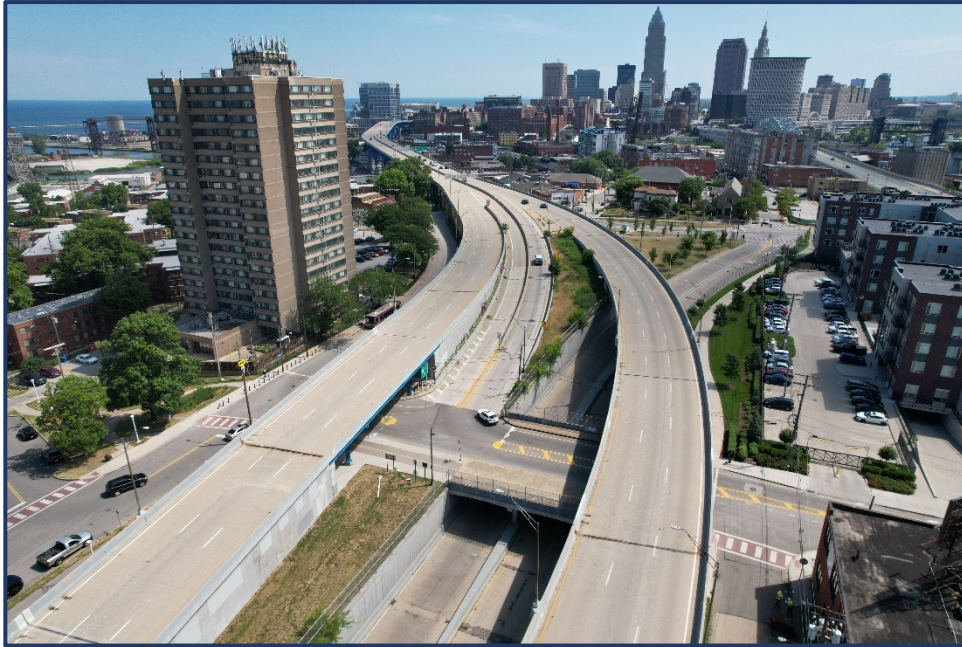
Unit I and II Deck Looking East

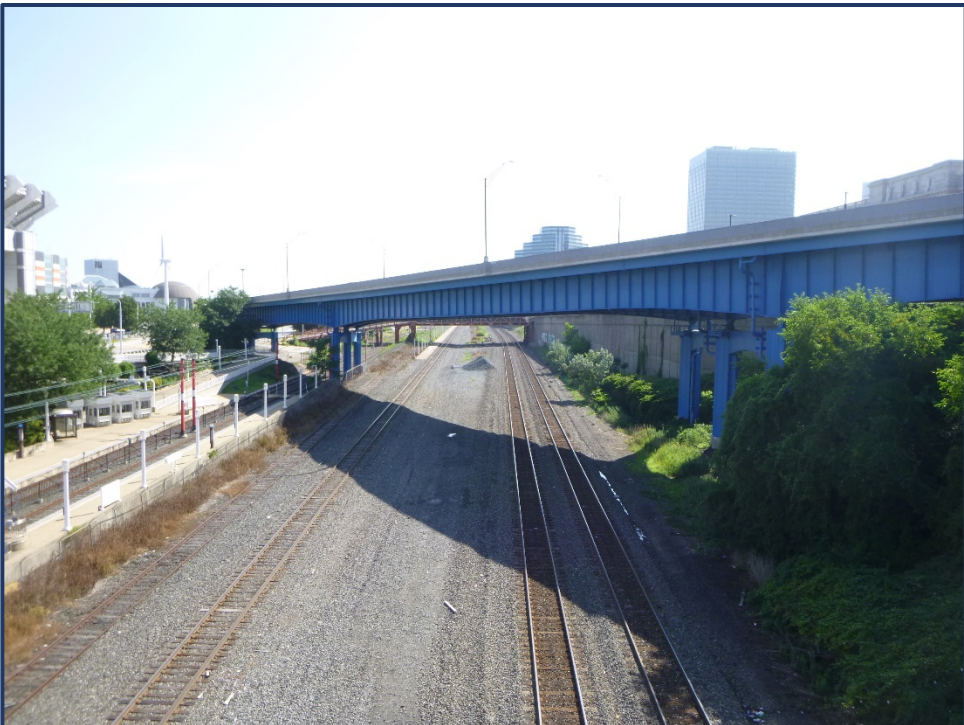
Unit V Lakefront Ramp Over CSX and NS Railroad Tracks Looking East

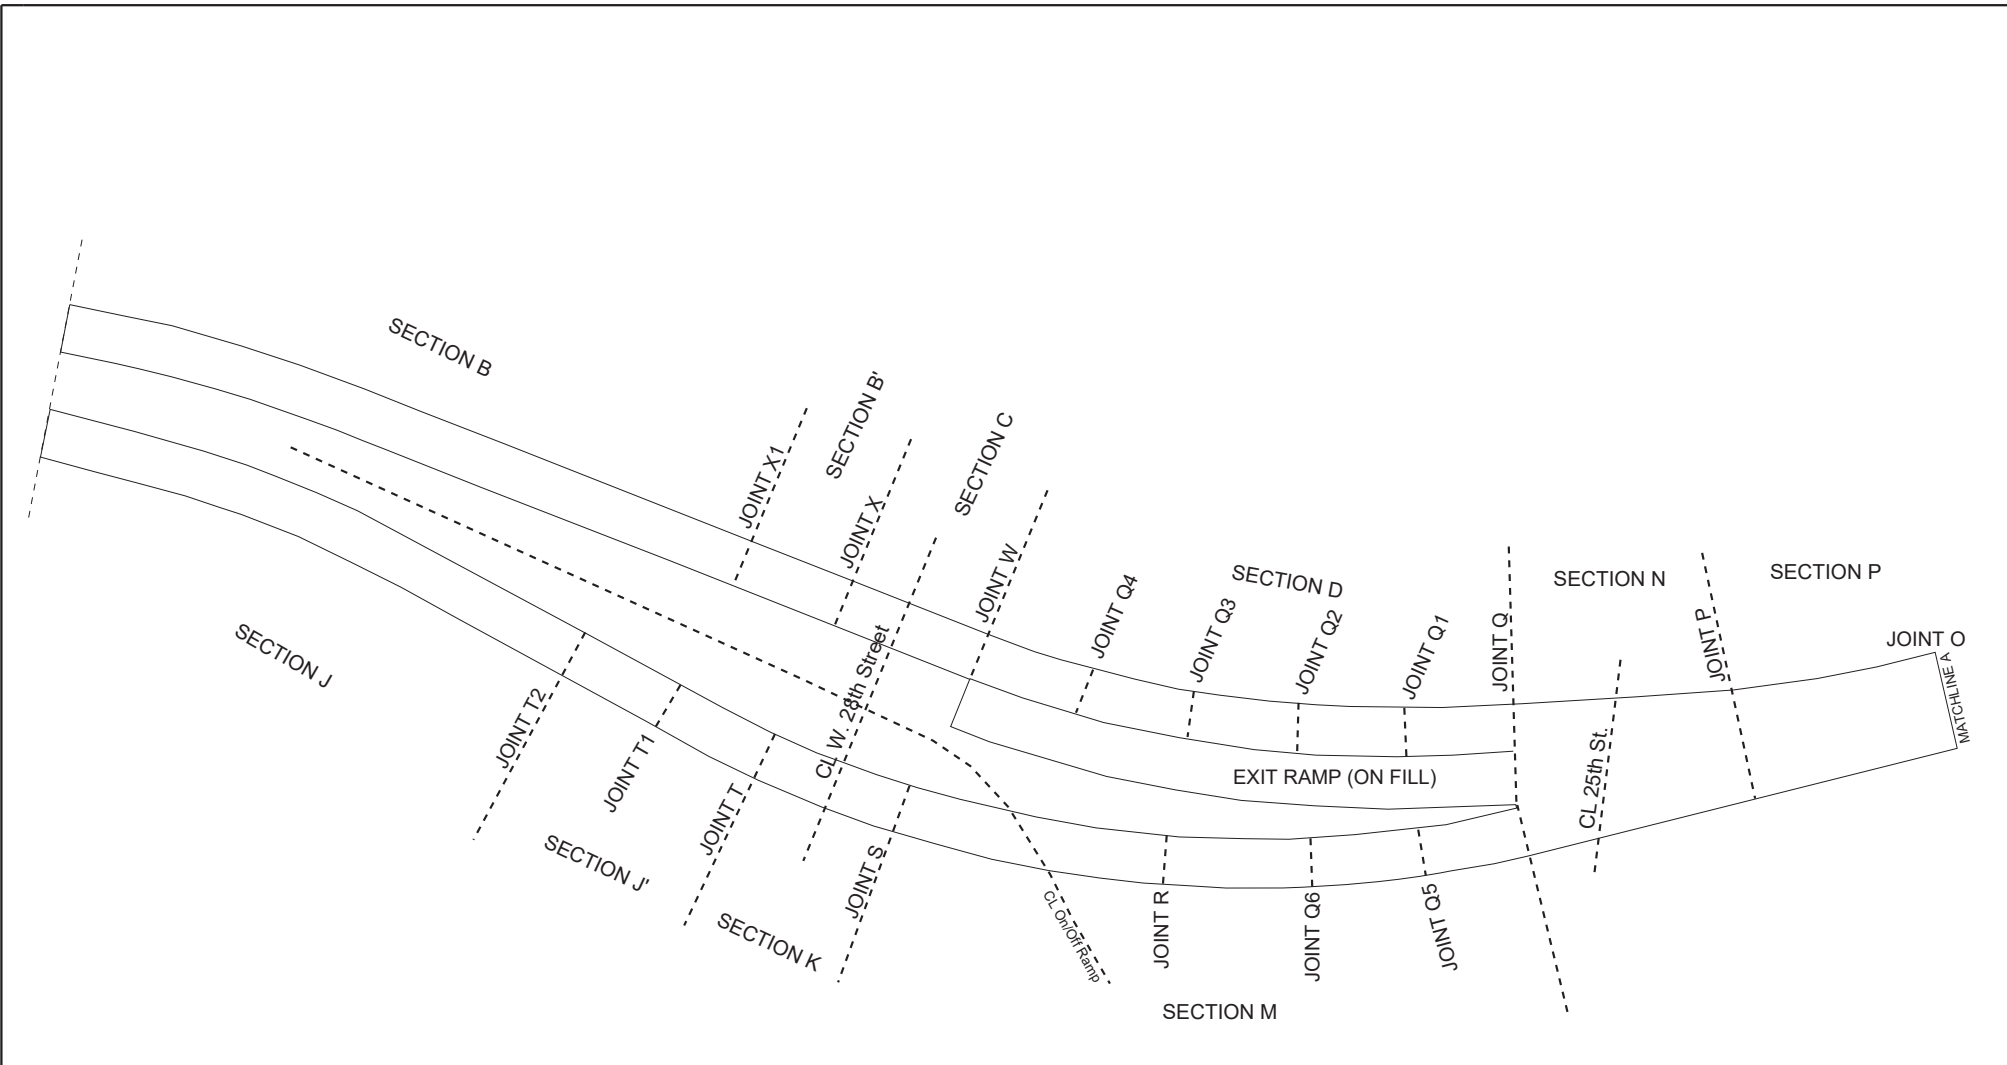
PLAN: WEST APPROACH - UNIT I

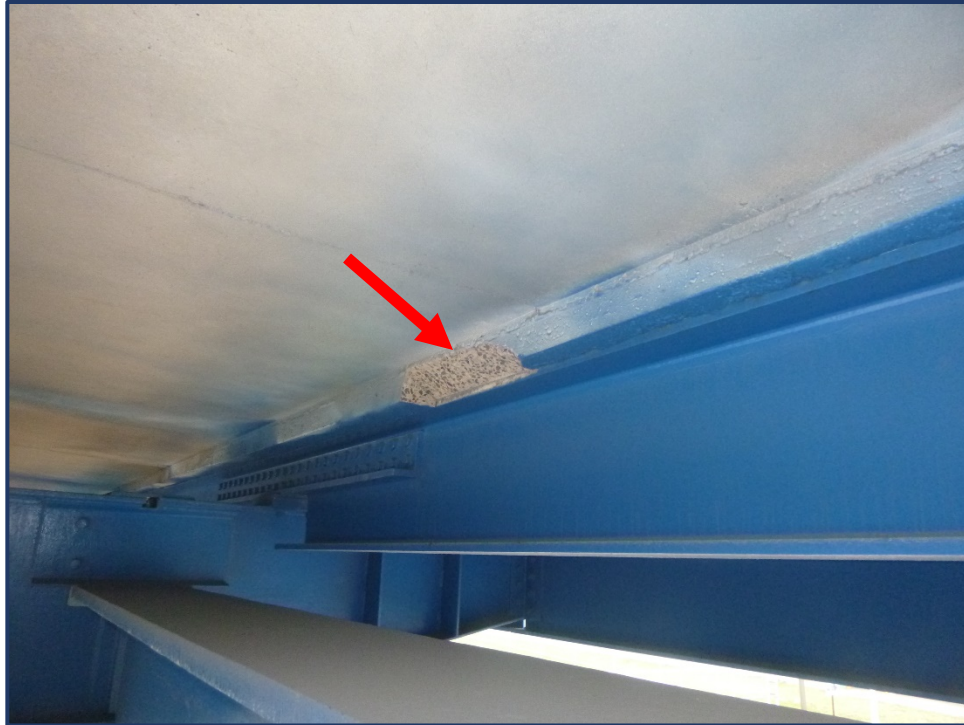
*Photo 12-1 – Scattered Haunch Spalling in Unit I*

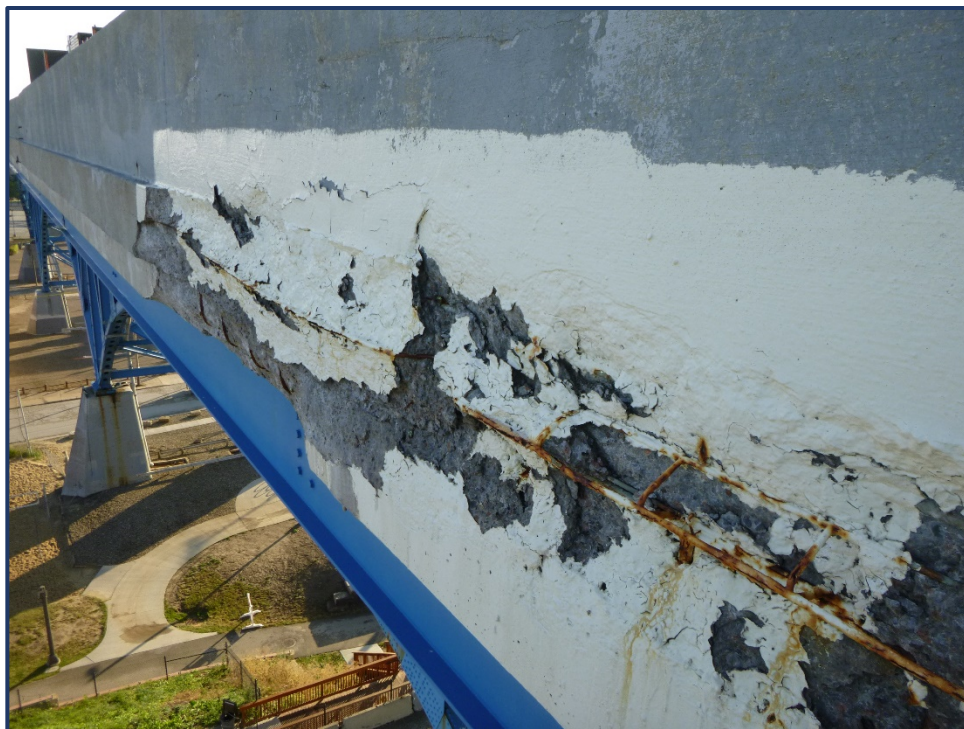
*Photo 12-2 – Deck Edge Spalling and Delamination in Unit II*

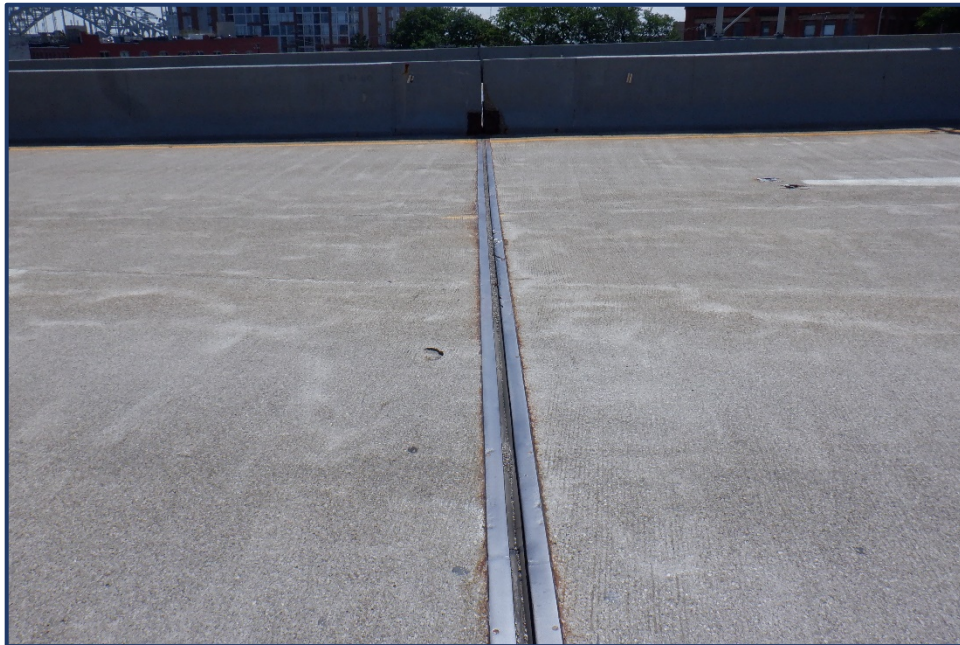
*Photo 300-1 – Typical Debris Impaction and Impact Damage in Strip Seal Joints*

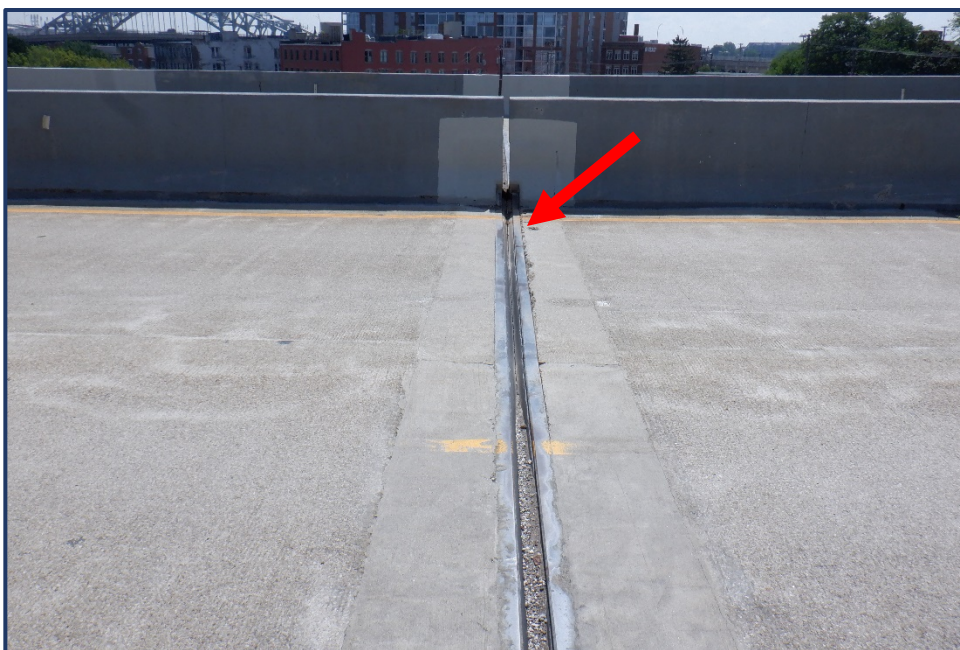
*Photo 300-2 – Joint O Loose Joint Armor and Spalled*

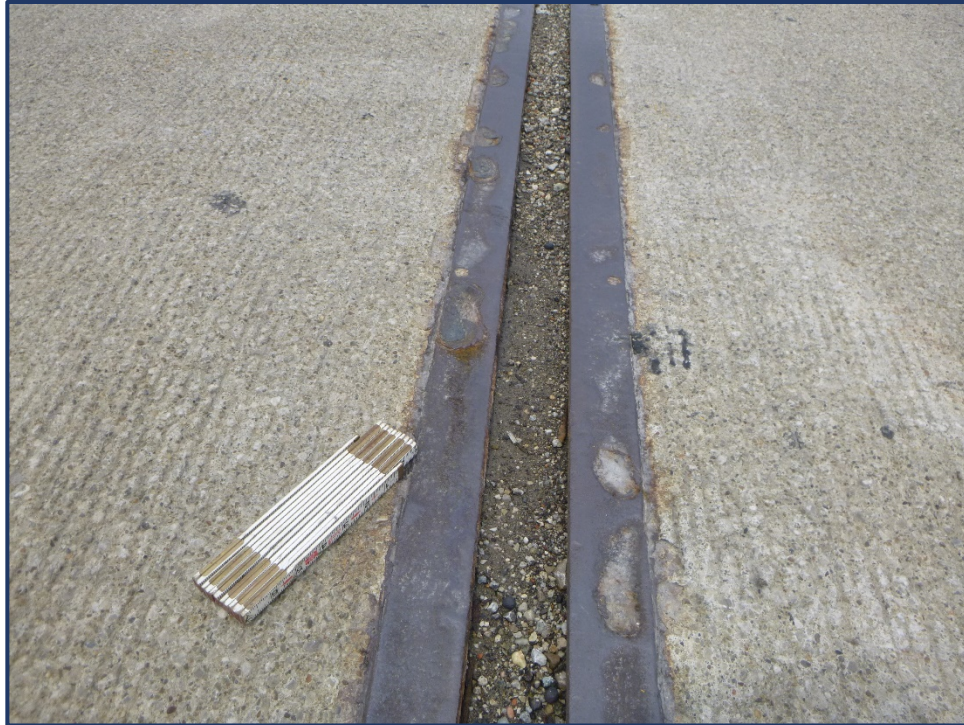
*Photo 302-1 – Typical Debris Impaction and Section Loss in Compression Seal Joints*

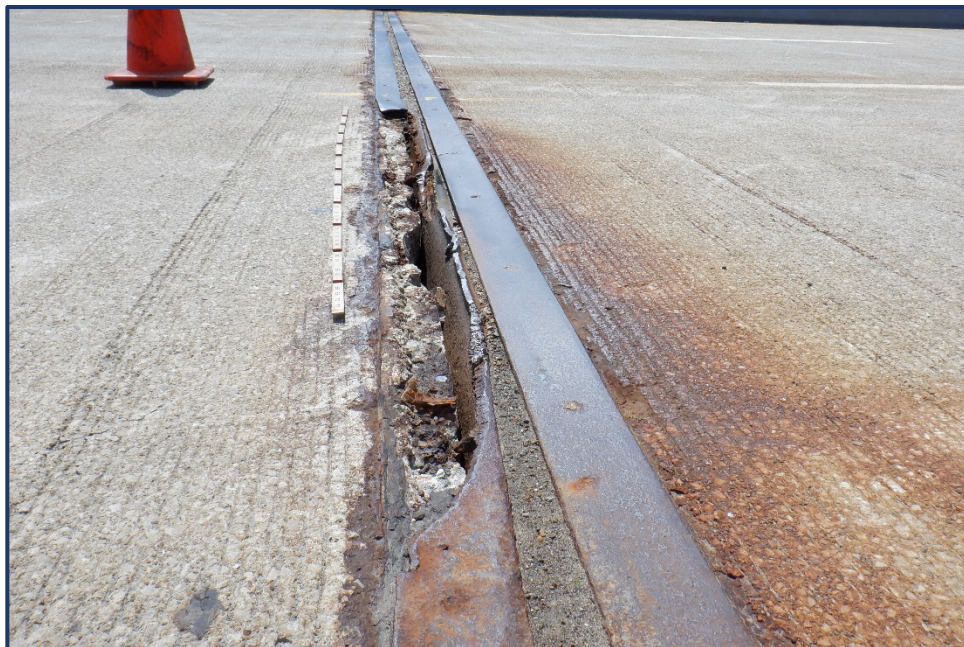
*Photo 302-2 – Unit I, Joint X, 10-ft Section of Broken Retainer in Westbound Lane 3*

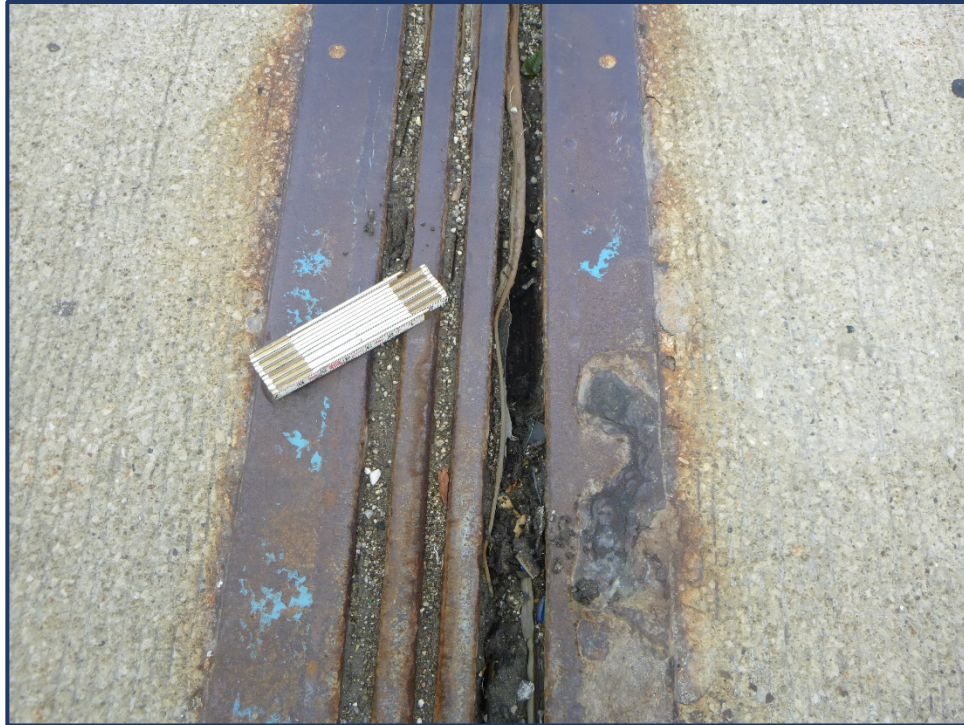
*Photo 303-1 – Unit II, Joint K, Debris Impaction, Section Loss and Area of Tearing Joint Seal*

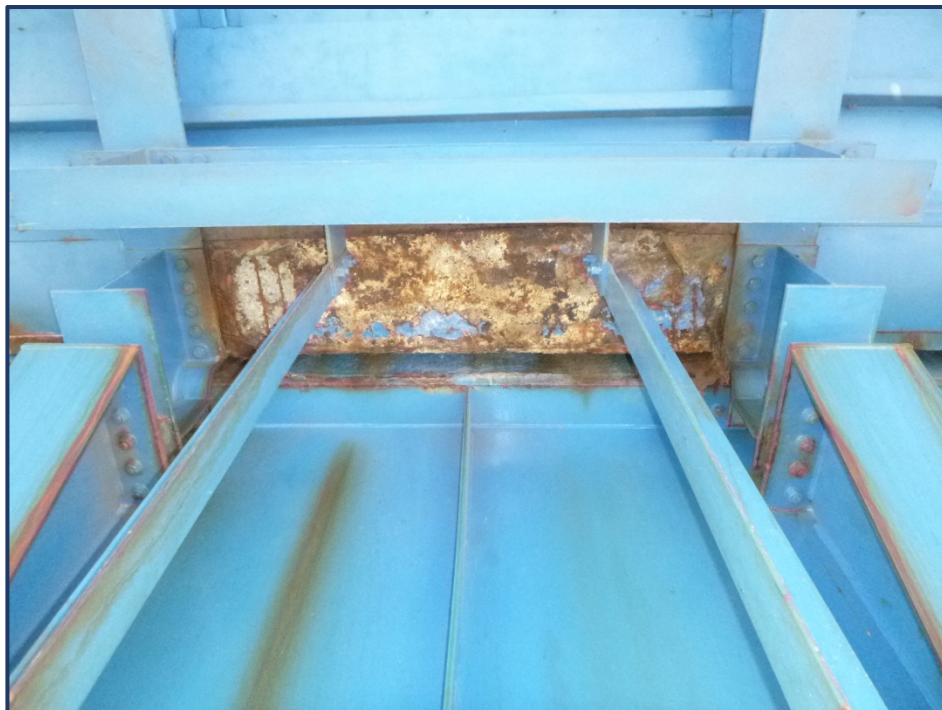
*Photo 303-2 – Unit II, Joint J Header Spalled and Delaminated Concrete*

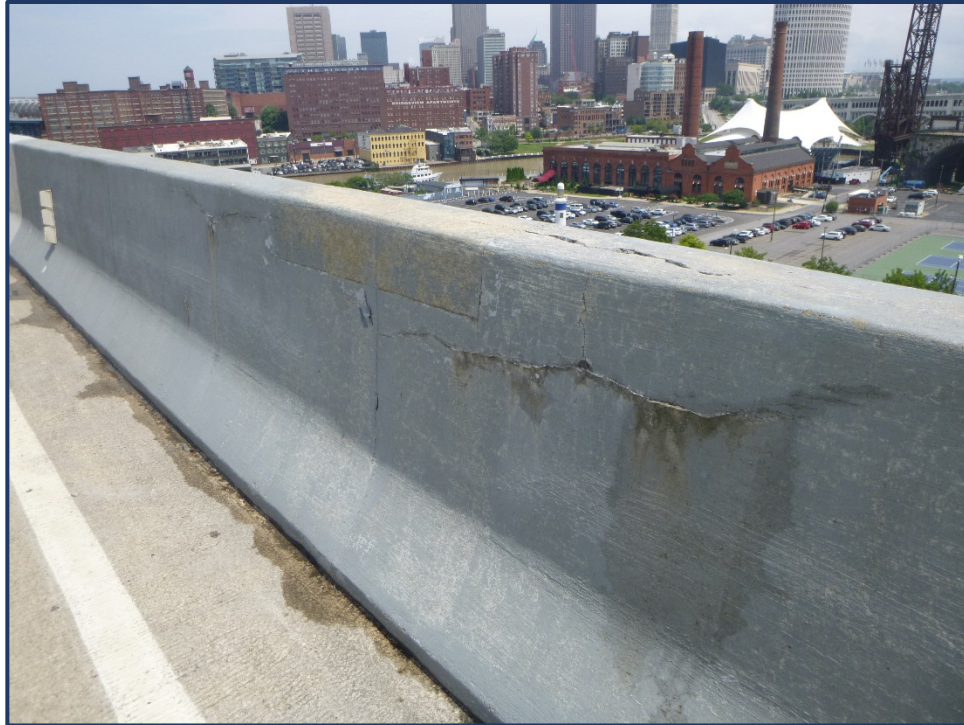
*Photo 331-1 – Typical Area of Cracking, Parapet Interior Face*

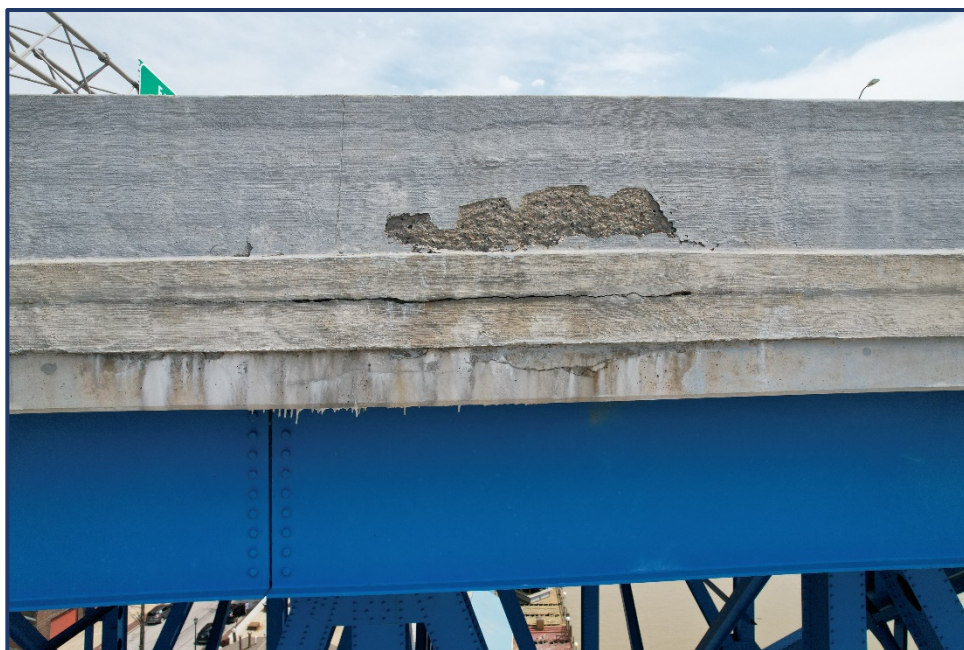
*Photo 331-2 – Typical Area of Delamination & Spalling, Parapet Exterior Face*

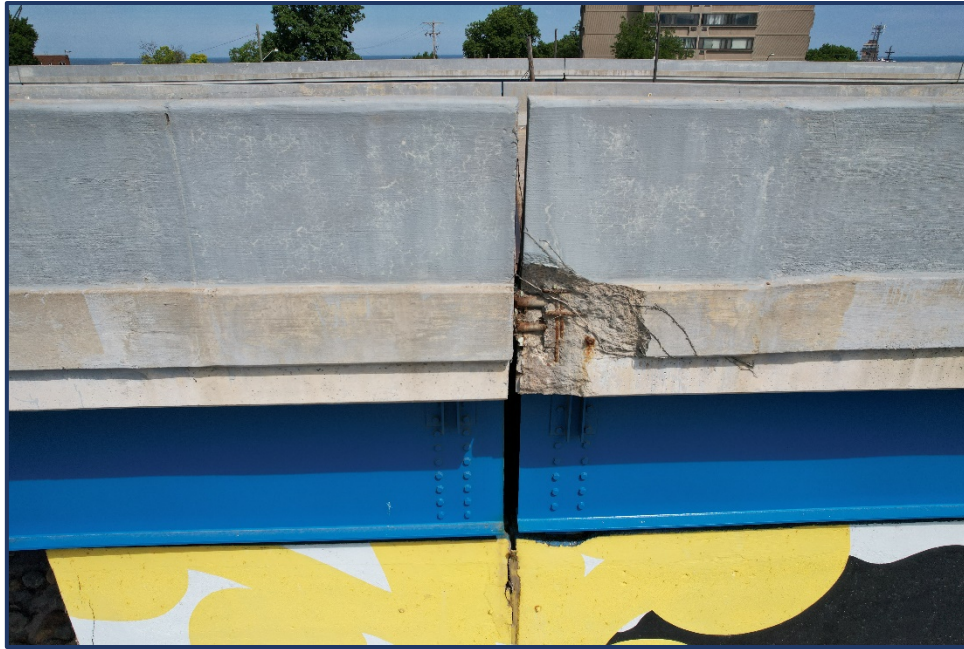
*Photo 331-1 – Area of Parapet Spalling at Deck Joint.*

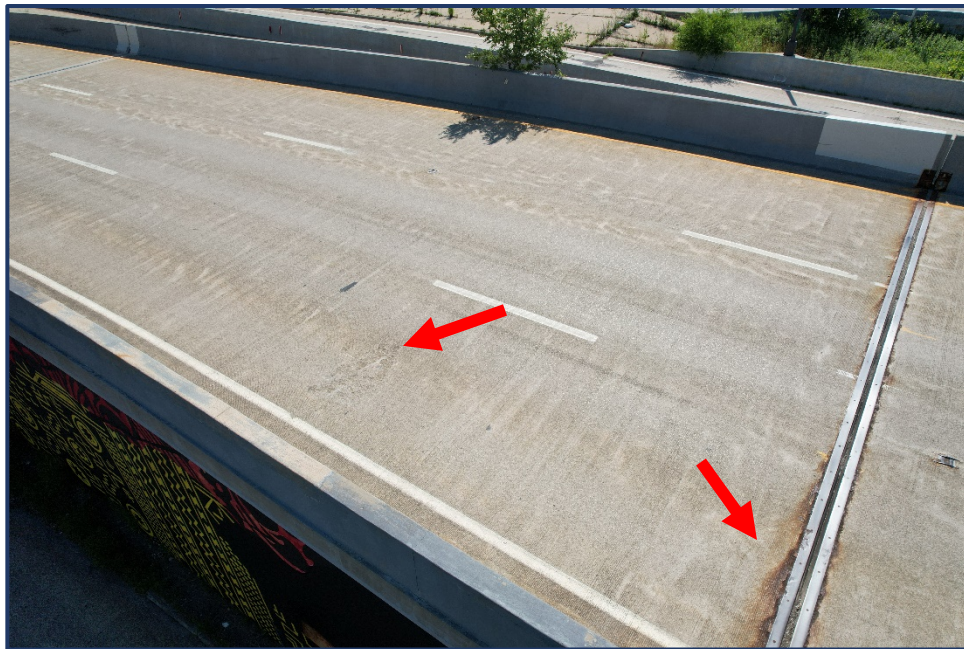
*Photo 510-1 – Scaling of Wearing Surface and Shallow Spalls at Joint Header*

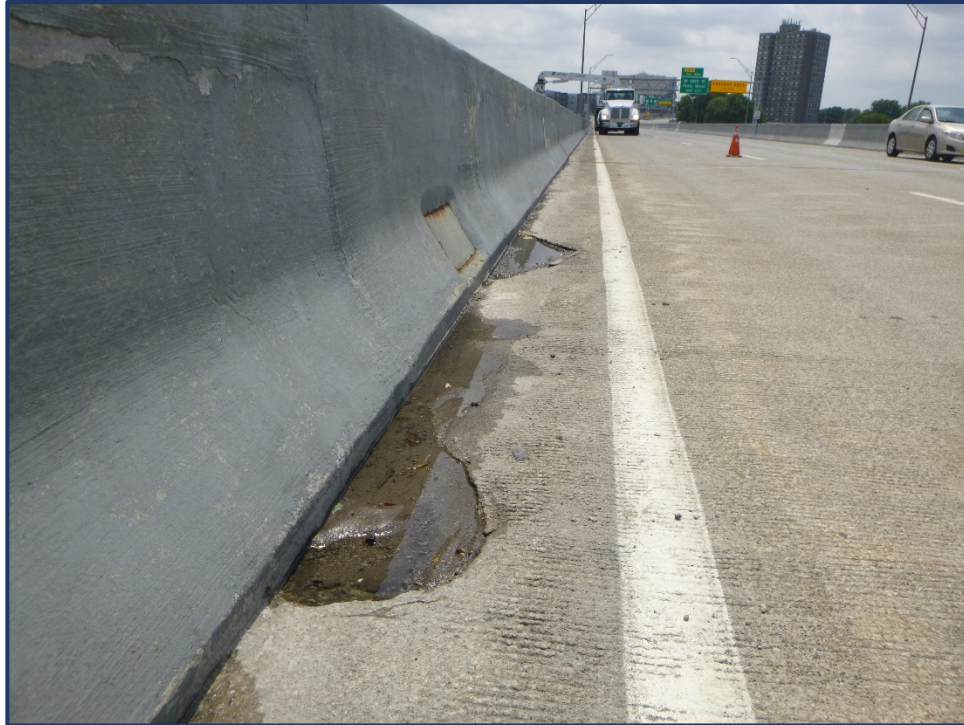
*Photo 510-2 – Typical Spalling of Wearing Surface along Parapet*

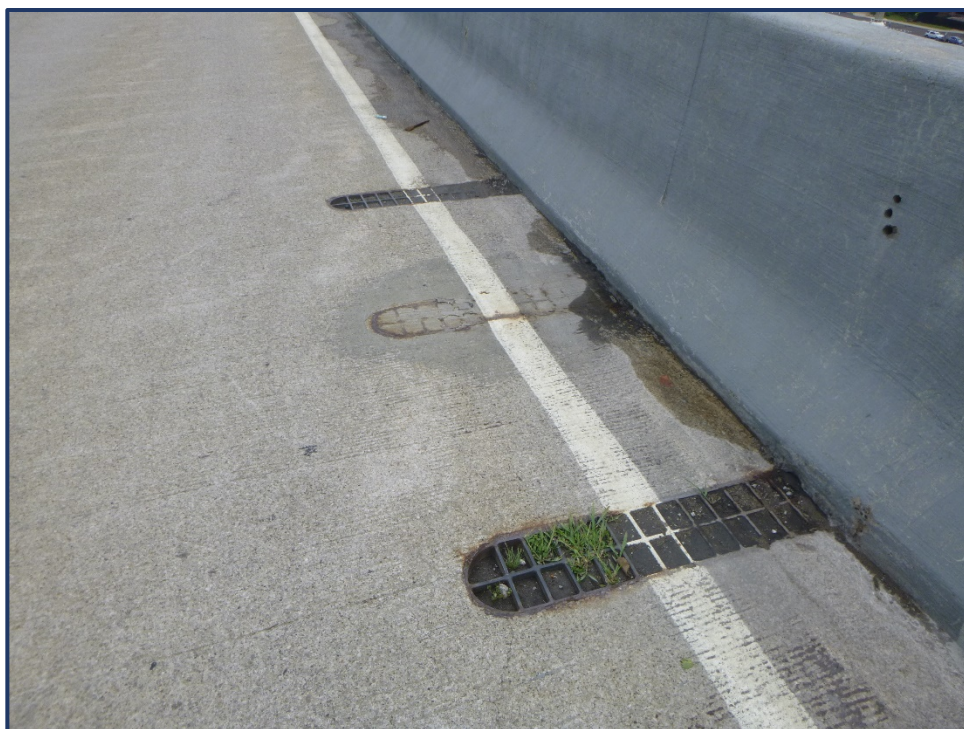
*Photo 815-1 – Typical Clogged Scupper Inlets*

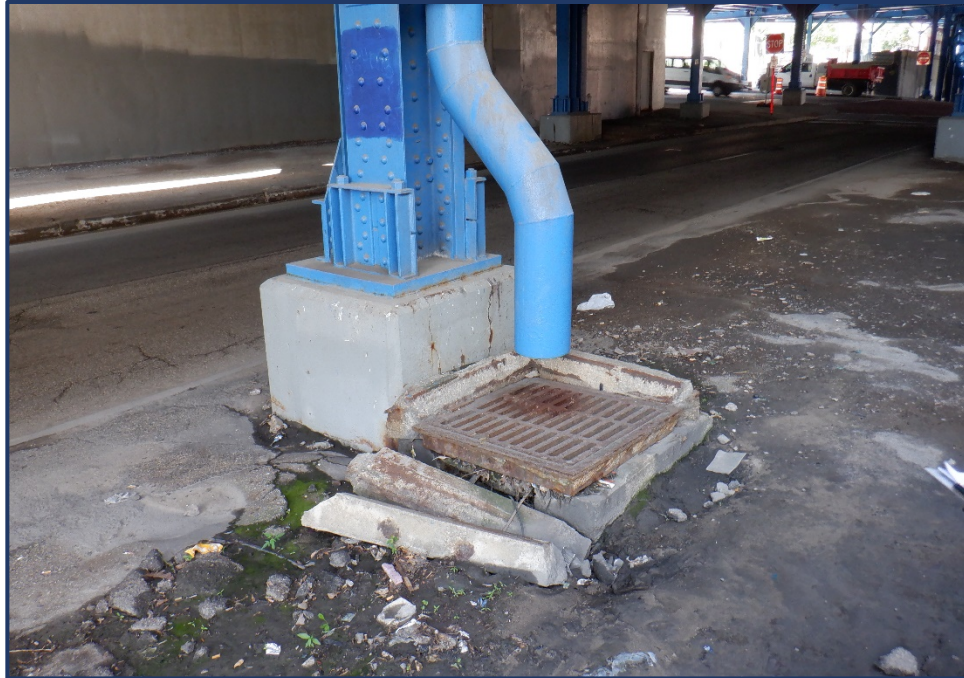
*Photo 815-2 – Unit IV, Bent 15 Catch Basin, Heavy Spalling of Frame and Shifting  
Grate*

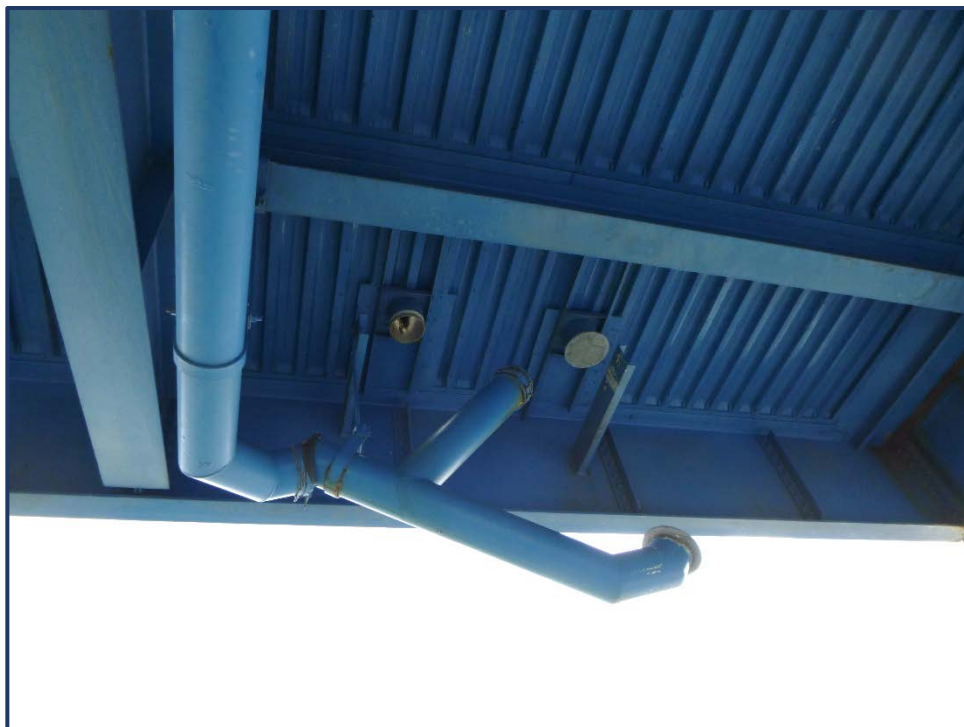
*Photo 815-3 – Unit II, Span 9, North Side Scupper Downspout Disconnected*

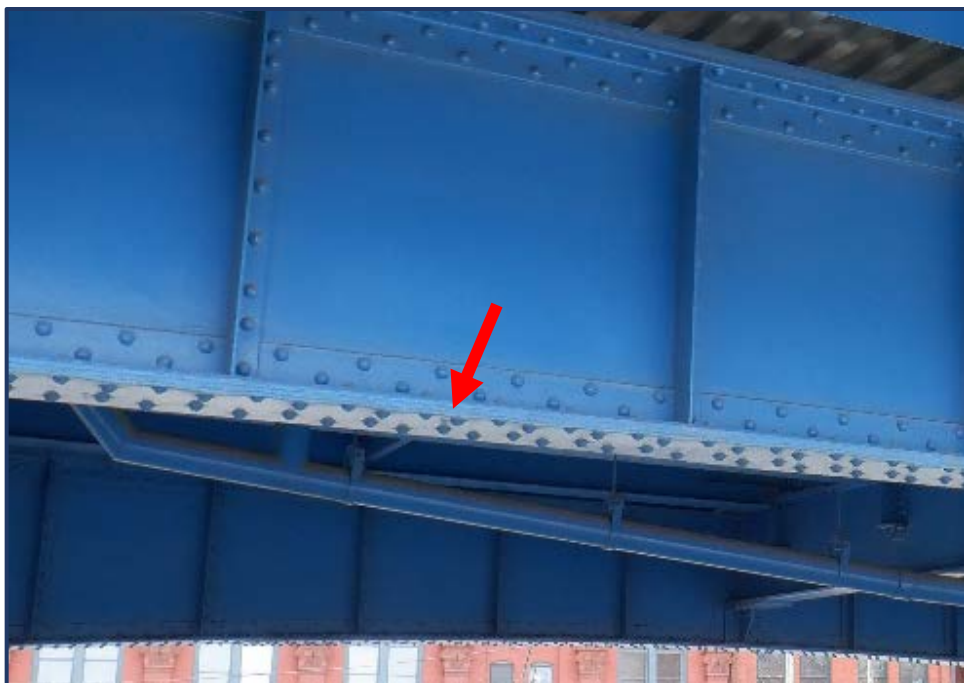
*Photo 107-2 – Unit IV, North Girder at B22, Bottom Flange Painted over Pack Rust up to 1"*

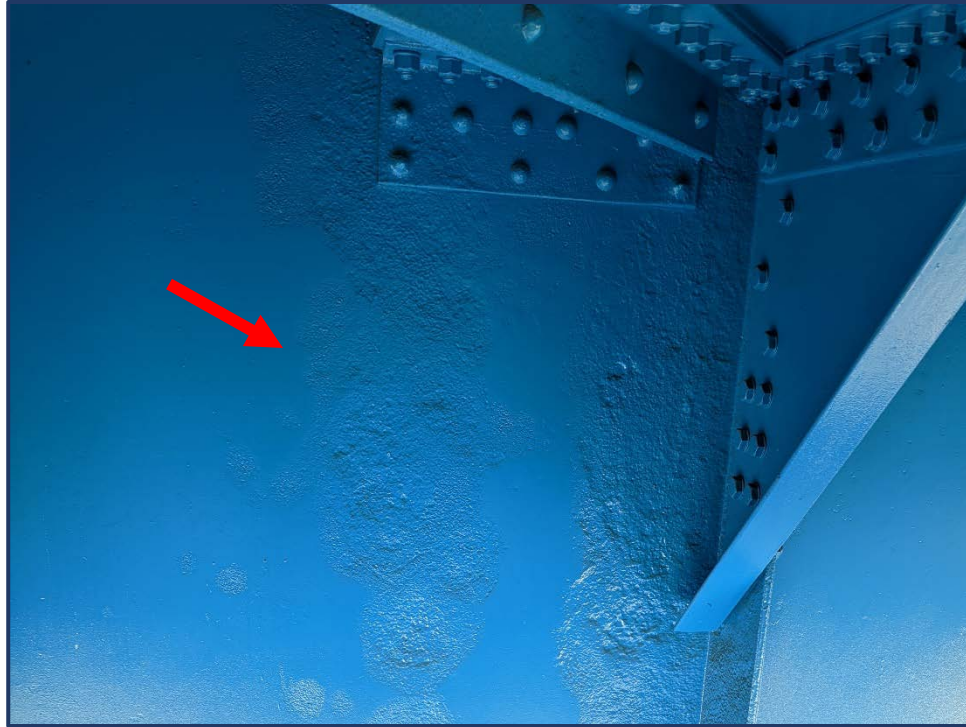
*Photo 107-3 – Unit V, North Girder at FB 77, Painted over Section Loss on Web*

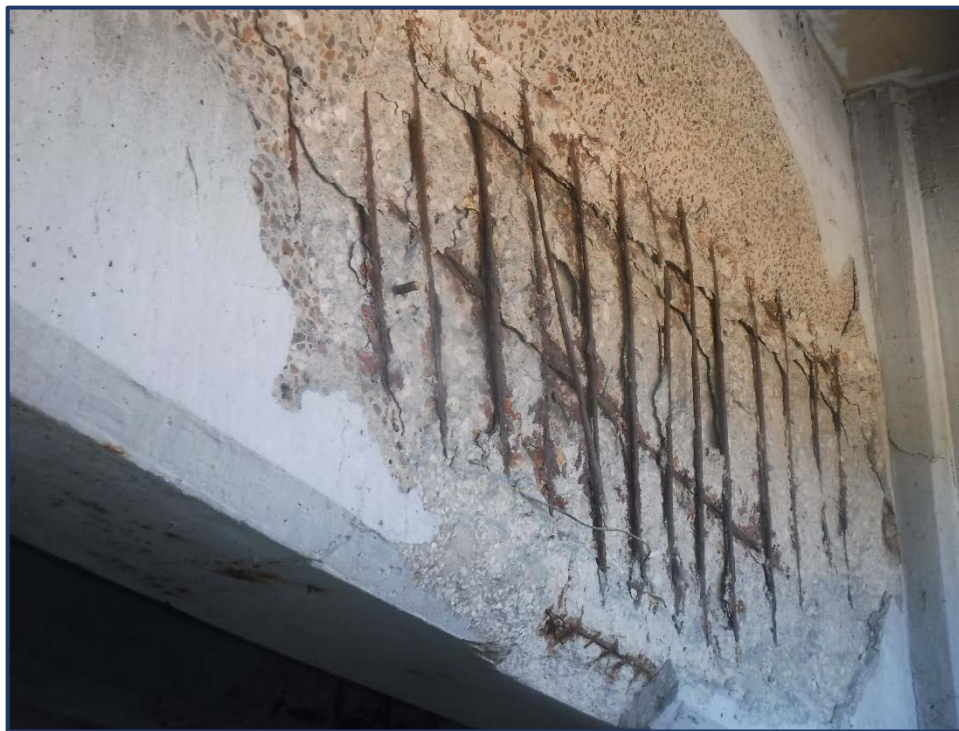
*Photo 116-1 – Unit I, Section P, Girder 14, Spalling with Corroded Rebar*

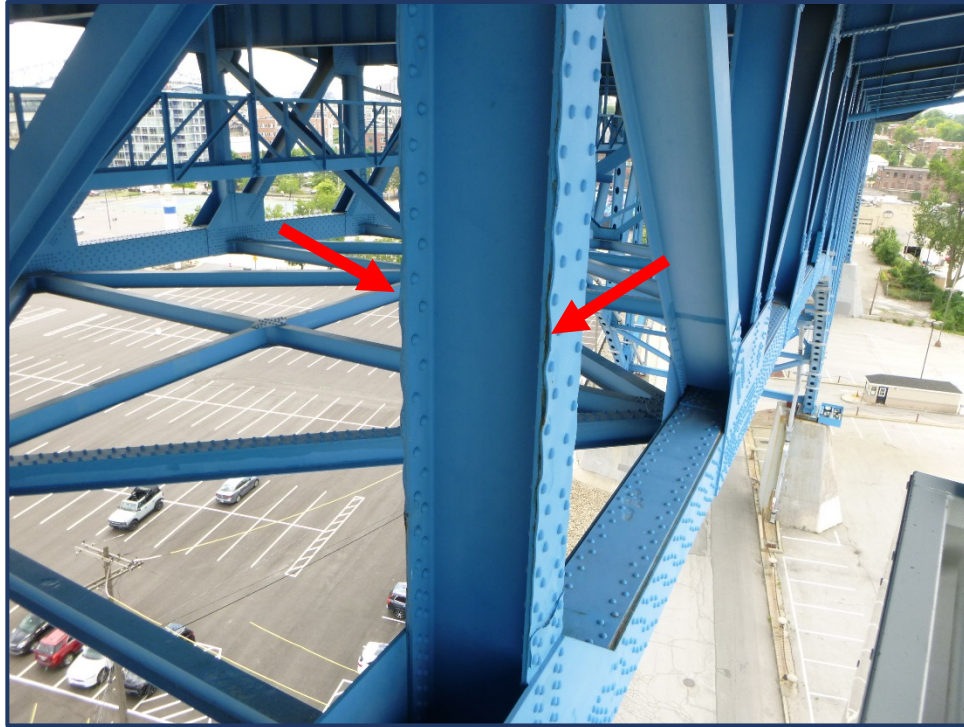
*Photo 120-1 – Span 8, North Truss, L12-U12 Distortion of Cover Plates due to Pack Rust*

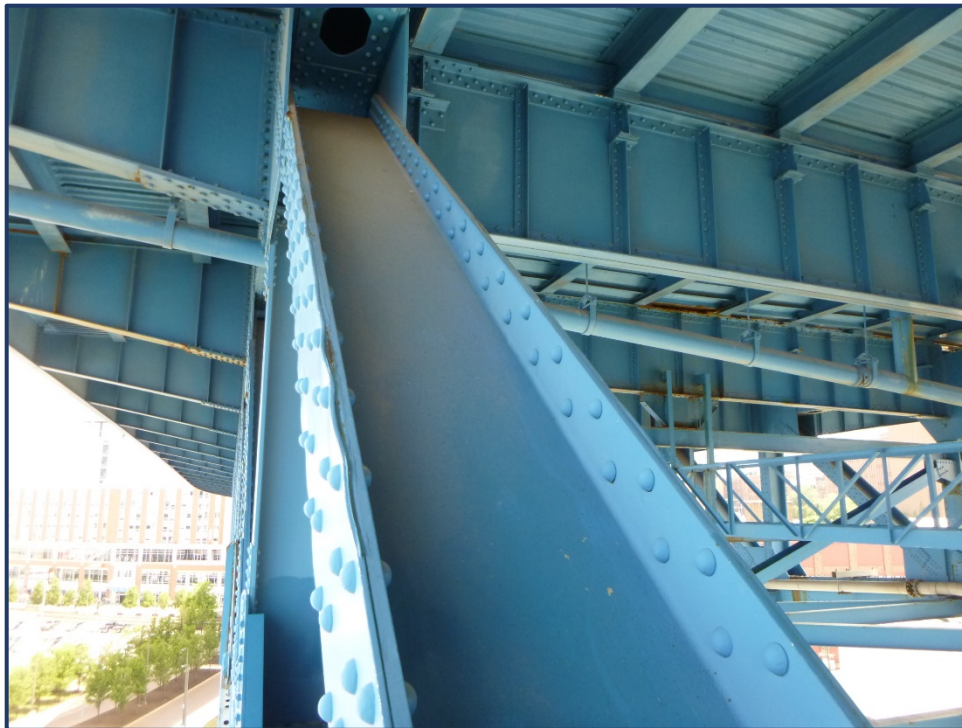
*Photo 120-2 – Typical Distortion of Diagonal Flange Plates due to Sealed Pack Rust*

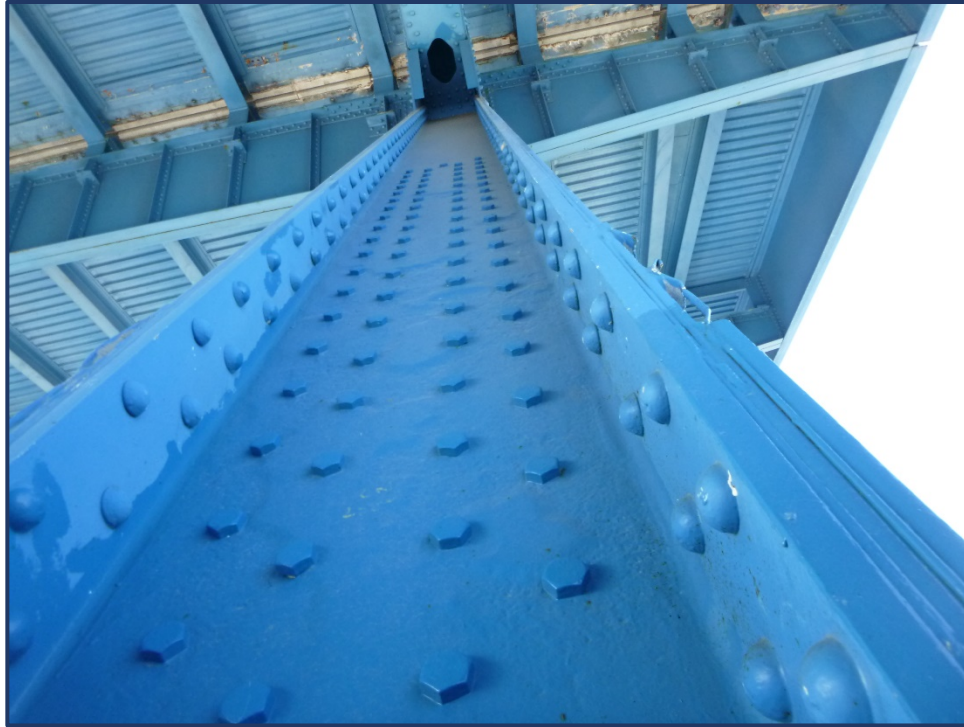
*Photo 120-3 – Area of Painted over Section Loss on Diagonal with Retrofit Plate on Back Side*

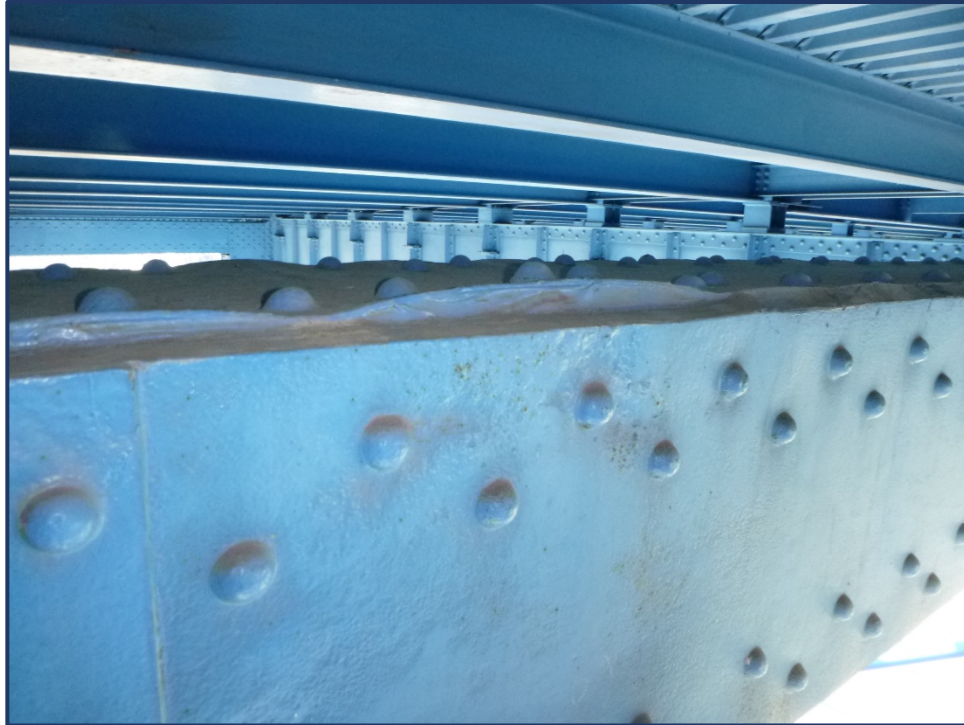
*Photo 120-5 – Span 6, South Truss, U14-U15, Painted over Pack Rust*

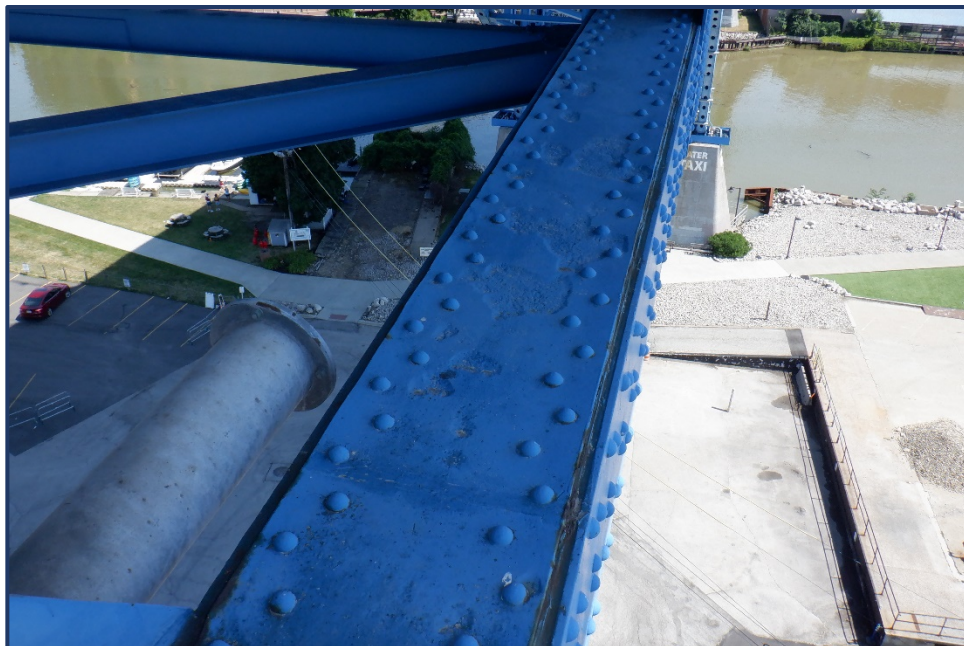
*Photo 120-6 – Span 8, South Truss, L8-L9, Painted over Section Loss*

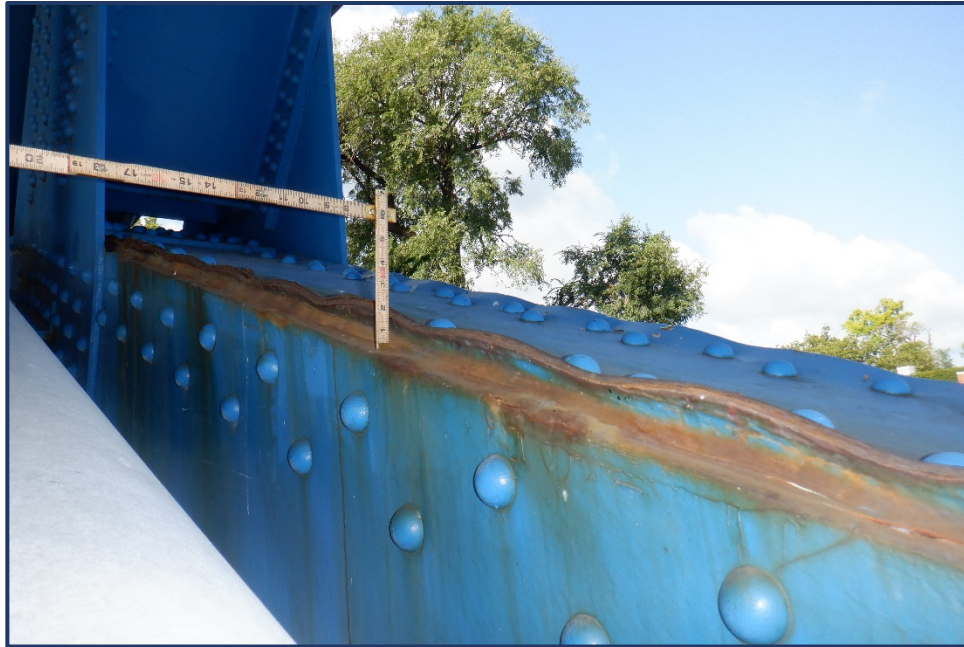
*Photo 120-7 – Span 2, South Truss, L1-L2, Distortion of Top Flange Plate due to Pack Rust*

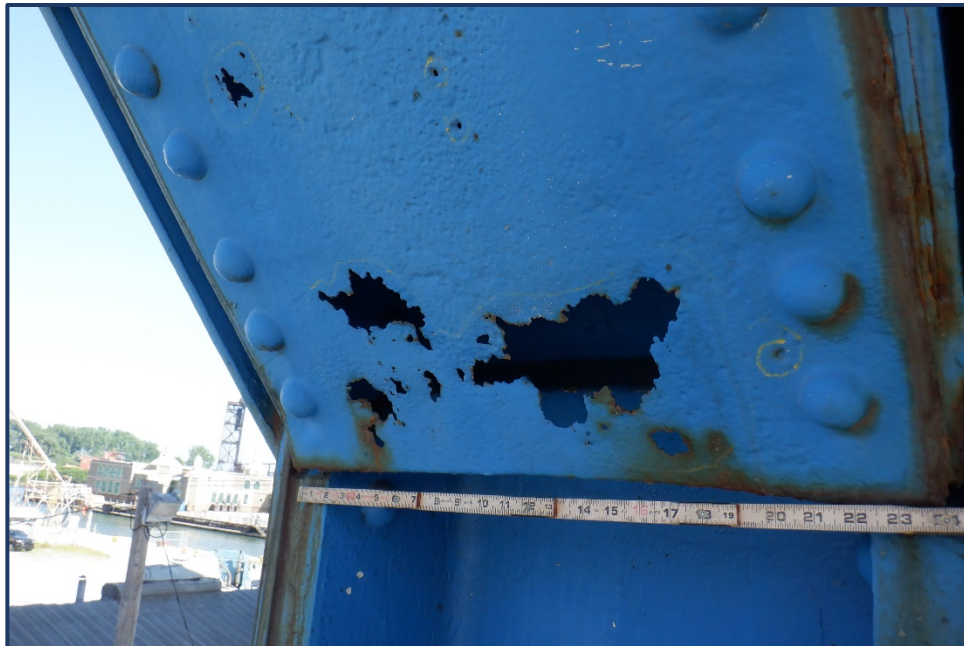
*Photo 120-8 – Span 4, South Truss, L1-L2, Painted over Corrosion Holes in Bottom Flange*

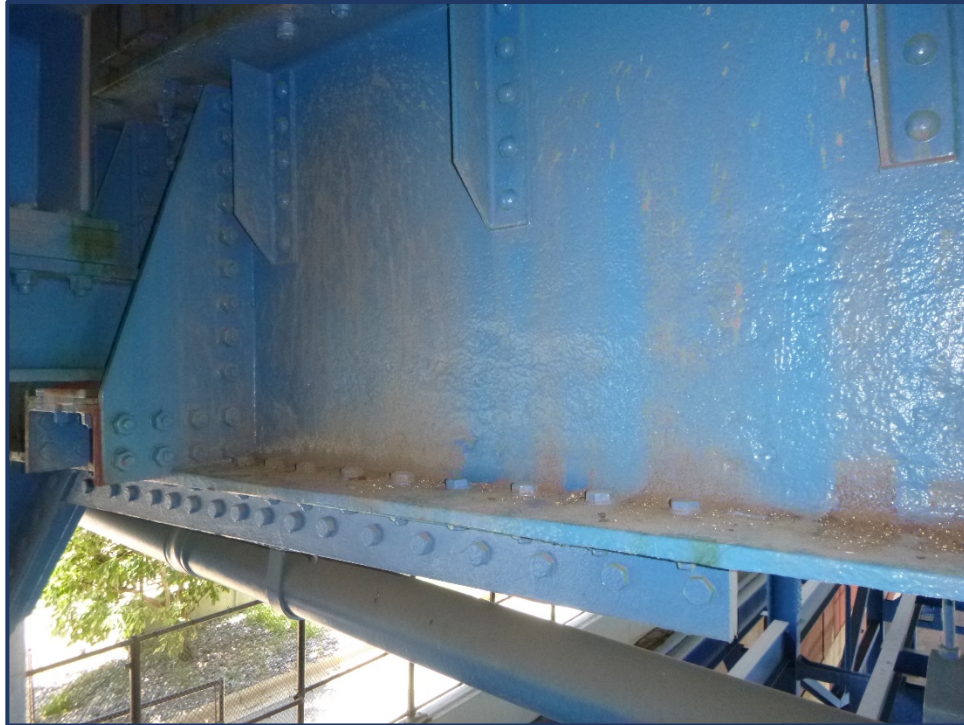
*Photo 152-1 – Unit III, FB7, Painted over Section Loss in Lower Half of Floorbeam*

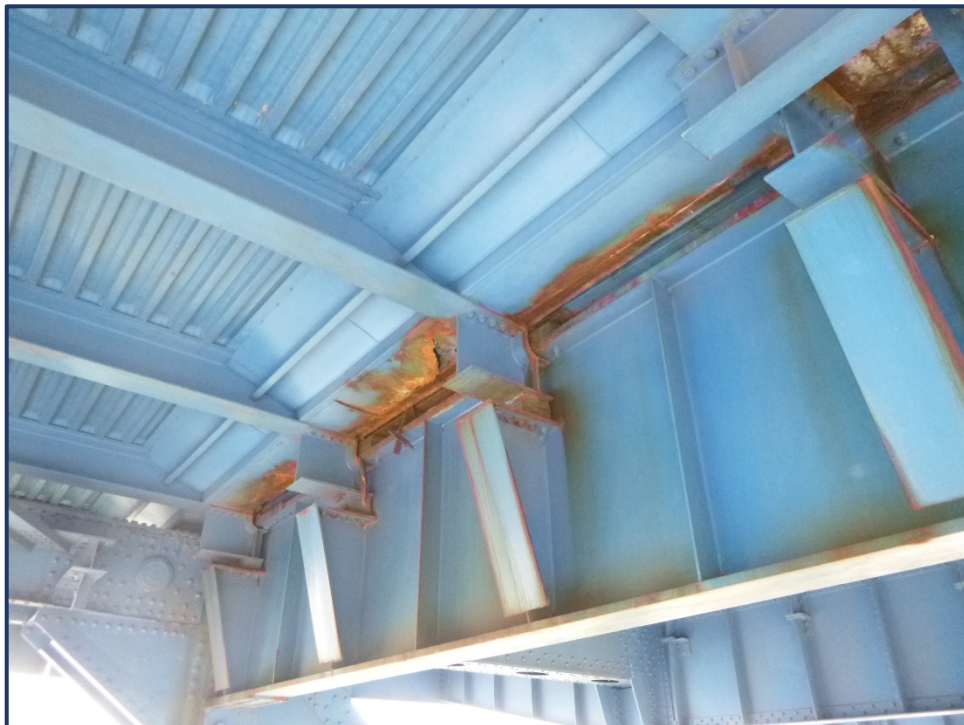
*Photo 152-2 – Unit II, Span 8, FB 25, Active Surface Corrosion due to Deck Drainage*
