**Physical Condition Report for  
CUY-002-1441  
SFN 1800035  
Main Avenue Bridge over the Cuyahoga River  
2022 Routine Inspection**

**Prepared for:**

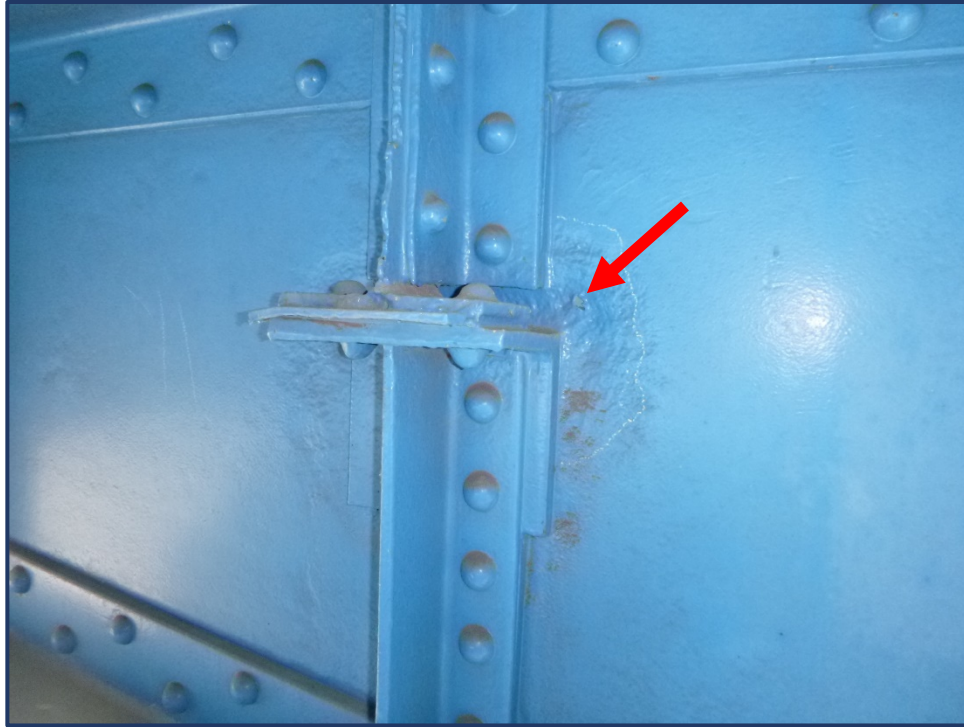
*Photo 152-3 – Unit II, Span 10, FB 16, Areas of Painted over Section Loss with Corrosion Holes at Abandoned Stringer Connection*

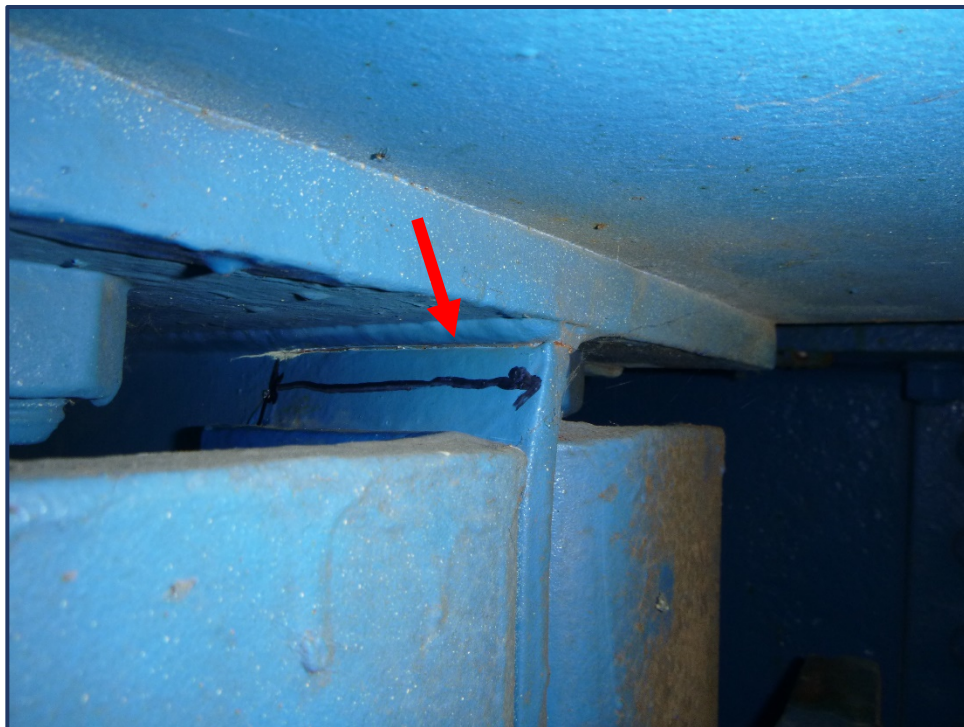
*Photo 152-4 – Unit III, Span 11, FB 14 at North Truss, New Crack in OB Top Flange Cope*

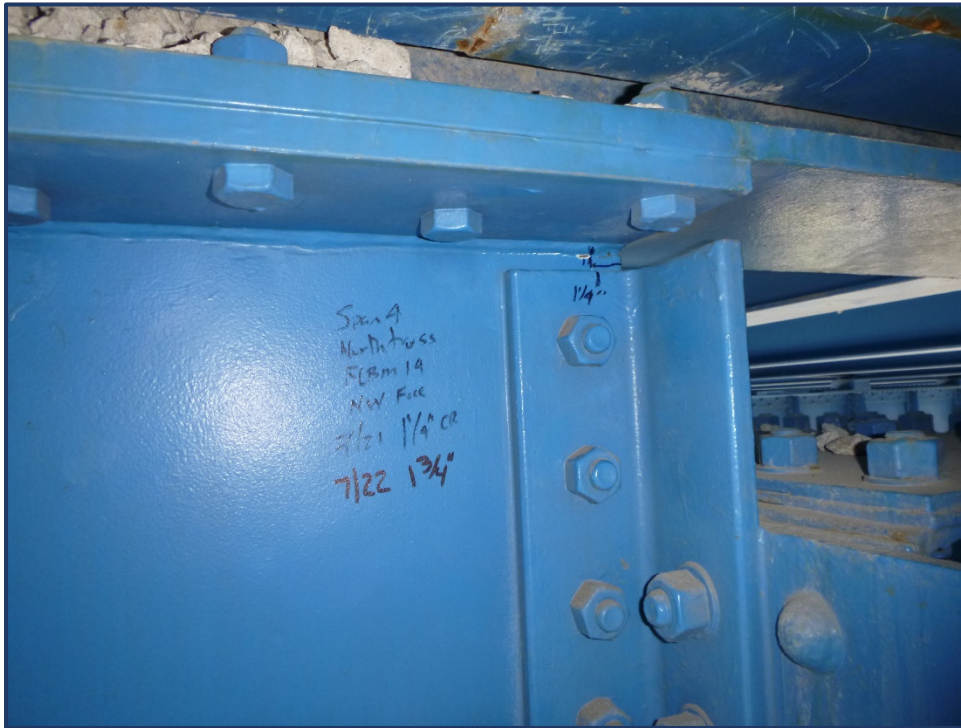
*Photo 152-5 – Unit II, Span 4, FB 14 at North Truss, Crack in OB Top Flange Cope Exhibiting Slow Growth*

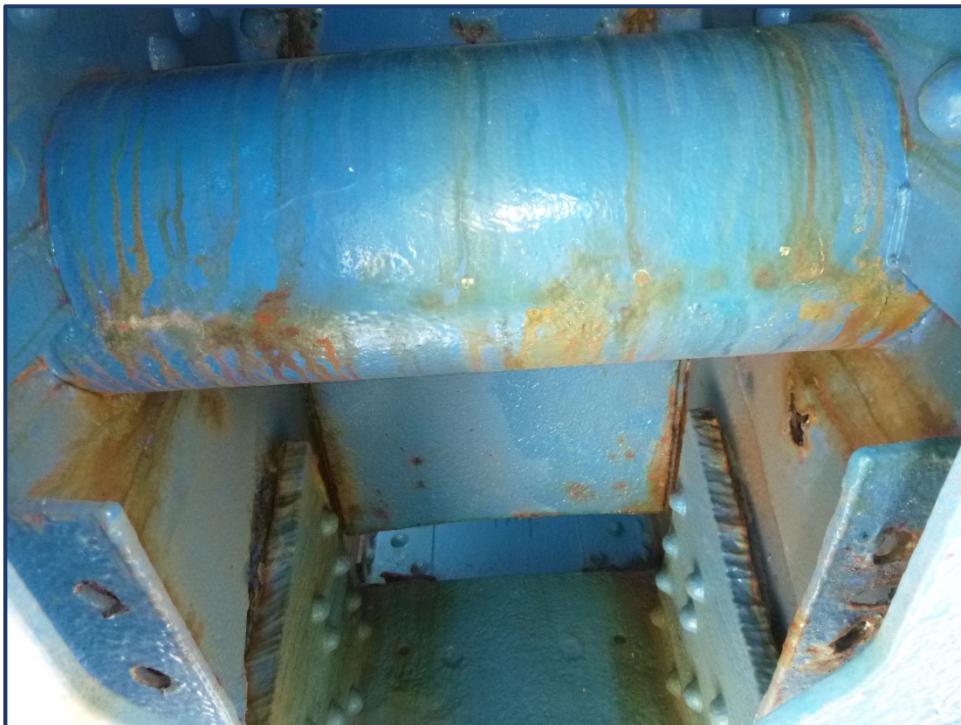
*Photo 161-1 – Unit II, Span 8, North Truss at U25, Painted over Pitting on Pin with Rust Staining*

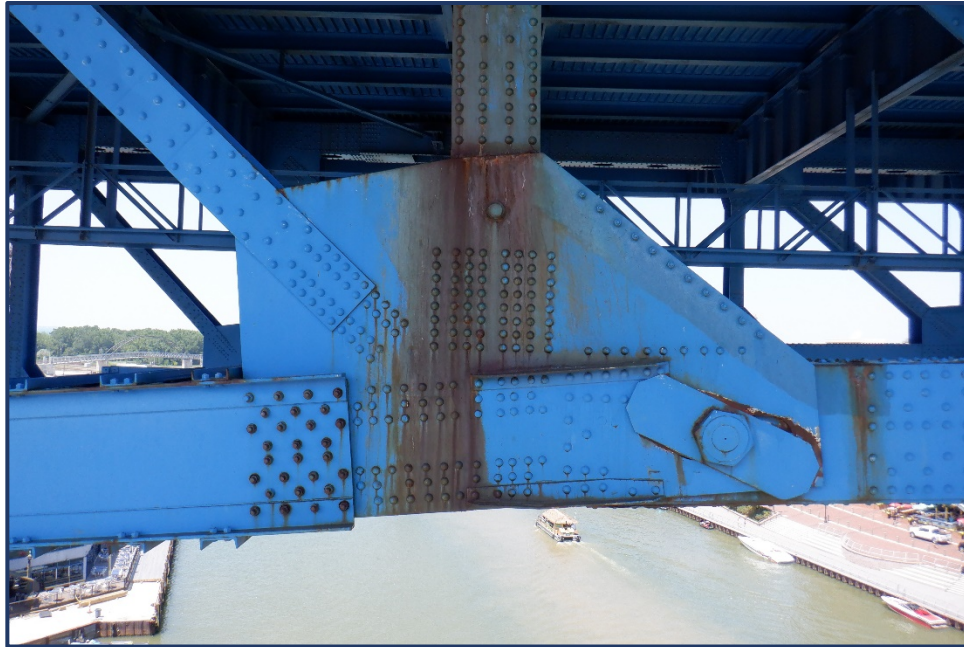
*Photo 161-2 – Unit II, Span 9, South Truss, Rotated Pin Plate at L0*

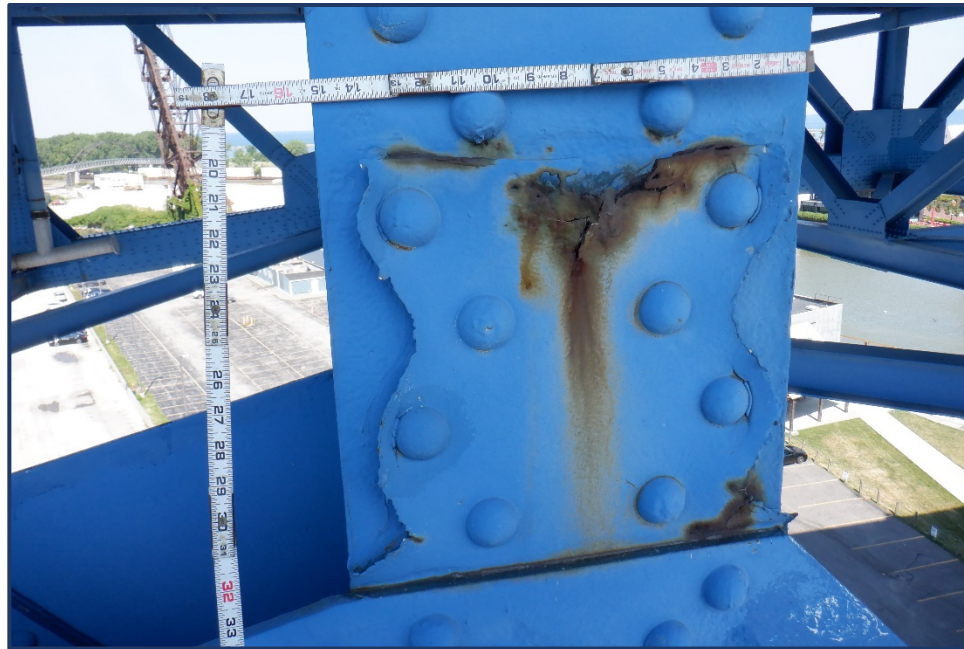
*Photo 162-3 – Unit II, Span 8, North Truss, Corrosion Complete Section Loss In Fill Plate at L9*

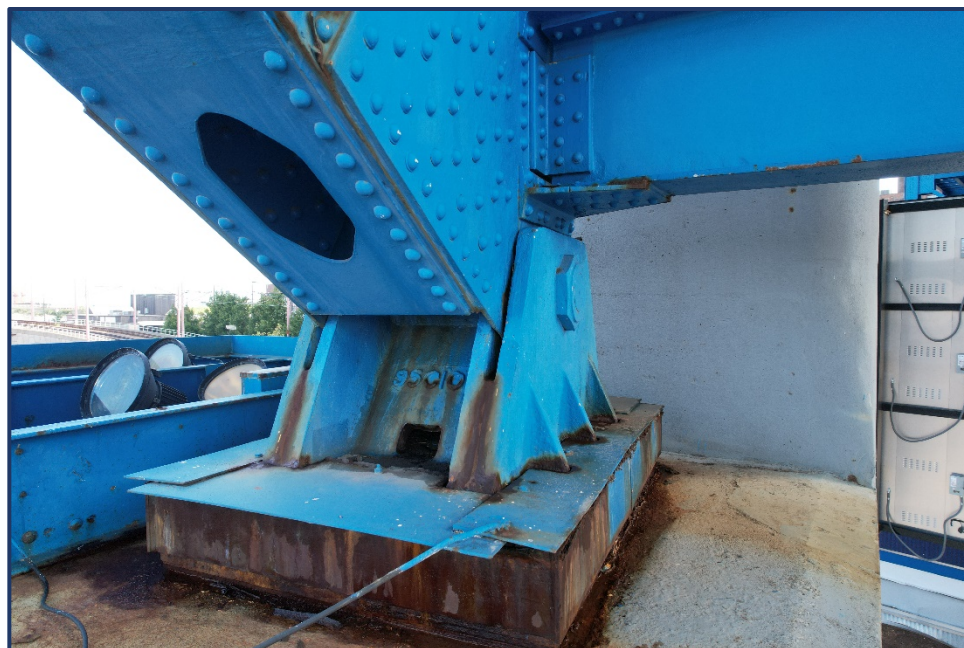
*Photo 311-1 – Unit II, Pier 10, North Truss Bearing, Layered Corrosion*

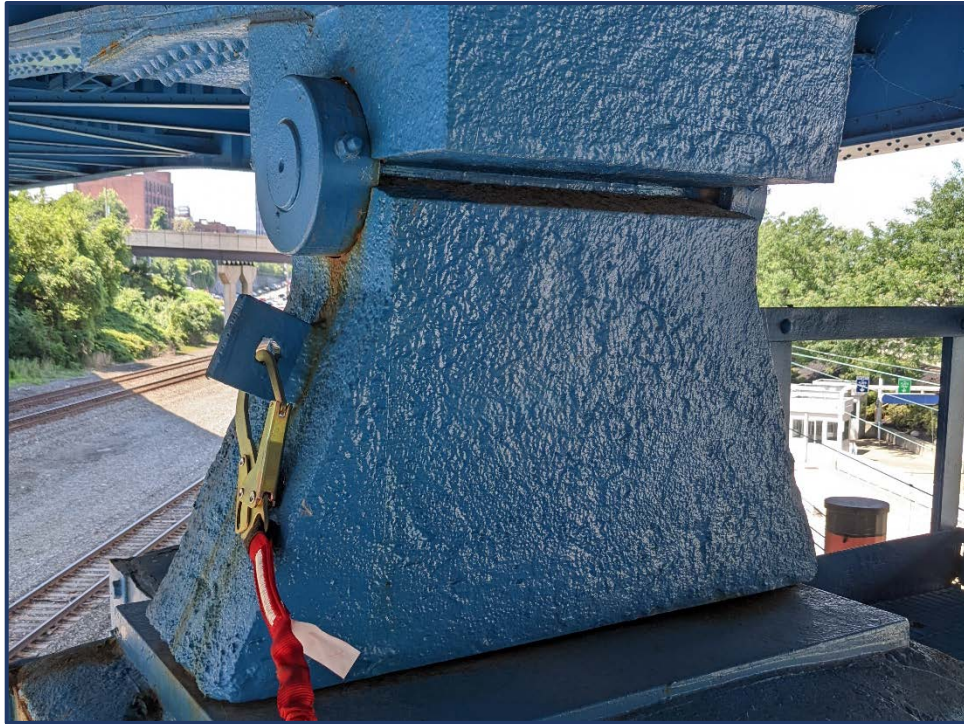
*Photo 311-2 – Unit V, Pier 39, Center Bearing, Painted Over Pitting*

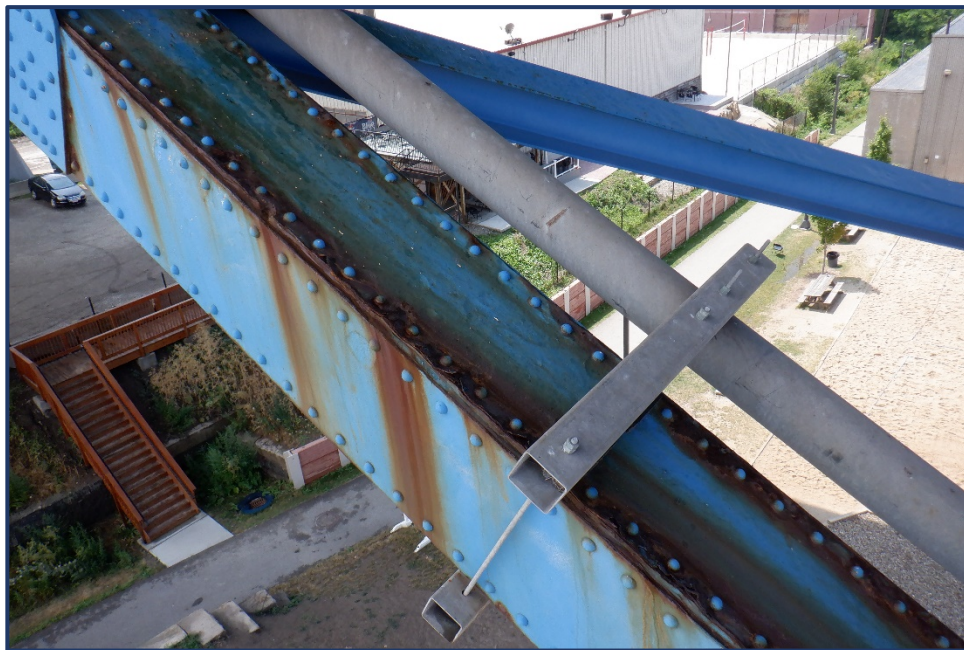
*Photo 515-1 – Typical Active Corrosion near Deck Joint*

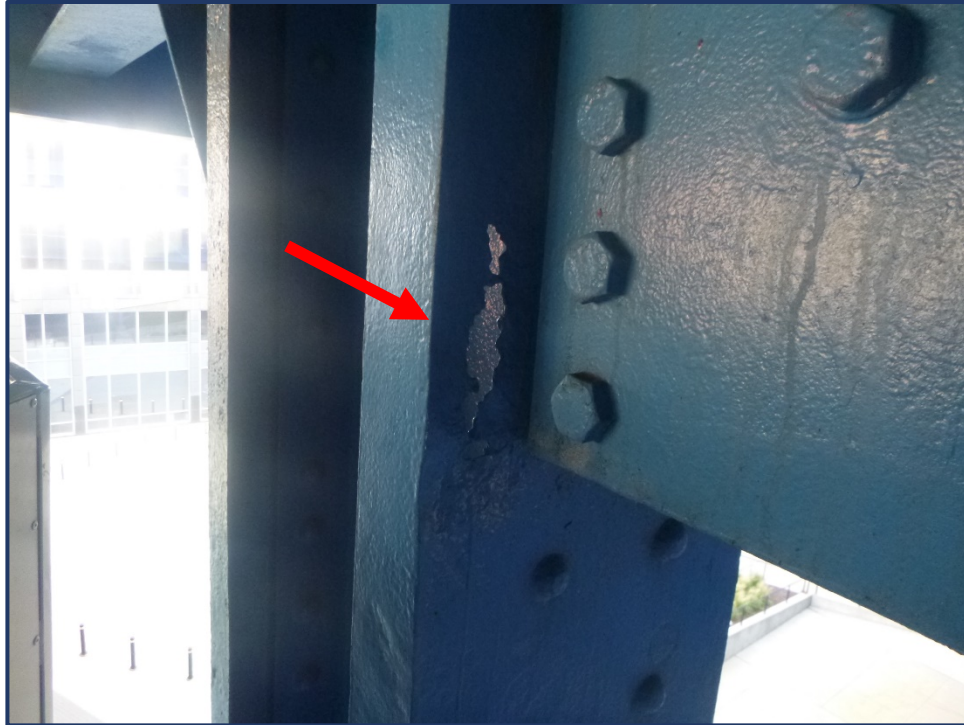
*Photo 202-1 – Unit III, Bent 4 North Column, Painted Over Corrosion Hole at Bracing Connection*

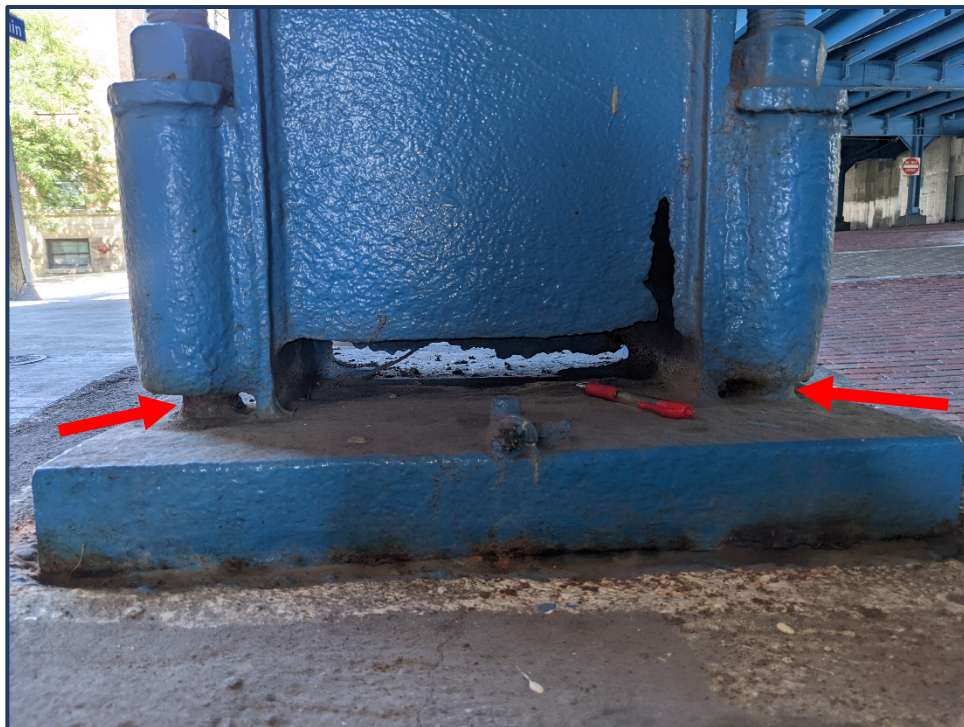
*Photo 202-2 – Unit III, Bent 10 North Column, Painted Over Section Loss, Corrosion Holes, and Section Loss of Anchor Bolts*

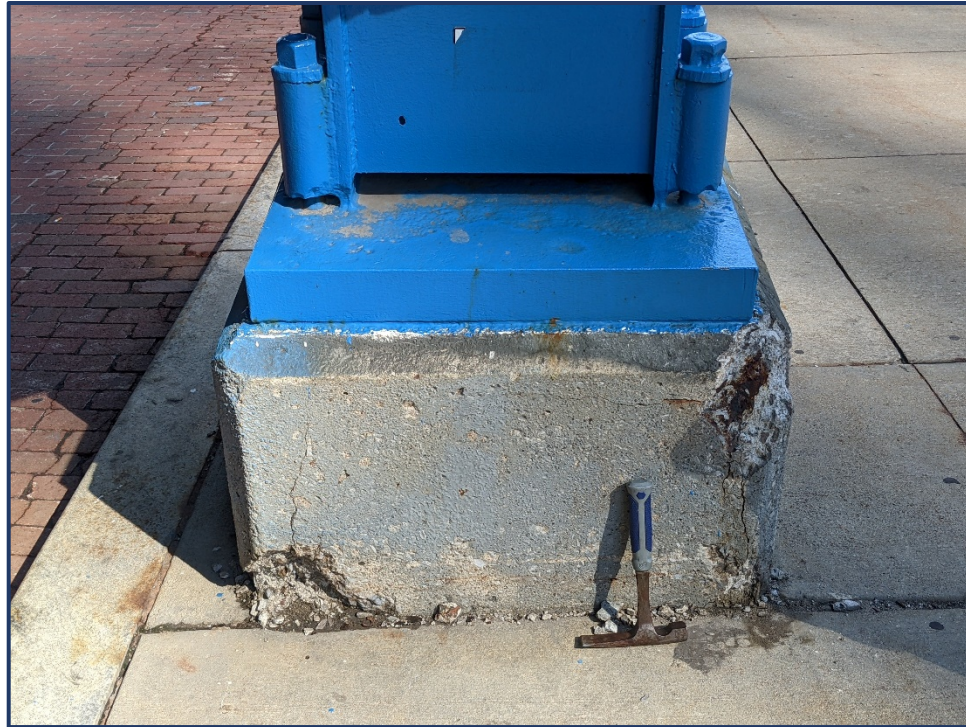
*Photo 202-3 – Unit III, Bent 2 North Column, Cracking and Spalling of Column Base*

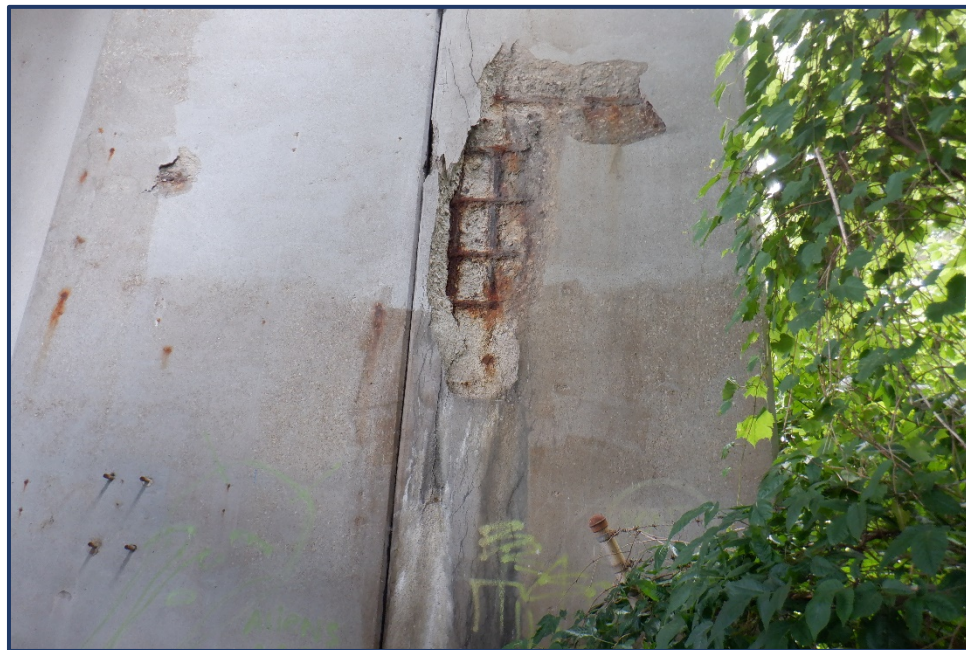
*Photo 205-1 – Unit I, Section P, East Pier, Spalling of North Column*

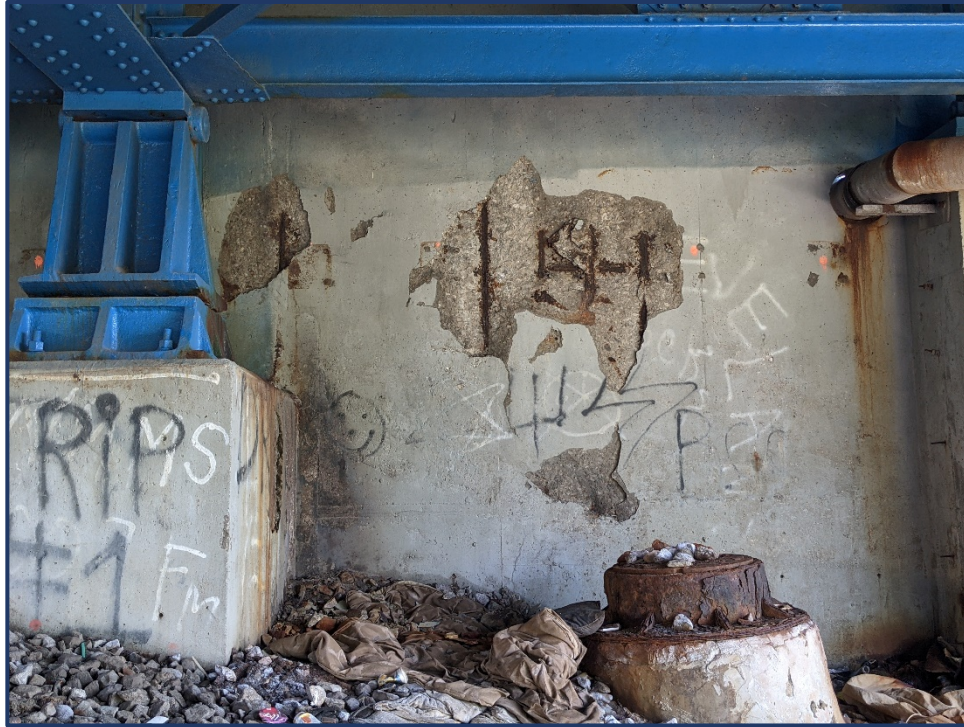
*Photo 210-1 – Pier 37, East Face, Delamination and Spalling of Pier Wall*

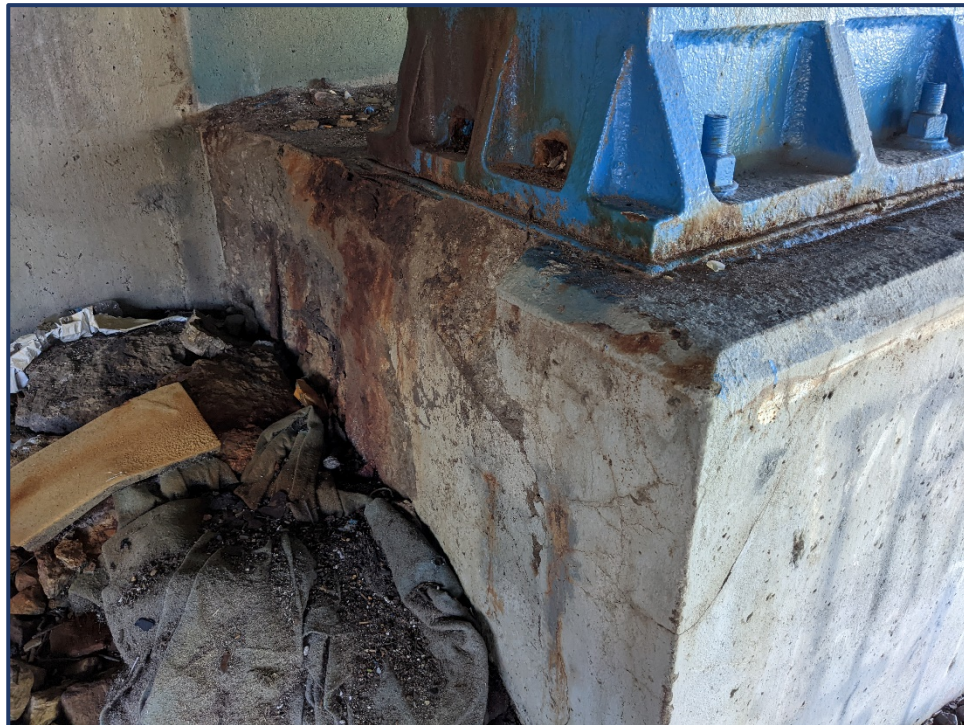
*Photo 210-2 – Pier 37, Span 38 South Bearing Pedestal Spalling with Exposed Reinforcing*

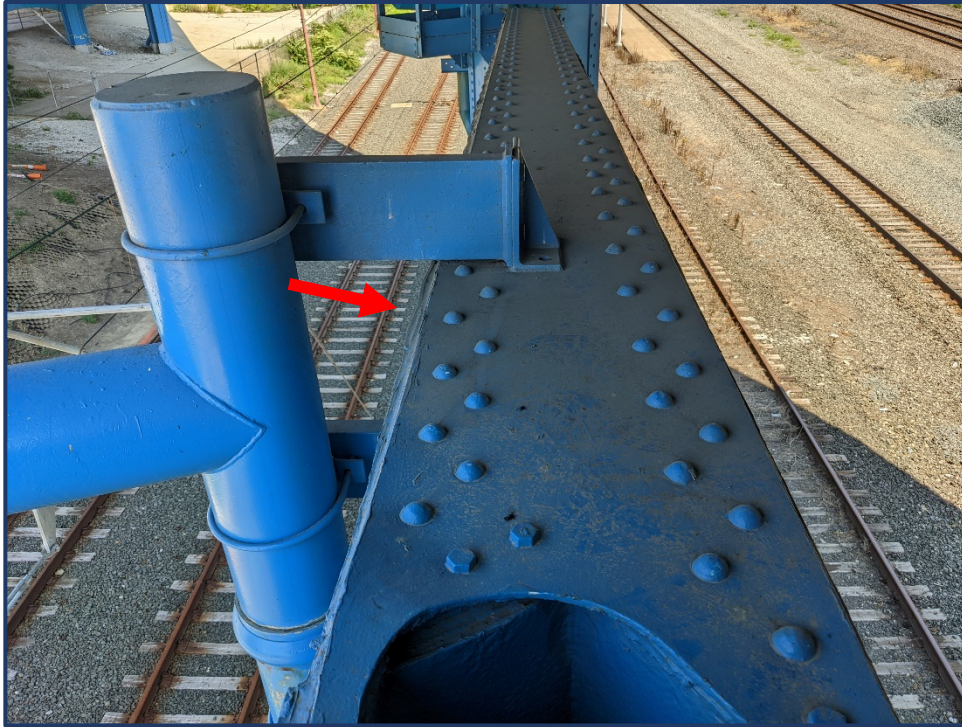
*Photo 231-1 – Unit V, Pier 39, Painted over Pack Rust on Pier Cap*

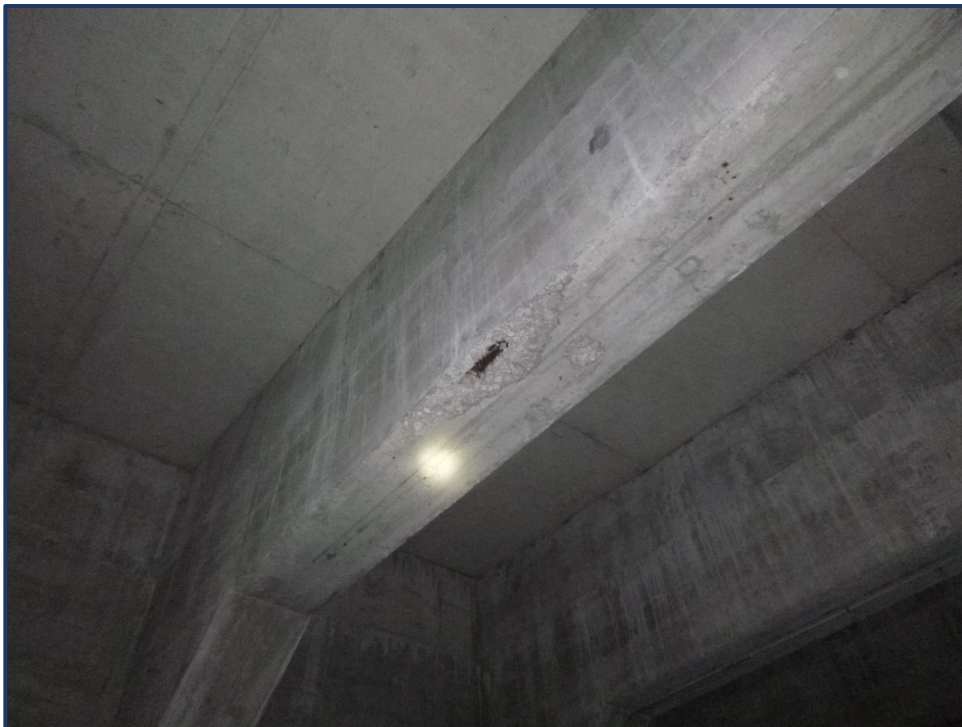
*Photo 234-1 – Unit I, Pier 12 Cap, Spall with Exposed Reinforcing*

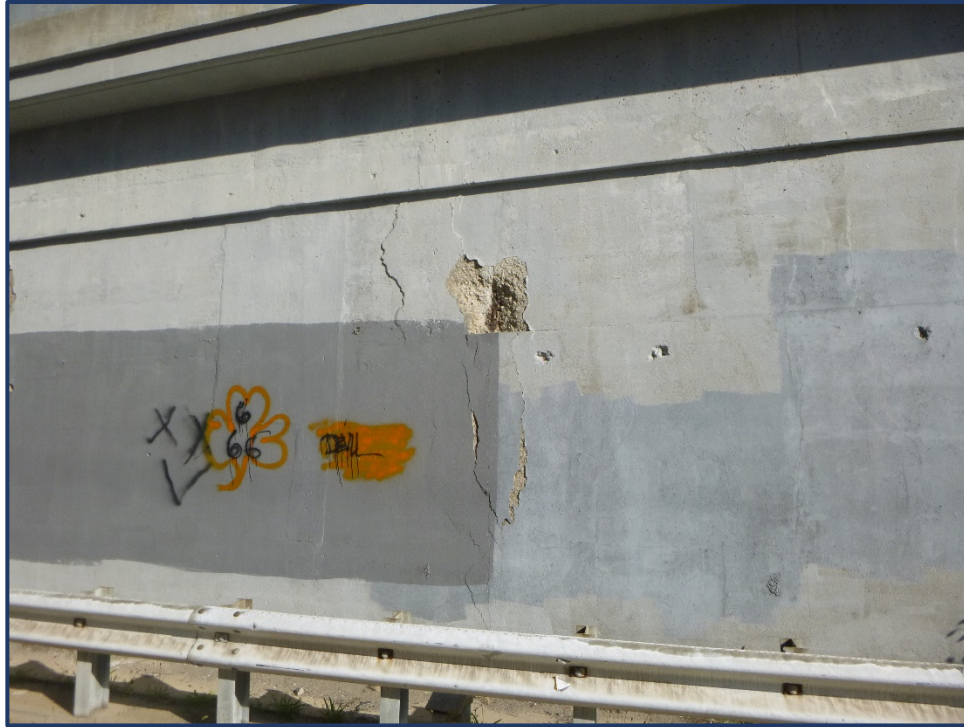
*Photo MW-1 – Unit I, Section J', Spalling and Delamination in South Mask Wall*

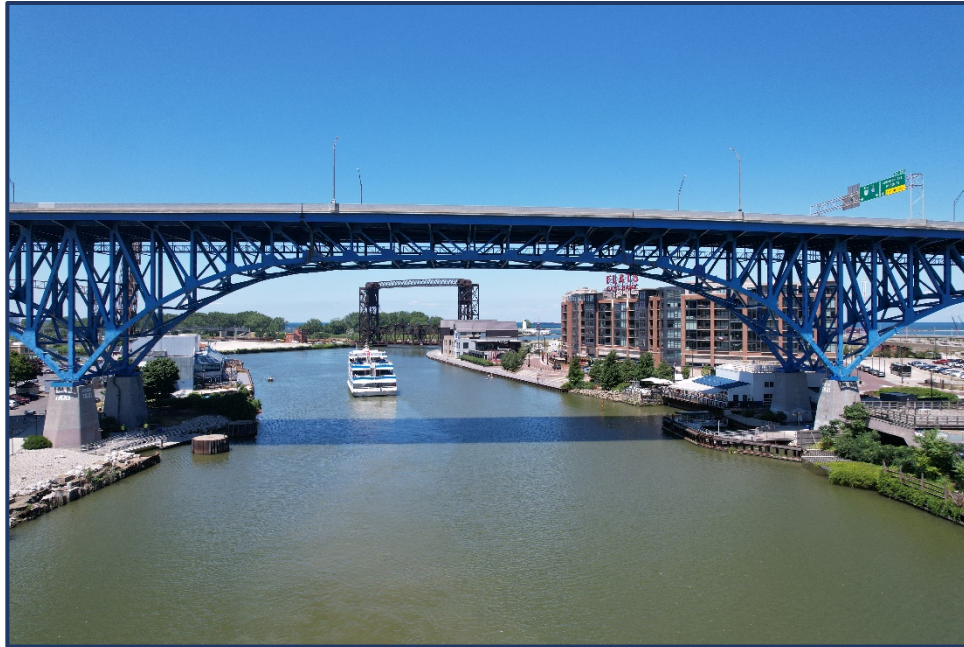
*Photo CH-1 – Channel at Bridge Looking North*

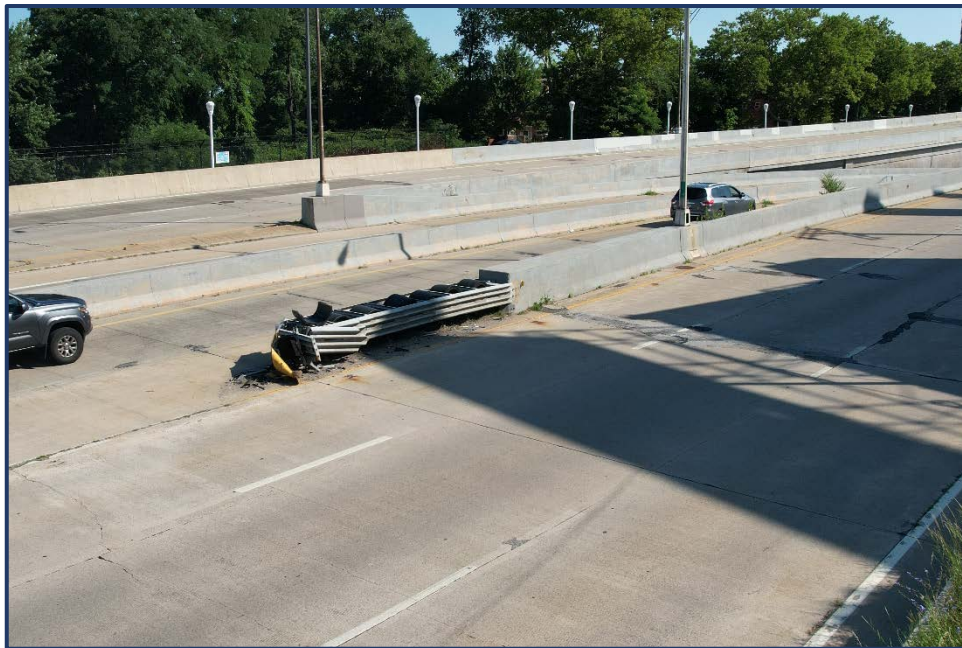
*Photo APR-2 – Eastbound Exist to W. 25<sup>th</sup> St., Damaged Impact Attenuator*

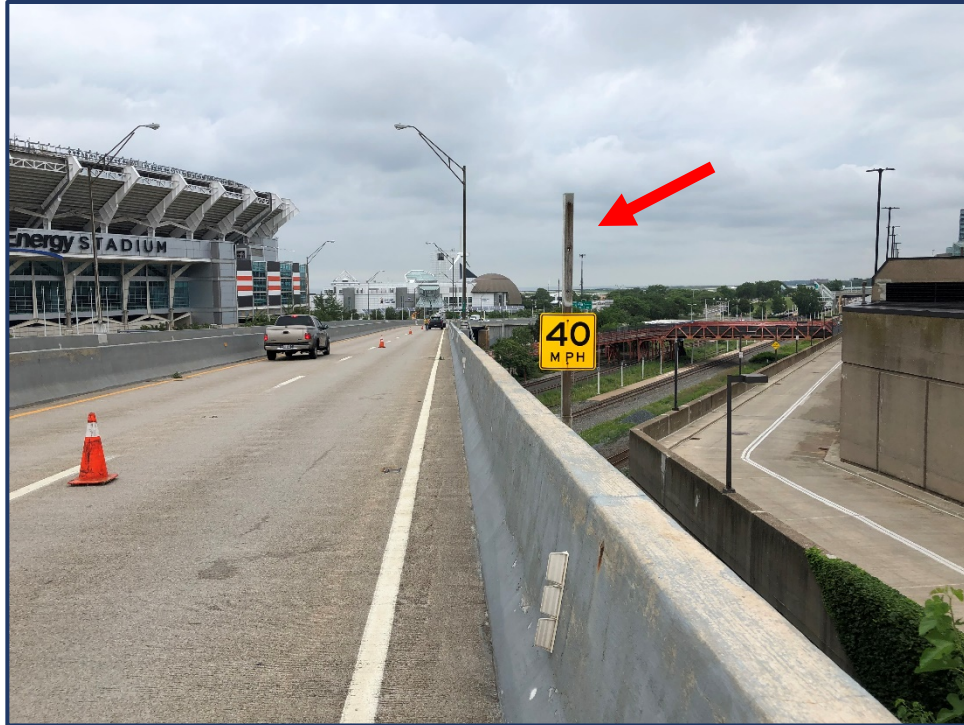
*Photo SIG-1 – Unit V, Eastbound, Missing Sign on Right Parapet*

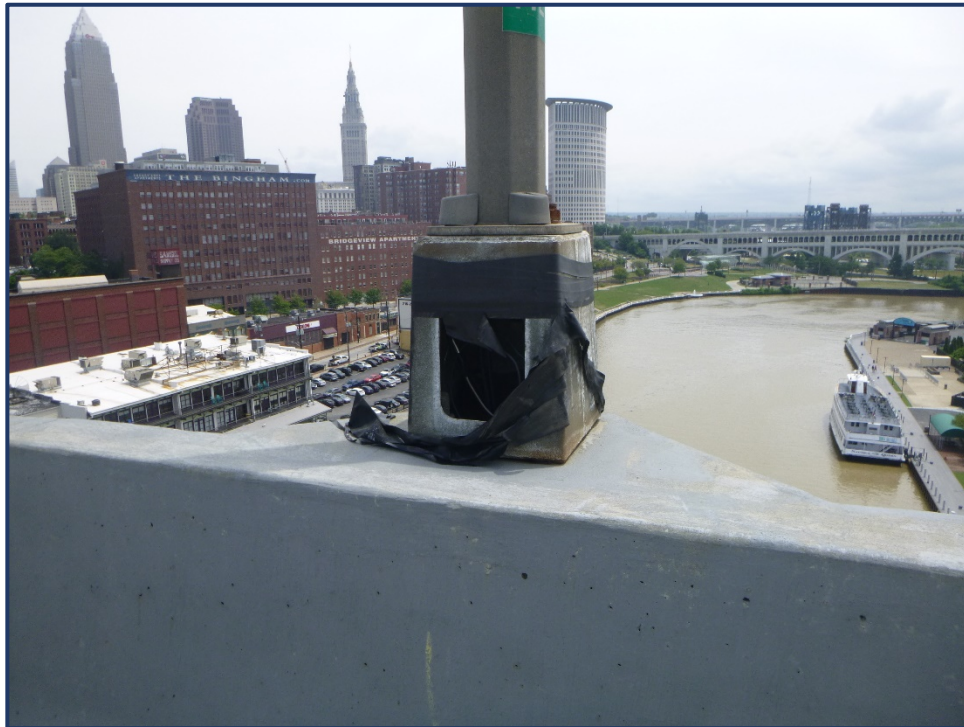
*Photo LI-1 – Typical missing Utility Cover at Light Pole*

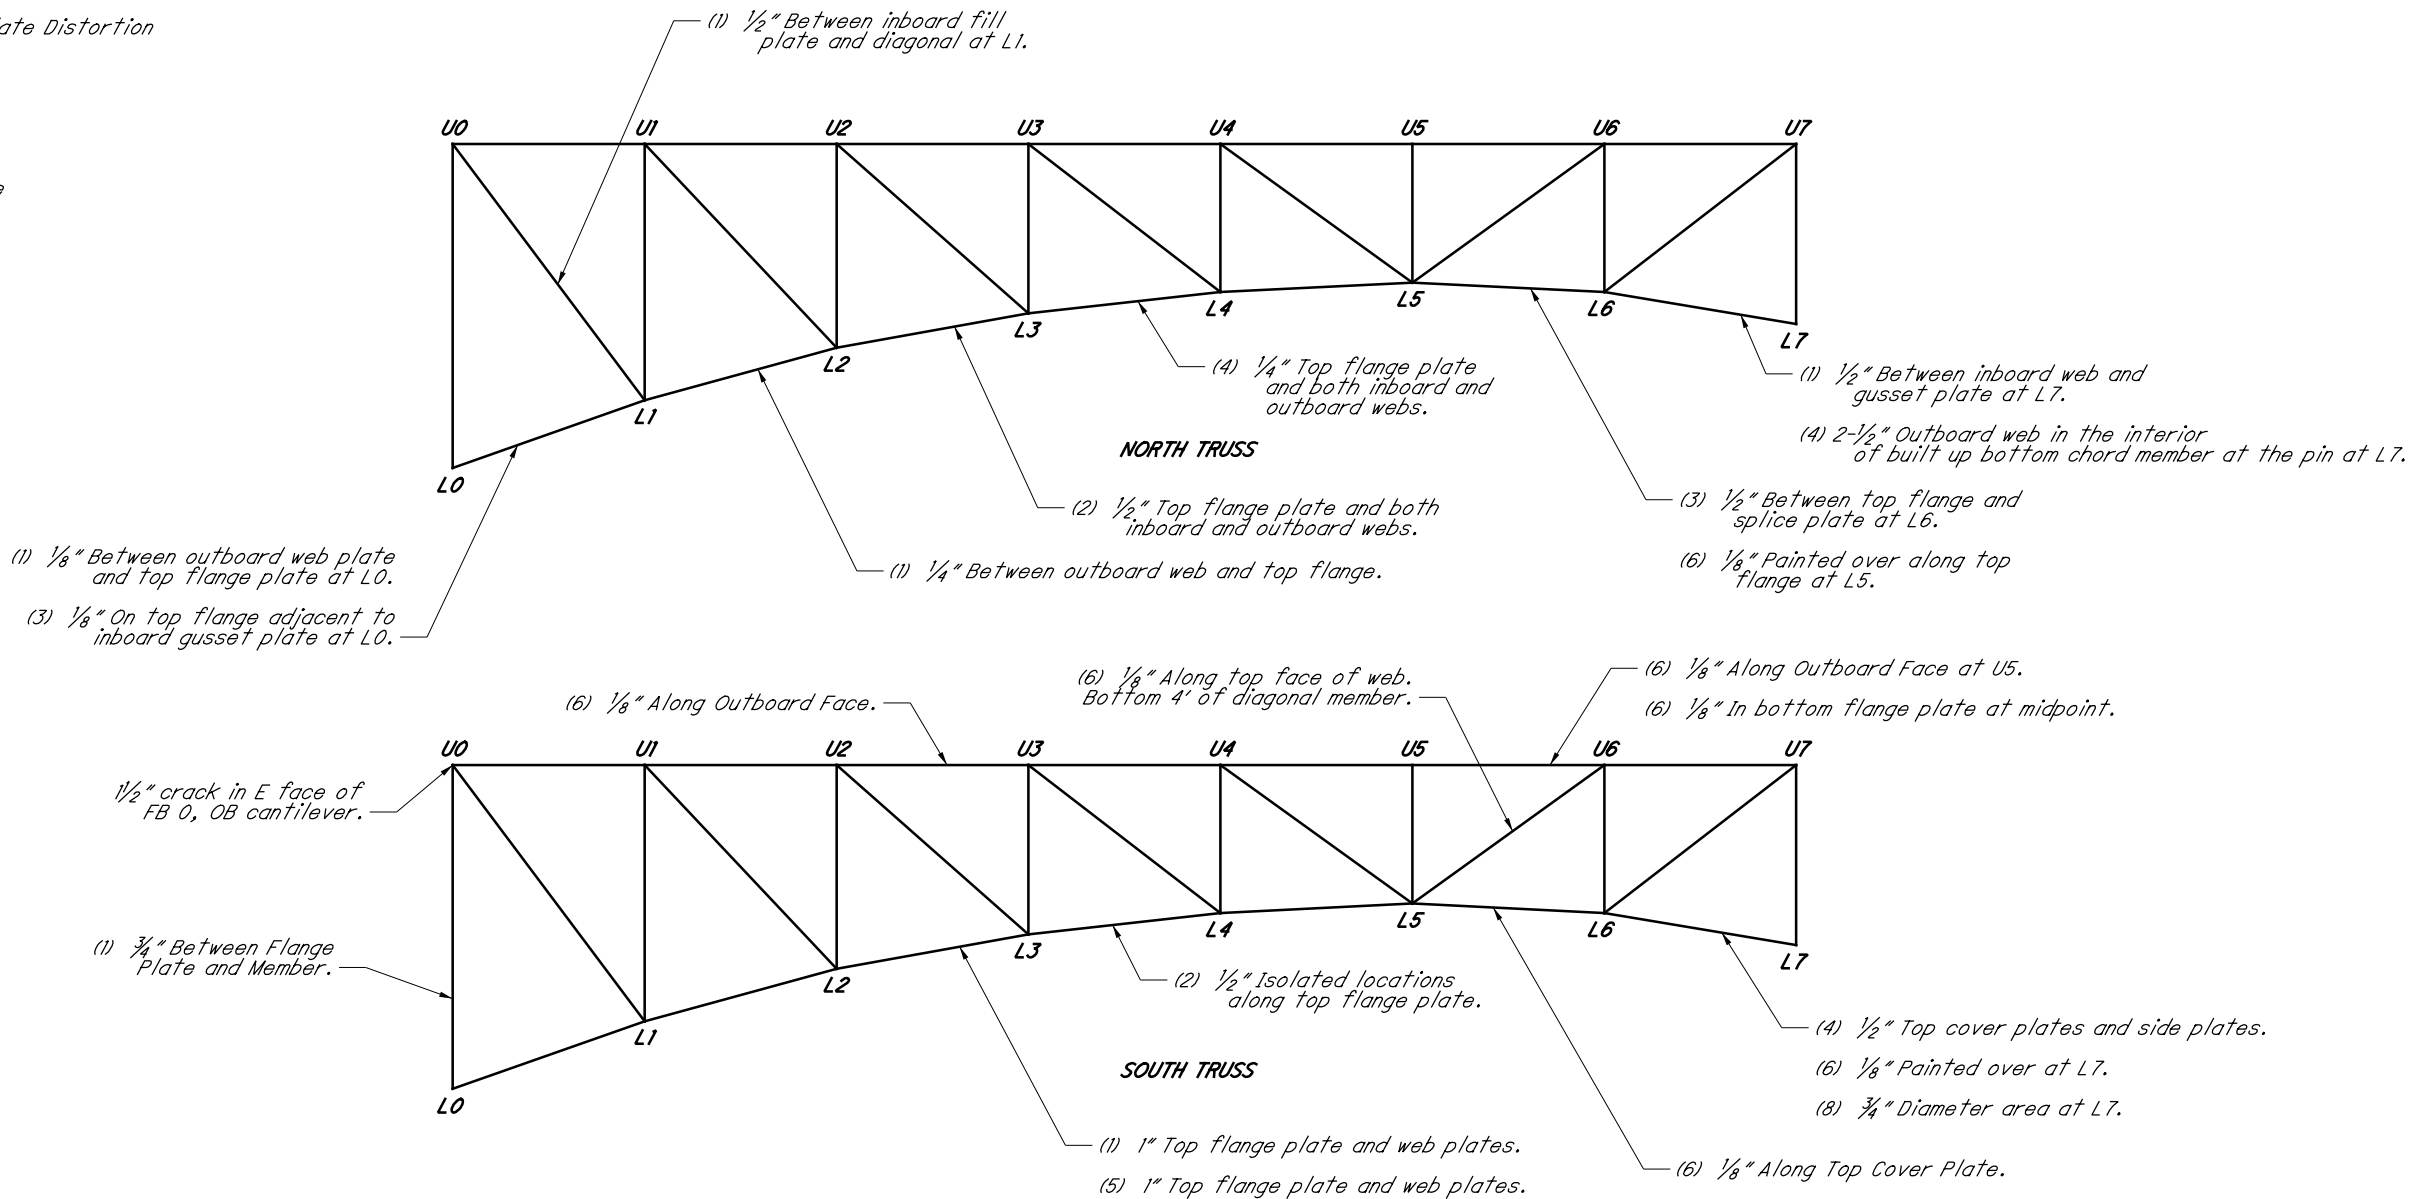
South Truss Gusset Plate Deficiencies:

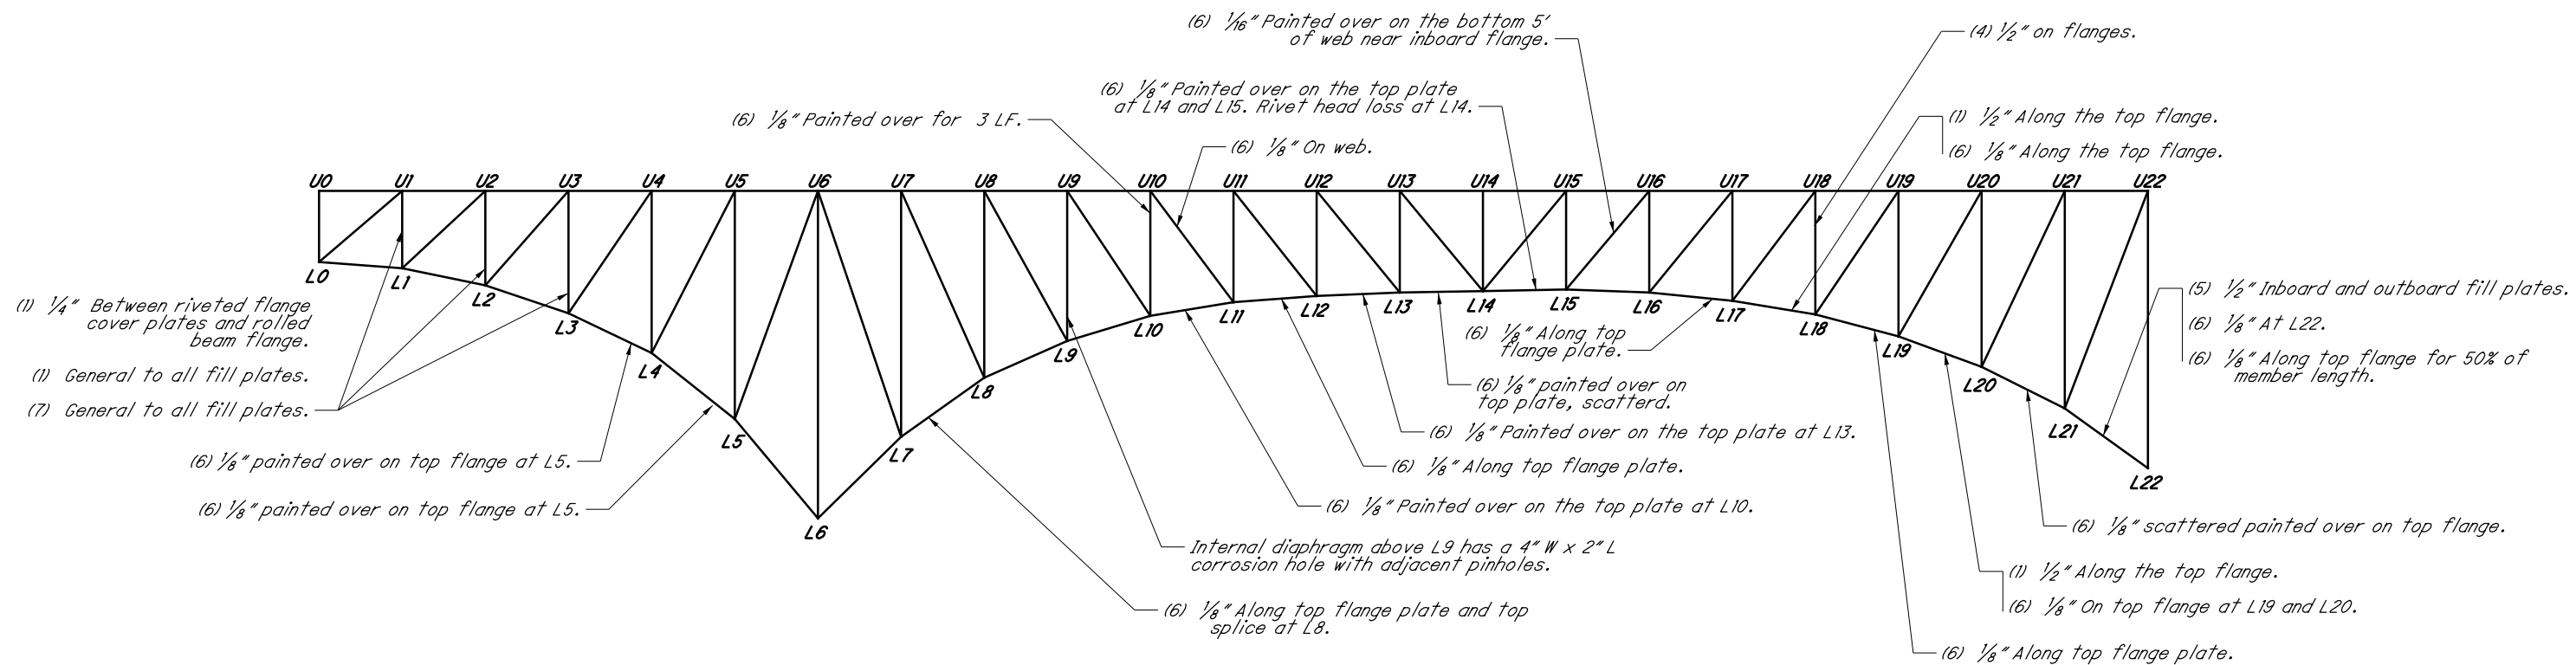
**North Truss Gusset Plate Deficiencies:**

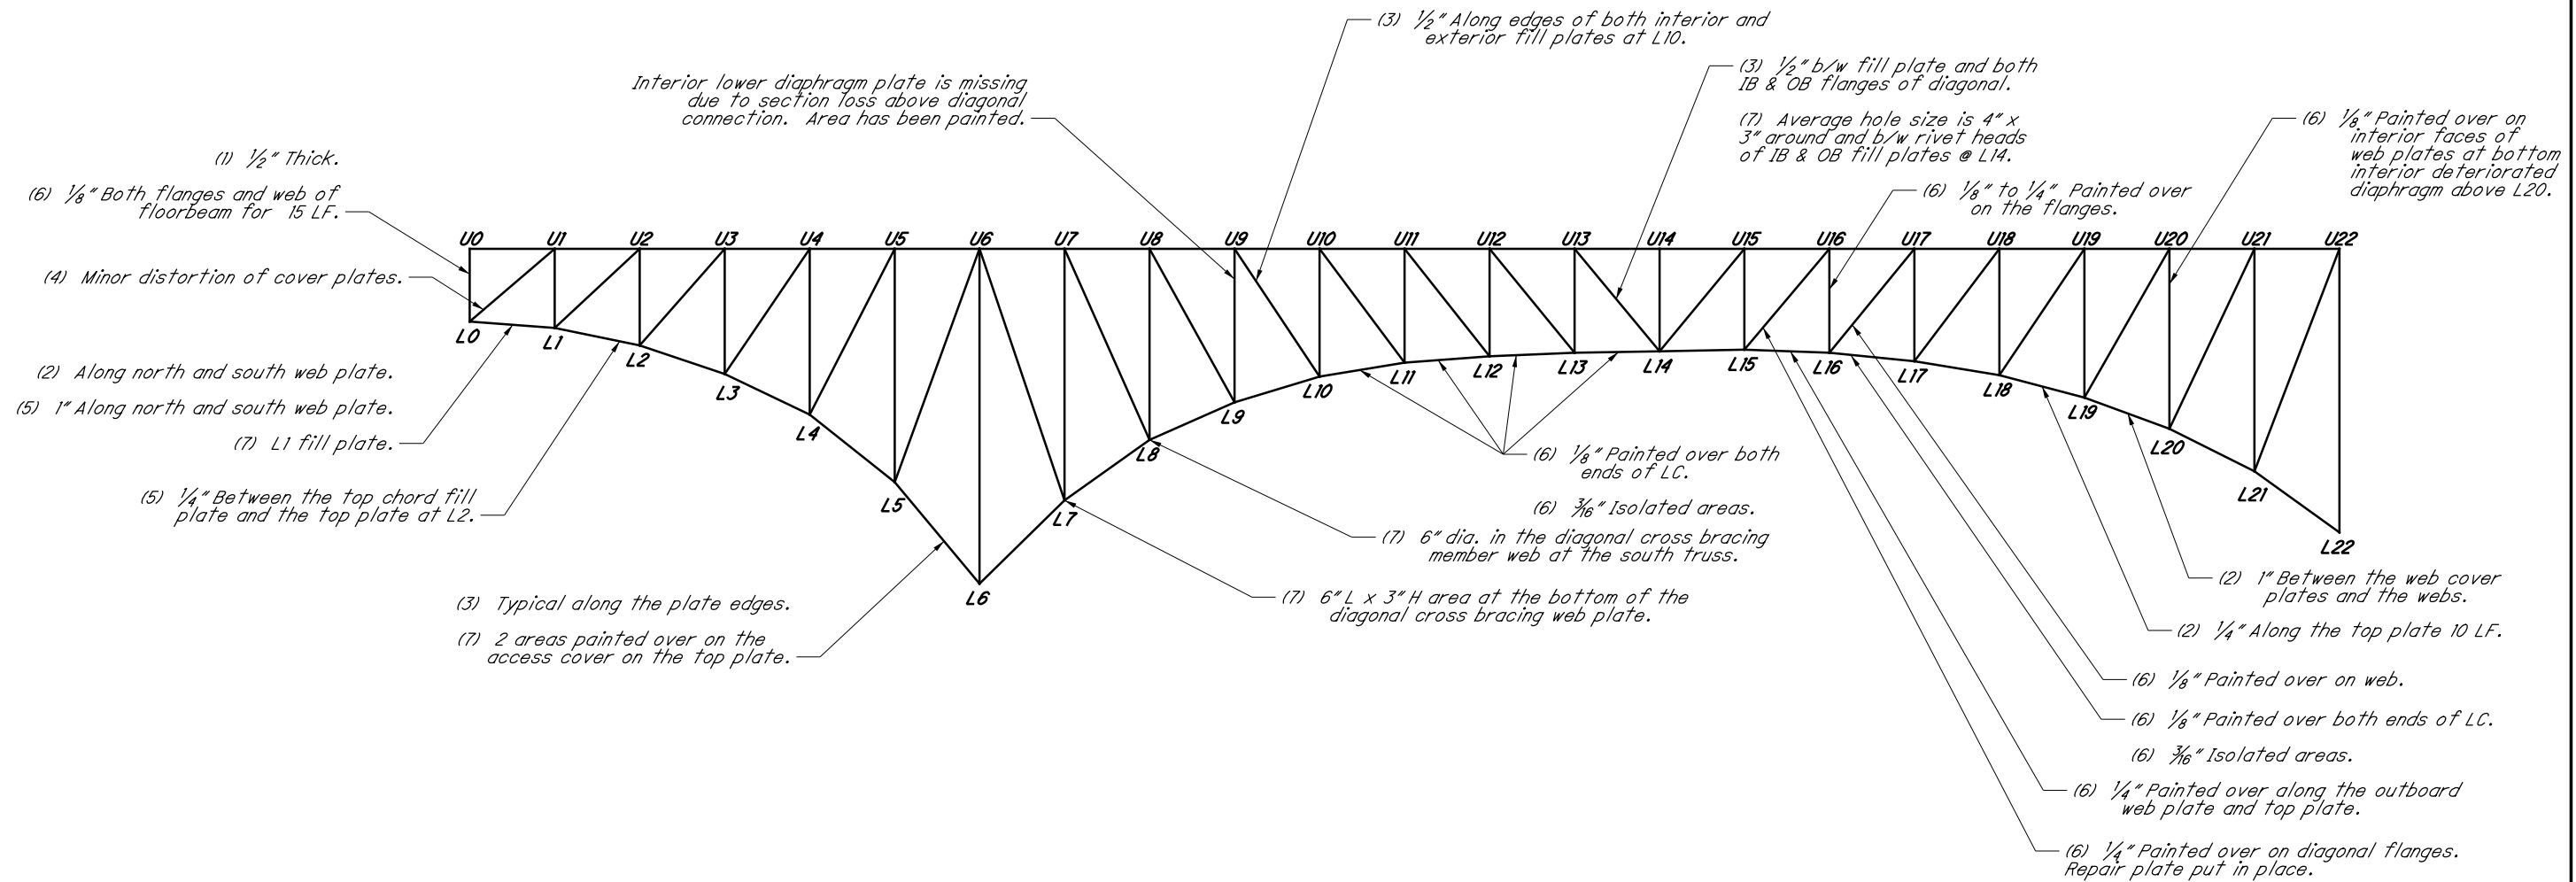
**Floorbeam Deficiencies:**
