**Physical Condition Report for  
CUY-002-1441  
SFN 1800035  
Main Avenue Bridge over the Cuyahoga River  
2022 Routine Inspection**

**Prepared for:**

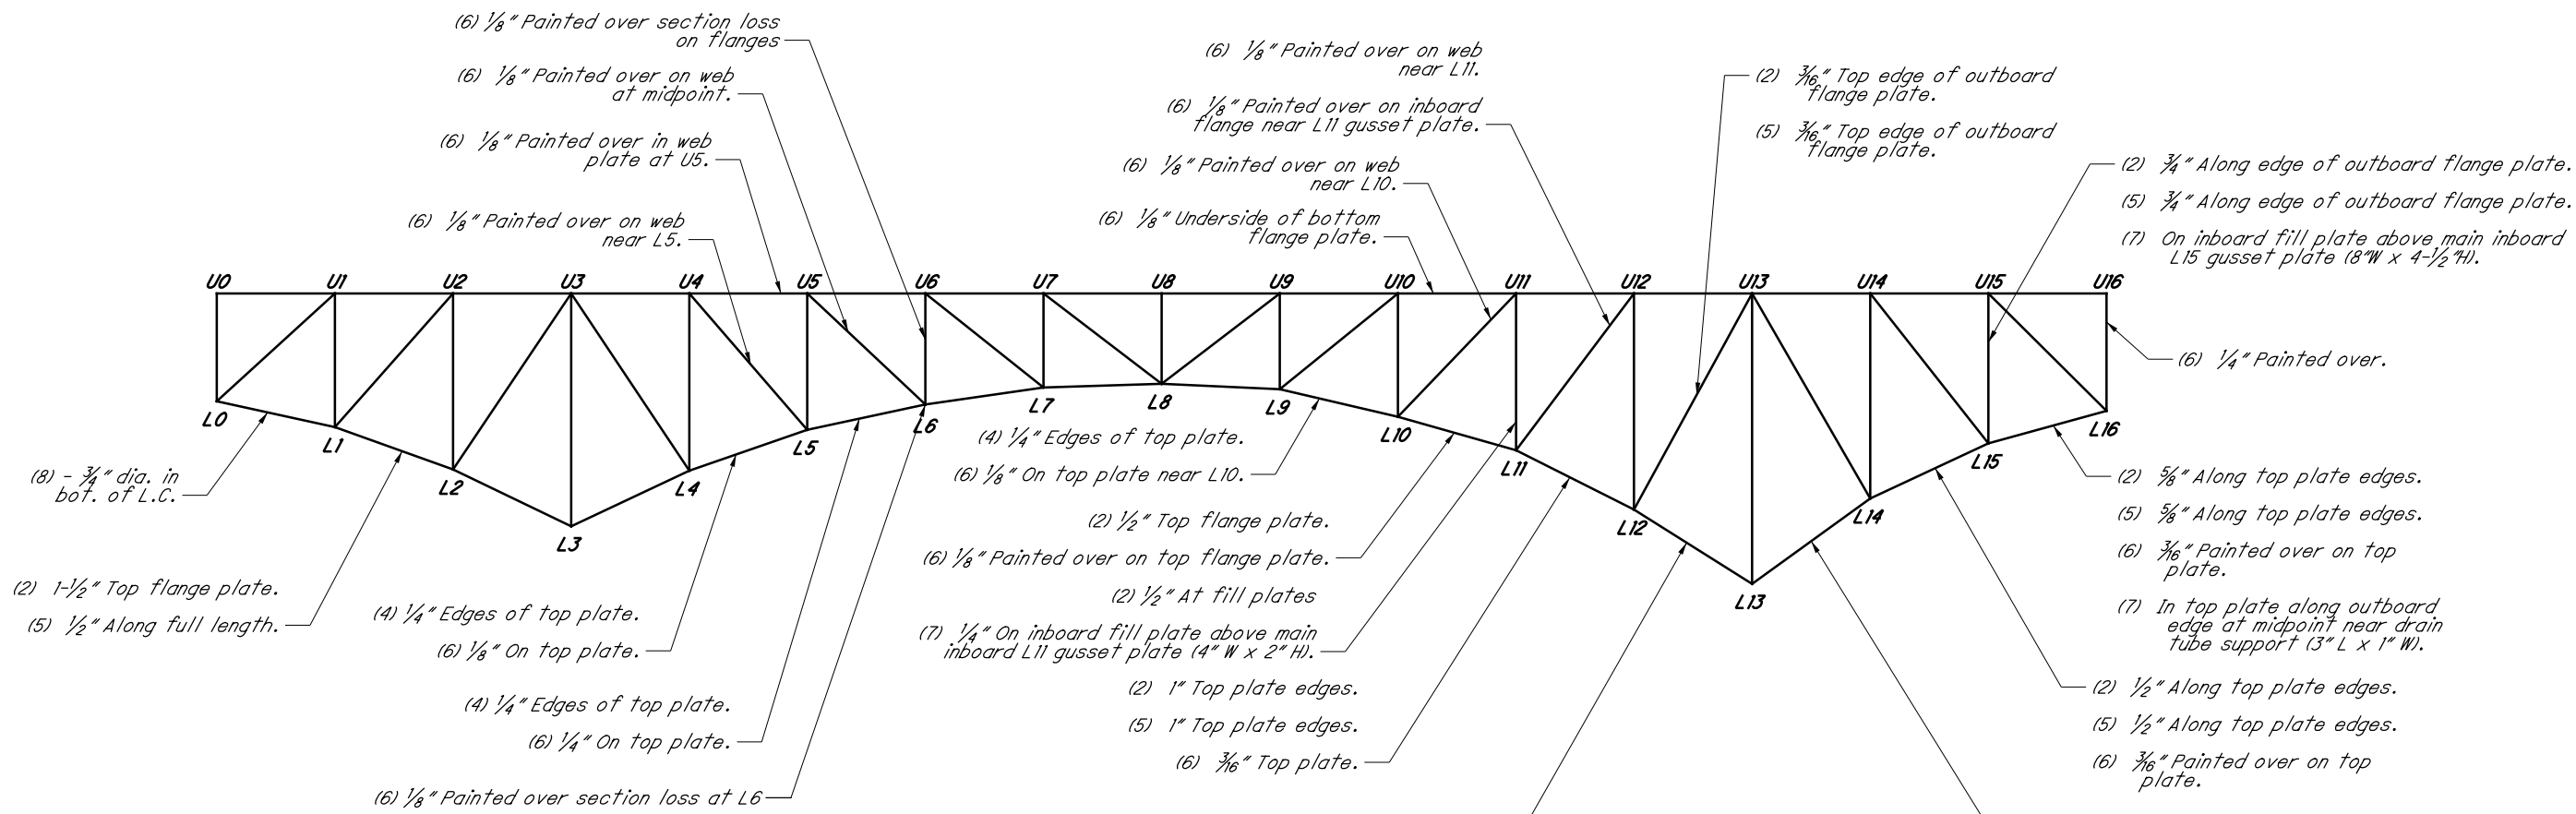
J:\000T\109534\_VAR-D12\_Inspection\Inspection\CUY-2-14-41\_Main\_Ave\_1800035\2022\_Inspection\CAD\CUY-2-14-41\_Truss\_Span\_2 - North II/28/2022 10:41:05 AM adam-l

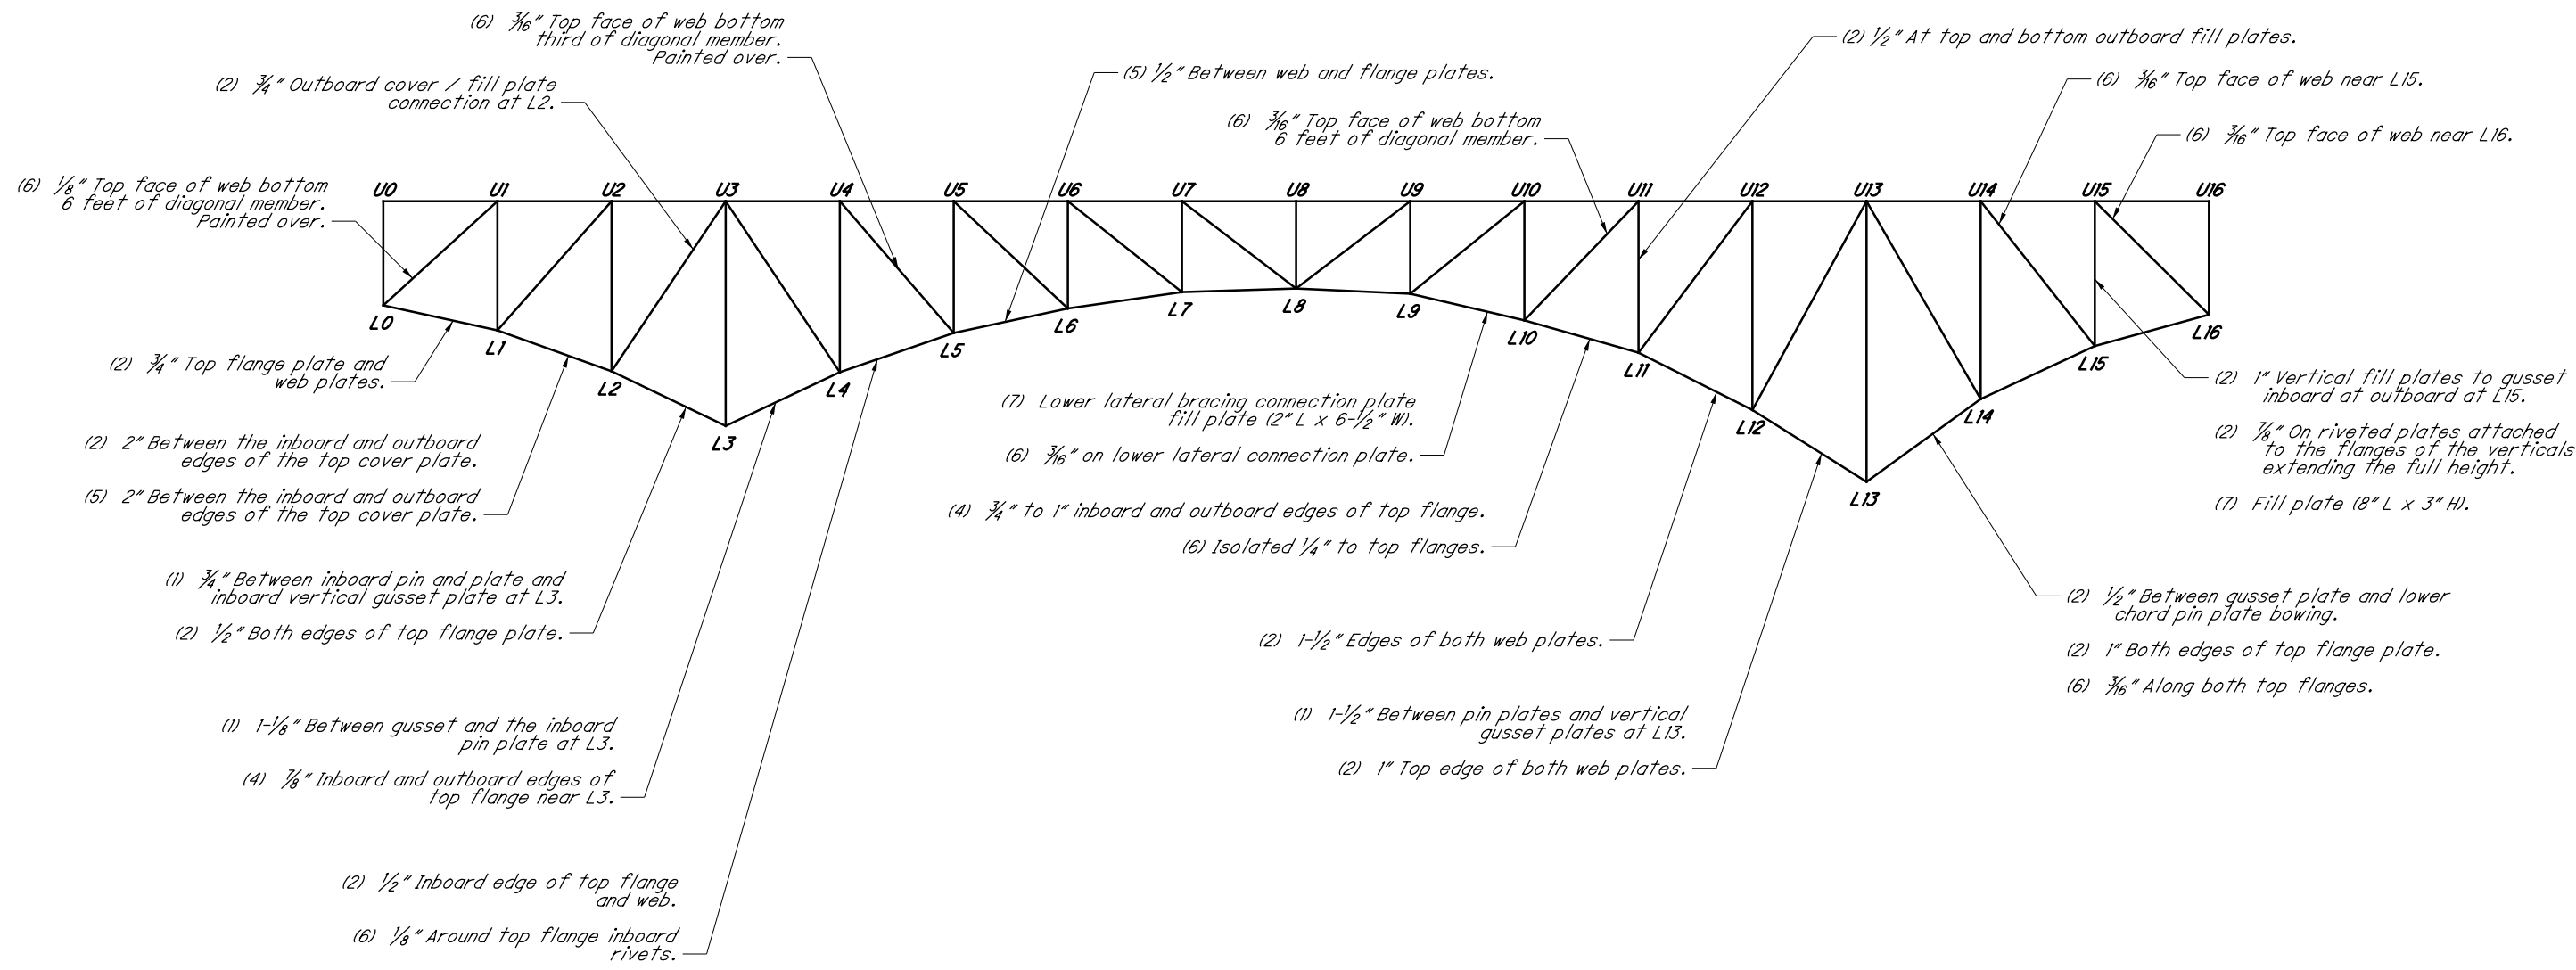
**DRAINAGE DEFICIENCIES:**

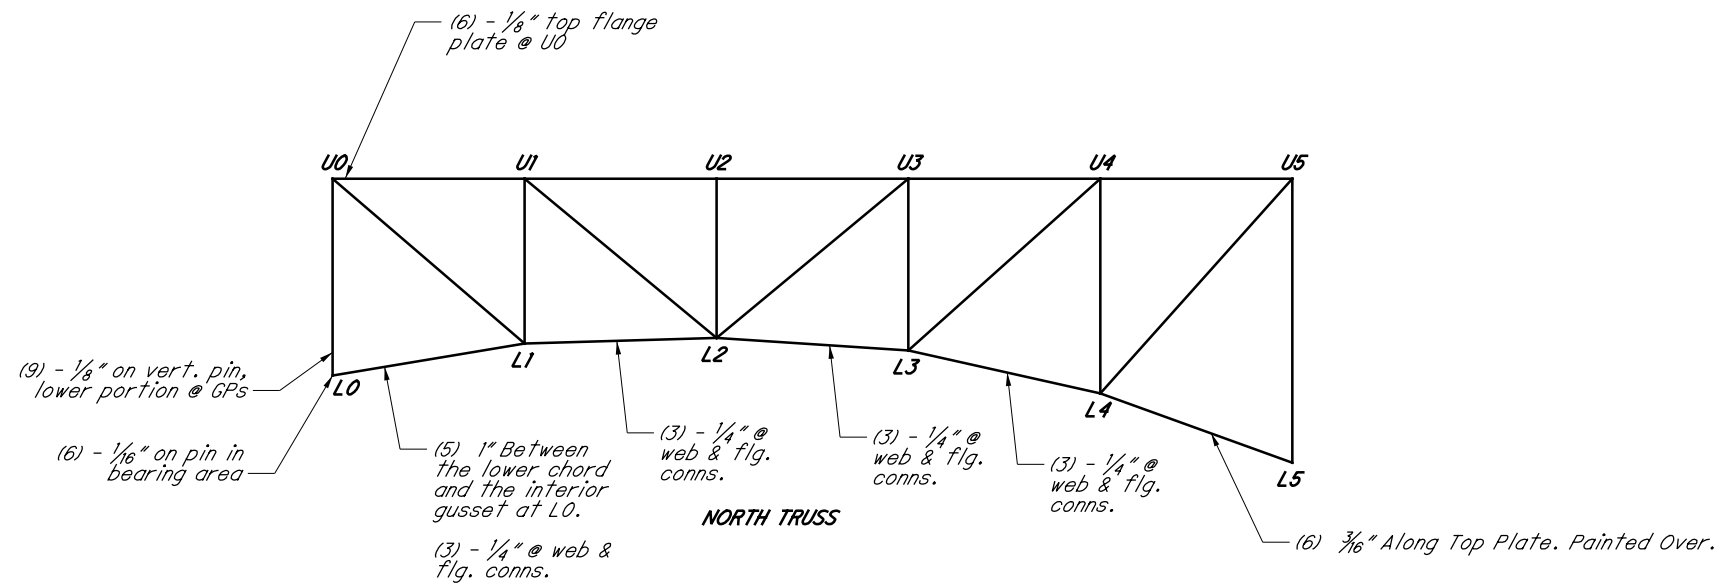
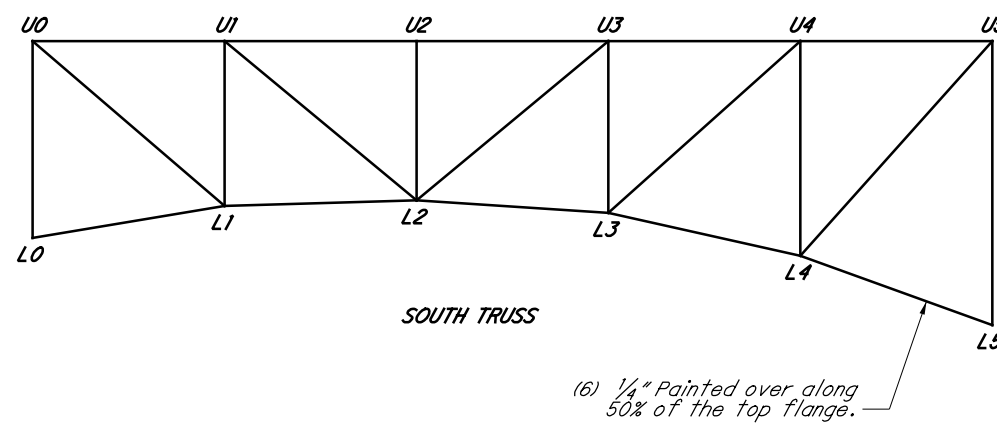
**SOUTH TRUSS GUSSET PLATE DEFICIENCIES:**

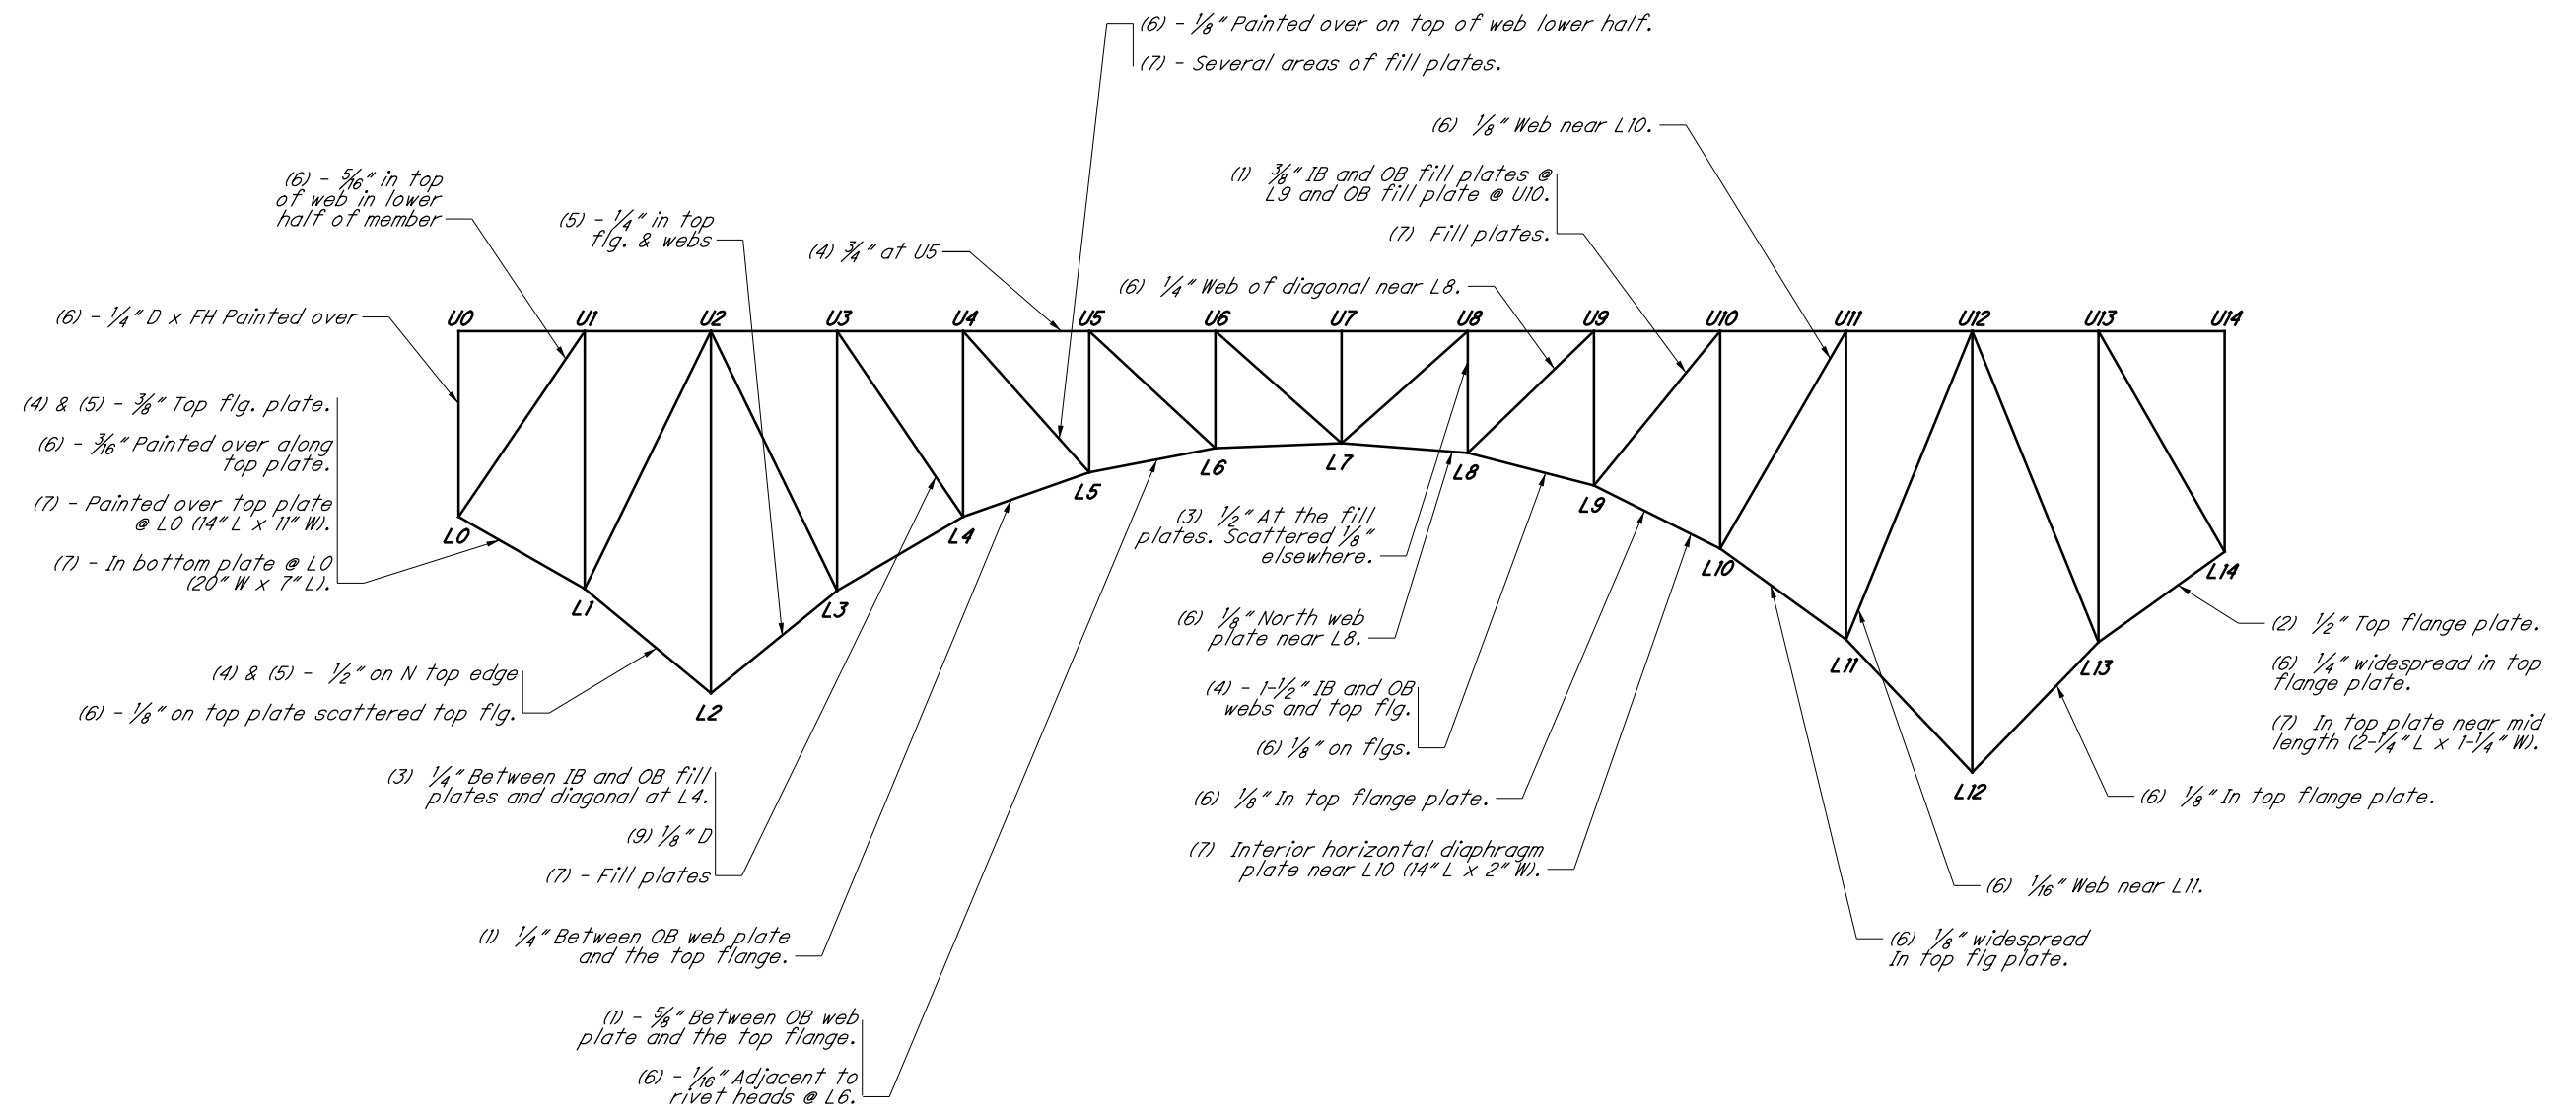
**FLOORBEAM DEFICIENCIES:**

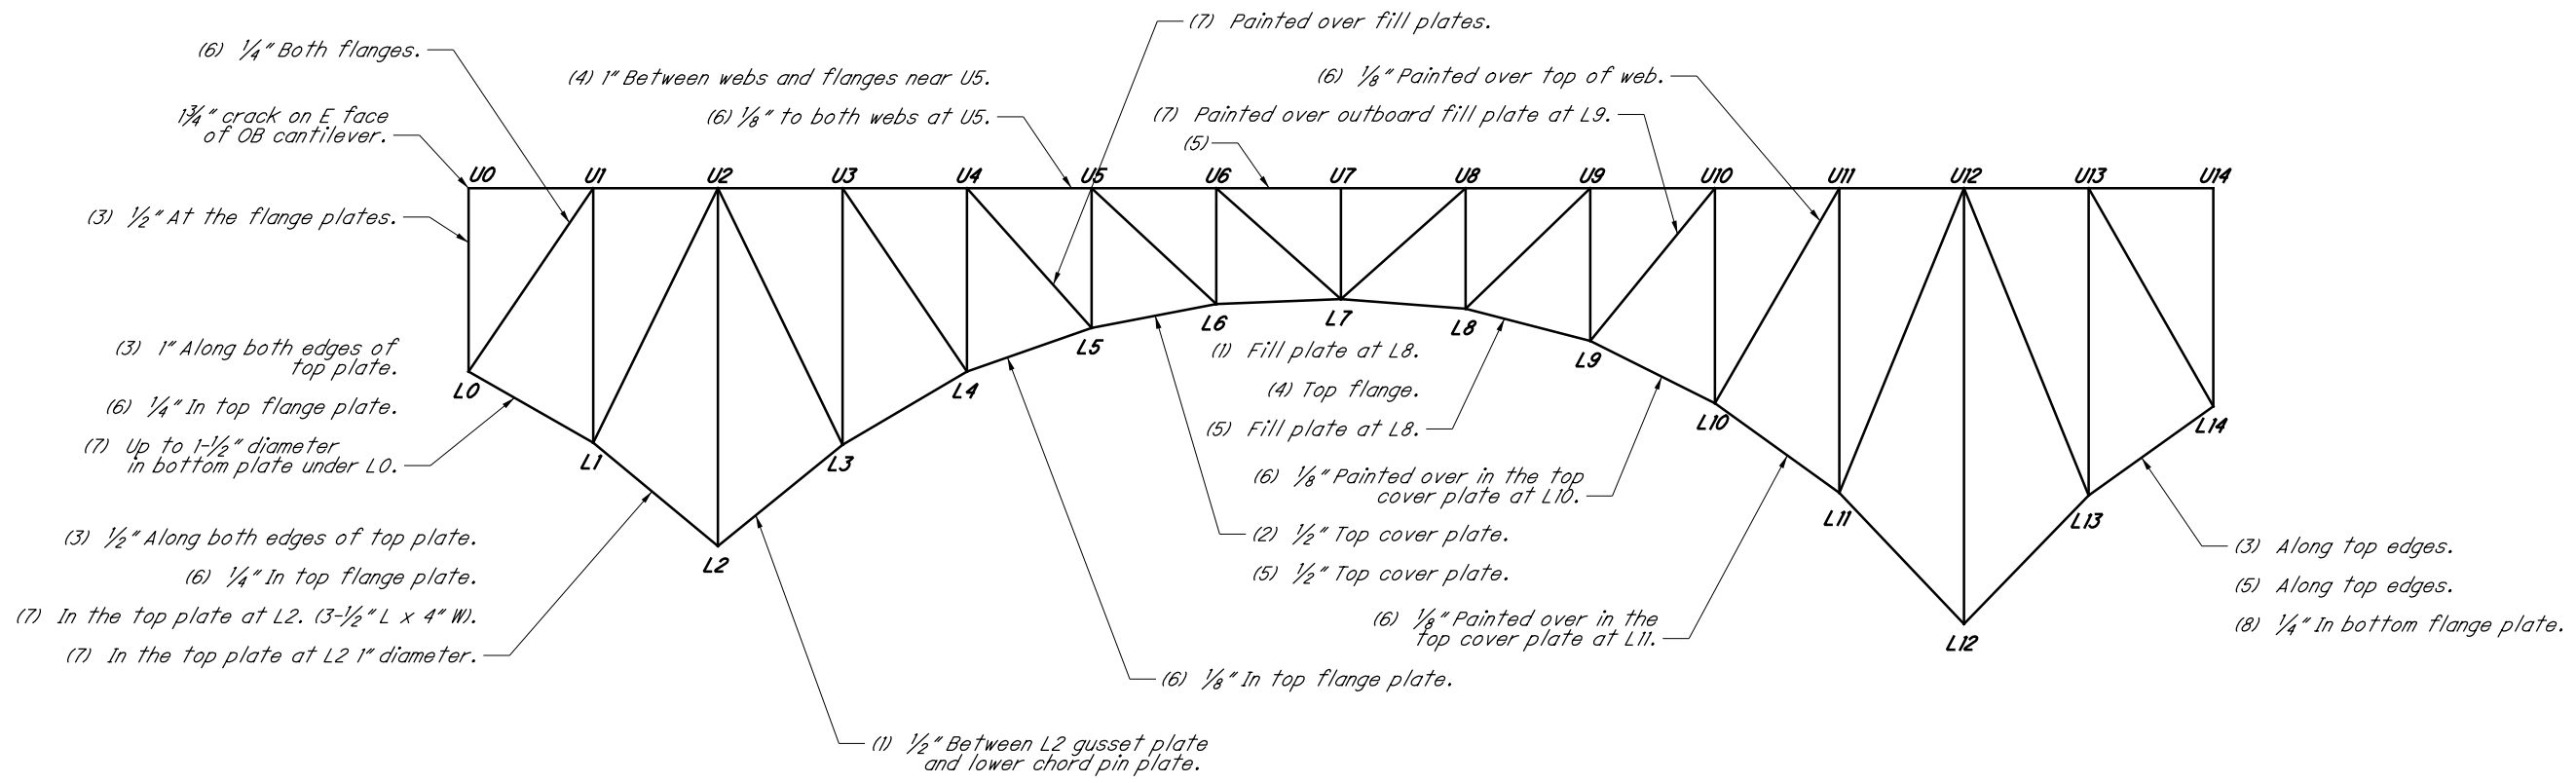
**FLOORBEAM DEFICIENCIES:**

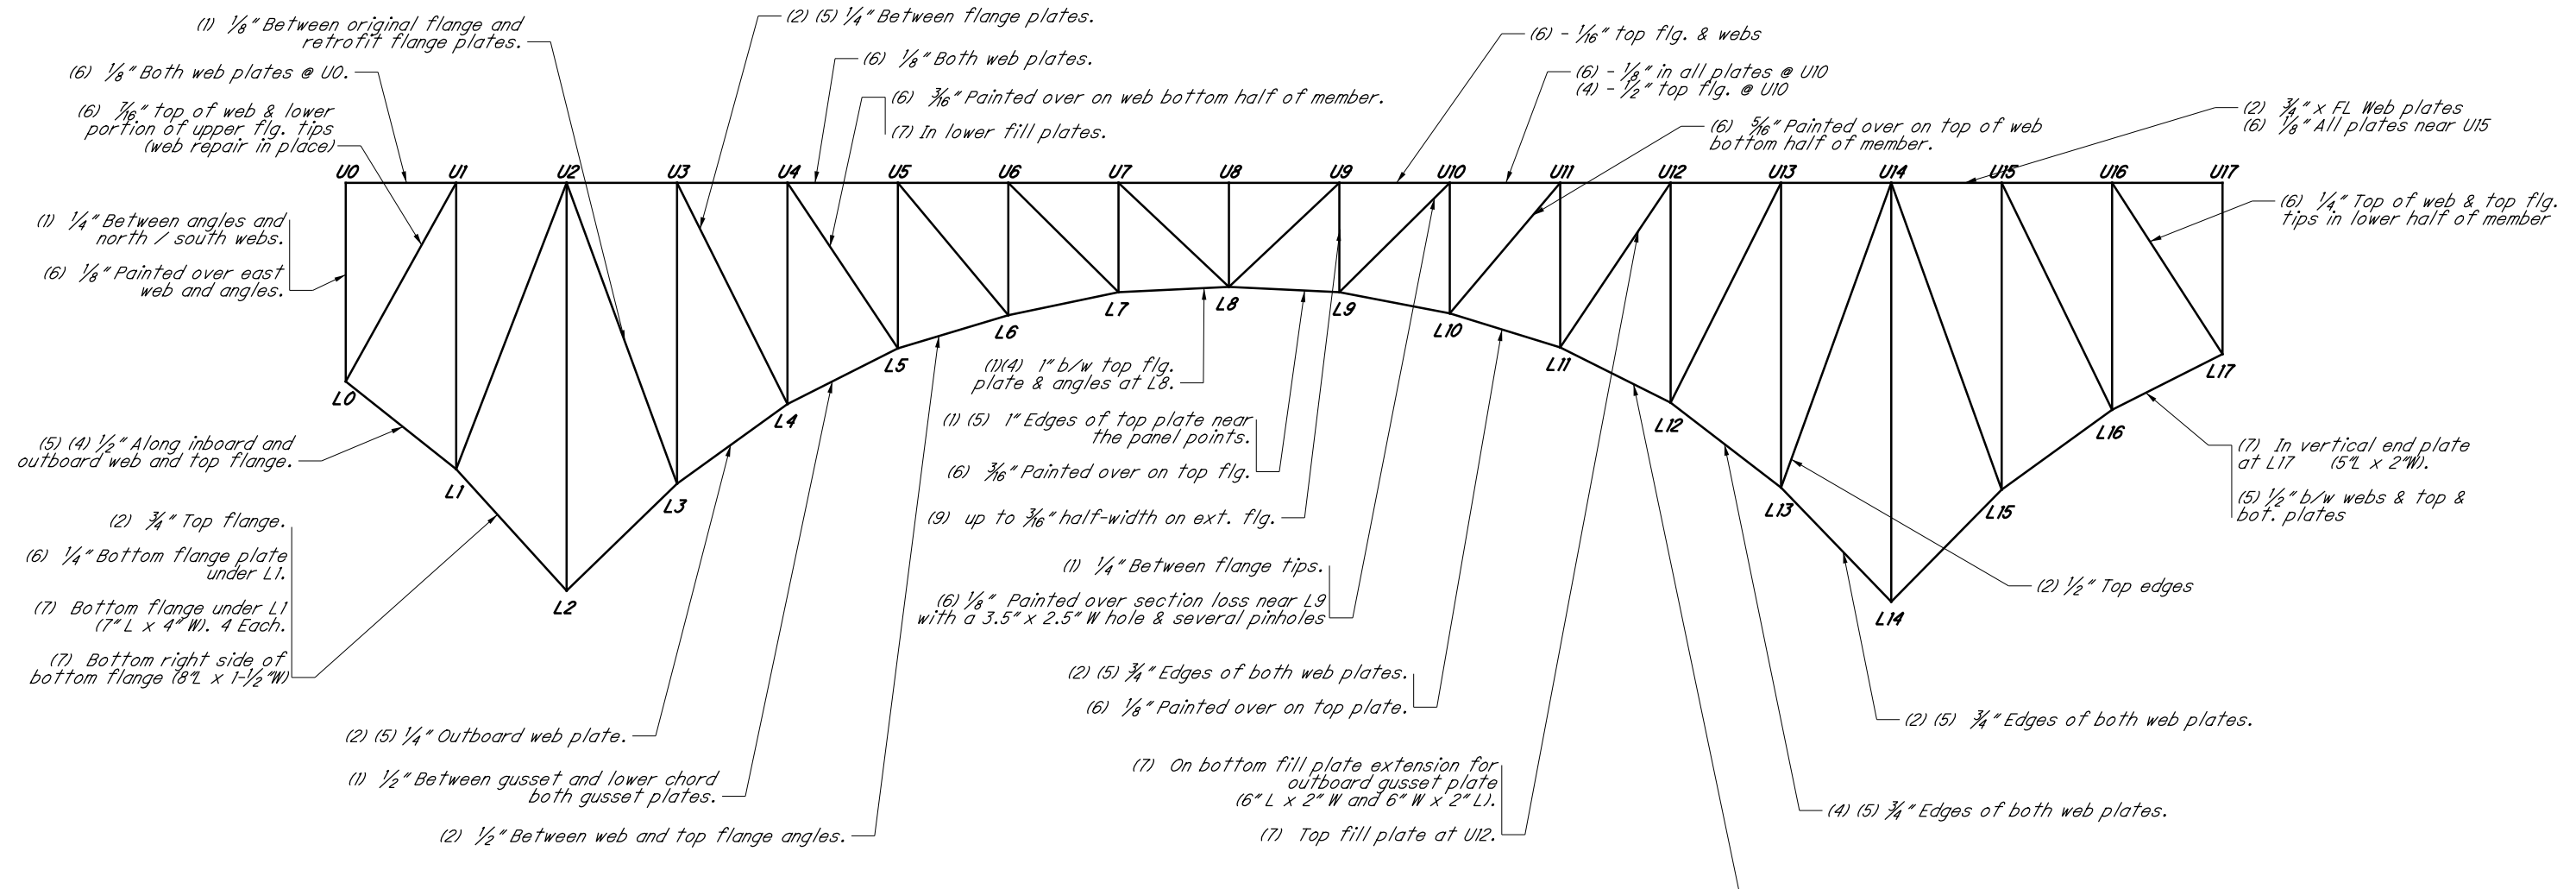
**Floorbeam Deficiencies:**

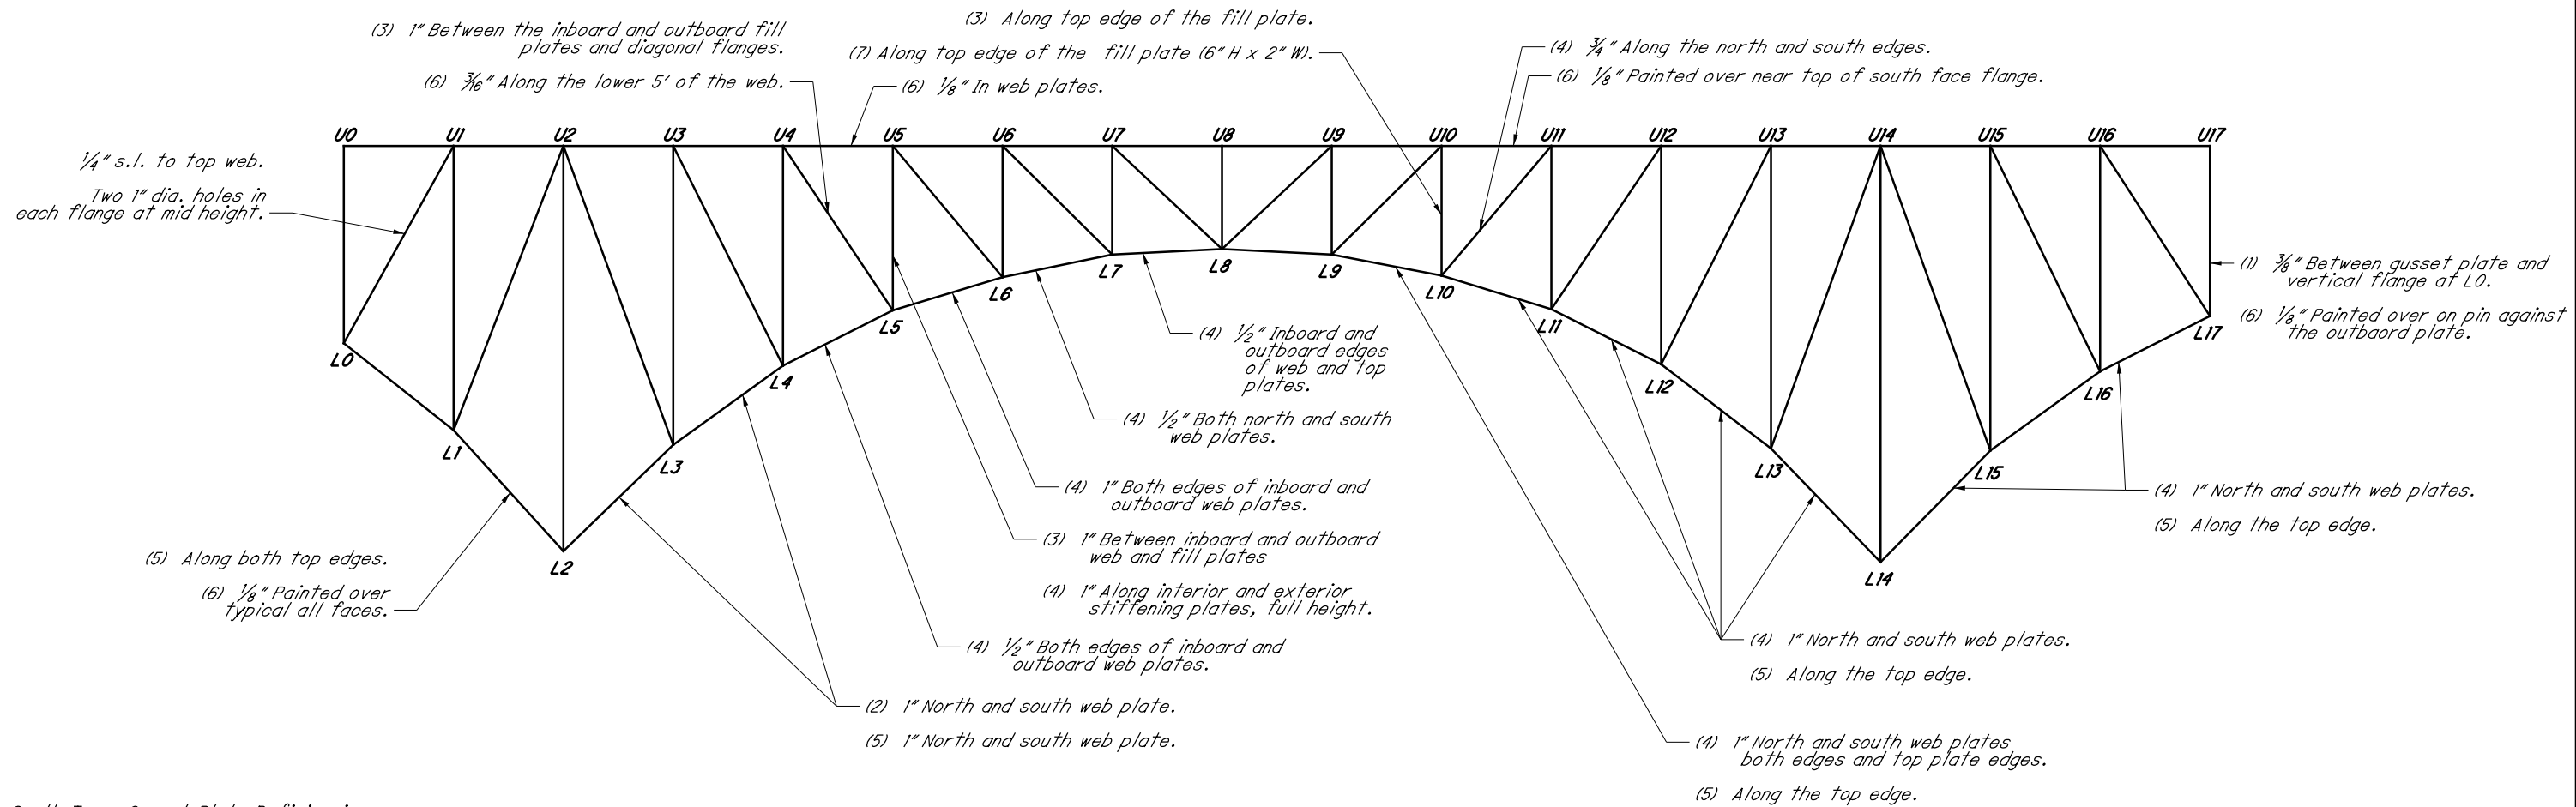
**South Truss Gusset Plate Deficiencies:**

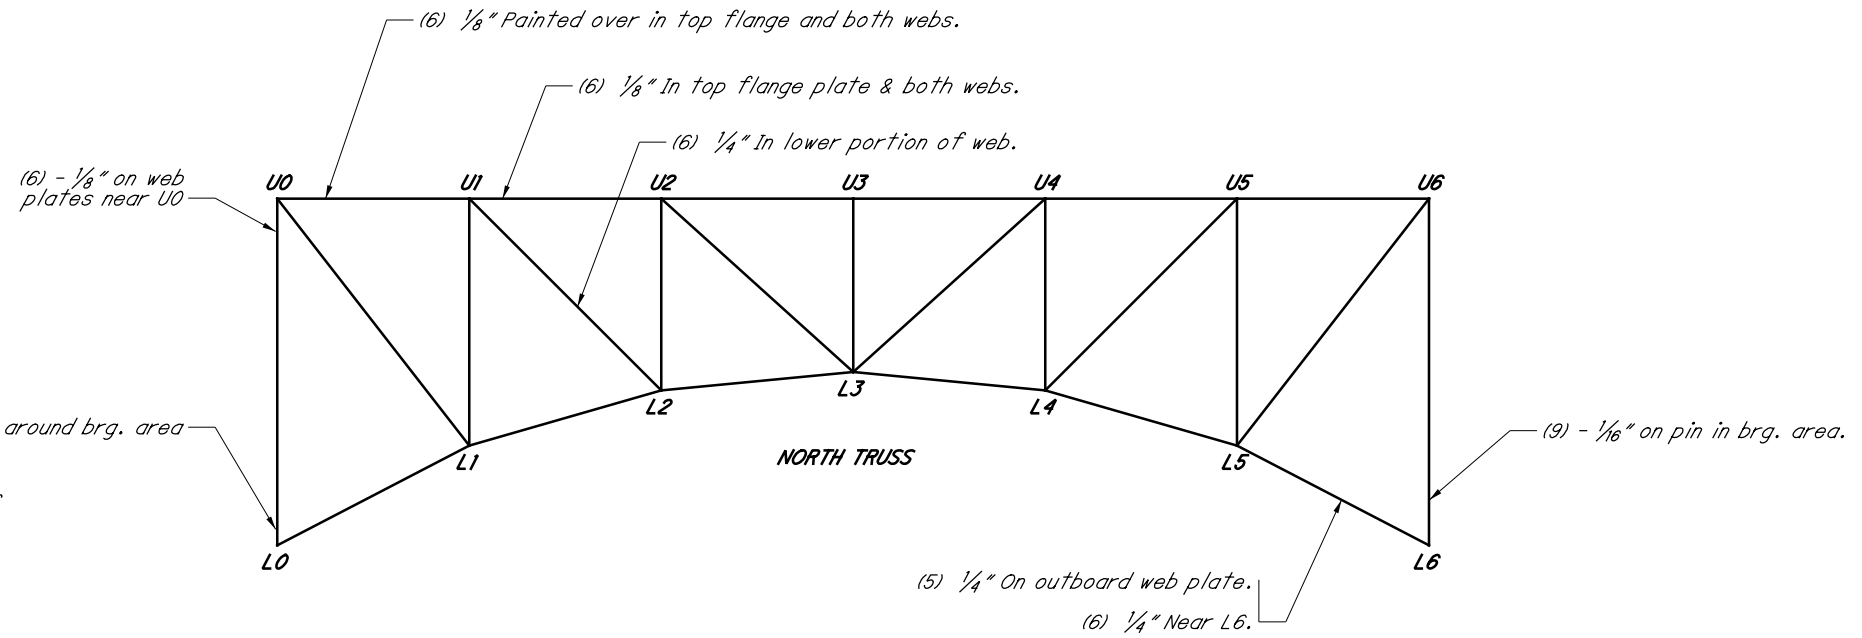
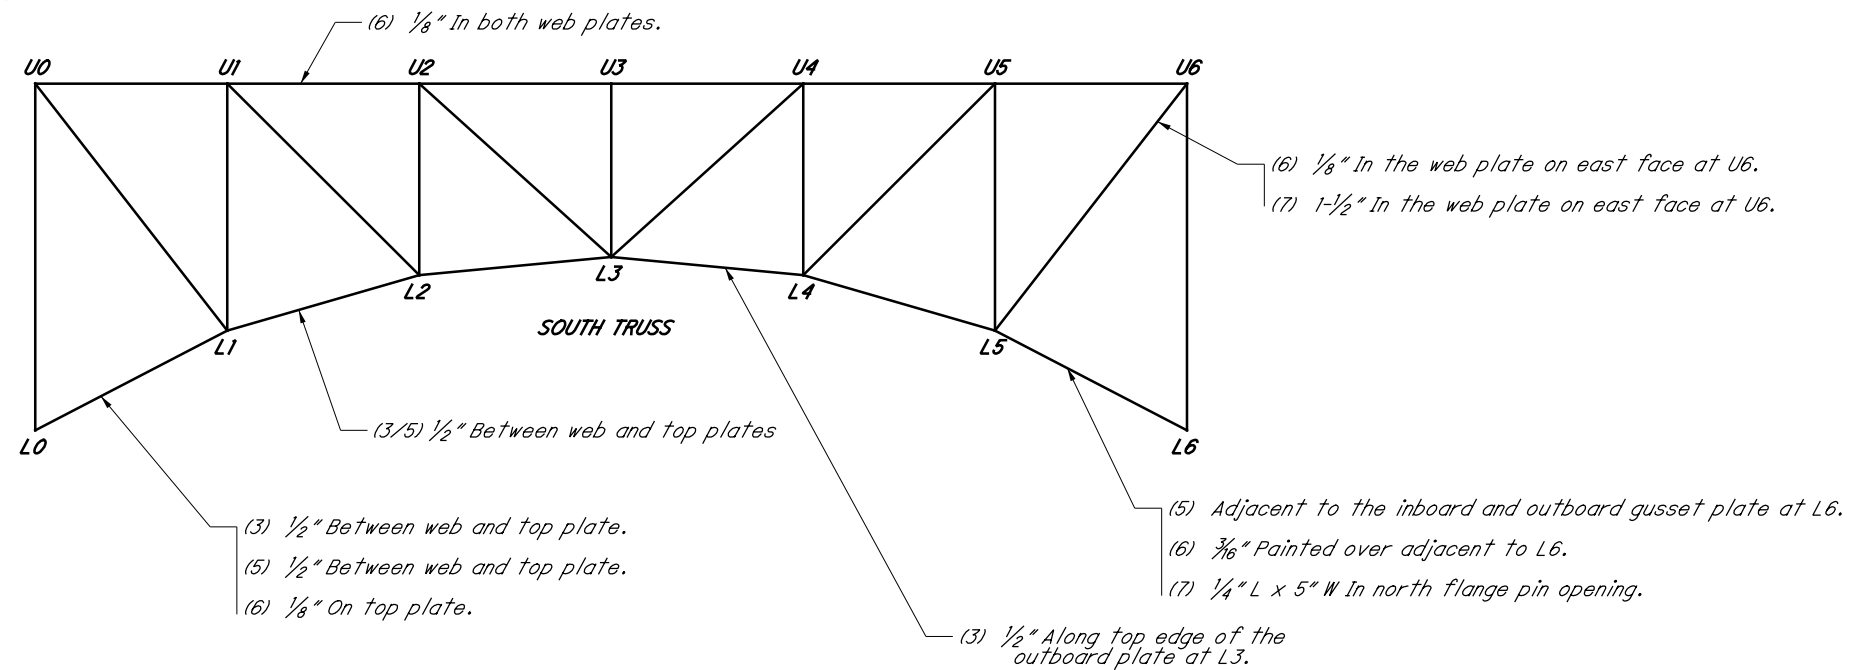
**South Truss Gusset Plate Deficiencies:**

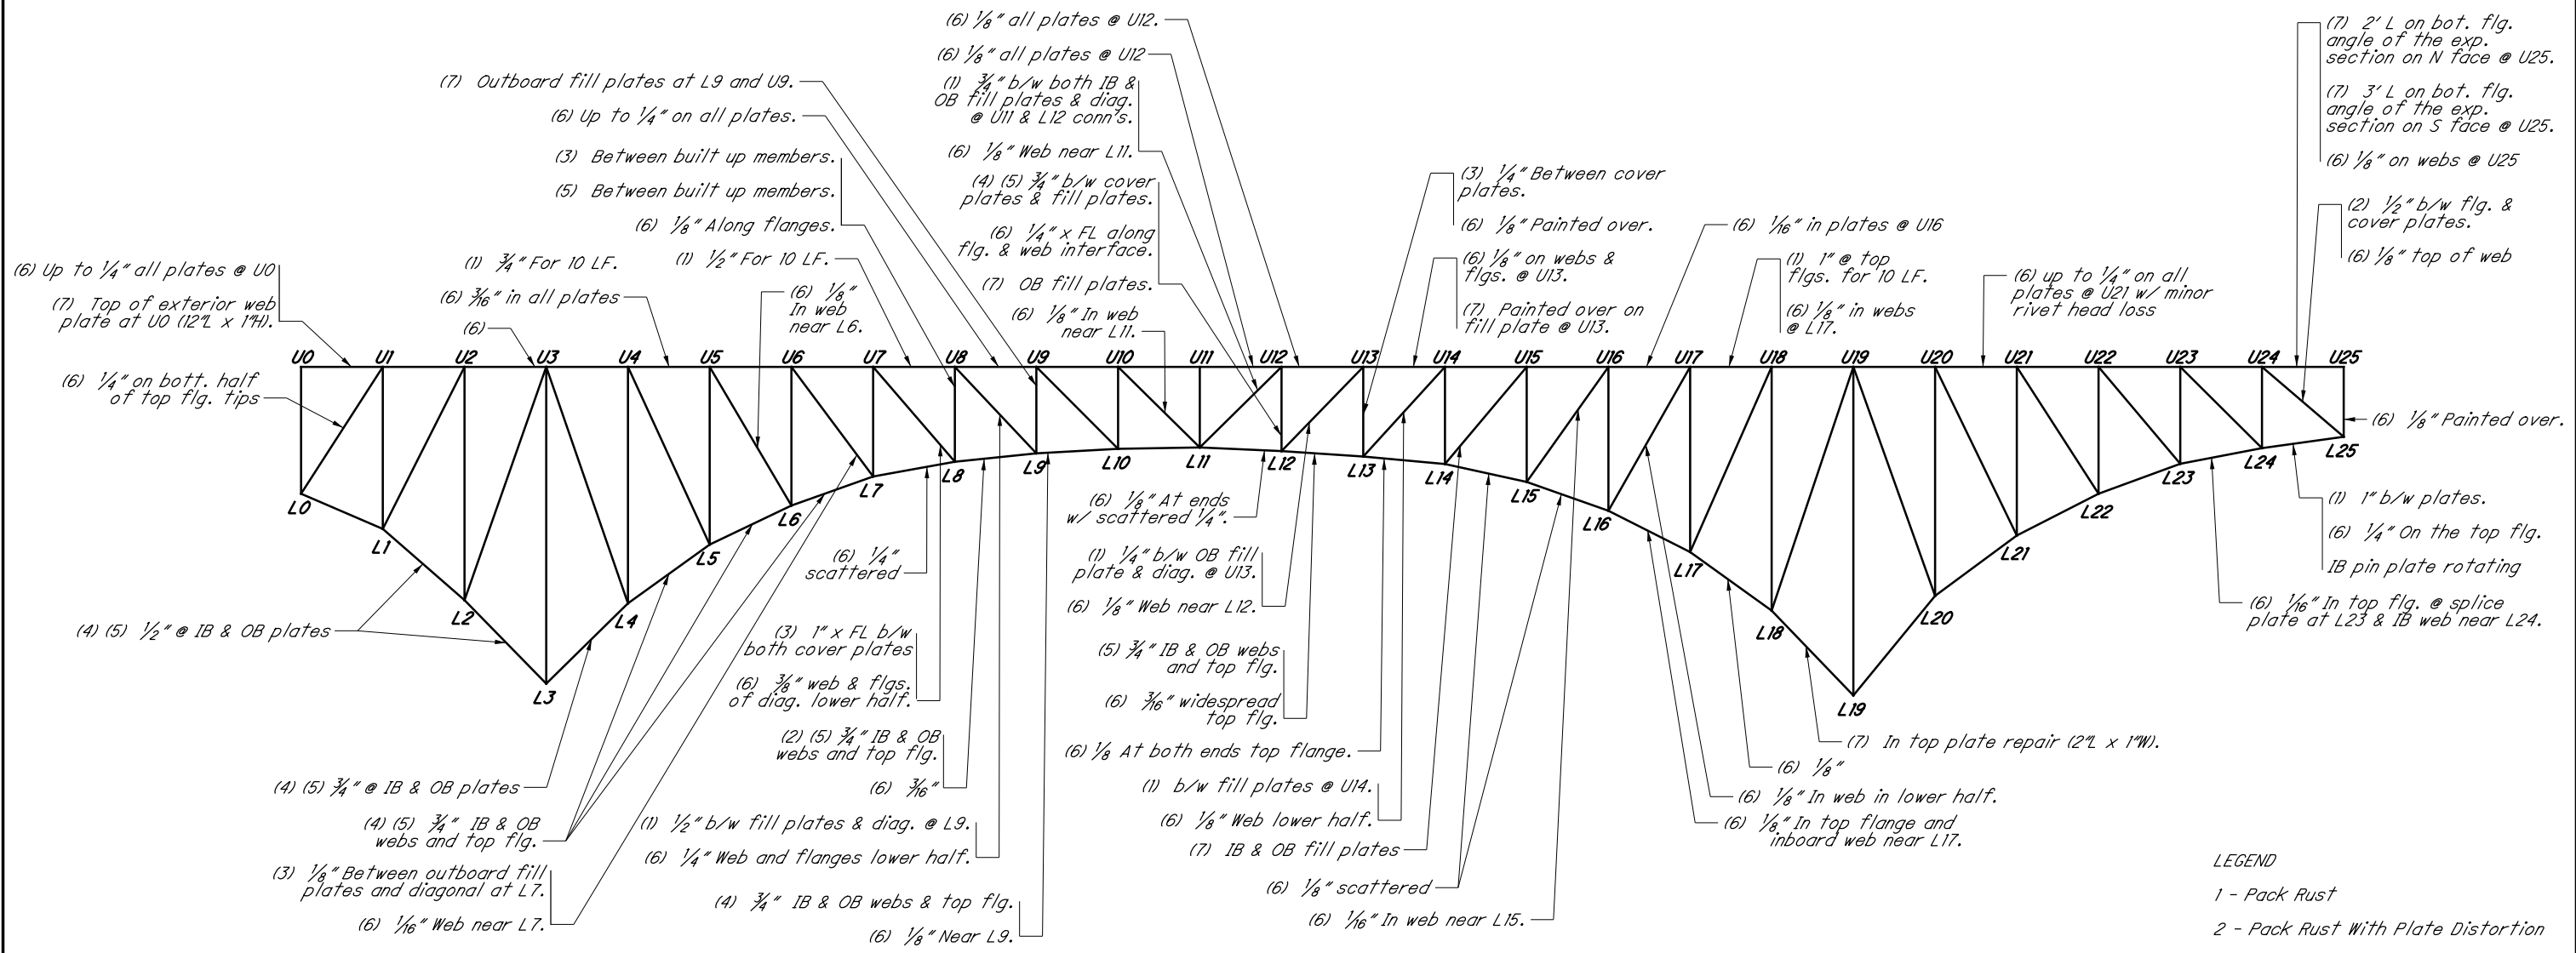
**North Truss Gusset Plate Deficiencies:**

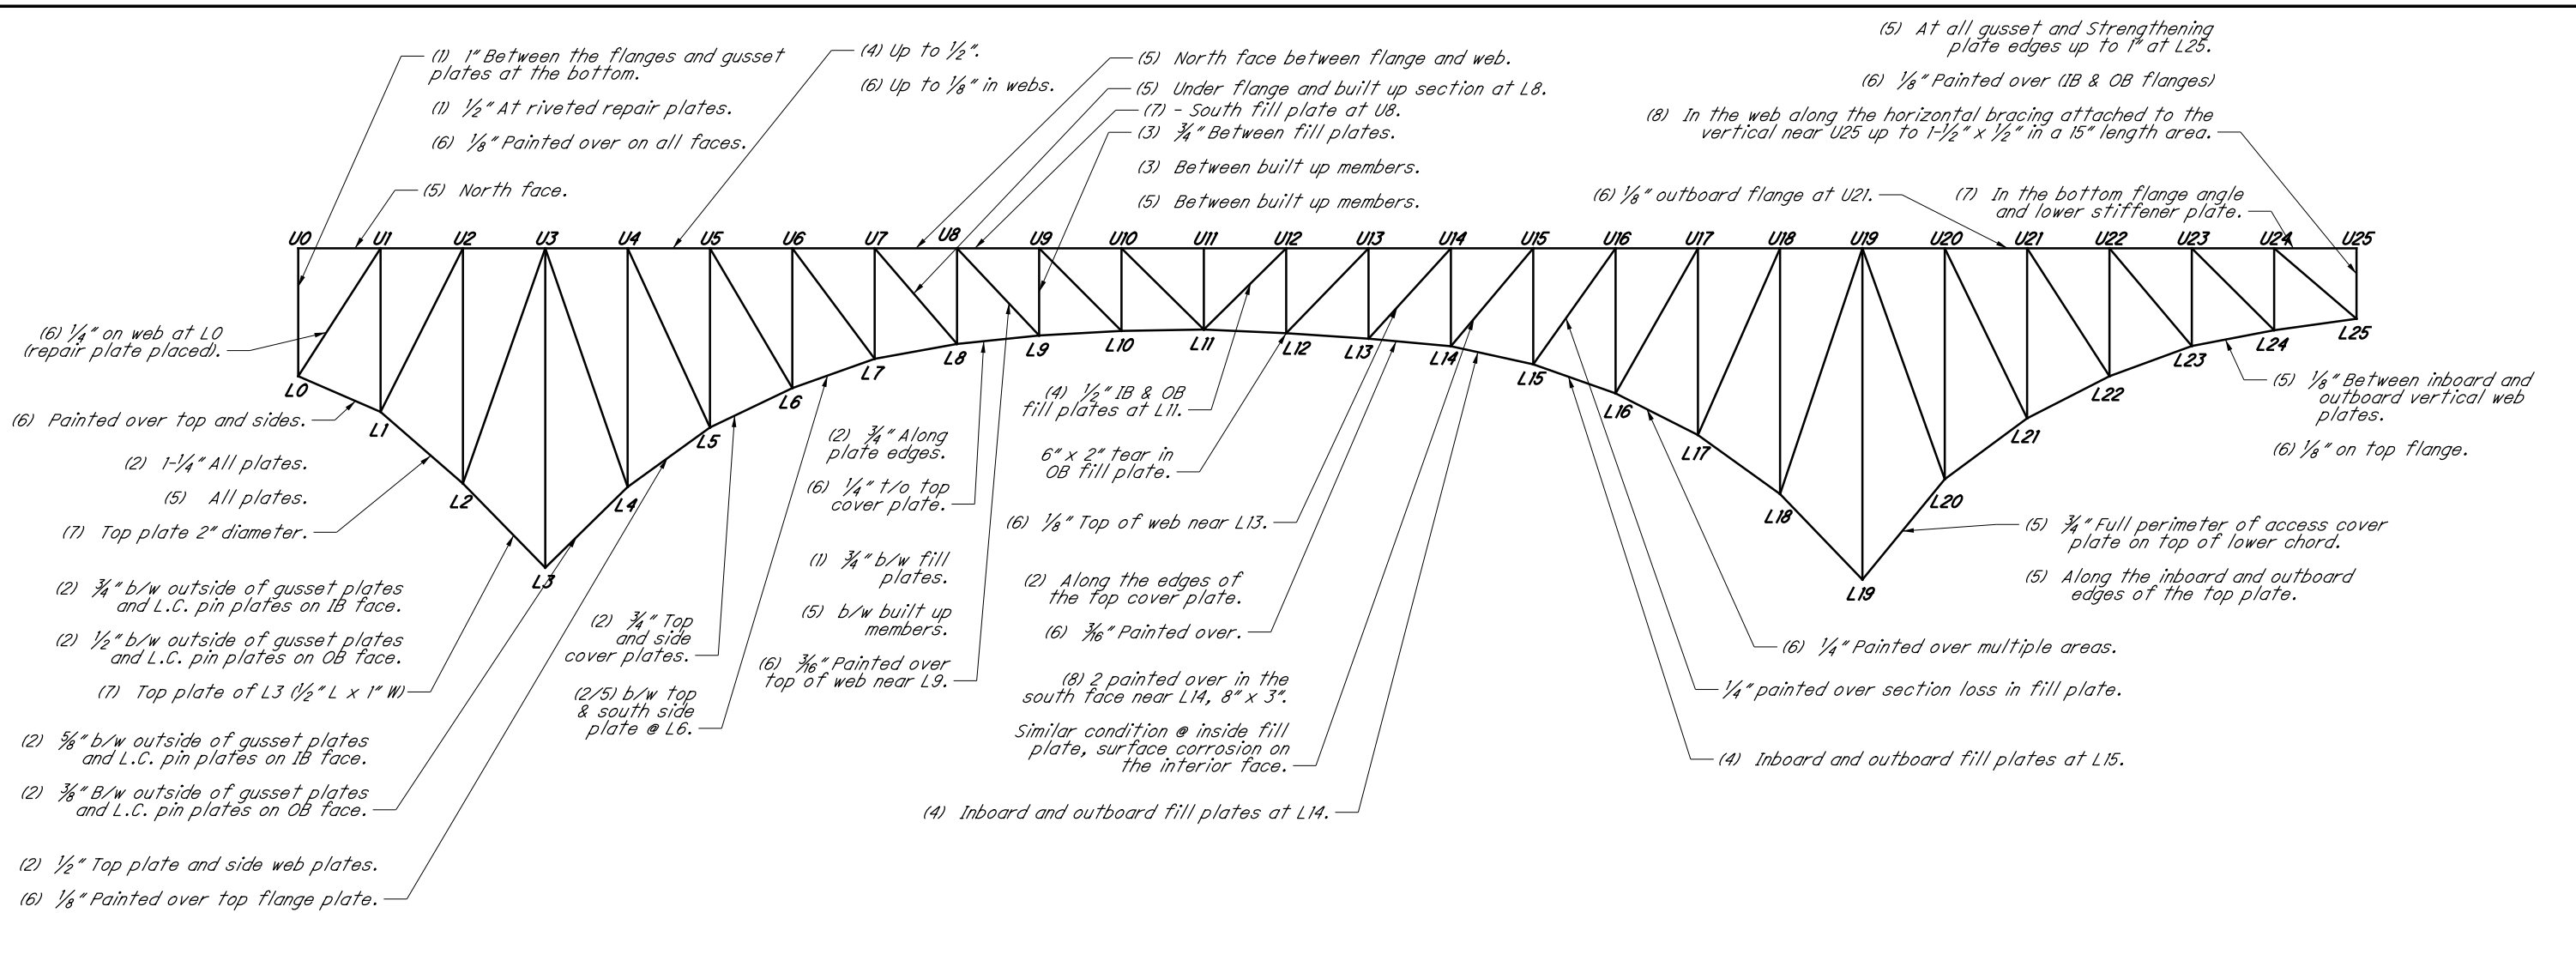
**South Truss Gusset Plate Deficiencies:**
