**Physical Condition Report for  
CUY-002-1441  
SFN 1800035  
Main Avenue Bridge over the Cuyahoga River  
2022 Routine Inspection**

**Prepared for:**

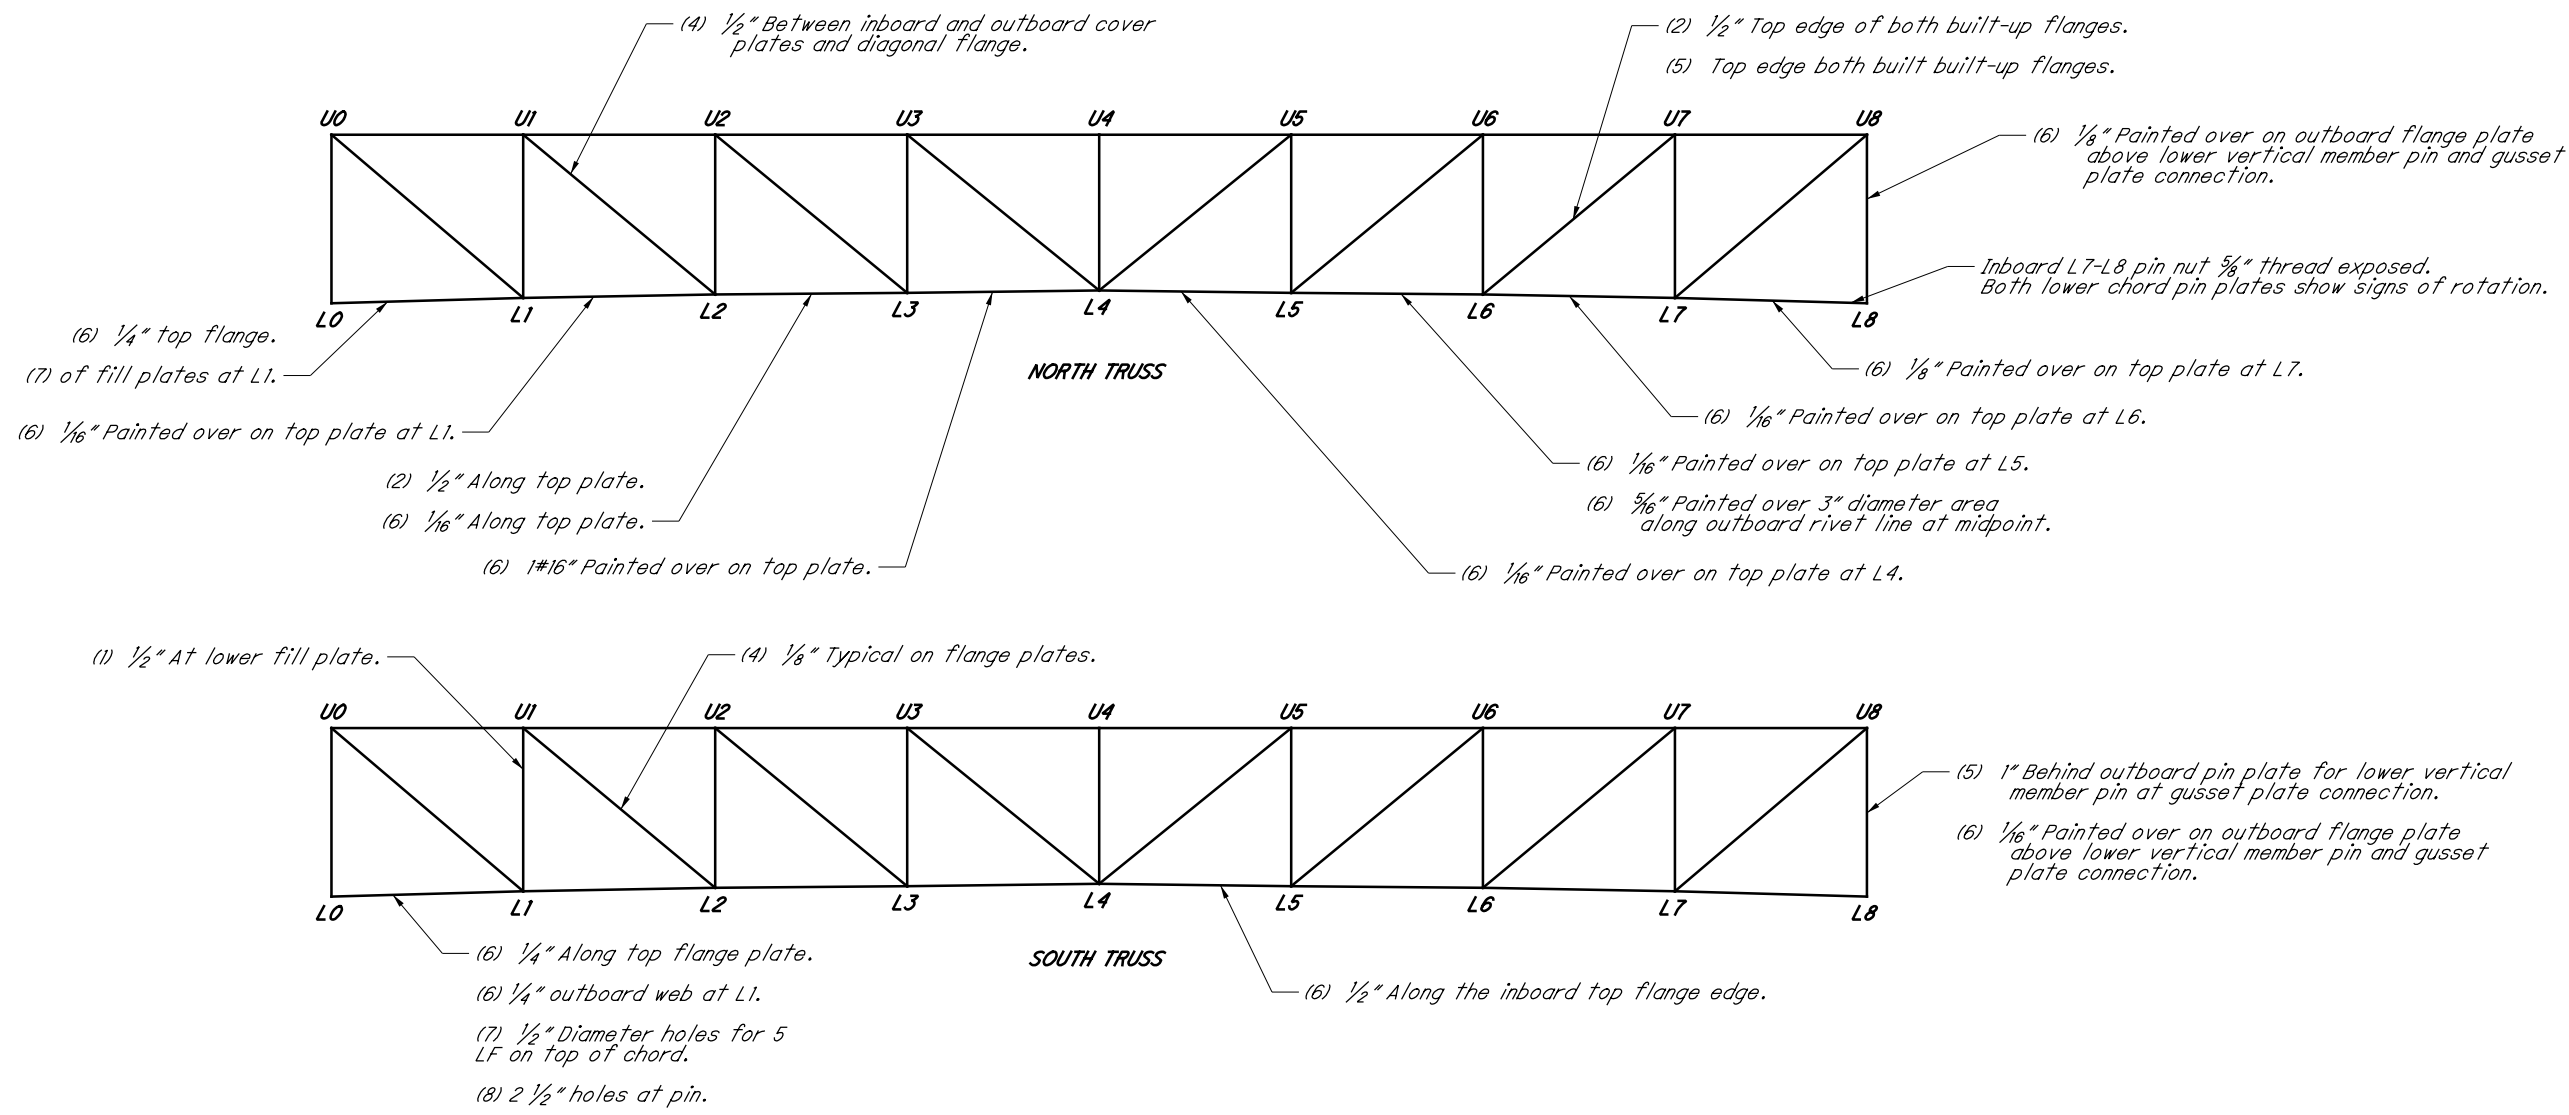
**North Truss Gusset Plate Deficiencies:**

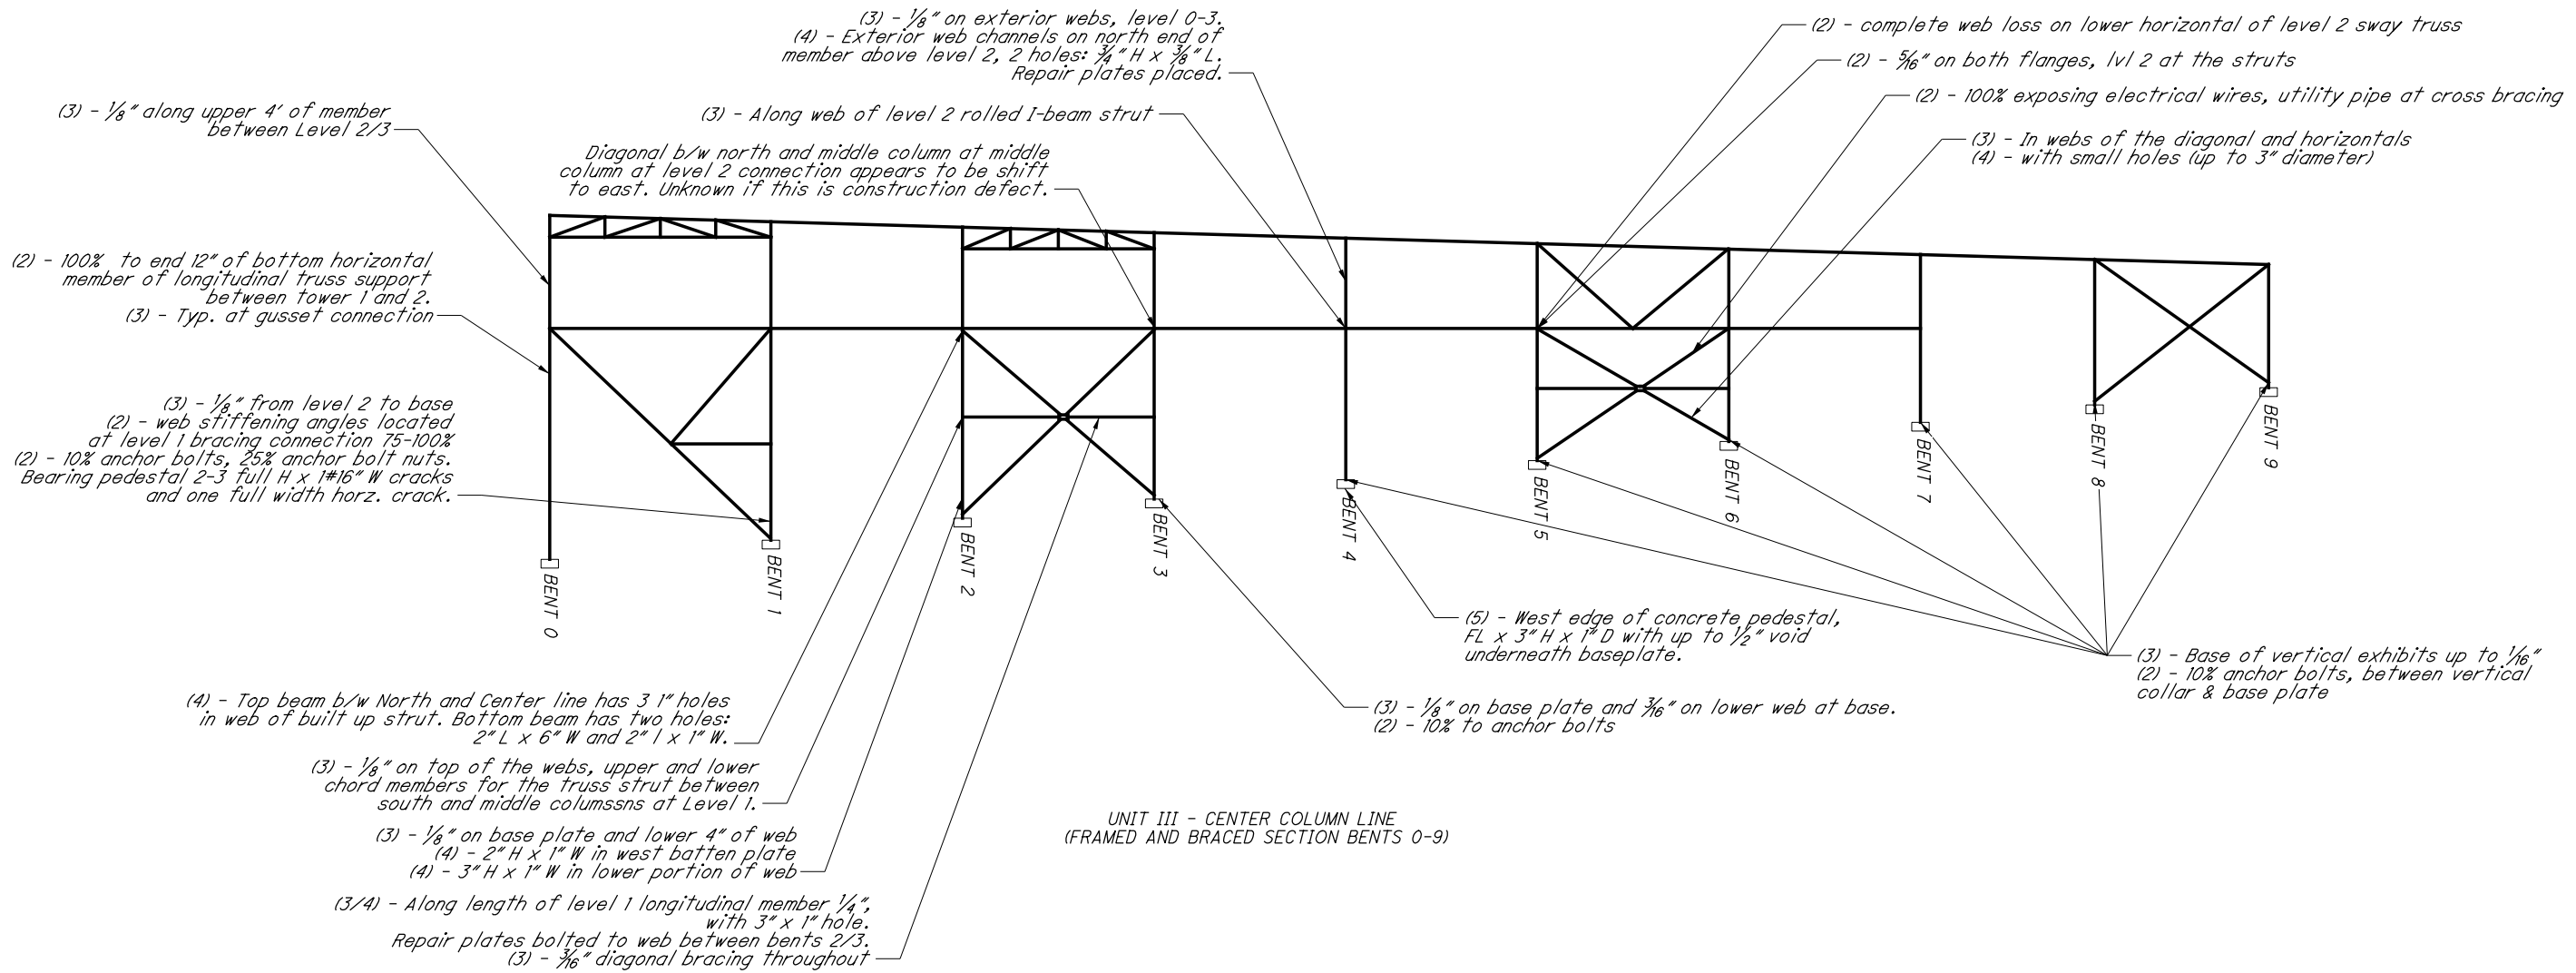
UNIT III - CENTER COLUMN LINE  
(FRAMED AND BRACED SECTION BENTS 0-9)

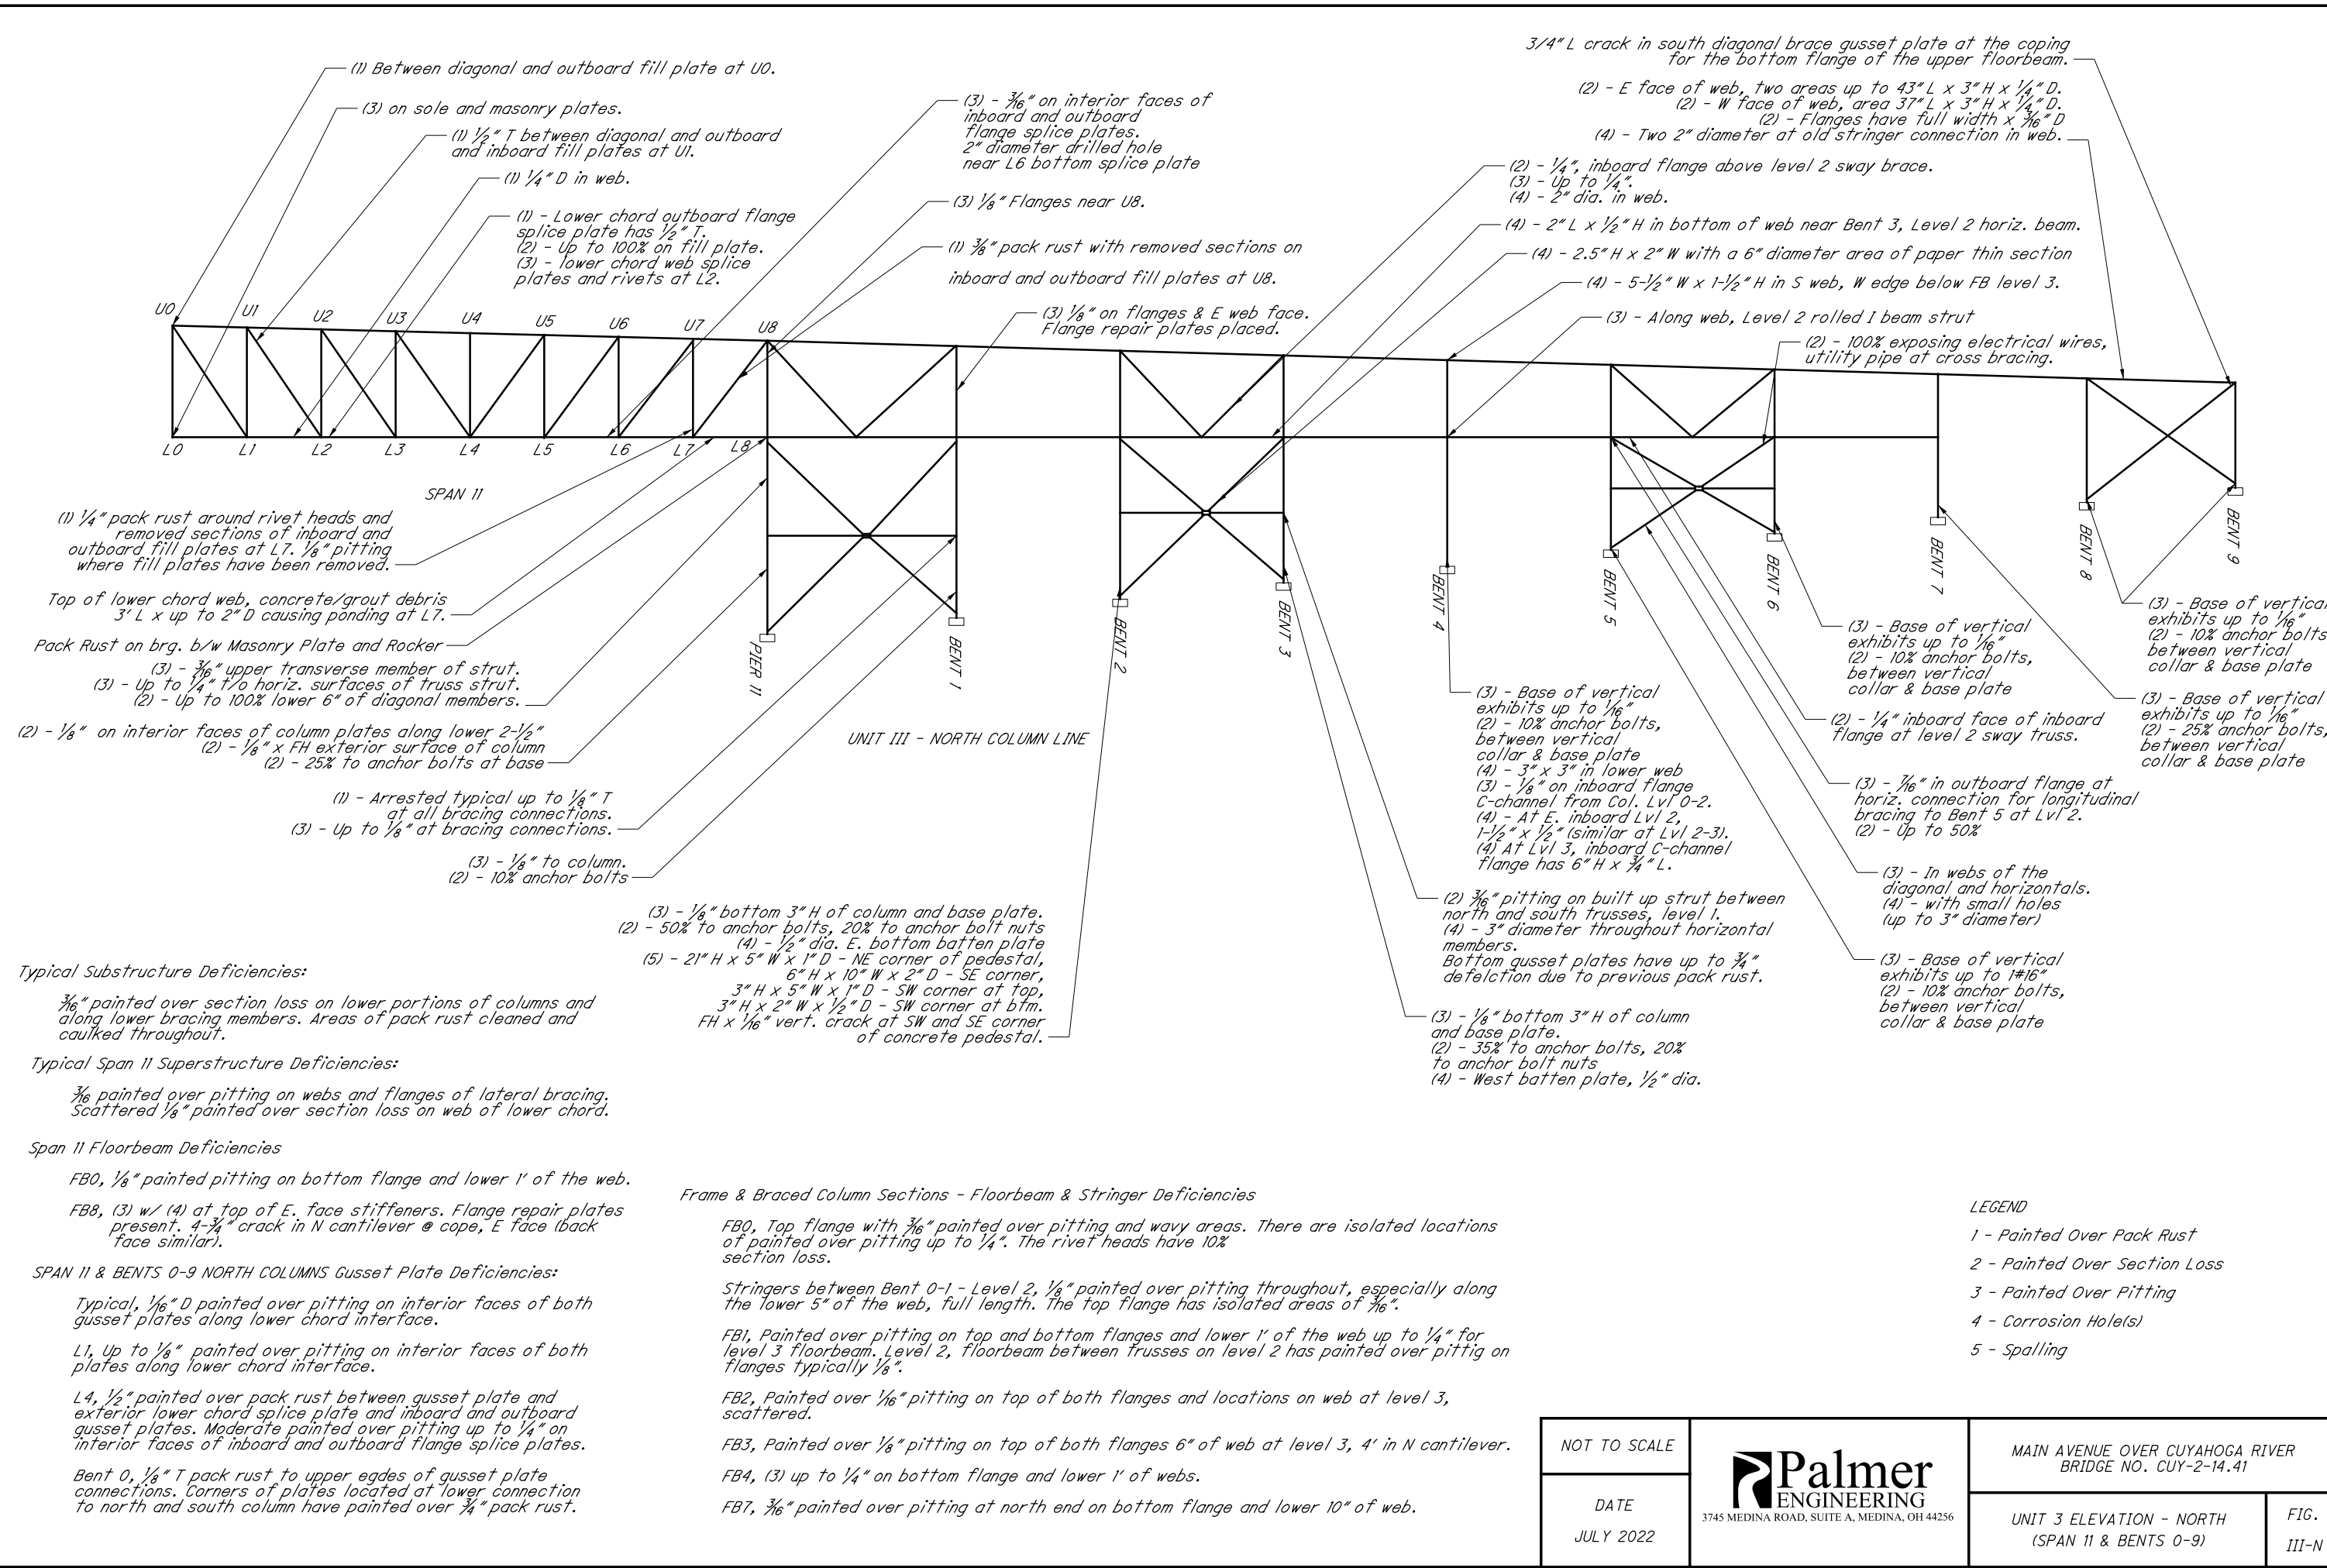
NOT TO SCALE	<p><b>Palmer ENGINEERING</b> 3745 MEDINA ROAD, SUITE A, MEDINA, OH 44256</p>	MAIN AVENUE OVER CUYAHOGA RIVER BRIDGE NO. CUY-2-14.41	
DATE JULY 2022		UNIT 3 ELEVATION - NORTH (SPAN 11 & BENTS 0-9)	FIG. III-N

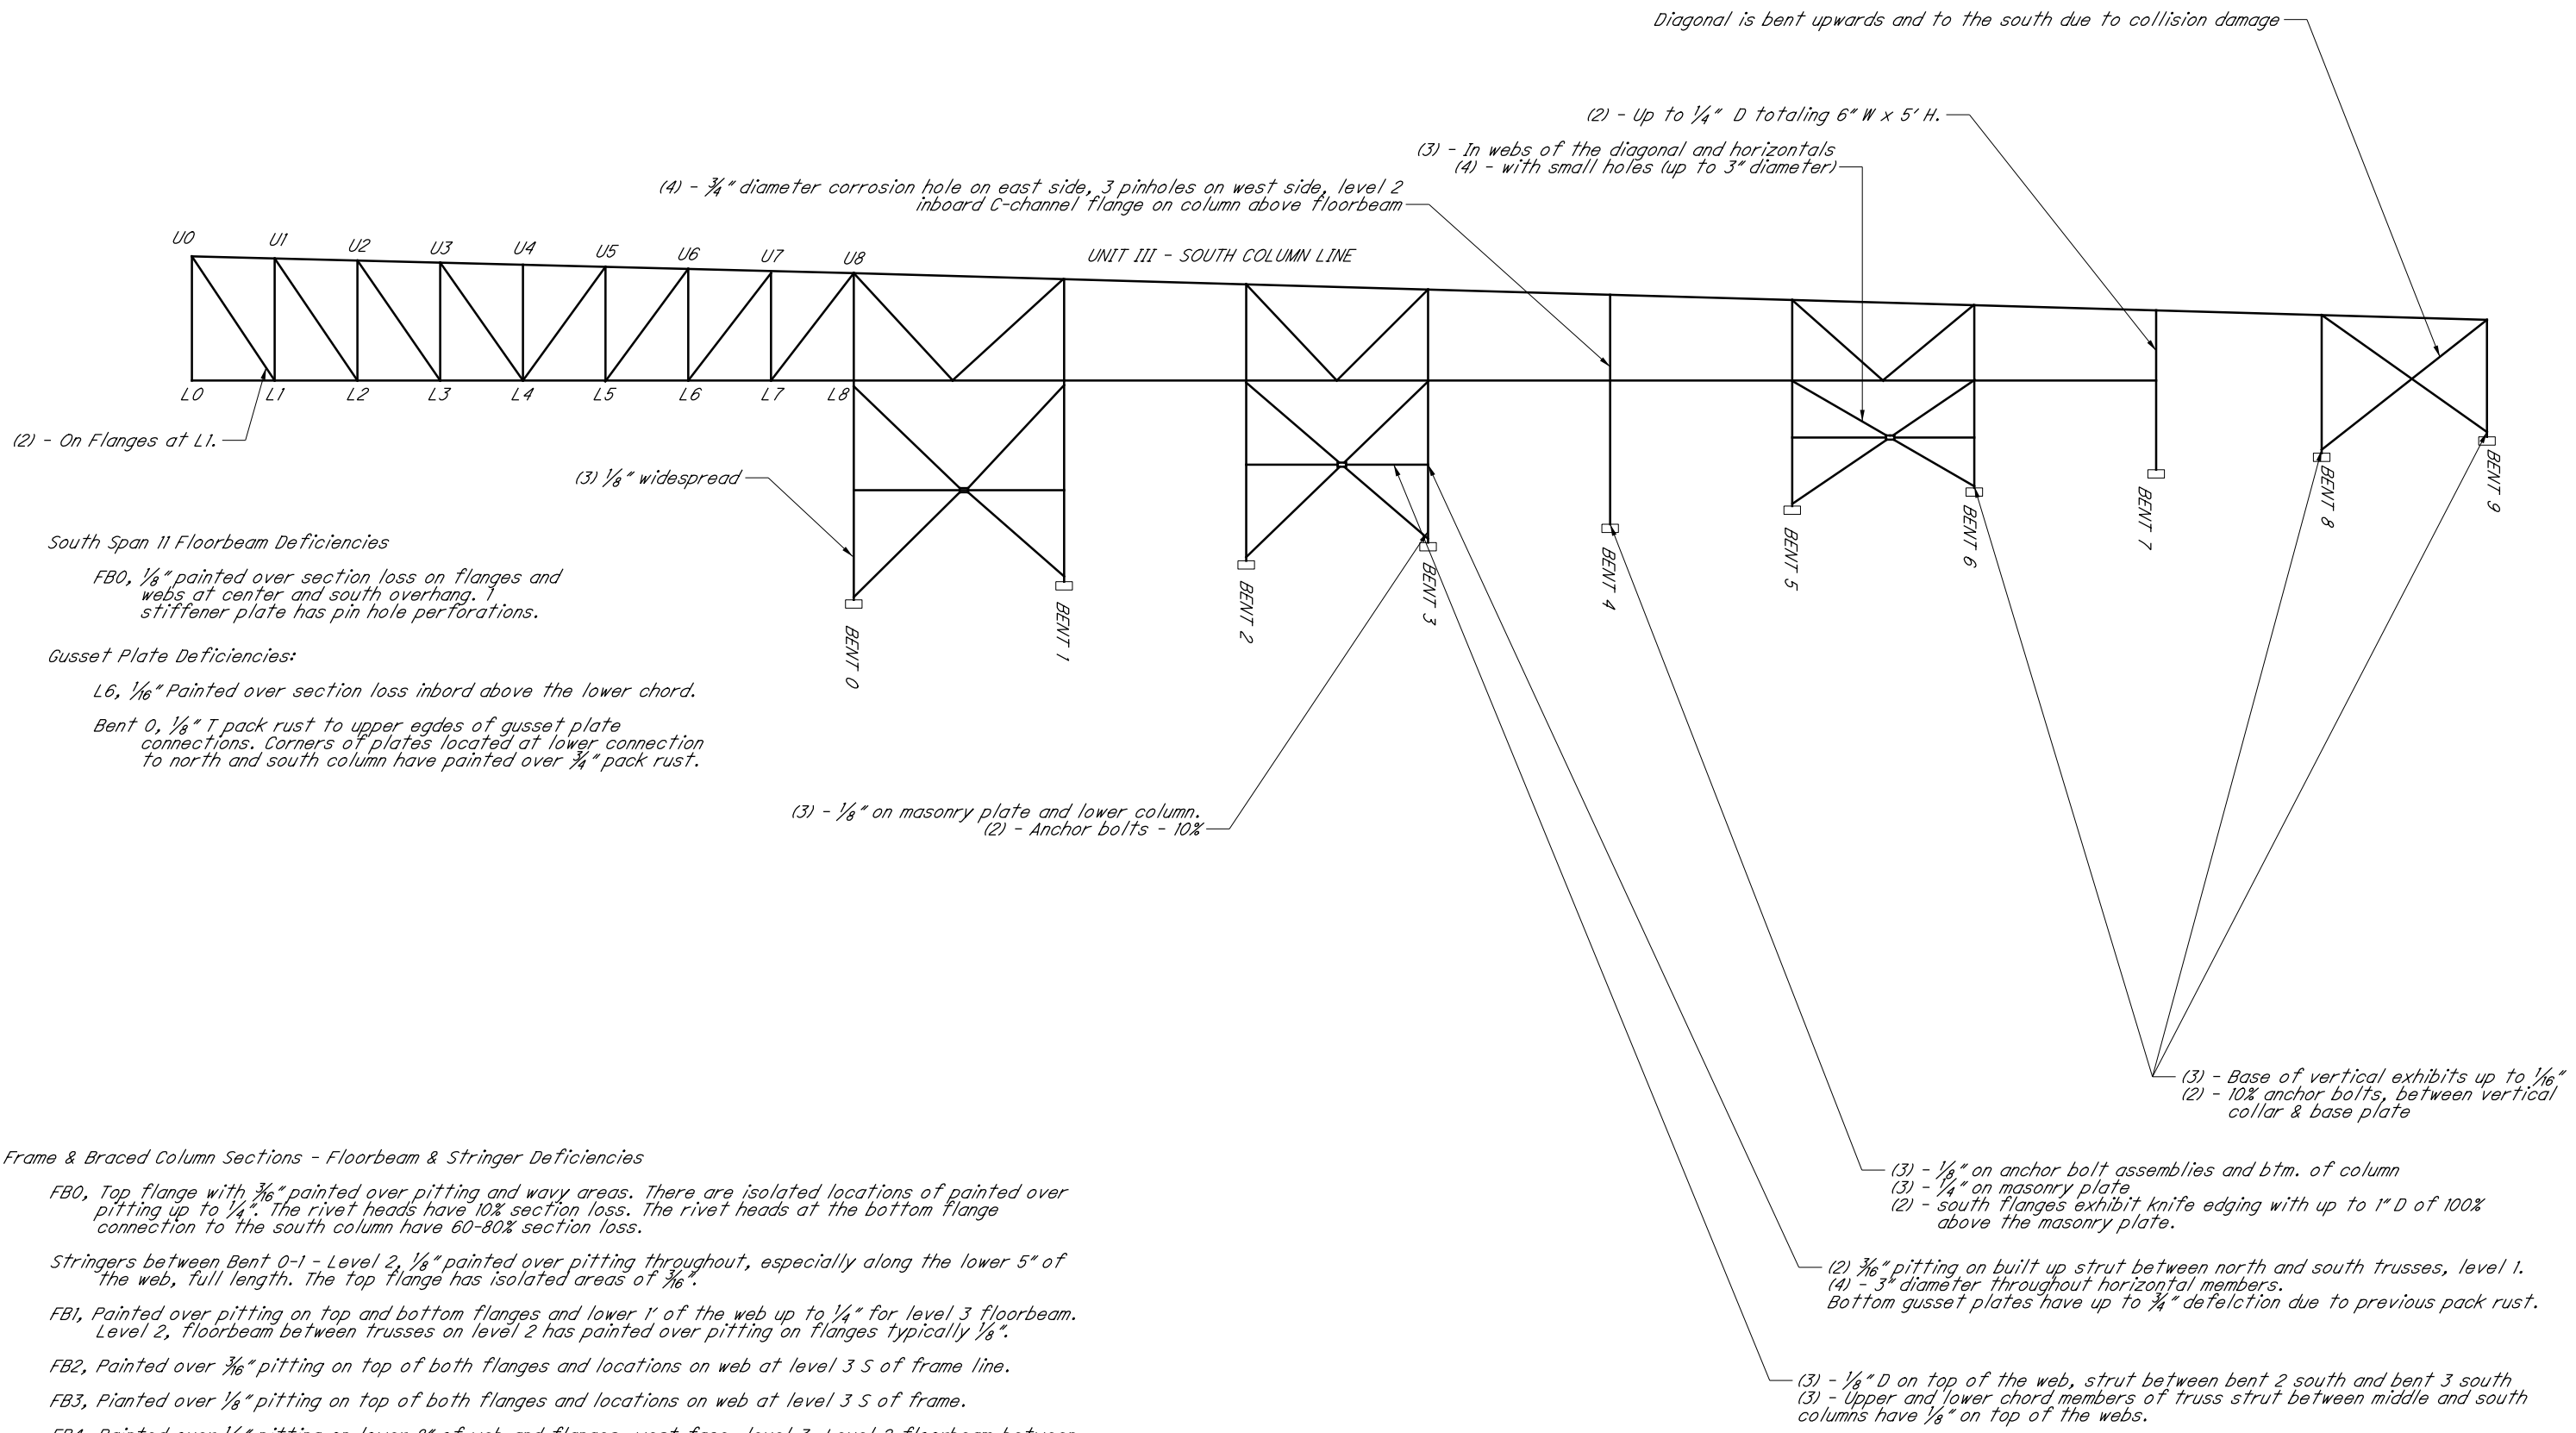
**South Span II Floorbeam Deficiencies**
