2023 ROUTINE AND FRACTURE CRITICAL INSPECTION REPORT

Bridge CUY-02-1441

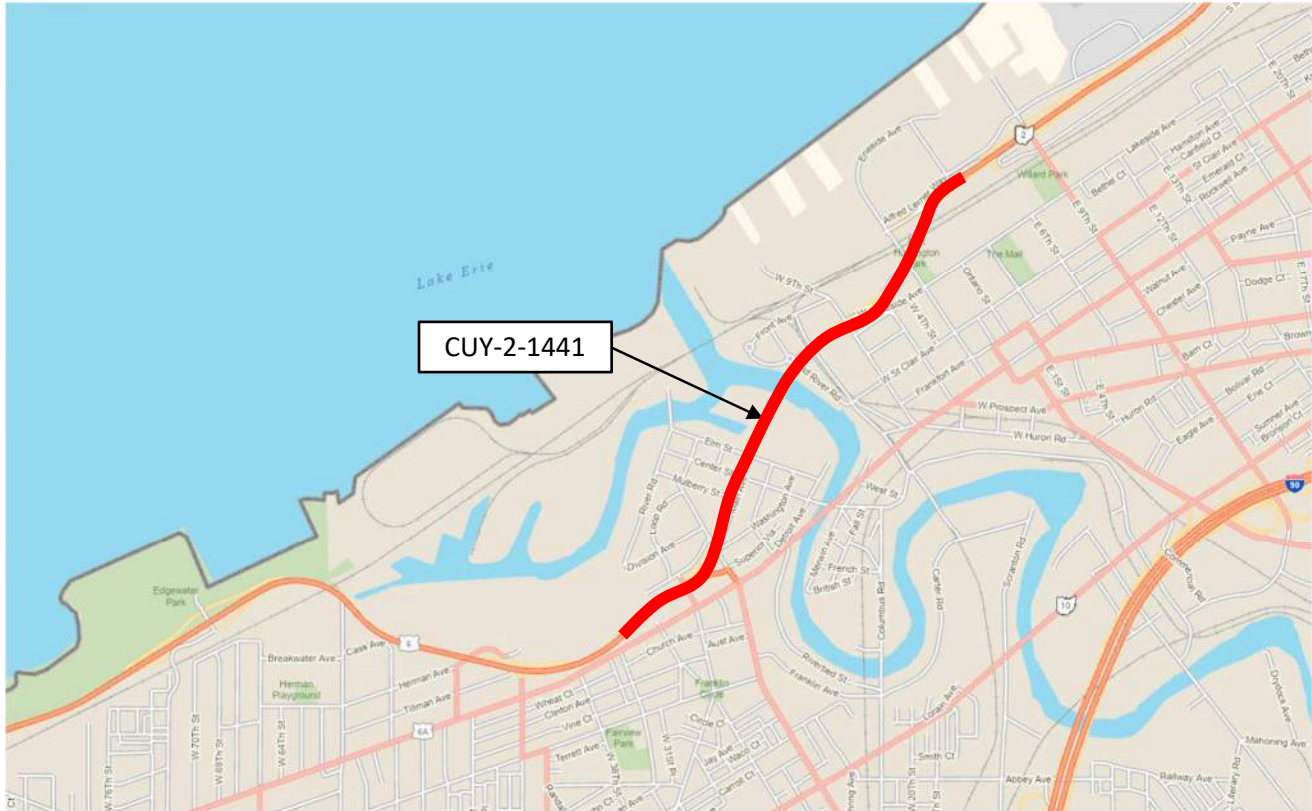
Structure: CUY-2-1441
Main Avenue Bridge over the Cuyahoga River Valley
Cleveland, OH

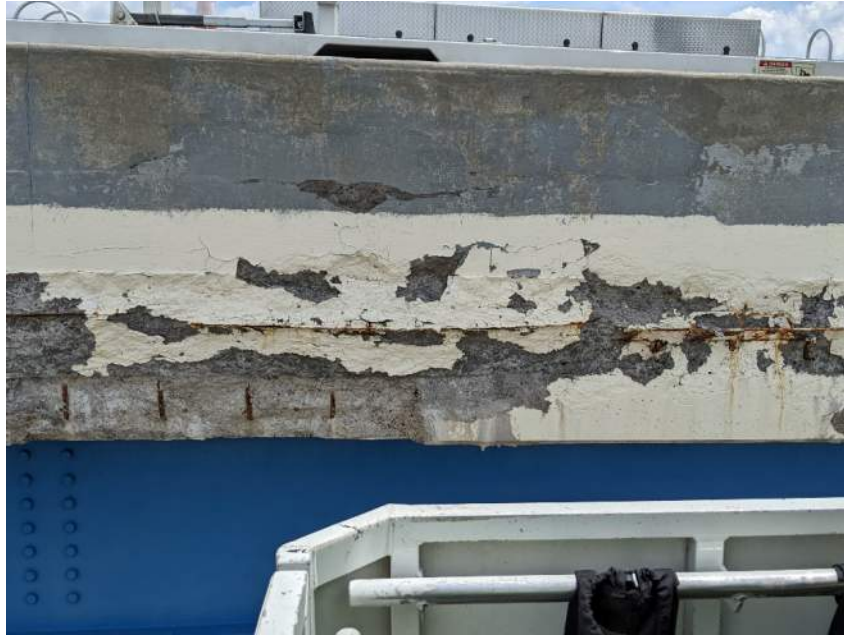
Photo 1: Deck Edge Spalling

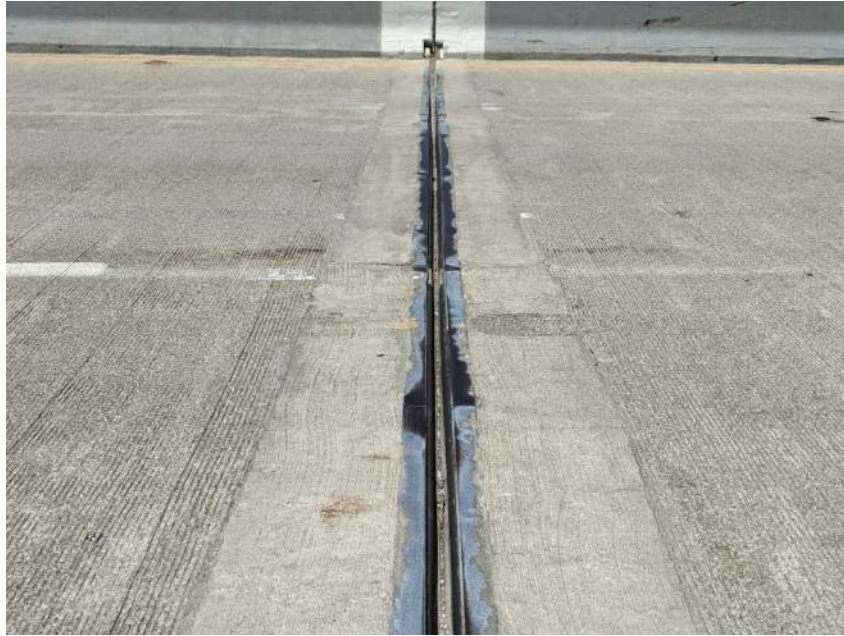
Photo 2: Typical Debris Impaction of Strip Seal Expansion Joints

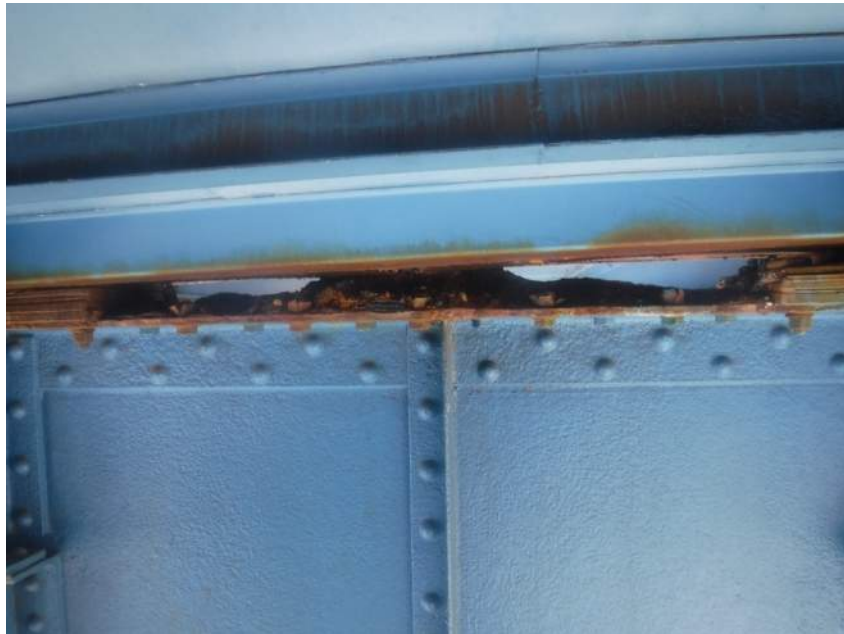
Photo 3: Visible Daylight and Debris Collection on Floorbeam Below Joint I1

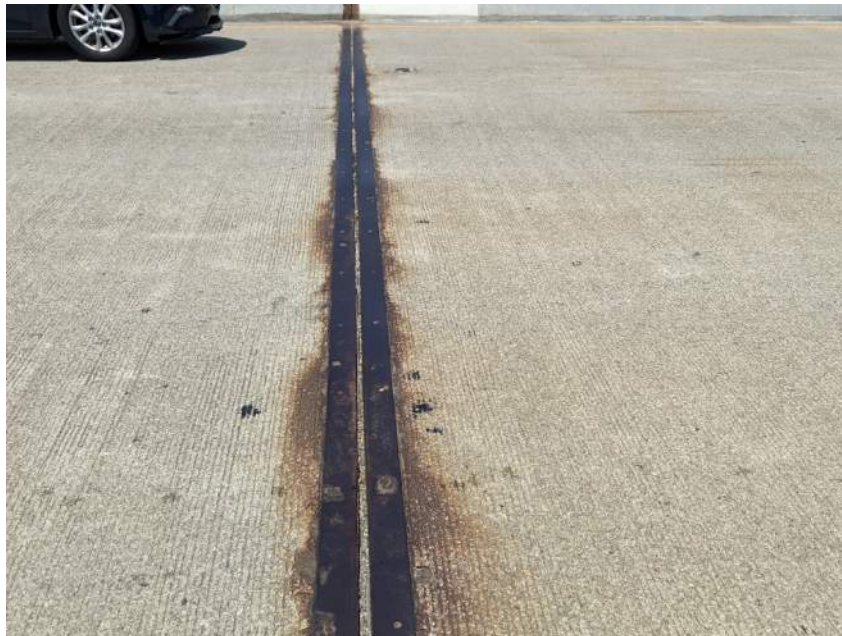
Photo 4: Typical Compression Seal Joint Debris Impaction

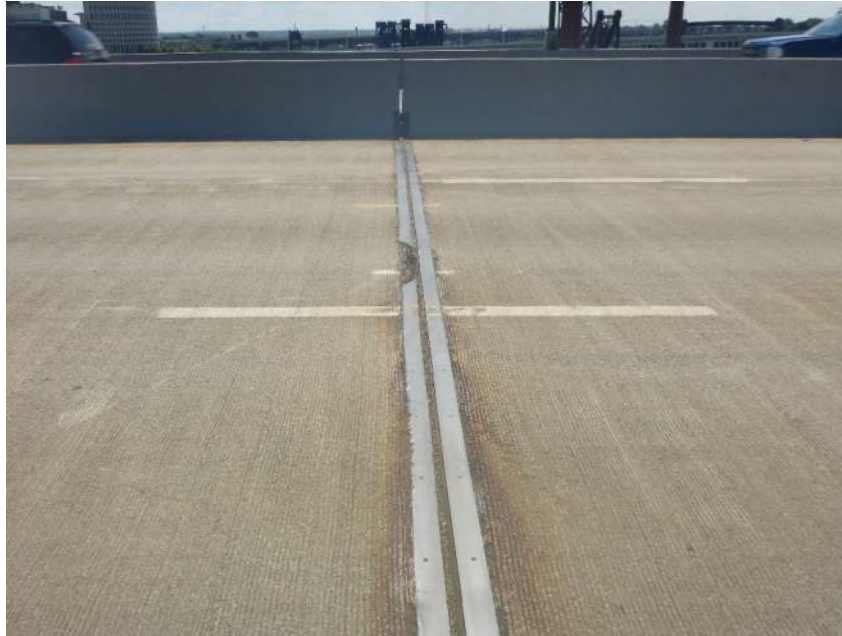
Photo 5: Missing Joint Armor on Eastbound Joint 8Q

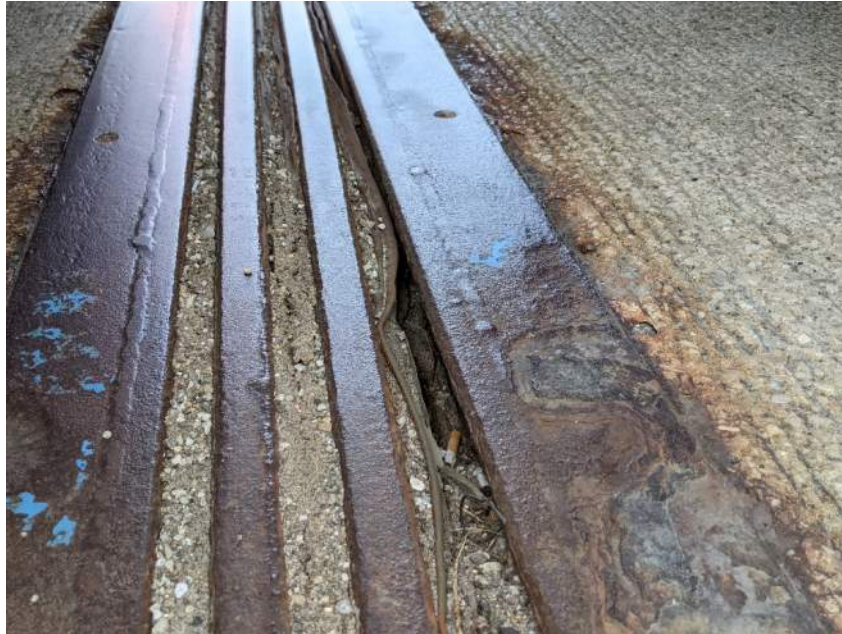
Photo 6: Assembly Joint with Seal with Splitting Seal

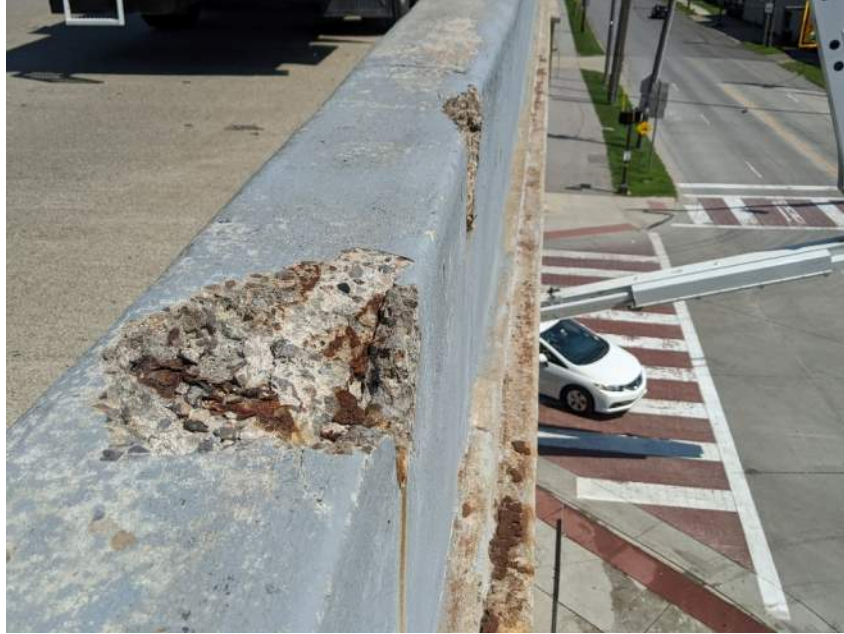
Photo 7: Railing spalls on South Railing, West of W. 25th Street

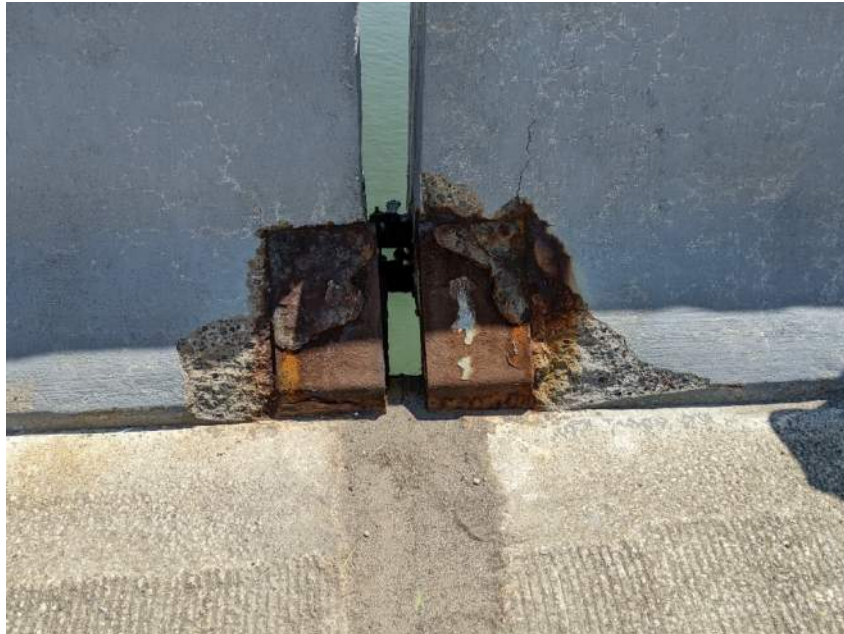
Photo 8: Typical Railing Spalls Adjacent to Joint Armor

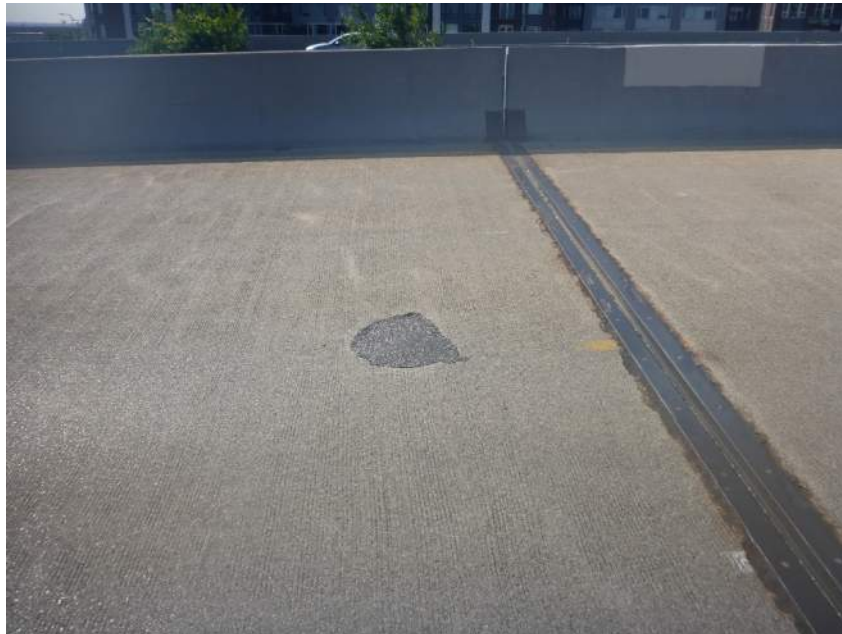
Photo 9: Wearing Surface Spall Patched with Asphalt

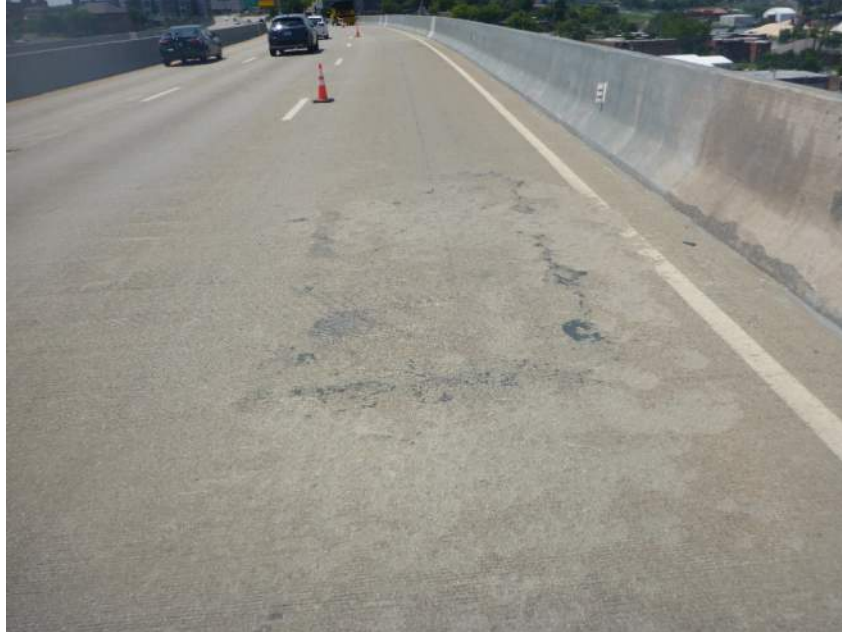
Photo 10: Wearing Surface Damage Due to Vehicle Fire in Right Westbound Lane In Unit II

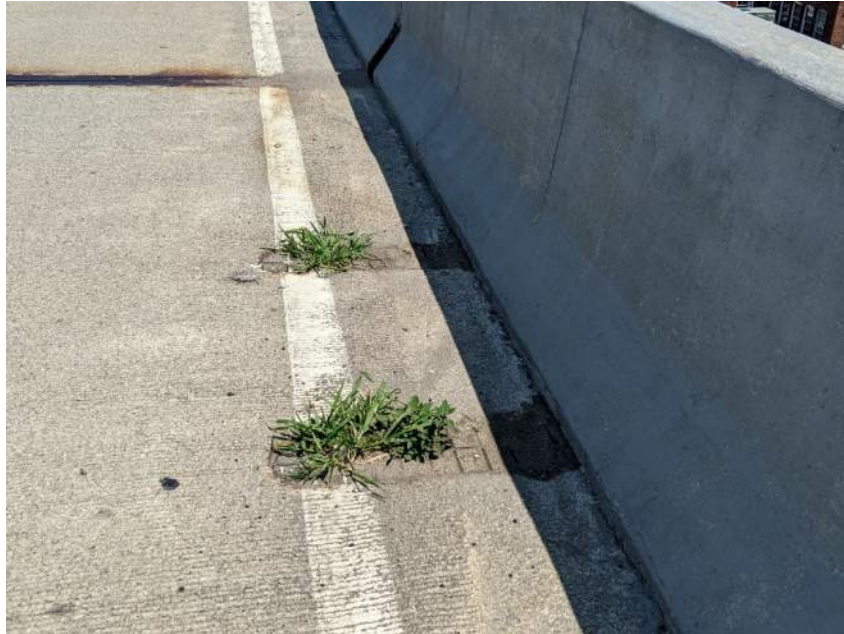
Photo 11: Typical Fully Clogged Scuppers

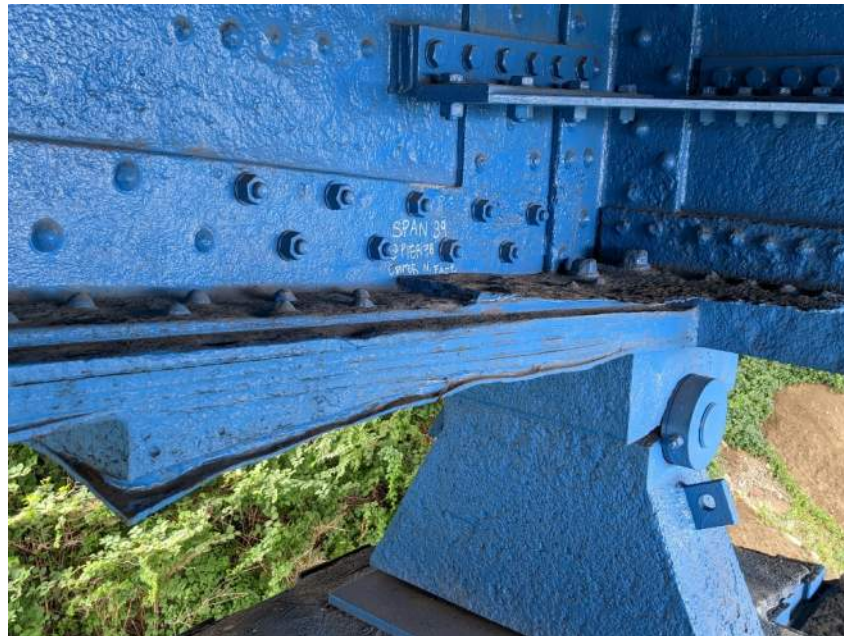
Photo 14: Pitting and Distorted Plates of Center Girder in Unit V, Span 39 at Pier 38, North Face

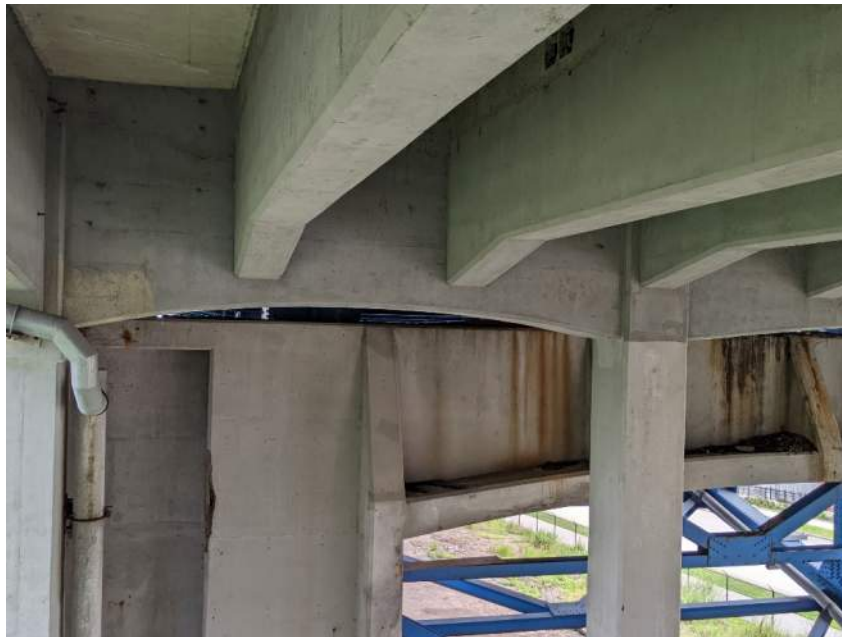
Photo 15: Reinforced Concrete Stringers, Unit I, Section P

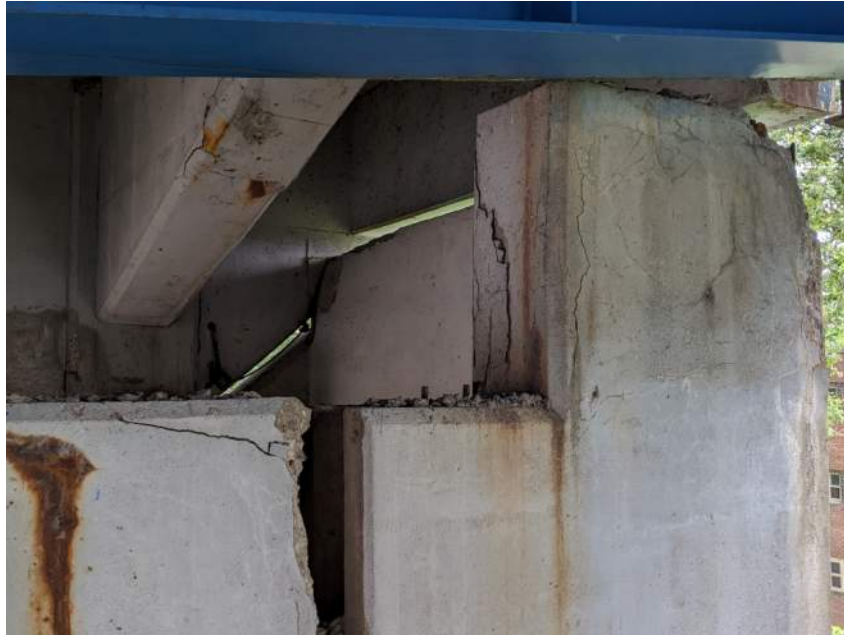
Photo 16: Reinforced Concrete Stringer with Cracking with Rust Staining Near North Fascia at End of Unit I at Joint O, Section P

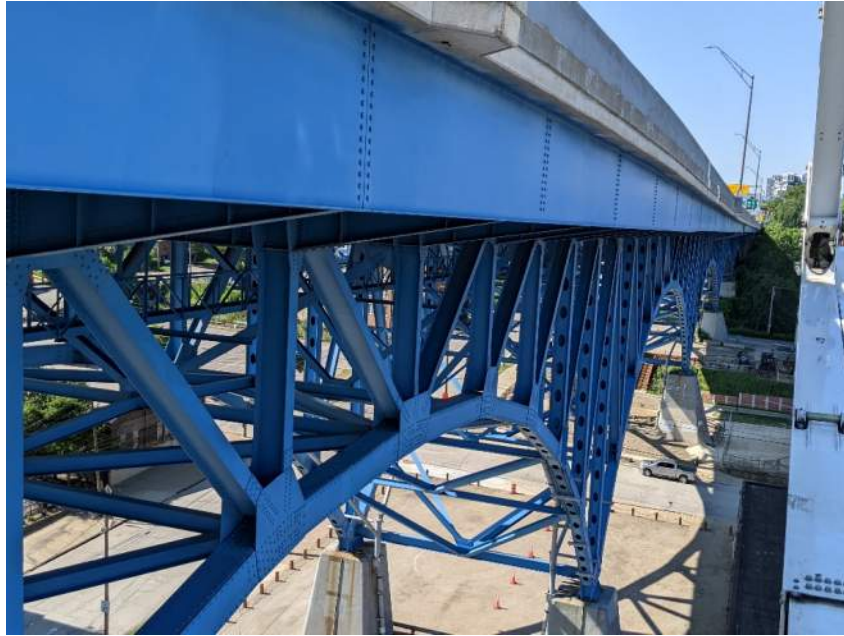
Photo 17: North Truss Elevation, Spans 1 Thru 3

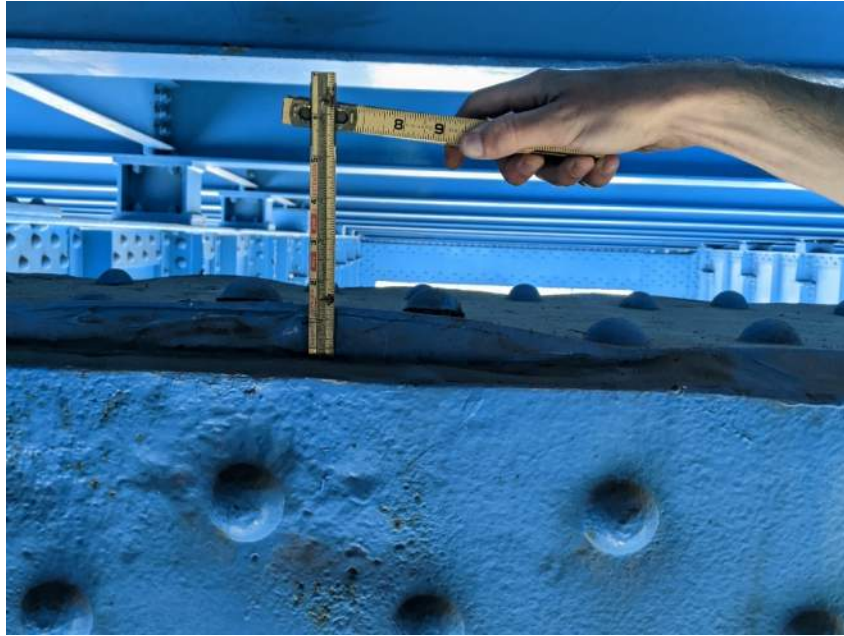
Photo 18: Distortion of Top Flange of Top Chord Due to Pack Rust

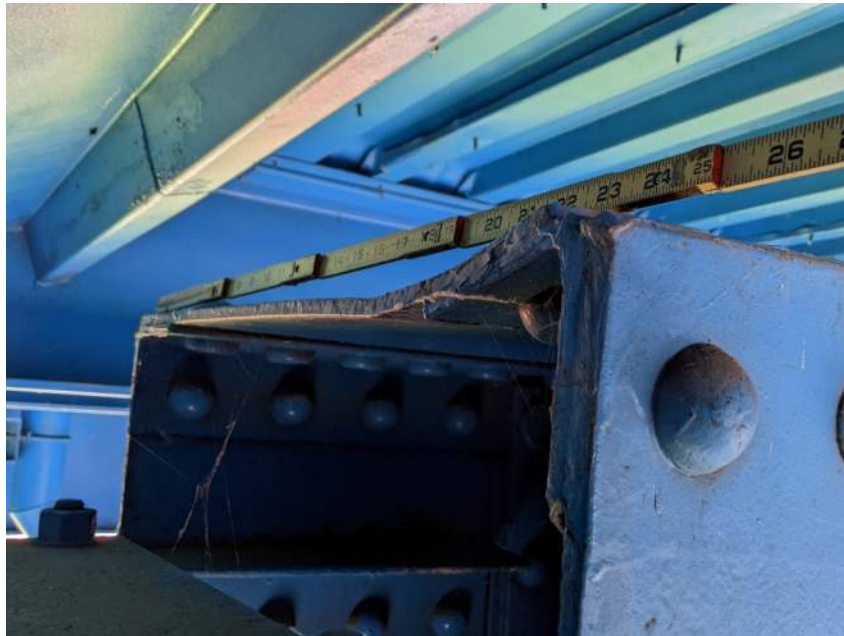
Photo 19: Bowing of Top Chord, Top Flange

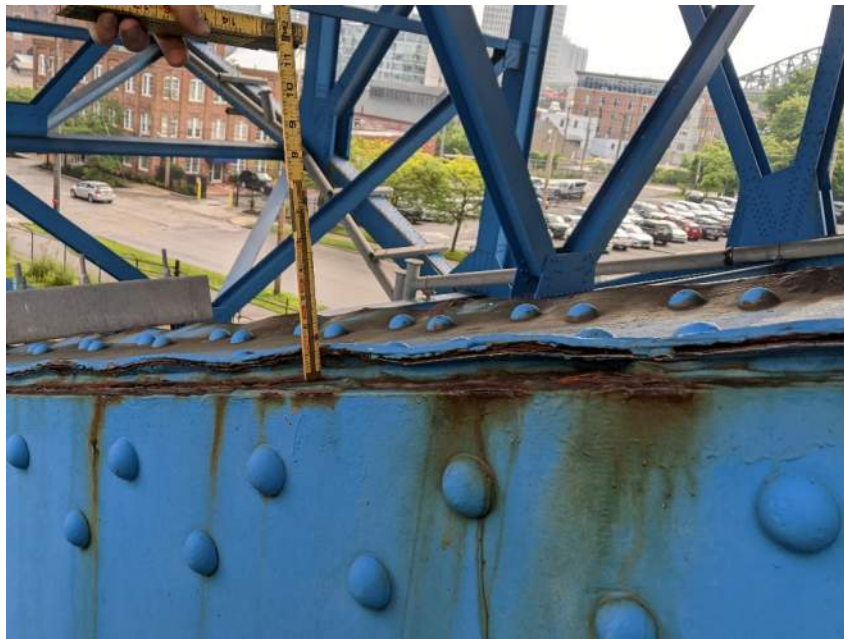
Photo 20: Painted Over and Reactivating Pack Rust Typical Between Web and Flange Plates

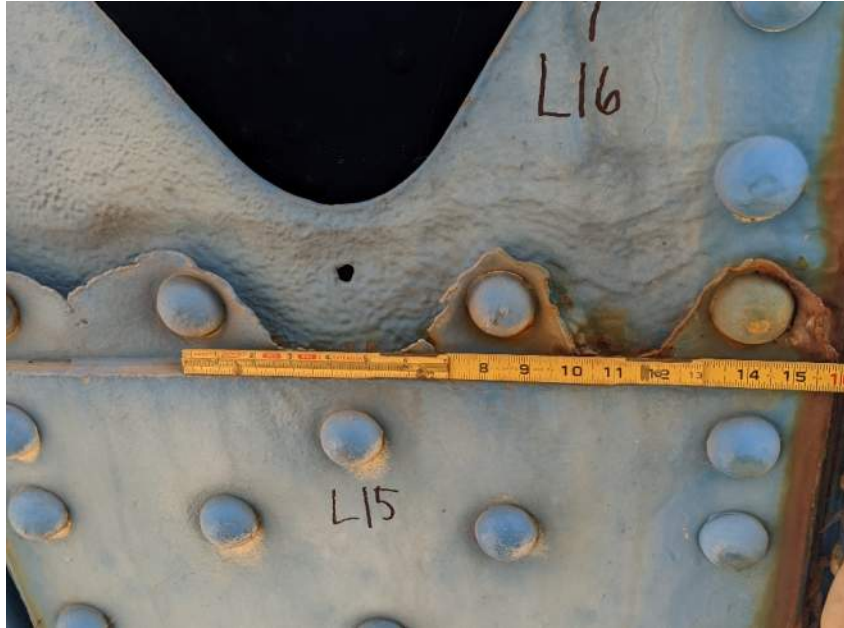
Photo 21: Painted Over Pitting, Pack Rust at Fill Plates of L15L16

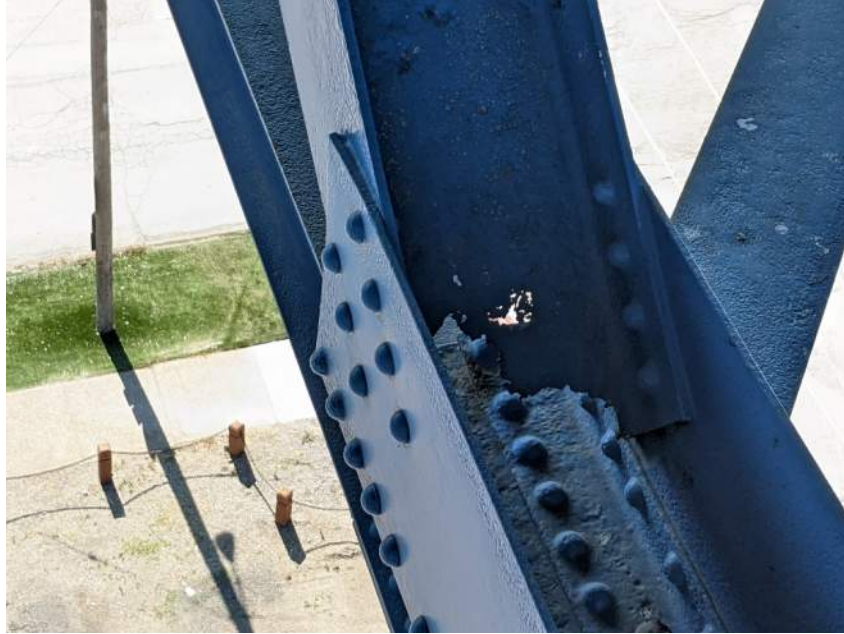
Photo 22: Painted Over Pitting and Corrosion Holes in Sway Bracing

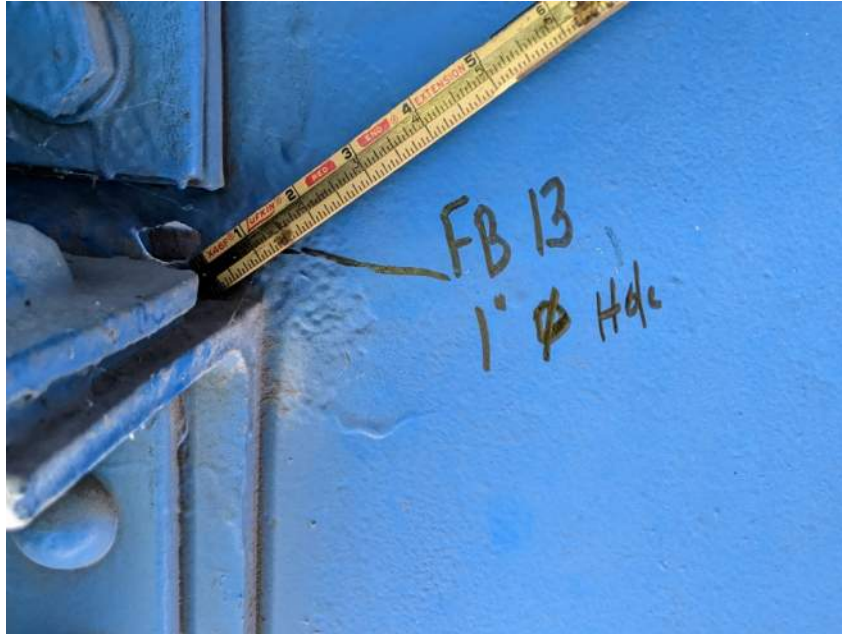
Photo 23: Painted Over Pitting and Corrosion Holes in Floorbeam

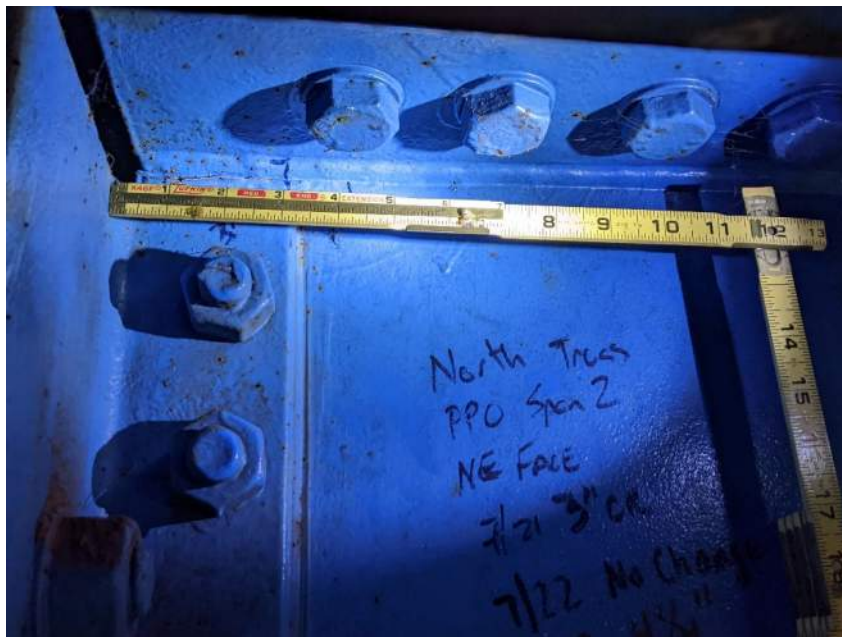
Photo 24: Propagating Crack in North Truss Floorbeam

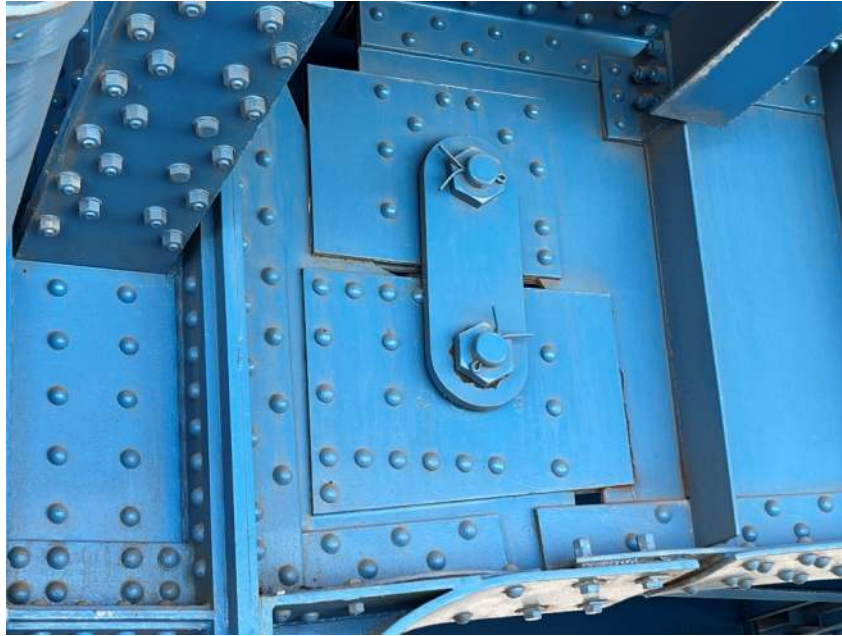
Photo 25: Pin and Hanger Assembly

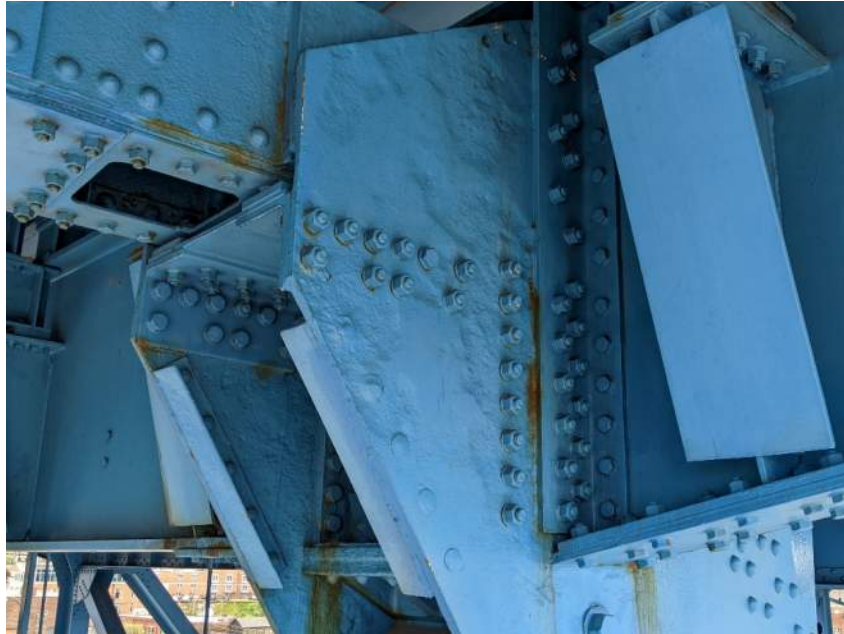
Photo 26: Painted over pitting at Span 6, U0, Outboard Gusset Plate

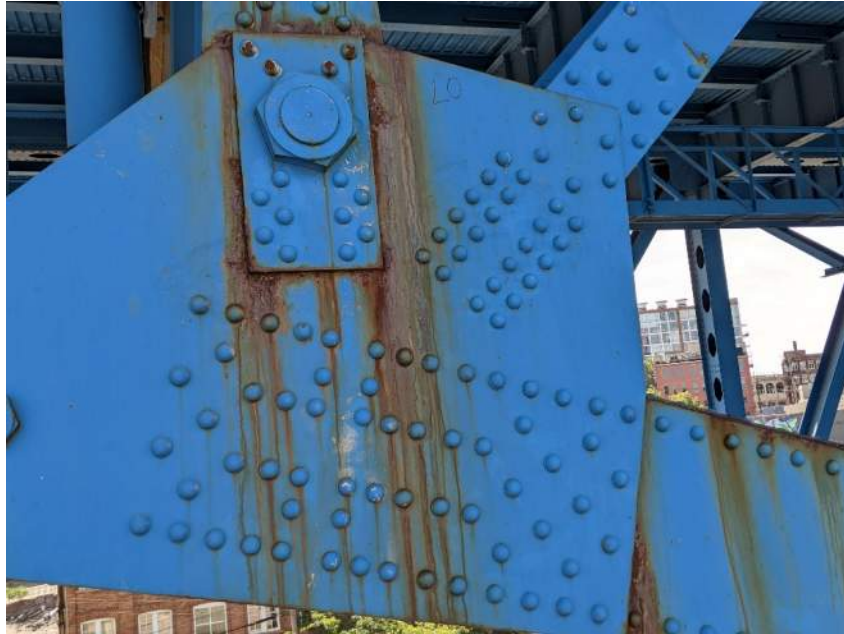
Photo 28: Rust Staining at Lower Chord Gusset Plate in Span 3 North Truss, L0

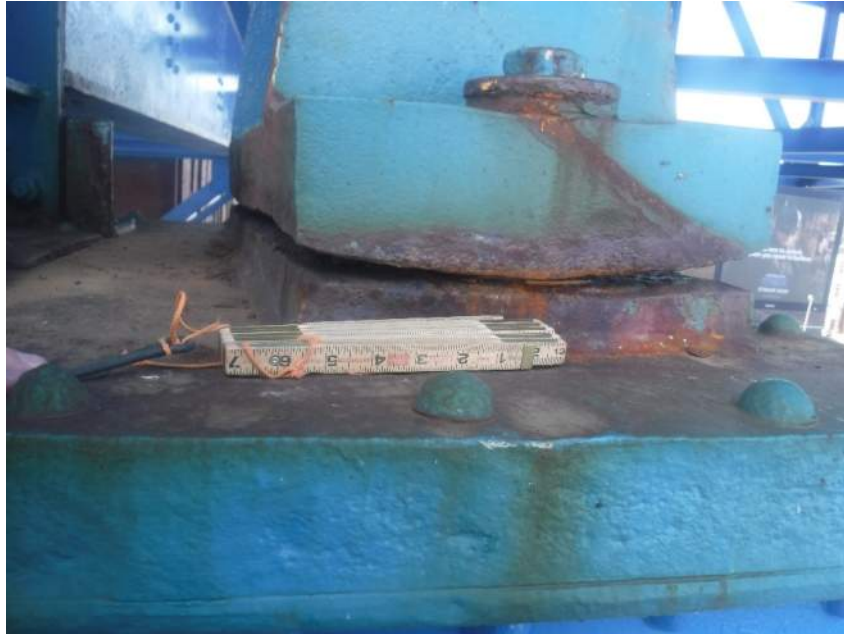
Photo 29: Active Corrosion with Section Loss Up To ¼" at Bearing Below L8 In Span 11

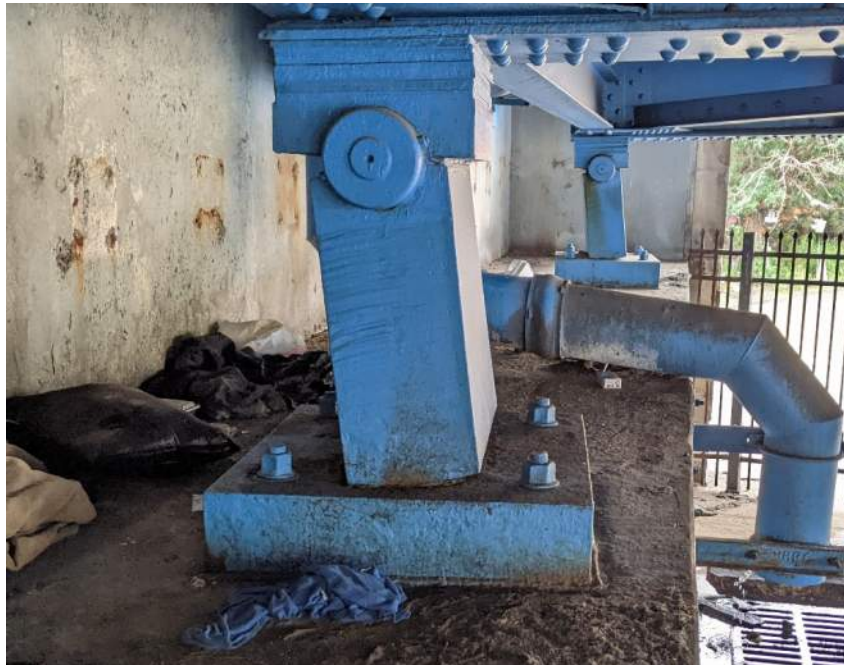
Photo 30: Painted Over Pitting of Movable Bearings at Abutment A

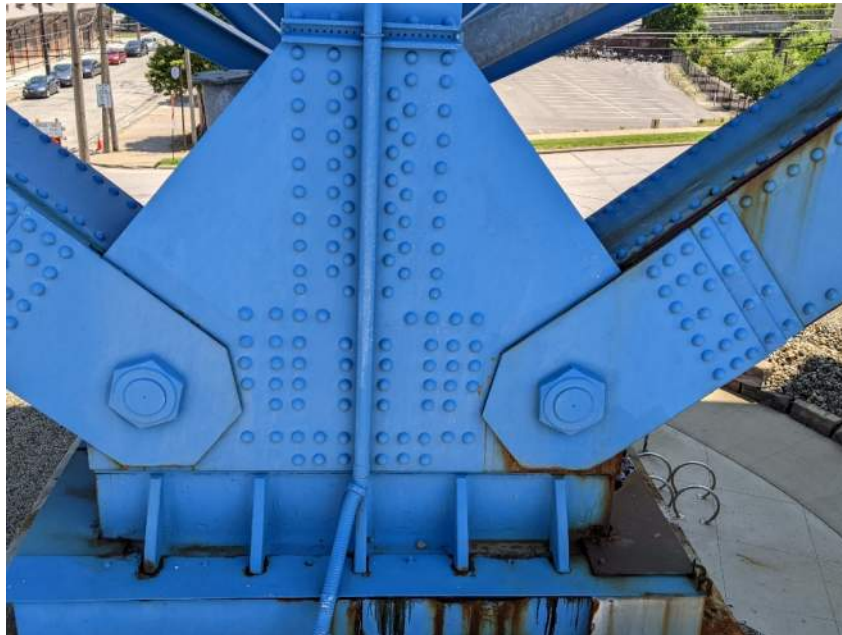
Photo 31: Typical Fixed Bearing with Moderate Corrosion

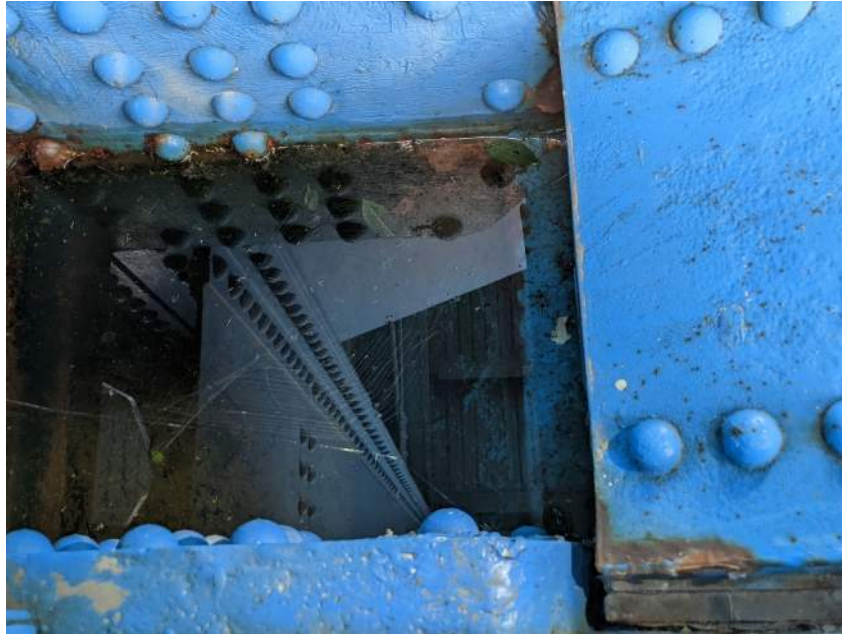
Photo 32: Standing Water in A Bearing Assembly in Unit II

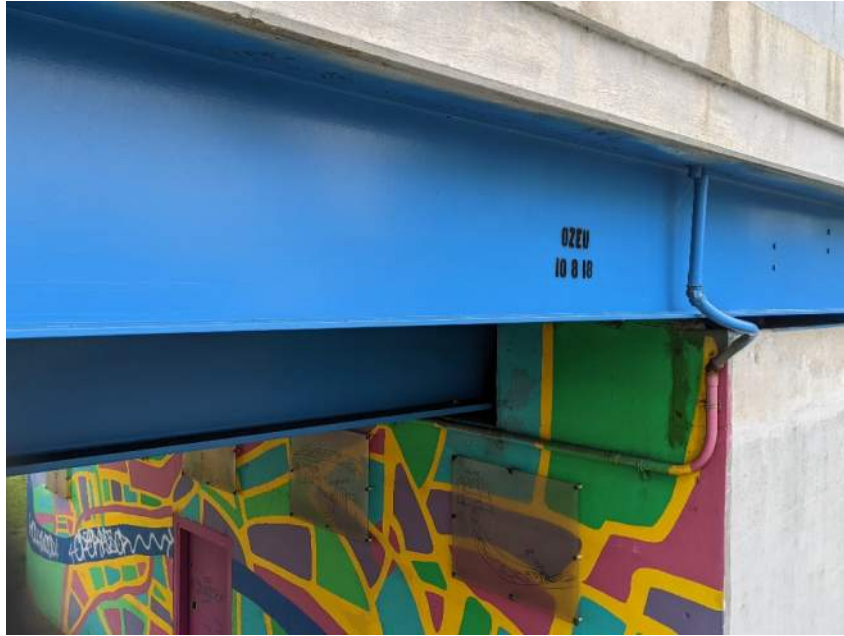
Photo 33: Protective Coating System in Unit I

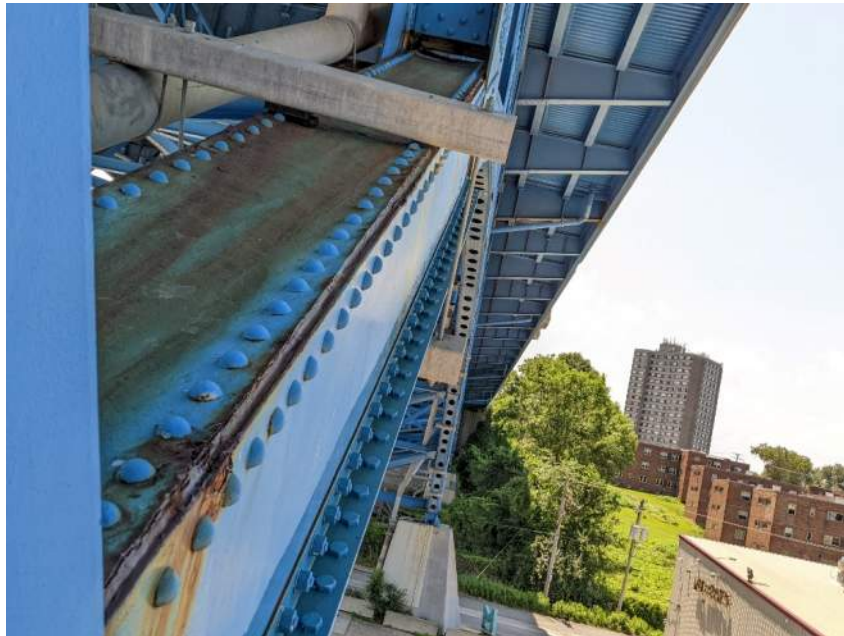
Photo 34: Protective Coating System with Reactivating Corrosion Near a Joint

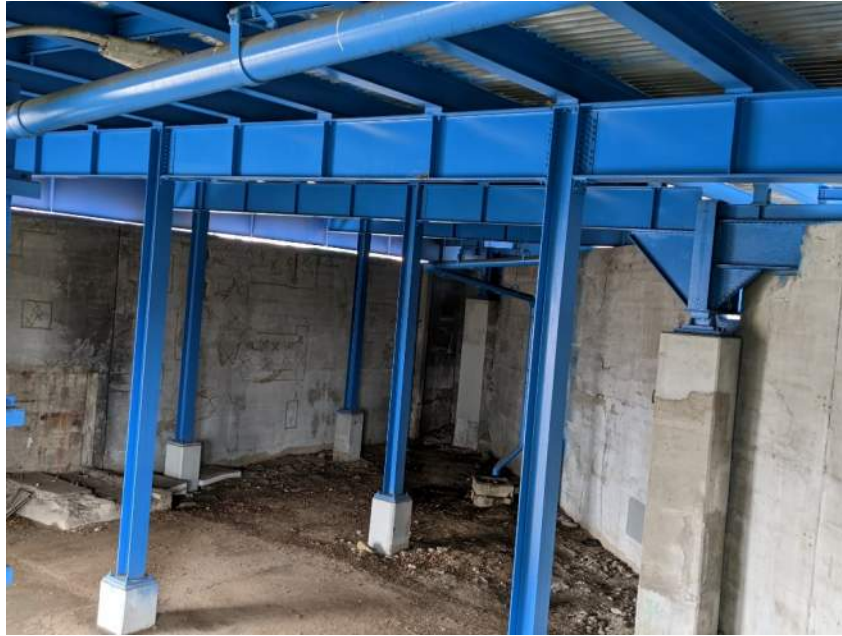
Photo 35: Steel Columns in Unit 1

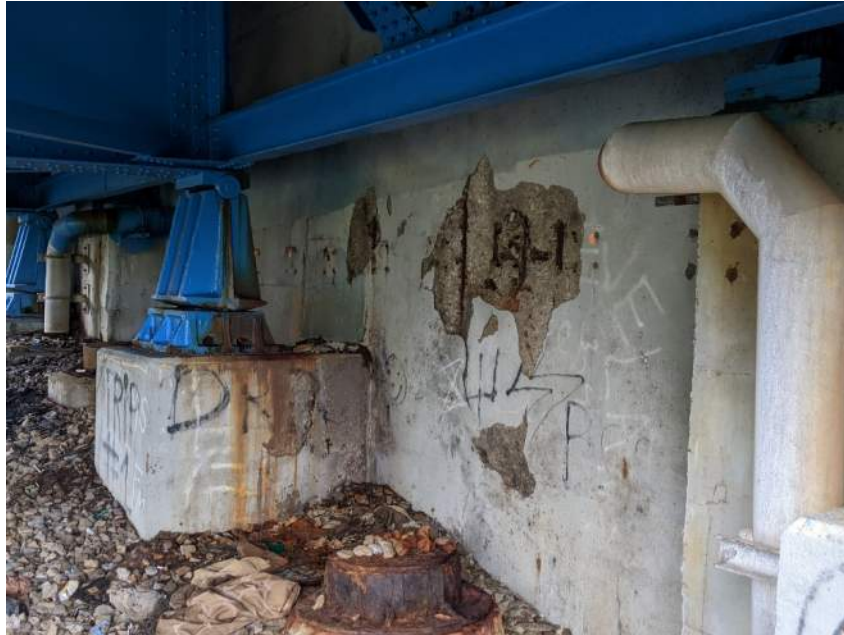
Photo 36: Pier 37 Wall Spalls

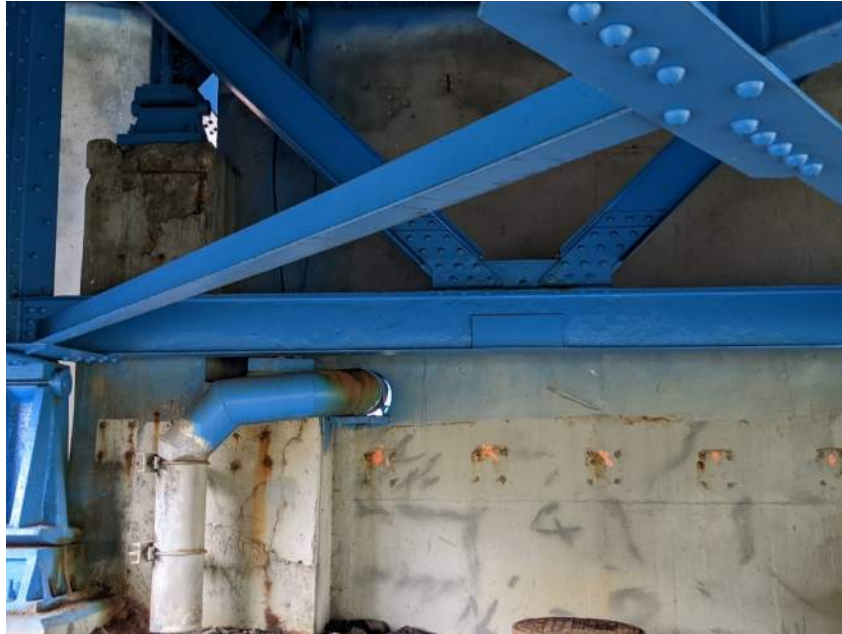
Photo 37: Pier 37 Bearing Pedestals Spalling

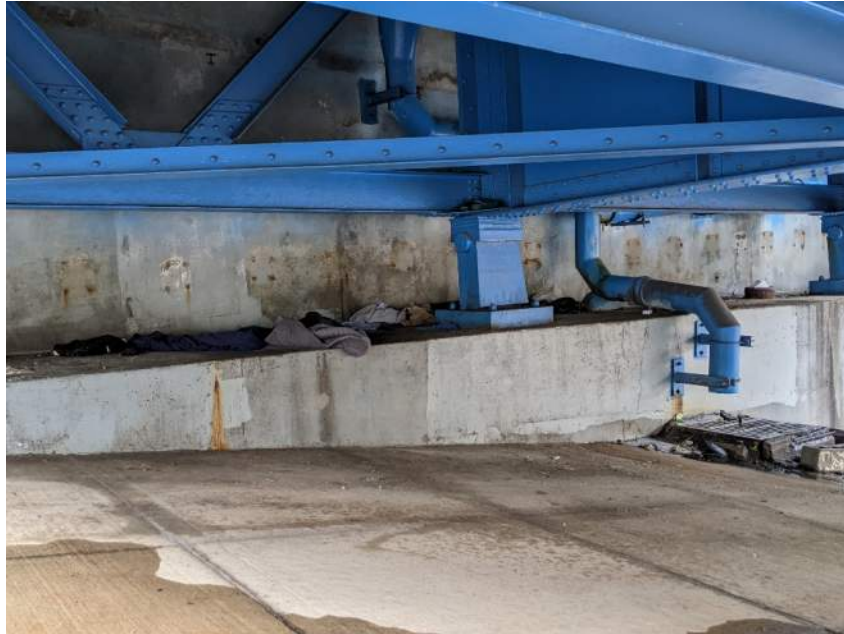
Photo 38: East Abutment

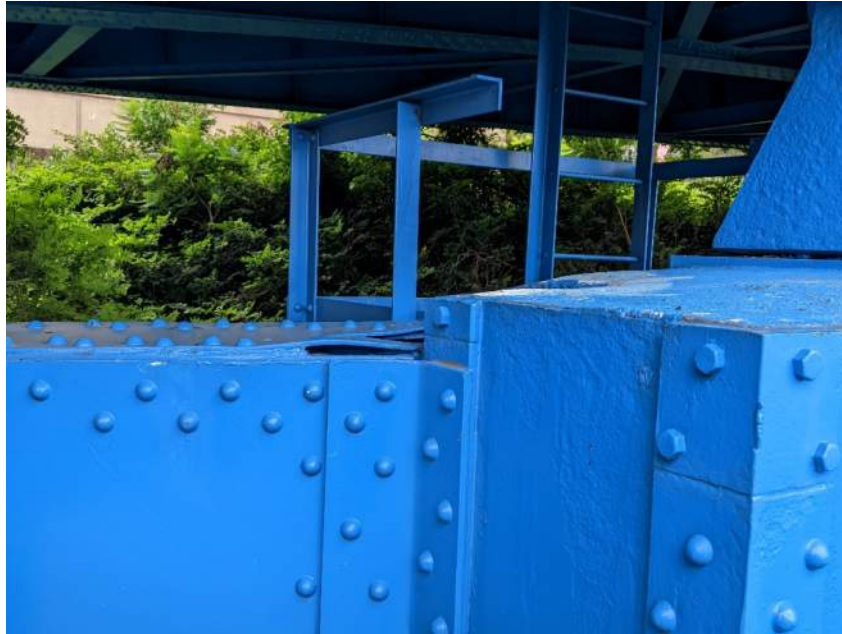
Photo 39: Unit V Steel Pier Cap Plate Distortion Due to Pack Rust

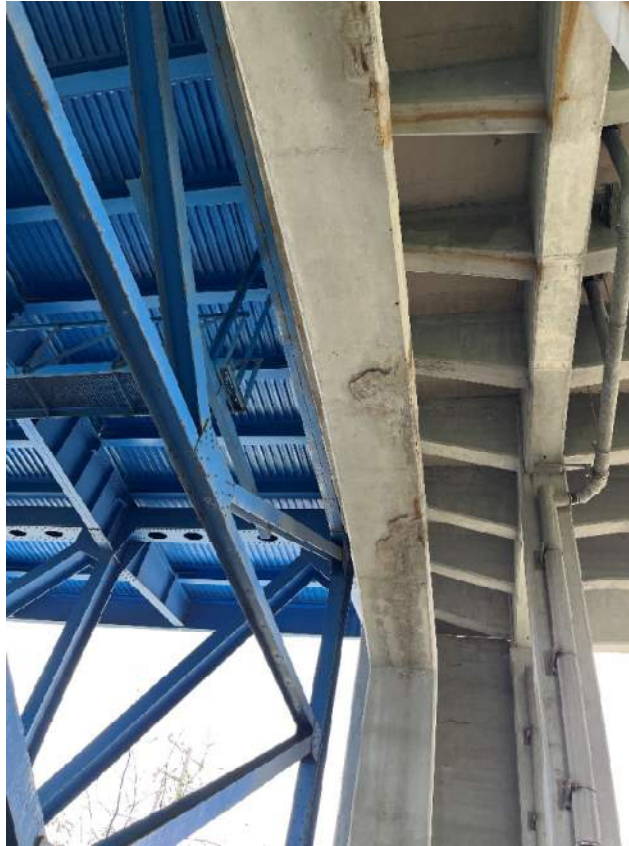
Photo 40: Underside of Pier O in Section P Delaminations

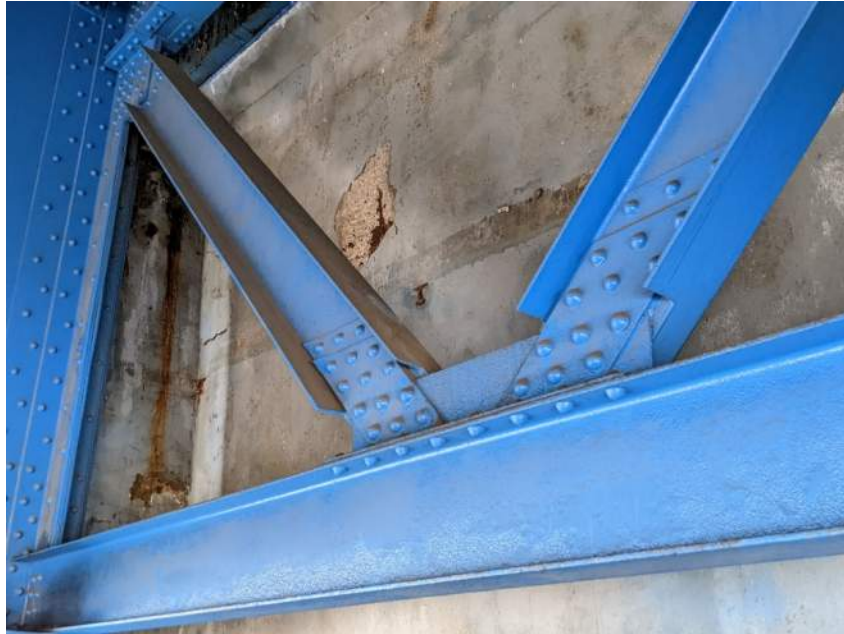
Photo 41: East Abutment Backwall Spall with Exposed Rebar

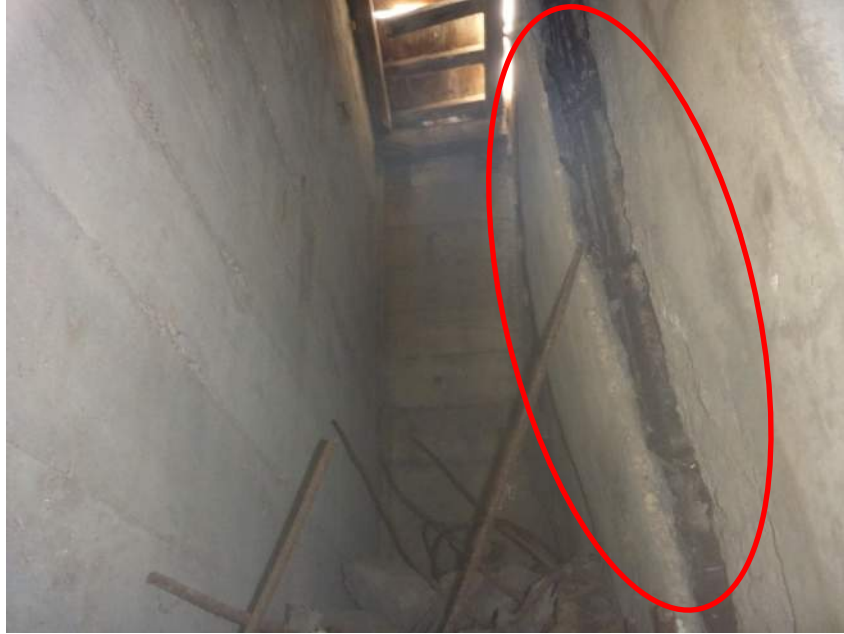
Photo 42: Section N Wall with Very Large Delamination

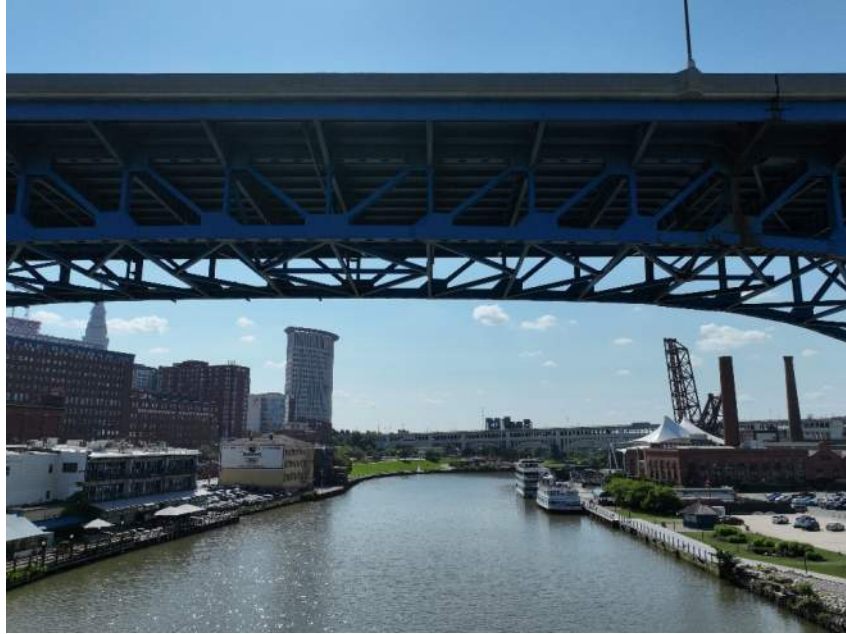
Photo 43: Channel at Bridge, Looking Upstream
