2023 ROUTINE AND FRACTURE CRITICAL INSPECTION REPORT

Bridge CUY-02-1441

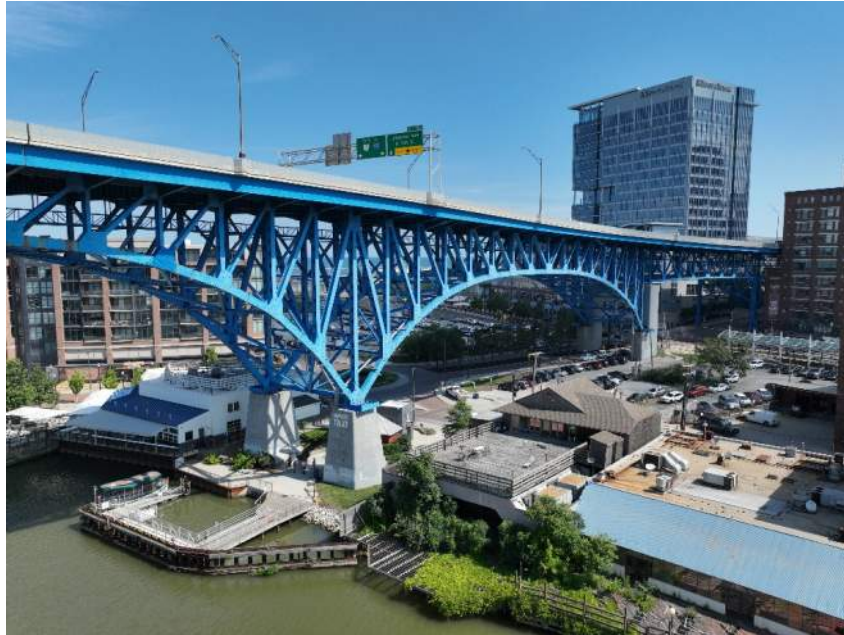
Photo 45: Channel Protection, East Bank

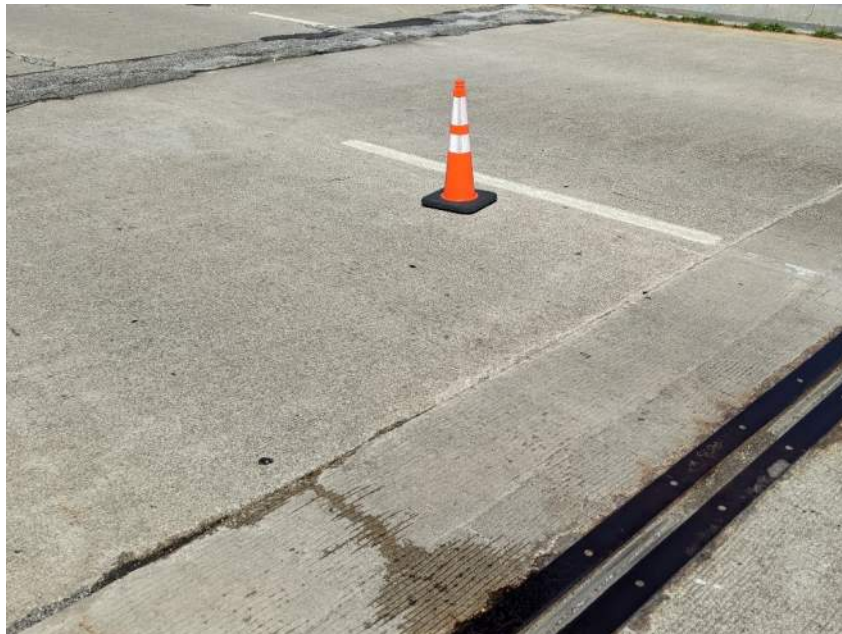
Photo 47: Approach Slab with Asphalt Patching At End Of Eastbound, West Approach

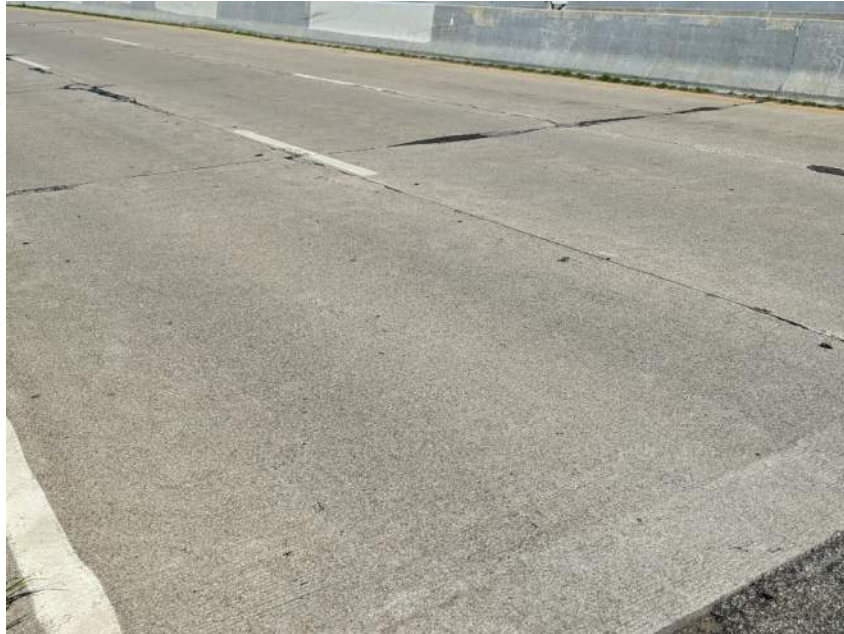
Photo 48: Typical Approach Wearing Surface

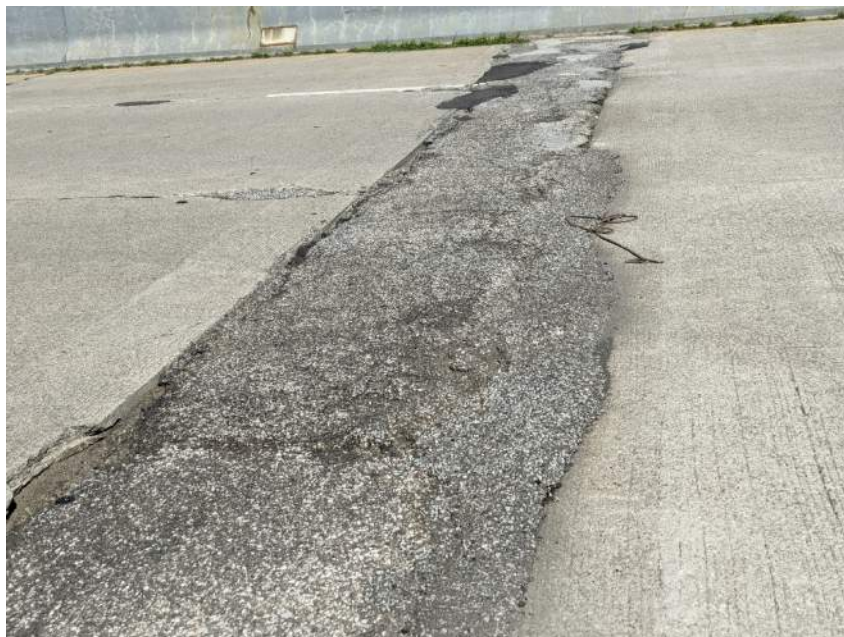
Photo 49: Asphalt Patching at End Of Eastbound, West Approach Slab

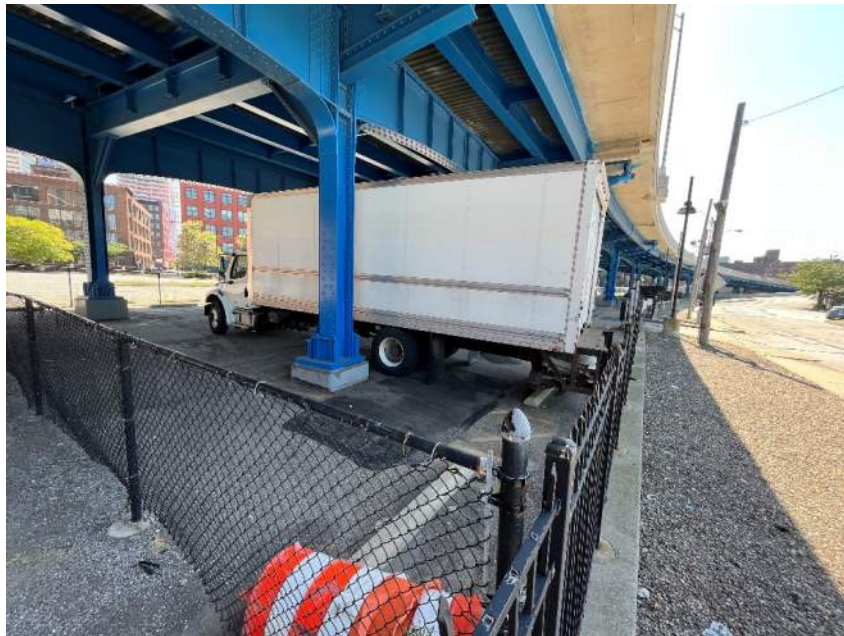
Photo 50: Sink Hole Patch

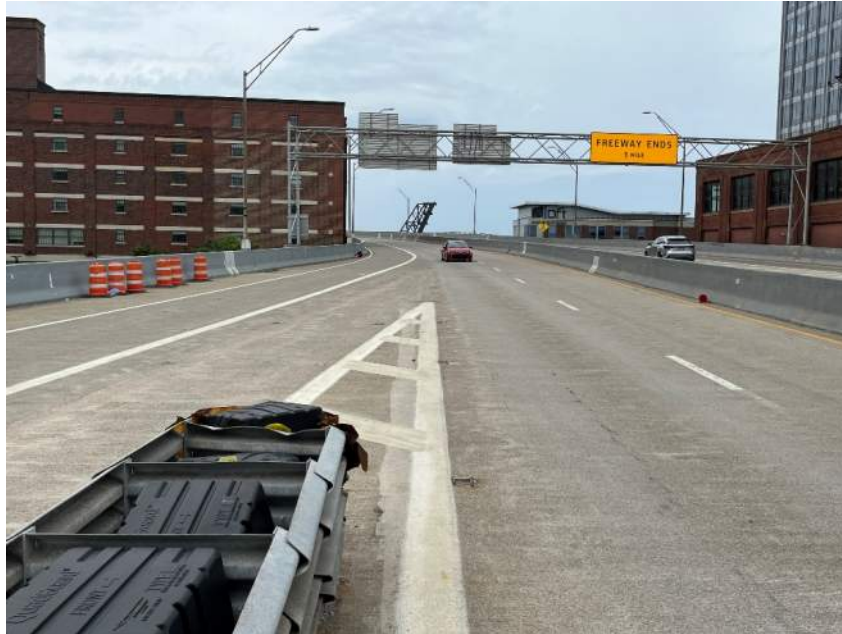
Photo 51: Damage to Impact Attenuator at Eastbound Exit to W. 6th Street

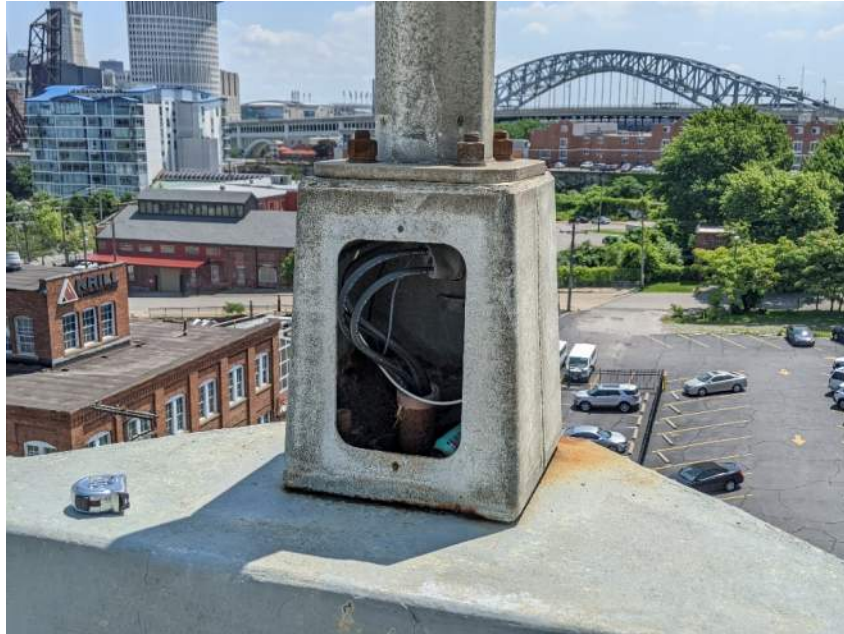
Photo 52: Missing Cover with Exposed Wiring At The Base Of A Light Pole

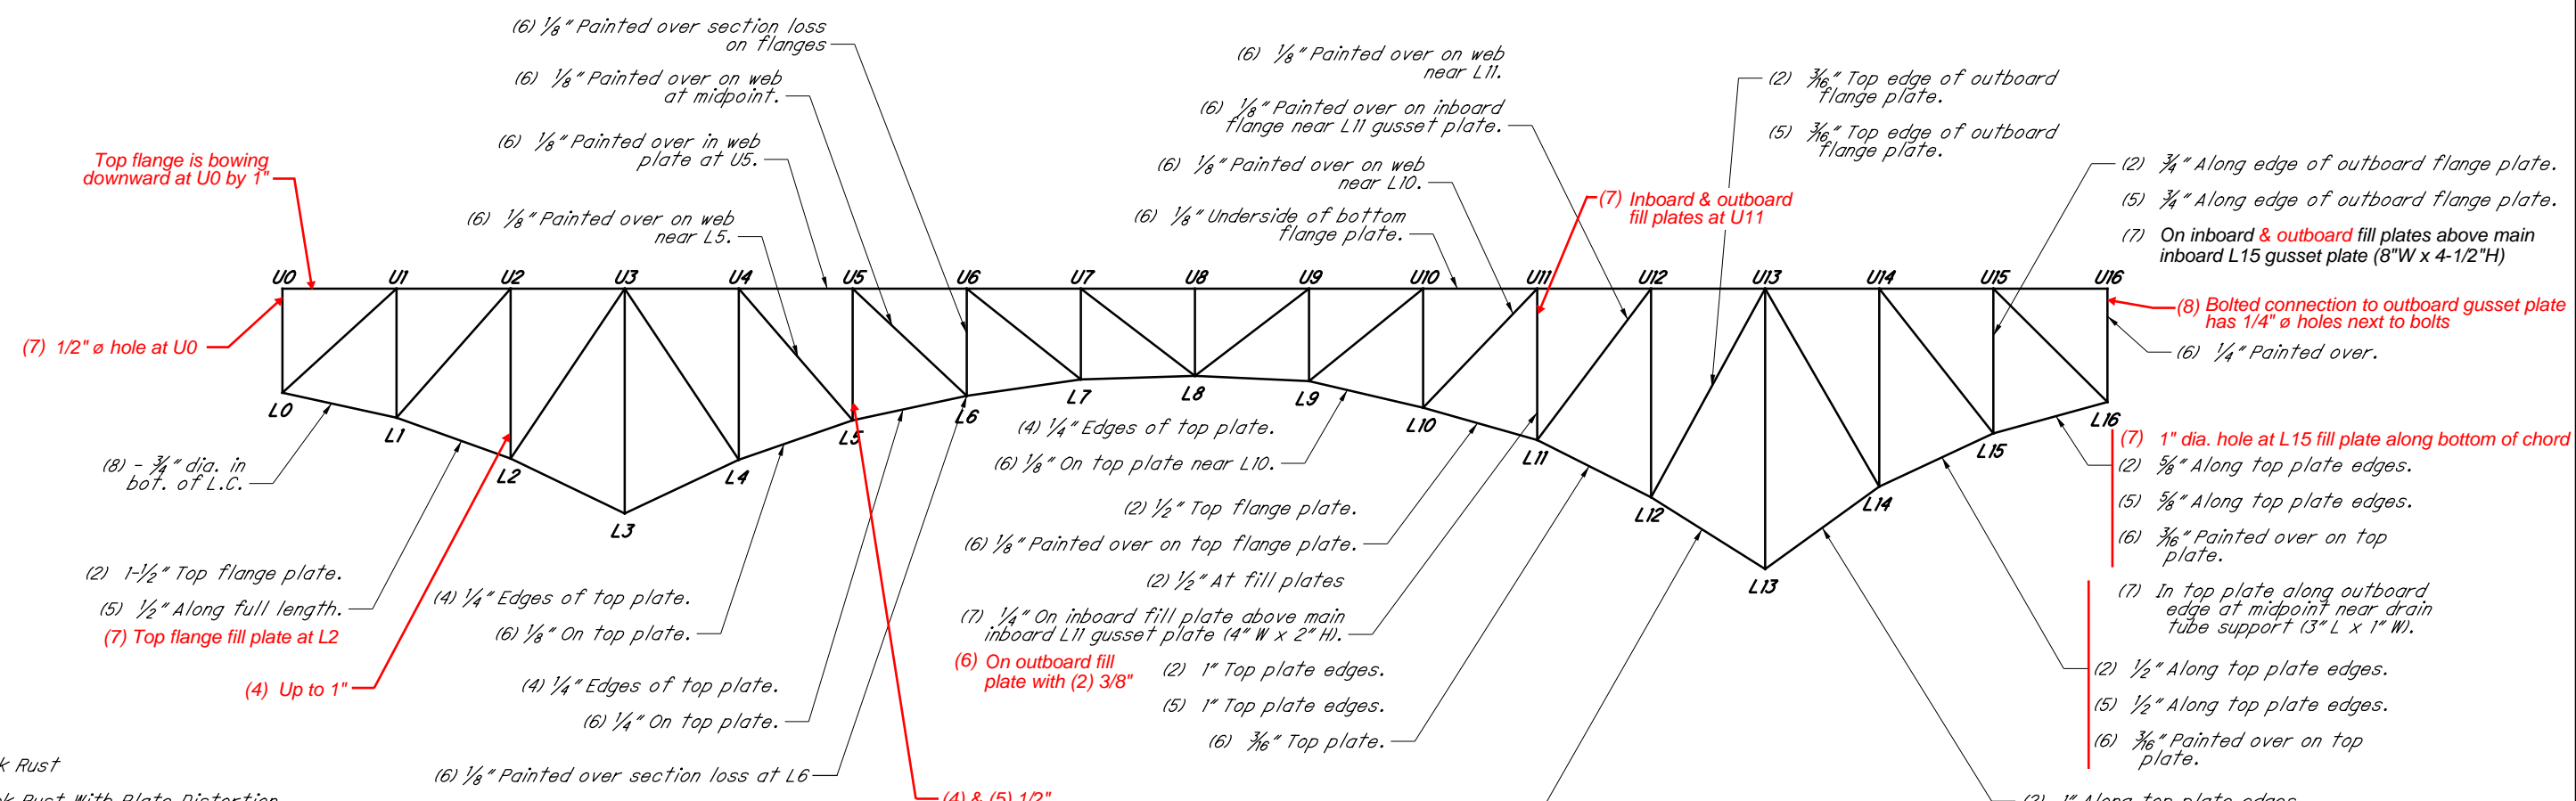
J:\000T\09534_VAR-D12_Inspection\Inspection\CUY-2-14.41_Main_Ave_1800035\2022_Inspection\CAD\CUY-2-14.41_Truss_Span_2 - North_11/28/2022 10:41:05 AM adam-l

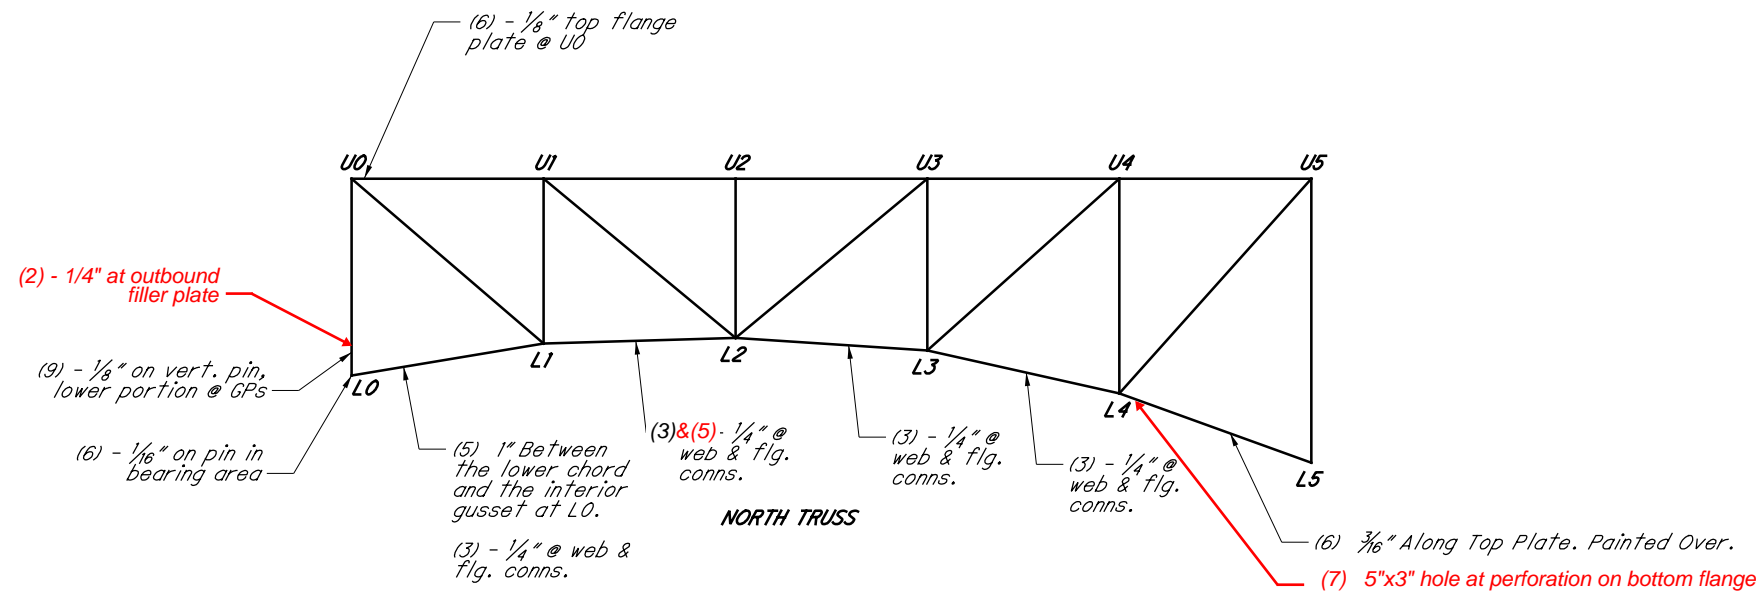
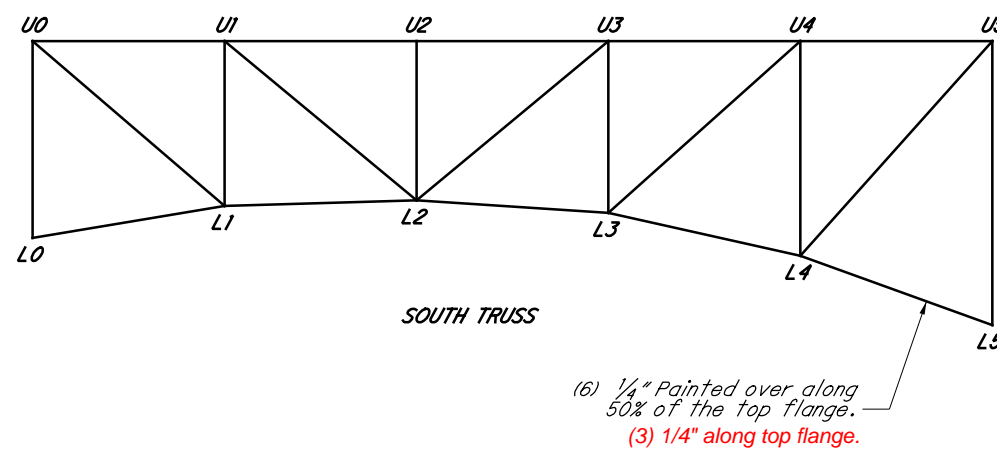
SOUTH TRUSS GUSSET PLATE DEFICIENCIES:

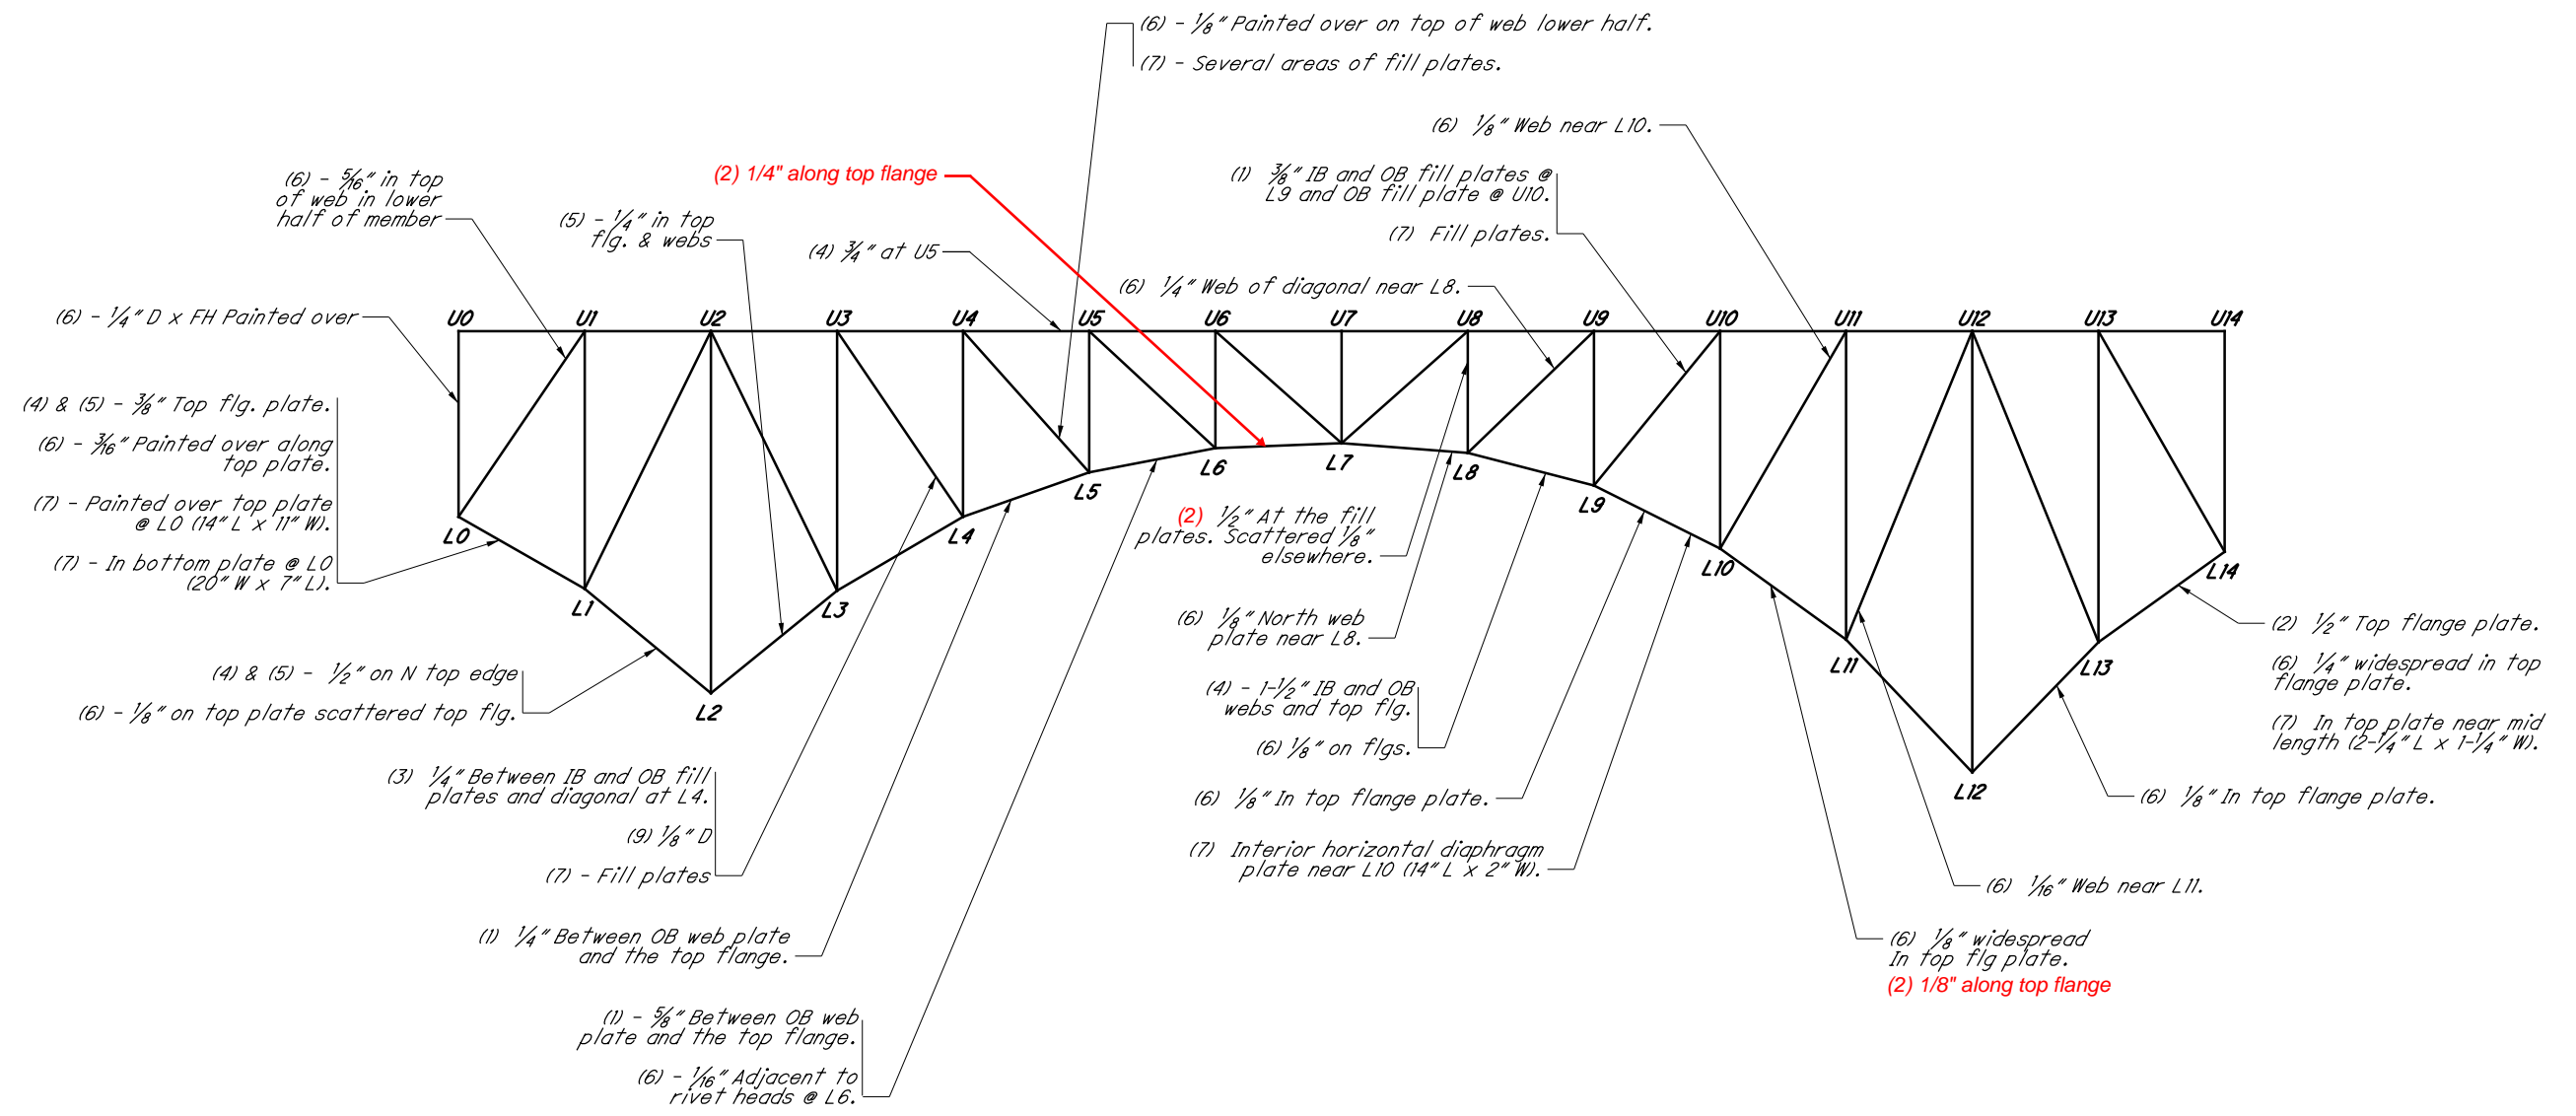
FLOORBEAM DEFICIENCIES:

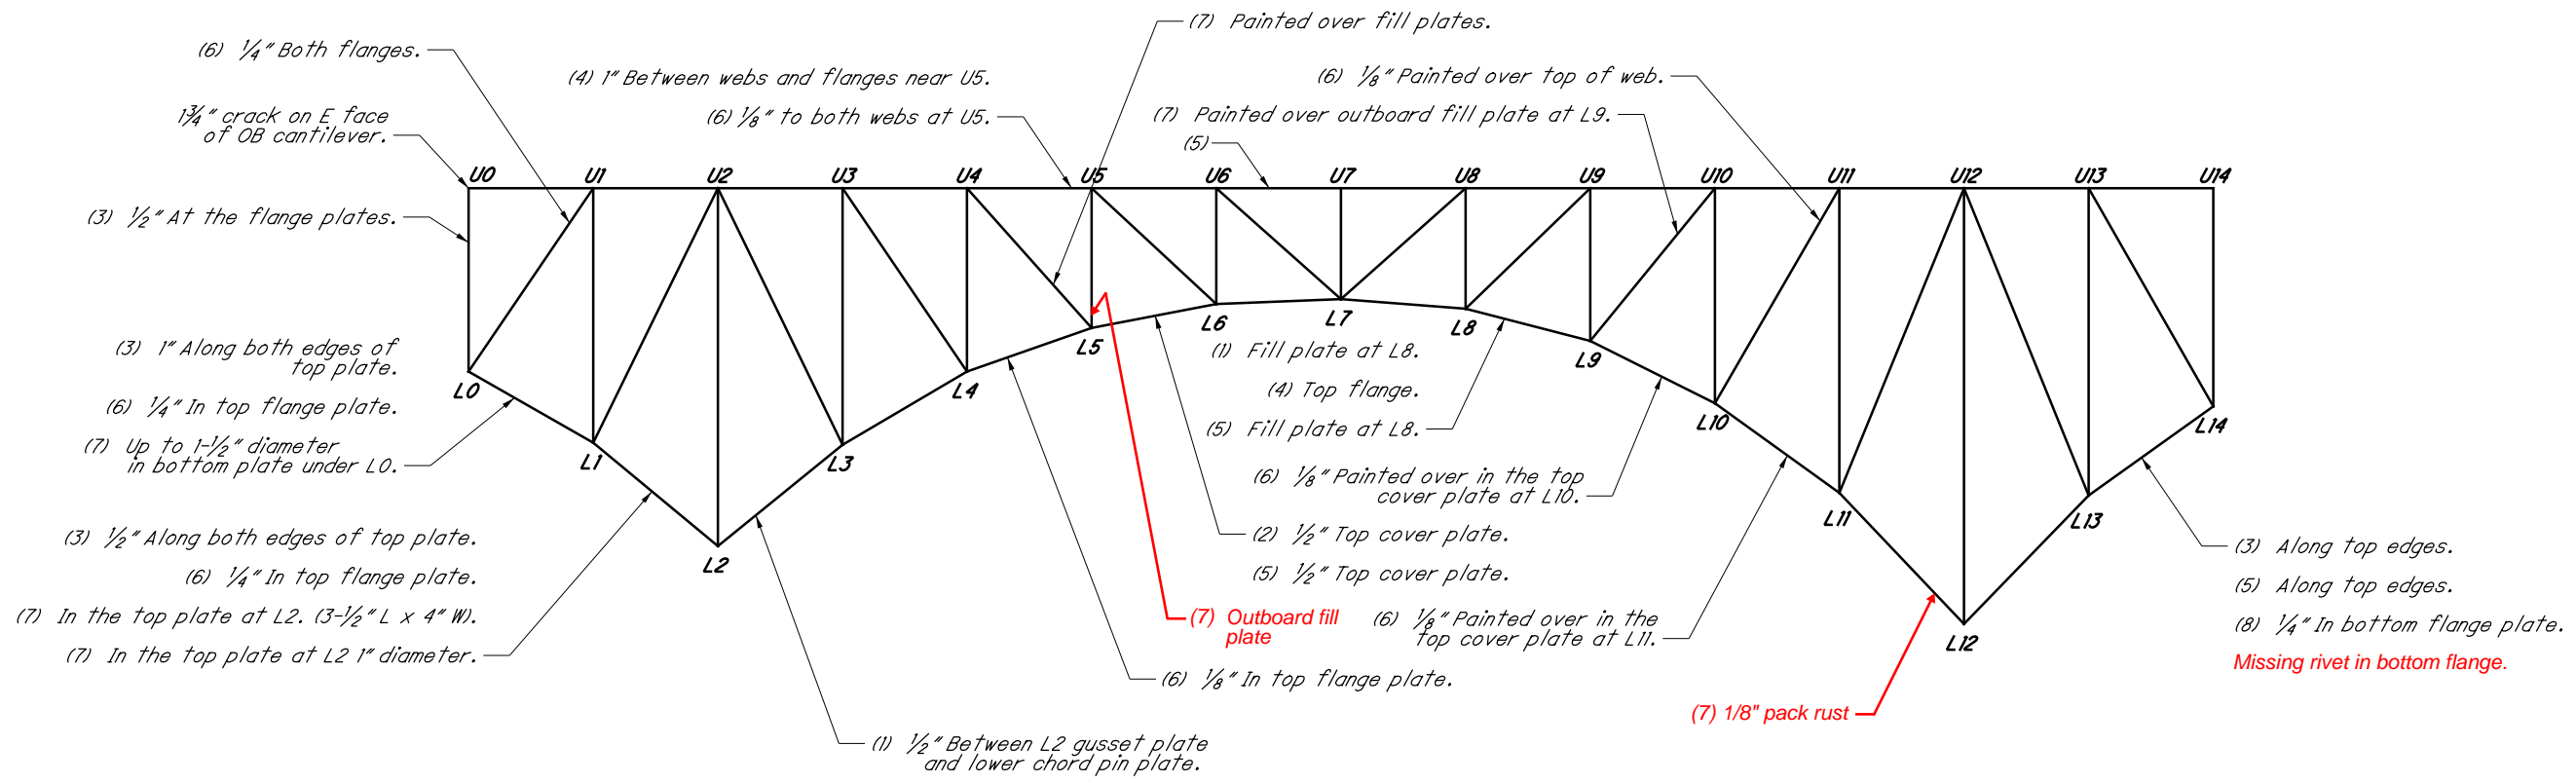
FLOORBEAM DEFICIENCIES:

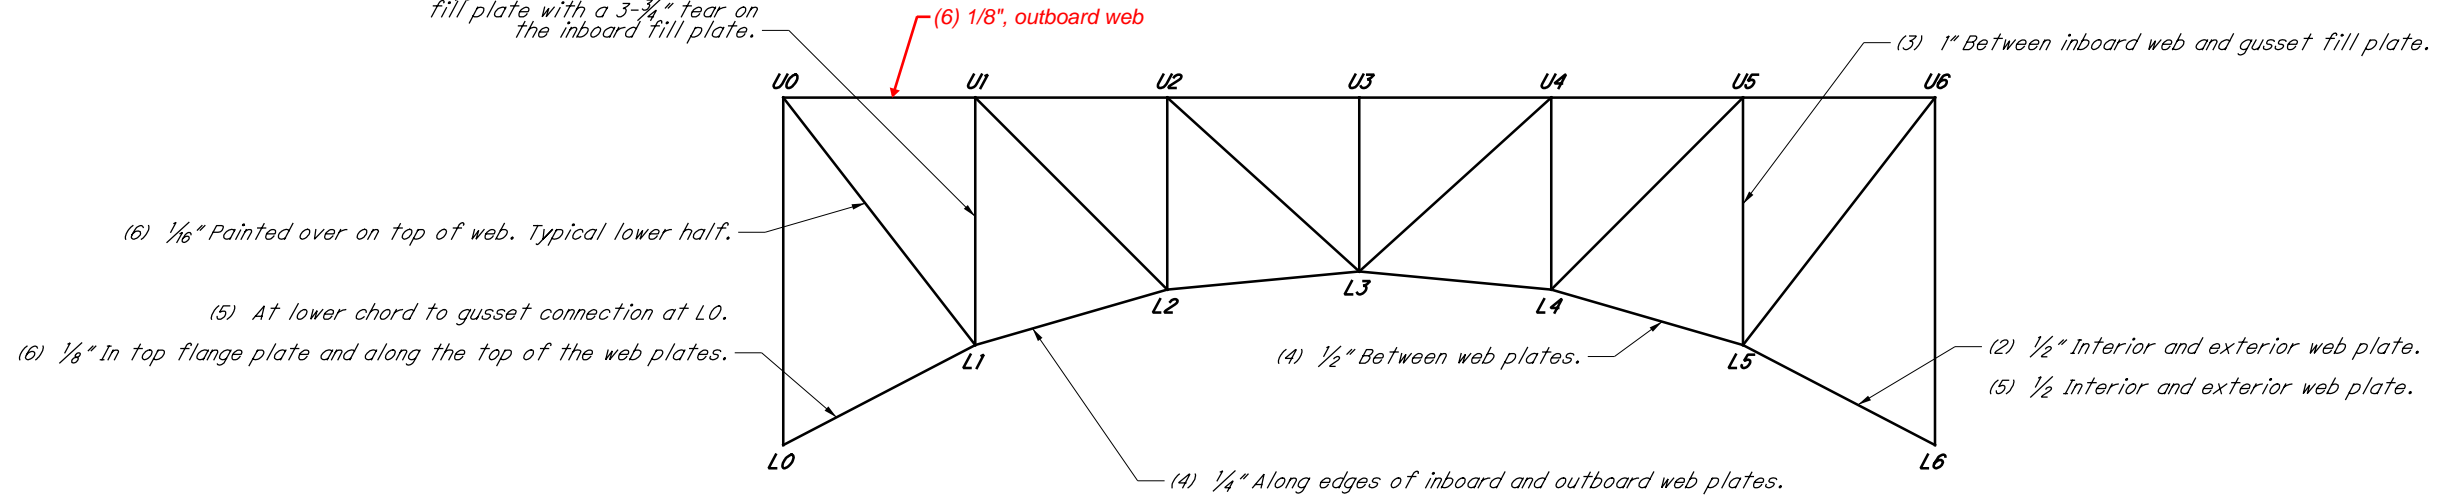
(3) 1- $\frac{5}{8}$ " On inboard and outboard fill plate with a 3- $\frac{3}{4}$ " tear on the inboard fill plate.

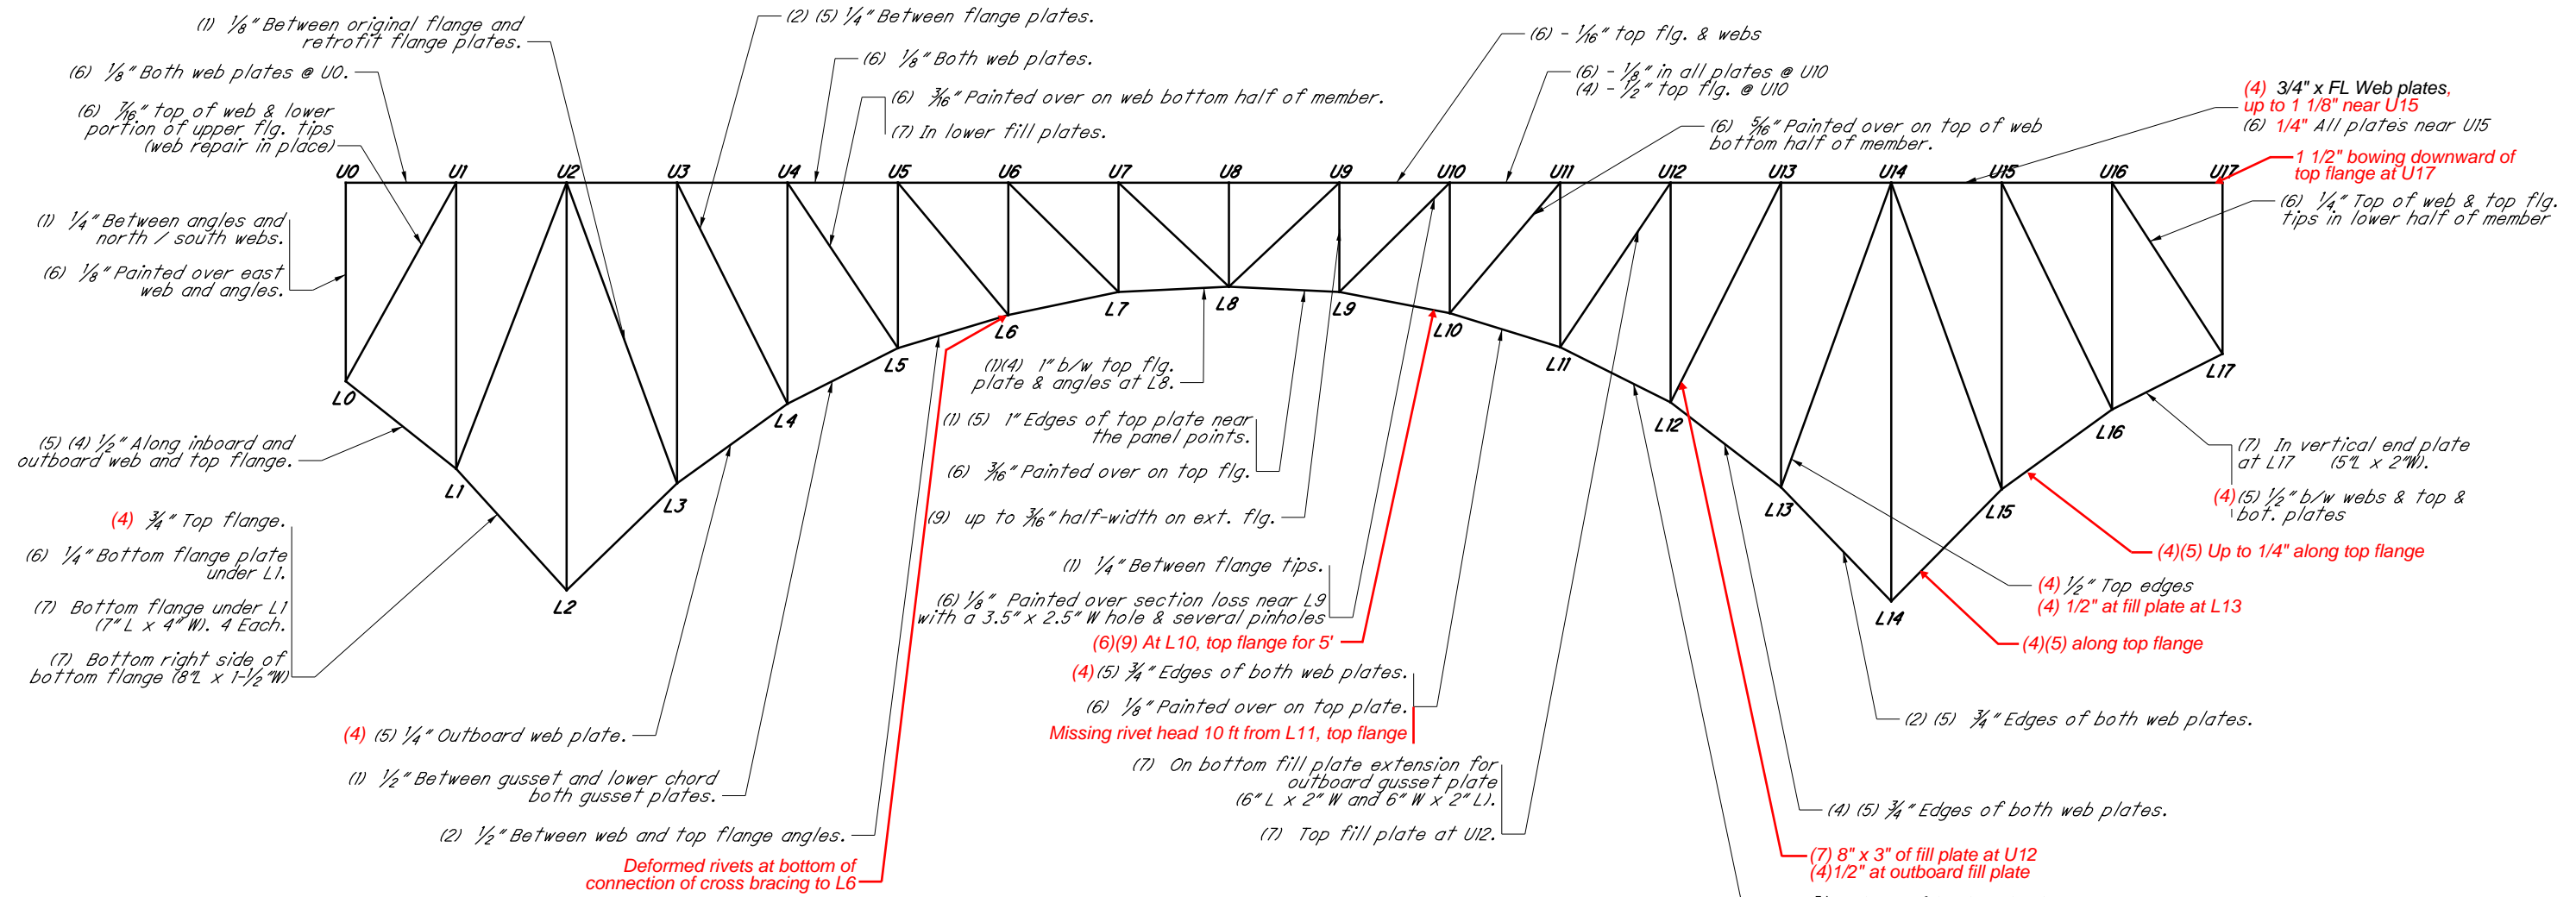
Floorbeam Deficiencies:

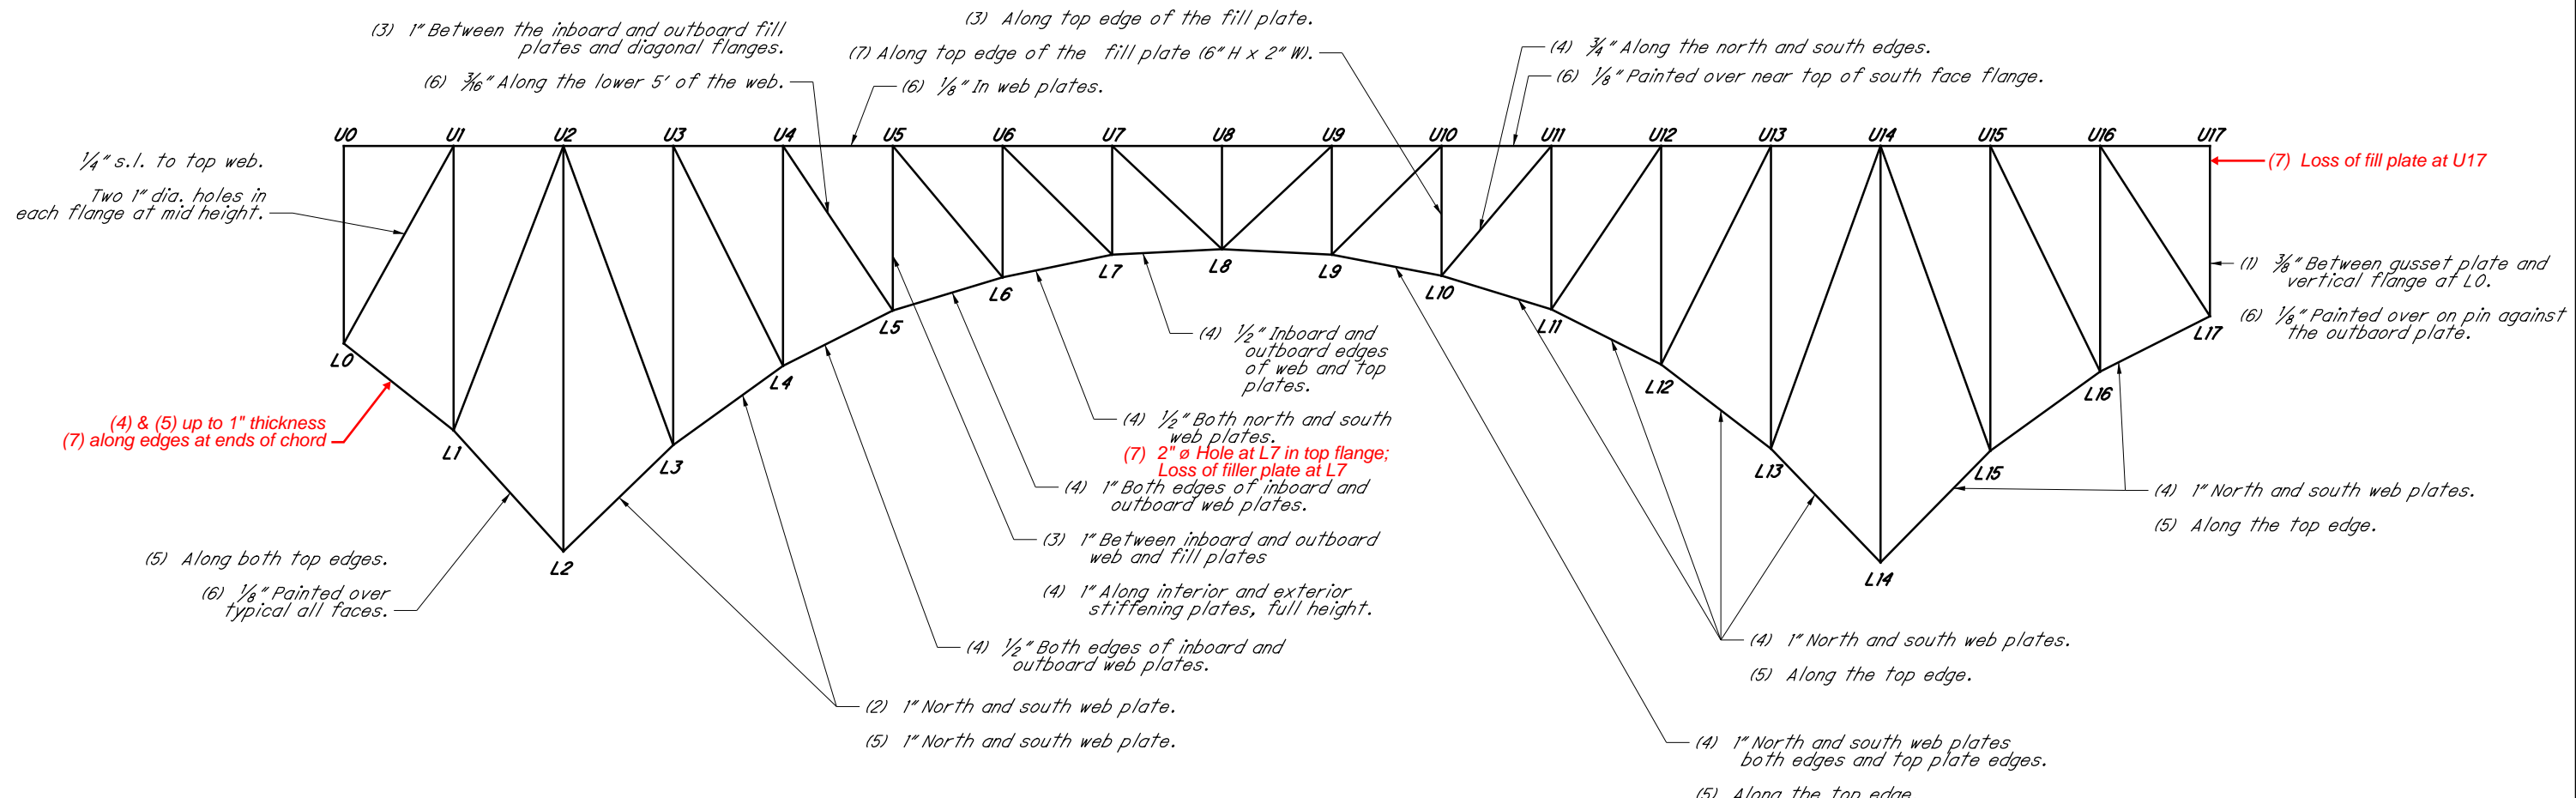
South Truss Gusset Plate Deficiencies:

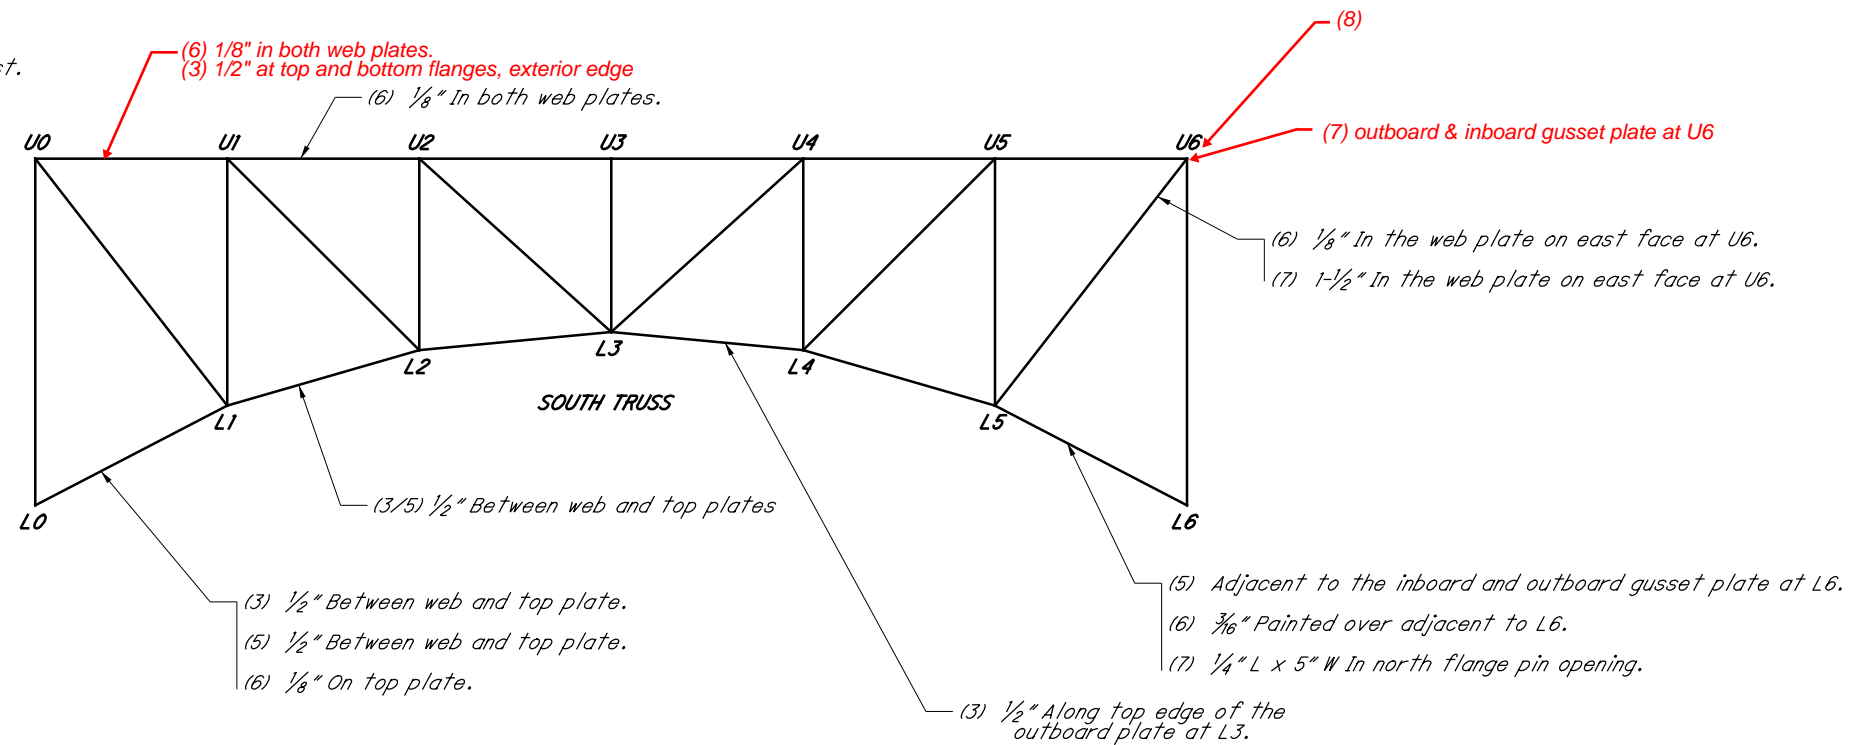
South Truss Gusset Plate Deficiencies:

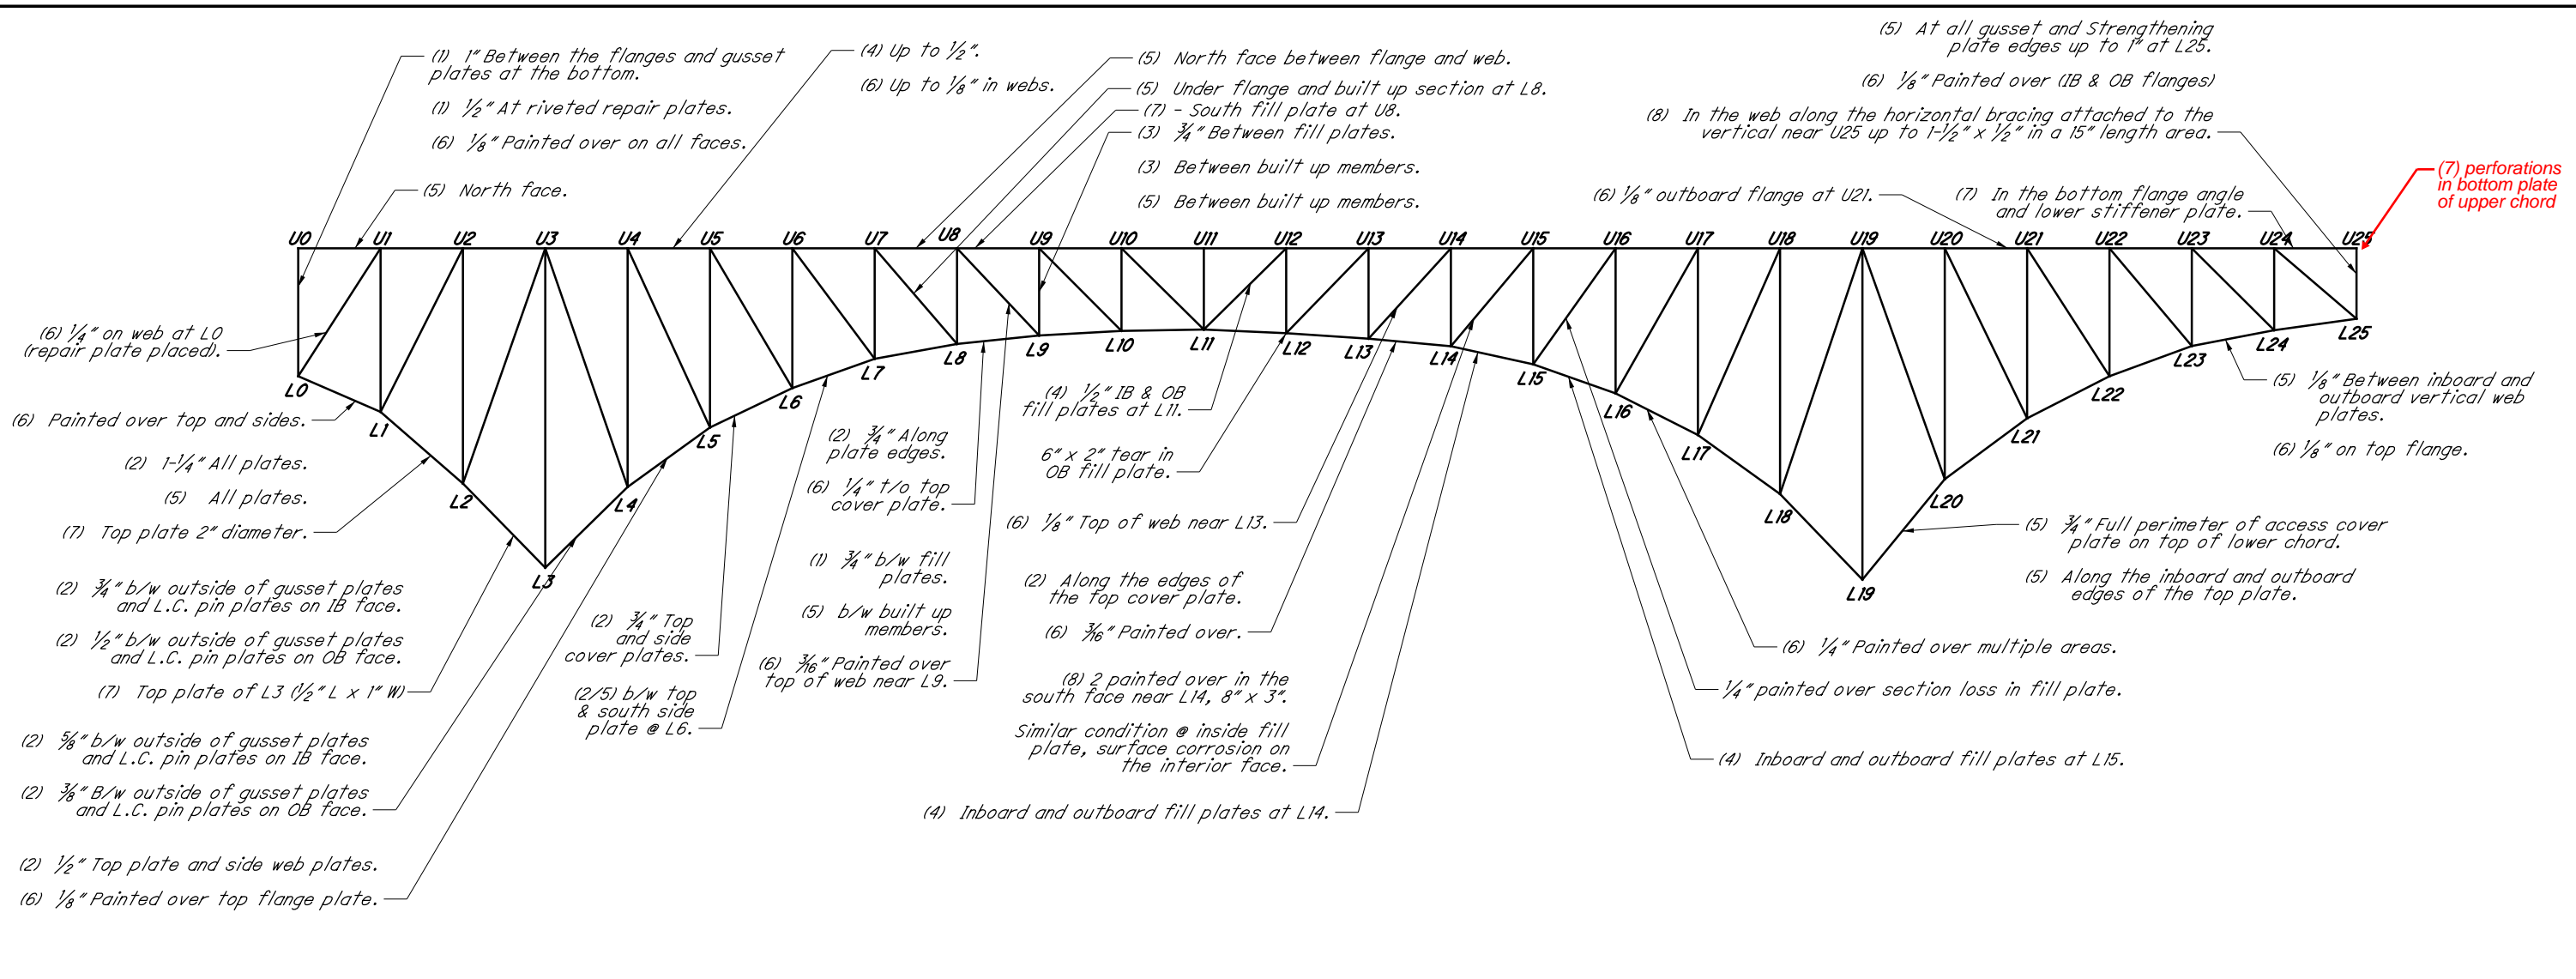
South Truss Gusset Plate Deficiencies:
