2023 ROUTINE AND FRACTURE CRITICAL INSPECTION REPORT

Bridge CUY-02-1441

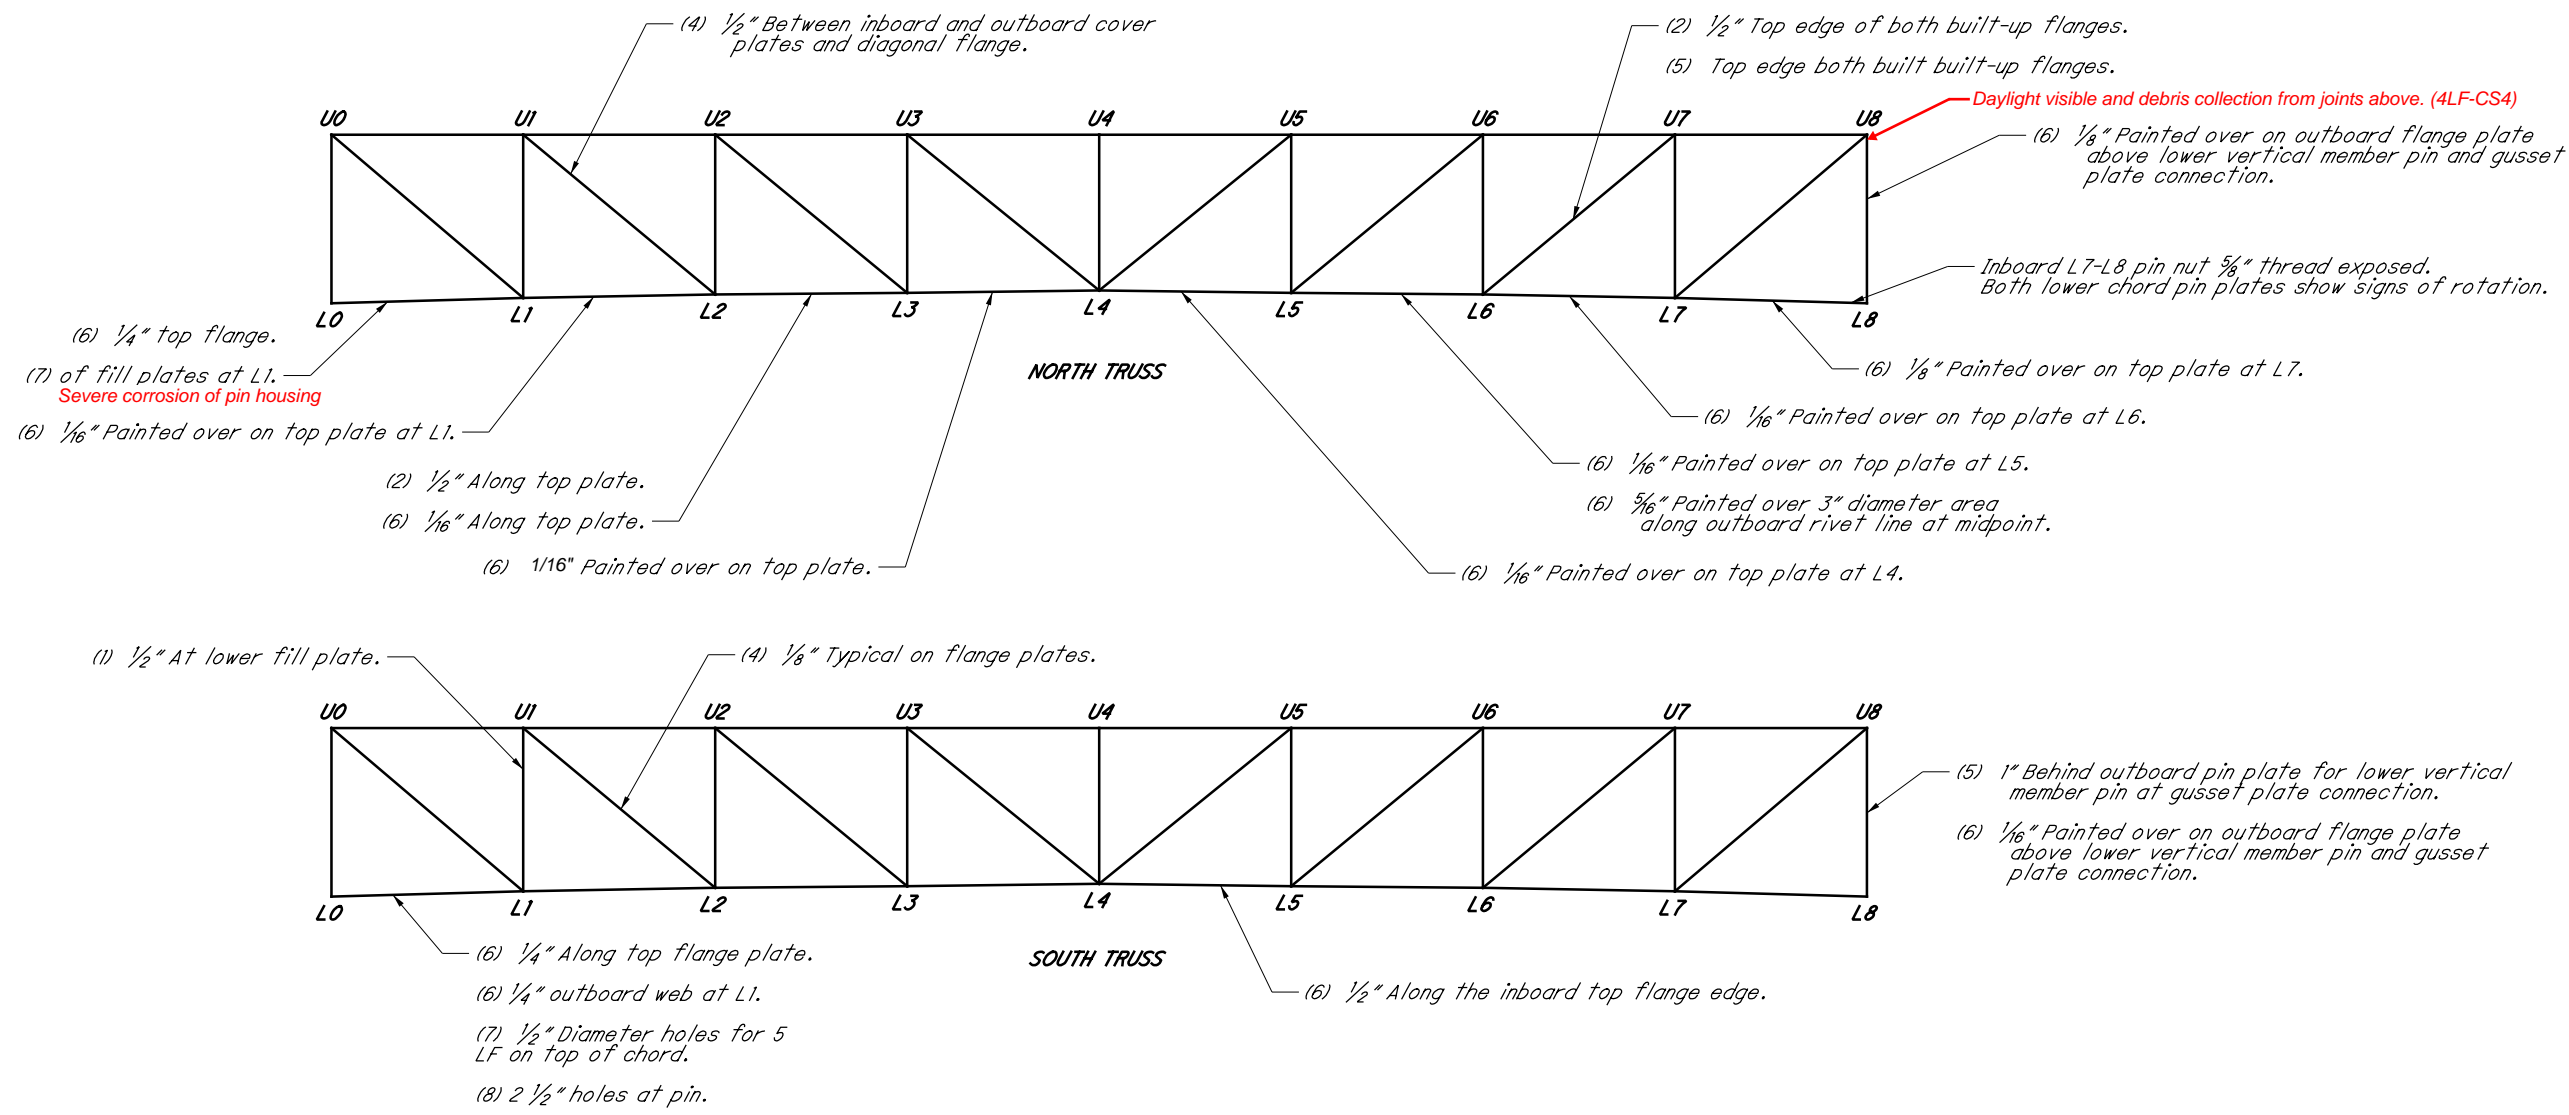
North Truss Gusset Plate Deficiencies:

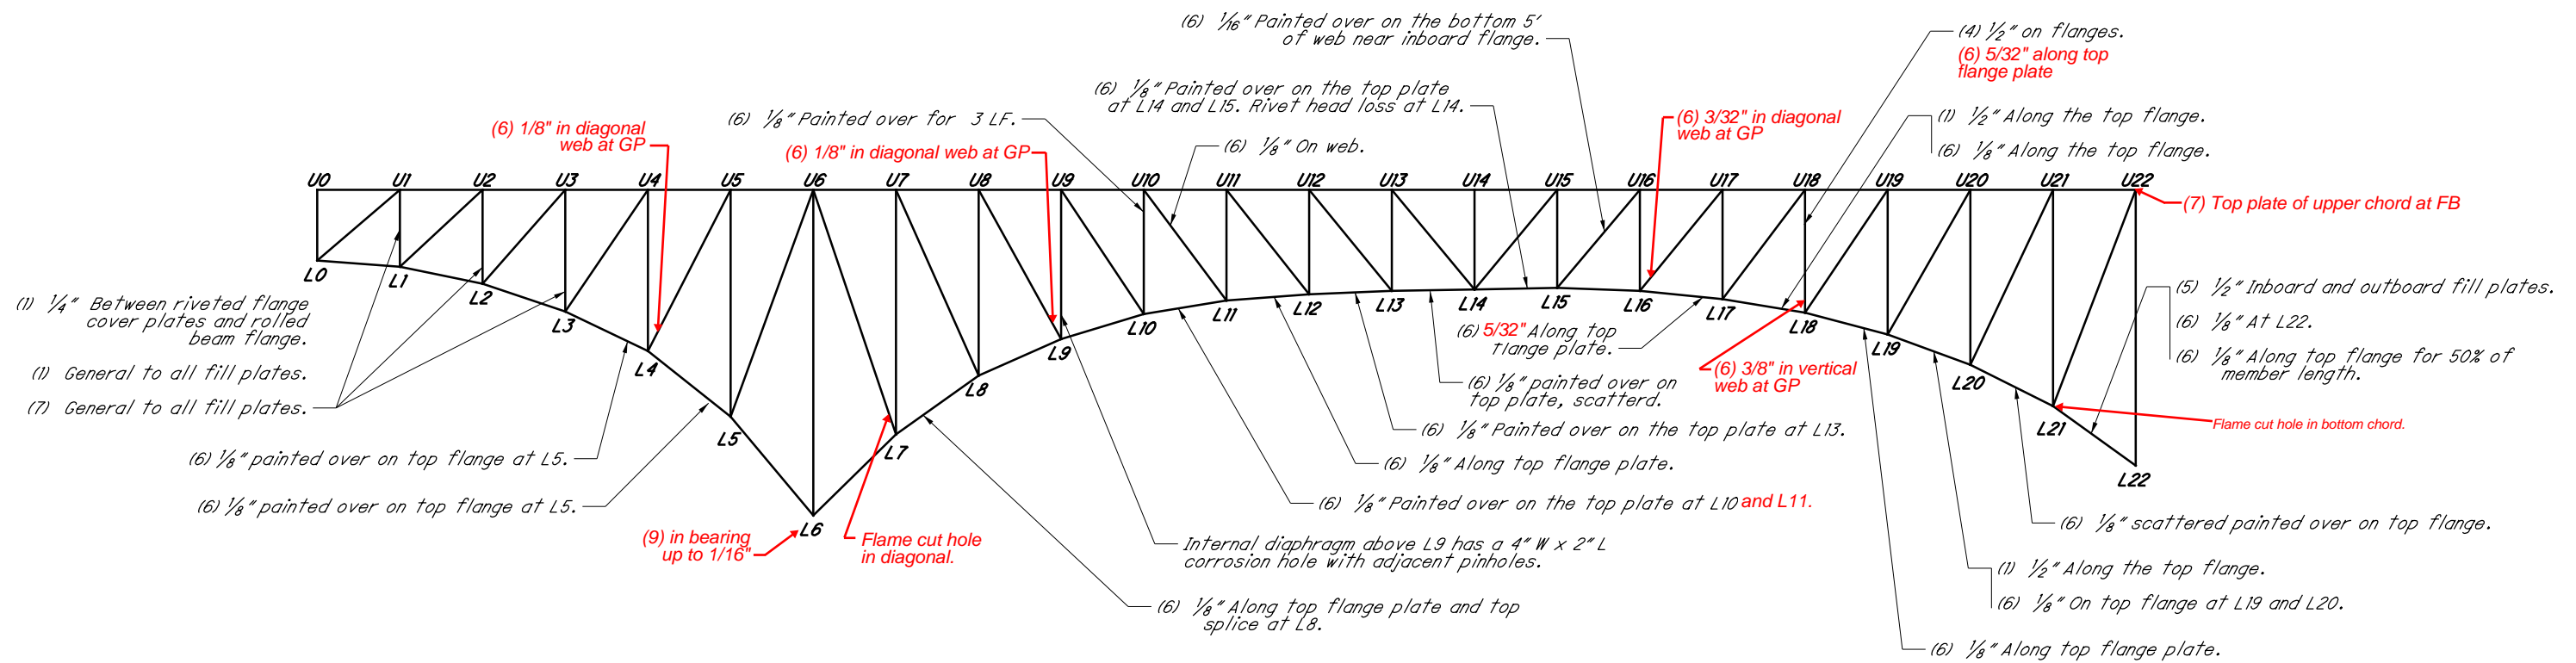
North Truss Gusset Plate Deficiencies:

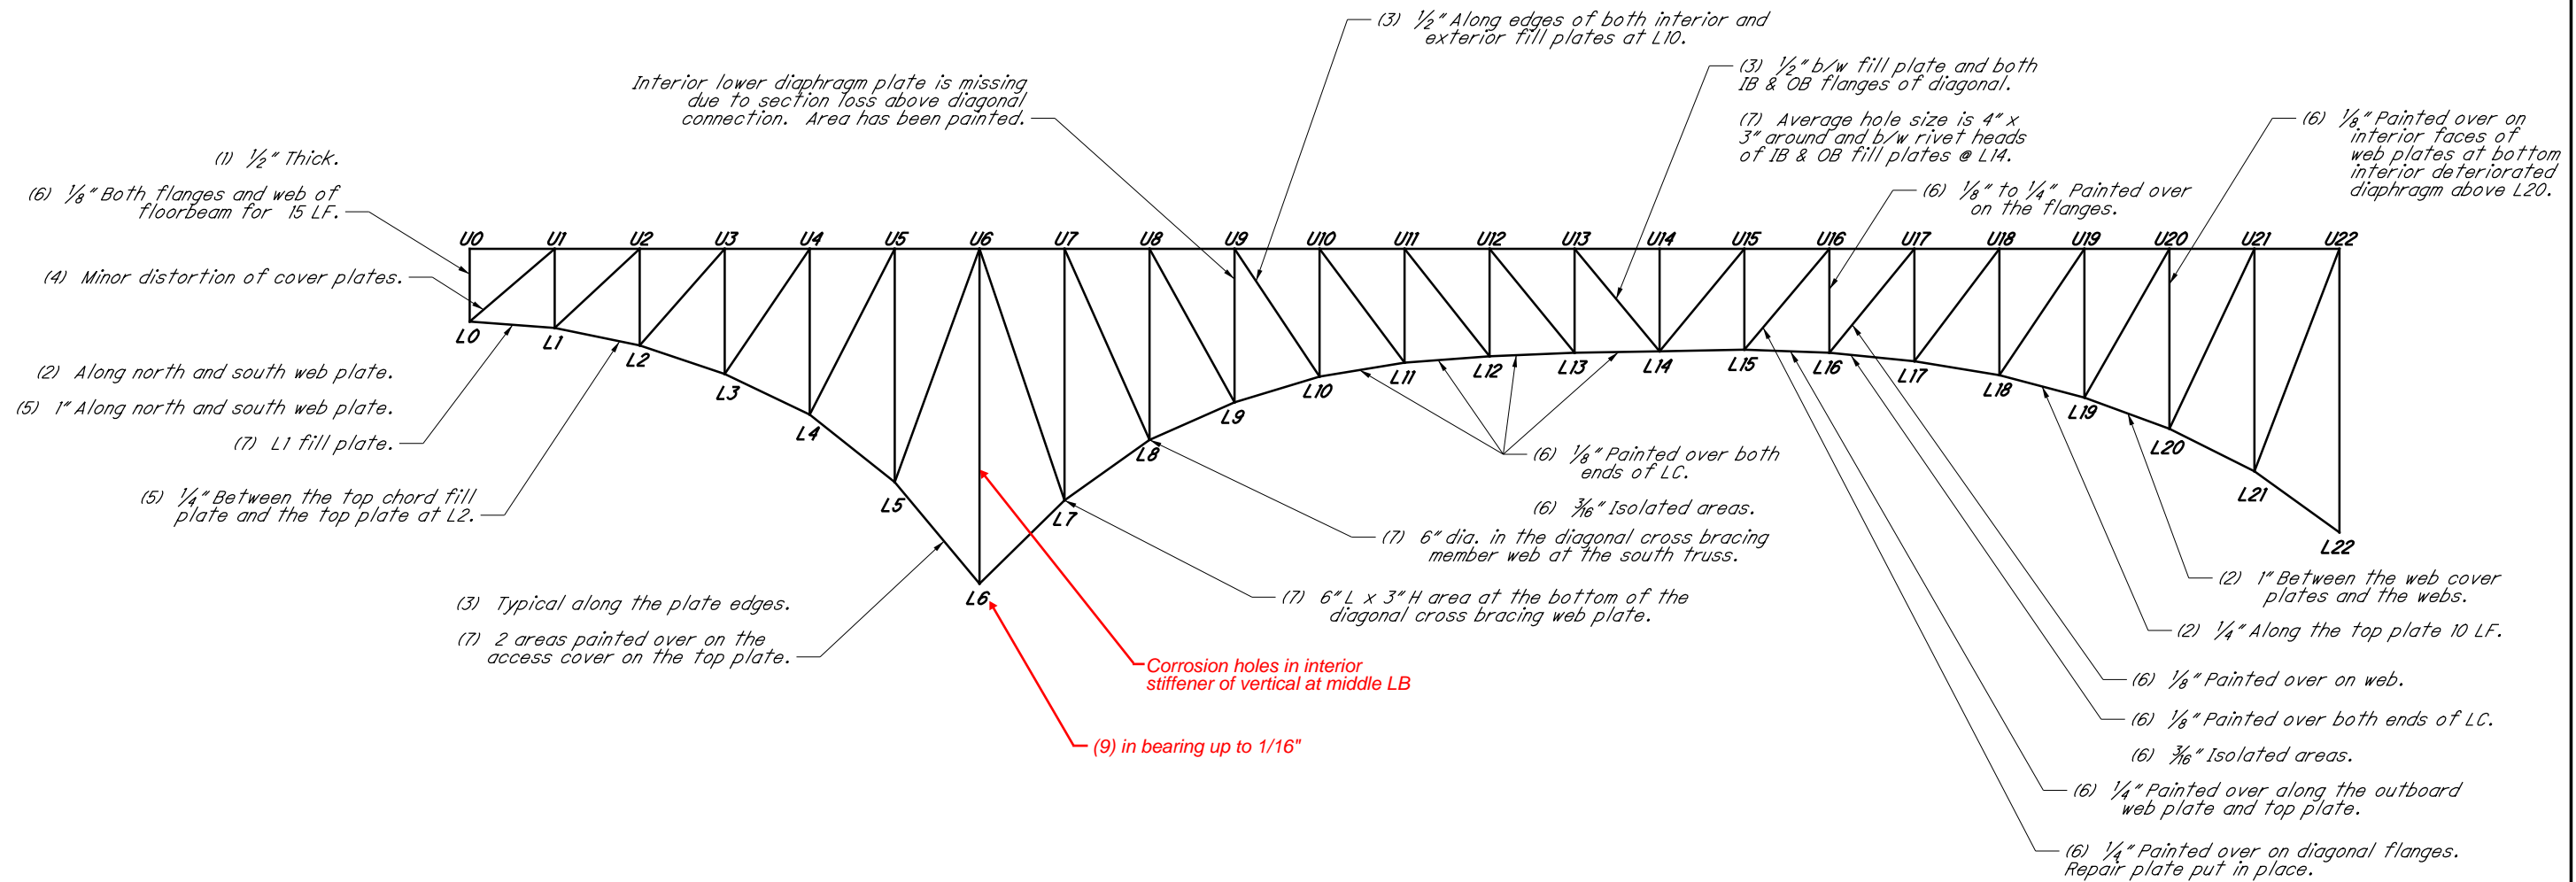
Floorbeam Deficiencies:

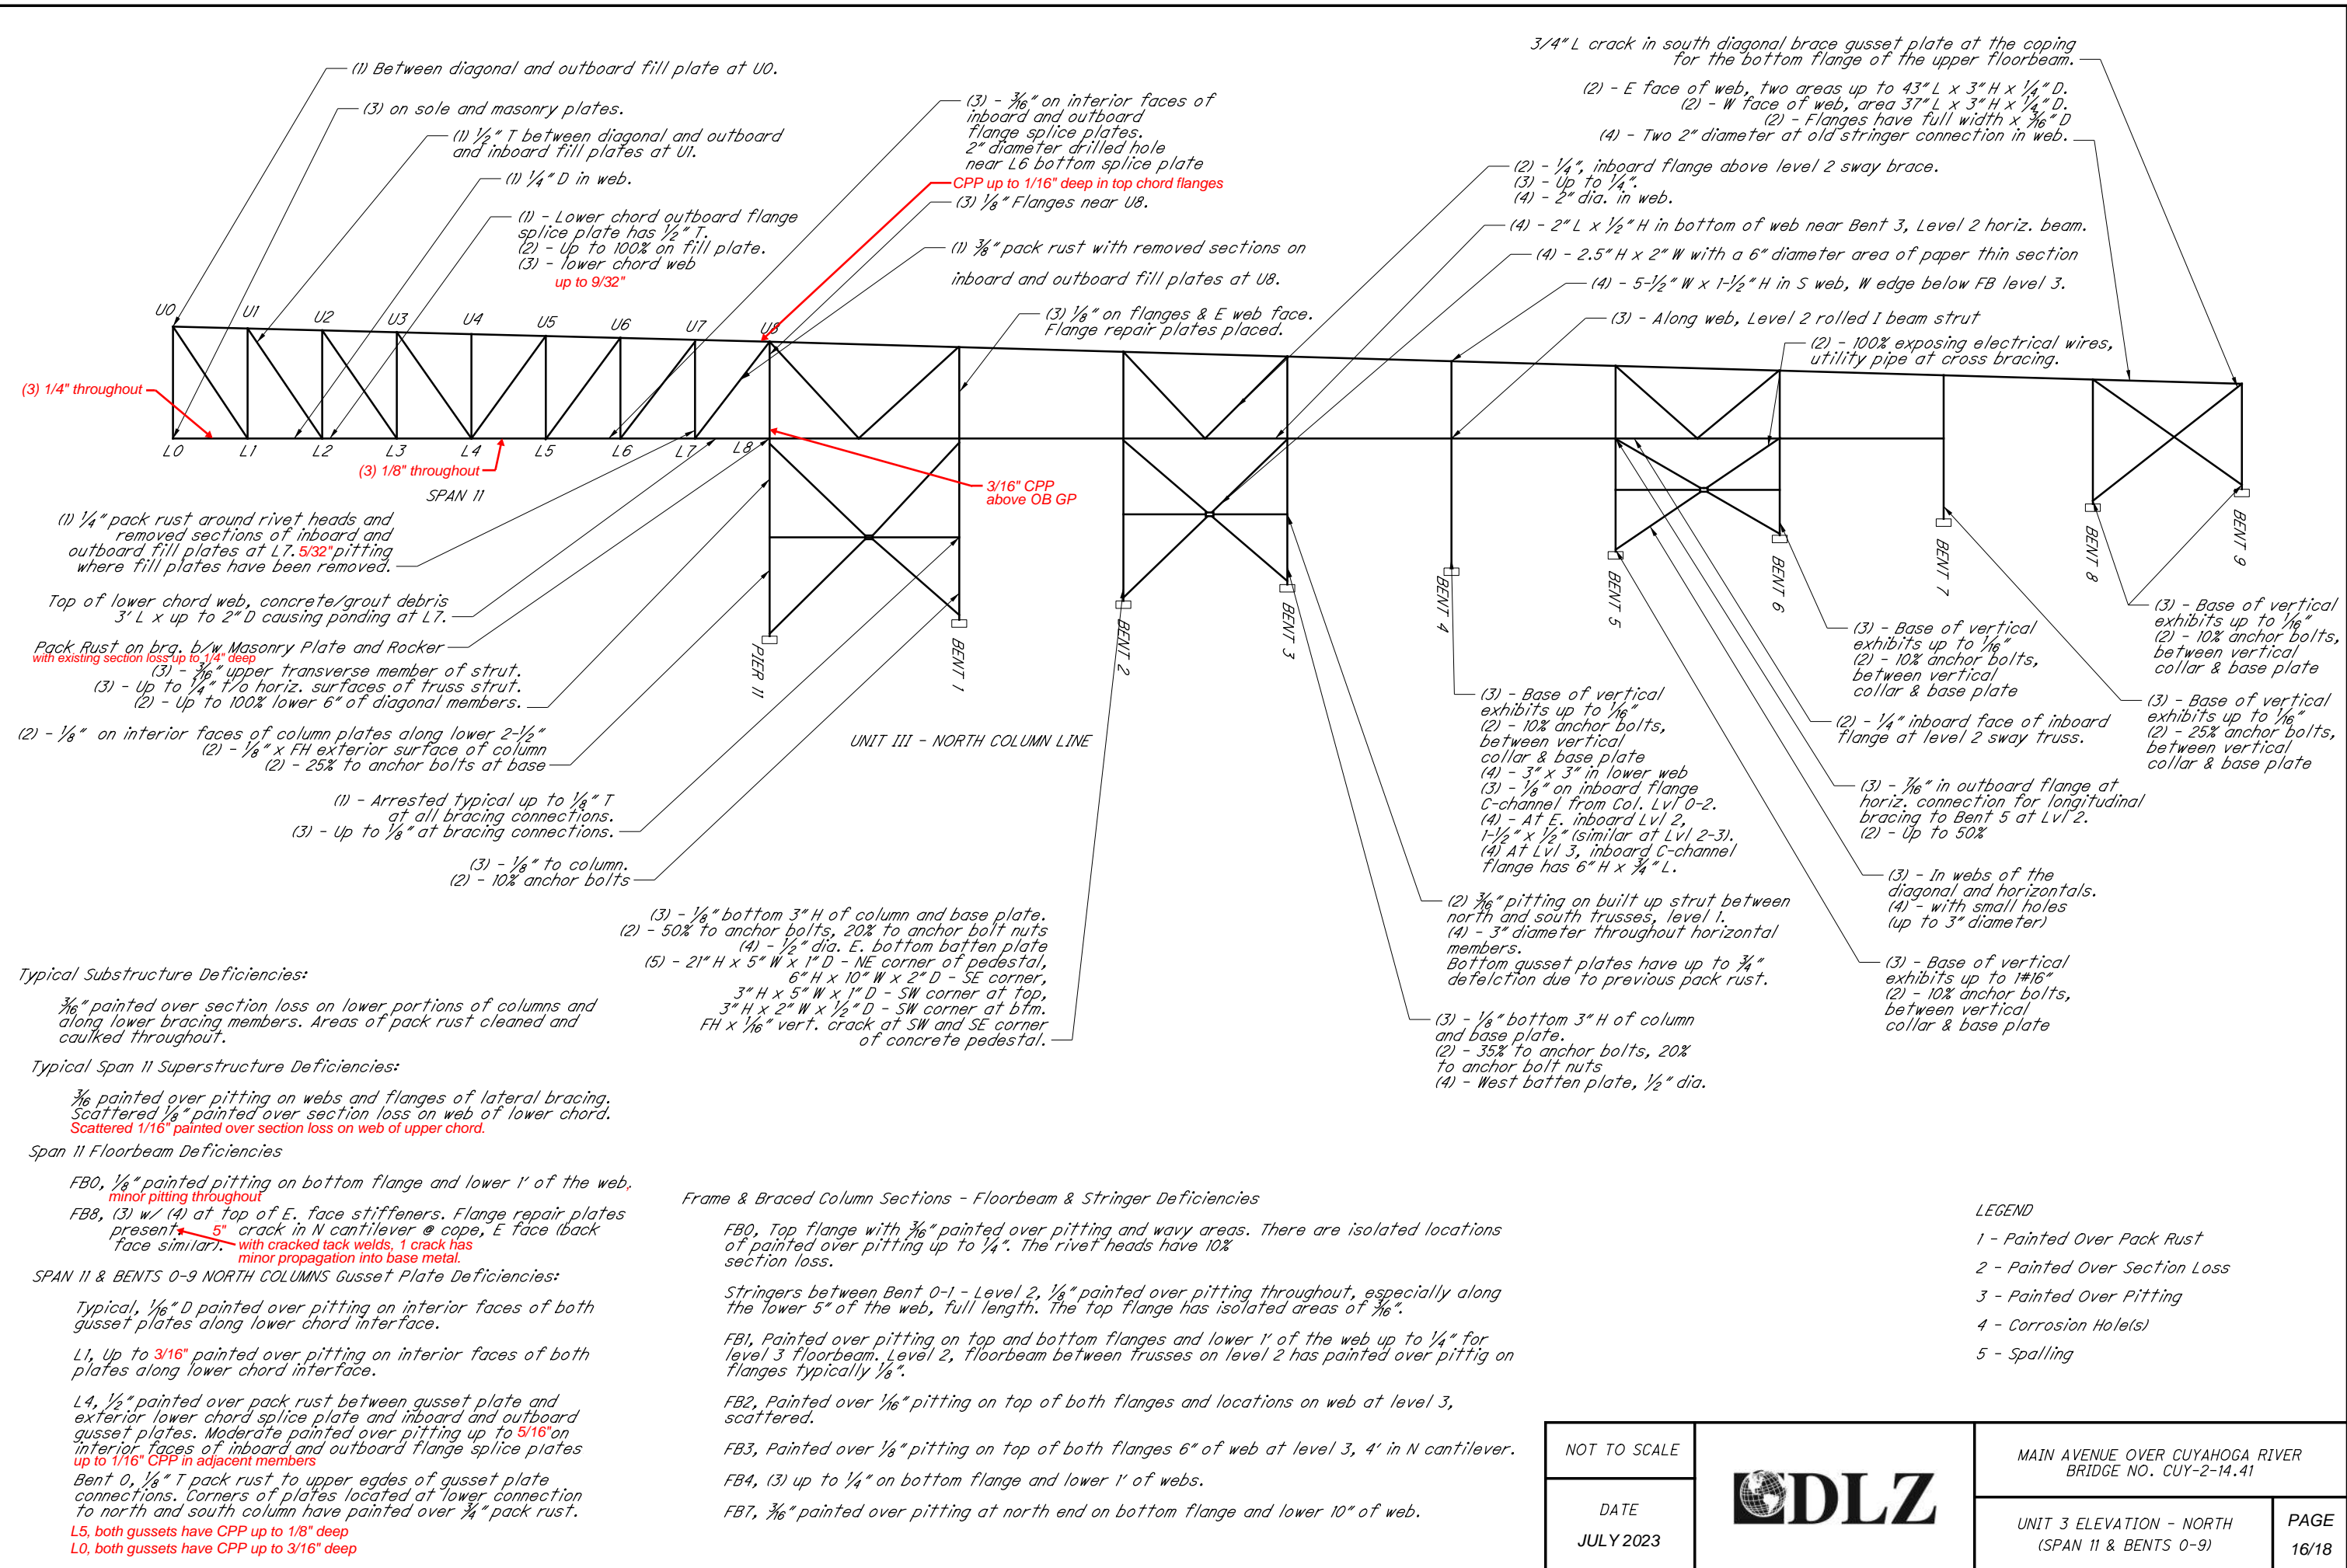
Typical Substructure Deficiencies:

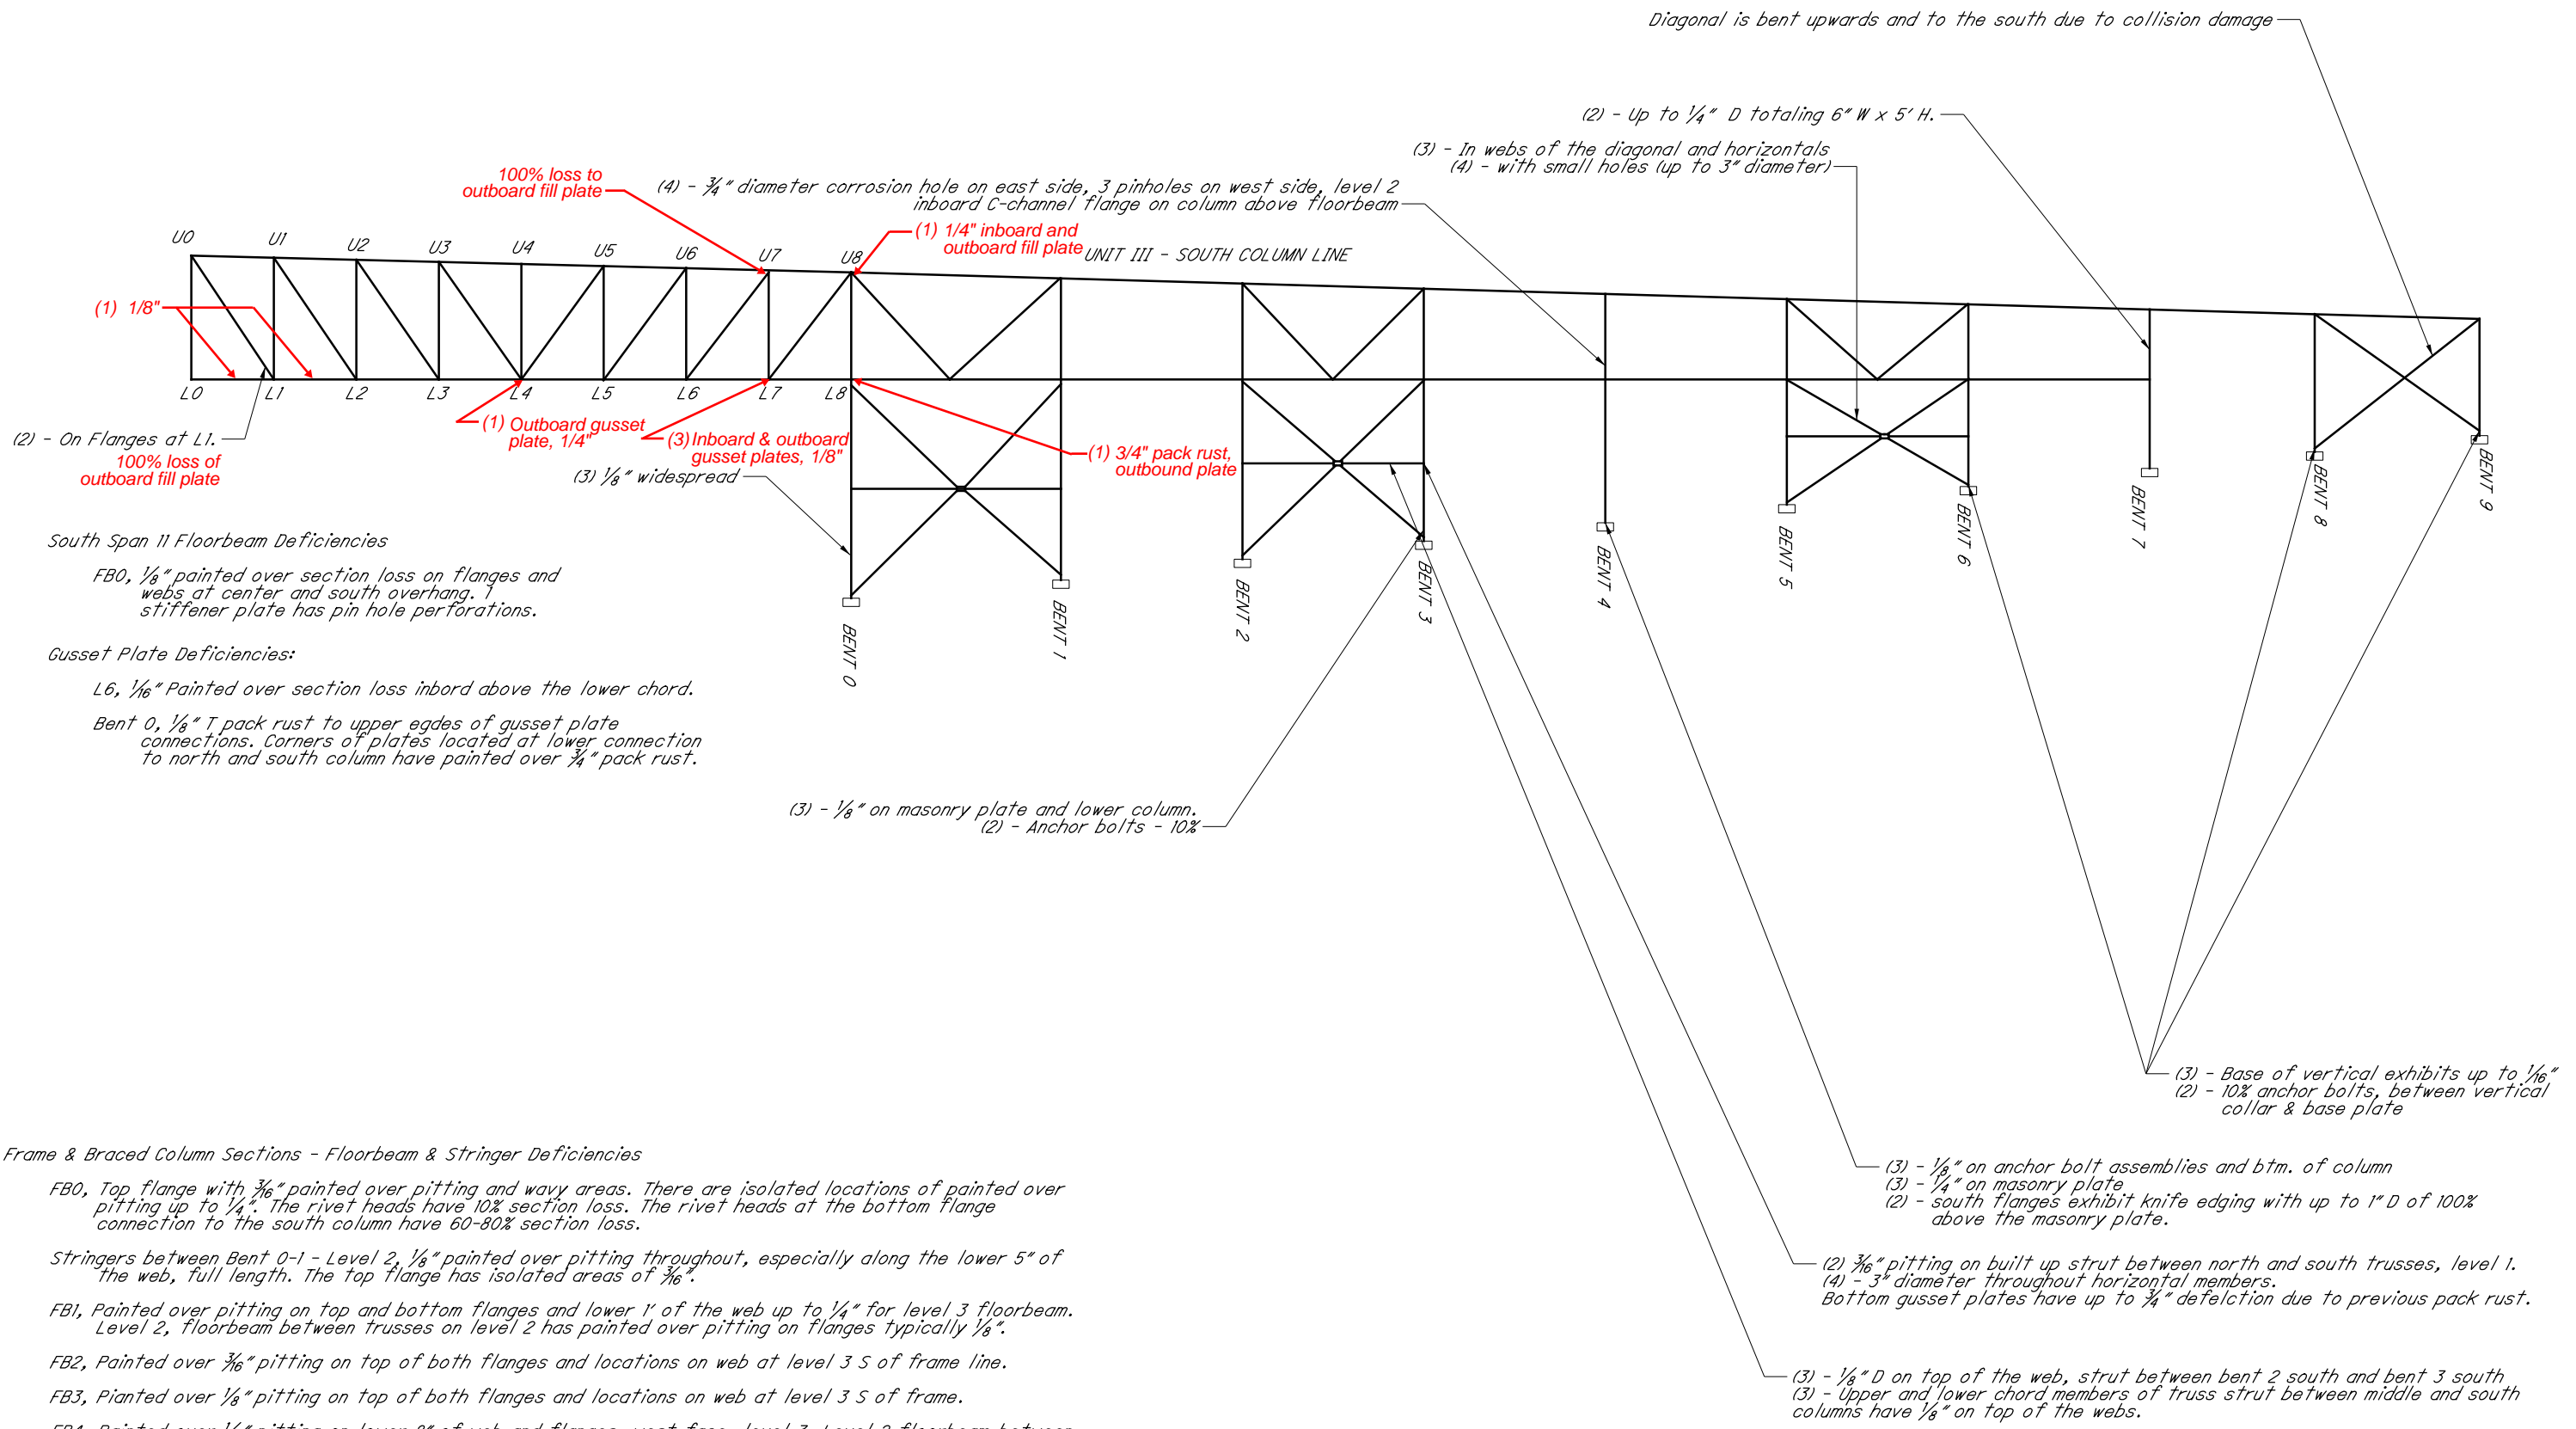
South Span II Floorbeam Deficiencies

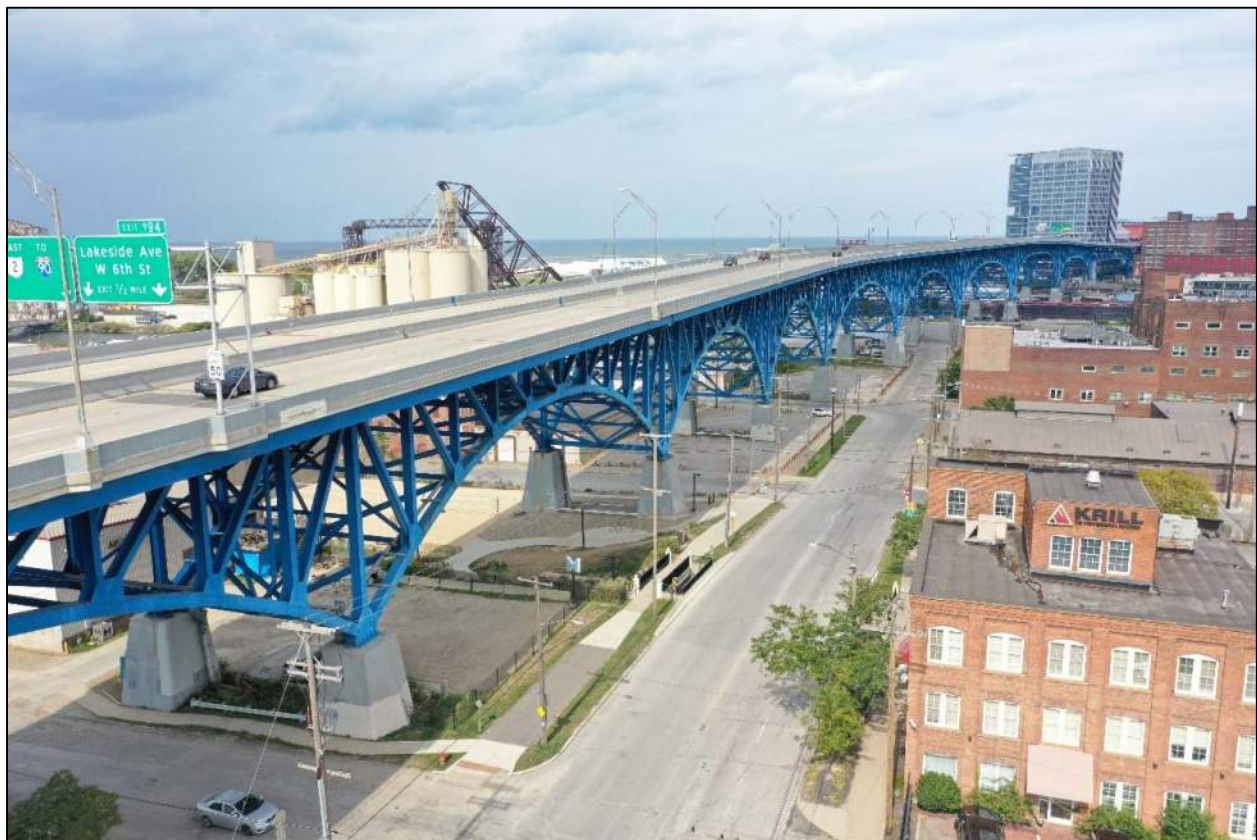
Figure 1: CUY-10-1613 over the Cuyahoga River

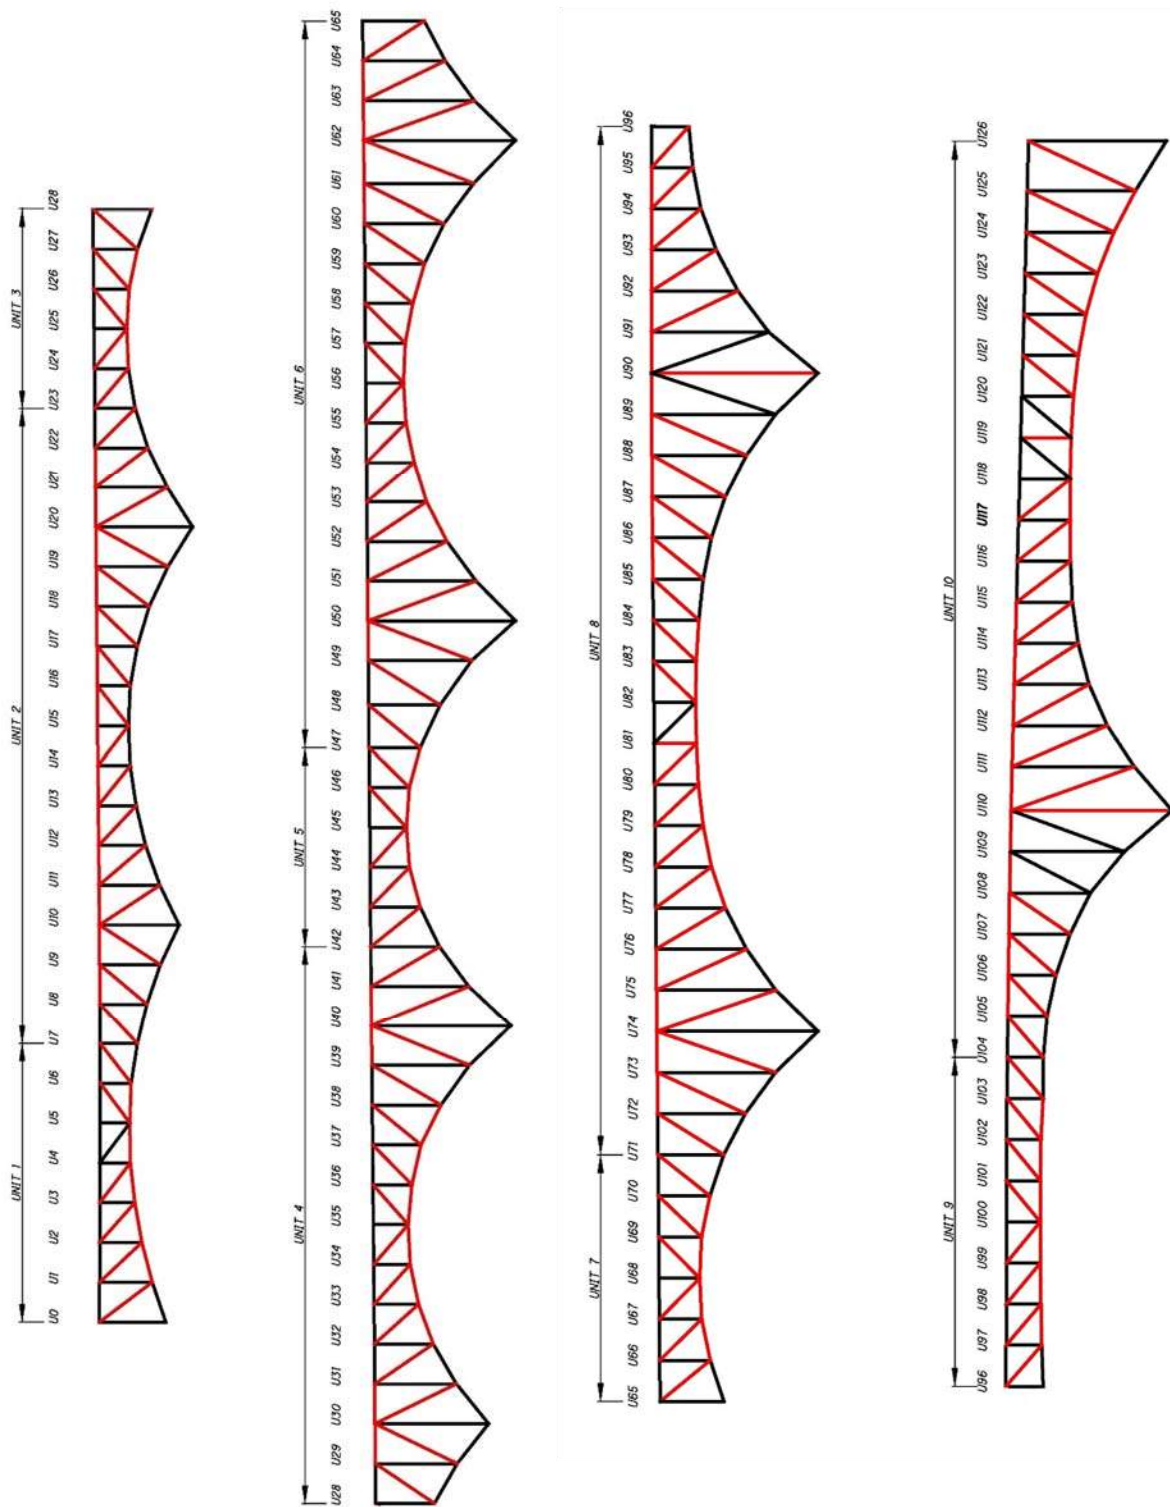
Figure 3: Main Truss Spans Fracture Critical Member Locations (Highlighted Red)

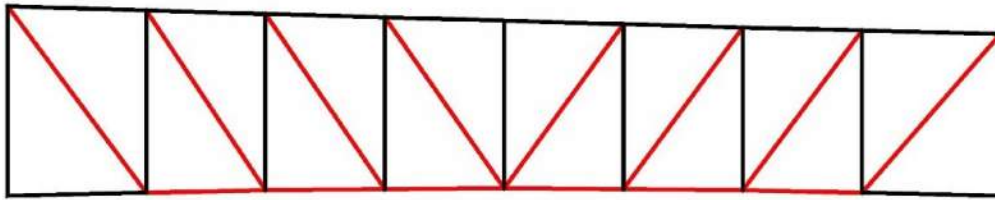
Figure 4: Span 11 Fracture Critical Member Locations (Highlighted Red)

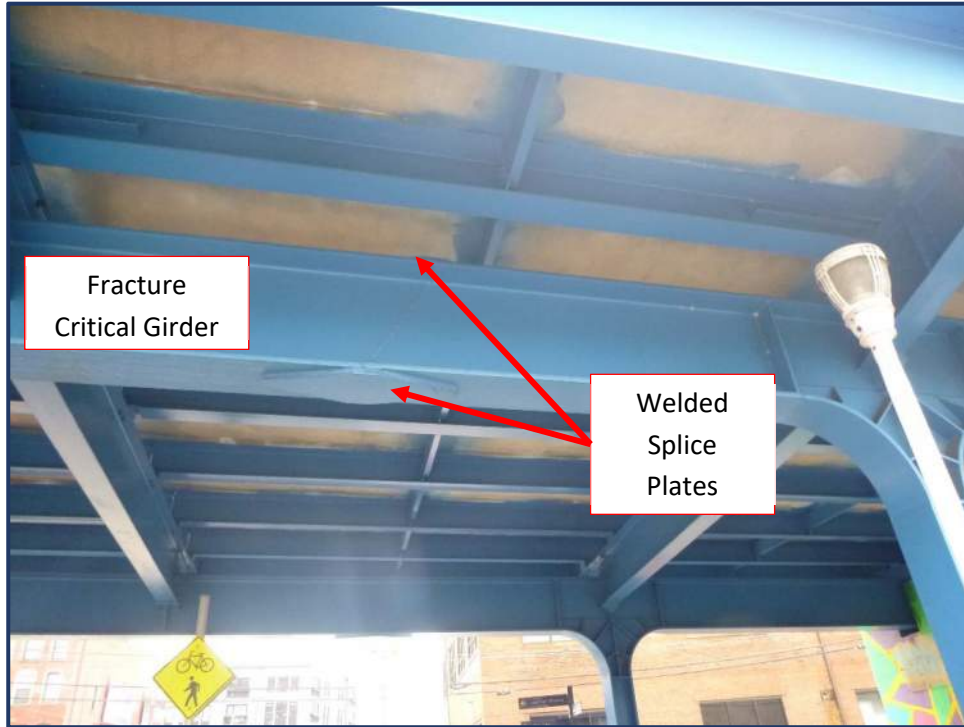
Photo 1 – Welded Cover Plates at Girders in Unit I

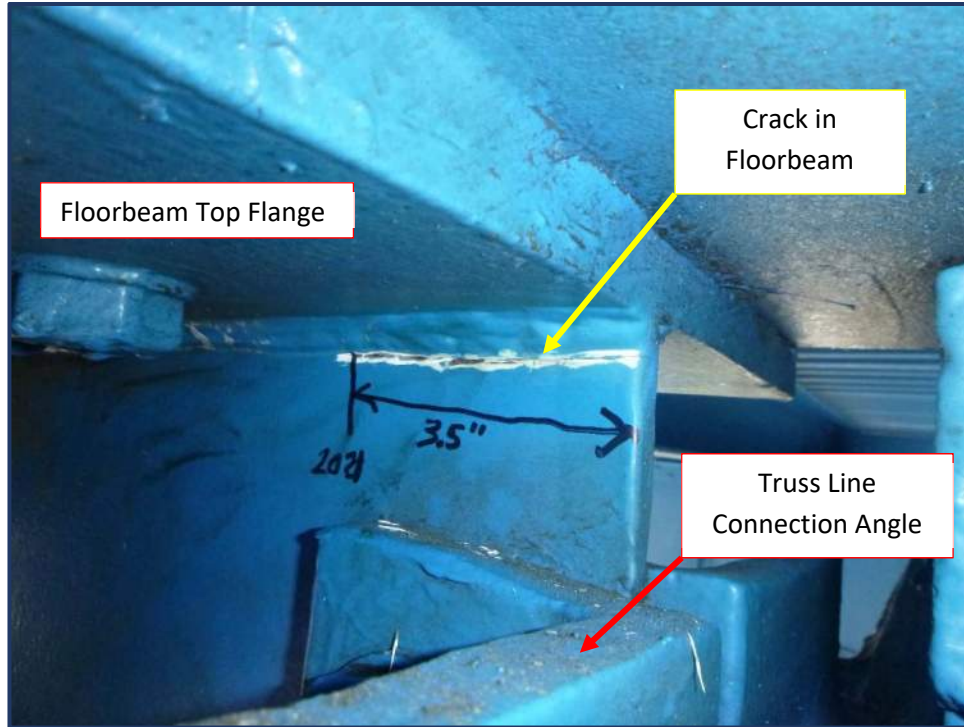
Photo 3 – Cracks in Unit II Floorbeam Web at Top Flange, at Truss Lines

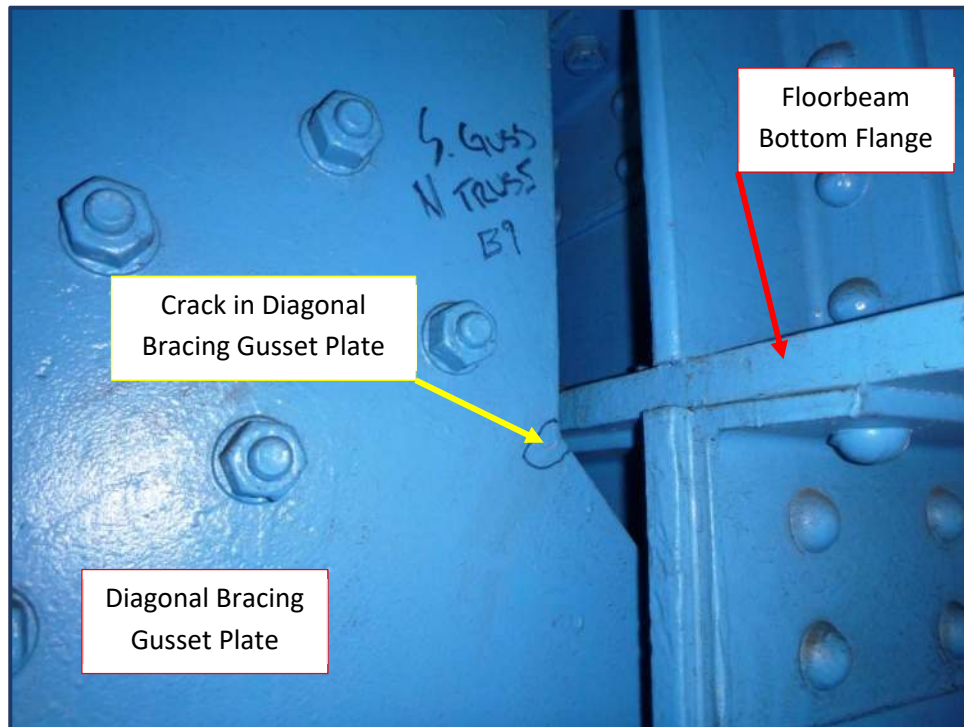
Photo 4 – Crack in Diagonal Bracing Gusset Plate, Unit III, Floorbeam 9, North Column
