# Ohio Department of Transportation

## Fracture Critical Member and Fatigue Prone Connection Identification Plan

District: 12  
County-Route-SLM: CUY-002-1441  
Structural File Number: 1800035

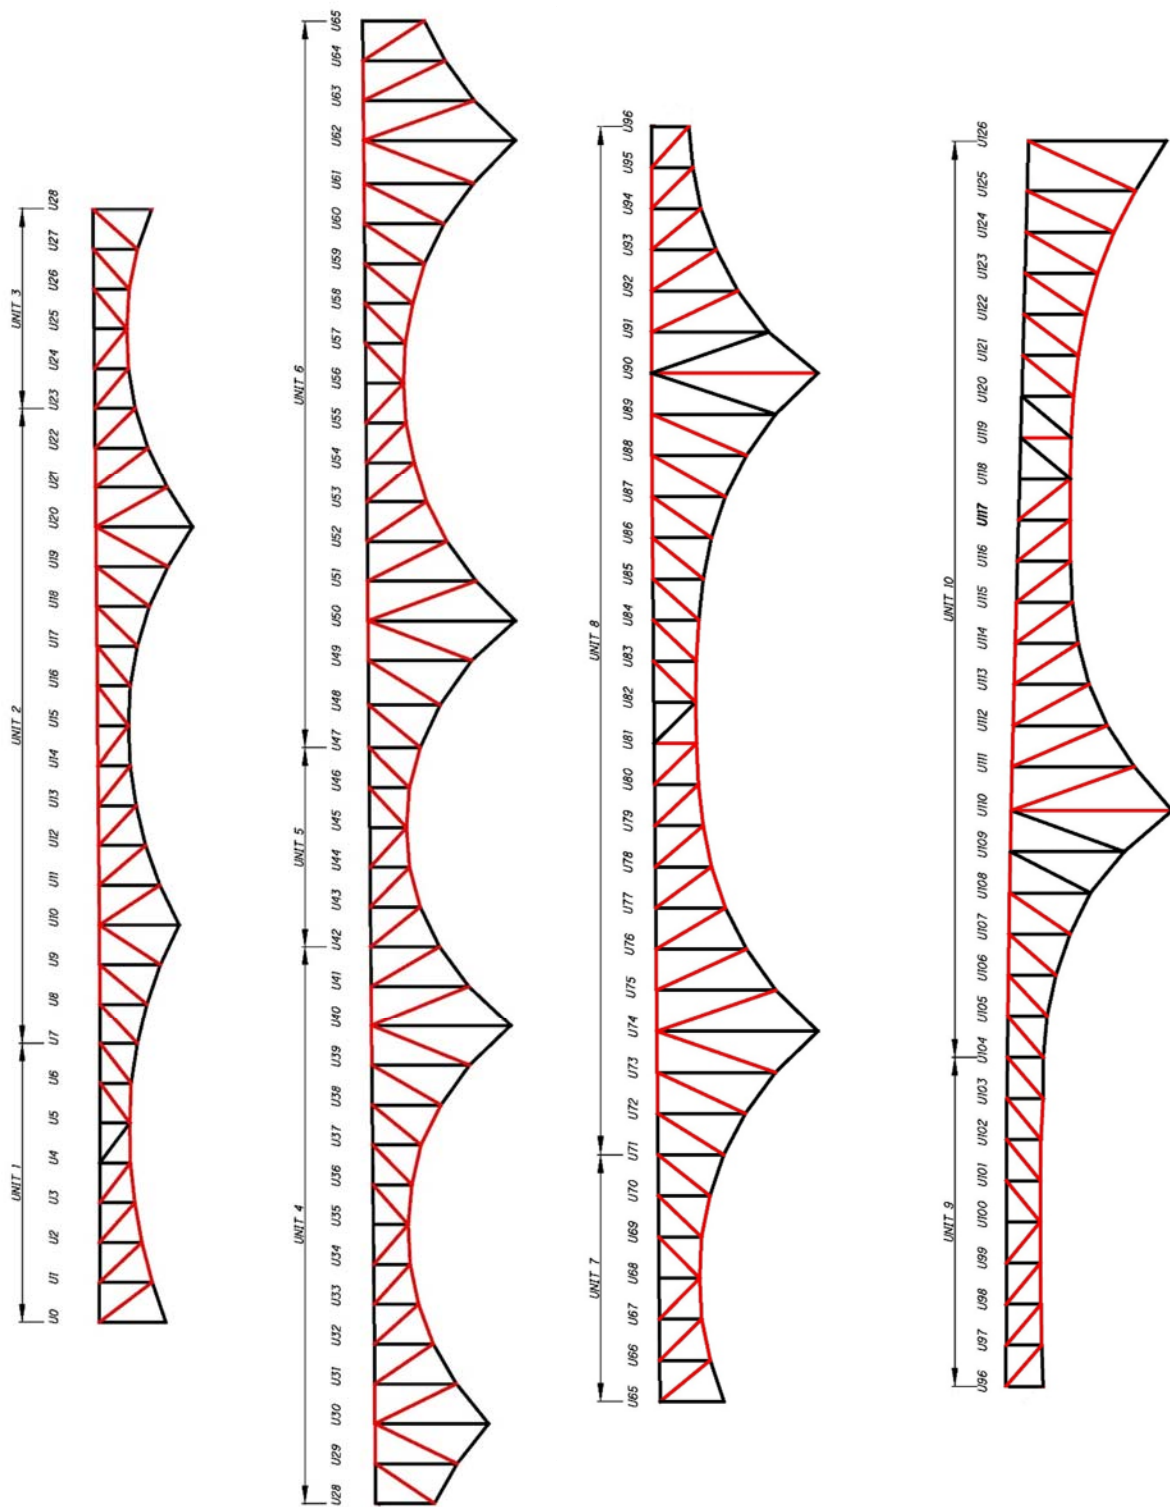
**Figure 3:** Main Truss Spans Fracture Critical Member Locations (Highlighted Red)

*Fracture critical members:* All floorbeams and select truss chords, diagonals, pins and gusset plates. See *Figure 3* for locations of fracture critical truss chords and diagonals.

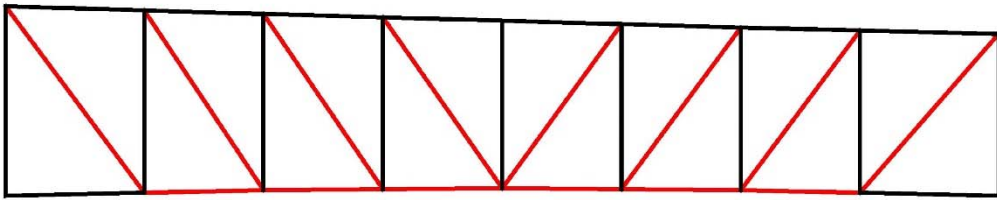
**Figure 4:** Span 11 Fracture Critical Member Locations (Highlighted Red)

*Fracture critical members:* All upper deck floorbeams; Select truss chords, diagonals and gusset plates in Span 11. See *Figure 4* for locations of fracture critical truss chords and diagonals in Span 11.

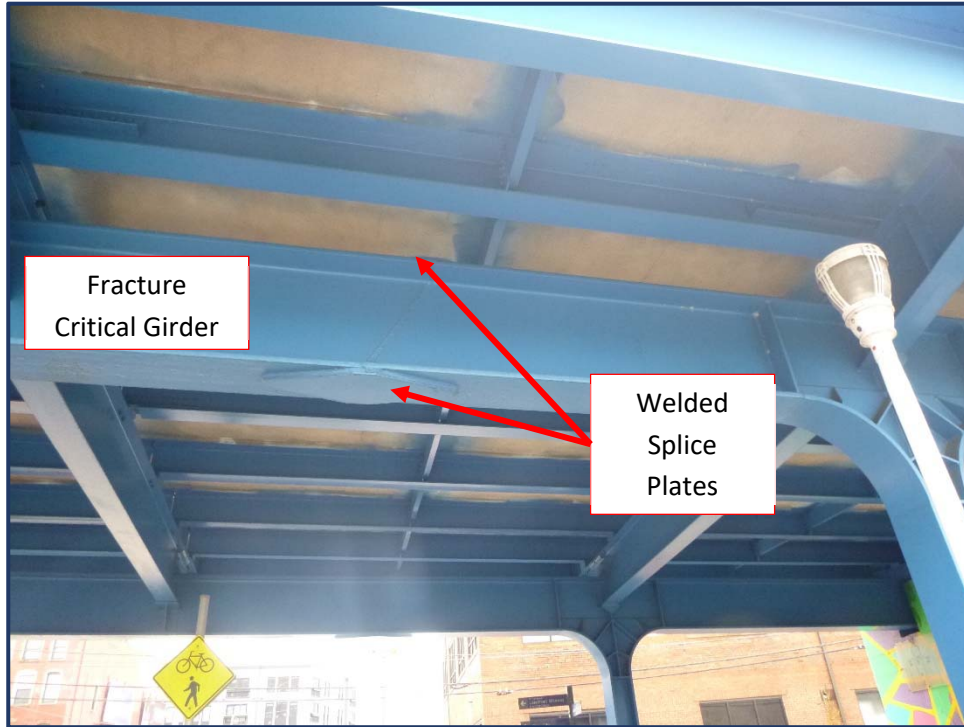
Photo Reference	Label / Fatigue Category	Where?	Description
1	Welded Flange Plates, <b>Fatigue Category E'</b>	Unit I Sections C & K Girders	Ends of field splice plates welded to top and bottom flanges (four girders total with two splice locations on each girder)
2	Abandoned Utility Brackets, <b>Fatigue Category E'</b>	Unit IV Section A Girder Webs	Abandoned utility brackets welded to webs of girders. Some are E/E' depending on length and location.
3	Cracks in Floorbeam Webs	Unit II Floorbeams at truss upper chords	Cracks in coped corners of floorbeam webs adjacent to truss lines in Unit II (Span 1 FBs 0, 6 & 7; Span 2 FB 0; Span
4	Crack in Diagonal Bracing Gusset Plate	Unit III Frame and Braced Column Floorbeam 9	3/4" crack in south diagonal brace gusset plate at the coping for the bottom flange of the upper floorbeam.

*Photo 1 – Welded Cover Plates at Girders in Unit I*

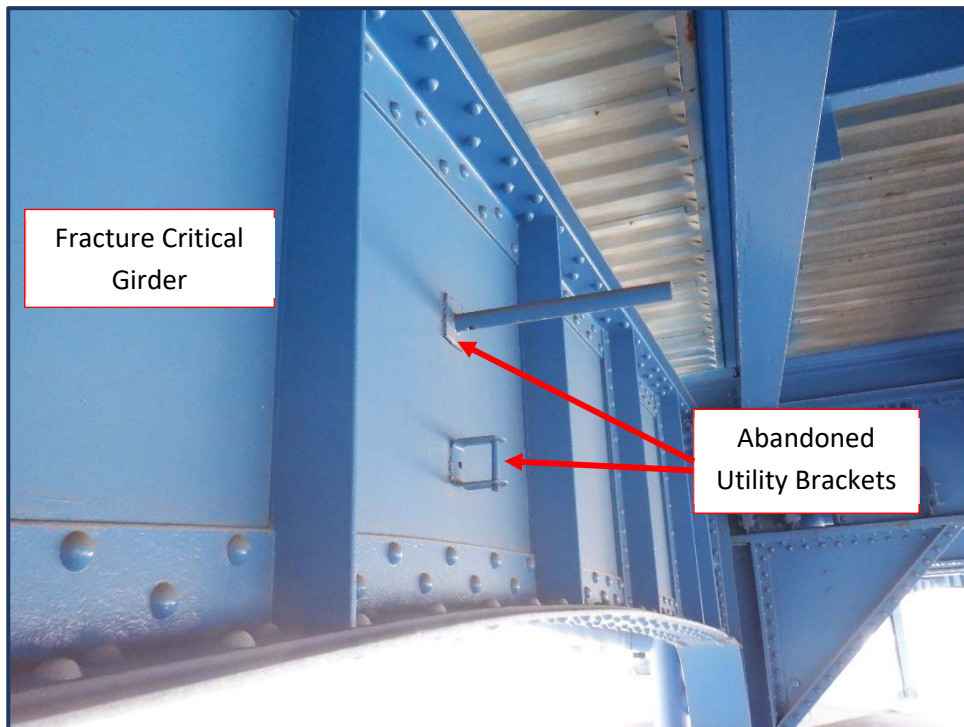
*Photo 2 – Abandoned Utility Brackets on Unit IV Girder Webs*

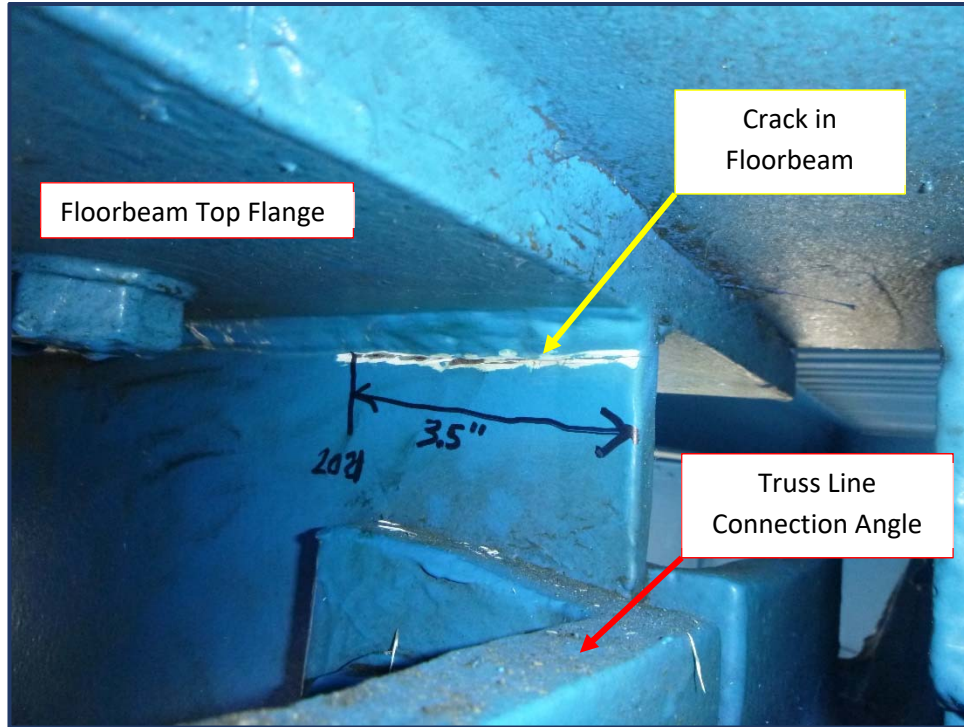
Photo 3 – Cracks in Unit II Floorbeam Web at Top Flange, at Truss Lines

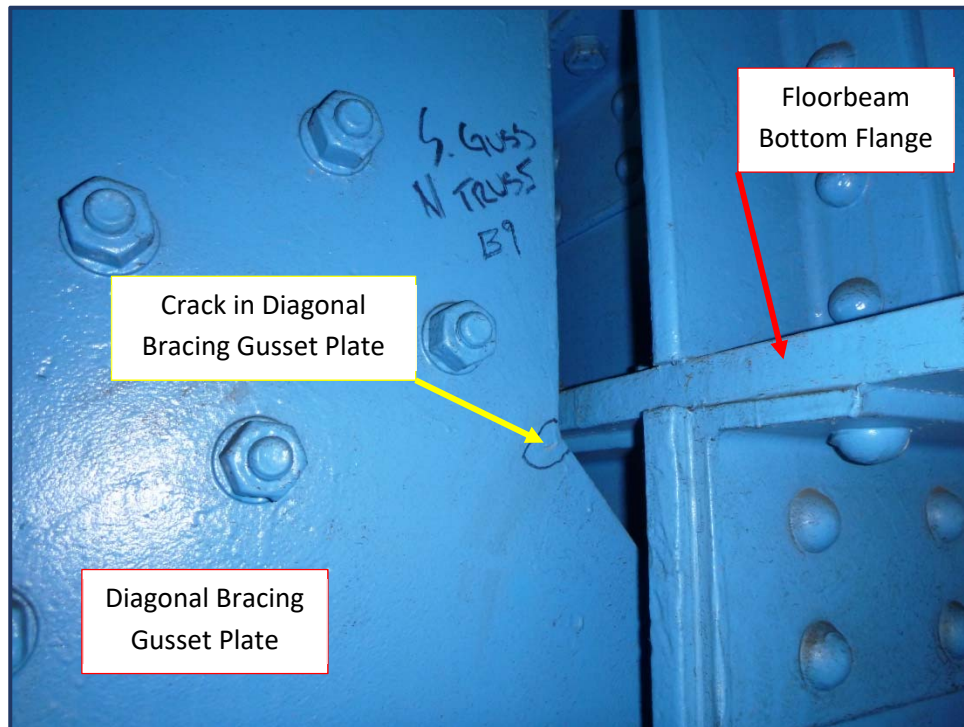
Photo 4 – Crack in Diagonal Bracing Gusset Plate, Unit III, Floorbeam 9, North Column
