I-480 *Bridge Repair*

The Emergency Bridge Closing and Repair of I-480 WB over the Rocky River (Bridge CUY-480-0647)

Preliminary Report

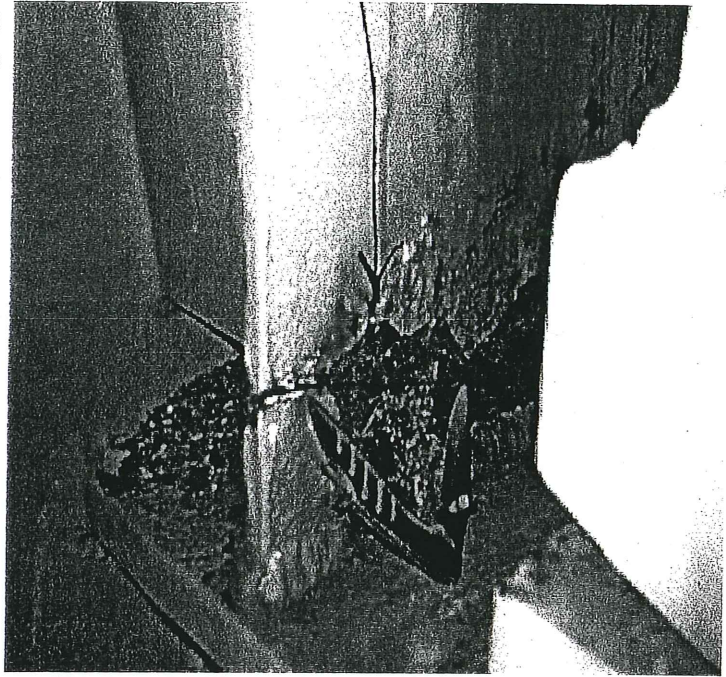
Picture 1- Initial Crack in the Upper Box Plate Photo/ODOT

Thursday, October 12, 2000 During routine bridge inspection, D-12 Bridge Inspector Ken Banaszak discovered a crack in the **upper box plate** (see Picture 1). The crack appeared to propagate from the fatigue prone detail noted in the 1994 inspection by Everett. Jeff Lechak, D-12 Bridge Engineer, was called to investigate. The crack, south of the girder web, did not appear to propagate into the **web** or the **horizontal plate** (seated hinge top flange). Since the bridge only has three girders, the structural redundancy was in question. Because of the questionable structural redundancy Lechak decided not to use the common crack retrofit method of drilling or reaming out the tip of the crack. Lechak conferred with Michael Malloy, D-12 Bridge Design Engineer. It was necessary to use finite element analysis to better understand the situation, since the upper box plate

was designed as a finish plate with no structural value. No lanes were closed at this time since there was no indication that there were cracks in structurally critical areas. The D-12 bridge engineers concluded that if the crack was in either the web or horizontal plate, then at a minimum, the #1 lane on 480 westbound would have to be closed.

Week of October 16-21 Through the preliminary finite element analysis and field inspection, Malloy found that the upper box plate was not functioning as designed (as a non-structural finish plate). The upper box plate was actually in tension, carrying half of the load from the hinge support. The upper box plate, designed as one plate welded at the end of the web, was actually constructed using two plates welded to each side of the web. Thus, if the crack were to grow, it would propagate through the girder web.

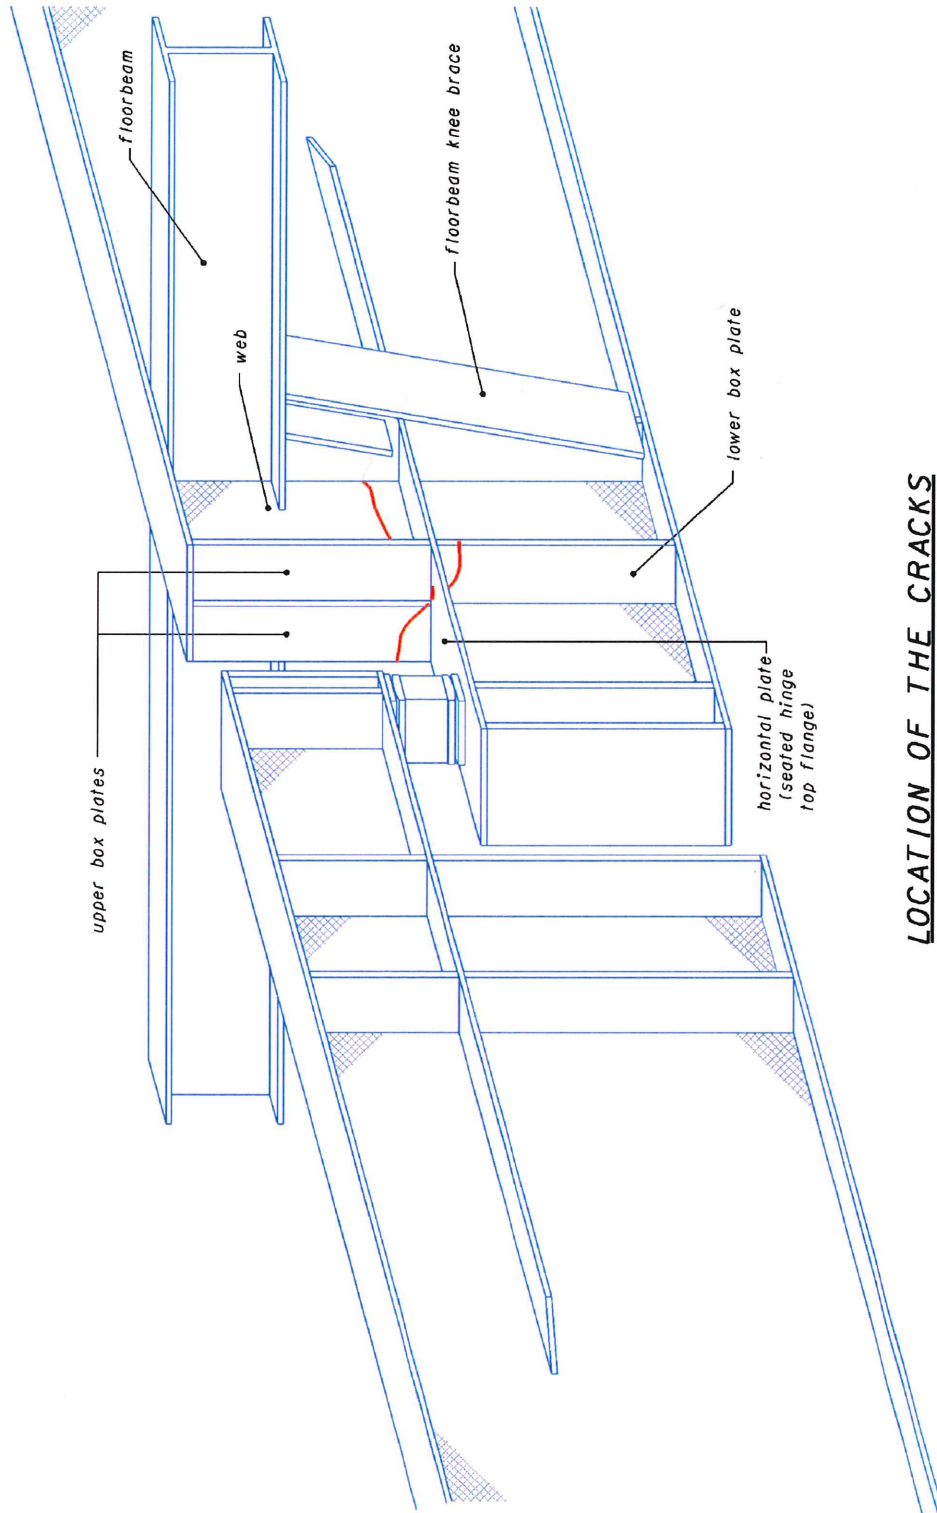
LOCATION OF THE CRACKS
(CRACKS SHOWN IN RED)

- October 2000** Cracks were found in the median fascia girder, which led to the temporary closing of this structure. The following is an overview of these events.

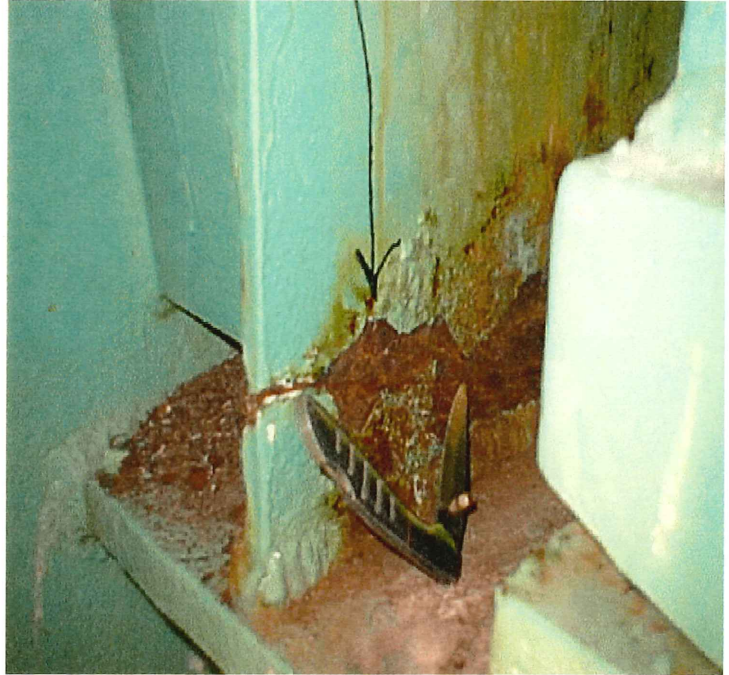
Picture 1- Initial Crack in the Upper Box Plate Photo/ODOT

Thursday, October 12, 2000 During routine bridge inspection, D-12 Bridge Inspector Ken Banaszak discovered a crack in the **upper box plate** (see Picture 1). The crack appeared to propagate from the fatigue prone detail noted in the 1994 inspection by Everett. Jeff Lechak, D-12 Bridge Engineer, was called to investigate. The crack, south of the girder web, did not appear to propagate into the **web** or the **horizontal plate** (seated hinge top flange). Since the bridge only has three girders, the structural redundancy was in question. Because of the questionable structural redundancy Lechak decided not to use the common crack retrofit method of drilling or reaming out the tip of the crack. Lechak conferred with Michael Malloy, D-12 Bridge Design Engineer. It was necessary to use finite element analysis to better understand the situation, since the upper box plate

was designed as a finish plate with no structural value. No lanes were closed at this time since there was no indication that there were cracks in structurally critical areas. The D-12 bridge engineers concluded that if the crack was in either the web or horizontal plate, then at a minimum, the #1 lane on 480 westbound would have to be closed.

Week of October 16-21 Through the preliminary finite element analysis and field inspection, Malloy found that the upper box plate was not functioning as designed (as a non-structural finish plate). The upper box plate was actually in tension, carrying half of the load from the hinge support. The upper box plate, designed as one plate welded at the end of the web, was actually constructed using two plates welded to each side of the web. Thus, if the crack were to grow, it would propagate through the girder web.

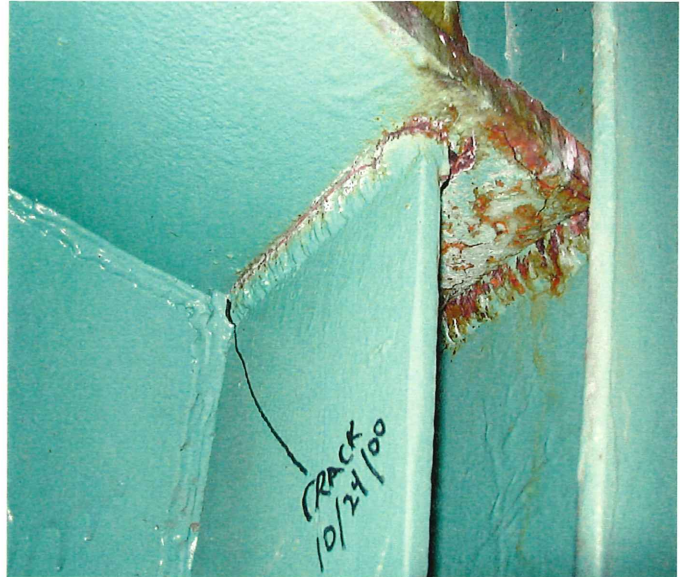
Picture 2 - Second Crack in Lower Box Plate
Photo/ODOT

Inspection in the area of the crack was extremely difficult. There was no easy access. The ODOT Reachall was not able to reach the girder line, so the inspectors had to climb the steel. In addition, the floorbeam knee brace flange and stiffener obstructed the view of the girder web. Banaszak and Everett further probed into location of the crack, this time attempting to remove as much rust and loose paint as possible. At this time, Banaszak found a second crack in the **lower box plate** on the north side of the girder web under the horizontal plate (see Picture 2).

Friday, November 3 District 12 finished the detailed finite element analysis, and determined that the web plate was overstressed under the structure's own dead load. The web plastically deformed and redistributed the load to the floor beams. The structure remained stable, but repairs were still necessary.

Malloy, Slack and Hebebrand discussed a temporary repair of the girder with steel contractor Tri-State Steel. Inspection and repair access to the crack location had to be made by cutting a hole in the floor beam knee brace. Next, the contractor would have to grind out and re-weld the cracks, drill three retrofit holes in the girder web, and four retrofit holes in the box plates. This would be a temporary fix until a permanent retrofit could be designed and installed in project PID 21562.

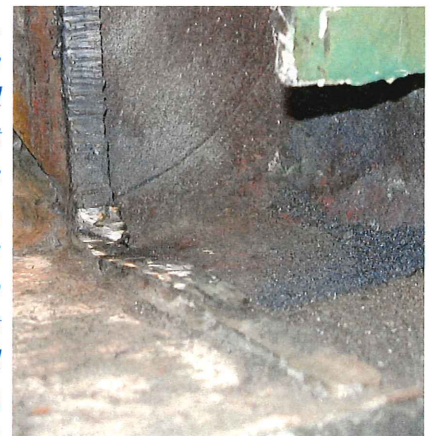
Picture 5 - Crack in the Girder Web Photo/ODOT

Lechak, Malloy, Richland, and Tri-State sought a solution. Tri-State would cut out the upper box plate above the flange crack in order to get a better idea of what was going on, and possibly drill it out and re-open the bridge. Once Tri-State cut out the upper box plate exposing the girder web, a crack in the girder web was found (see Picture 5). With this discovery, installation of a carrier beam would be necessary before the bridge could be re-opened. Richland was instructed to perform an independent finite element analysis and to start design for a carrier beam. The carrier beam was designed from material available at Tri-State's yard. District 12 began contingency plans that would put both directions of travel on the eastbound structure if the carrier beam was not practical.

structure actually passed through the floor beam knee brace. This knee brace was the last remaining internal redundancy on the bridge. This web crack was drilled out to prevent further propagation.

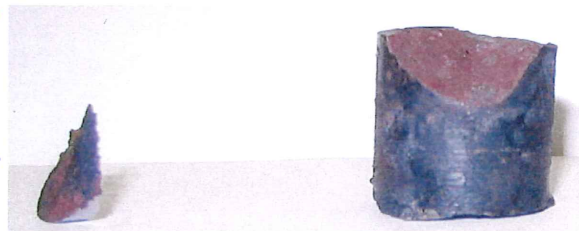
Picture 6 - Drilled Out "J" Divot Photo/ODOT

Tri-State completed preparation of the upper box plate for steel testing. It was found that the horizontal plate crack looked like a "J" which went around a stiffener. It appeared that the upper box plate was actually pulling a divot of steel out of the horizontal plate. This was verified later after a hole was drilled out at the hook in the "J" (see Picture 6).

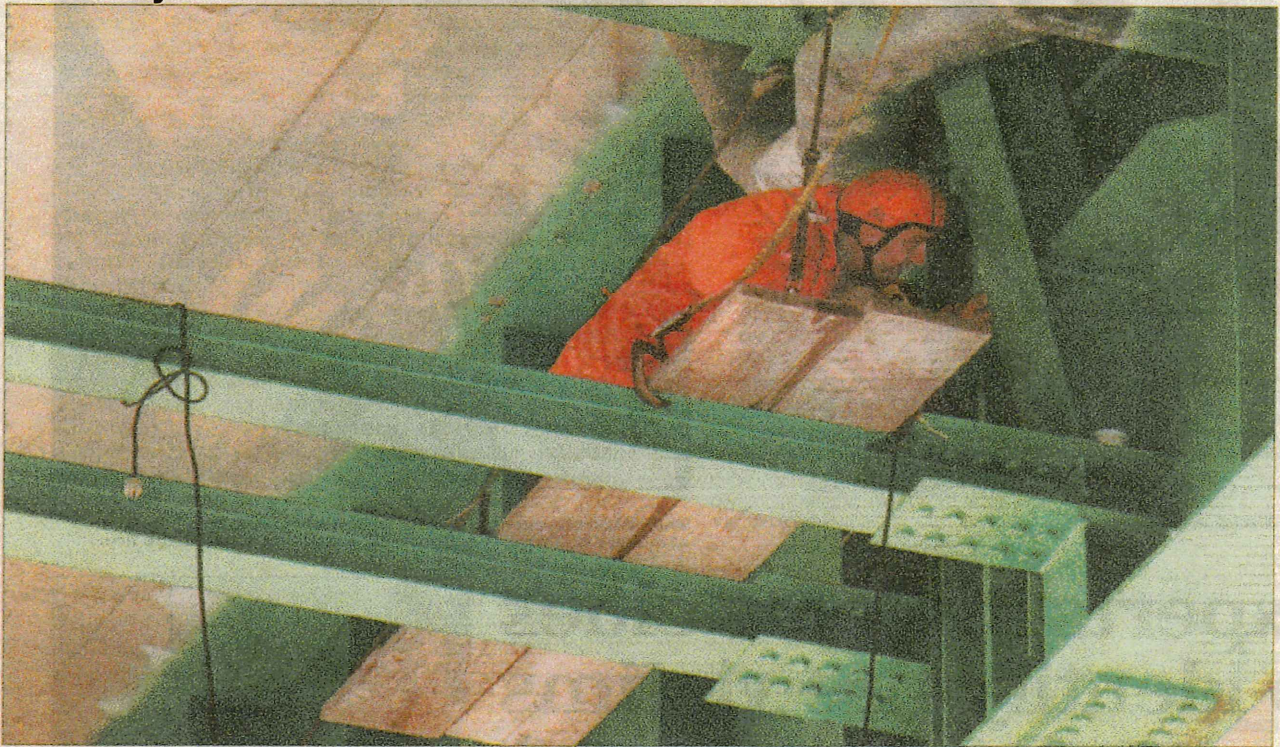
Cracks in the steel beams supporting the I-480 westbound bridge over the Rocky River had Dave Everett, an Ohio Department of Transportation bridge inspector, suspended 80 feet above the ground yesterday and stretching to get a closer look.
