**PHYSICAL CONDITION REPORT
FOR THE 2022 ROUTINE ELEMENT LEVEL AND FRACTURE CRITICAL INSPECTION**

I-480 OVER THE ROCKY RIVER VALLEY

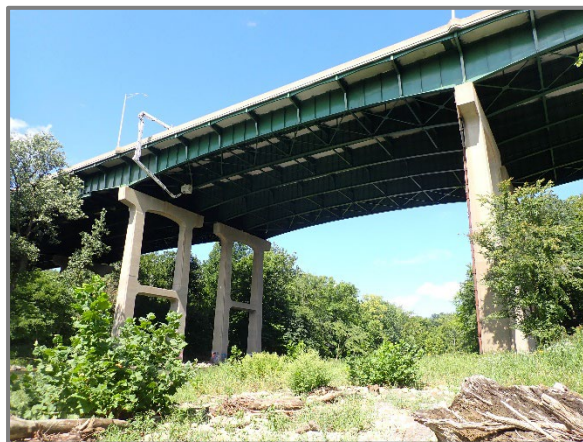
Photo 1 – Partial south elevation of the CUY-480-0647 Bridge, looking northwest. Note snooper access in Span 7.

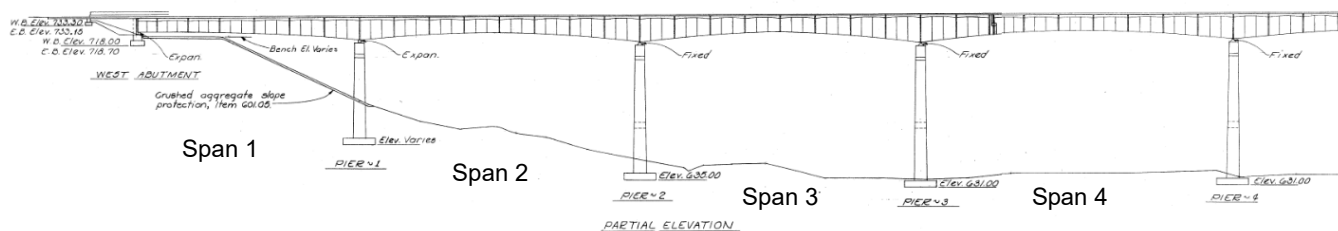
Figure 1 – Partial south elevation of CUY-480-0647 (west half).

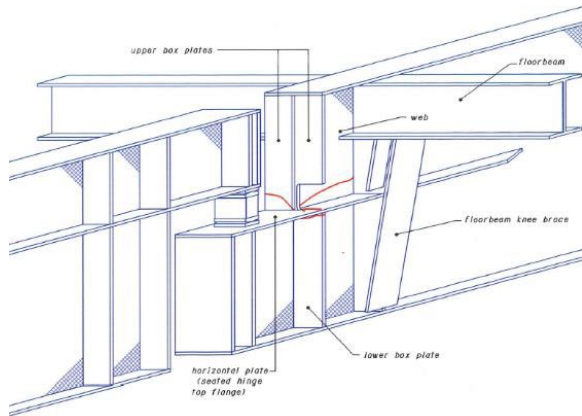
Figure 2 – Schematic diagram showing location of cracks found during the 2000 inspection (cracks shown in red).

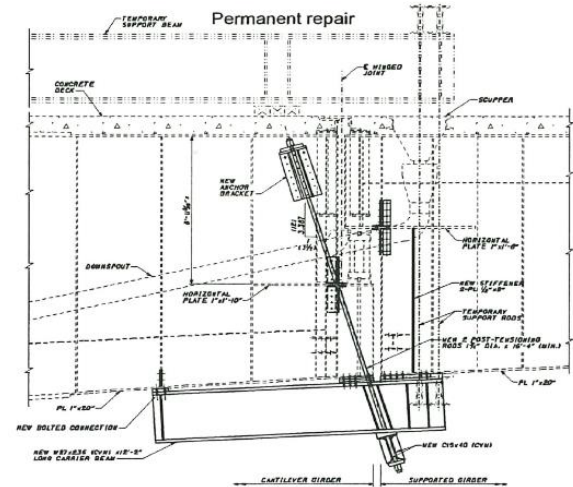
Figure 3 – Plan details showing carrier beam retrofits installed during 2001 emergency repair.

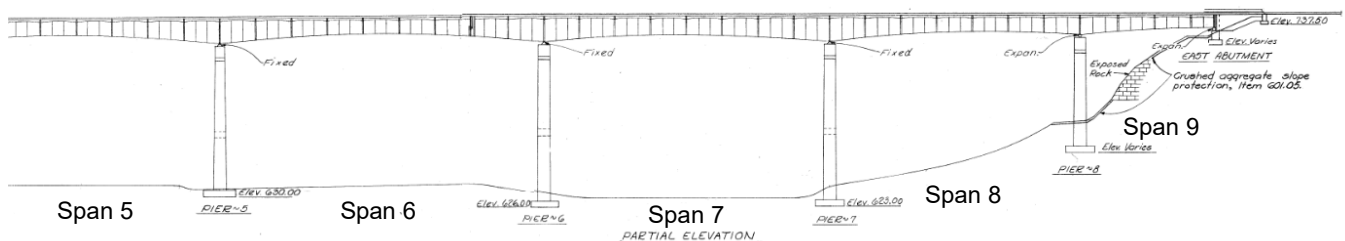
Figure 4 – Partial south elevation of CUY-480-0647 (east half).

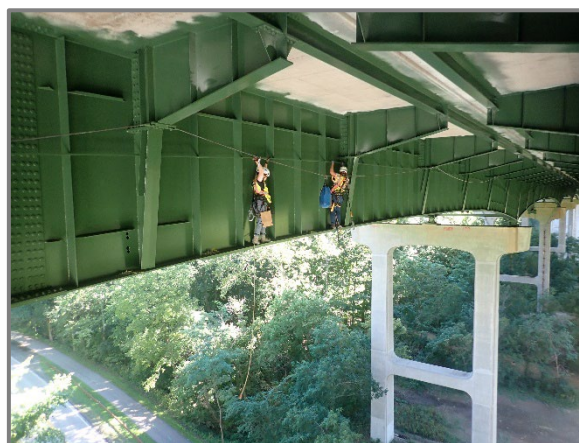
Photo 2 – Typical protected climbing and rope access techniques utilizing the safety cables along the girders, looking northeast at Girder D in Span 3.

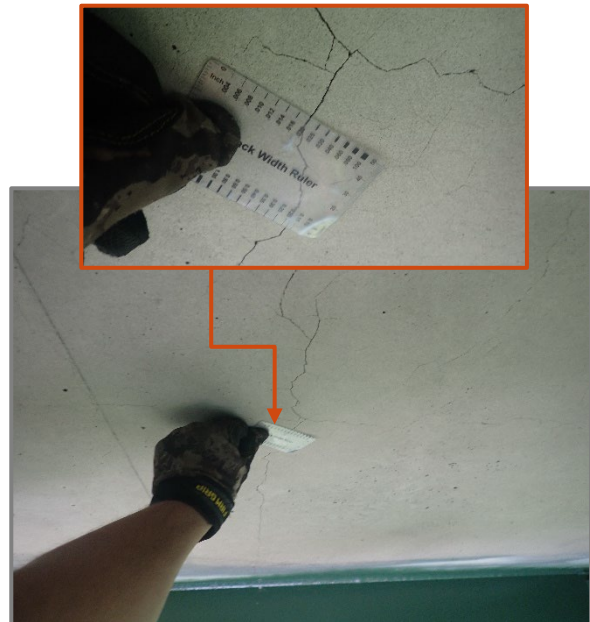
Photo 3 – 0.020" wide transverse crack in the Span 4 underside of deck between Floorbeams 24 and 25 of the eastbound structure, looking south.

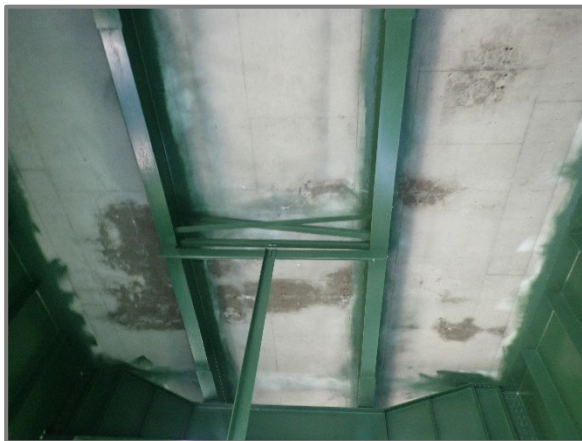
Photo 4 – Several areas of moisture staining and efflorescence in the deck underside between Girders E and F between Floorbeams 43 and 44, looking west. Note these locations are defects are typically located between failing patches in the wearing surface.

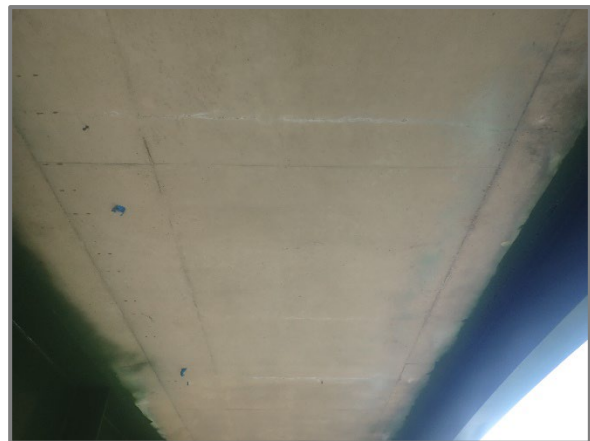
Photo 5 – Typical hairline transverse cracks with light efflorescence in the deck overhangs, looking east at the south overhang of the eastbound structure between Floorbeams 10 and 11, looking east.

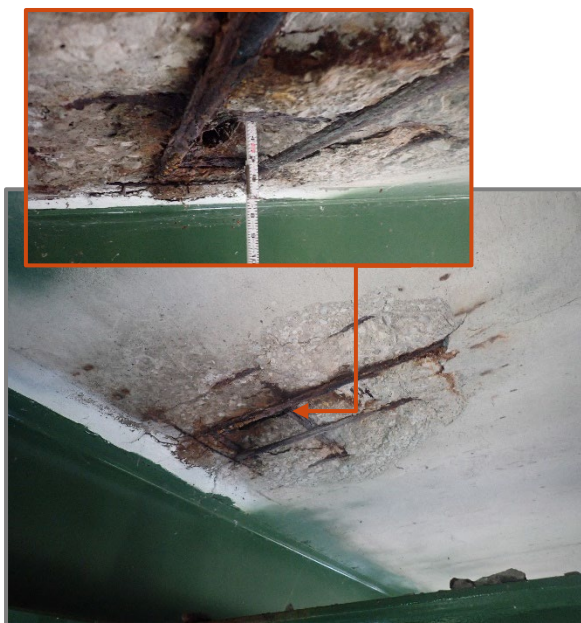
Photo 6 – 36" long by 42" wide by 5" deep spall with debonded and corroded reinforcement along the south side of Stringer 11 at Floorbeam 42 on the westbound structure, looking northeast.

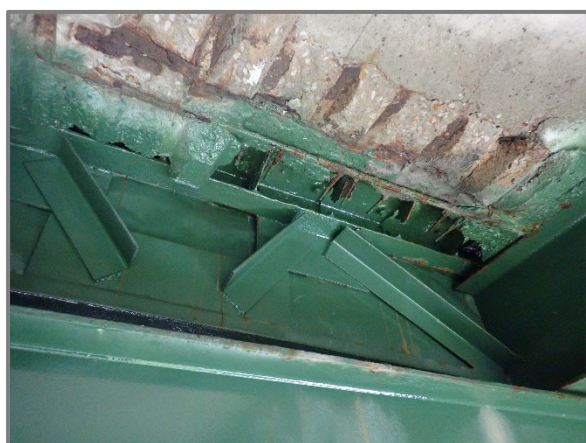
Photo 7 – 7' wide by up to 15" long by full depth spall with two layers of fully exposed and corroded reinforcement at the end of the eastbound structure deck along the Span 6 expansion joint armor, looking east.

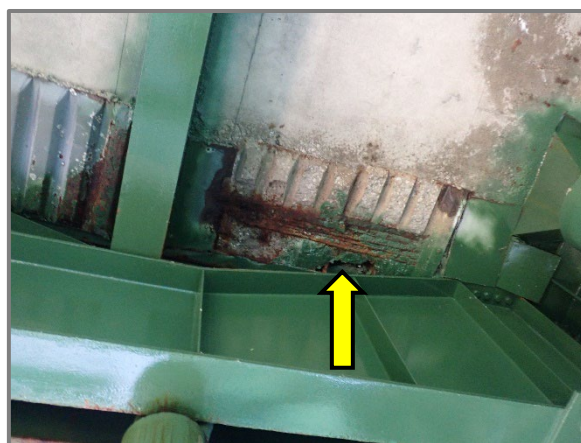
Photo 8 – 18" long by 8" wide by full depth spall with exposed and corroded reinforcement in the westbound structure deck underside along the Span 4 expansion joint, looking west.

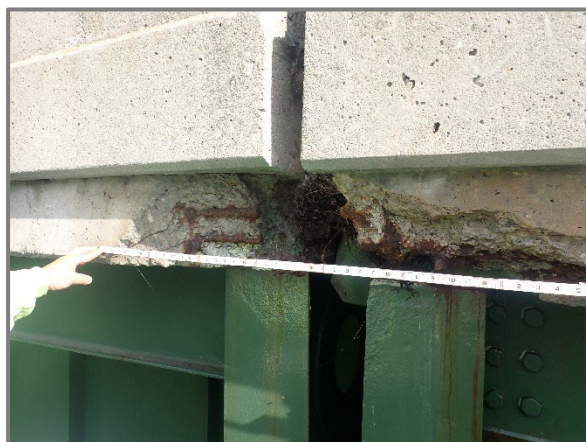
Photo 9 – Large spalls with multiple layers of exposed and corroded reinforcement in the south deck edge of the eastbound structure at the Span 4 expansion joint, looking northwest.

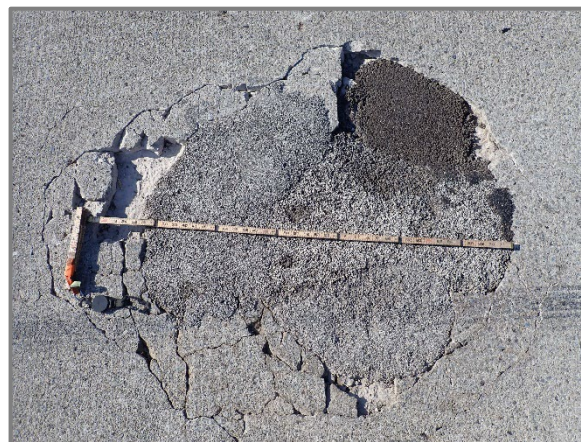
Photo 10 – Typical failing patch in the right lane of the westbound structure wearing surface in Span 5, looking south. Note additional broken up wearing surface material around the perimeter of the patch.

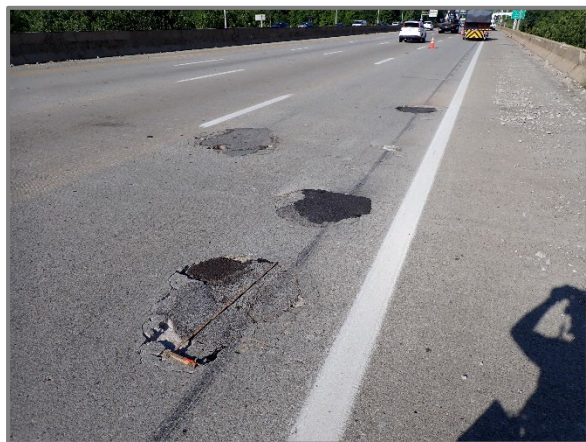
Photo 11 – Several potholes and failing patches in the right lane of the Span 6 wearing surface on the westbound structure, looking west.

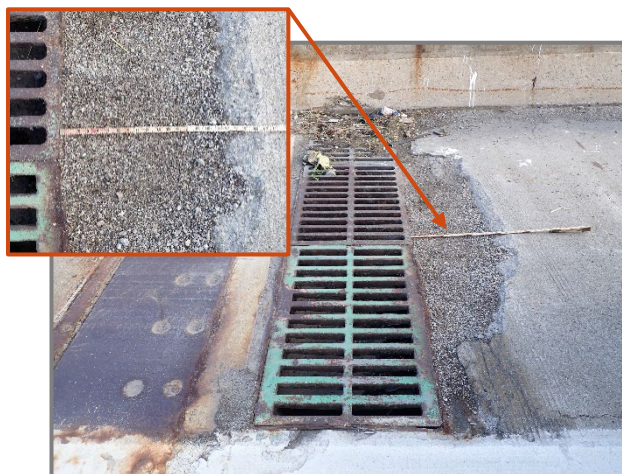
Photo 12 – Typical potholes along the drainage scuppers, looking north at a drainage scupper in the westbound right shoulder in Span 4.

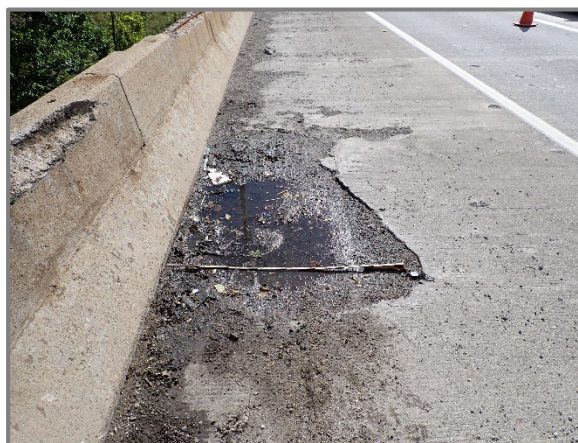
Photo 13 – Large pothole in the right shoulder of the Span 8 wearing surface on the westbound structure at the base of the bridge railing, looking east.

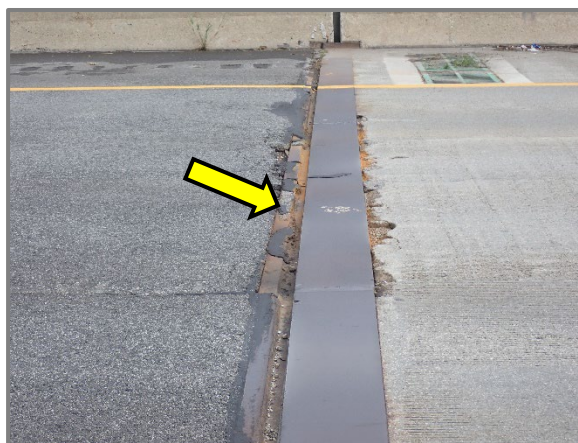
Photo 14 – 1/2" vertical misalignment at the Rear Abutment joint for the eastbound structure, looking north. Note the adjacent spalling to the joint header and that this joint bounces under live load traffic in the 2nd lane (from left).

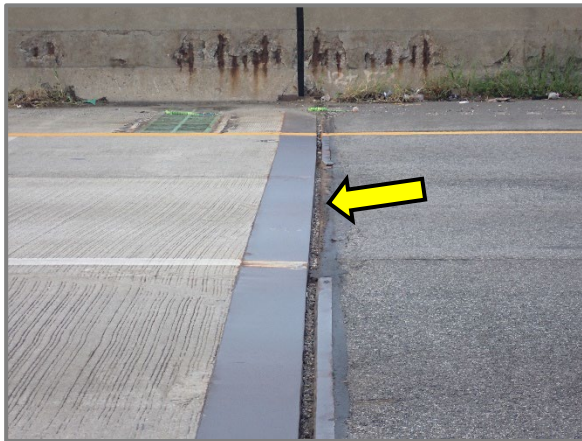
Photo 15 – Joint armor discontinuous and depressed approximately 1/2" at the westbound Rear Abutment joint in the 2nd lane (from left).

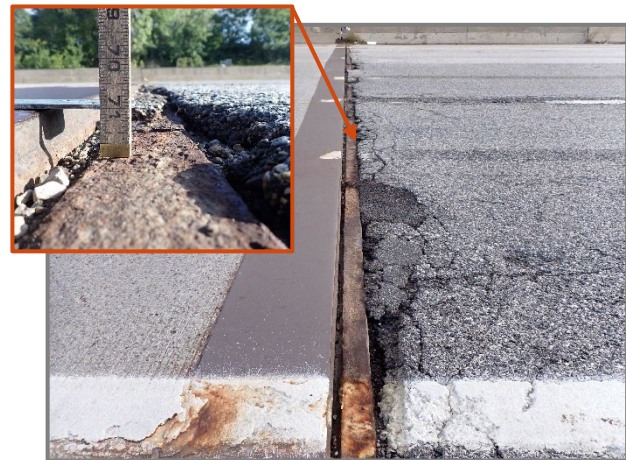
Photo 16 – Up to 1" vertical misalignment at the eastbound Forward Abutment joint in the right two lanes, looking north. Note the broken up joint header on the approach side with previous patches beginning to fail.

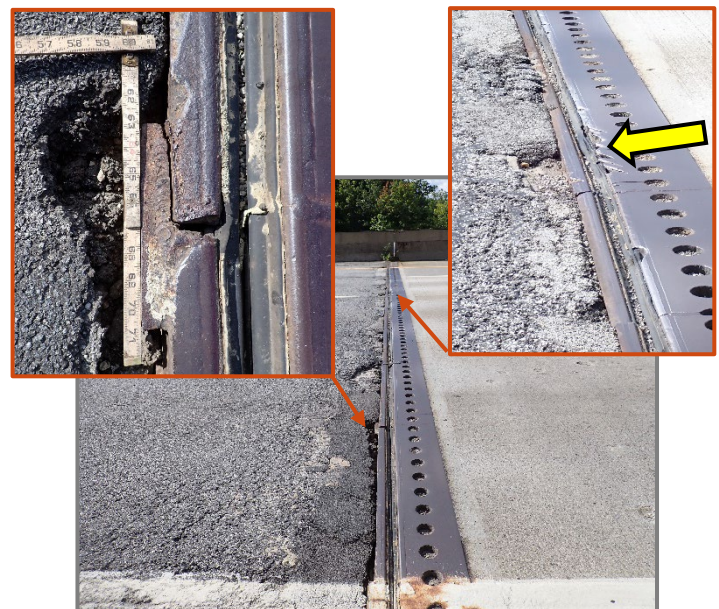
Photo 17 – Up to 1/2" vertical misalignment at the westbound Forward Abutment joint with moderate plow damage to the joint armor, looking south. Note the weld between the east joint armor sections in the right lane are broken, causing the section to bounce under live load.

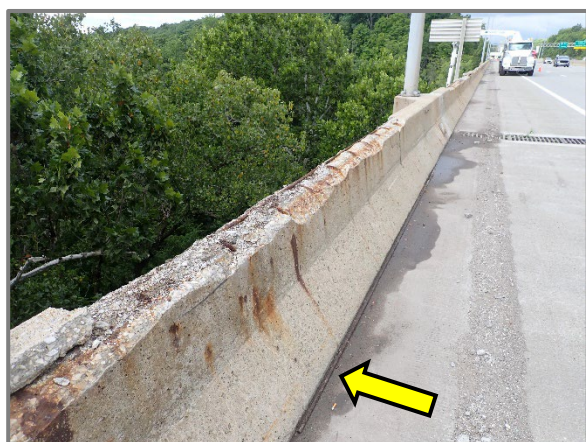
Photo 18 – Typical full width spalls with exposed, corroded, missing, and debonded reinforcement along the top edges of the exterior bridge railings, looking west at the south railing in Span 5 of the eastbound structure. Note the missing bar laying at the base of the railing.

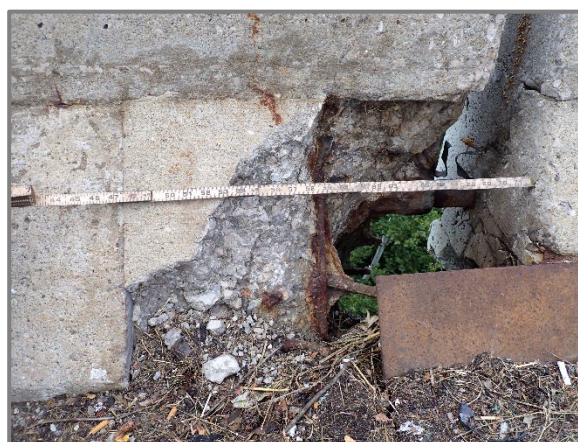
Photo 19 – 24" long by 24" high by full depth spall in the south bridge railing on the east side of the Span 6 joint on the eastbound structure, looking south. Note that spalls of this nature are typically present at the hinge joints.

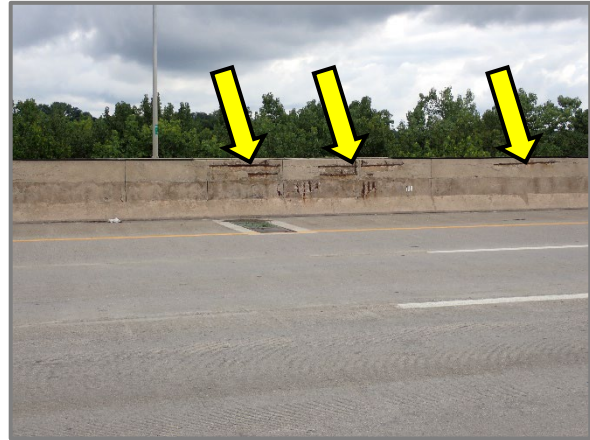
Photo 20 – Widespread spalling of the median barrier on the eastbound structure near Pier 4, looking south.

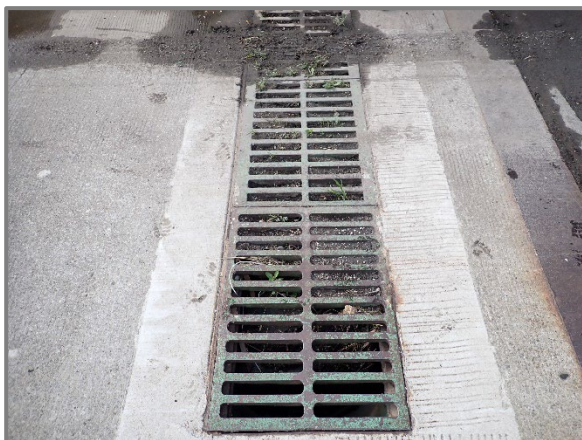
Photo 21 – Typical partially clogged drainage scupper (approximately 85% clogged), looking south at the west end of the bridge on the eastbound structure.

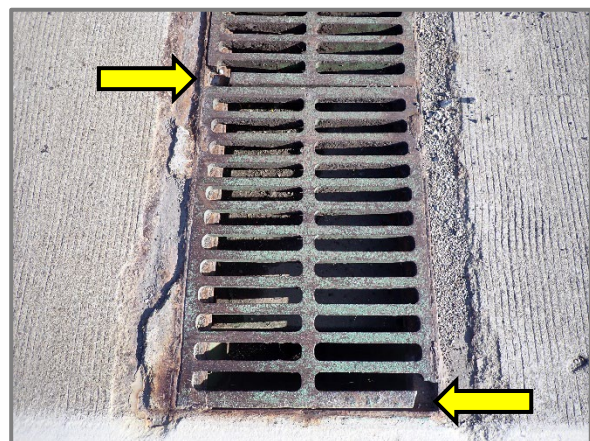
Photo 22 – Scupper grate near Pier 4 of the westbound structure with broken grate bars at the corners, looking north.

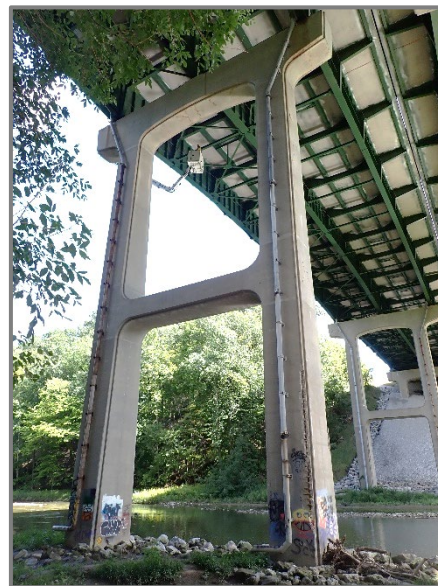
Photo 23 – West elevation of Pier 5 of the westbound structure, looking northeast. Note minor to moderate corrosion of the downspouts and large rubble rip rap in place at the column bases.

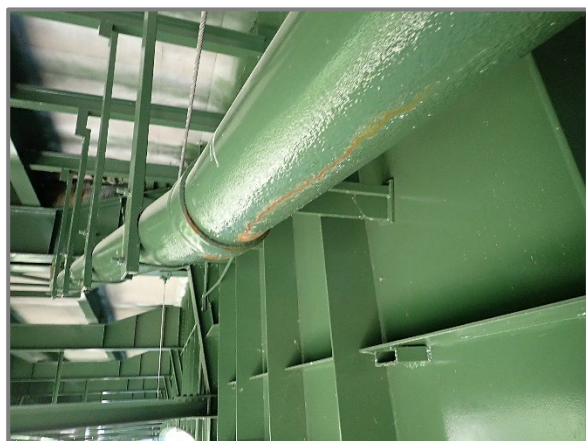
Photo 24 – Evidence of leakage in the north downspout near the hinge joint in Span 6 of the westbound structure, looking west. Note that corrosion holes were observed during the 2020 inspection but have not been noted since.

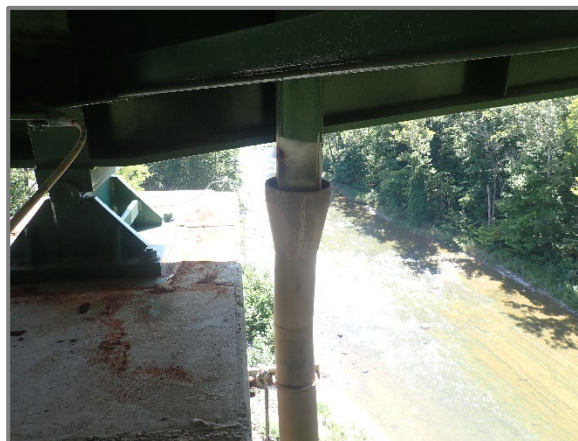
Photo 25 – Downspout at Pier 7 for the eastbound bridge fully clogged approximately 12' from the top, looking south.

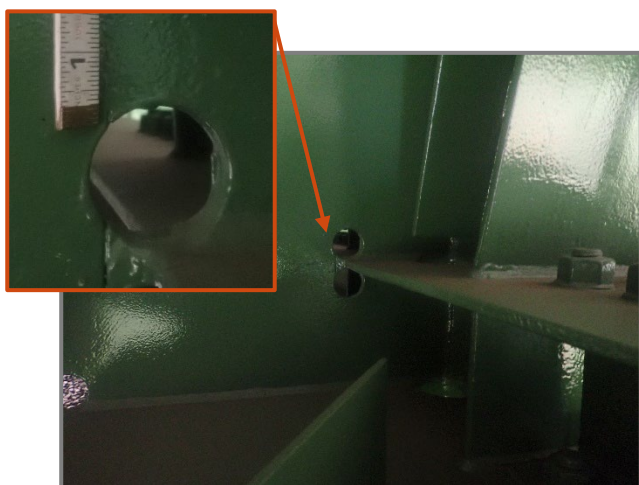
Photo 26 – Typical dogbone retrofit overcut in the girder web, looking north at Girder B at Floorbeam 4.

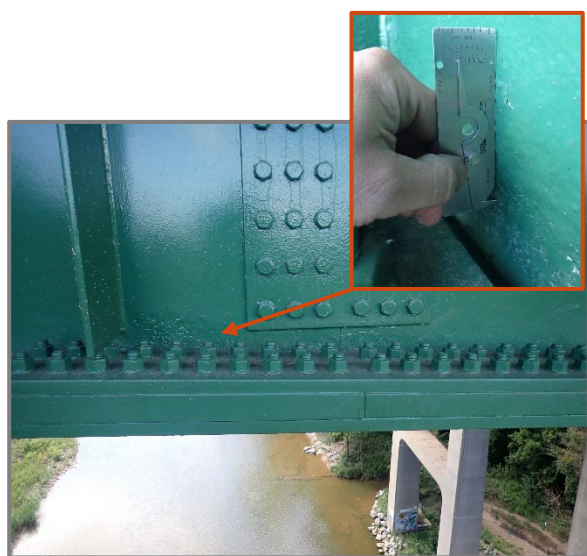
Photo 27 – Cleaned and painted pitting 1/8" deep on the bottom of the north face of the Girder F web along the bolted splice between Floorbeams 54 and 55, looking south.

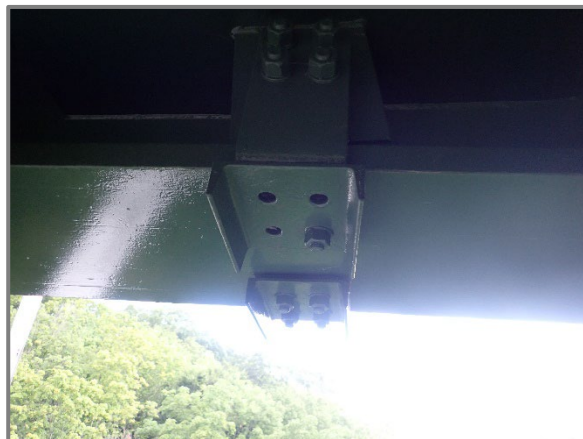
Photo 28 – 3 of 4 bottom flange bolts missing in the Girder F knee brace connection retrofit at Floorbeam 15, looking north.

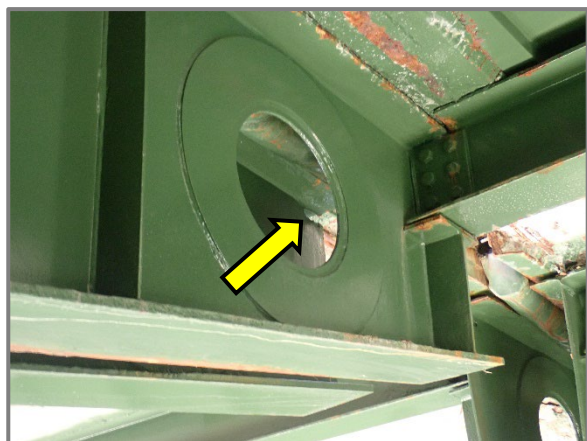
Photo 29 – 3" long by 1" high corrosion hole at the top of the Floorbeam 26 north cantilever on the eastbound structure at its end, looking northwest. Note that Floorbeam 27 is similar.

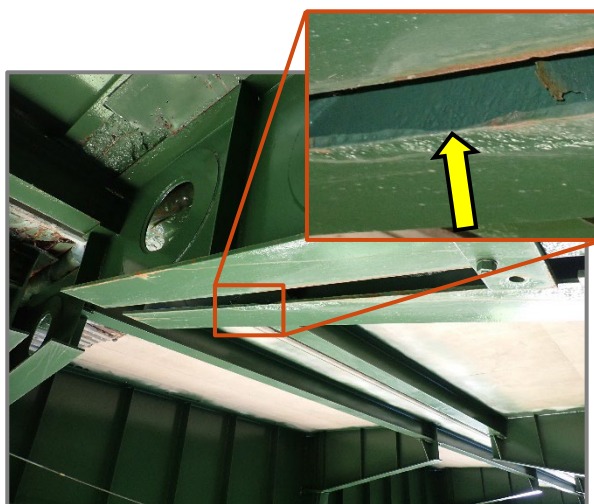
Photo 30 – Floorbeam 26 south cantilever on the westbound structure with one area of cleaned and painted pitting down to 1/8" remaining thickness, looking southwest.

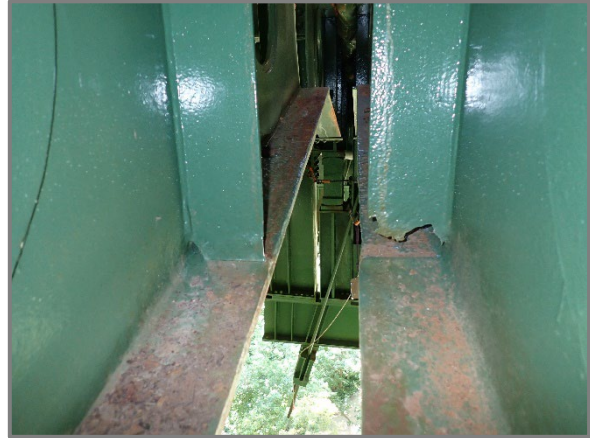
Photo 31– South cantilever of Floorbeam 26 on the westbound structure with 100% section loss at the base of a transverse stiffener near the base, looking south.

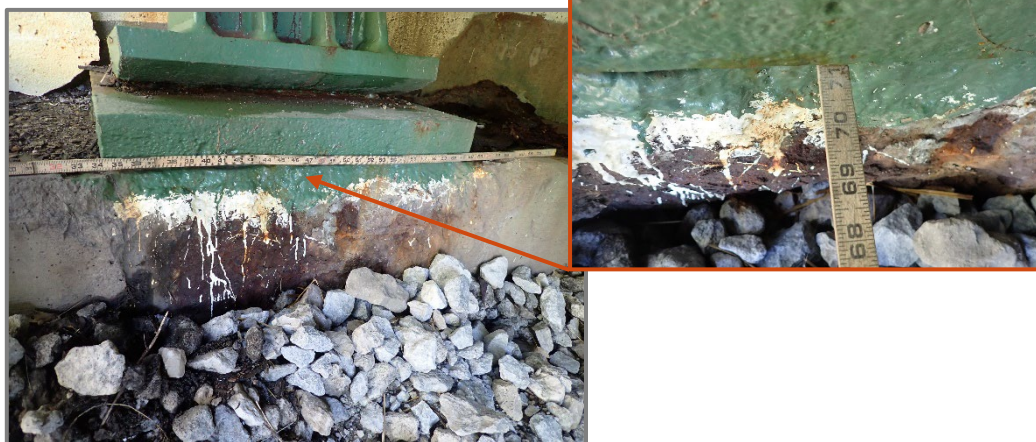
Photo 32 – Spall in the west face of the Girder F seat pedestal at the Forward Abutment undermining the bearing masonry plate up to 3/4" deep, looking east.

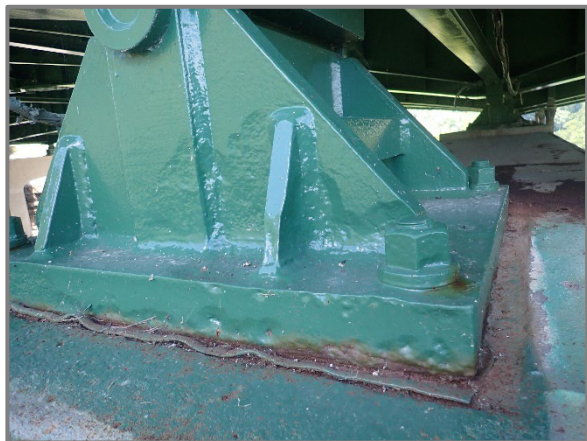
Photo 33 – Up to 1/4" deep cleaned and painted pitting on the bearing assembly and masonry plate for Girder F at Pier 7, looking south.

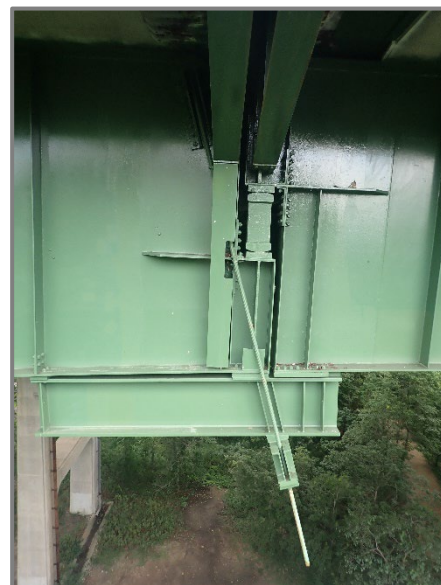
Photo 35 – Typical carrier beam retrofit installed below the seated hinge joints, looking north at Girder A at the Span 4 expansion joint.

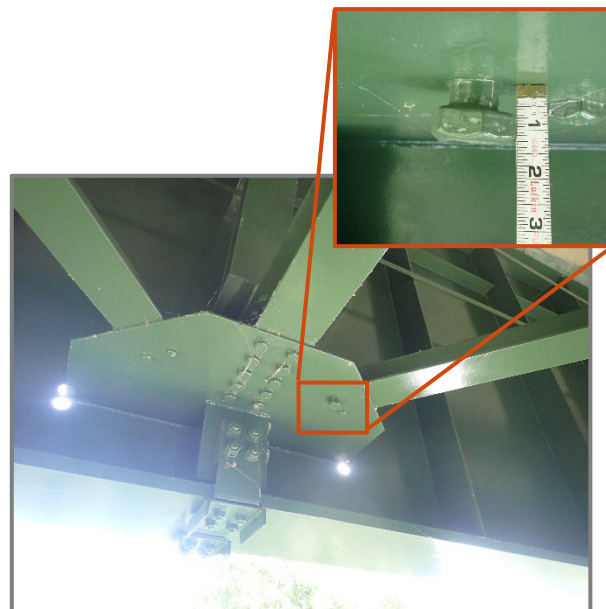
Photo 36 – Backed off (loose) erection bolt in the lateral bracing connection plate at Floorbeam 47 at Girder A, looking southwest.

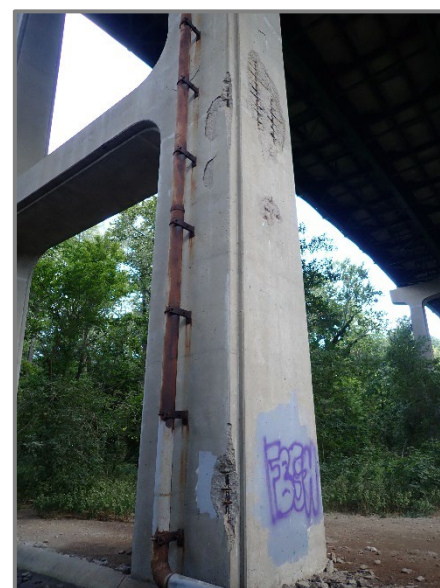
Photo 37 – Numerous delaminations and spalls with exposed reinforcement throughout the north column at Pier 3 of the eastbound structure, looking southwest.

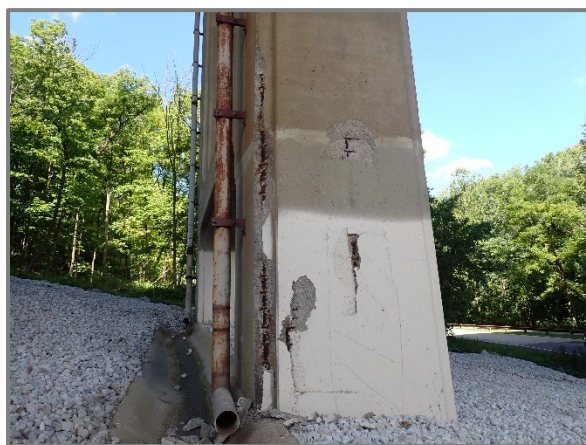
Photo 38 – Numerous spalls with exposed reinforcement on the south column at Pier 2 of the westbound structure, looking northeast.

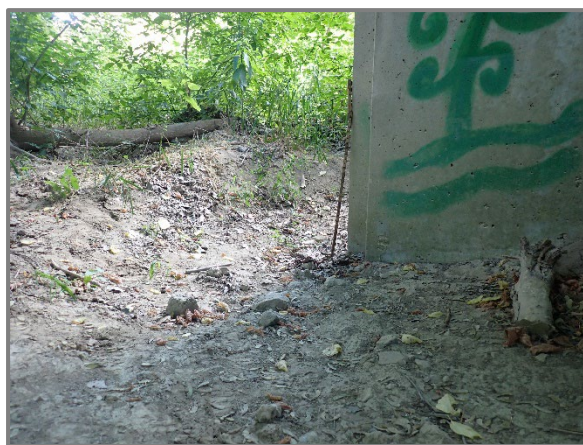
Photo 39 – Minor localized scour along the base of Pier 5 columns, looking south at the south column on the westbound structure.

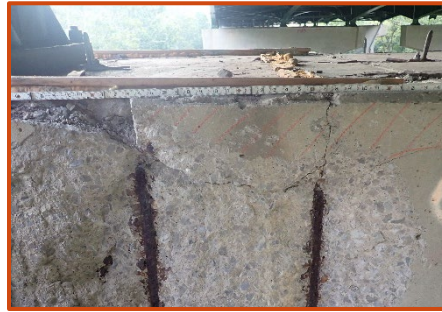
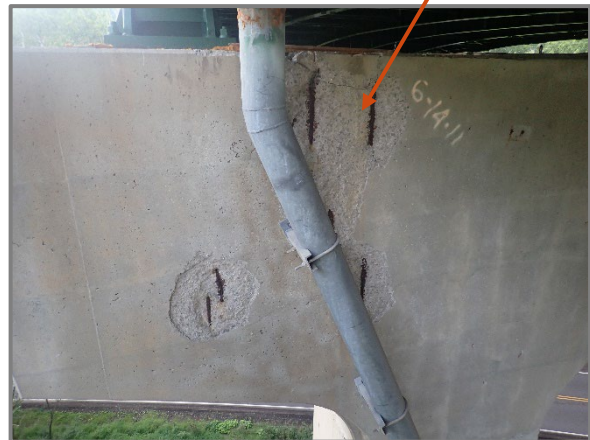
Photo 40 – 72" high by 42" wide by 2" deep spall with exposed and corroded reinforcement behind the downspout on the west face of the Pier 2 cap for the westbound structure, looking east.

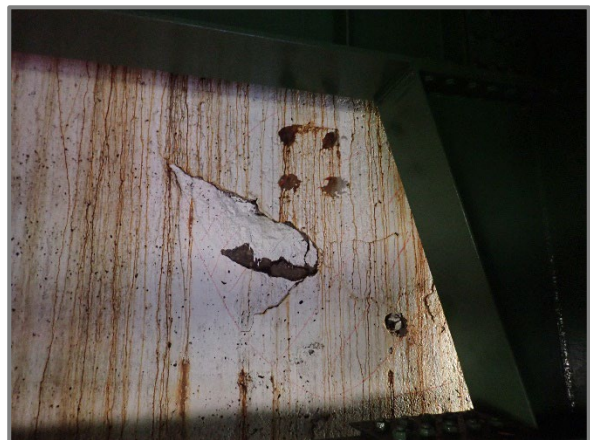
Photo 41 – 8' wide by 4' delamination with an adjacent spall in the Rear Abutment backwall behind Girder F, looking west.

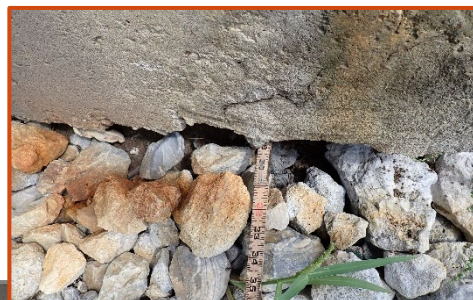
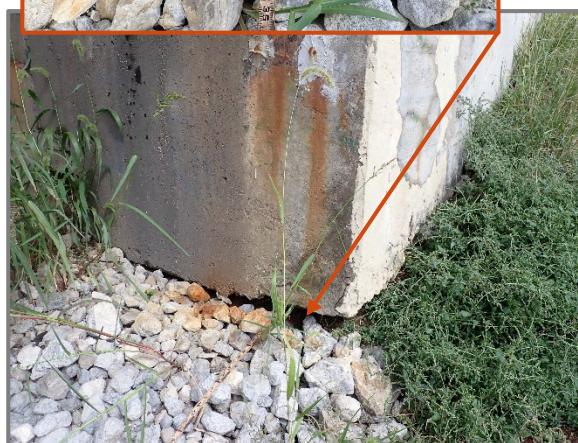
Photo 42 – Forward Abutment backwall and wingwall for the eastbound structure undermined up to 30" deep/long at its south end, looking east.

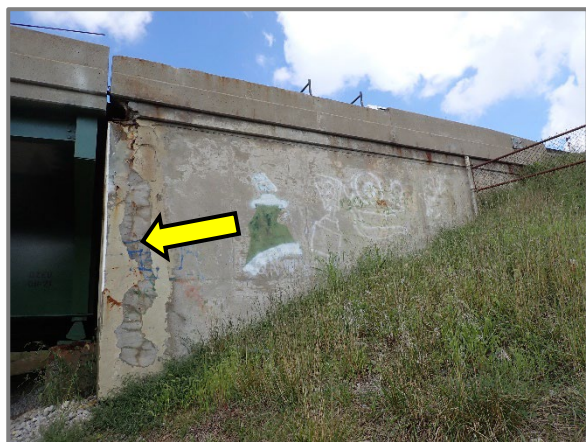
Photo 43 – 12" wide patch beginning to fail in the south wingwall at the along the Forward Abutment connection, looking north.

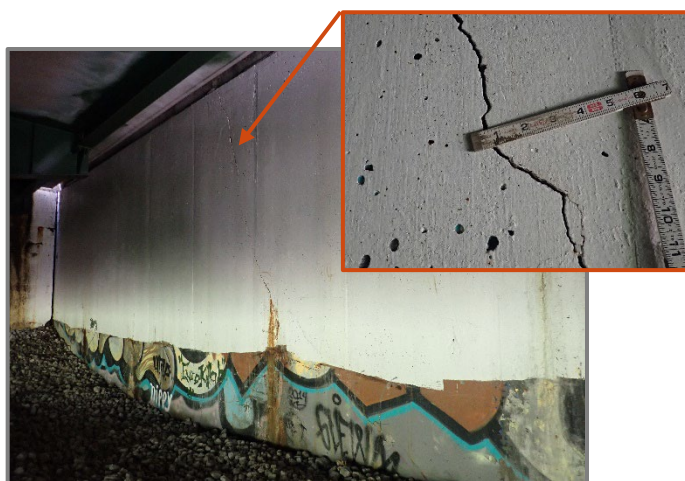
Photo 44 – 1/8" wide vertical/diagonal crack with moderate efflorescence and light rust staining in the interior wingwall at the Rear Abutment, looking northwest.

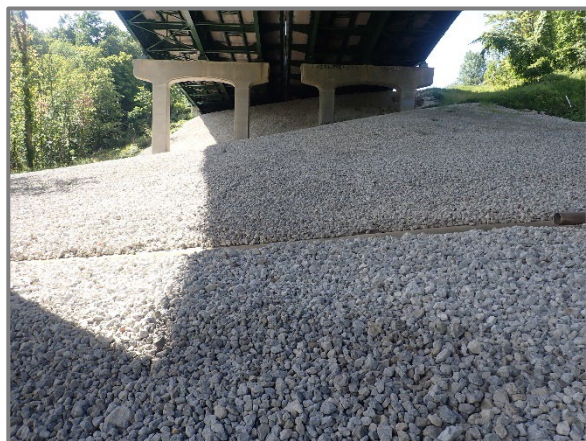
Photo 45 – Recently installed slope protection in front of the Rear Abutment, looking west.

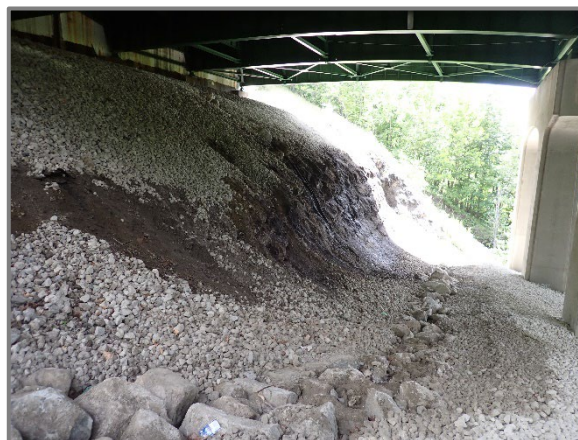
Photo 47 – Erosion channel in front of the Forward Abutment, looking east. Note that new slope protection should mitigate further erosion.

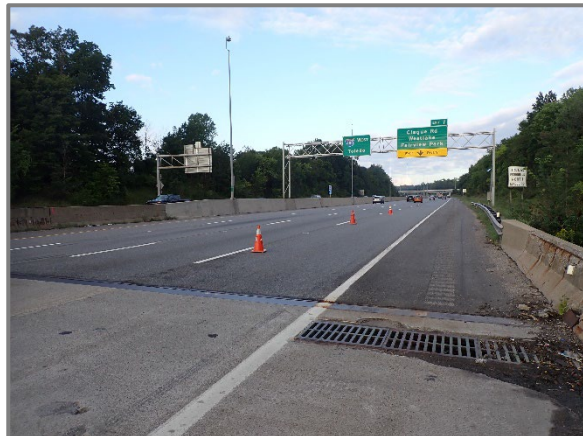
Photo 48 – Rear approach roadway resurfaced since the previous inspection, looking southwest.

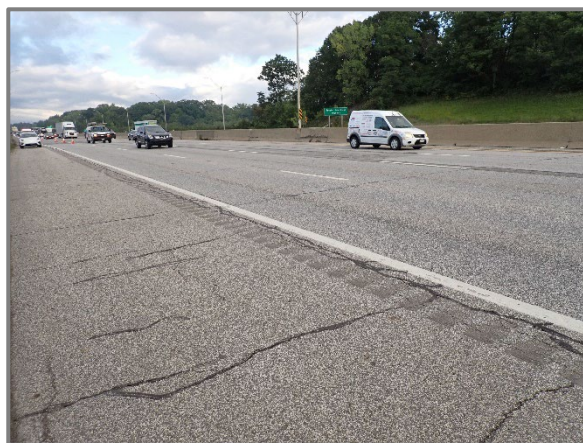
Photo 49 – Typical transverse and longitudinal cracks in the forward approach roadway surface, looking southeast at the end of the westbound structure.

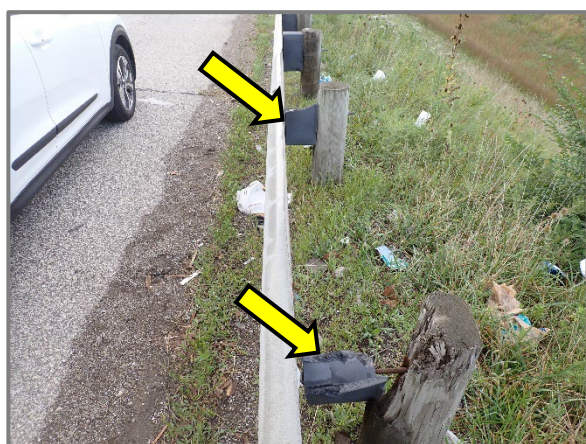
Photo 51 – Damaged timber posts and plastic blockouts on Posts 3 through 6 from the bridge end in the southeast corner approach guardfence, looking east.

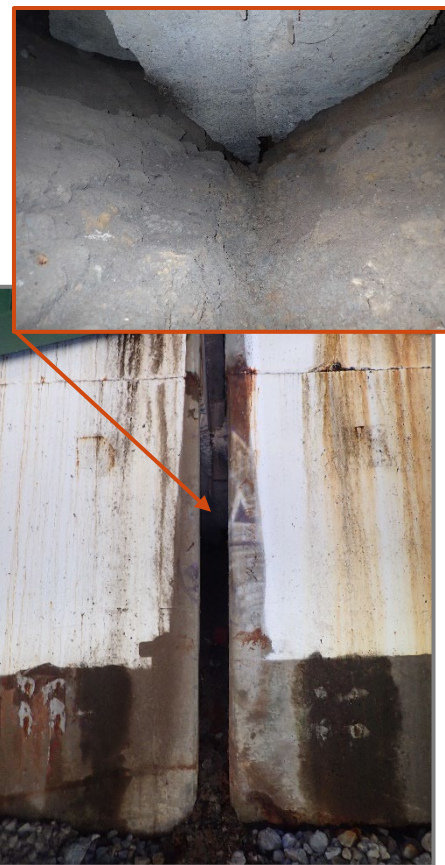
Photo 50 – Embankment fill spilling out from behind the Forward Abutment backwall through the median joint, looking north. Note the 8' tall by 15' wide by 30' deep void that has resulted below the approach slabs.

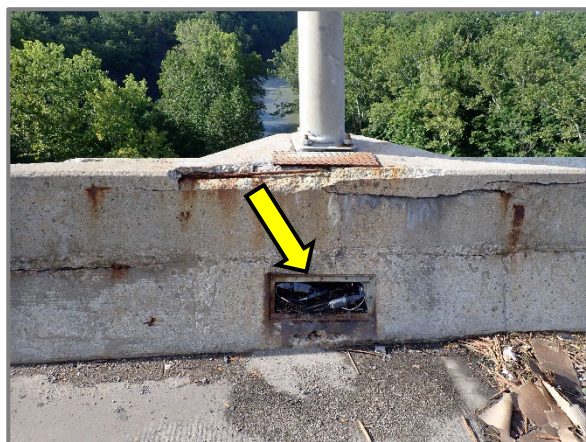
Photo 52 – Typical missing electrical panel access hatch below the light poles, looking north at Pier 7. Note exposed wiring, dirt, granular debris, and vegetation growth inside the panel.

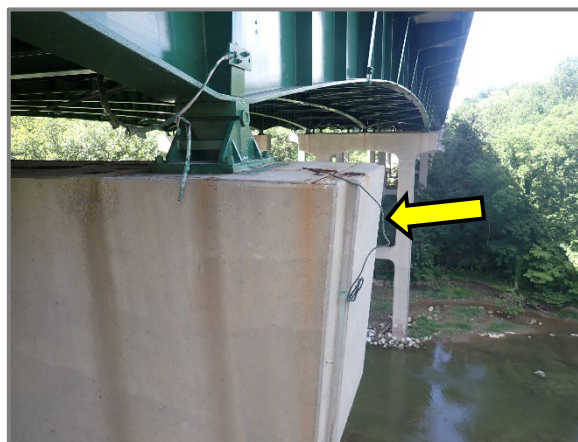
Photo 53 – Typical broken grounding cable at the pier caps, looking west at Pier 7 adjacent to Girder F.

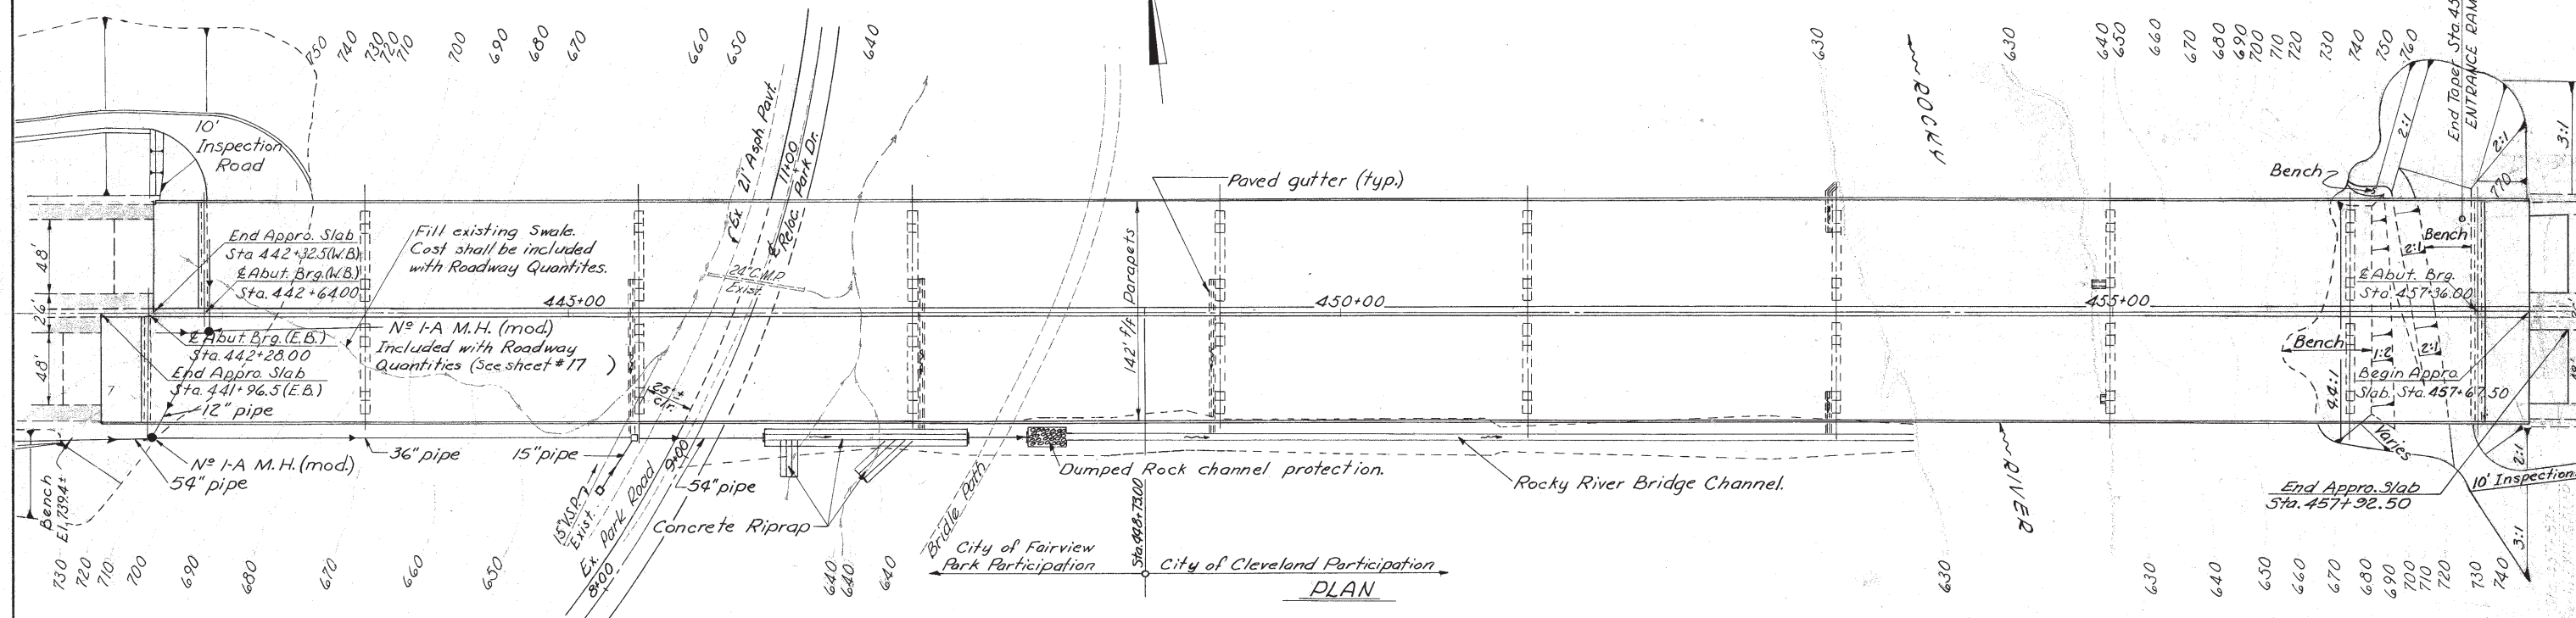
PROPOSED STRUCTURE
 TYPE: Continuous haunched steel girder with transverse floorbeams, longitudinal stringers, concrete deck and concrete substructure.
 SPANS: E.B. Lanes 139'-8", 2@117'-4", 3@199'-6", 117'-4", 155'-2", 82'-8" 9/16 Brgs.
 W.B. Lanes 103'-8", 2@117'-4", 3@199'-6", 117'-4", 155'-2", 82'-8" 9/16 Brgs.
 ROADWAY: 142' ff parapets, with Type 2 Railing, including 26'-0" median and 10'-0" shoulders.
 LOADING: CF-2000 (1957) - Adequate for AASHTO alternate loading.
 WEARING SURFACE: 1" monolithic concrete.
 SKEW: None
 ALIGNMENT: Tangent
 APPROACH SLABS: AS-1-67 (25' long)

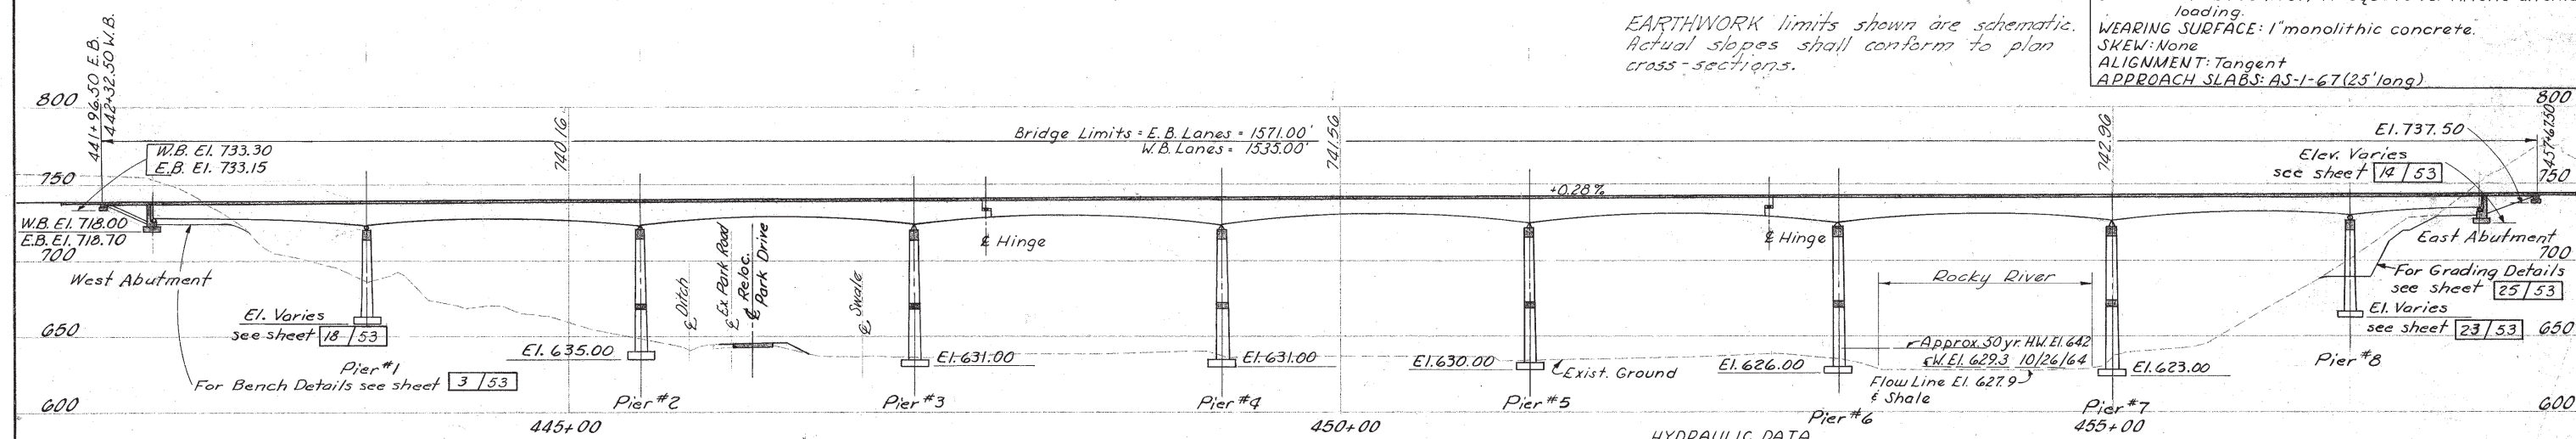
HYDRAULIC DATA
 Drainage Area: 283 sq. mi.
 $Q_{50} = 24,600$ c.f.s.
 $V_{50} = 5.1$ ft./sec. (includes overbank)
 $V_{10} = 10.4$ ft./sec. (Main channel)

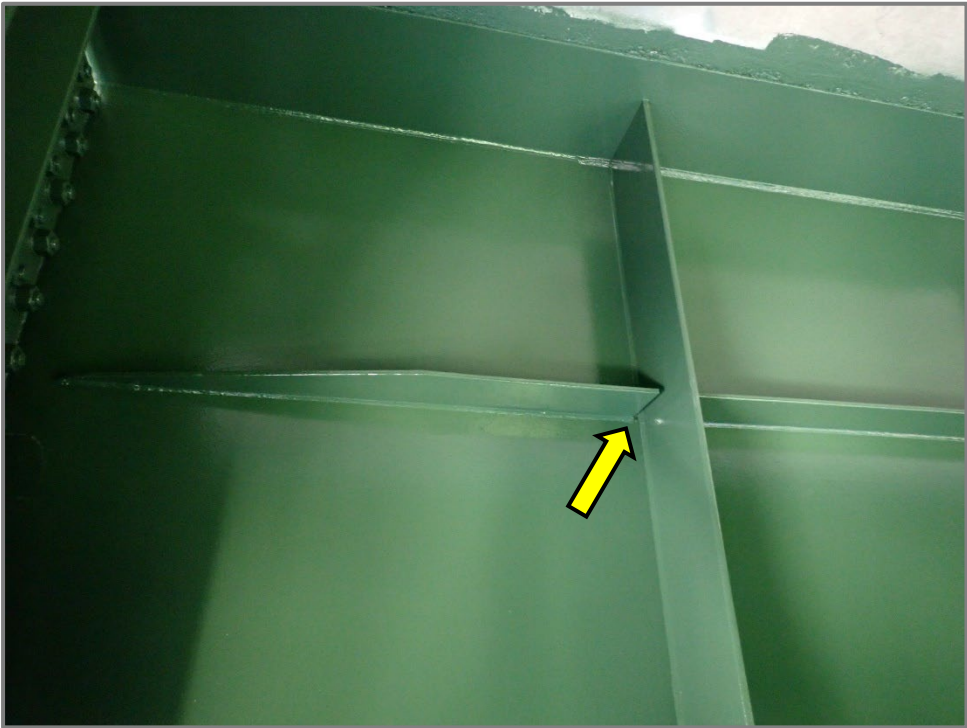
Photo 1 – Base metal at the end termination of longitudinal stiffener to girder web welds with no transition radius (Category E). Girder E at Floorbeam 18 shown, looking northeast.
