**PHYSICAL CONDITION REPORT  
FOR THE 2023 ROUTINE ELEMENT LEVEL INSPECTION**

**I-480 OVER THE ROCKY RIVER VALLEY**

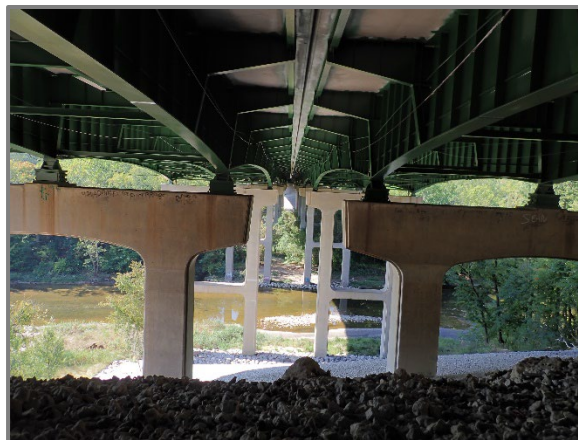
Photo 1 – Superstructure underside of the CUY-480-0647 Bridge, looking west from Forward Abutment.

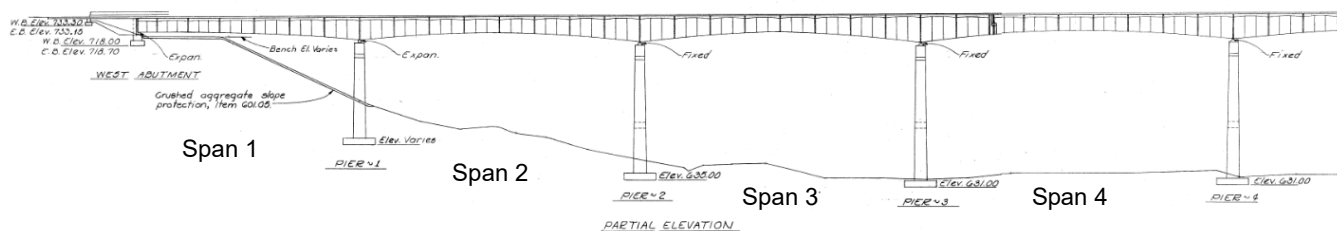
Figure 1 – Partial south elevation of CUY-480-0647 (west half).

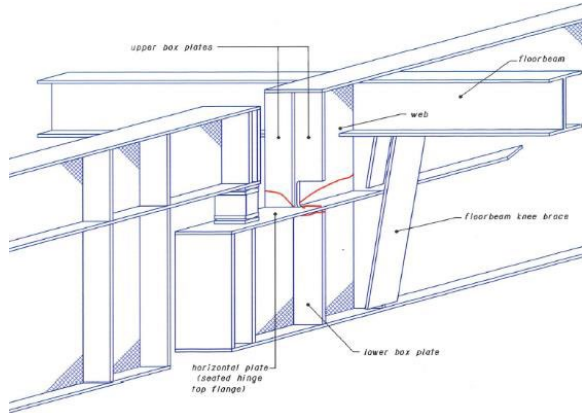
Figure 2 – Schematic diagram showing location of cracks found during the 2000 inspection (cracks shown in red).

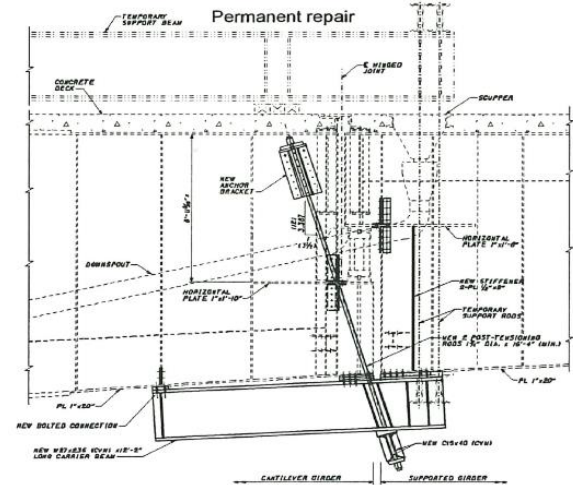
Figure 3 – Plan details showing carrier beam retrofits installed during 2001 emergency repair.

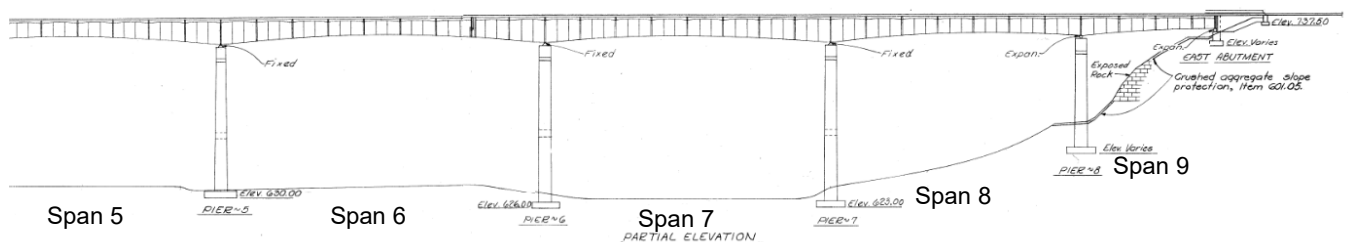
Figure 4 – Partial south elevation of CUY-480-0647 (east half).

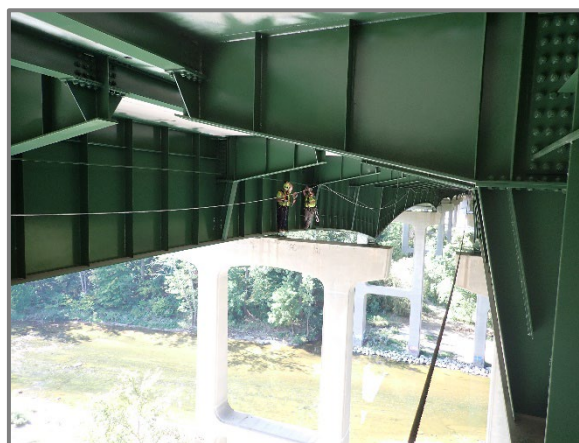
Photo 2 – Typical protected climbing and rope access techniques utilizing the safety cables along the girders, looking southwest at Girder C in Span 8.

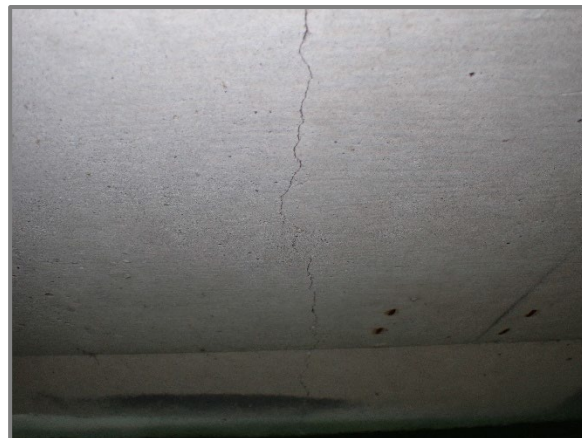
Photo 3 – Typical crack transverse crack, up to 0.020" wide, in the Span 4 underside of deck between Floorbeams 24 and 25 of the eastbound structure, looking north.

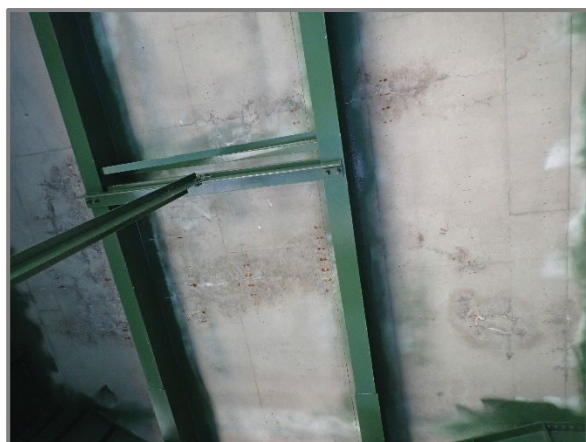
Photo 4 – Several areas of moisture staining and efflorescence in the deck underside between Girders E and F between Floorbeams 43 and 44, looking west. Note these are defects are typically located between failing patches in the wearing surface.

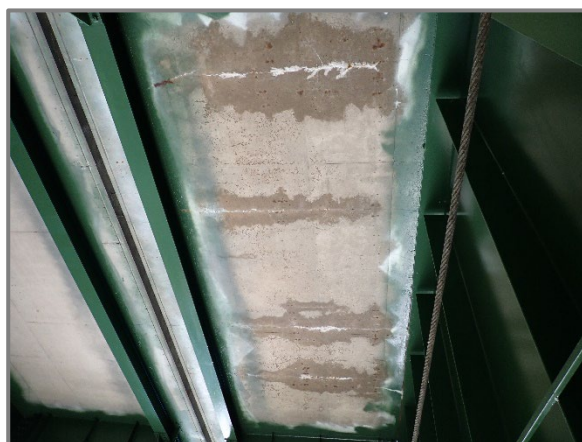
Photo 5 – Typical hairline transverse cracks with light efflorescence and leakage in the deck overhangs, looking west at the south overhang of the westbound structure between Floorbeams 23 and 24.

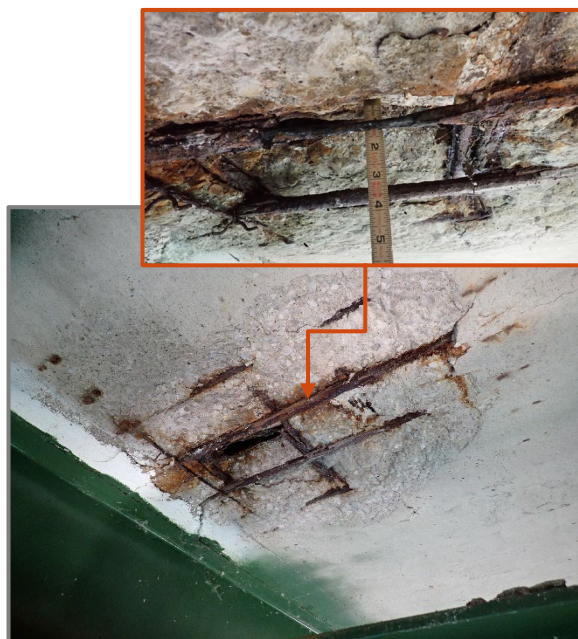
Photo 6 – 36" long by 42" wide by up to 5" deep spall with debonded and corroded reinforcement (up to 90%) along the south side of Stringer 11 at Floorbeam 42 on the westbound structure, looking northeast.

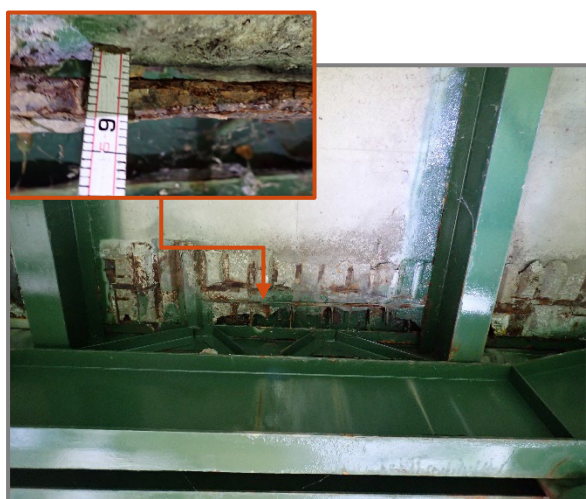
Photo 7 – 7' wide by up to 15" long by full depth spall with two layers of fully exposed and corroded reinforcement at the end of the eastbound structure deck along the Span 6 expansion joint armor, looking east. Note up to 20% section loss to the exposed reinforcement.

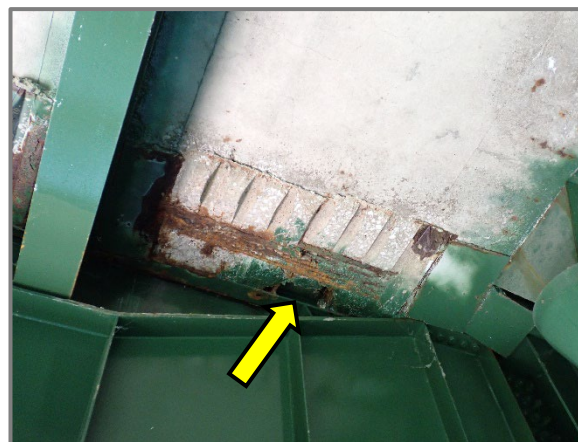
Photo 8 – 18" long by 8" wide by full depth spall with exposed and corroded reinforcement in the westbound structure deck underside along the Span 4 expansion joint, looking west.

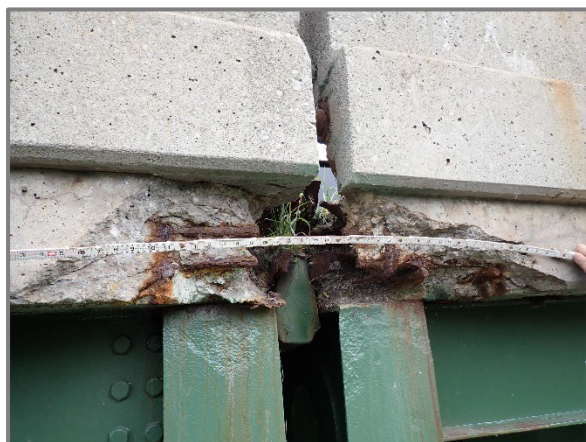
Photo 9 – Large spalls with multiple layers of exposed and corroded reinforcement in the south deck edge of the eastbound structure at the Span 4 expansion joint, looking north.

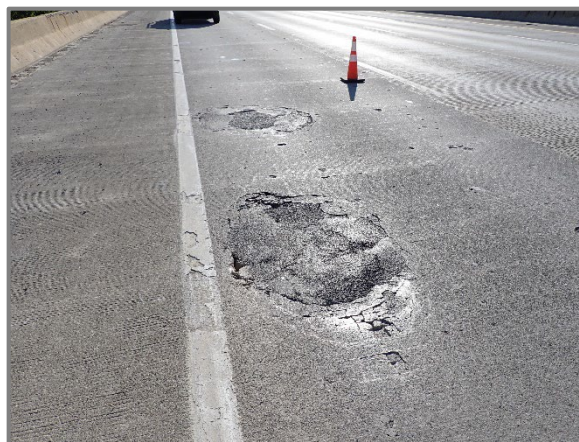
Photo 10 – Typical failing patches in the right lane of the westbound structure wearing surface in Span 5, looking east. Note additional broken up wearing surface material around the perimeter of the patches.

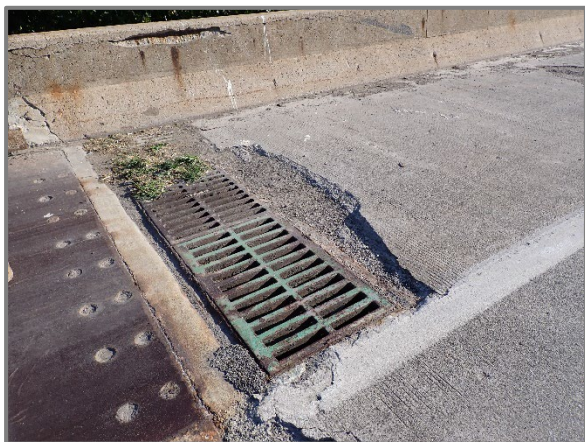
Photo 11 – Typical potholes along the drainage scuppers, looking northeast at a drainage scupper in the westbound right shoulder in Span 4.

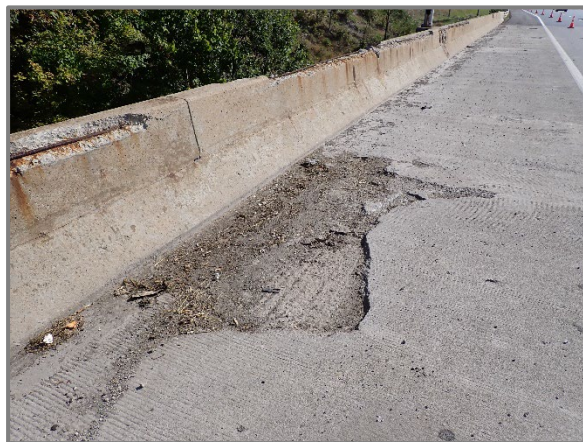
Photo 12 – Large pothole in the right shoulder of the Span 8 wearing surface on the westbound structure at the base of the bridge railing, looking northeast.

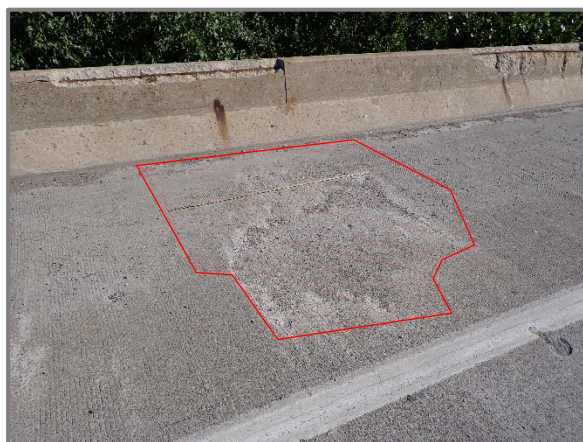
Photo 13 – Delaminated area with moderate abrasion, up to 7'-3" long by 9' wide, in westbound right shoulder, looking north.

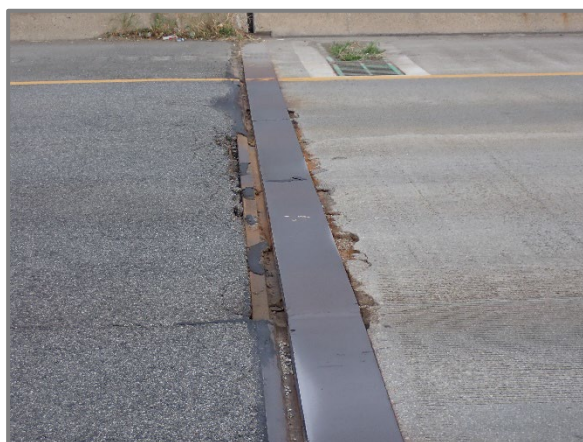
Photo 14 – 1/2" vertical misalignment at the Rear Abutment joint for the eastbound structure, looking north. Note the adjacent spalling to the joint header in the 2<sup>nd</sup> lane (from left).

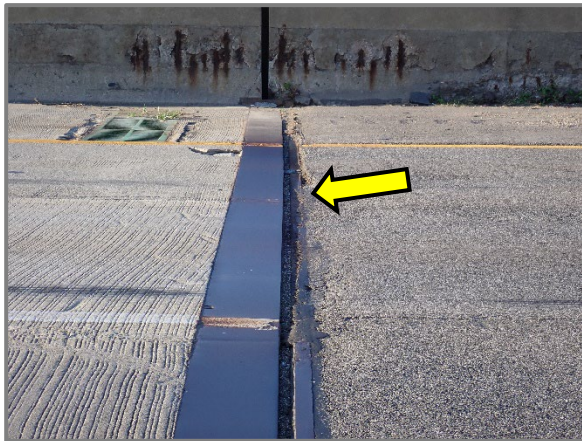
Photo 15 – Joint armor discontinuous and depressed approximately 1/2" at the westbound Rear Abutment joint in the 2<sup>nd</sup> lane (from left), looking south.

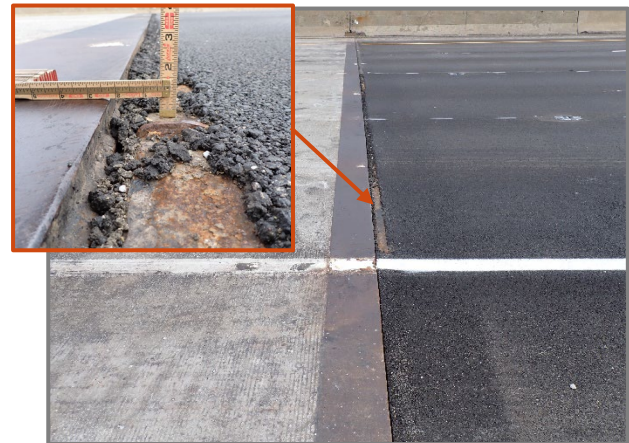
Photo 16 – Up to 1" vertical misalignment at the eastbound Forward Abutment joint in the right two lanes, looking north. Note the asphalt on the east side of the joint has been replaced since the previous inspection.

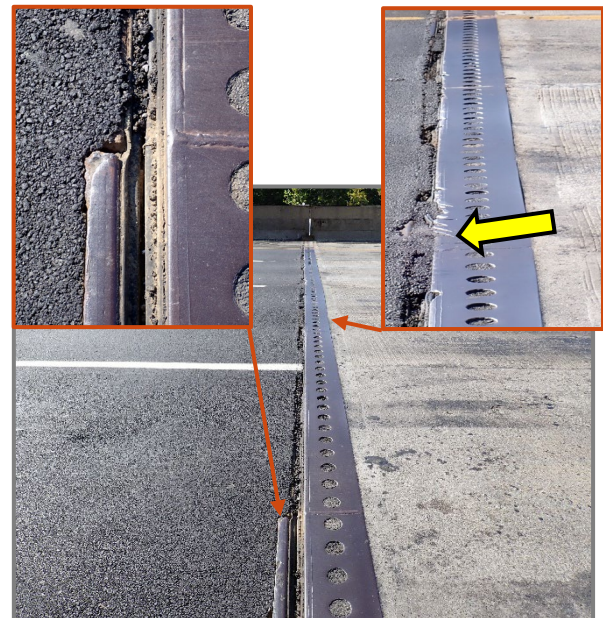
Photo 17 – Westbound Forward Abutment joint with moderate plow damage to the west joint armor and break in the east armor in the right shoulder, looking south. Note east approach has been repaved since the previous inspection and asphalt now covers majority of east joint armor.

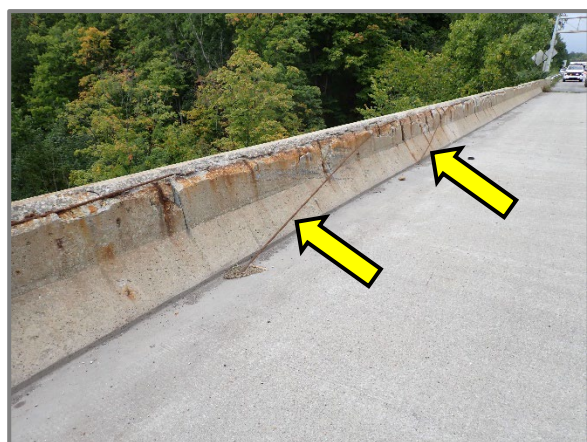
Photo 18 – Typical spalls, up to full width, with exposed, corroded, missing, and debonded reinforcement along the top edges of the exterior bridge railings, looking southwest at the south railing in Span 1 of the eastbound structure. Note the debonded top longitudinal bars hanging down.

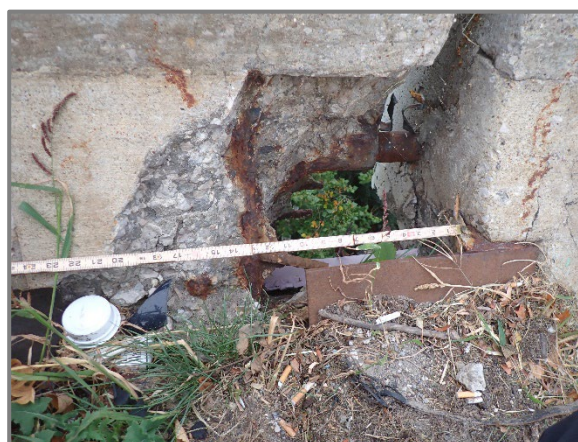
Photo 19 – 24" long by 24" high by full depth spall in the south bridge railing on the east side of the Span 6 joint on the eastbound structure, looking south. Note that spalls of this nature are typically present at the hinge joints.

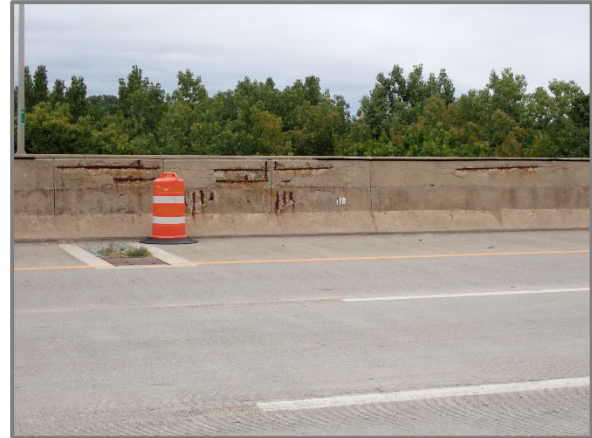
Photo 20 – Widespread spalling of the median barrier on the eastbound structure near Pier 4, looking north.

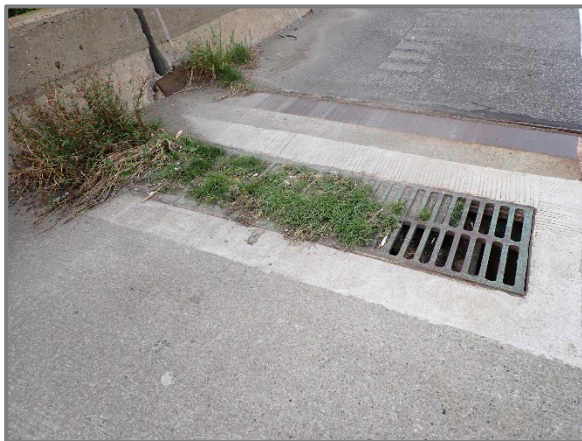
Photo 21 – Partially clogged drainage scupper (approximately 85% clogged), looking southwest at the west end of the bridge on the eastbound structure. Note downspout is clear.

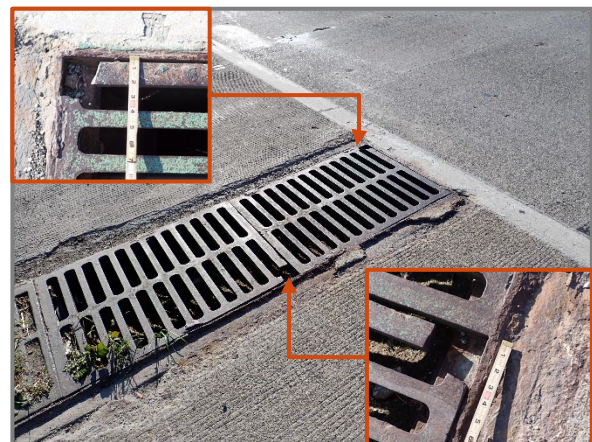
Photo 22 – Scupper grate near Pier 4 of the westbound structure with broken grate bars at the corners, looking southeast.

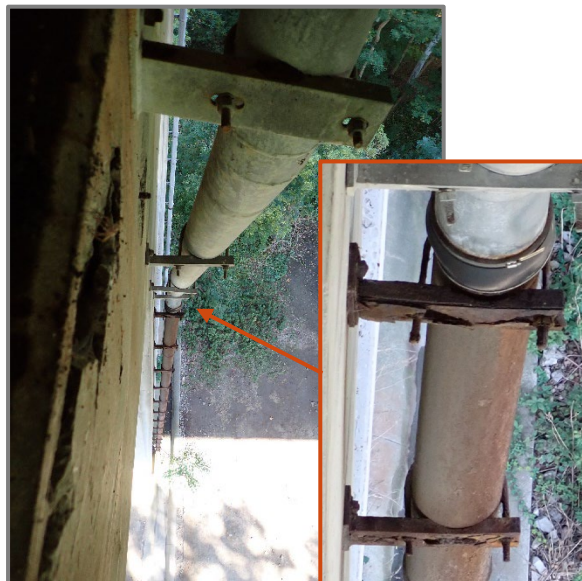
Photo 23 – Downspout on Pier 3 of westbound structure with moderate surface corrosion to downspout pipe and corrosion holes in downspout supports due to leakage from joint, looking north.

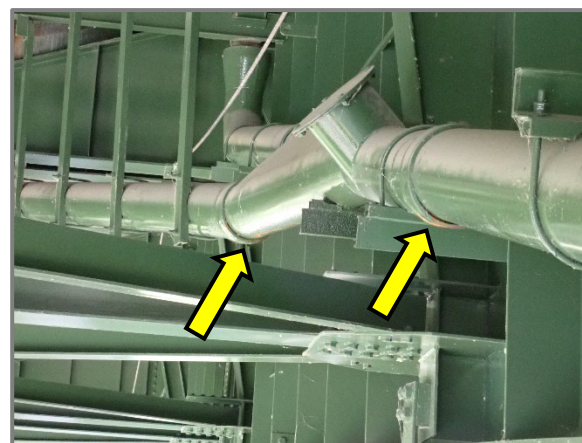
Photo 24 – Evidence of leakage in the north downspout near the hinge joint in Span 6 of the westbound structure, looking west. Note that corrosion holes were observed during the 2020 inspection but have not been noted since.

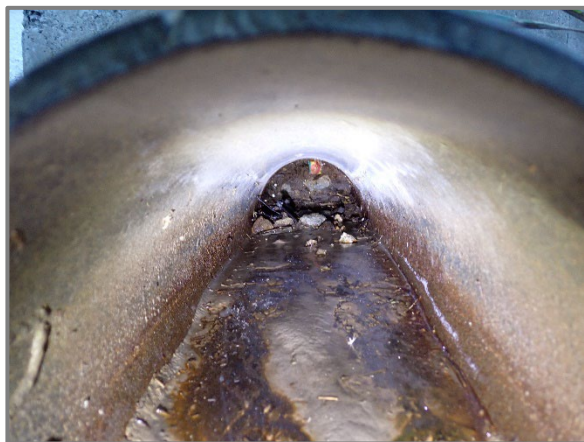
Photo 25 – Downspout at Pier 7 for the eastbound bridge fully clogged at bottom elbow approximately 4' from the outlet, looking east.

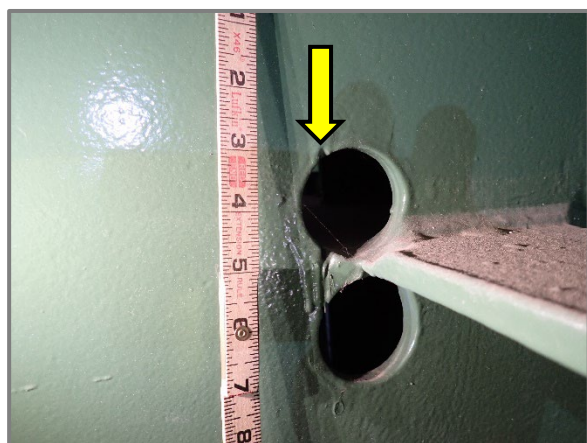
Photo 27 – Typical dogbone retrofit overcut in the girder web, looking north at Girder B at Floorbeam 6.

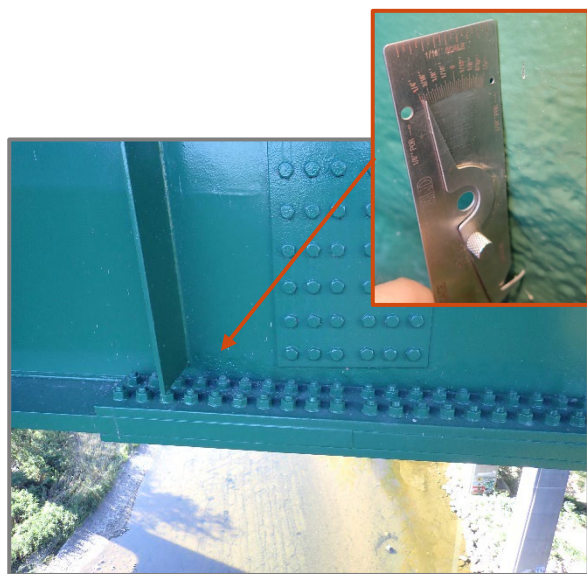
Photo 28 – Cleaned and painted pitting 1/8" deep on the bottom of the north face of the Girder F web along the bolted splice between Floorbeams 54 and 55, looking south.

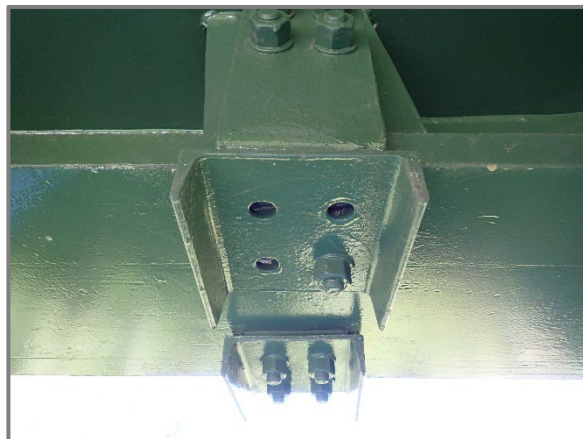
Photo 29 – 3 of 4 bottom flange bolts missing in the Girder F knee brace connection retrofit at Floorbeam 15, looking north.

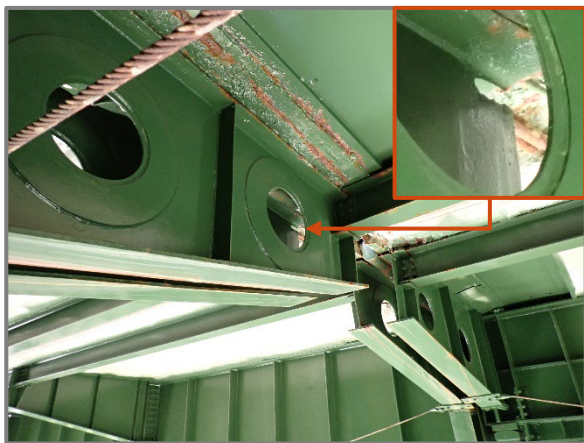
Photo 30 – 3" long by 1" high corrosion hole at the top of the Floorbeam 26 north cantilever on the eastbound structure at its end, looking northwest. Note that Floorbeam 27 is similar.

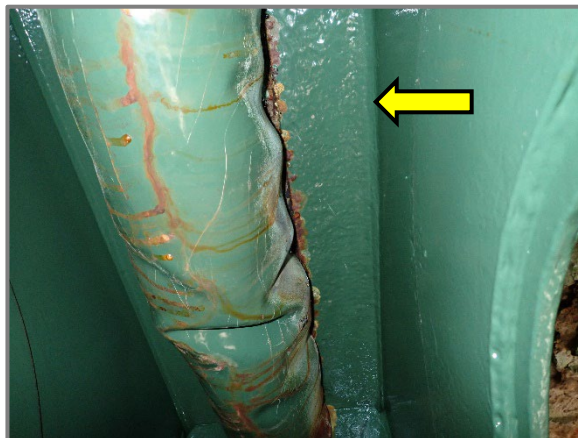
Photo 31 – Floorbeam 26 south cantilever on the westbound structure with cleaned and painted pitting 1/8" deep for the full width of the east top flange, looking south.

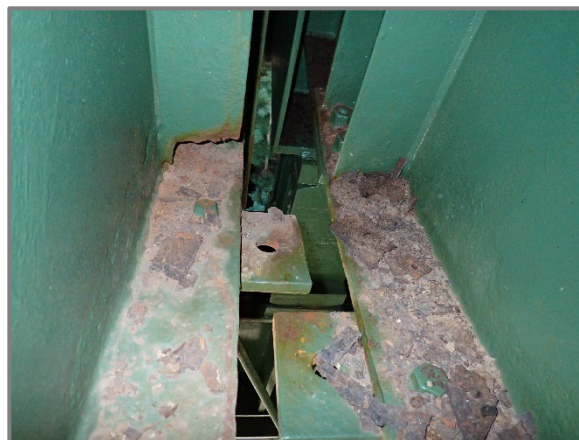
Photo 32– South cantilever of Floorbeam 26 on the westbound structure with 100% section loss at the base of a transverse stiffener near the base, looking north.

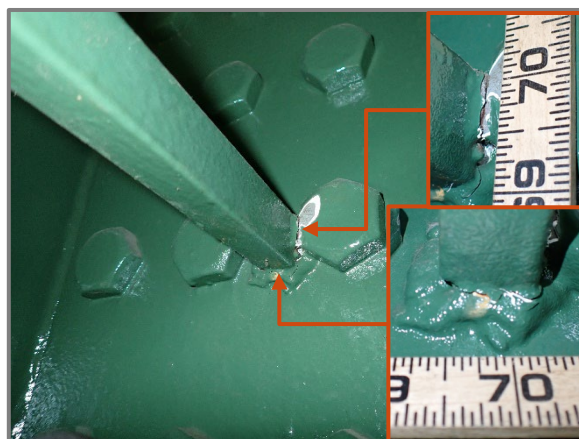
Photo 33– Broken welds on south face and underside on weld between handrail bar and west connection angle for south cantilever of Floorbeam 70 to Girder D on the westbound structure, looking east.

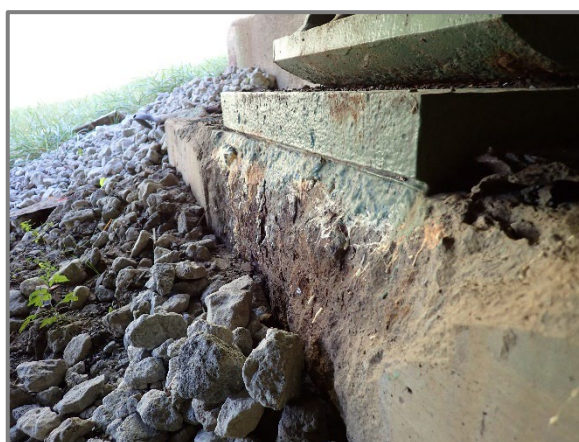
Photo 34 – Spall in the west face of the Girder F seat pedestal at the Forward Abutment undermining the bearing masonry plate up to 3/4" deep, looking north.

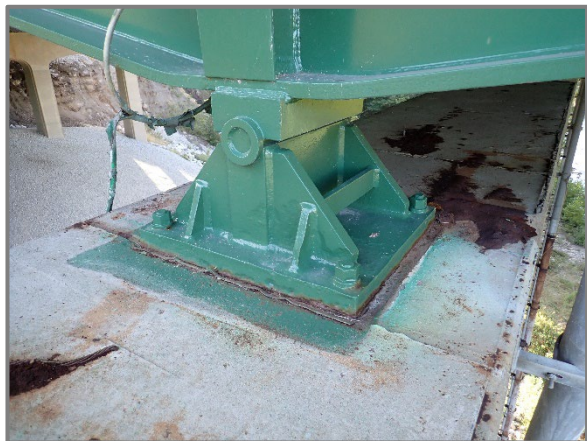
Photo 35 – Up to 1/4" deep cleaned and painted pitting on the bearing assembly and masonry plate for Girder F at Pier 7, looking south.

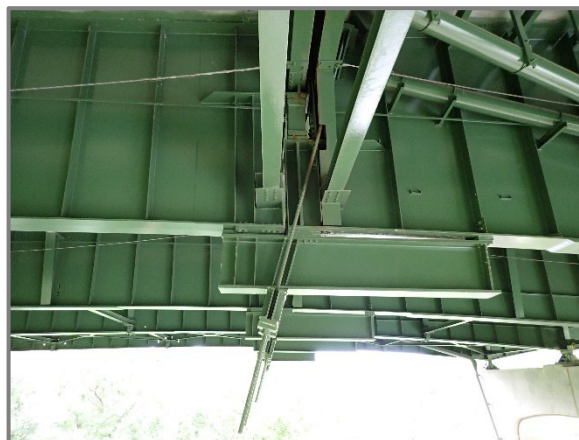
Photo 37 – Typical carrier beam retrofit installed below the seated hinge joints, looking north at Girder C at the Span 6 expansion joint.

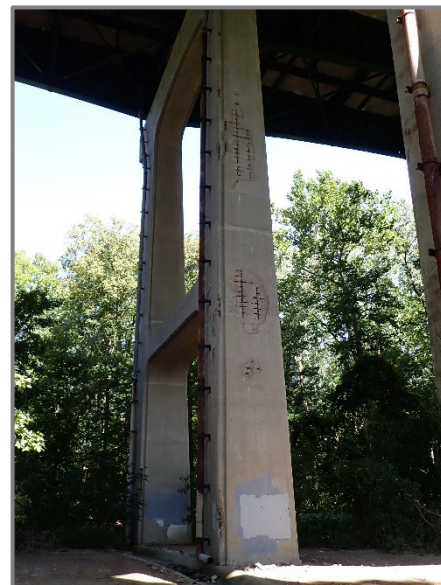
Photo 38 – Numerous delaminations and spalls with exposed reinforcement throughout the north column at Pier 3 of the eastbound structure, looking southwest.

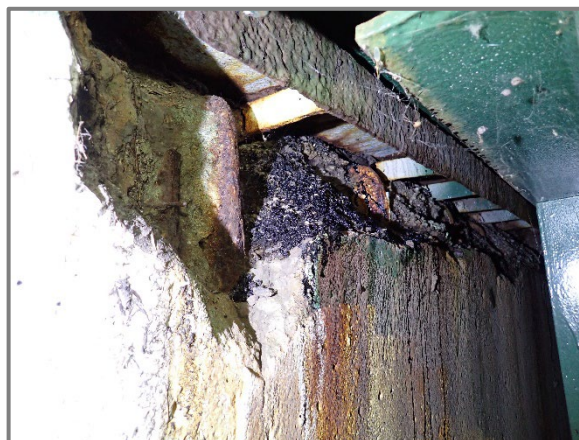
Photo 39 – Spall at the top of the Forward Abutment backwall behind Girder C undermining the joint armor above, looking northeast.

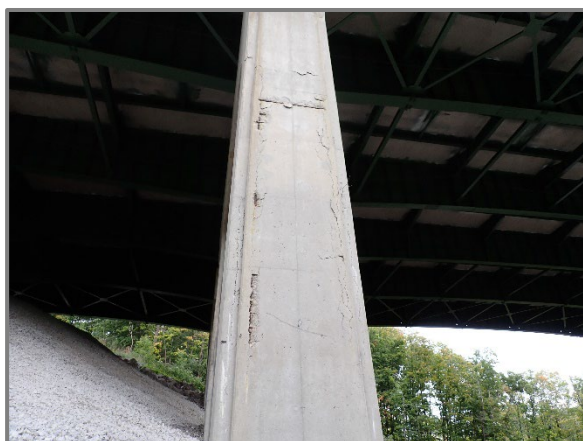
Photo 40 – Numerous spalls with exposed reinforcement and delaminations on the south column at Pier 1 of the eastbound structure, looking north.

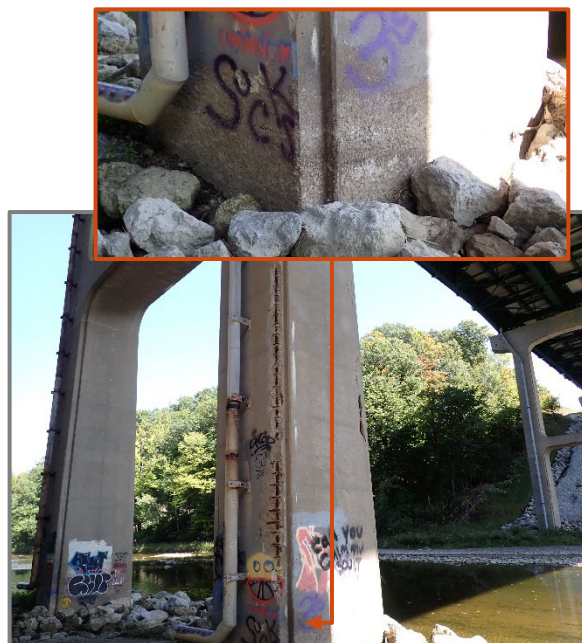
Photo 41 – Corner spalls with exposed reinforcing on south column of Pier 6 of the westbound structure, looking northeast. Note minor scaling to bottom 18" of column.

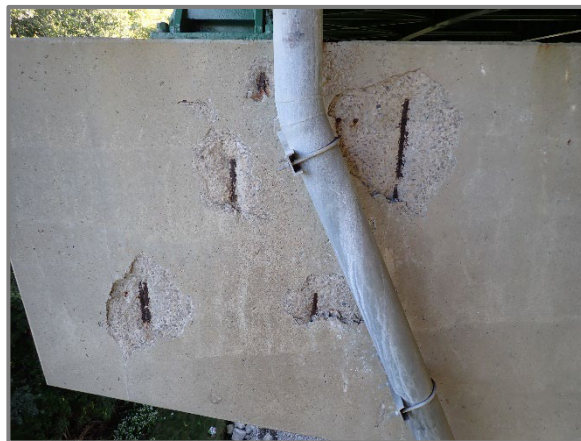
Photo 42 – 72" high by 60" wide area with that is delaminated and spalled up to 2" deep with exposed and corroded reinforcement behind the downspout on the west face of the Pier 7 cap for the westbound structure, looking east.

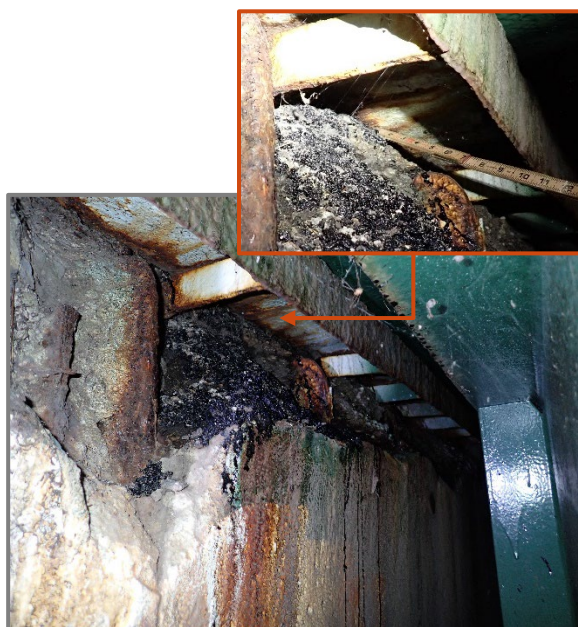
Photo 43 – 12" high by 10" deep by 8.5' wide spall with exposed reinforcement in the top of the Forward Abutment backwall behind Girder C that is undermining the joint armor support up to 10", looking southeast. Note this area is under the left shoulder of the eastbound bridge.

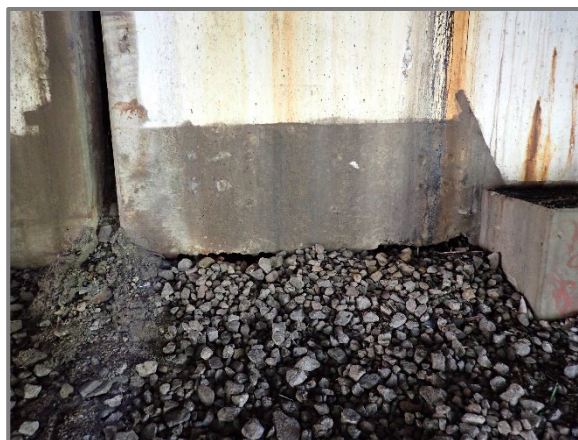
Photo 44 – Forward Abutment backwall for the eastbound structure undermined up to 5" high by 13" deep over a 7' length at the north end, looking east.

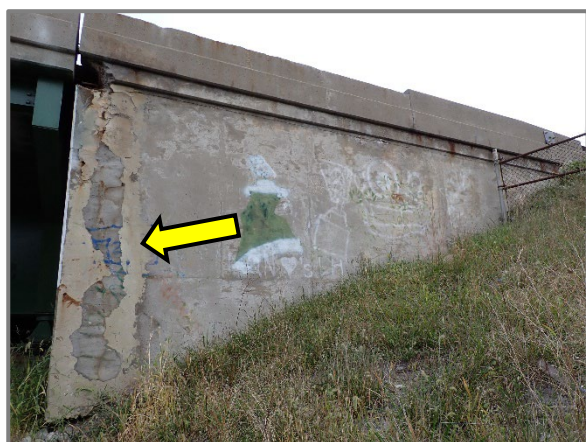
Photo 45 – 12" wide patch beginning to fail in the south wingwall at the along the Forward Abutment connection, looking north.

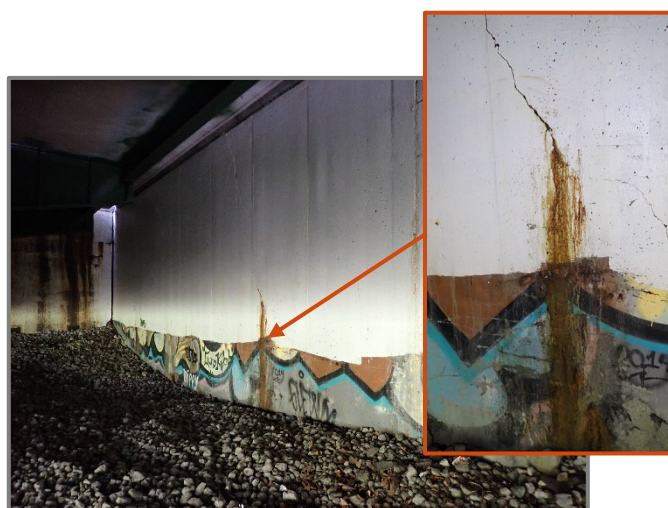
Photo 46 – 1/8" wide vertical/diagonal crack with moderate efflorescence and rust staining in the interior wingwall at the Rear Abutment, looking northwest.

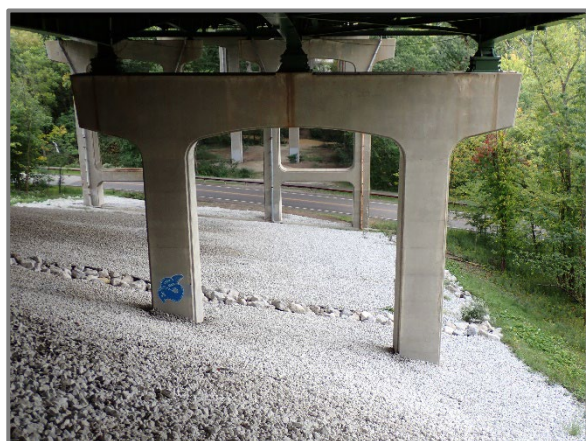
Photo 47 – View of slope protection on west slope from the Rear Abutment, looking east.

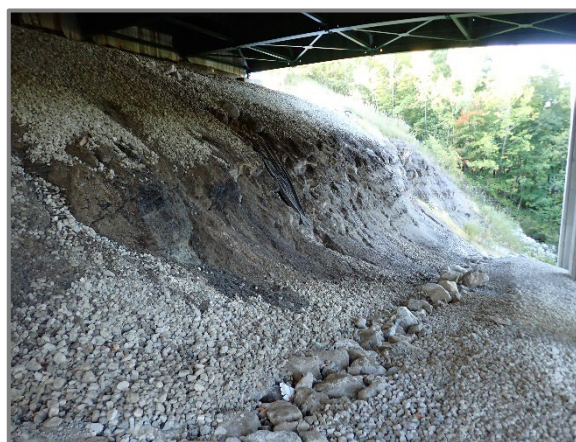
Photo 49 – Erosion channel in front of the Forward Abutment, looking south. Note that new slope protection should mitigate further erosion.

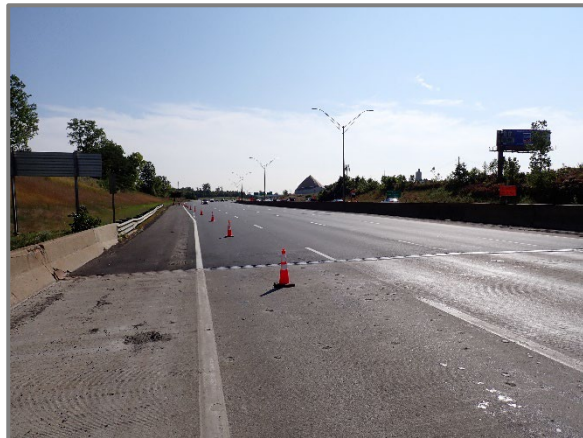
Photo 50 – Forward approach roadway resurfaced since the previous inspection, looking east.

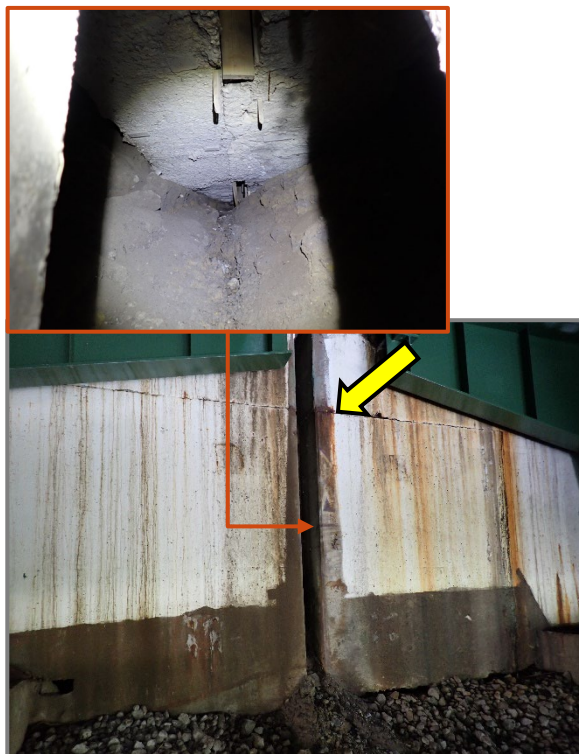
Photo 51 – Embankment fill spilling out from behind the Forward Abutment backwall through the median joint, looking north. Note this embankment fill is located below the reinforced concrete “abutment span” behind this backwall.

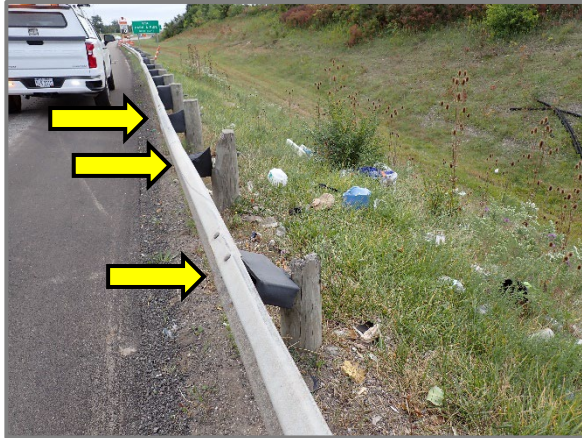
Photo 52 – Damaged timber posts and plastic blockouts on Posts 3 through 6 from the bridge end in the southeast corner approach guardfence, looking east.

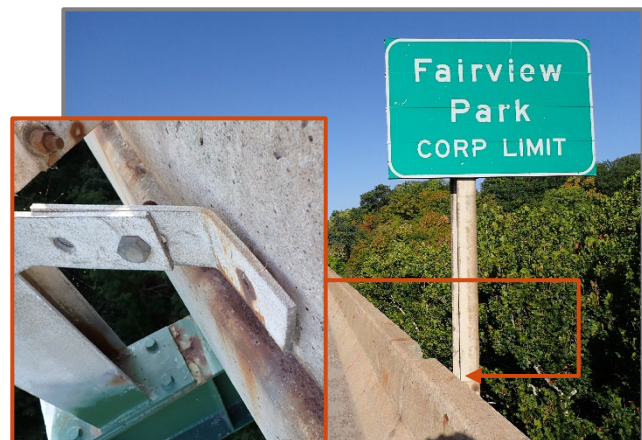
Photo 53 – Broken bolt connecting the "Corporation Limit" to the north rail of the westbound structure in Span 4, looking west. Note sign support still connected to floorbeam top flange.

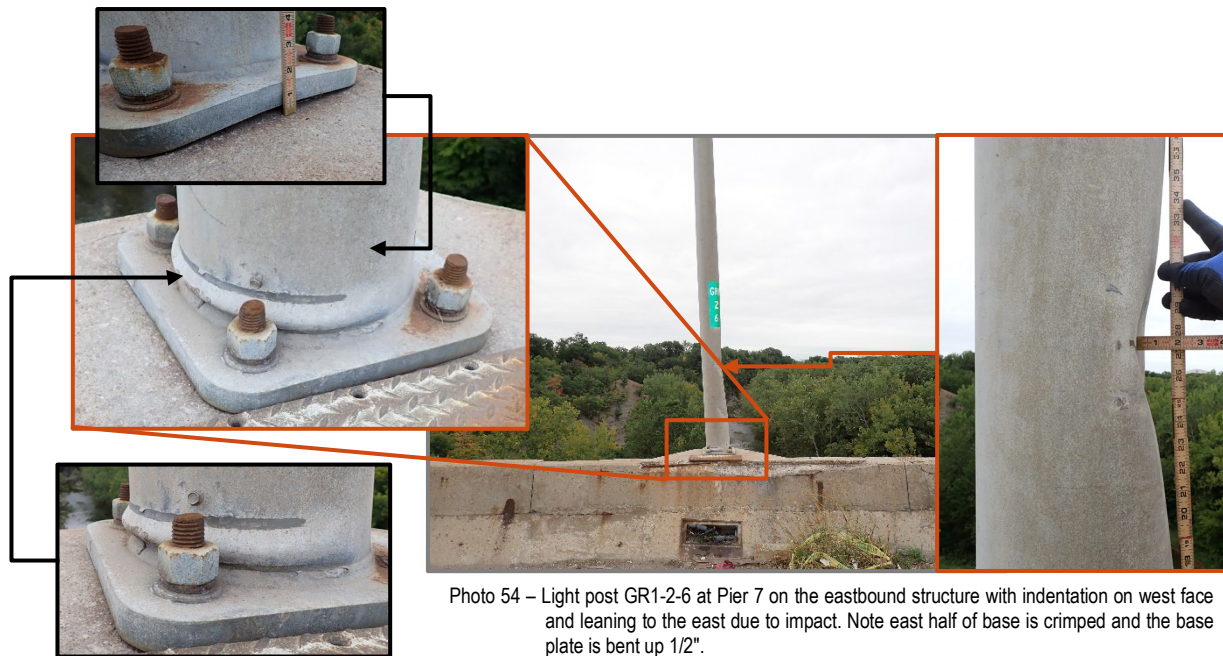
Photo 54 – Light post GR1-2-6 at Pier 7 on the eastbound structure with indentation on west face and leaning to the east due to impact. Note east half of base is crimped and the base plate is bent up 1/2".

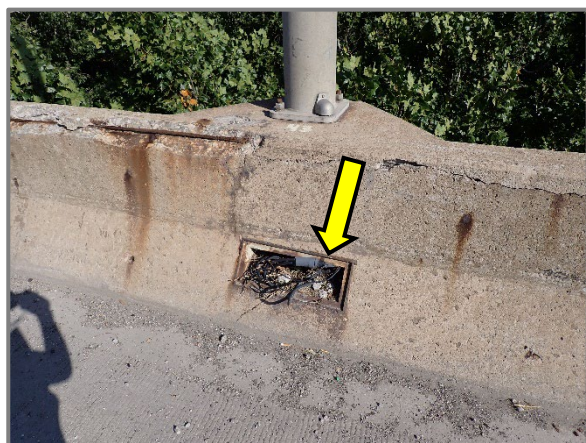
Photo 55 – Typical missing electrical panel access hatch below the light poles, looking north at north railing in Span 6. Note exposed wiring, dirt, granular debris, and vegetation growth inside the panel.

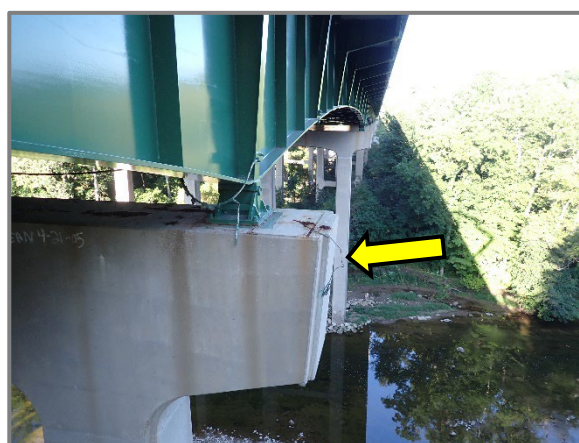
Photo 56 – Typical broken grounding cable at the pier caps, looking west at Pier 7 adjacent to Girder F.

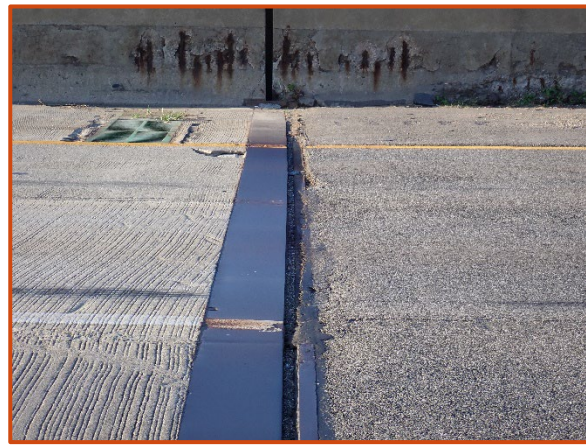
Joint armor discontinuous and depressed approximately 1/2" at the westbound Rear Abutment joint in the 2<sup>nd</sup> lane (from left), looking south.

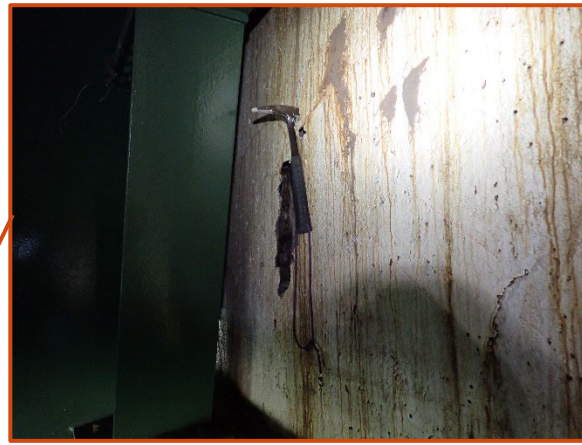
6' high by 4' wide by up to 3" deep delamination/spall in the Rear Abutment backwall behind Girder E, looking southwest.

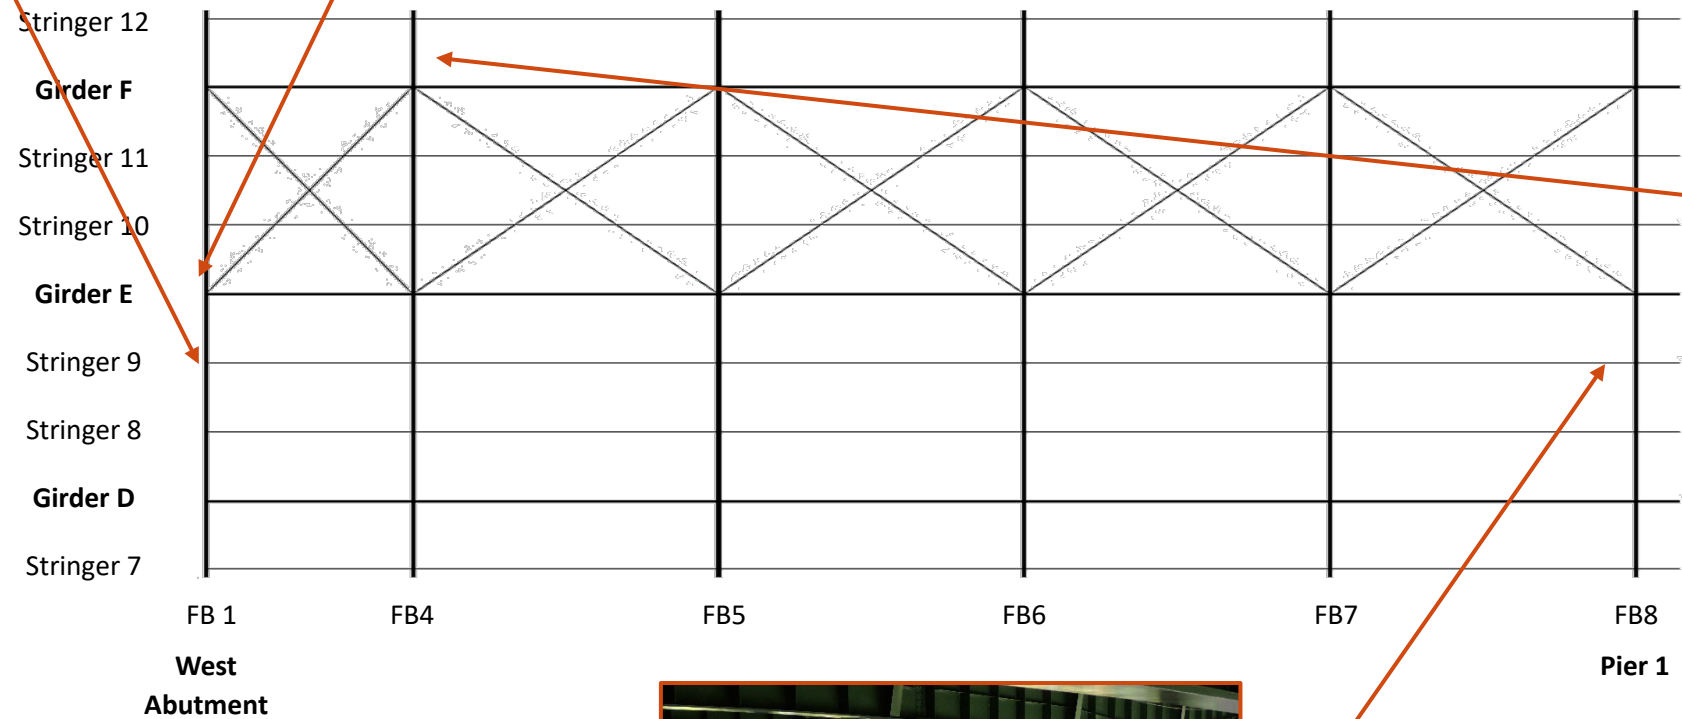
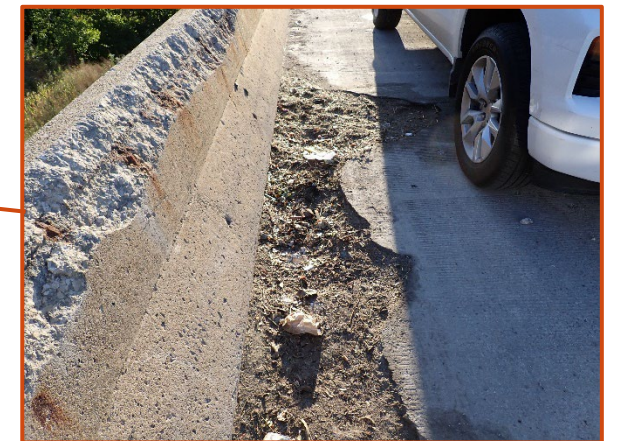
Up to 12' long by 50" wide by 2" deep pothole in the right shoulder of the Span 1 wearing surface for the westbound structure, looking east.

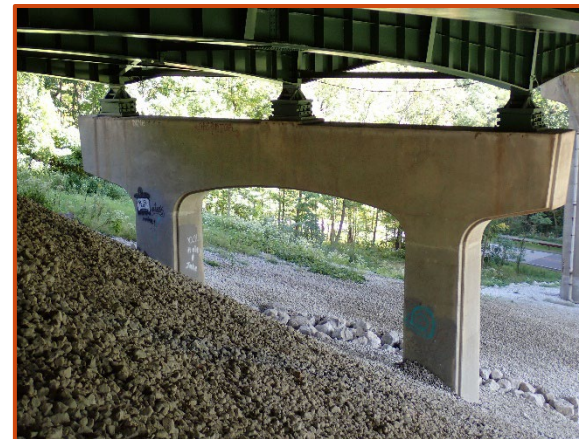
General view of Pier 1 for the westbound structure, looking east.

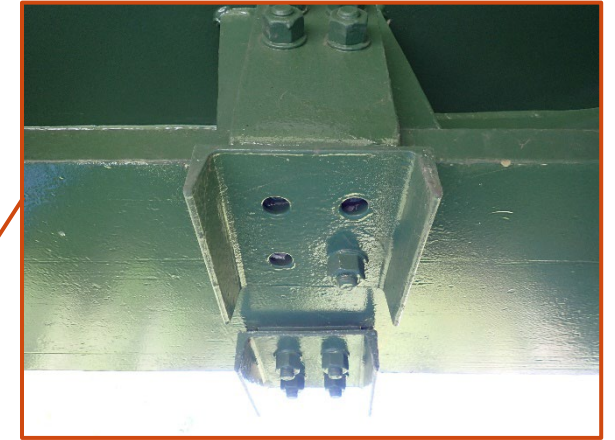
3 of 4 bottom flange bolts missing in the Girder F knee brace connection retrofit at Floorbeam 15, looking north.
