**PHYSICAL CONDITION REPORT  
FOR THE 2023 ROUTINE ELEMENT LEVEL INSPECTION**

**I-480 OVER THE ROCKY RIVER VALLEY**

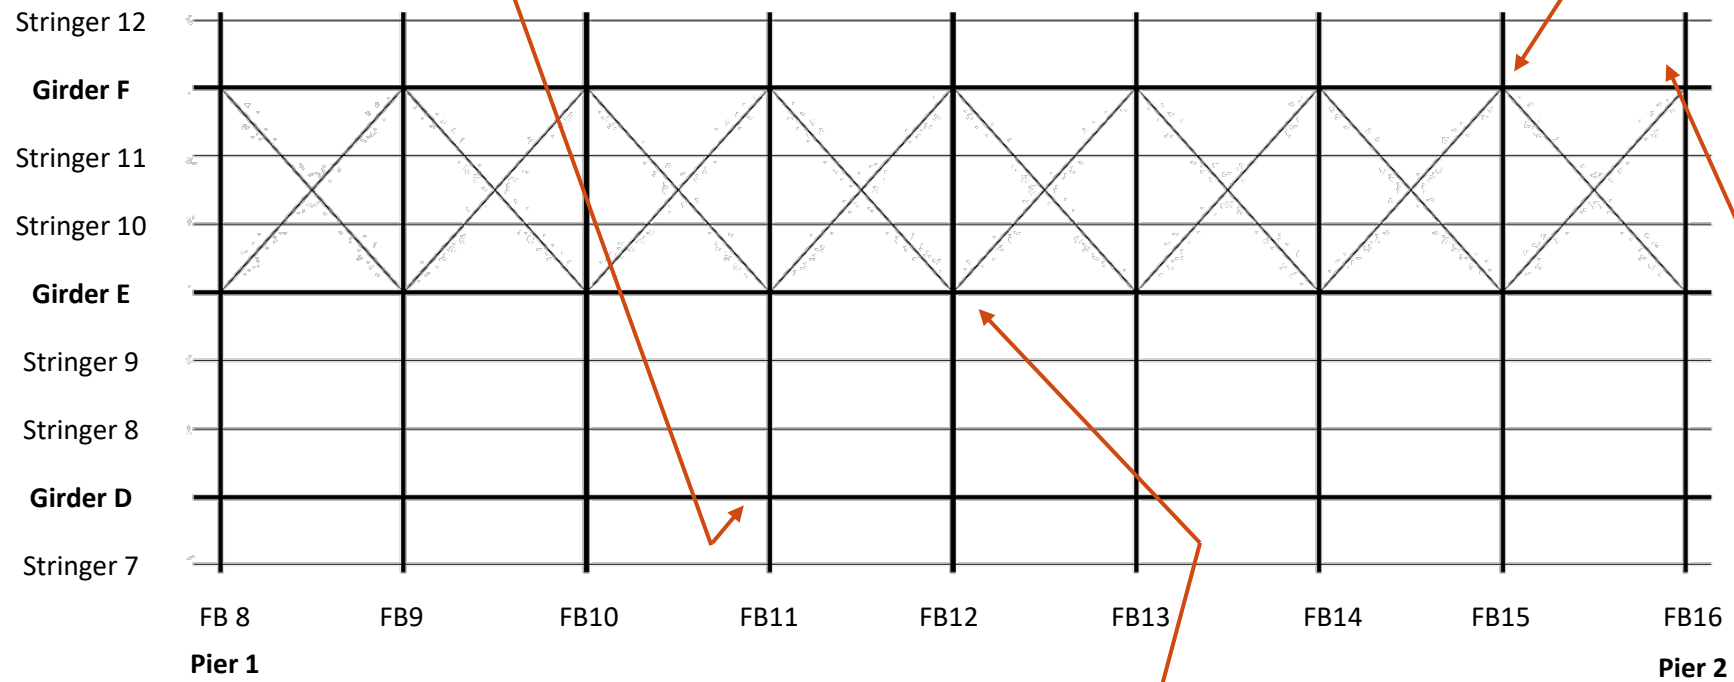
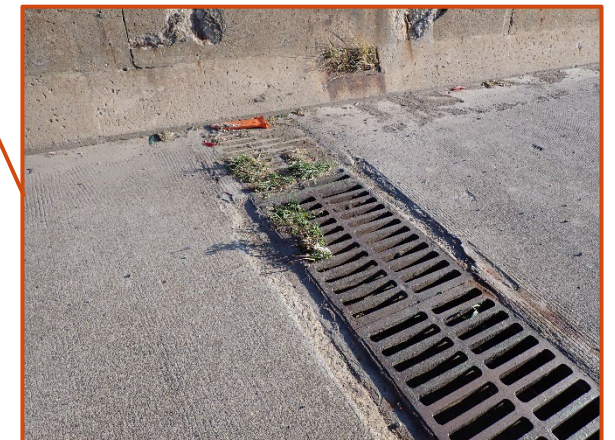
Scupper with typical clogging up to 50% and potholes in the surrounding wearing surface, looking north.

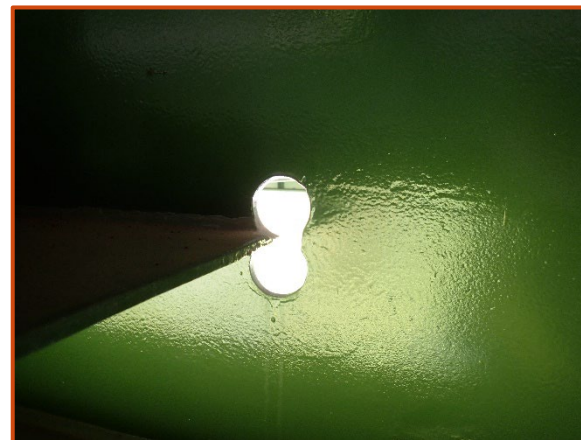
Dogbone undercut and overlapping drilled arrest holes in the web of Girder E on the west side of Floorbeam 12, looking north.

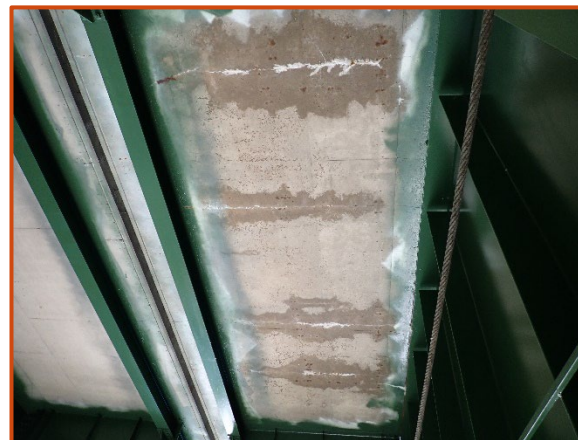
Typical hairline transverse cracks with light efflorescence and leakage in the deck overhangs, looking west at the south overhang of the westbound structure between Floorbeams 23 and 24.

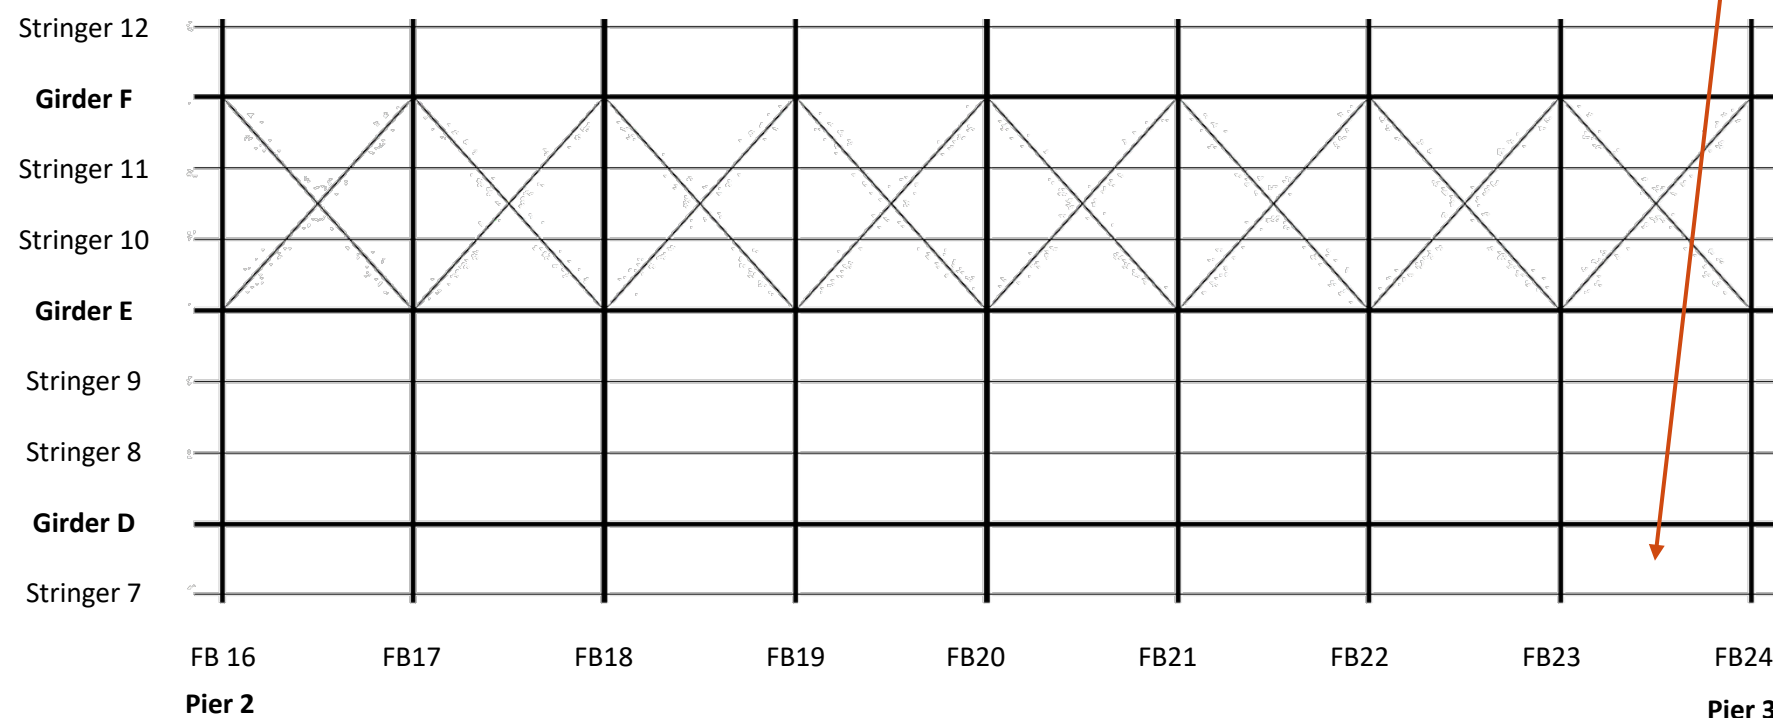
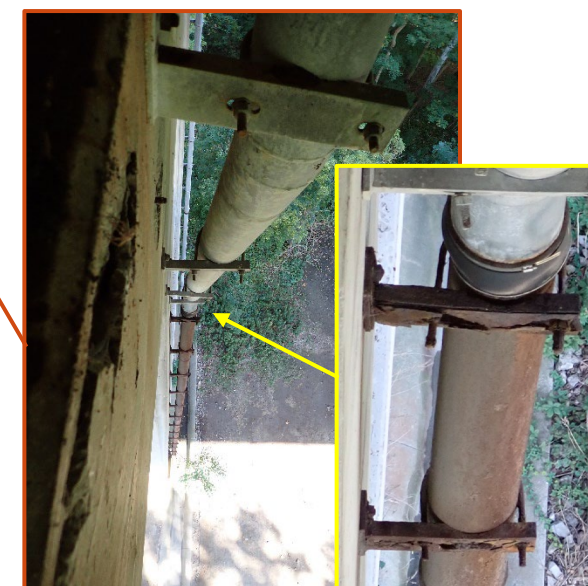
Downspout on Pier 3 of westbound structure with moderate surface corrosion to downspout pipe and corrosion holes in downspout supports due to leakage from joint, looking north.

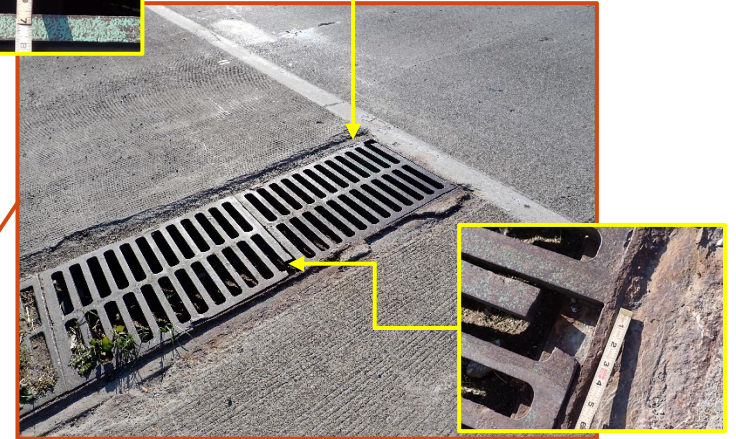
Scupper grate near Pier 4 of the westbound structure with broken grate bars at the corners, looking southeast.

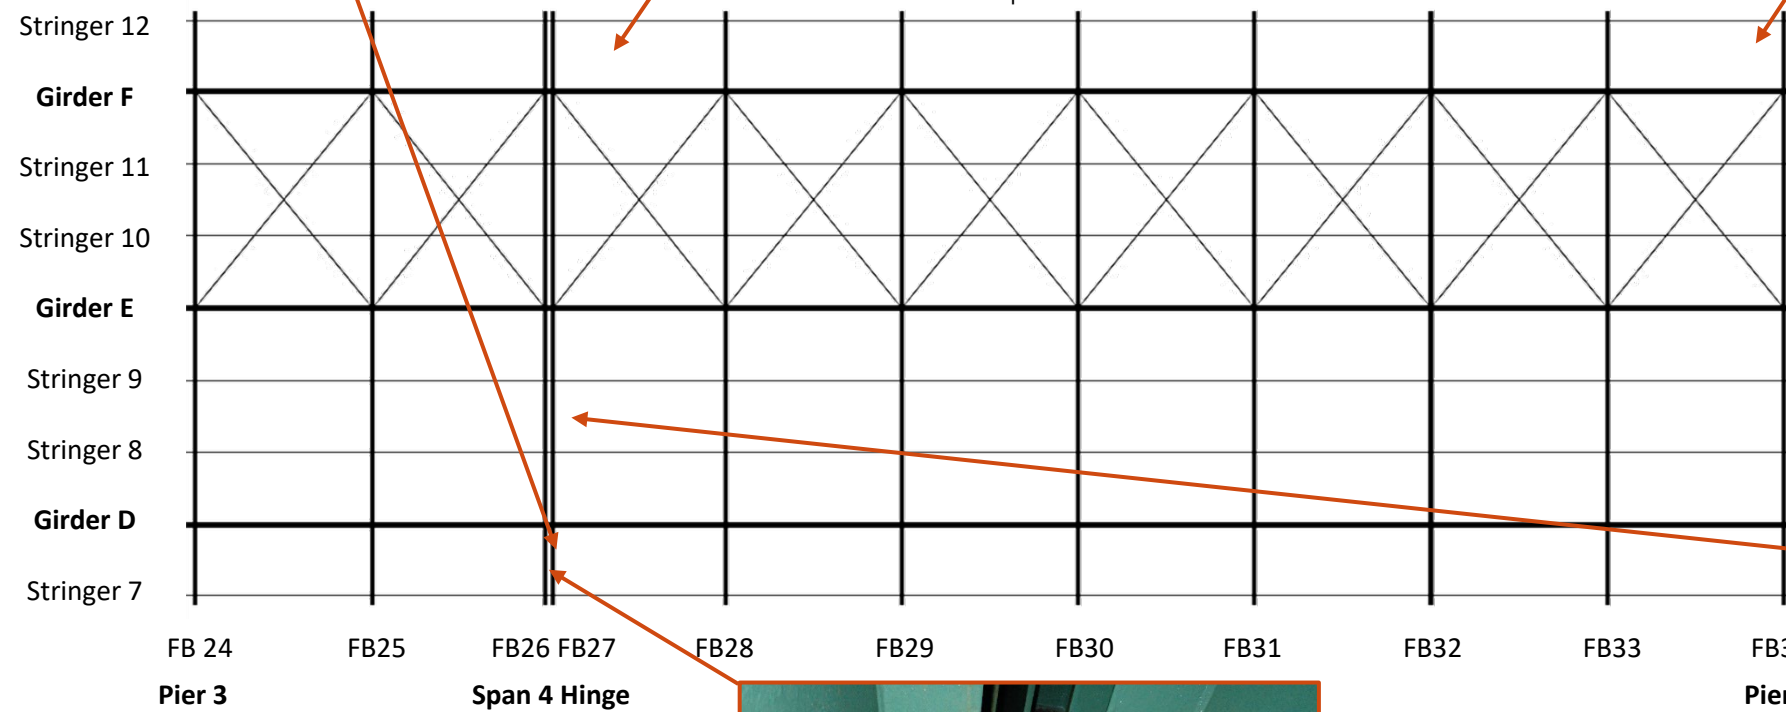
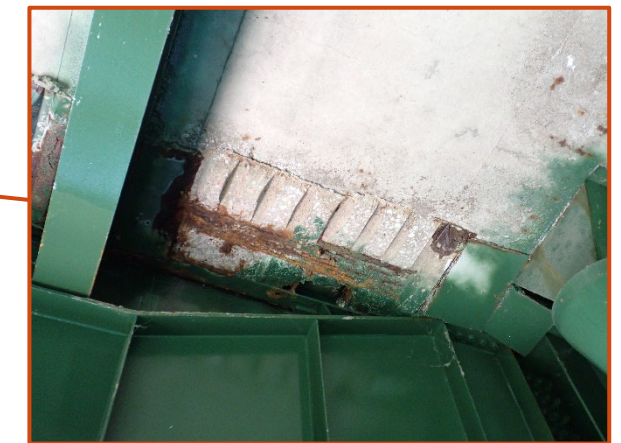
18" long by 8" wide by full depth spall with exposed and corroded reinforcement in the westbound structure deck underside along the Span 4 expansion joint, looking west.

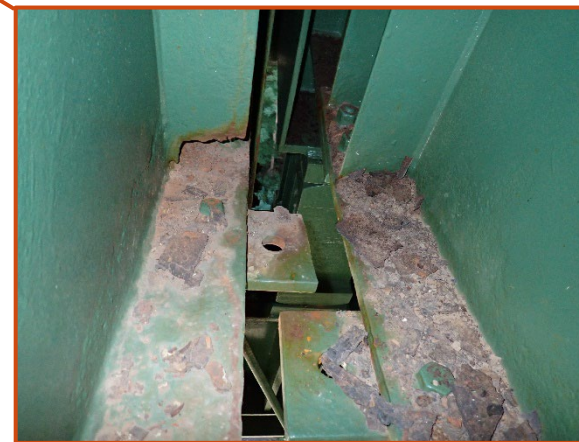
South cantilever of Floorbeam 26 on the westbound structure with 100% section loss at the base of a transverse stiffener near the base, looking north.

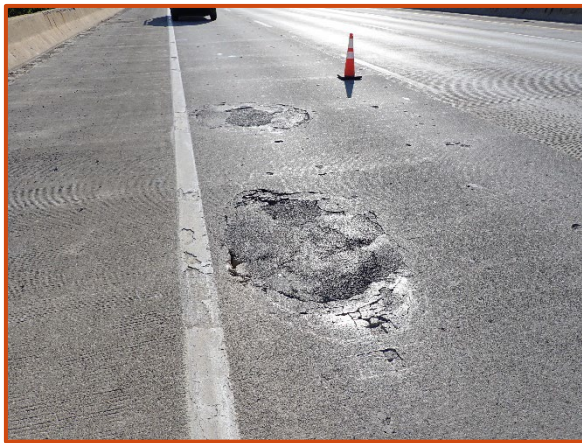
Typical failing patches in the right lane of the westbound structure wearing surface in Span 5, looking east. Note additional broken up wearing surface material around the perimeter of the patches.

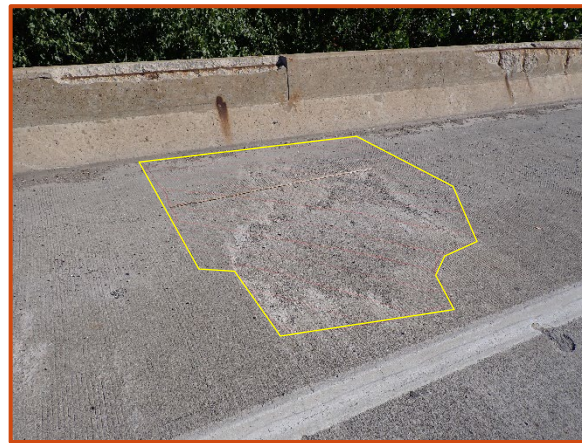
Delaminated area with moderate abrasion, up to 7'-3" long by 9' wide, in westbound right shoulder, looking north.

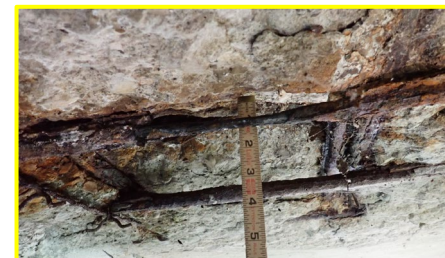
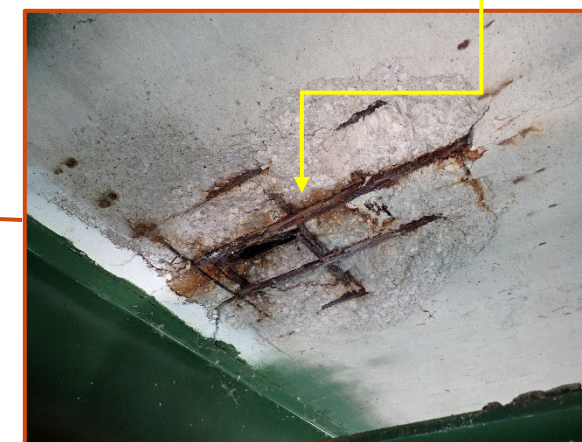
36" long by 42" wide by up to 5" deep spall with debonded and corroded reinforcement (up to 90%) along the south side of Stringer 11 at Floorbeam 42 on the westbound structure, looking northeast.

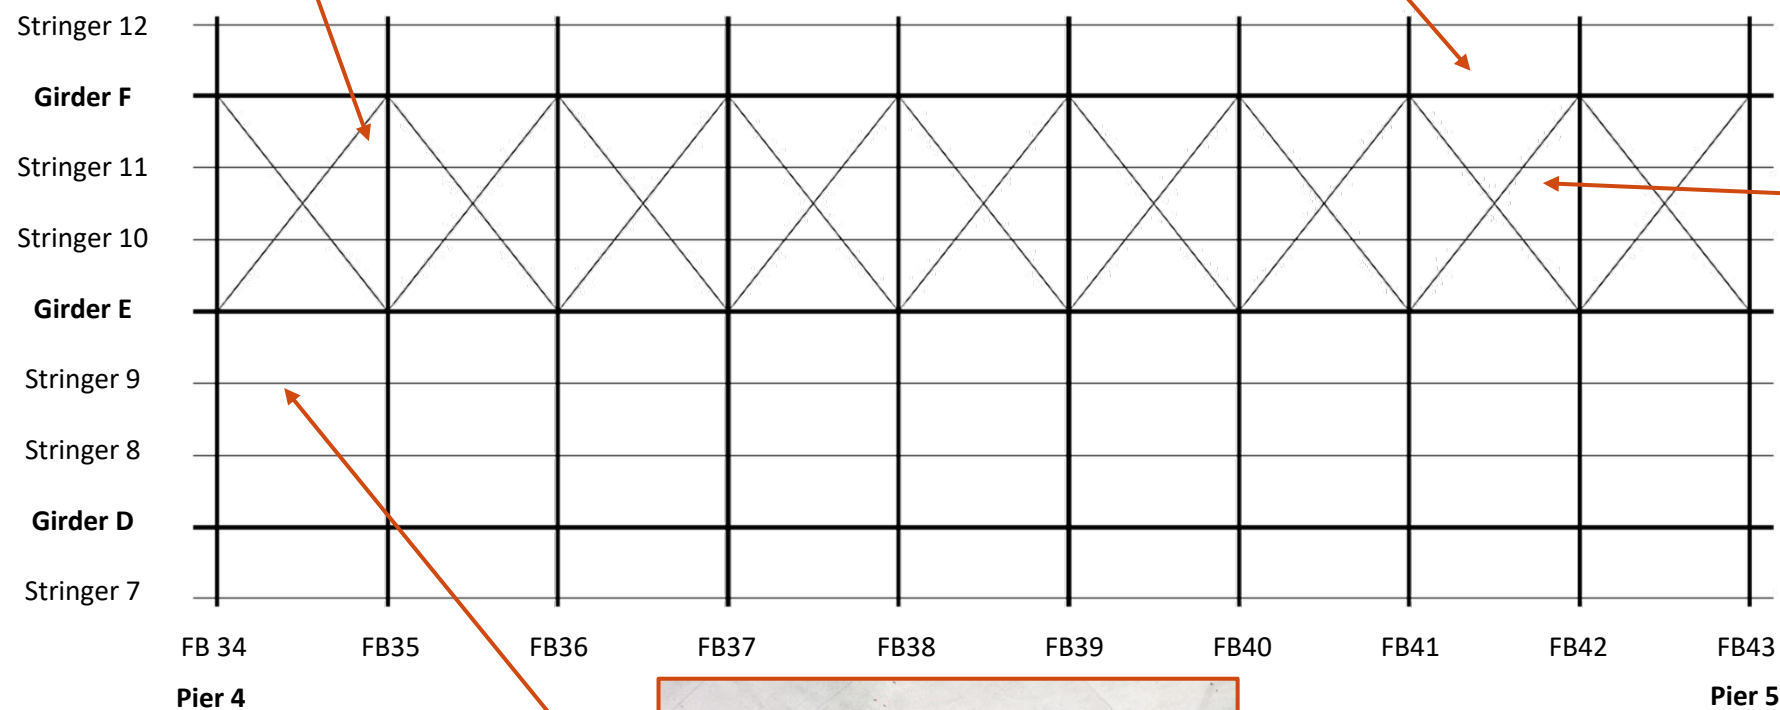
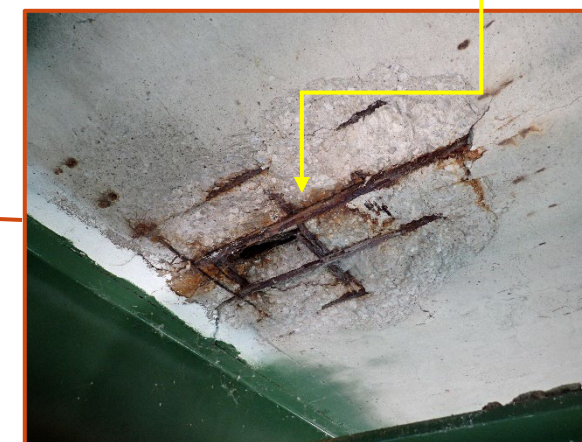
36" long by 42" wide by up to 5" deep spall with debonded and corroded reinforcement (up to 90%) along the south side of Stringer 11 at Floorbeam 42 on the westbound structure, looking northeast.

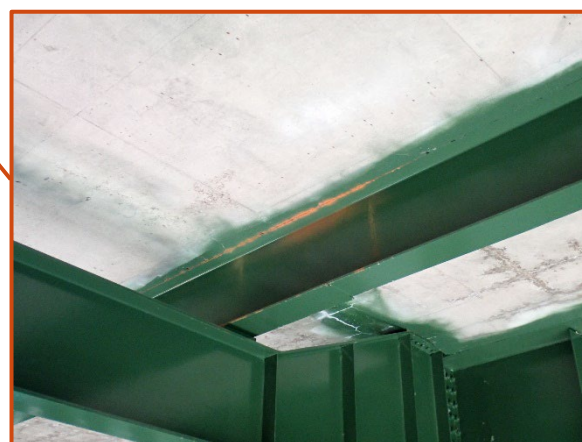
Minor abrasion rust along the top flange of Stringer 9 at Floorbeam 34, looking northwest.

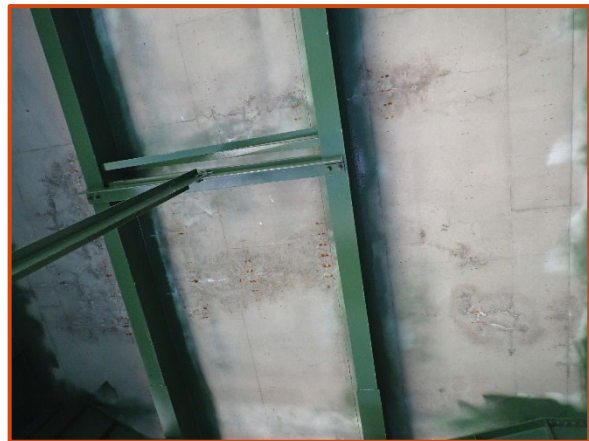
Several areas of moisture staining and efflorescence in the deck underside between Girders E and F between Floorbeams 43 and 44, looking west.

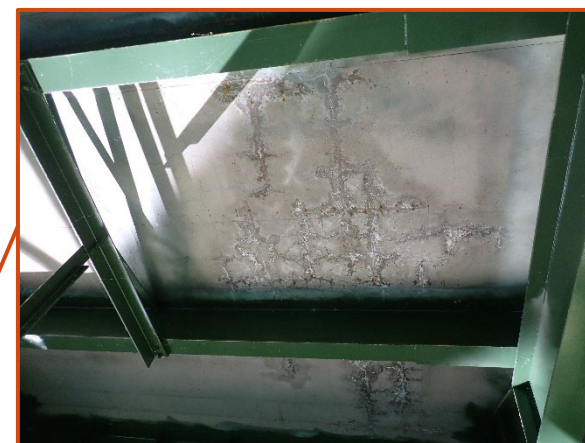
Efflorescence and moisture staining in the underside of deck between Girders E and F between Floorbeams 48 and 49, looking south.

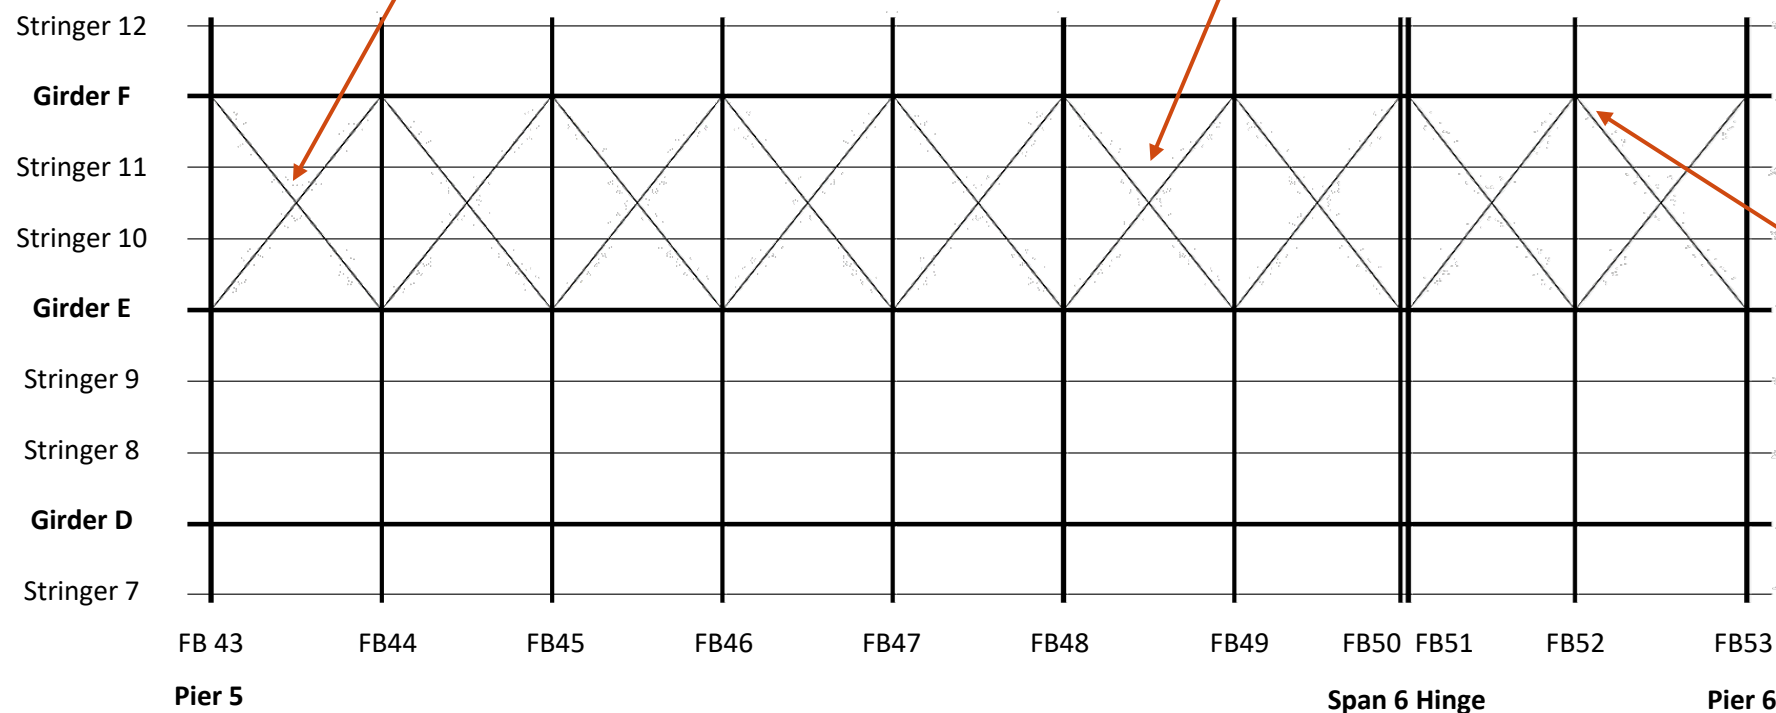
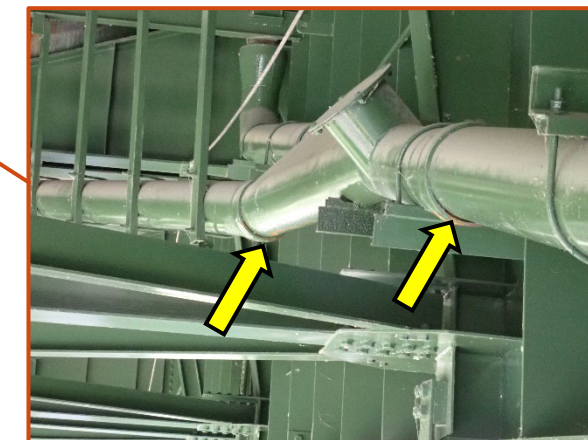
Evidence of leakage in the north downspout near the hinge joint in Span 6 of the westbound structure, looking west. Note that corrosion holes were observed during the 2020 inspection but have not been noted since.

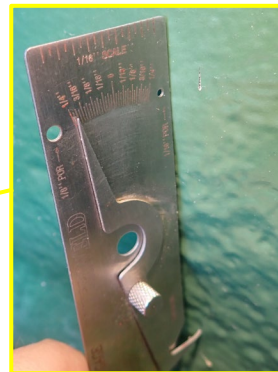
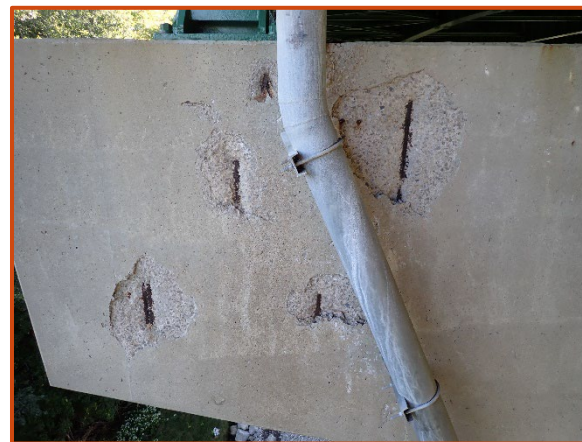
Spalls with exposed reinforcement in the west face of the Pier 7 cap on the westbound structure, looking east.

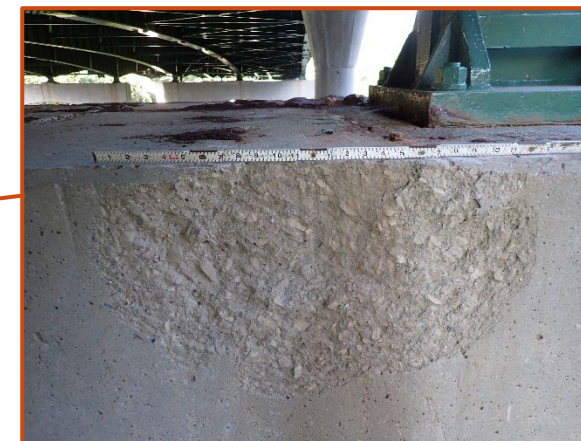
Top corner spall with exposed reinforcement in the east face of the Pier 7 cap on the westbound structure, looking west.

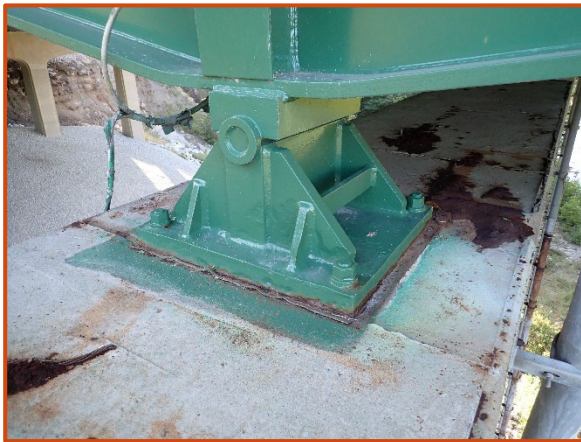
Up to 1/4" deep cleaned and painted pitting on the bearing assembly and masonry plate for Girder F at Pier 7, looking south.

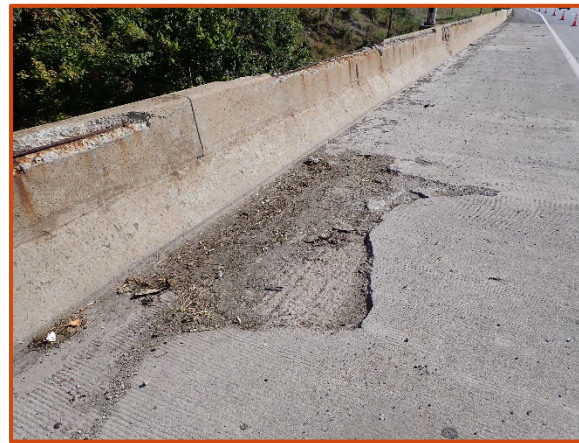
Large pothole in the right shoulder of the Span 8 wearing surface on the westbound structure at the base of the bridge railing, looking northeast.

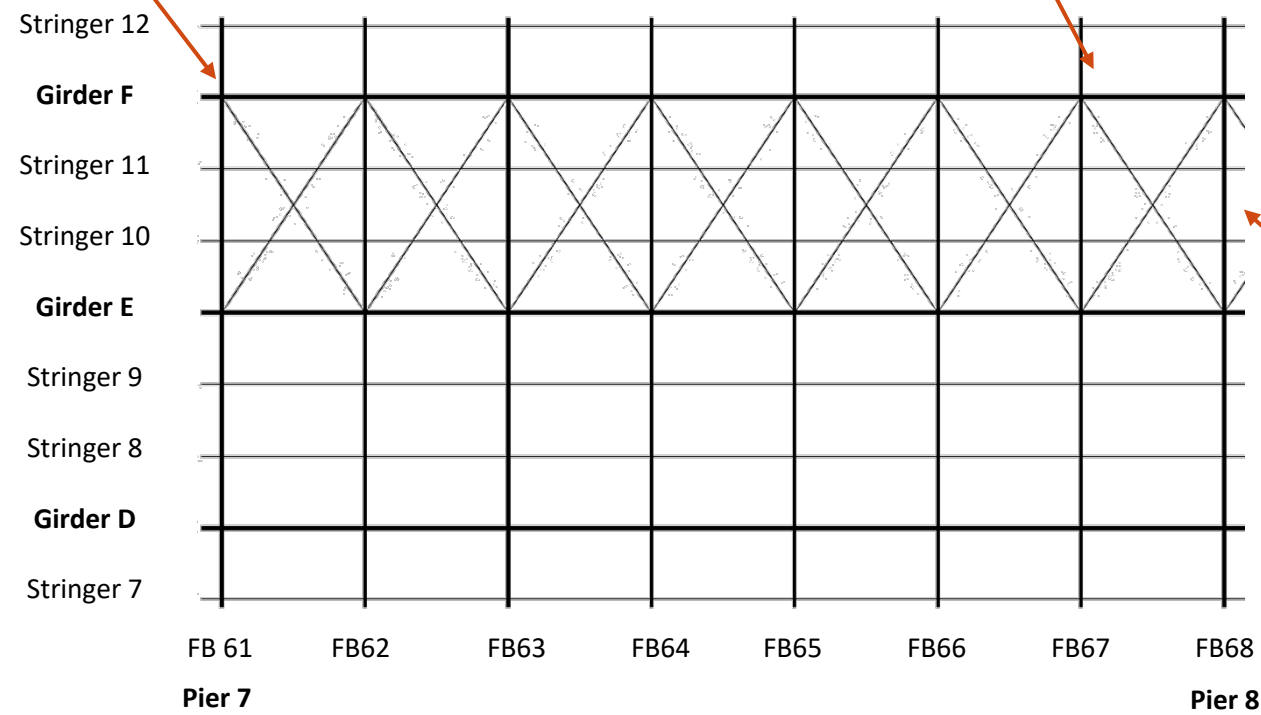
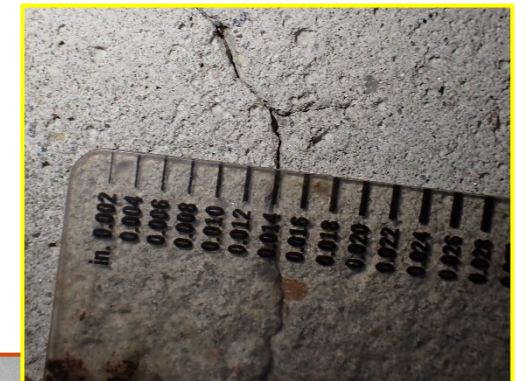
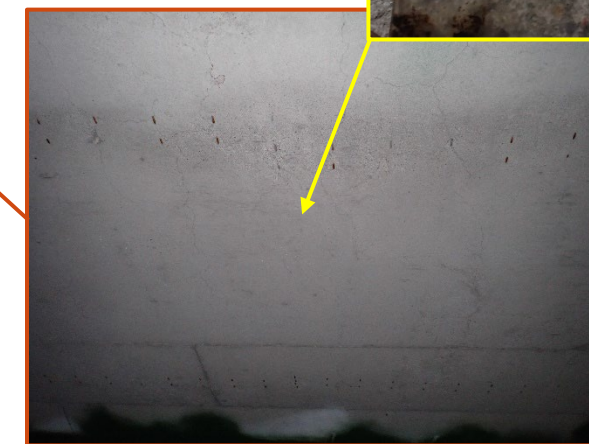
Typical 0.012" to 0.014" wide map cracking at 6" to 12" spacing in the underside of deck, looking north.

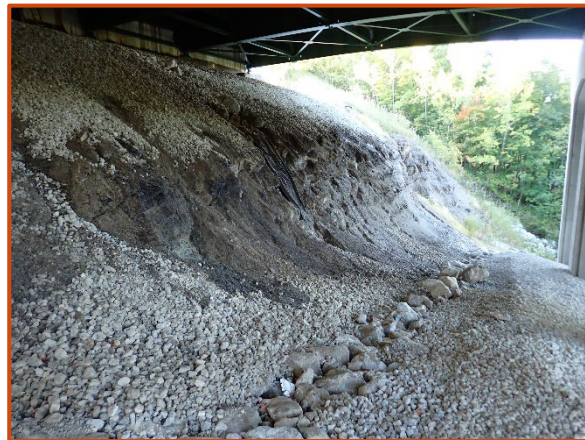
Erosion channel in front of the Forward Abutment, looking south. Note that new slope protection should mitigate further erosion.

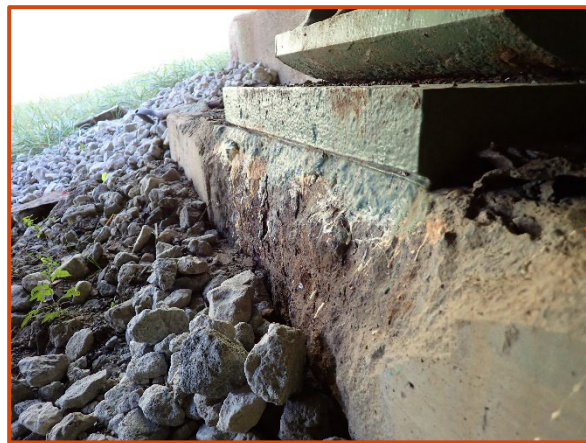
Spall in the west face of the Girder F seat pedestal at the Forward Abutment undermining the bearing masonry plate up to 3/4" deep, looking north.

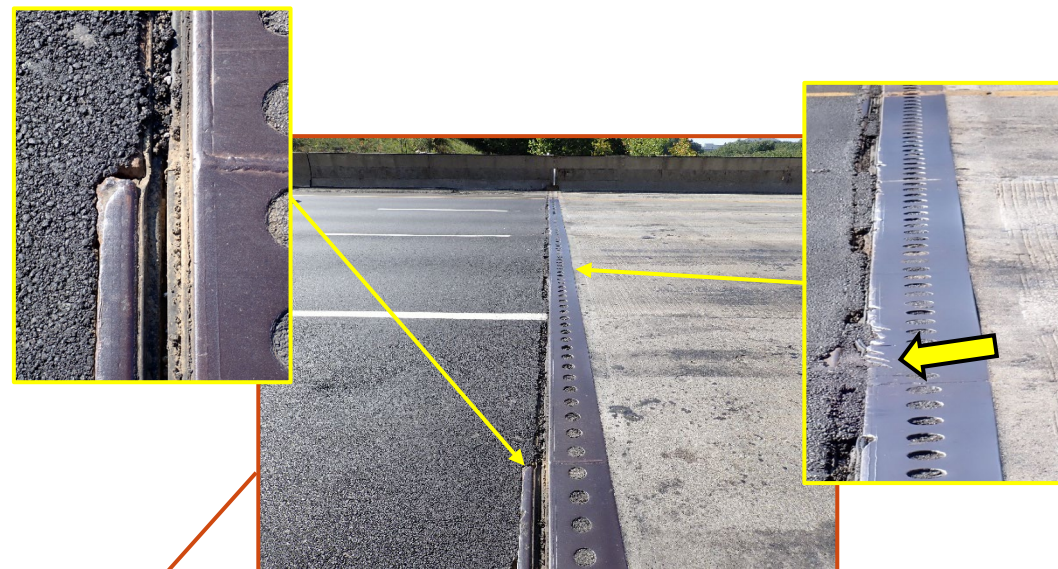
Westbound Forward Abutment joint with moderate plow damage to the west joint armor and break in the east armor in the right shoulder, looking south. Note east approach has been repaved since the previous inspection and asphalt now covers majority of east joint armor.

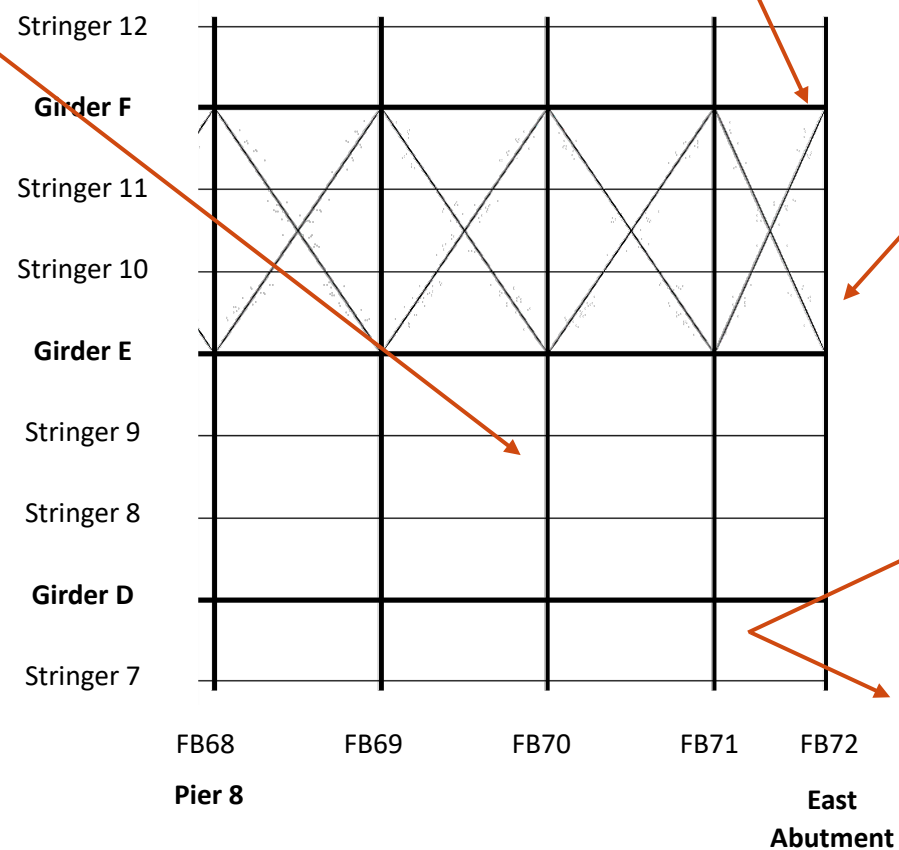
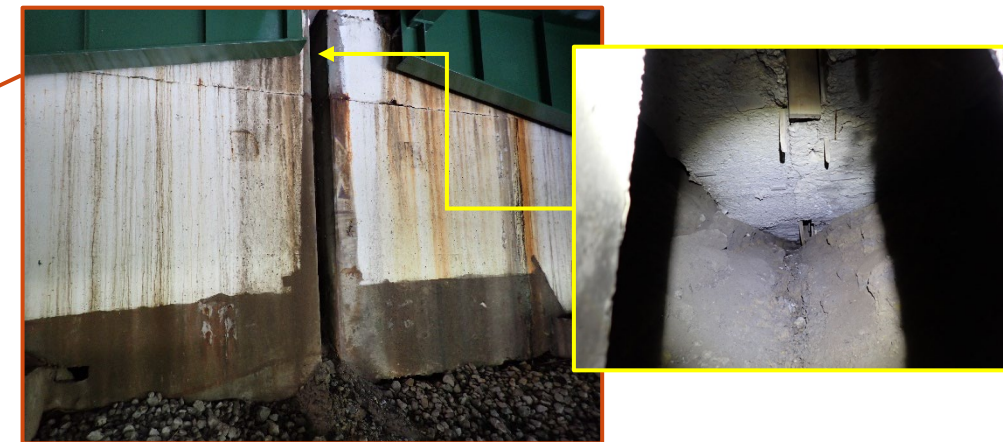
Embankment fill spilling out from behind the Forward Abutment backwall through the median joint, looking north. Note the 8' tall by 15' wide by 30' deep void that has resulted below the approach slabs with an active runoff erosion channel.

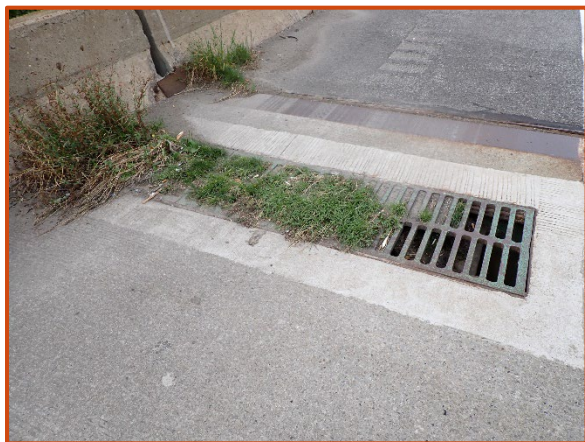
Cleaned and painted pitting up to 1/16" deep on the top of the Girder C bottom flange between Floorbeams 1 and 2, looking northwest.

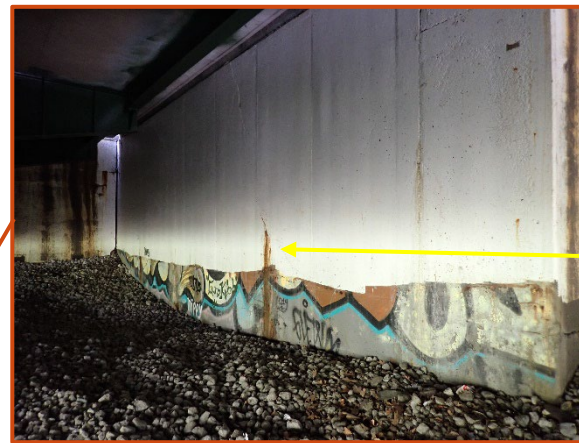
1/8" wide vertical/diagonal crack with moderate efflorescence and rust staining in the interior wingwall at the Rear Abutment, looking northwest.

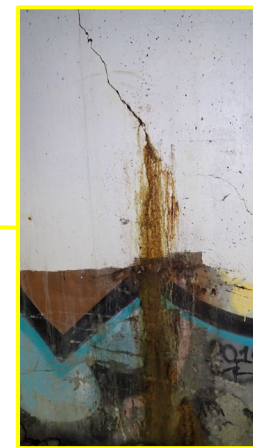
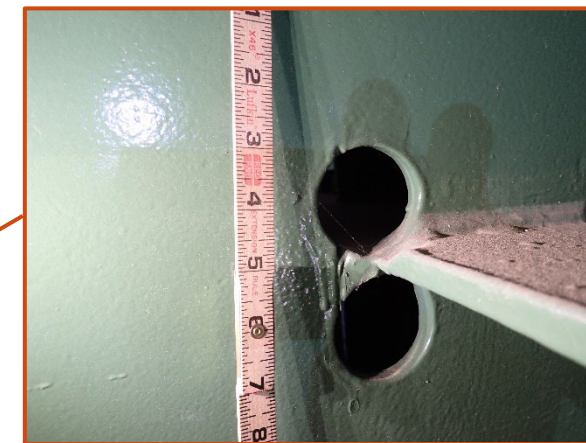
Typical dogbone retrofit overcut in the girder web, looking north at Girder B at Floorbeam 6.

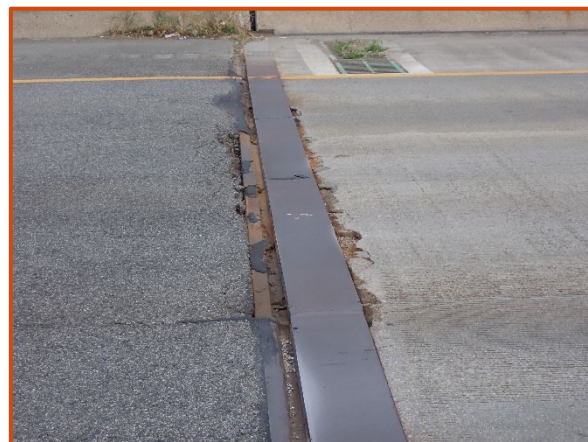
1/2" vertical misalignment at the Rear Abutment joint for the eastbound structure, looking north. Note the adjacent spalling to the joint header in the 2nd lane (from left).

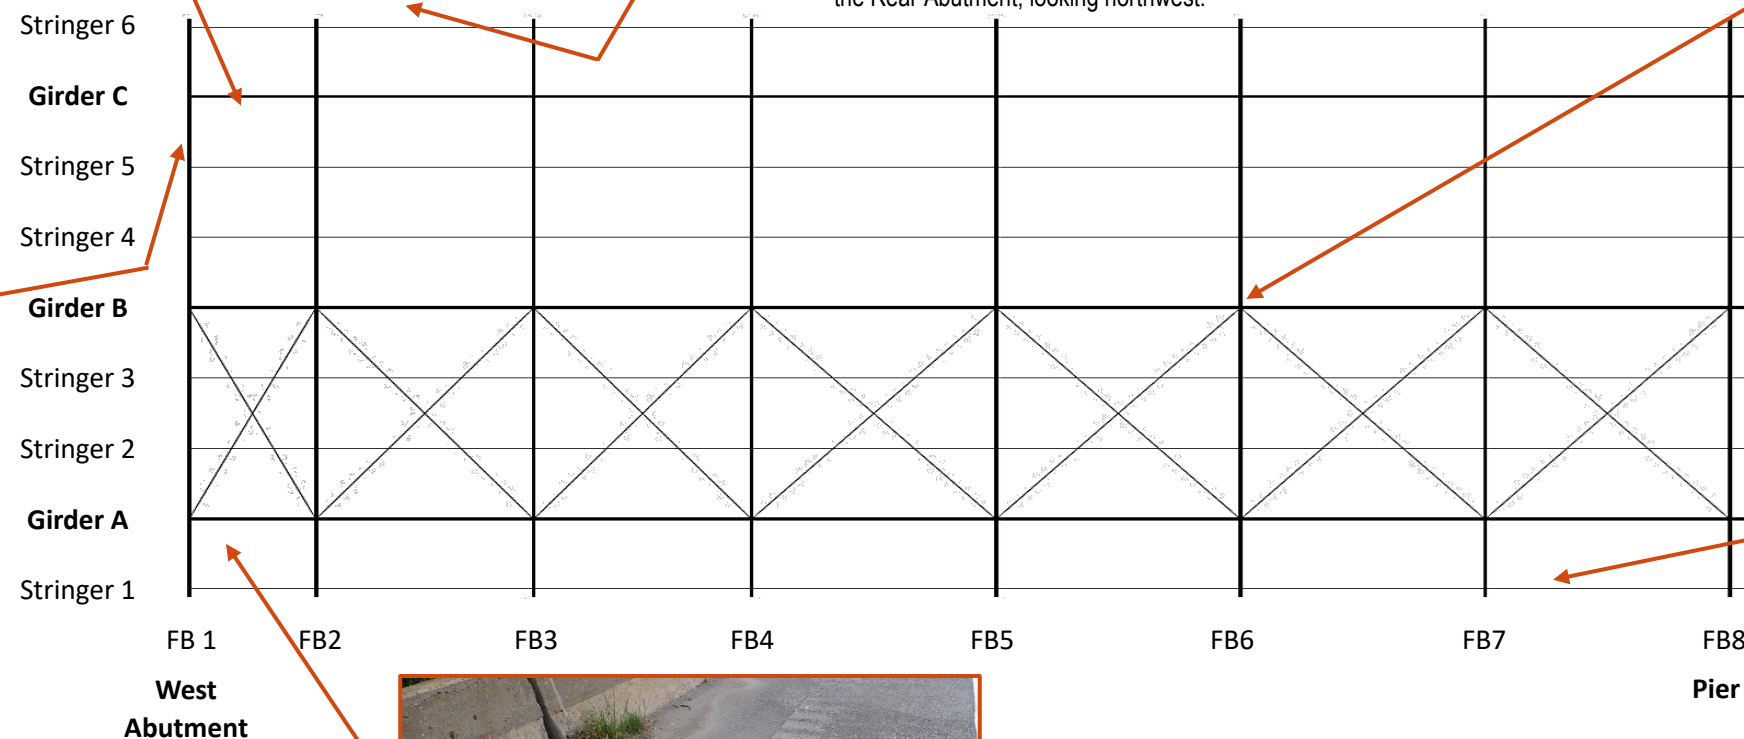
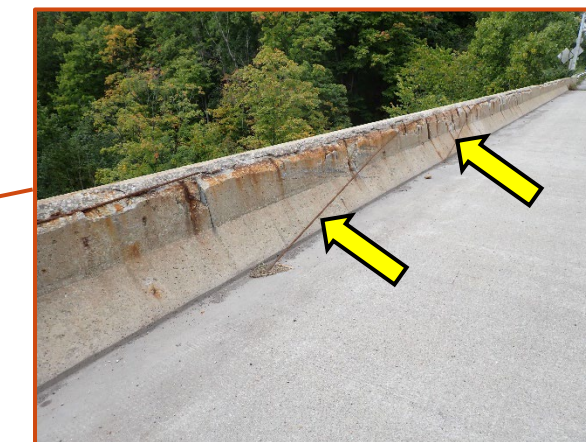
Typical spalls, up to full width, with exposed, corroded, missing, and debonded reinforcement along the top edges of the exterior bridge railings, looking southwest at the south railing in Span 1 of the eastbound structure. Note the debonded top longitudinal bars hanging down.

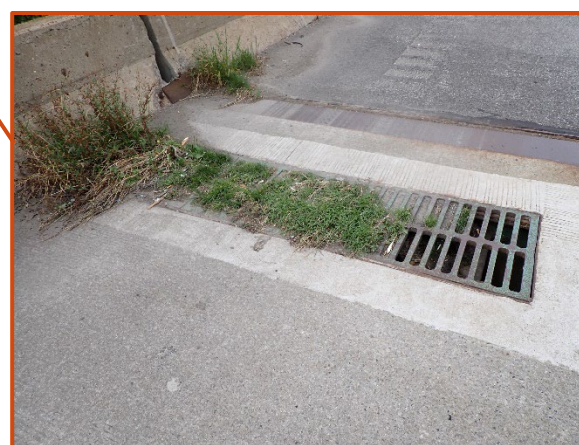
Partially clogged drainage scupper (approximately 85% clogged), looking southwest at the west end of the bridge on the eastbound structure. Note downspout is clear.

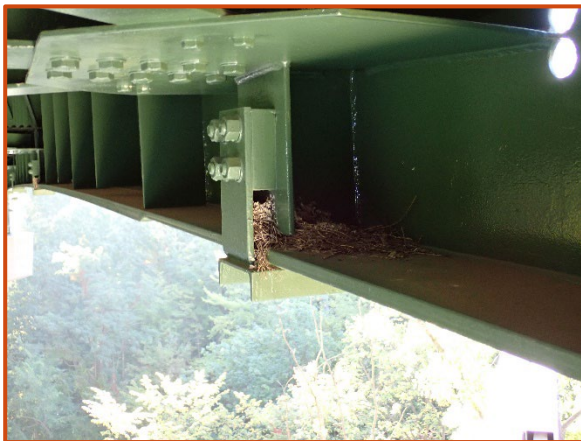
Typical bird nest on top of the girder bottom flange at the retrofit plate, looking southeast.

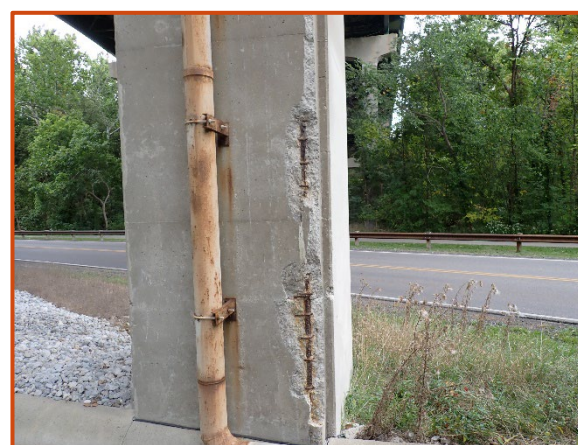
Southwest corner spall with exposed and corroded reinforcement near the base of the south column on Pier 2 of the eastbound structure, looking east.

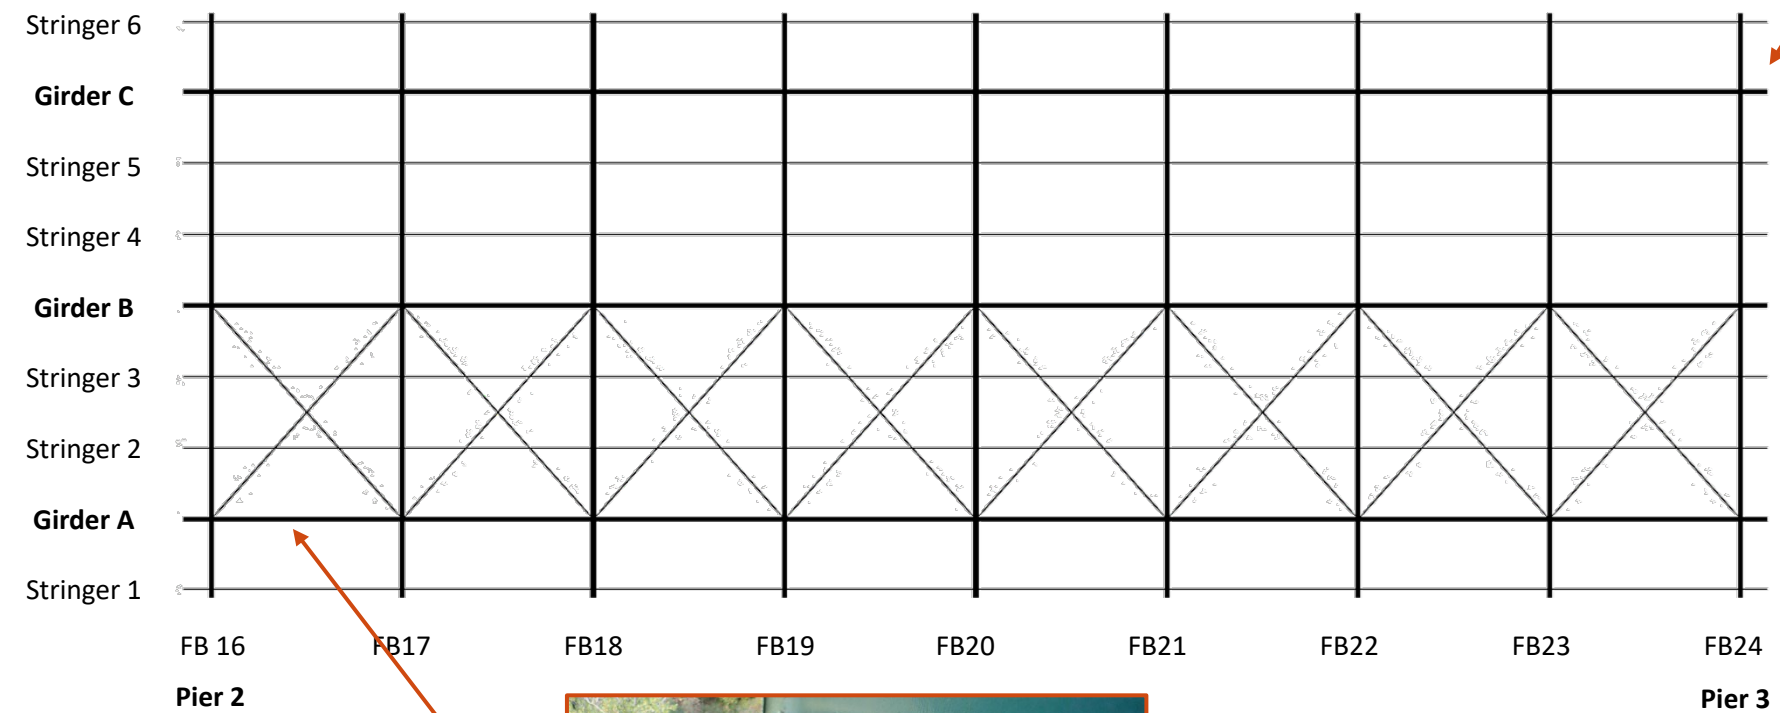
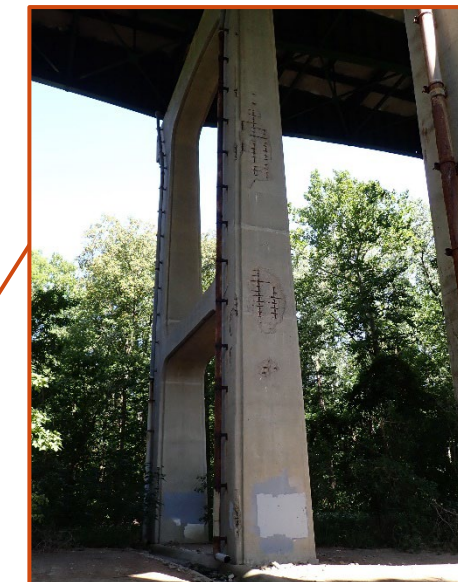
Numerous delaminations and spalls with exposed reinforcement throughout the north column at Pier 3 of the eastbound structure, looking southwest.

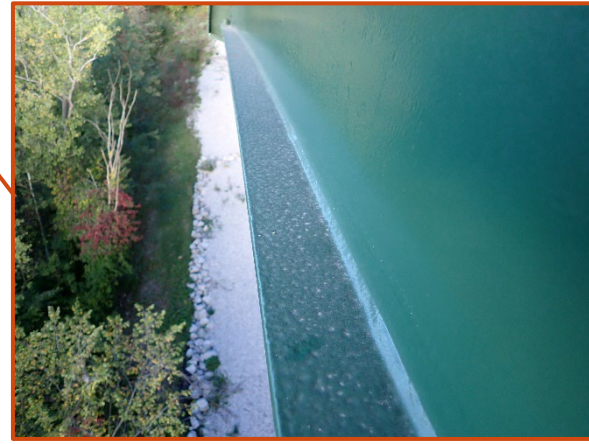
Less than 1/16" deep cleaned and painted pitting on the top face of the Girder A bottom flange on the exterior face between Floorbeams 16 and 18, looking west.

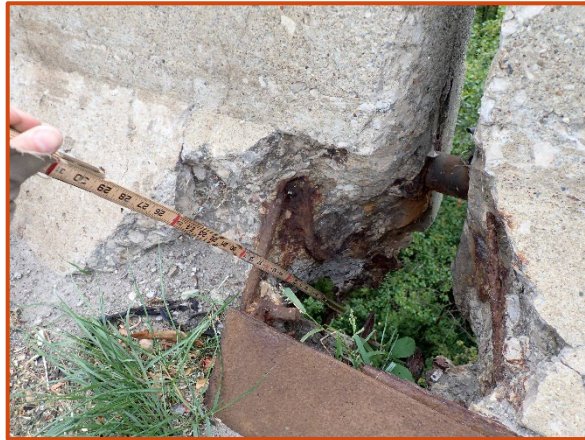
Deck edge and railing spalls with exposed and corroded reinforcement along the Span 4 expansion joint at the south edge of the eastbound structure, looking south.

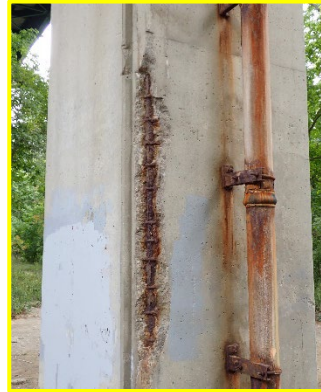
Laminate rust and corrosion on the downspout on the west face of the north column on Pier 4 of the eastbound structure, looking east. Note adjacent corner spall with exposed and corroded reinforcement.

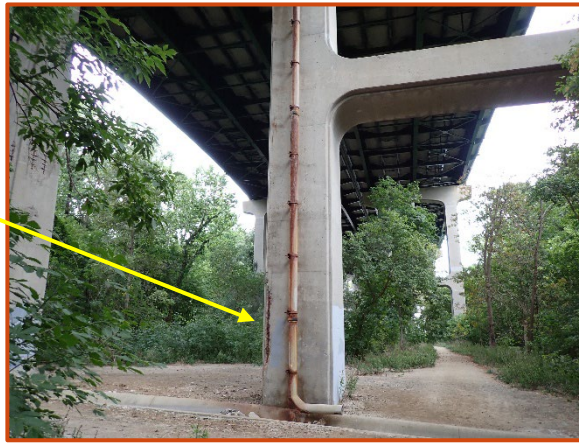
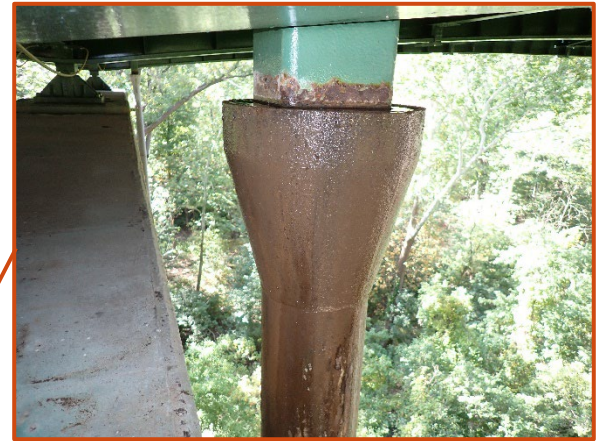
Downspout at Pier 4 for the eastbound bridge full of water at the time of inspection, looking south.
