**PHYSICAL CONDITION REPORT  
FOR THE 2023 ROUTINE ELEMENT LEVEL INSPECTION**

**I-480 OVER THE ROCKY RIVER VALLEY**

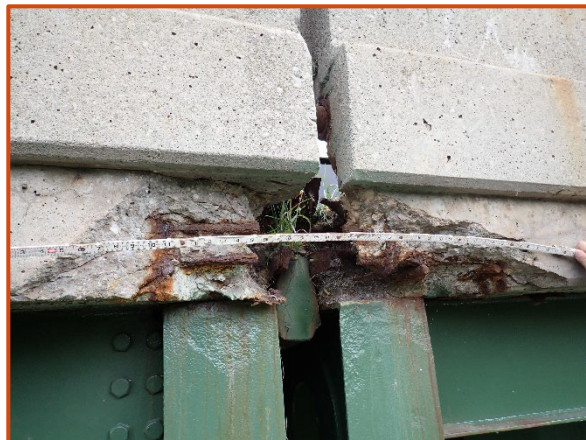
Large spalls with multiple layers of exposed and corroded reinforcement in the south deck edge of the eastbound structure at the Span 4 expansion joint, looking north.

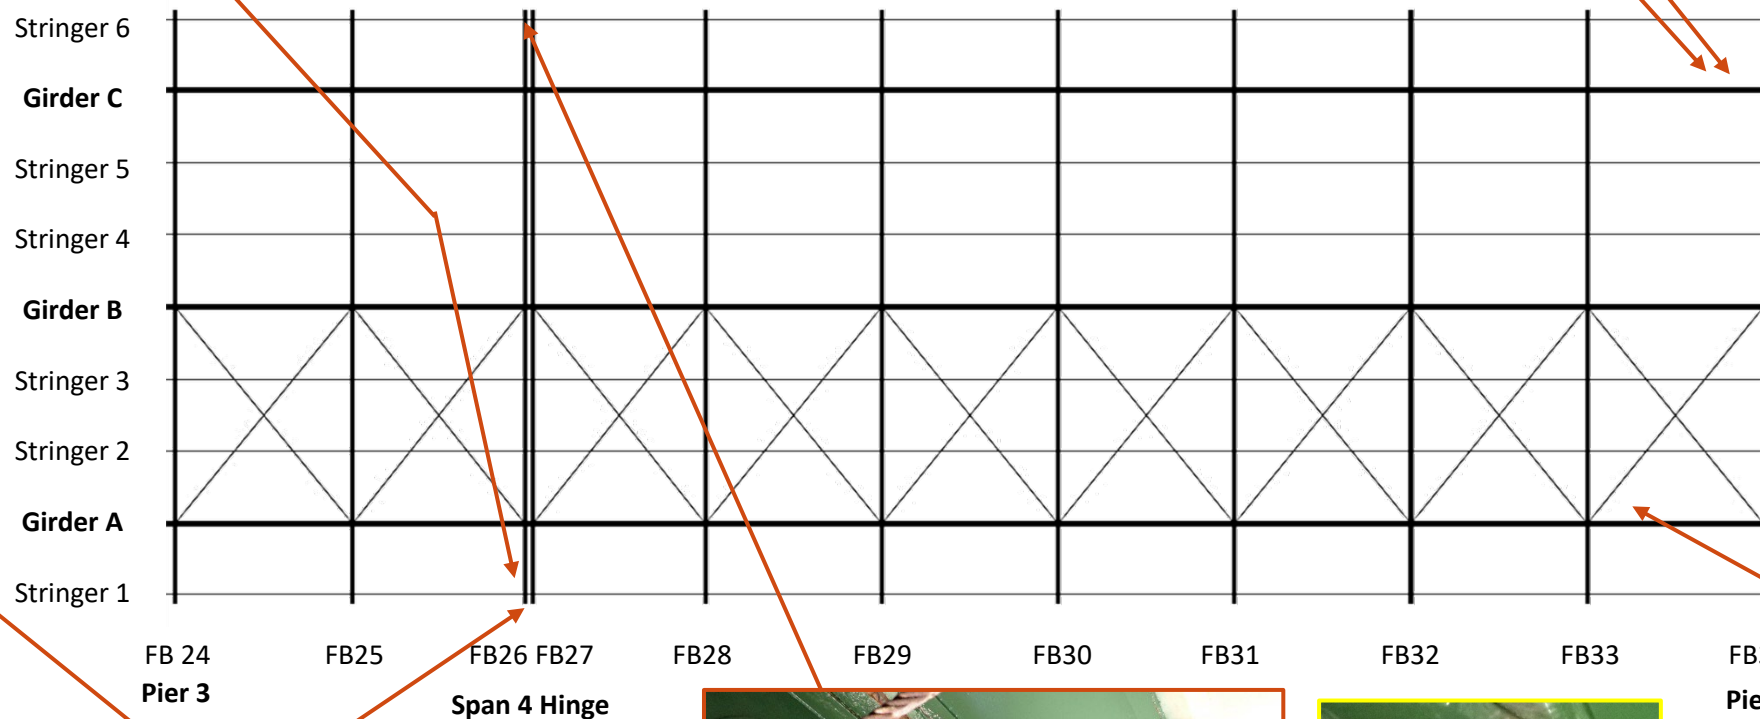
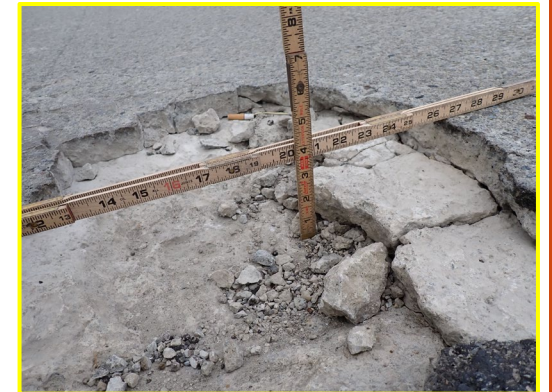
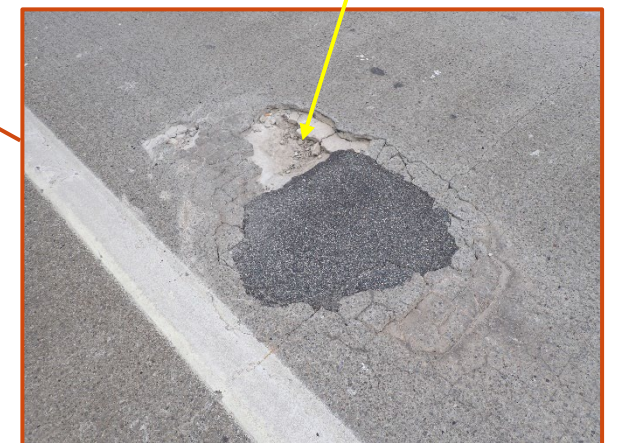
Up to 3 1/2" deep partially patched spall/pothole in the right lane of the Span 4 wearing surface on the eastbound structure, looking northwest.

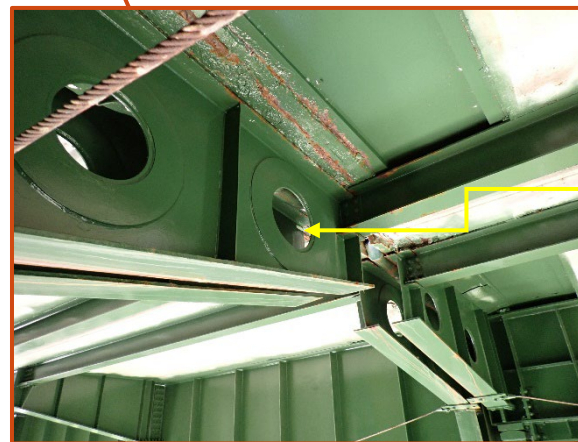
3" long by 1" high corrosion hole at the top of the Floorbeam 26 north cantilever on the eastbound structure at its end, looking northwest.

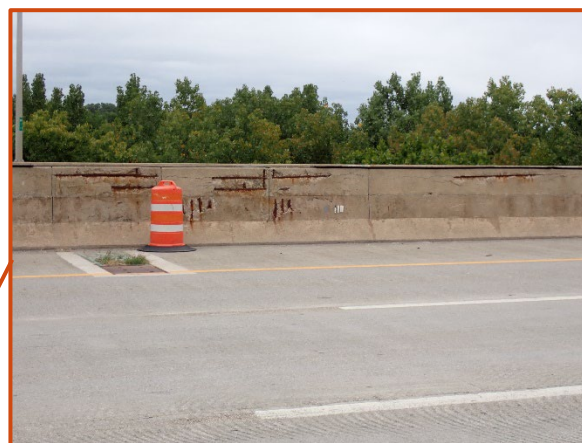
Widespread spalling of the median barrier on the eastbound structure near Pier 4, looking north.

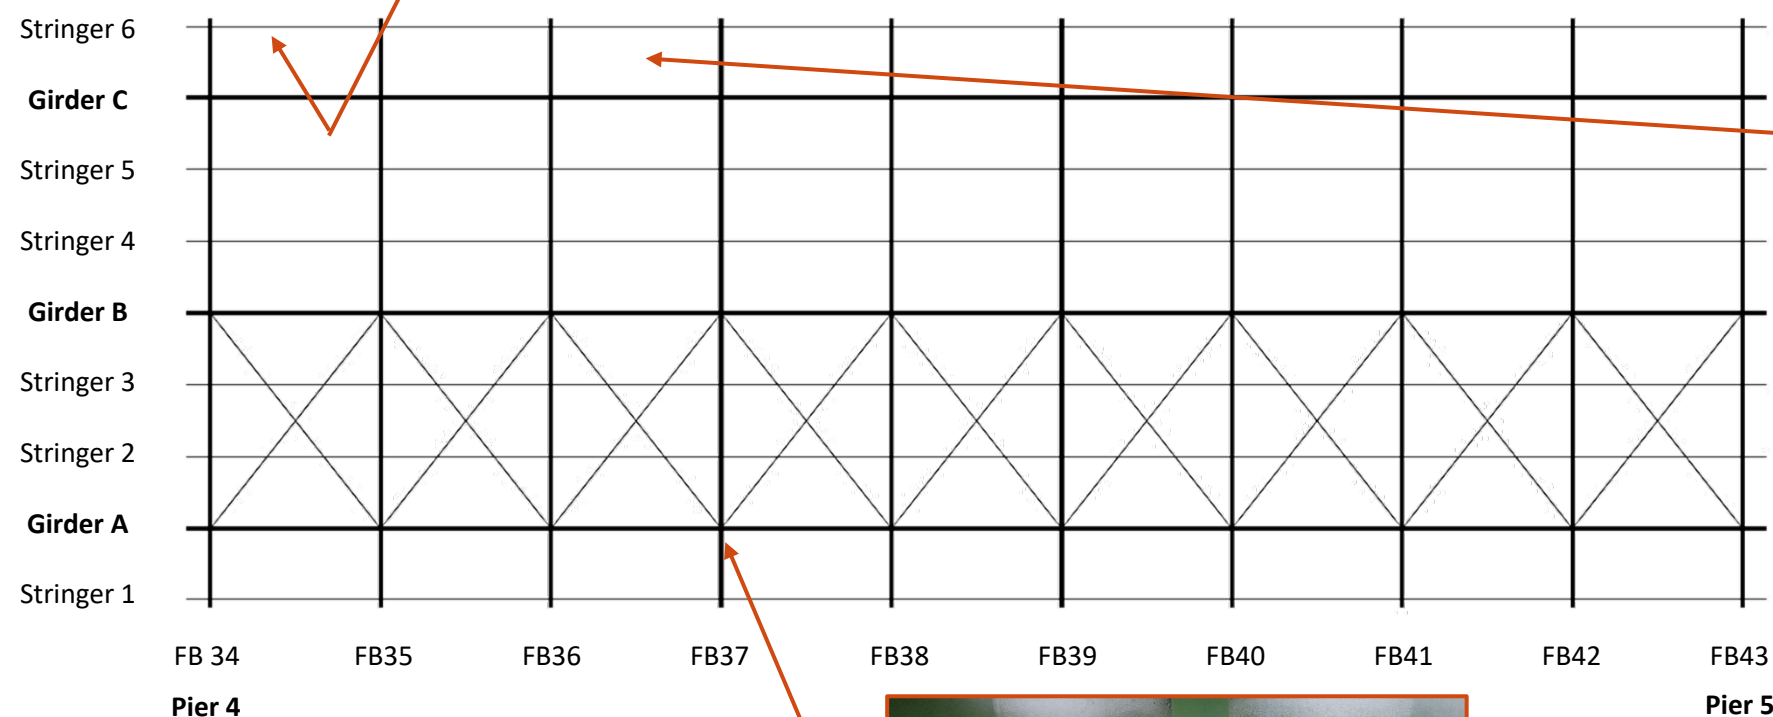
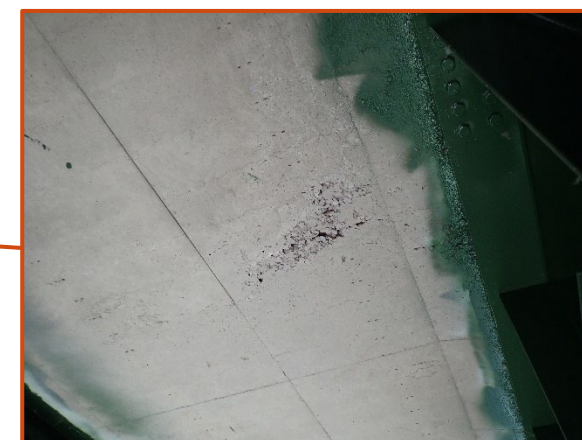
Minor honeycombing with exposed reinforcement in the north deck overhang between Floorbeams 36 and 37, looking northeast.

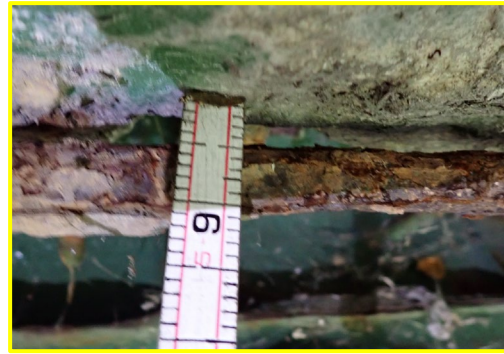
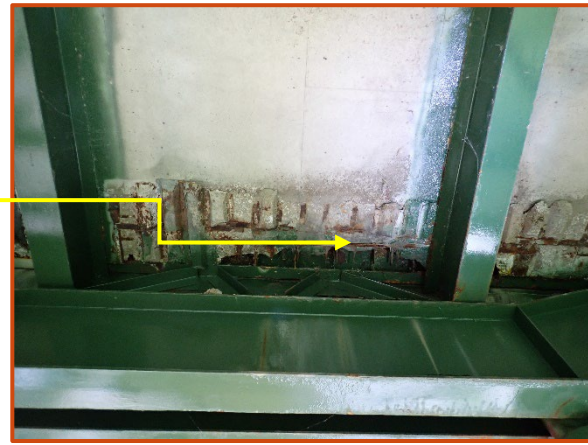
7" wide by up to 15" long by full depth spall with two layers of fully exposed and corroded reinforcement at the end of the eastbound structure deck along the Span 6 expansion joint armor, looking east. Note up to 20% section loss to the exposed reinforcement.

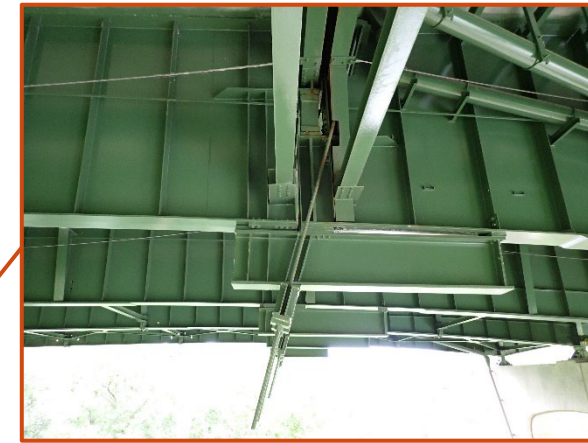
Typical carrier beam retrofit installed below the seated hinge joints, looking north at Girder C at the Span 6 expansion joint.

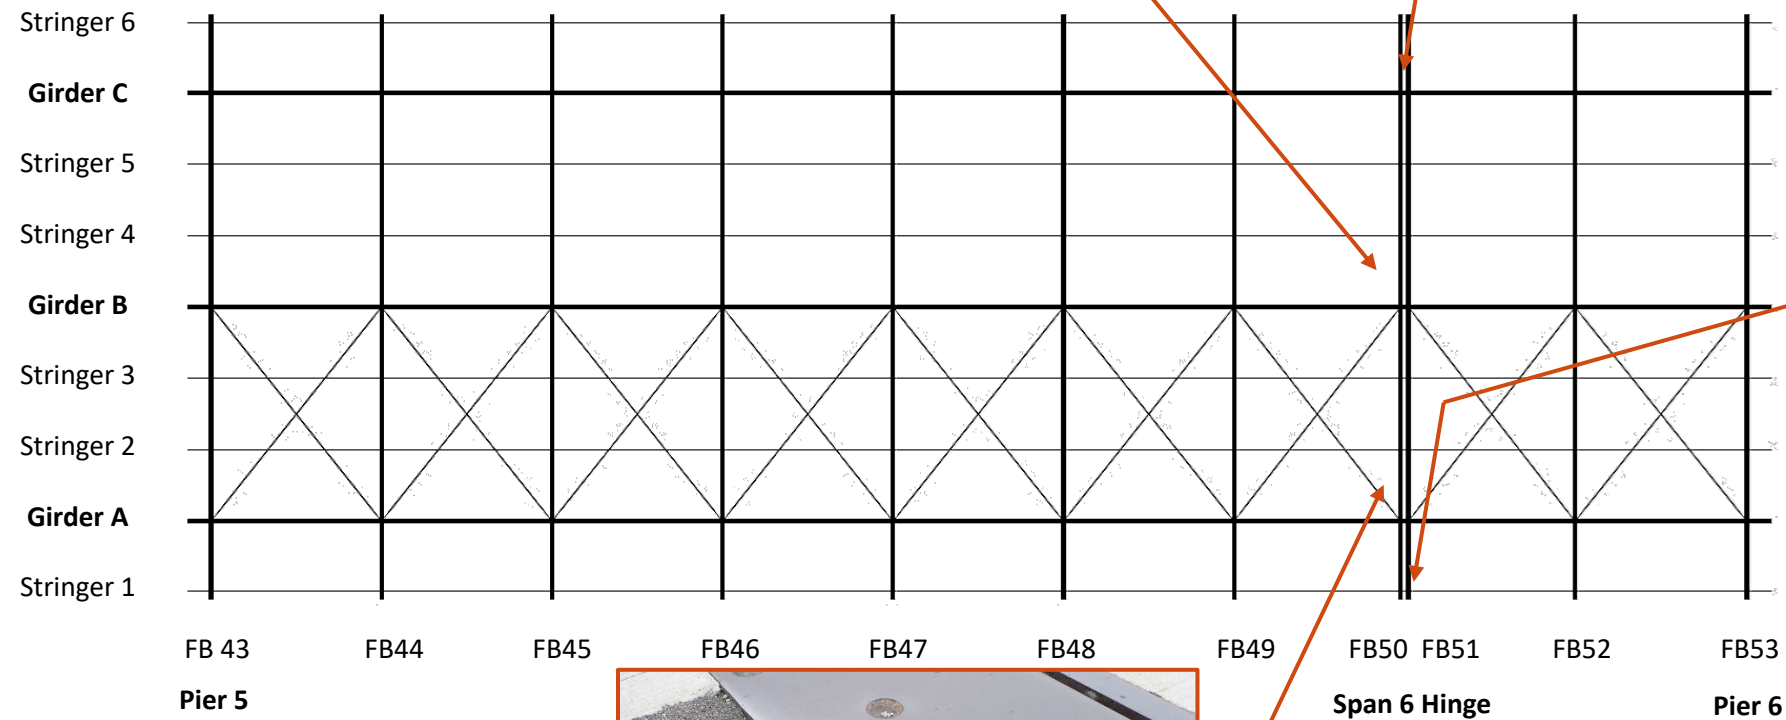
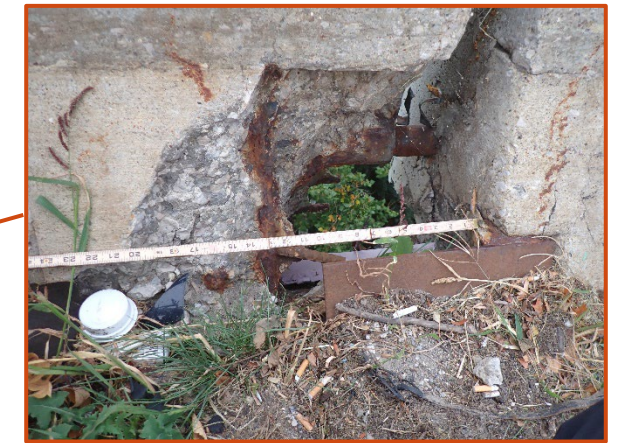
24" long by 24" high by full depth spall in the south bridge railing on the east side of the Span 6 joint on the eastbound structure, looking south. Note that spalls of this nature are typically present at the hinge joints.

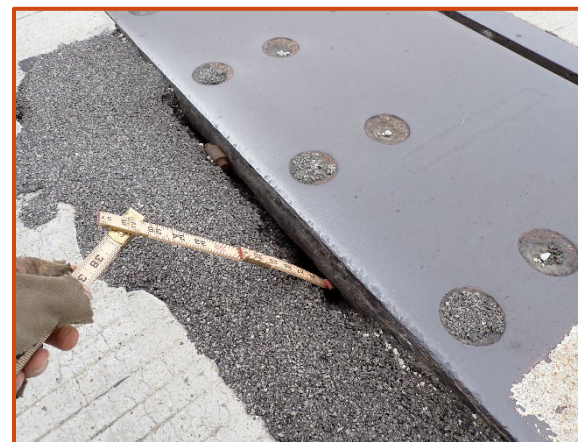
Patching and potholes along west side of Span 6 hinge joint with a 2' wide by 3" long full depth pothole in the right lane of the eastbound structure, looking northeast.

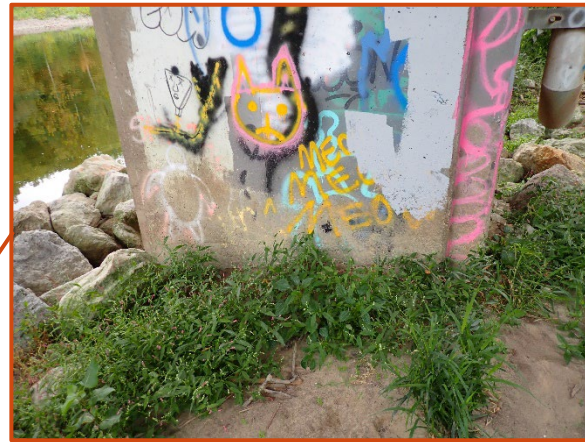
Minor scaling to the bottom 18" of the north column of Pier 6 of the eastbound structure, looking south.

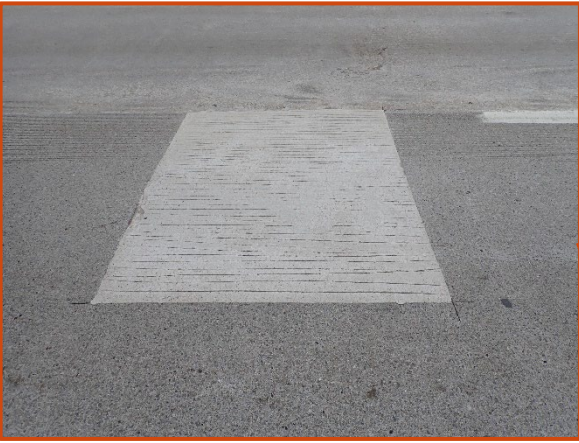
5' long by 6' wide patch in the right lane of the wearing surface in Span 8 of the eastbound structure, looking north.

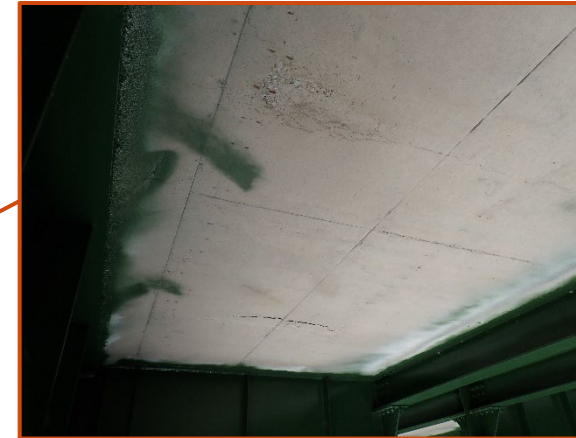
Delaminations in the north deck overhang of the eastbound structure between Floorbeams 64 and 65, looking west.

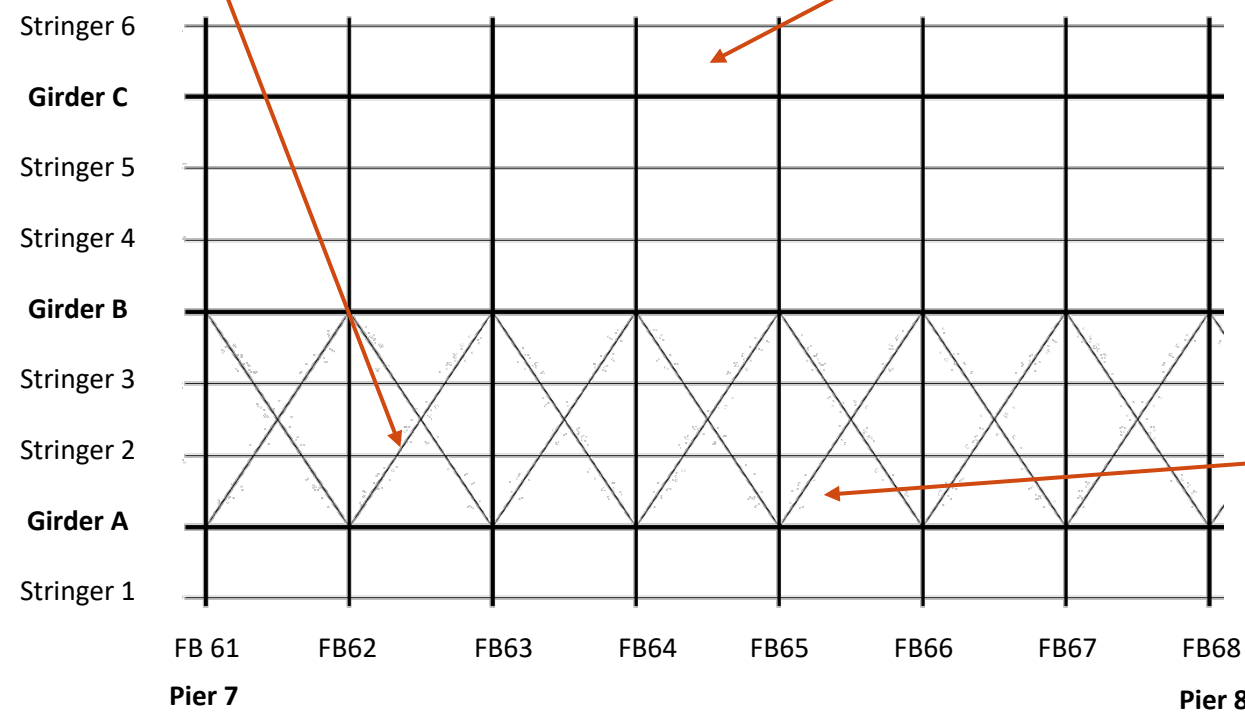
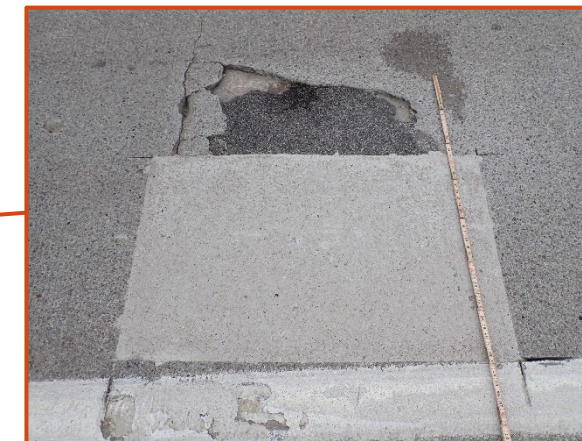
3' long by 1.5' by 3" deep pothole/spall (partially filled with asphalt) in the right lane of the wearing surface in Span 8 of the eastbound structure, looking north.

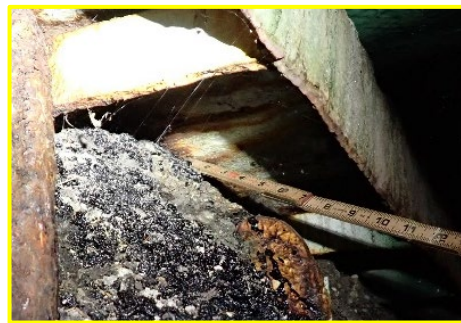
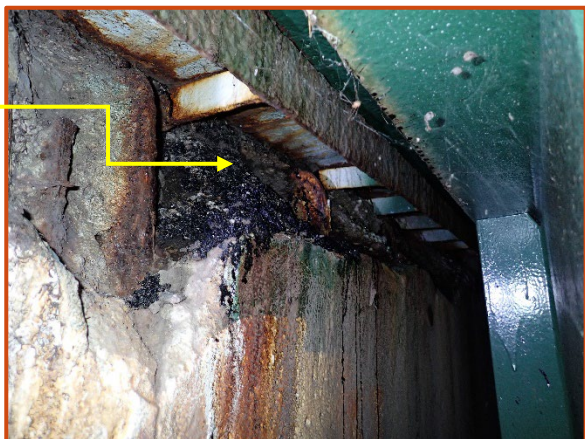
12" high by 10" deep by 8.5' wide spall with exposed reinforcement in the top of the Forward Abutment backwall behind Girder C that is undermining the joint armor support up to 10", looking southeast.

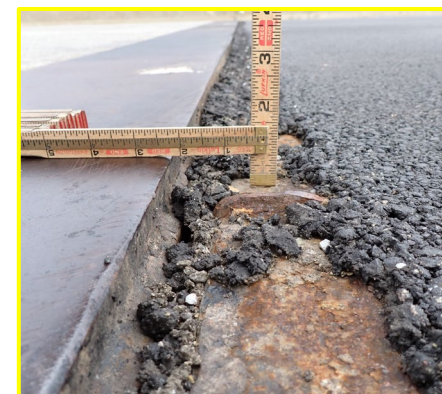
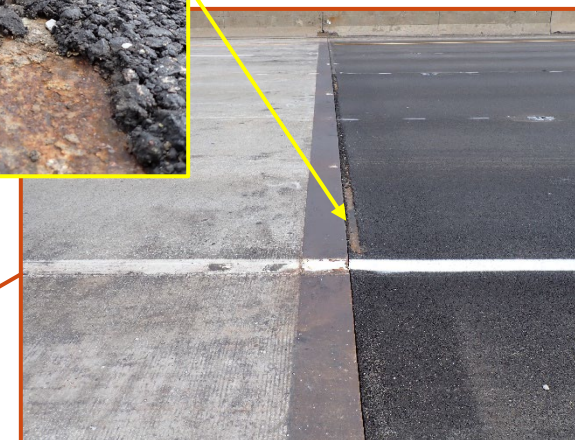
Up to 1" vertical misalignment at the eastbound Forward Abutment joint in the right two lanes, looking north. Note the asphalt on the east side of the joint has been replaced since the previous inspection.

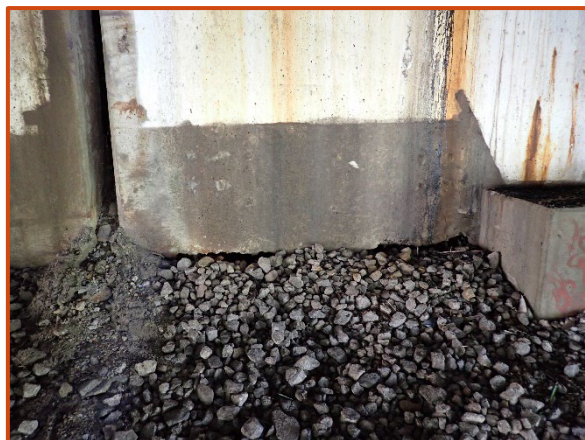
Forward Abutment backwall for the eastbound structure undermined up to 5" high by 13" deep over a 7' length at the north end, looking east.

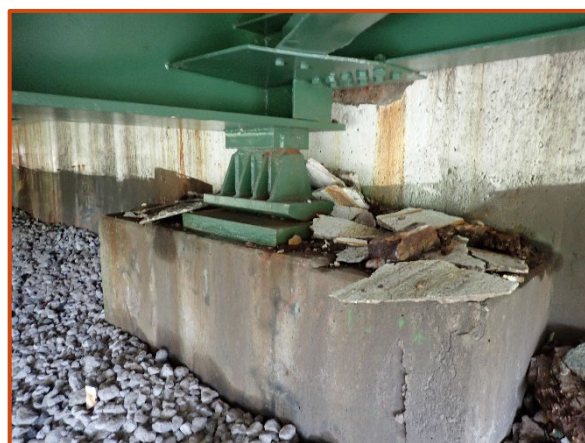
General view of Girder B bearing at the Forward Abutment, looking northeast. Note spalled concrete from backwall behind girder end.

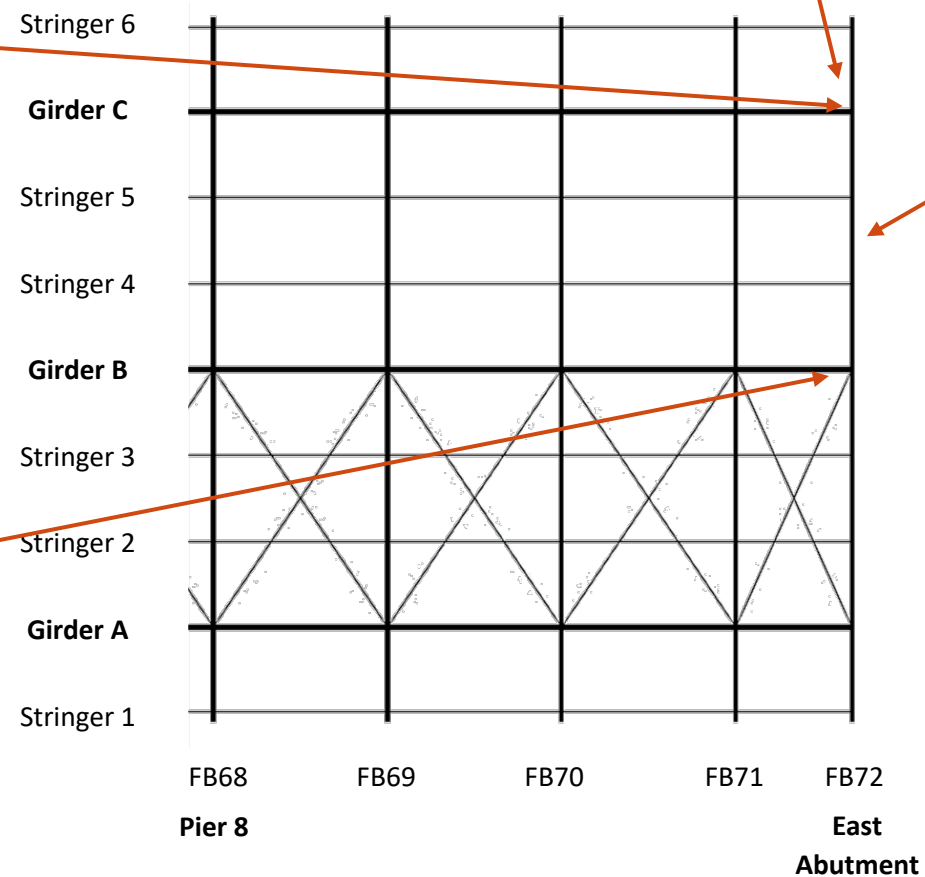
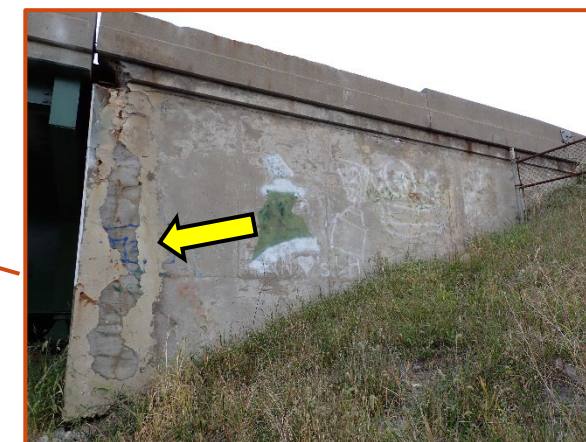
12" wide patch beginning to fail in the south wingwall at the along the Forward Abutment connection, looking north.

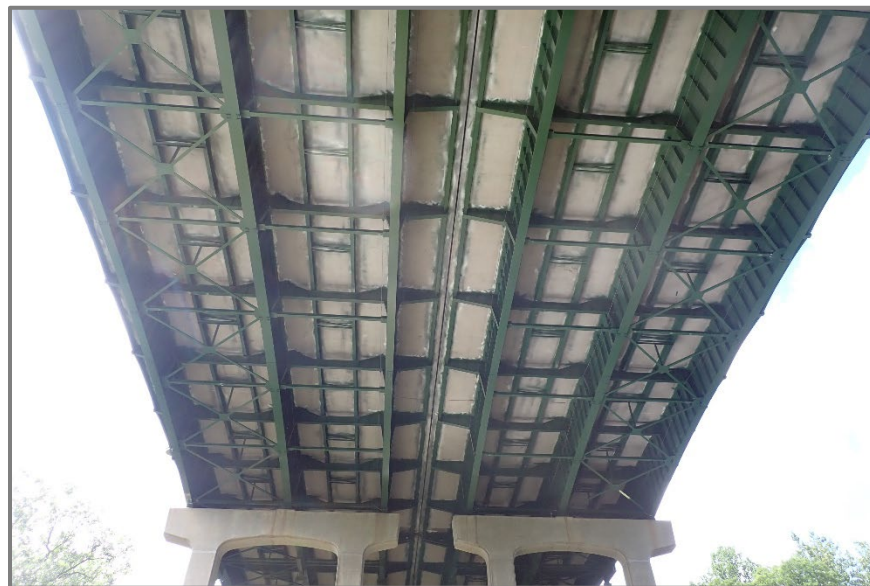
Figure 3 – CUY-480-0647 superstructure underside, looking west in Span 7.

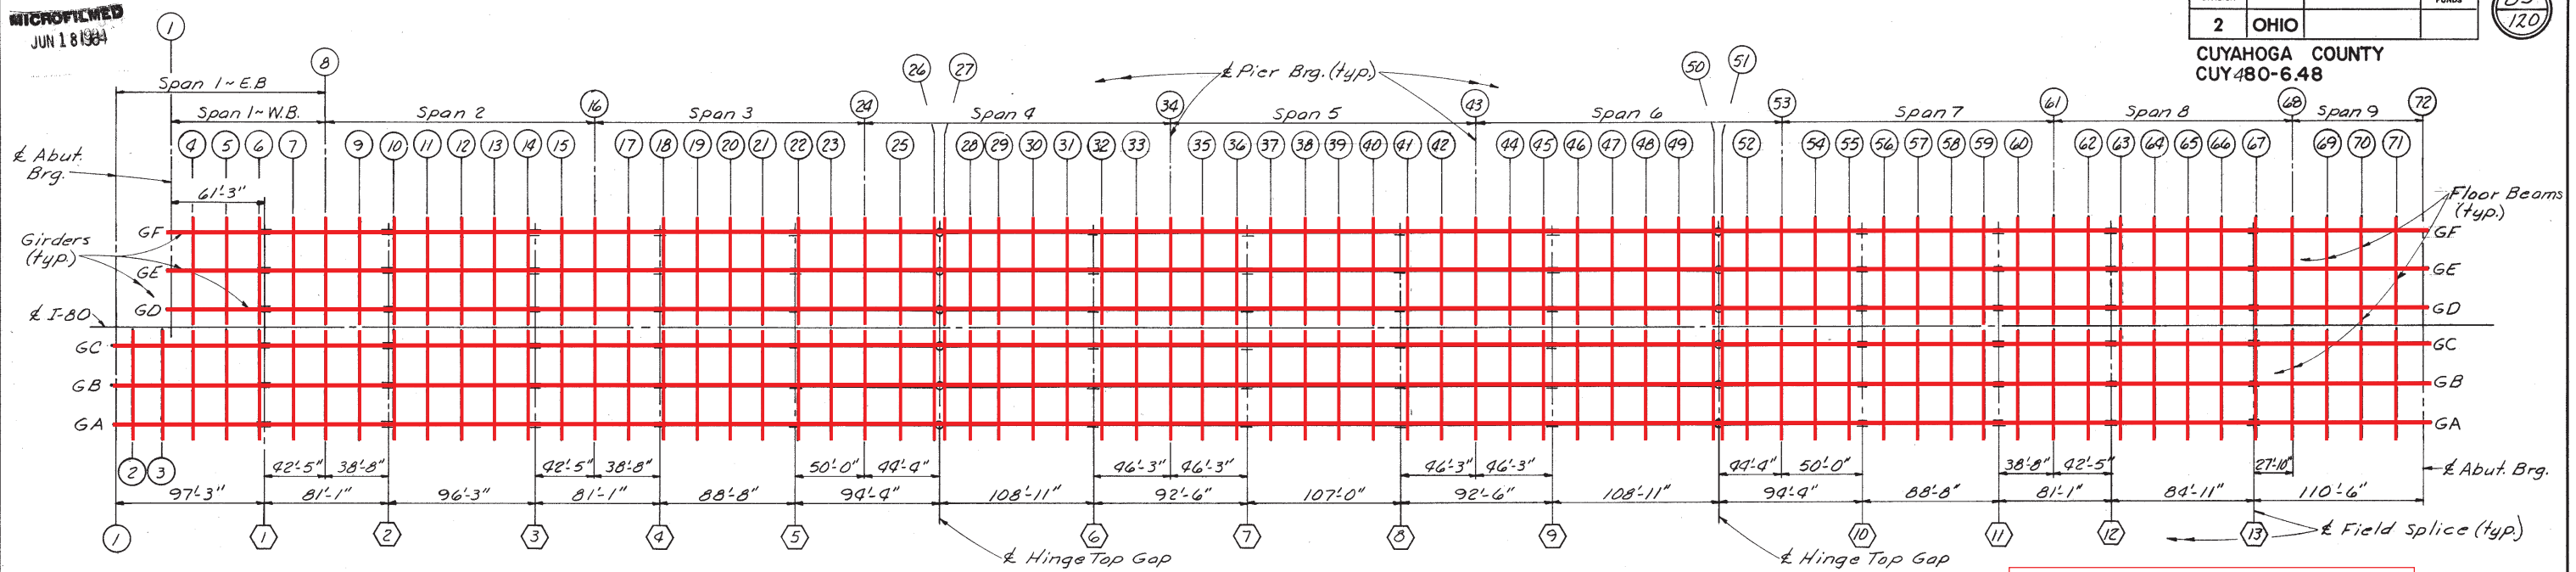
GENERAL FRAMING PLAN  
(Stringers & Lateral system not shown.)

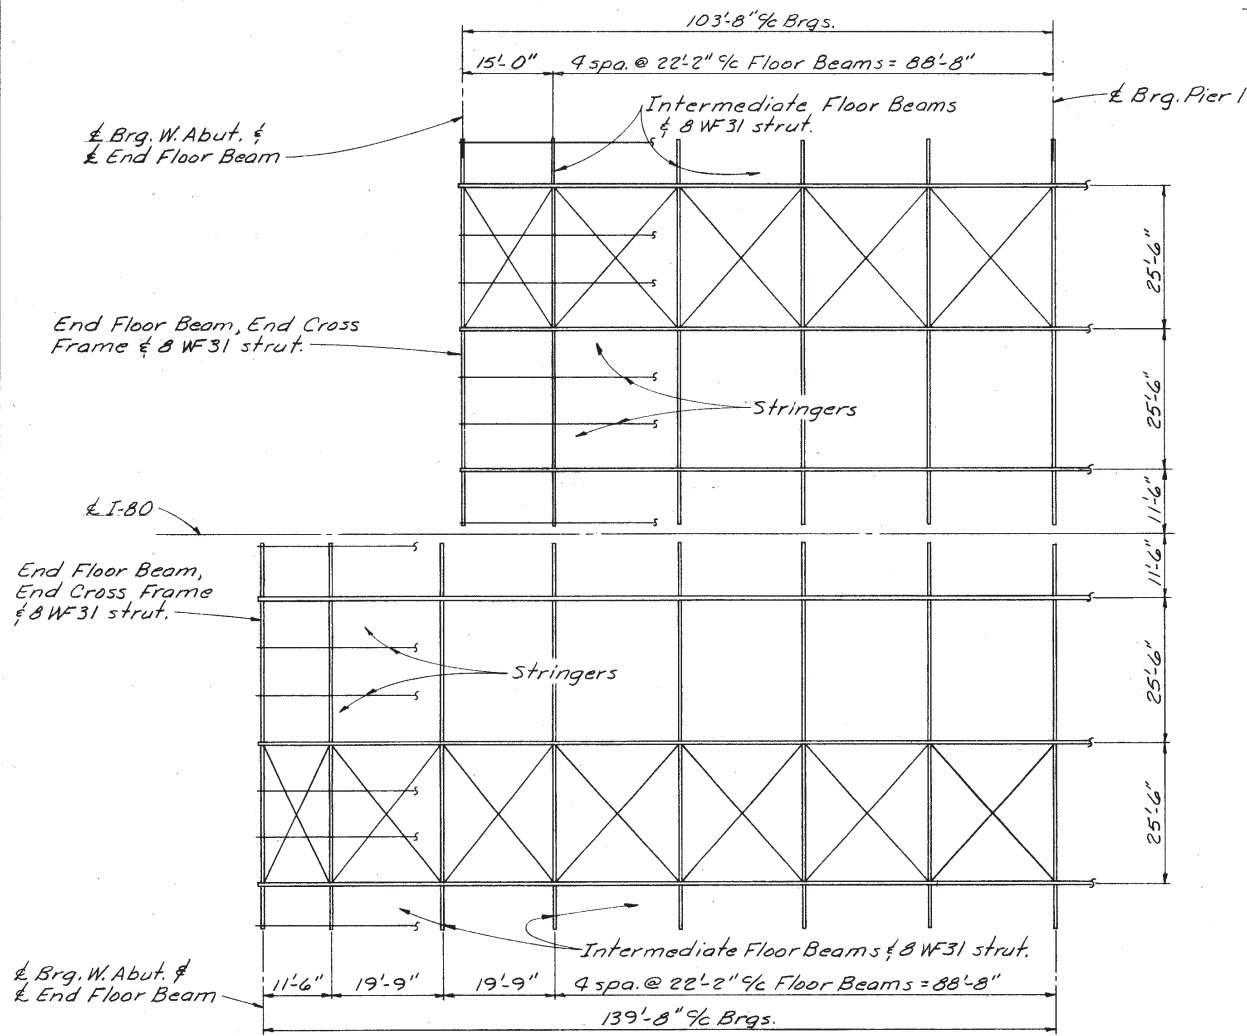
SPAN 1 FRAMING PLAN  
(Stringer intermediate crossframes not shown.)
