Fracture Critical Member (FCM) Inspection Procedure

Inspection Responsibility:	ODOT District 12
County-Route-SLM:	CUY-480-0647
Structural File Number:	1812831
Inspection Frequency:	24 Months
Fatigue Life Study:	Year of Study: <u>Not Calculated</u> Remaining Fatigue Life: <u>Not Calculated</u>
Load Path Redundant:	Main Spans: <u>No, Each structure is a three-girder system at 25'-6" spacing, and floorbeam spacing exceeds 14'.</u> Approach Spans: <u>None.</u>
Structurally Redundant:	<u>No, Girders are continuous spans.</u>
Internally Redundant:	<u>No, Tension members consist of welded built-up plate girders and built-up/rolled I-section members.</u>
System Redundant:	<u>No rigorous analysis performed (i.e. finite element, 3-D modeling)</u>

Figure 1 – CUY-480-0647 south elevation, looking northwest.

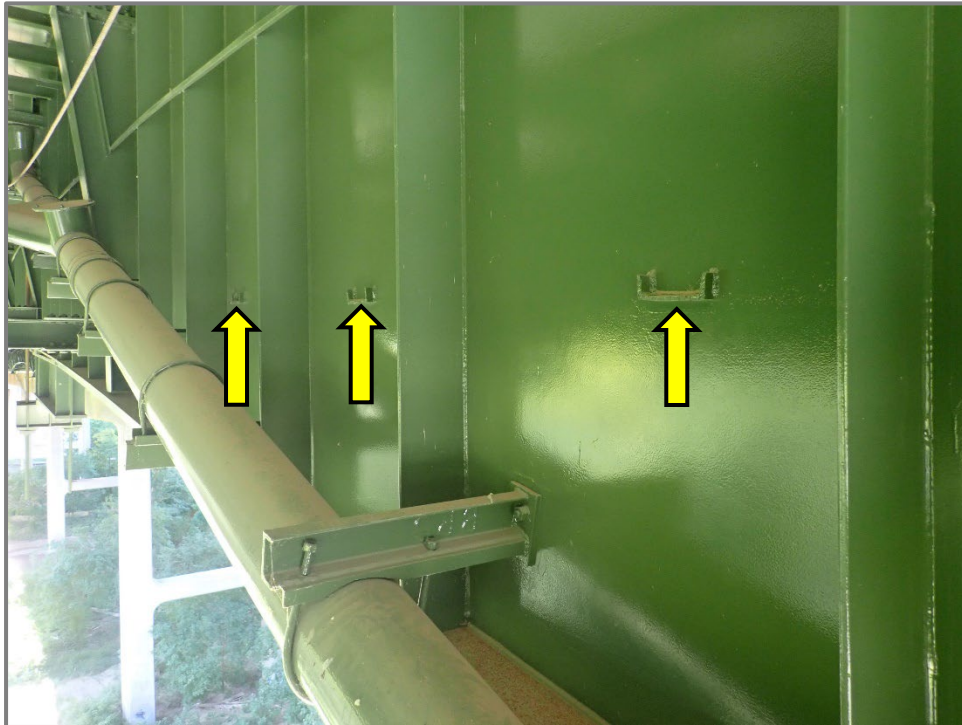
Photo 3 – Base metal at abandoned channel bracket to girder web welds (Category E). Girder C between Floorbeams 52 and 53 shown, looking northwest.

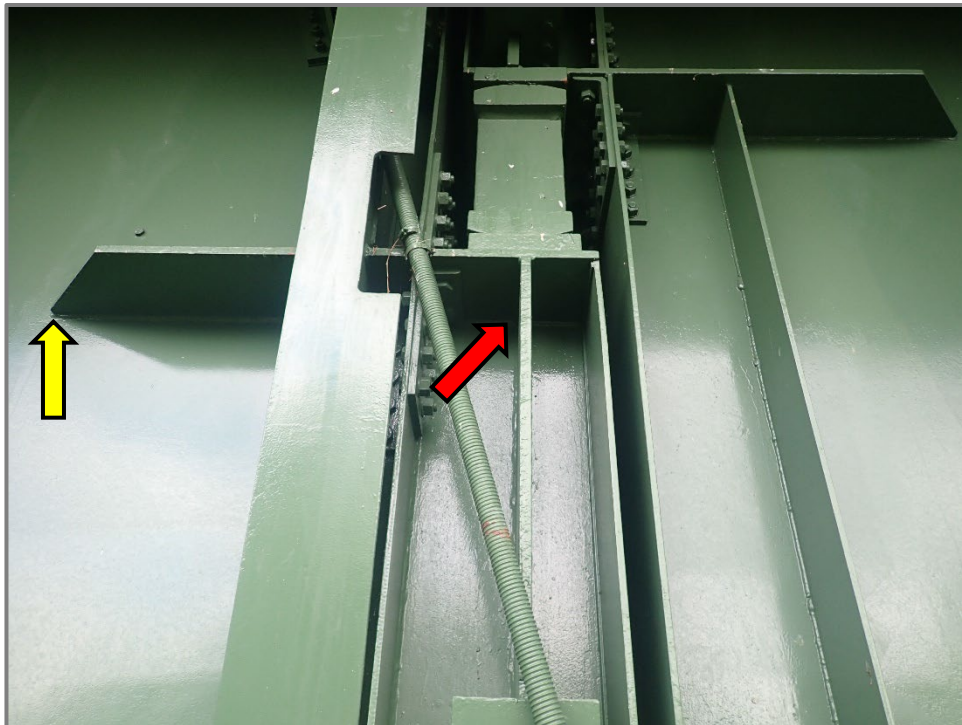
Photo 4 – Base metal at the termination of longitudinal seat plates welds to floorbeam webs (thickness > 0.8") (Category E'). Girder A at the Span 4 hinge shown, looking north. Note triaxial constraint below hinge.

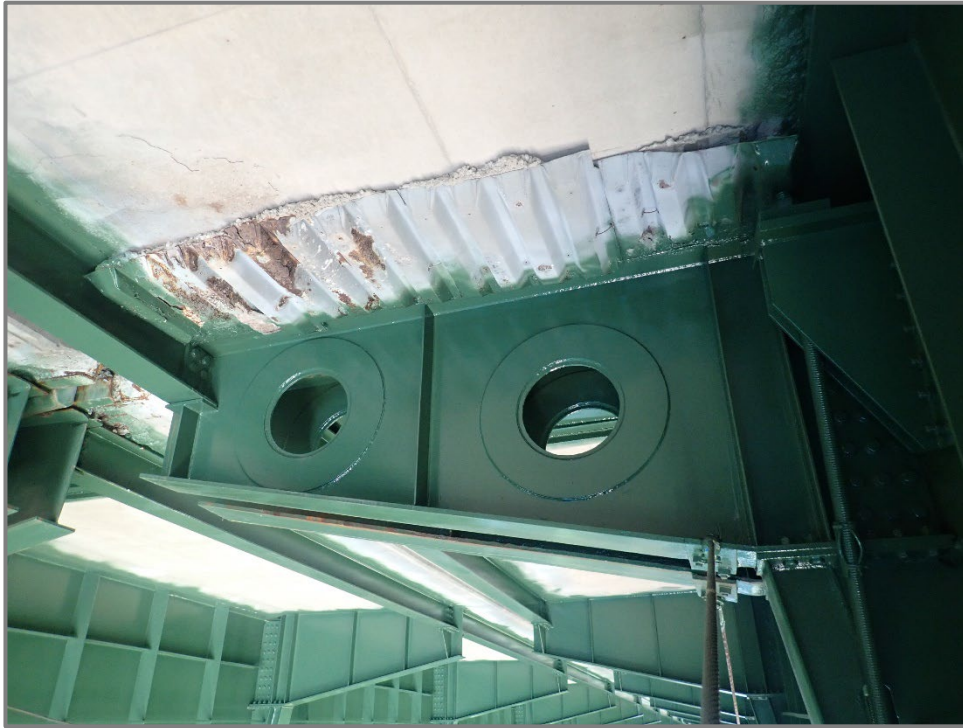
Photo 5 – Base metal at all-around access hole reinforcing plate welds to webs of floorbeam cantilevers (Category E). Floorbeam 26 north cantilever at Girder C shown, looking east.

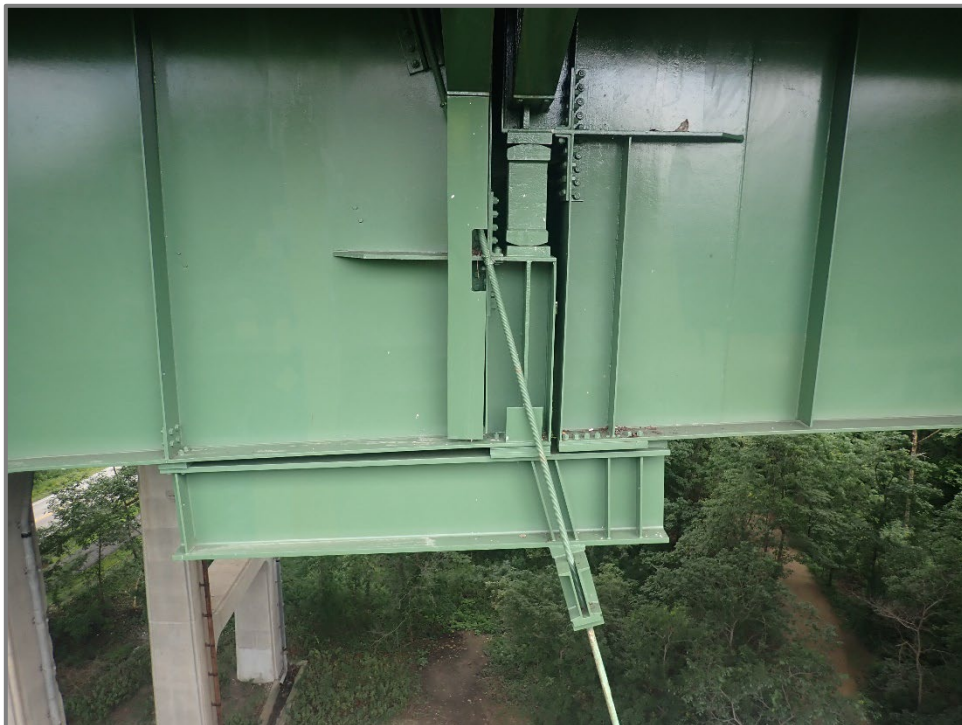
The westbound bridge was closed in 2000 due to a crack being found on the support side of the seated hinge in Span 4 at Girder D. Shortly thereafter, the bridge was repaired by jacking each seated hinge and installing carrier beam retrofits at all twelve hinge locations to provide redundancy. The structure has undergone several additional minor modifications and rehabilitations since its original construction.

Photo 8 – Typical carrier beam retrofit installed below the seated hinge joints, looking north at Girder A at the Span 4 expansion joint.
