Fracture Critical Member (FCM) Inspection Procedure

Inspection Responsibility:	ODOT District 12
County-Route-SLM:	CUY-480-0647
Structural File Number:	1812831
Inspection Frequency:	24 Months
Fatigue Life Study:	Year of Study: <u>Not Calculated</u> Remaining Fatigue Life: <u>Not Calculated</u>
Load Path Redundant:	Main Spans: <u>No, Each structure is a three-girder system at 25'-6" spacing, and floorbeam spacing exceeds 14'.</u> Approach Spans: <u>None.</u>
Structurally Redundant:	<u>No, Girders are continuous spans.</u>
Internally Redundant:	<u>No, Tension members consist of welded built-up plate girders and built-up/rolled I-section members.</u>
System Redundant:	<u>No rigorous analysis performed (i.e. finite element, 3-D modeling)</u>

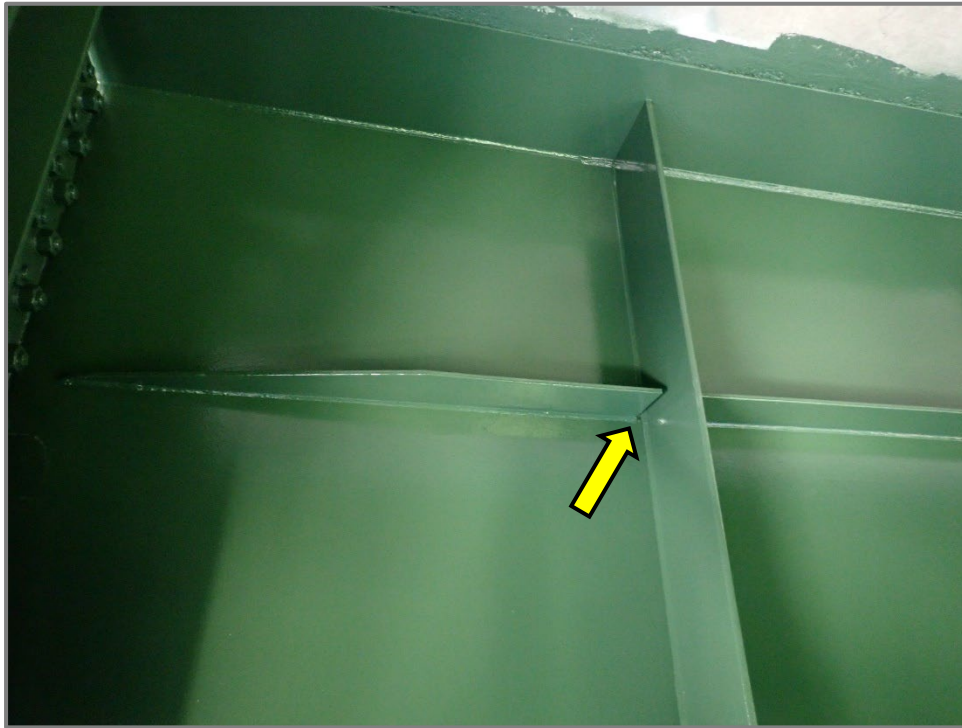
Photo 1 – Base metal at the end termination of longitudinal stiffener to girder web welds with no transition radius (Category E). Girder E at Floorbeam 18 shown, looking northeast.

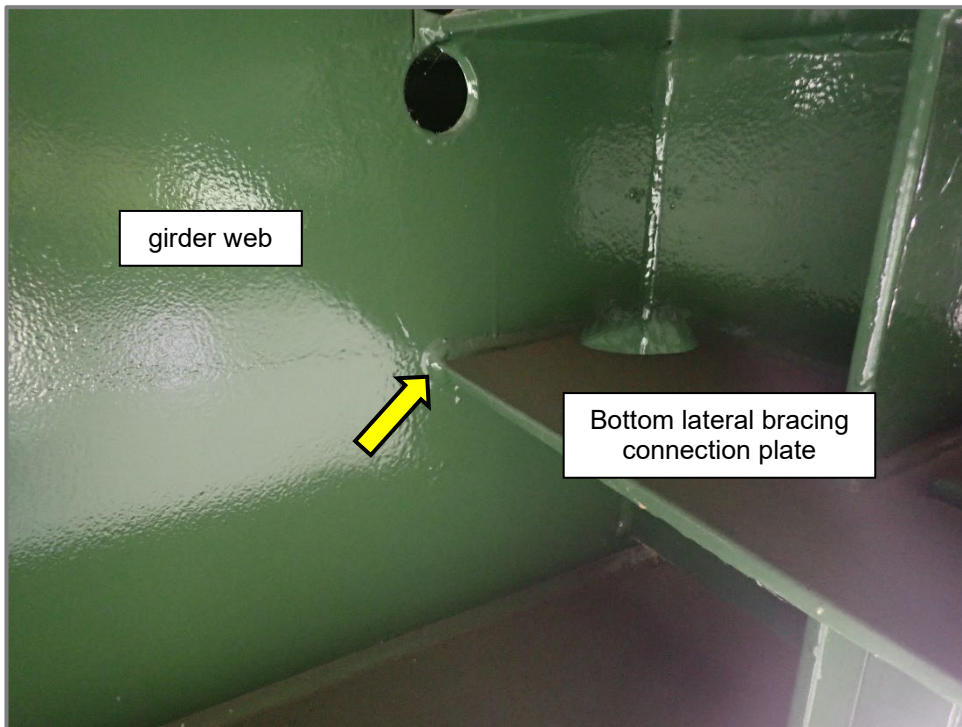
Photo 2 – Base metal at lateral bracing connection plate to girder web welds (Category E). Girder F at Floorbeam 37 shown, looking south.

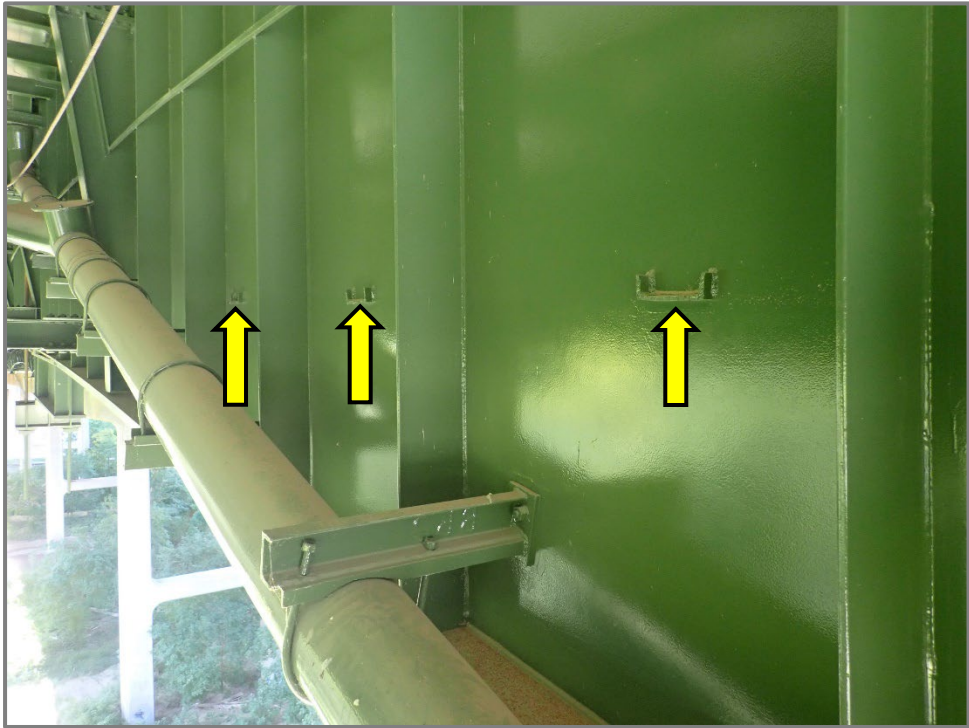
Photo 3 – Base metal at abandoned channel bracket to girder web welds (Category E). Girder C between Floorbeams 52 and 53 shown, looking northwest.

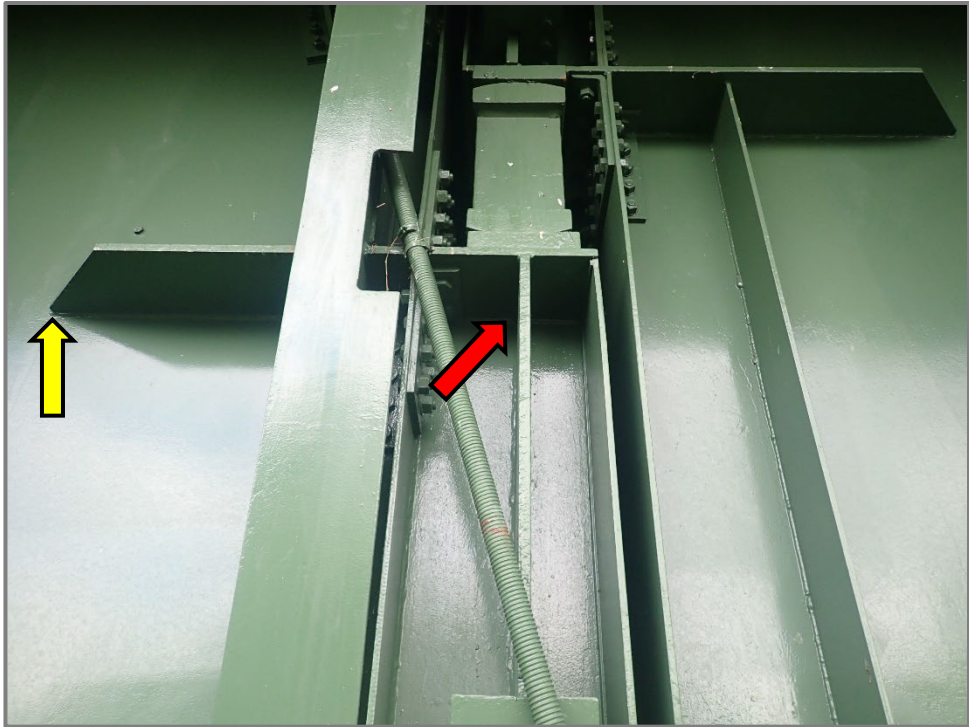
Photo 4 – Base metal at the termination of longitudinal seat plates welds to floorbeam webs (thickness > 0.8") (Category E'). Girder A at the Span 4 hinge shown, looking north. Note triaxial constraint below hinge.

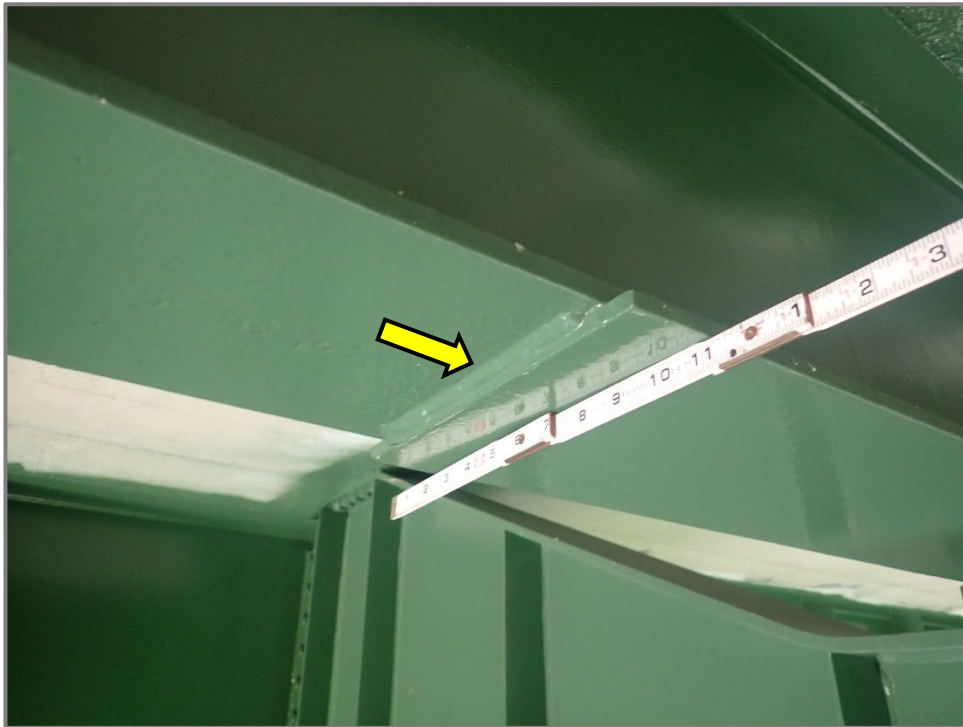
Photo 6 – Base metal at the termination of partial length welded cover plates with welds across the ends (flange thickness ≤ 0.8 ") (Category E). Stringer 3 on the west side of Floorbeam 20 shown, looking northeast.

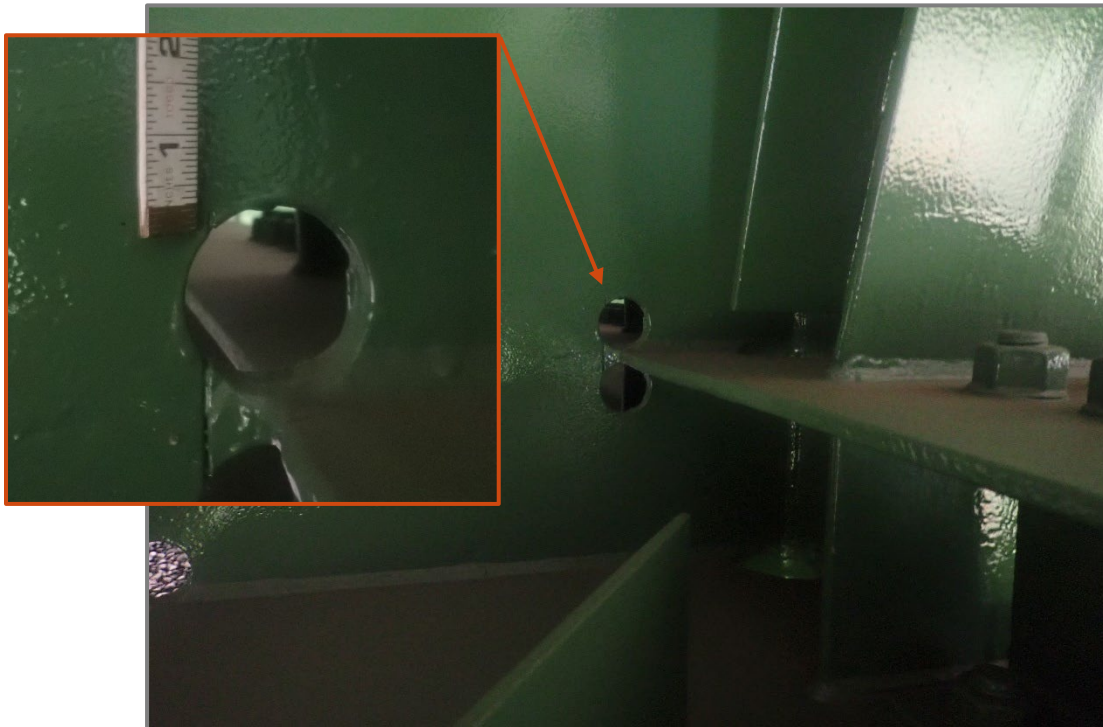
Photo 7 – Typical dogbone retrofit overcut in the girder web, looking north at Girder B at Floorbeam 4. Note that some overcut locations are not visible due to the new paint system.
