## **Fracture Critical Member and Fatigue Prone Connection Identification Plan**

**District:** 12  
**County-Route-SLM:** CUY-480-0647  
**Structural File Number:** 1812831  
**Access:** Snooper and climbing

**Load Path Redundant:** No, structure is fracture critical; inspect FCM's every 24 months.

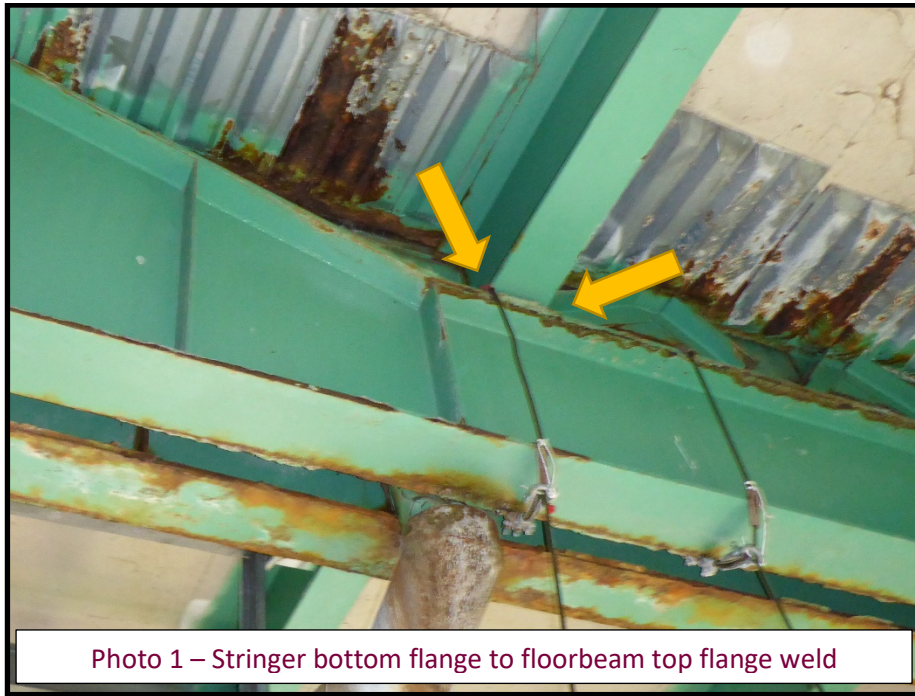
Photo Reference (photos on following pages)	Category (E, E', or R for Retrofit)	Distribution	Description
Photo 1	E		The stringer bottom flange to floorbeam top flange weld, flange thickness $\leq 0.8$ in.
Photo 2	E'		Partial length moment plate weld to stringer
Photo 3	E'		Tri-axial weld of the roller seat flange to the girder web at the expansion hinge
Photo 4	E		The end termination of the longitudinal stiffener weld to the web of the girder without a radius termination
Photo 5	R		Overcut of dogbone retrofit

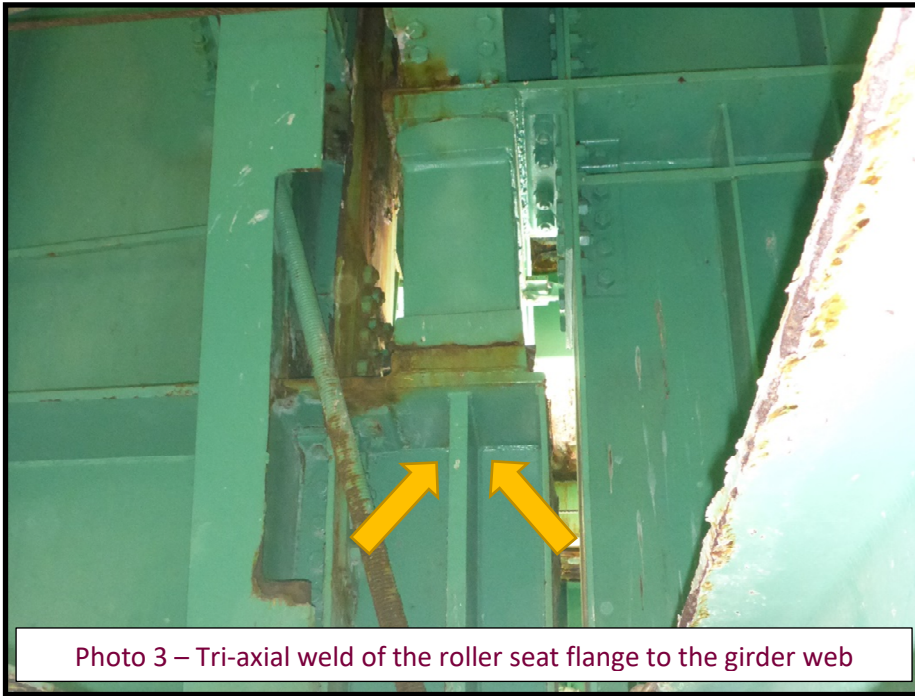
Photo 3 – Tri-axial weld of the roller seat flange to the girder web

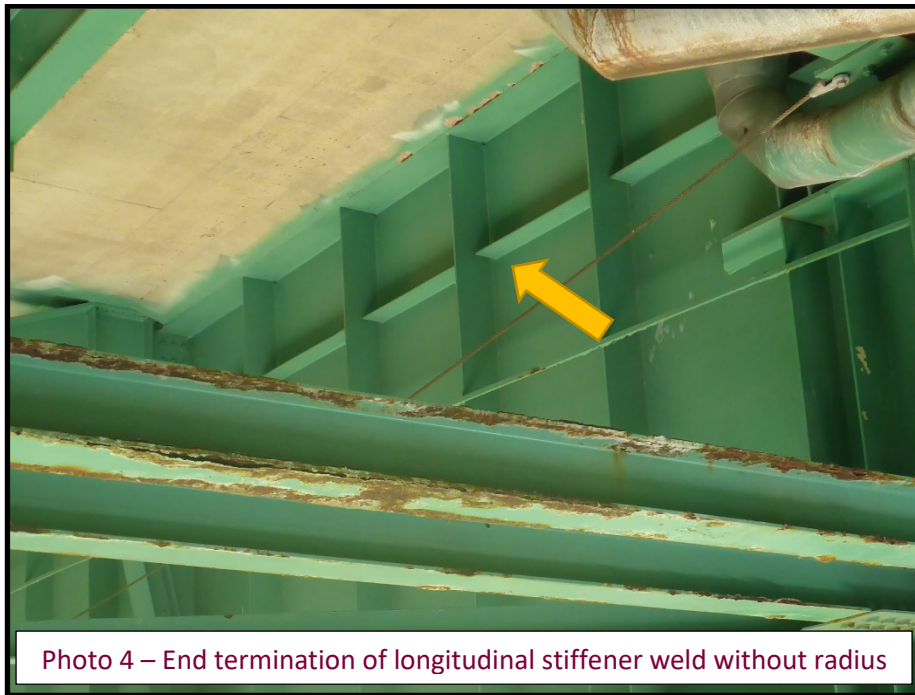
Photo 4 – End termination of longitudinal stiffener weld without radius

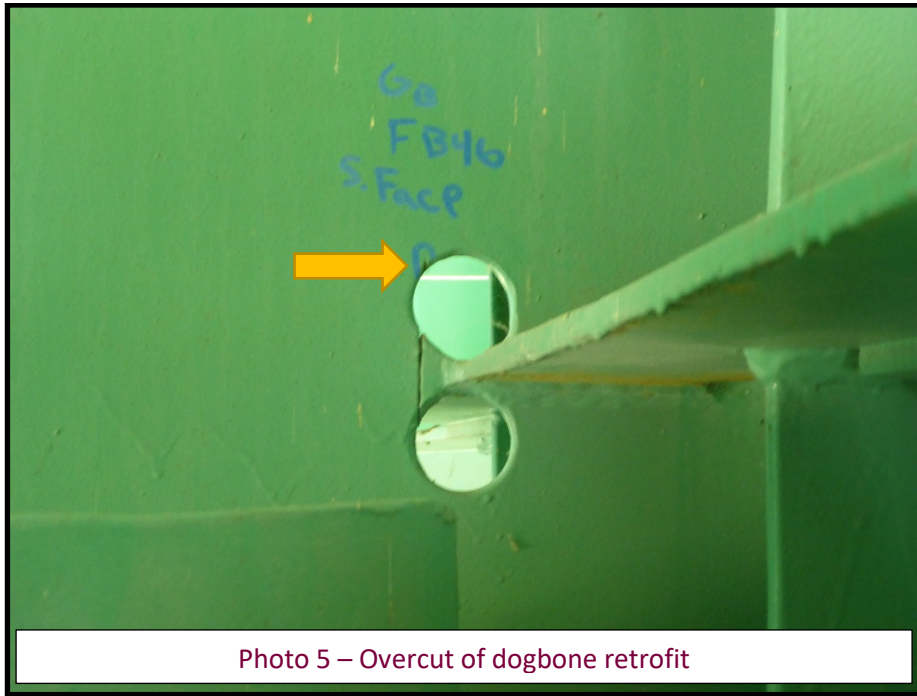
Photo 5 – Overcut of dogbone retrofit

Bridge	Span	Girder	Floorbeam	Side of FB	Location
Right	1E	B (south face)	2	West	Bottom
Right	1E	A (north face)	3	East	Bottom
Right	1E	B (south face)	4	West	Top
Right	1E	B (south face)	5	West	Bottom
Right	1E	C (south face)	5	West	Bottom
Right	1E	B (south face)	6	West	Top
Right	1E	C	6	East	
Right	1E	C	6	West	
Right	2E	A (north face)	13	West	Top
Right	2E	C (south face)	14	East	Top
Right	2E	B (south face)	15	West	
Right	4E	A (north face)	25	West	Bottom
Right	4E	A (north face)	29	East	Bottom
Right	4E	B (south face)	29	East	Top
Right	4E	B (north face)	30	East	Bottom
Right	5E	C	35	West	
Right	5E	C (south face)	38	East	Bottom
Right	5E	A	40	West	
Right	5E	C (north face)	40	West	Top
Right	6E	B (south face)	46	West	Top
Right	6E	C (south face)	48	West	Bottom
Right	6E	C (south face)	53	East	Bottom
Right	6E	C (south face)	53	West	Bottom
Right	7E	B (south face)	56	East	Top
Right	7E	C (south face)	56	East	Bottom
Right	7E	C (south face)	59	East	Bottom

Right	7E	C (south face)	59	West	Bottom
Right	8E	B (south face)	66	East	Bottom
Right	8E	B (south face)	66	East	Top
Left	1W	F (north face)	5	West	Top
Left	1W	F (south face)	8	West	Bottom
Left	2W	E (north face)	12	West	Bottom
Left	2W	E (north face)	13	East	Bottom
Left	3W	F (north face)	17	West	Top
Left	3W	F (north face)	17	West	Bottom
Left	3W	F (south face)	19	West	Top
Left	3W	F (south face)	21	East	Bottom
Left	3W	F (south face)	23	West	Bottom
Left	4W	E (north face)	30	West	Bottom
Left	4W	F (south face)	31	East	Top
Left	4W	F (north face)	33	West	Top
Left	5W	D (north face)	37	East	Bottom
Left	7W	E (north face)	55	West	Top
Left	7W	F (south face)	56	East	Bottom
Left	7W	D (north face)	60	West	Top
Left	7W	F (south face)	60	West	Top
Left	8W	F (south face)	66	West	Bottom

\*\* NO sawcut between holes

\*\* Incomplete sawcut between holes

Total Overcuts:                      Top Locations:    17  
   Bottom Locations:    28
