# VAR-D12-BI-2019-1

## 2021 Physical Condition Element Level Routine Inspection Report

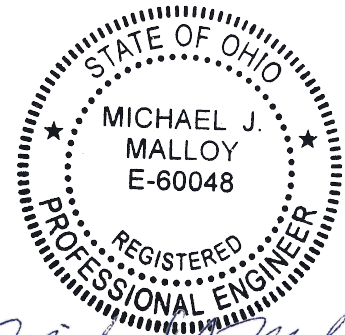
Inspection findings were documented with field notes, sketches, pictures, and measurements. Detailed discussion of all related issues can be found in pertinent sections of this inspection report.

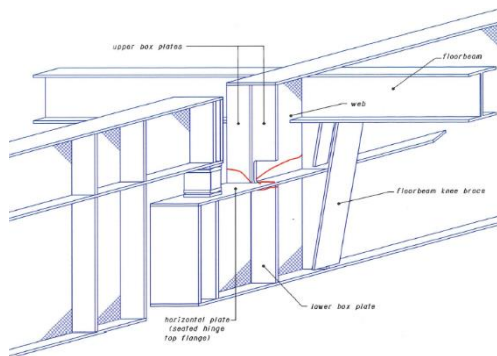
LOCATION OF THE CRACKS  
(CRACKS SHOWN IN RED)

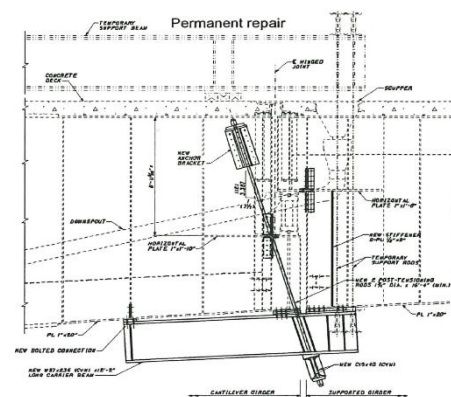
Carrier Beam Retrofit

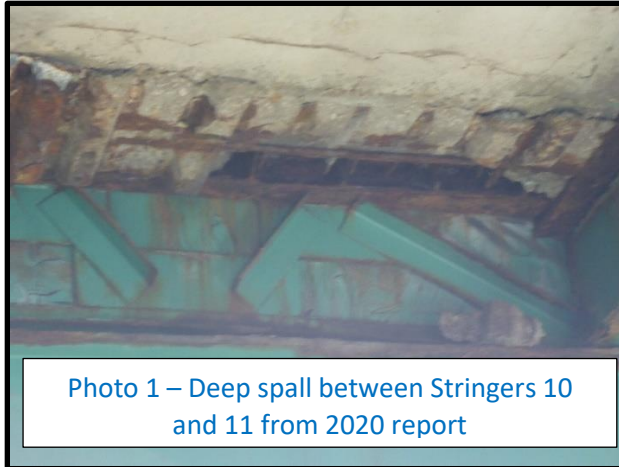
Photo 1 – Deep spall between Stringers 10 and 11 from 2020 report

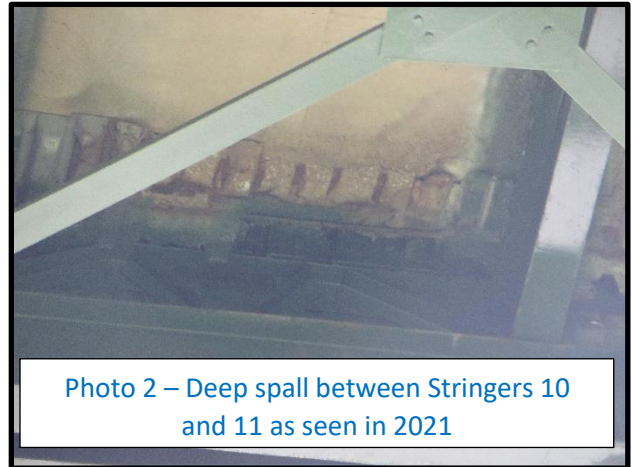
Photo 2 – Deep spall between Stringers 10 and 11 as seen in 2021

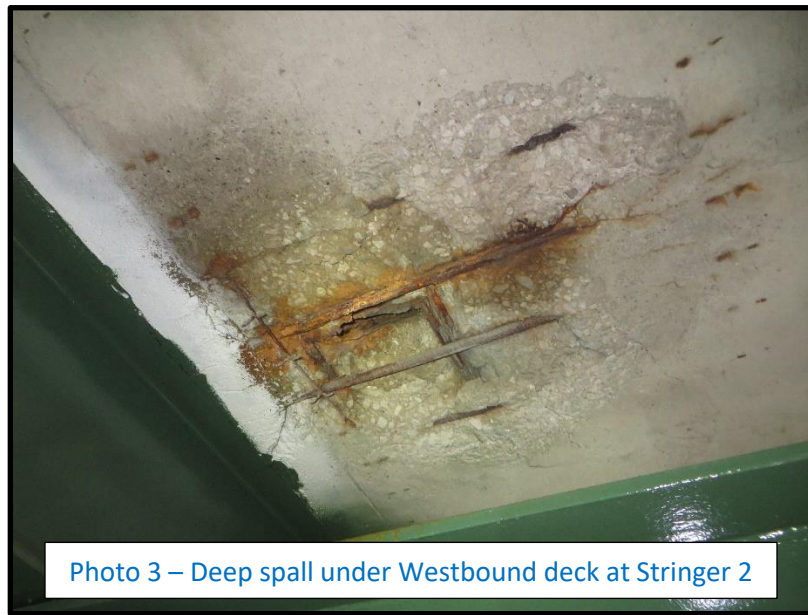
Photo 3 – Deep spall under Westbound deck at Stringer 2

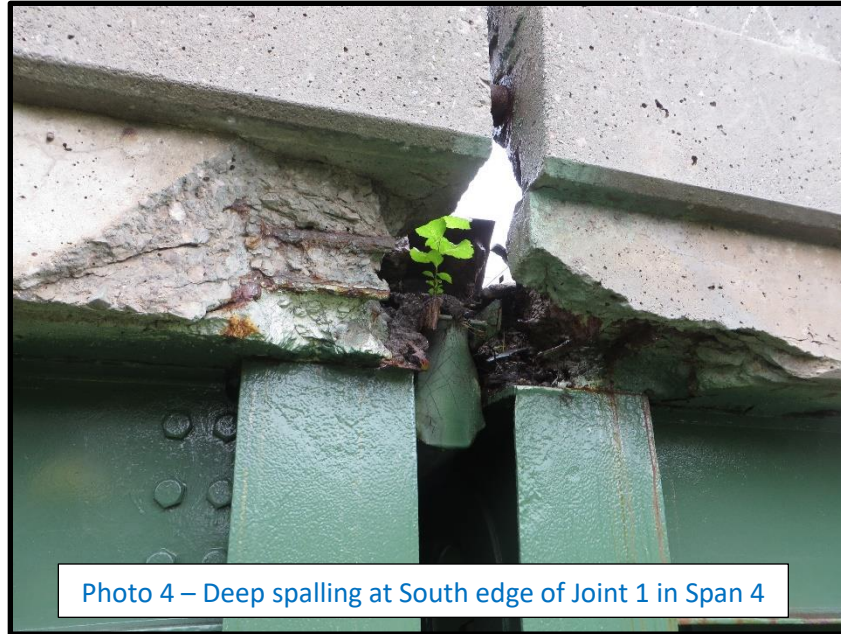
### V.1.3 BRIDGE WEARING SURFACE

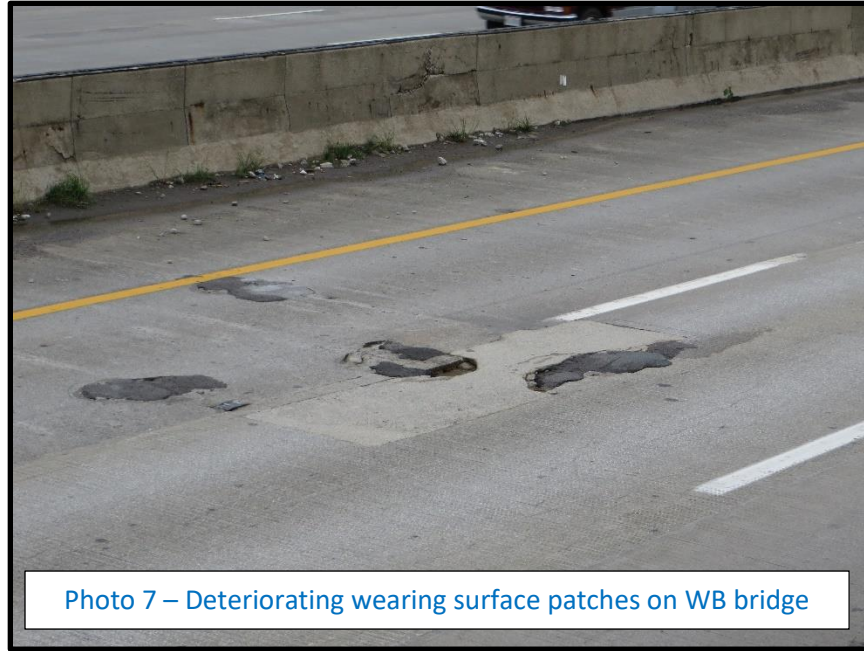
Photo 7 – Deteriorating wearing surface patches on WB bridge

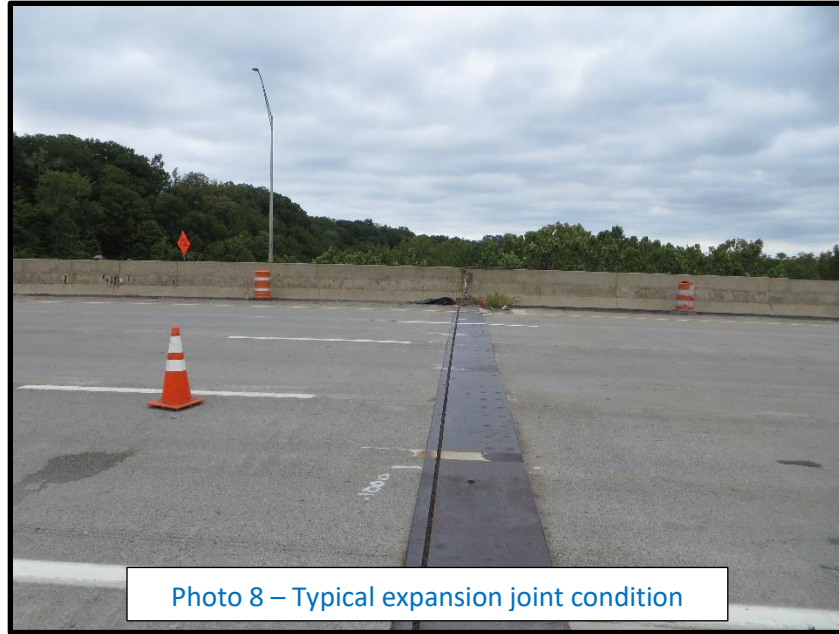
Photo 8 – Typical expansion joint condition

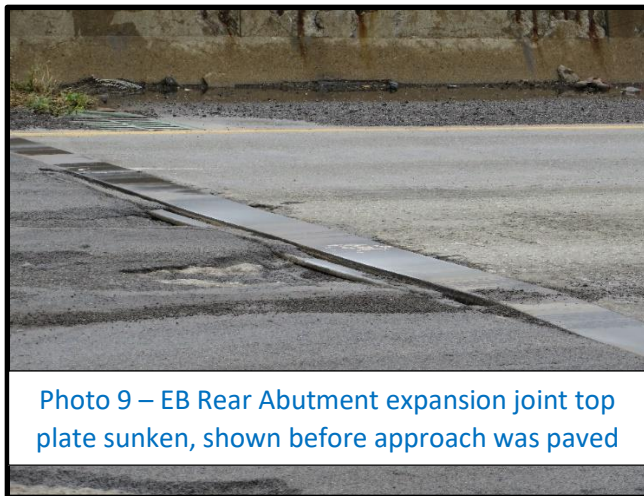
Photo 9 – EB Rear Abutment expansion joint top plate sunken, shown before approach was paved

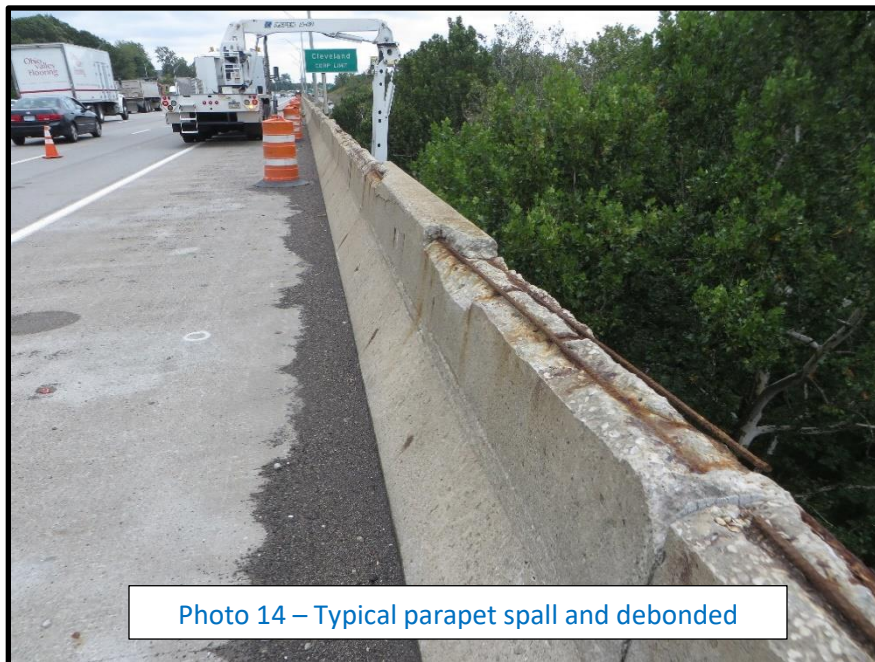
Photo 14 – Typical parapet spall and debonded

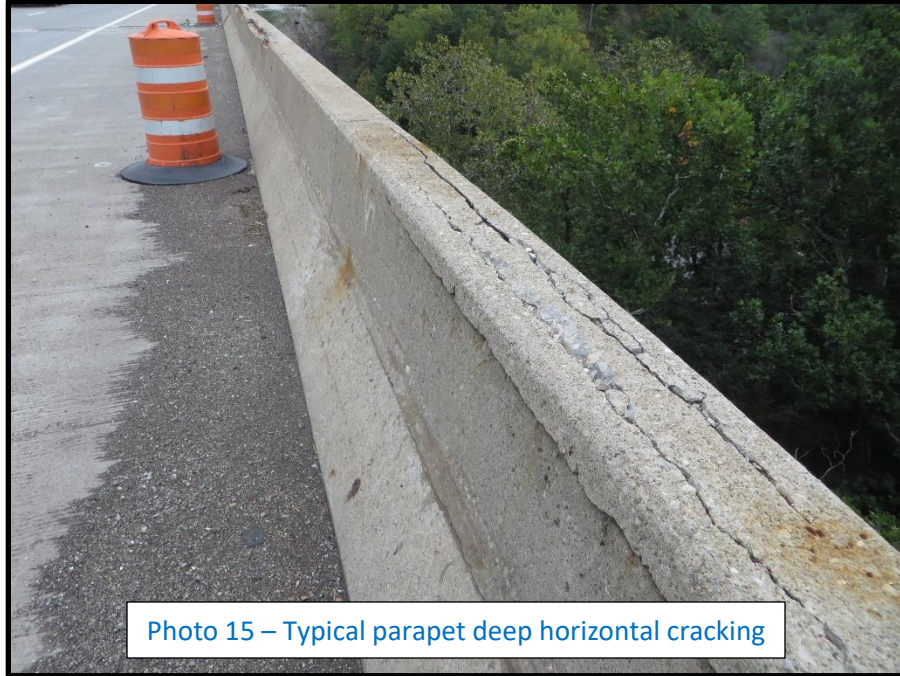
Photo 15 – Typical parapet deep horizontal cracking

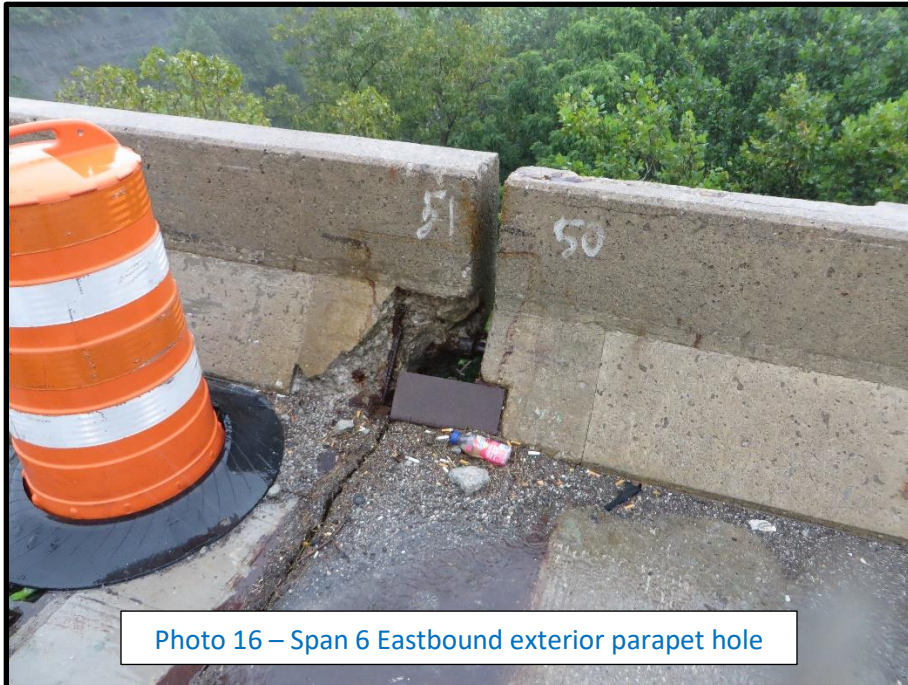
Photo 16 – Span 6 Eastbound exterior parapet hole

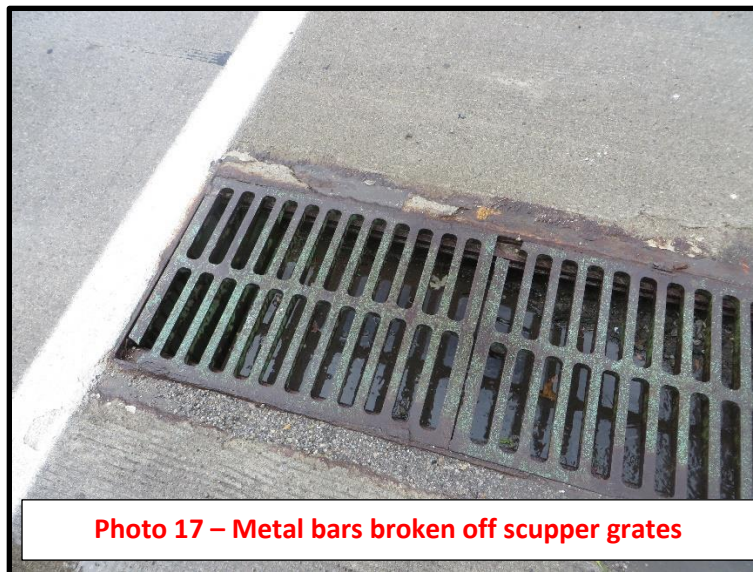
**Photo 17 – Metal bars broken off scupper grates**

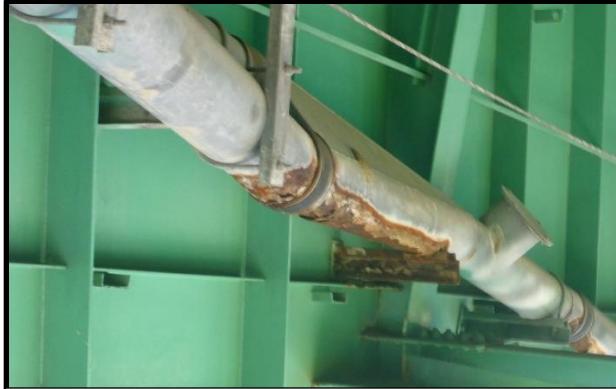
Photo 18 – Westbound Span 6 downspout 2020

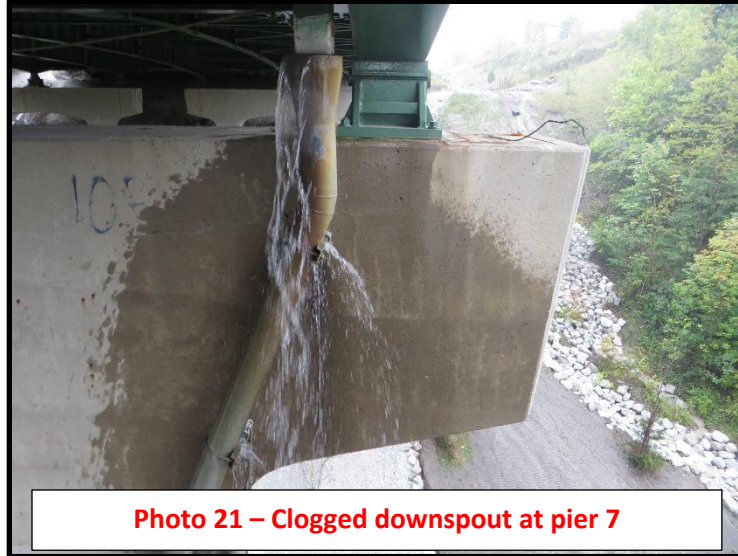
Photo 20 – New rock protection below Pier 6

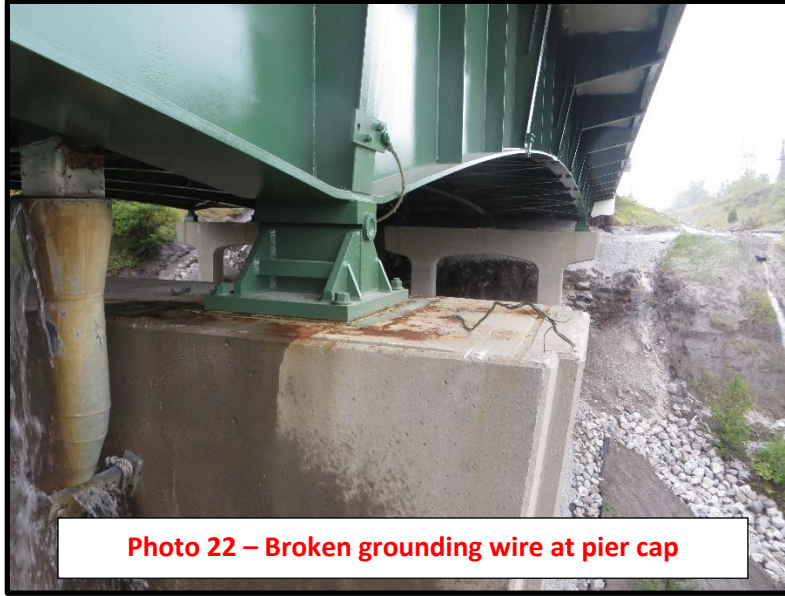
**Photo 22 – Broken grounding wire at pier cap**

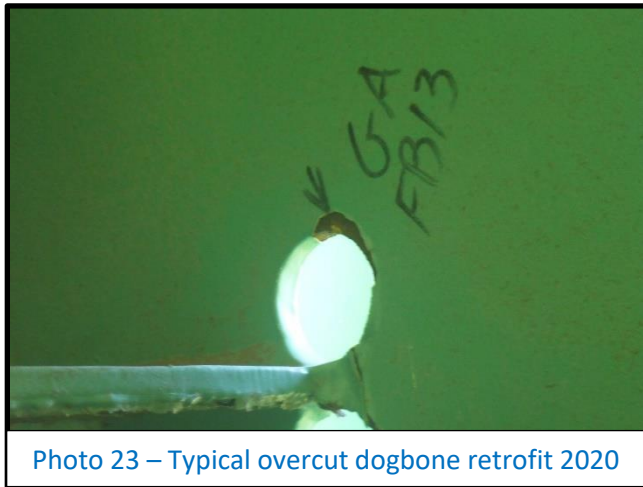
Photo 23 – Typical overcut dogbone retrofit 2020

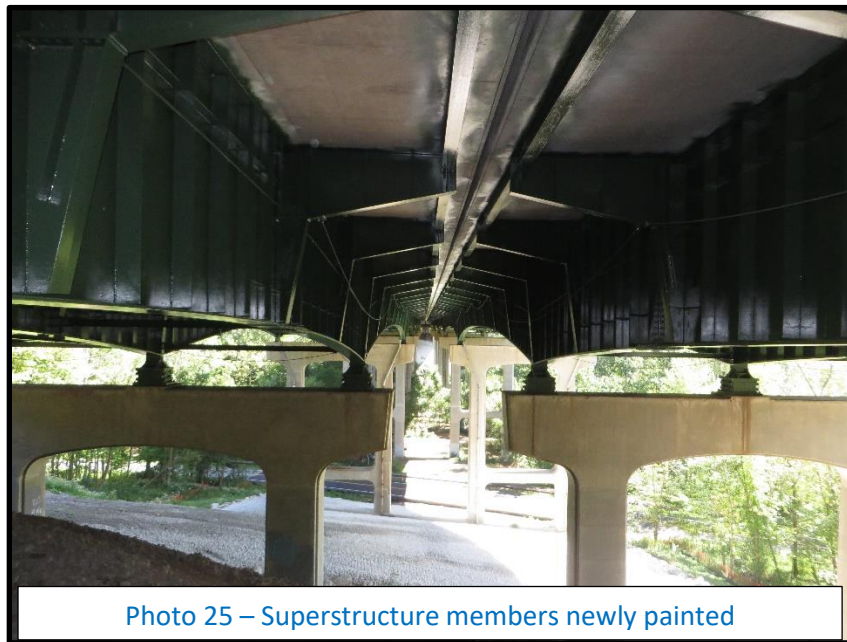
Photo 25 – Superstructure members newly painted

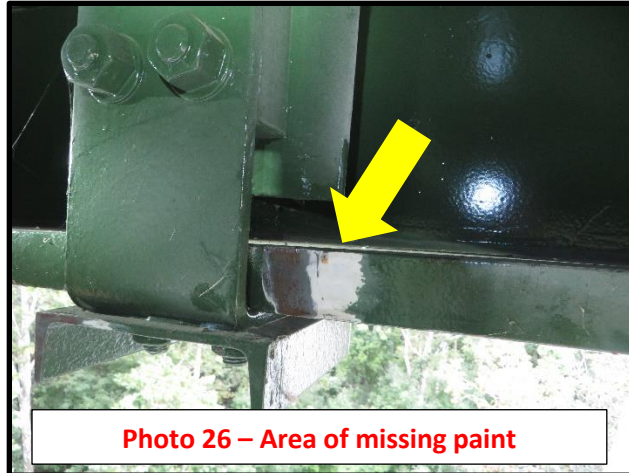
**Photo 26 – Area of missing paint**

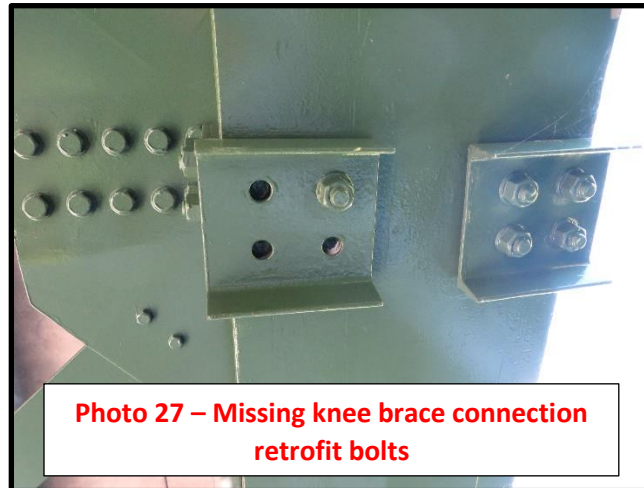
## V.2.7 DIAPHRAGMS/X-FRAMES

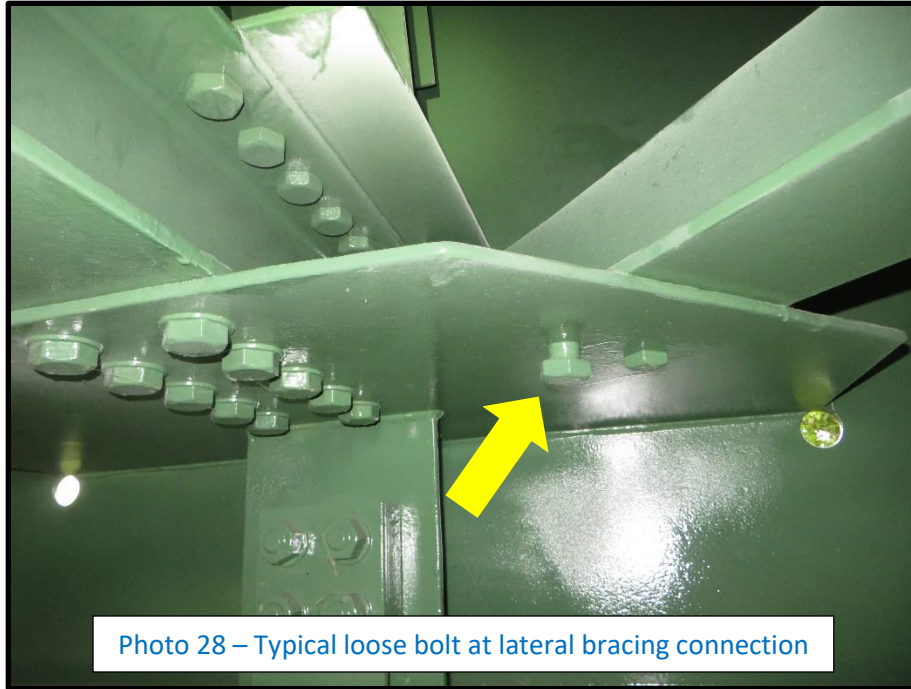
Photo 28 – Typical loose bolt at lateral bracing connection

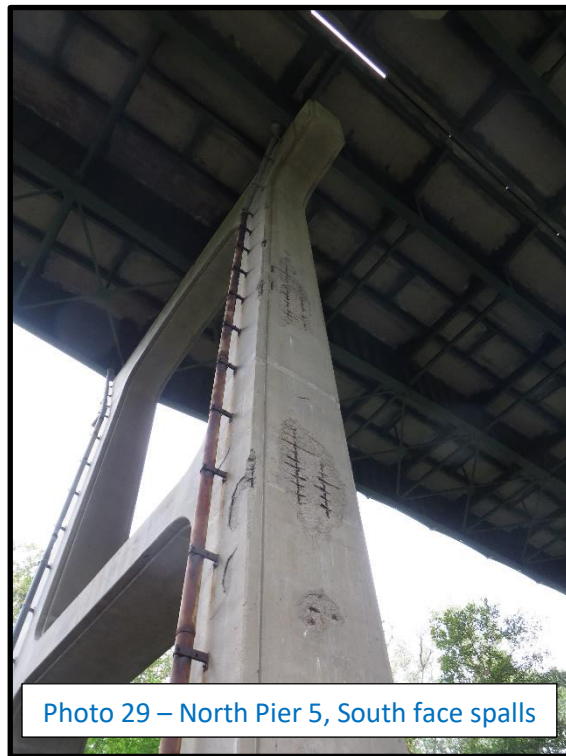
The pier columns are in **fair** condition. Several pier columns exhibit delaminations and spalls, some with deteriorated rebar (Photo 29), over their full height and localized around the relief detail at the column corners (Photo 30). Vertical cracks were also noted on several pier columns.

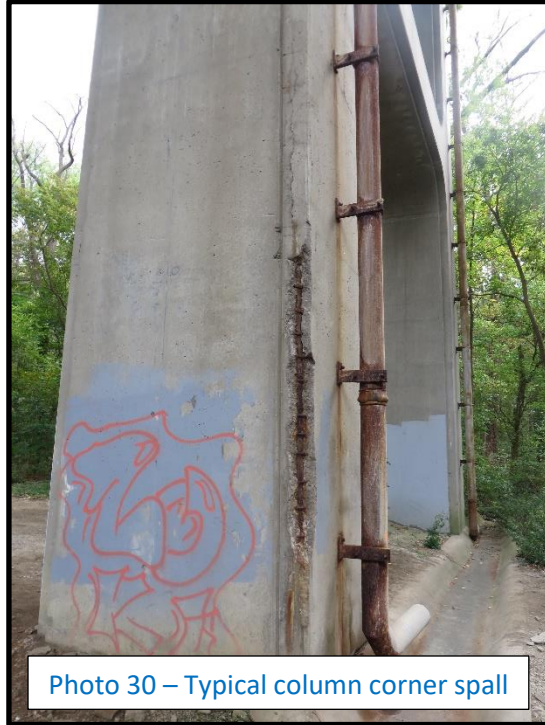
Photo 30 – Typical column corner spall

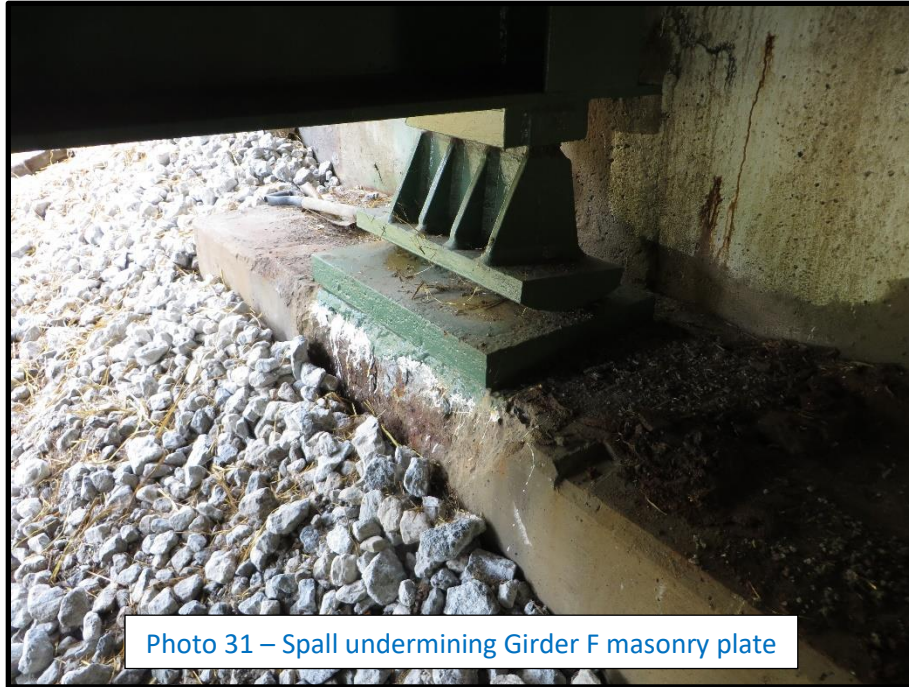
Photo 31 – Spall undermining Girder F masonry plate

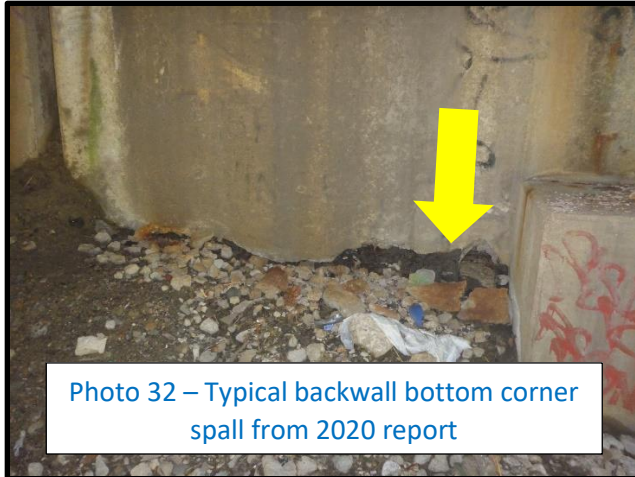
Photo 32 – Typical backwall bottom corner spall from 2020 report

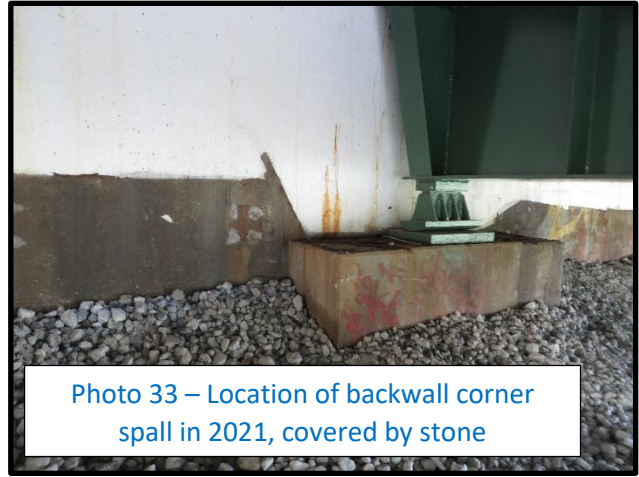
Photo 33 – Location of backwall corner spall in 2021, covered by stone

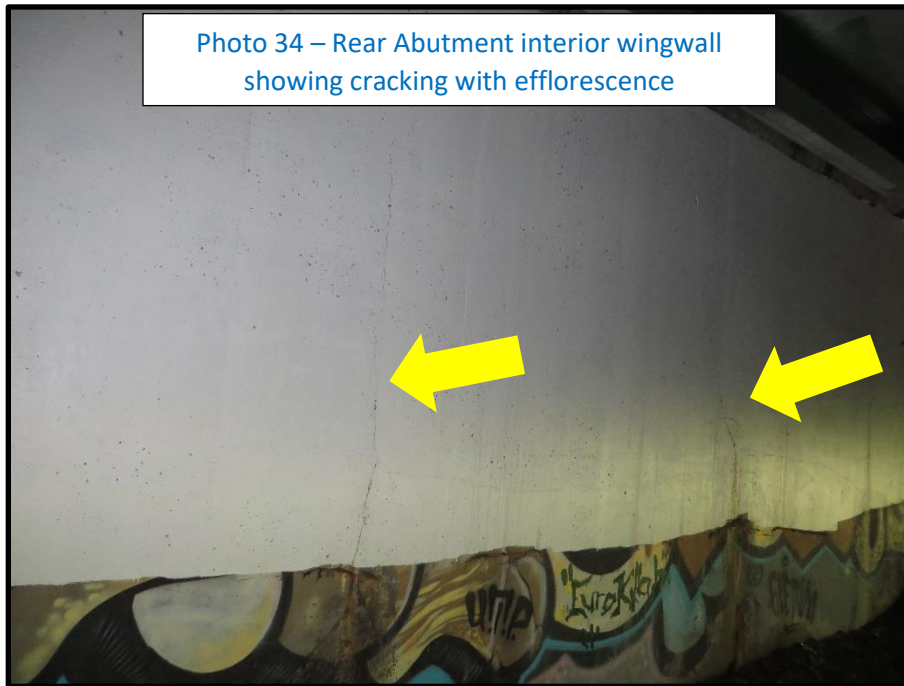
Photo 34 – Rear Abutment interior wingwall showing cracking with efflorescence

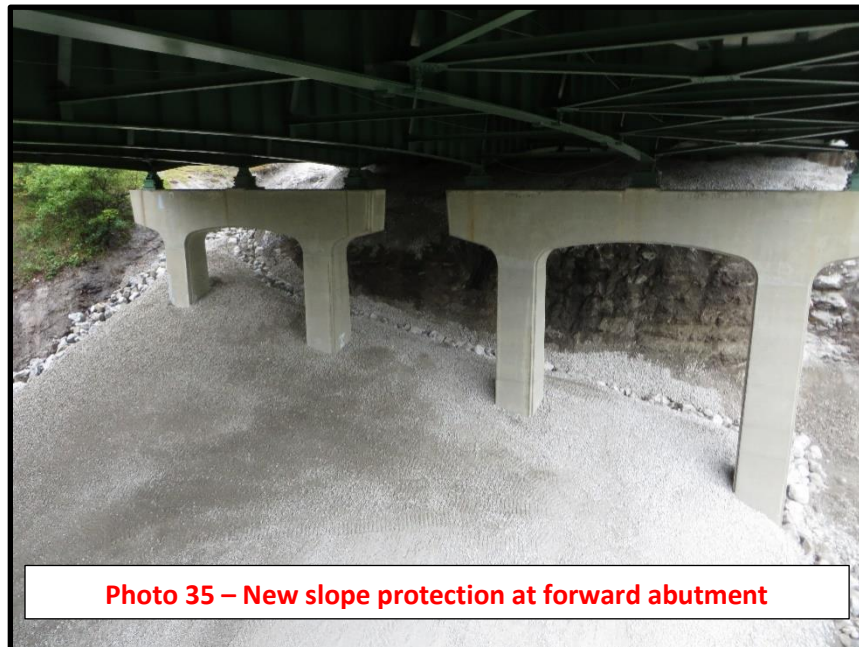
**Photo 35 – New slope protection at forward abutment**

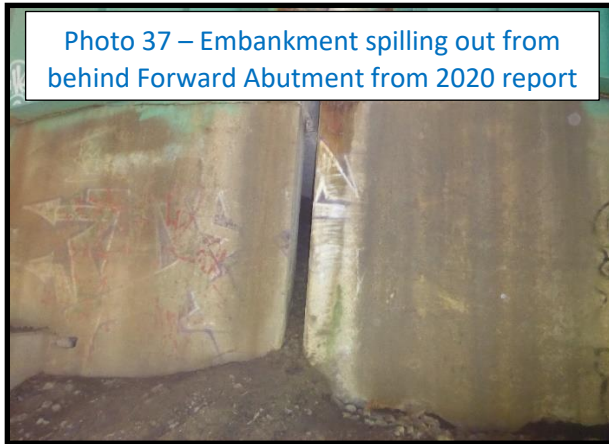
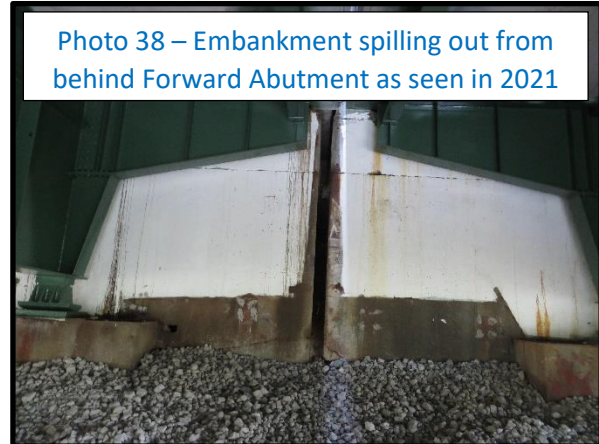
### V.4.4 APPROACH GUARDRAIL

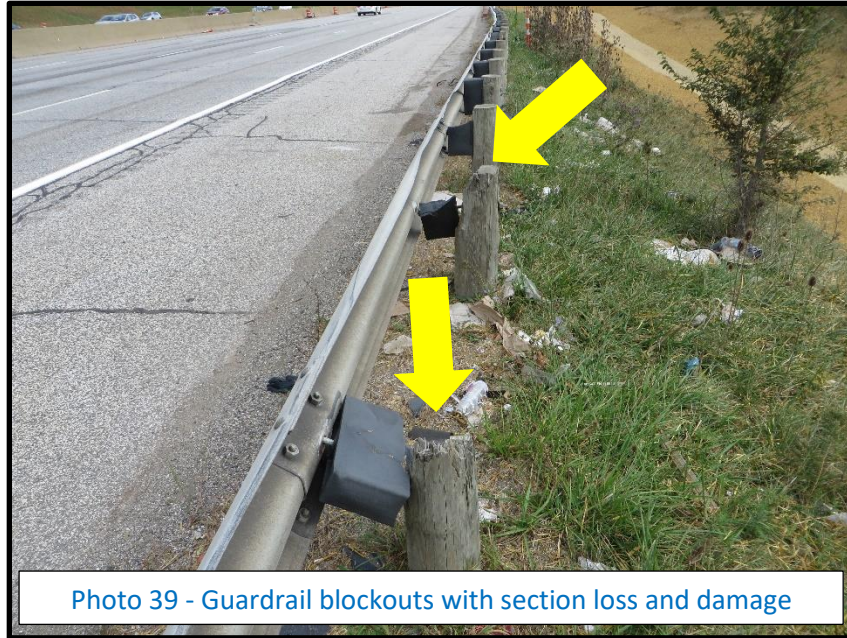
Photo 39 - Guardrail blockouts with section loss and damage

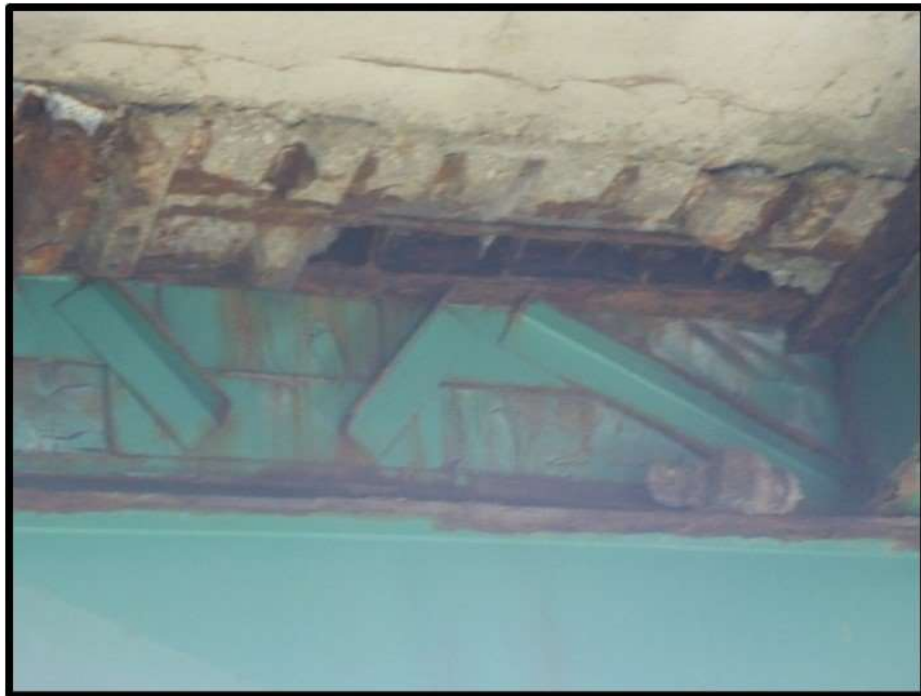
Description Photo 39 - Guardrail blockouts with section loss and damage

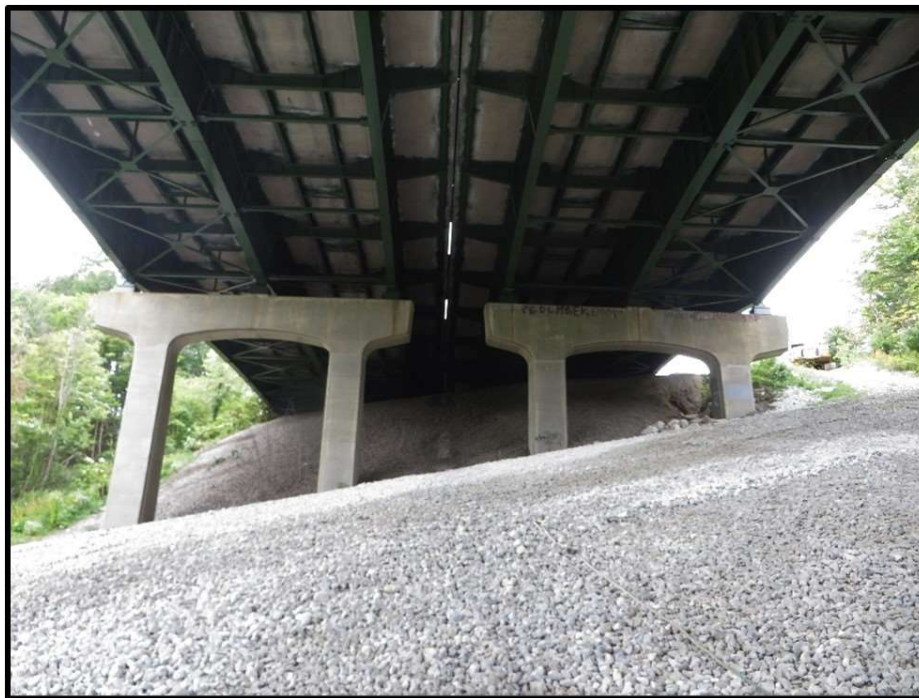
Description Photo 22 – Broken grounding wire at pier cap

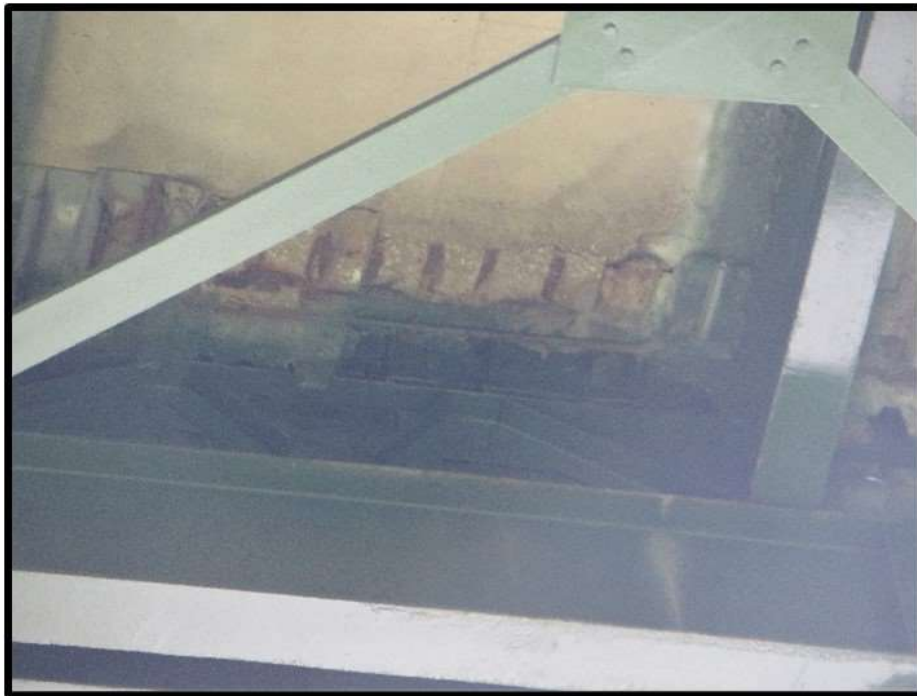
Description Photo 24 – Location of previous dogbone      overcut in 2021 after painting

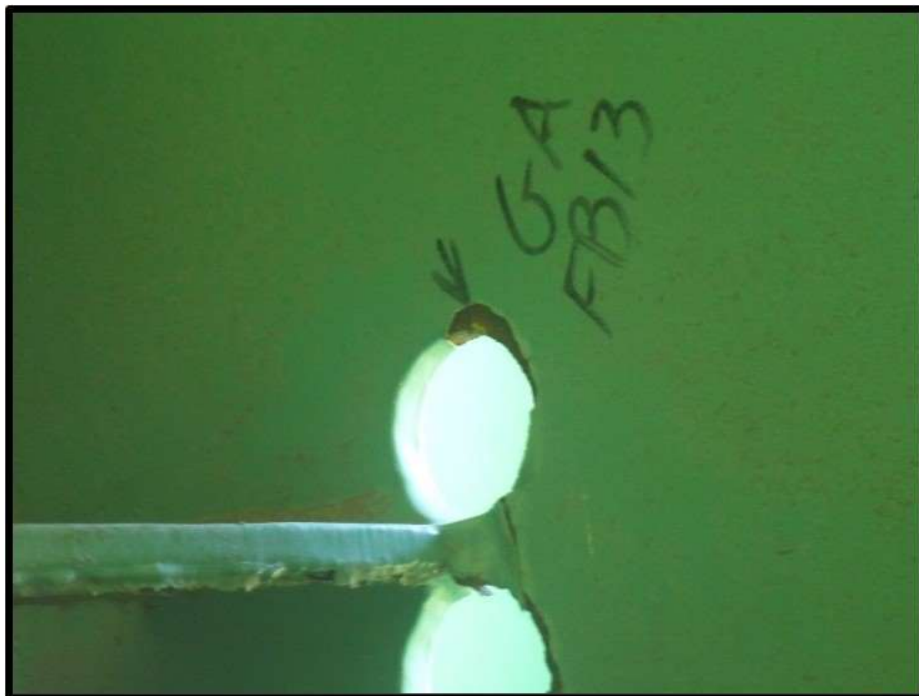
Description Photo 3 – Deep spall under Westbound deck at Stringer 2

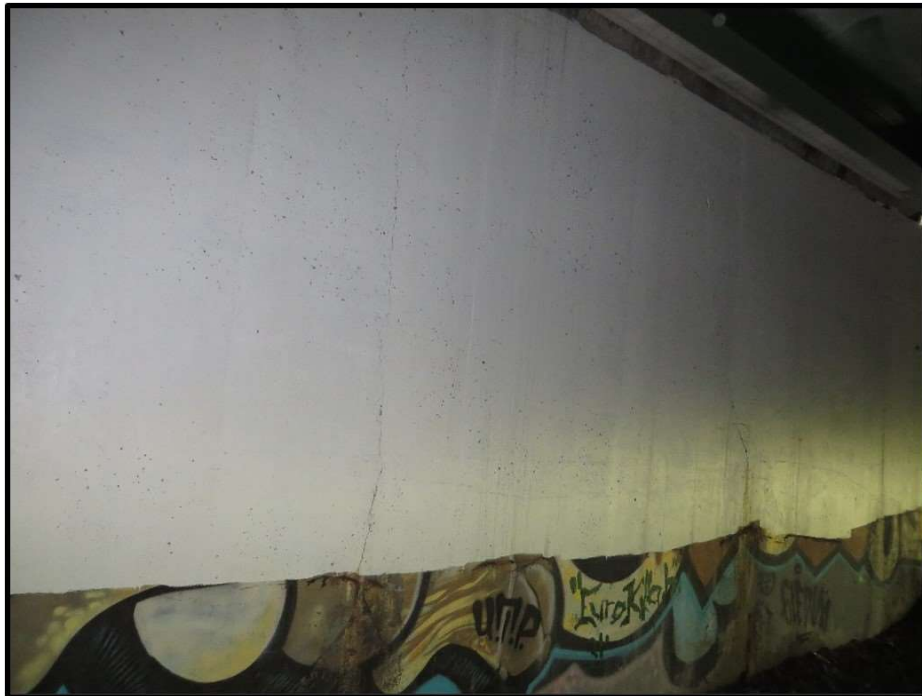
Description Channel Under Bridge

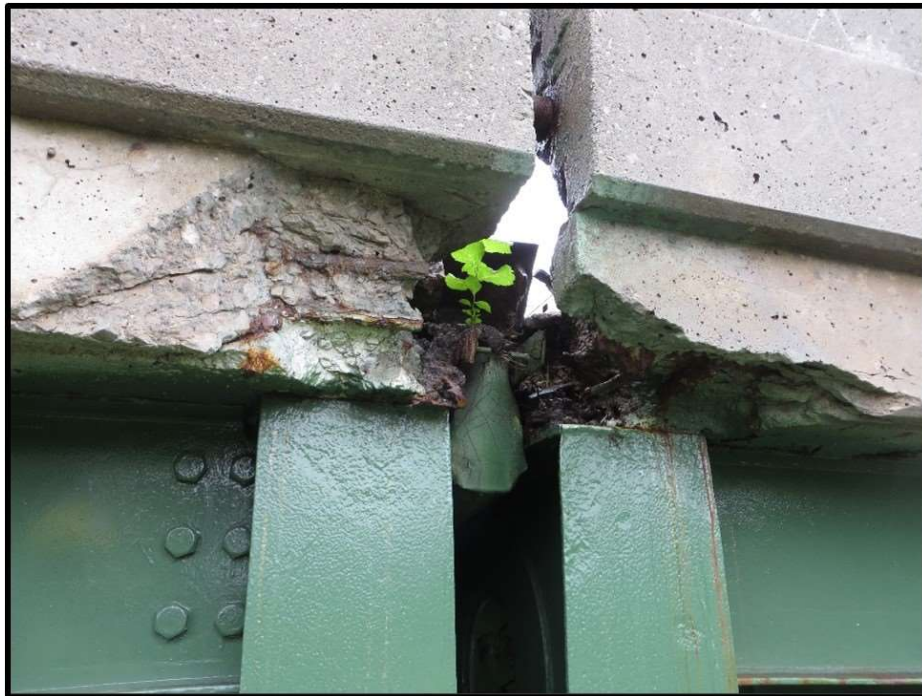
Description Photo 35 – New slope protection at forward abutment

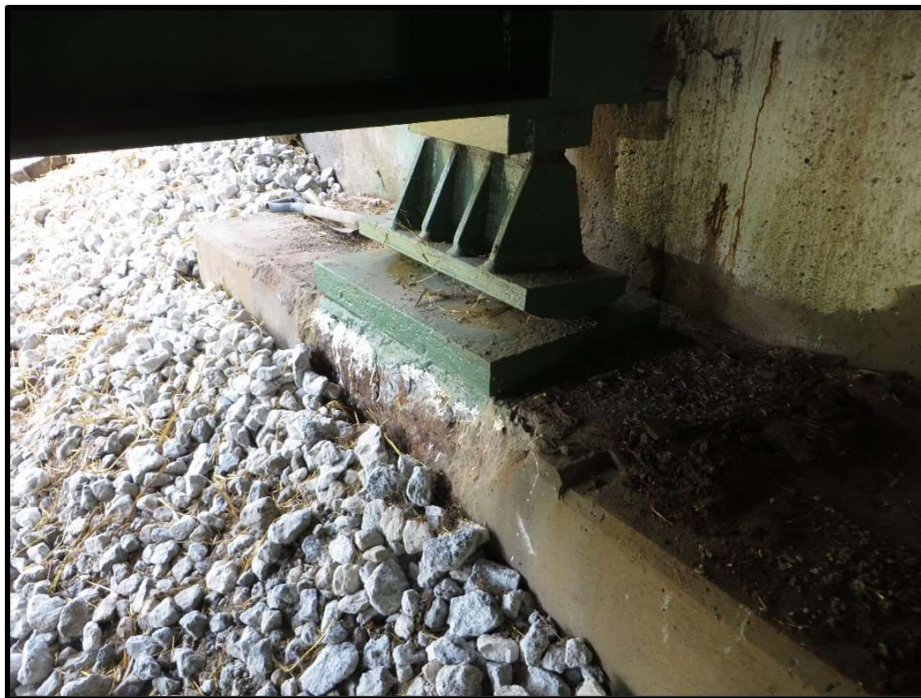
Description Photo 5 – Typical scupper halo spalling

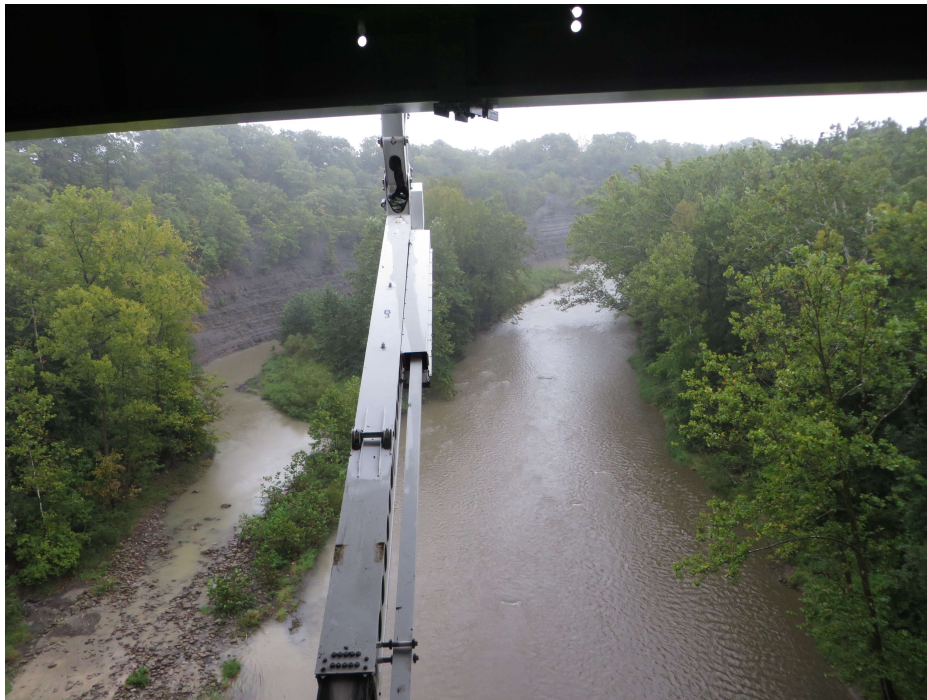
Description Photo 33 – Location of backwall corner spall in 2021, covered by stone

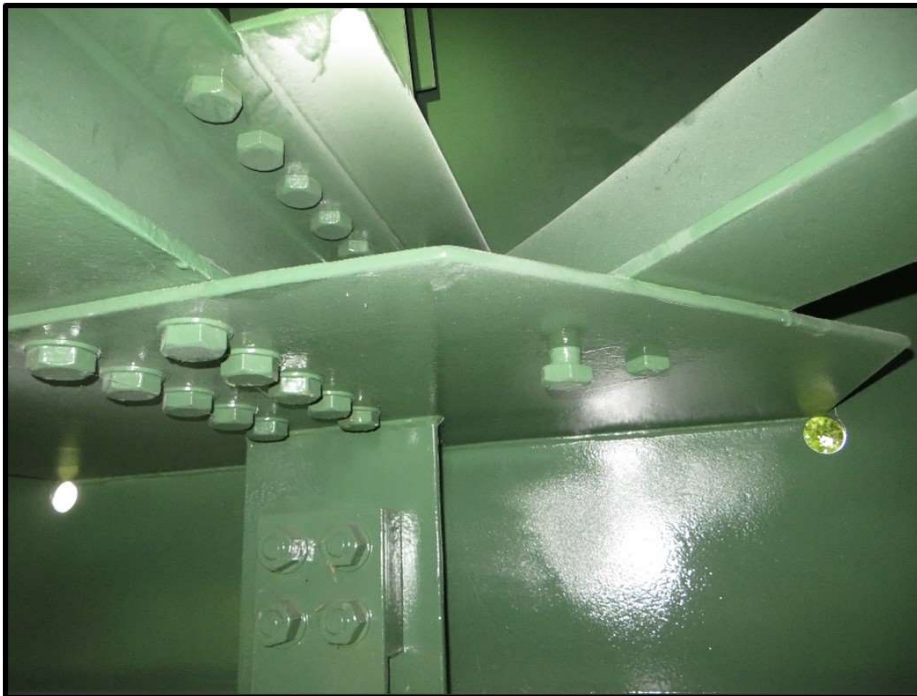
Description Photo 32 – Typical backwall bottom corner spall from 2020 report

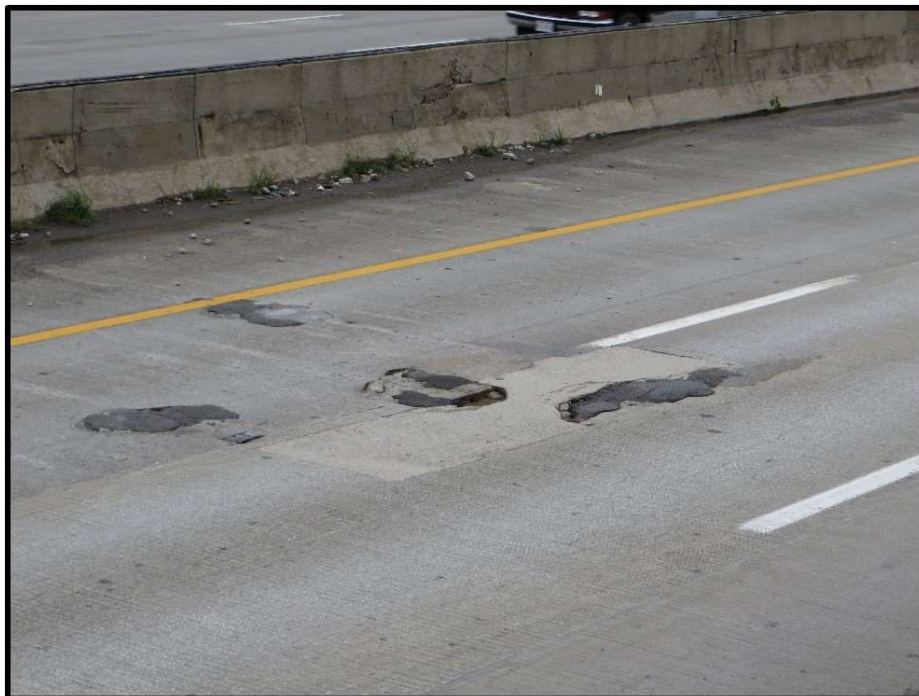
Description Photo 6 – Typical Westbound shoulder spall

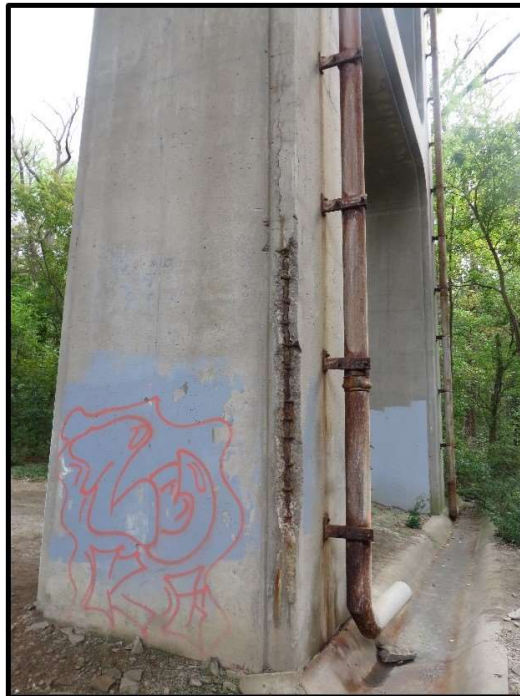
Description Photo 27 – Missing knee brace connection retrofit bolts

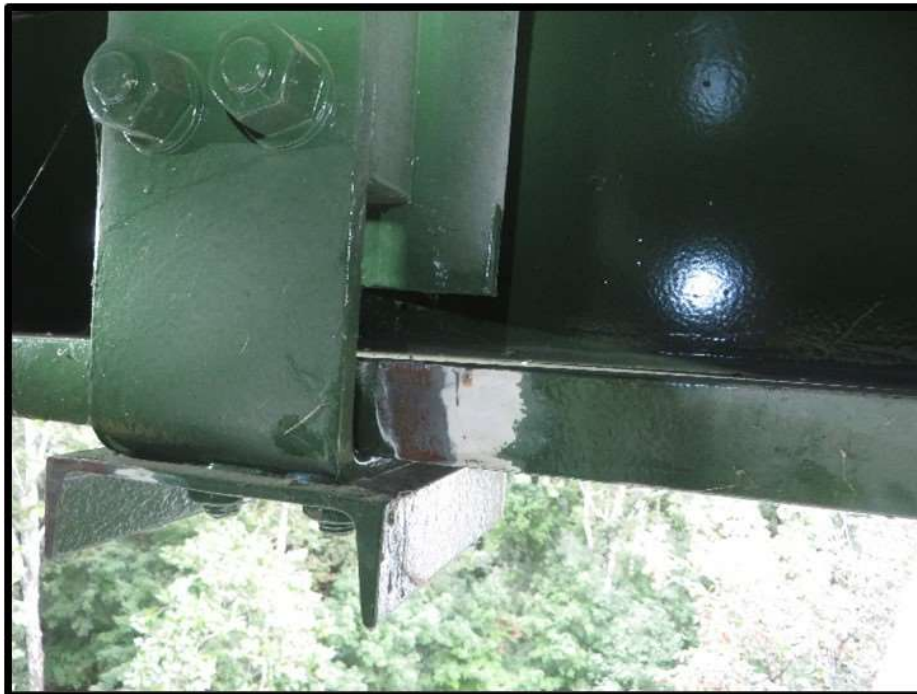
Description Photo 29 – North Pier 5, South face spalls

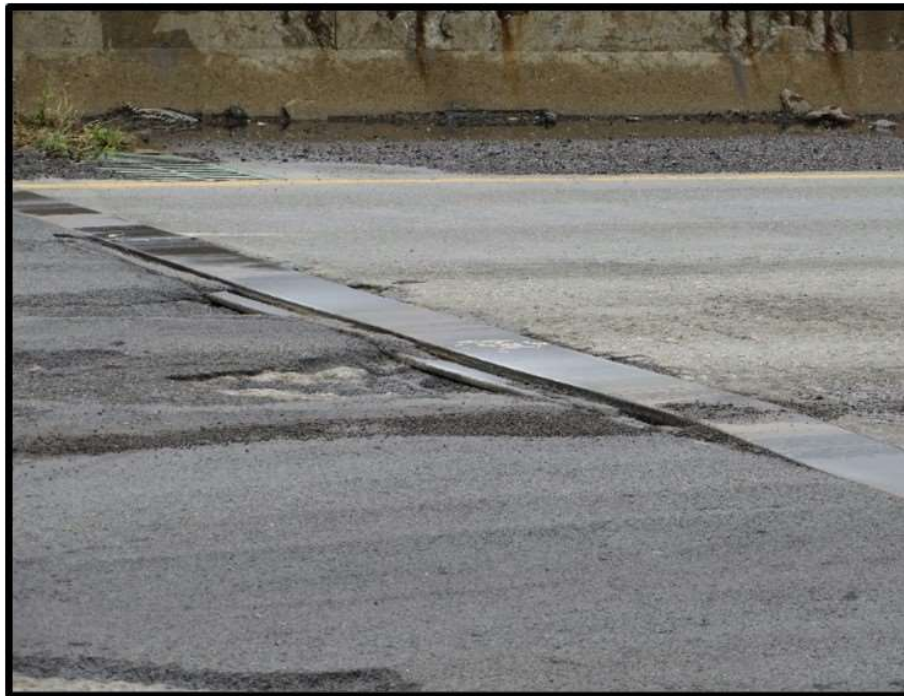
Description Photo 8 – Typical expansion joint condition

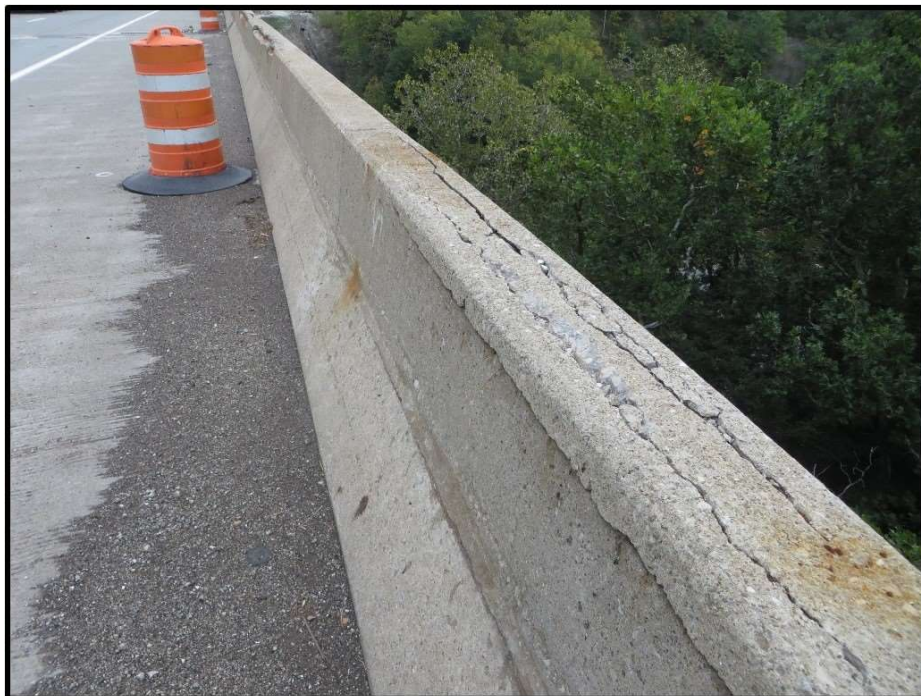
Description Photo 14 – Typical parapet spall and debonded
