# VAR-D12-BI-2019-1

## 2021 Physical Condition Element Level Routine Inspection Report

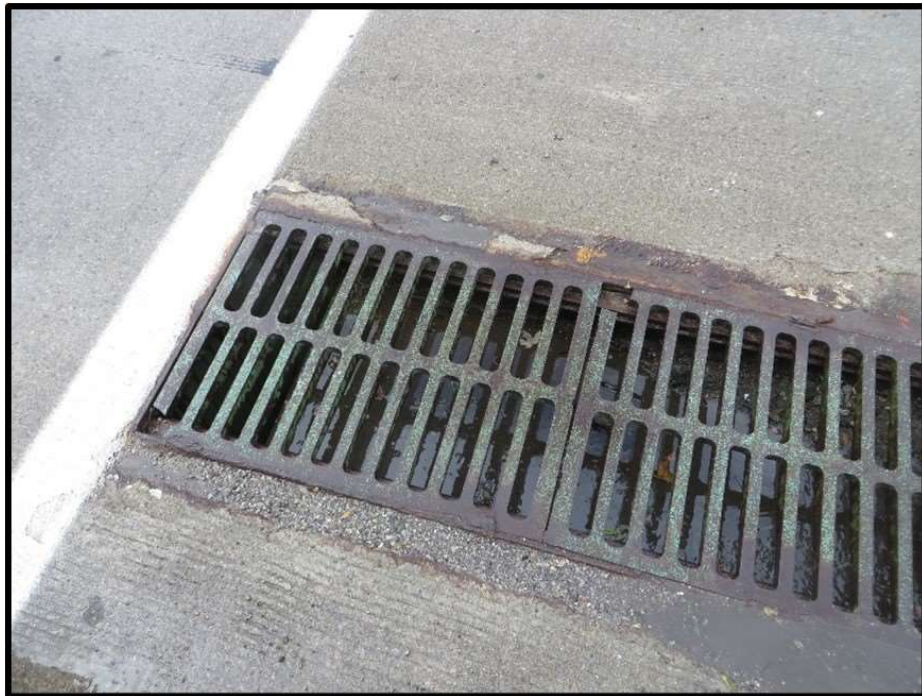
Description Photo 16 – Span 6 Eastbound exterior parapet hole

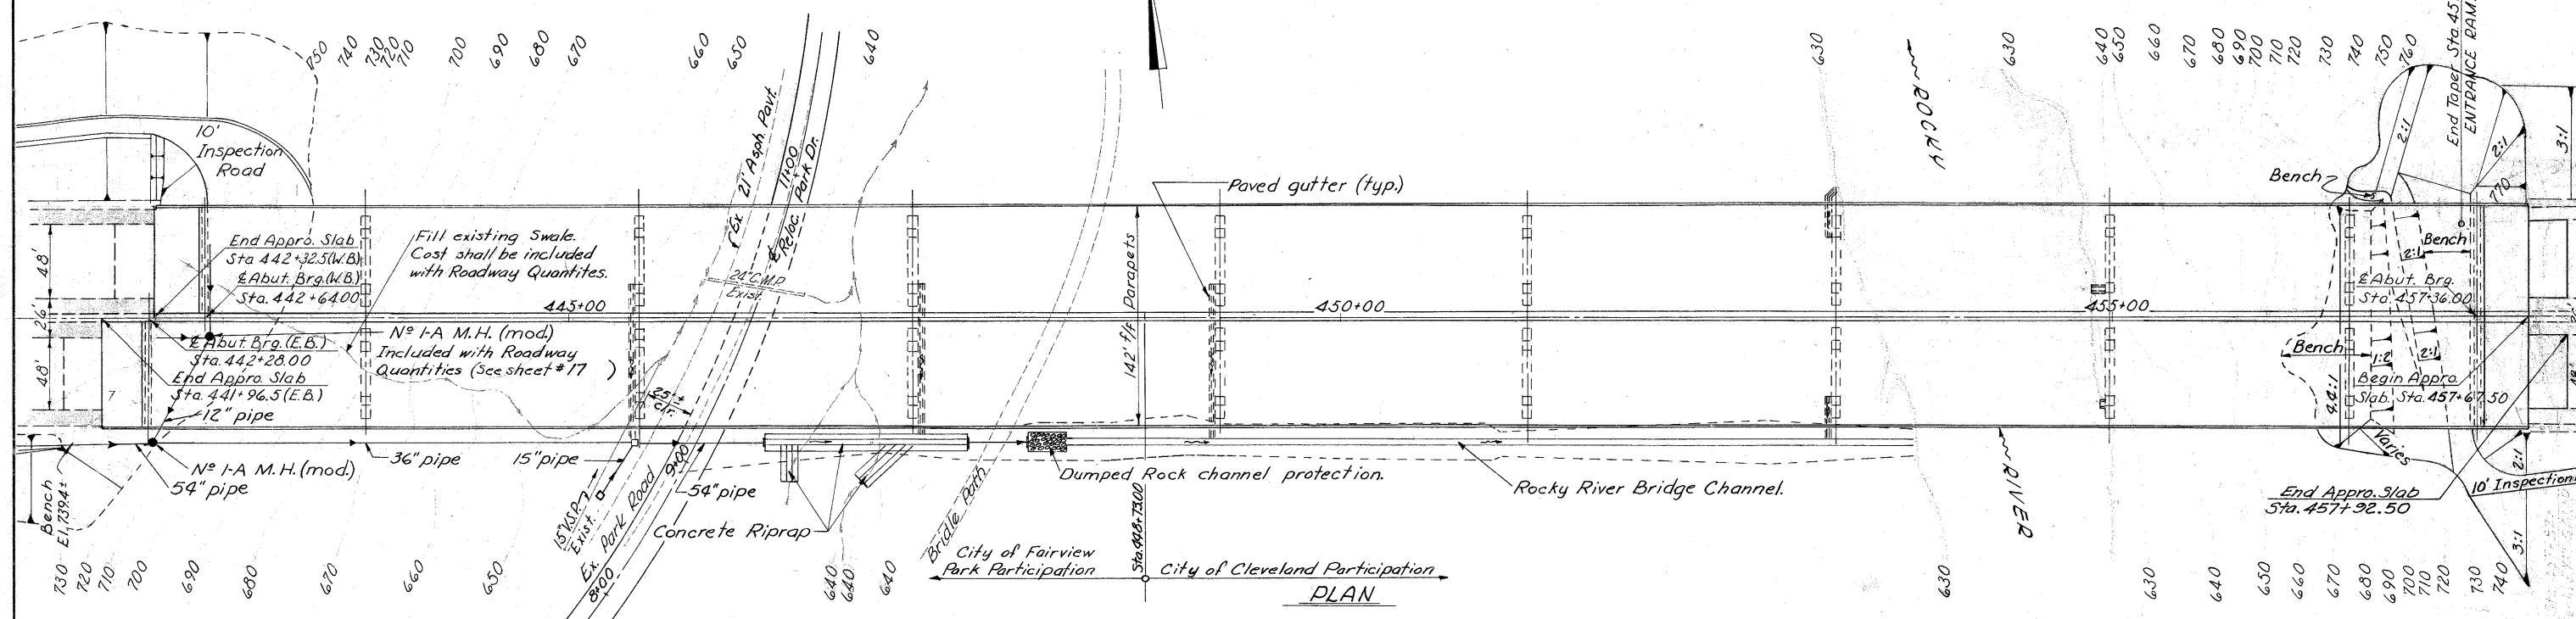
**PROPOSED STRUCTURE**  
 TYPE: Continuous haunched steel girder with transverse floorbeams, longitudinal stringers, concrete deck and concrete substructure.  
 SPANS: E.B. Lanes 139'-8", 2@177'-4", 3@199'-6", 177'-4", 155'-2", 82'-8" 96 Brqs.  
 W.B. Lanes 103'-8", 2@177'-4", 3@199'-6", 177'-4", 155'-2", 82'-8" 96 Brqs.  
 ROADWAY: 142' f/f parapets, with Type 2' Railing, including 26'-0" median and 10'-0" shoulders.  
 LOADING: CF-2000 (1957) - Adequate for AASHTO alternate loading.  
 WEARING SURFACE: 1" monolithic concrete.  
 SKEW: None  
 ALIGNMENT: Tangent  
 APPROACH SLABS: AS-1-67 (25' long)

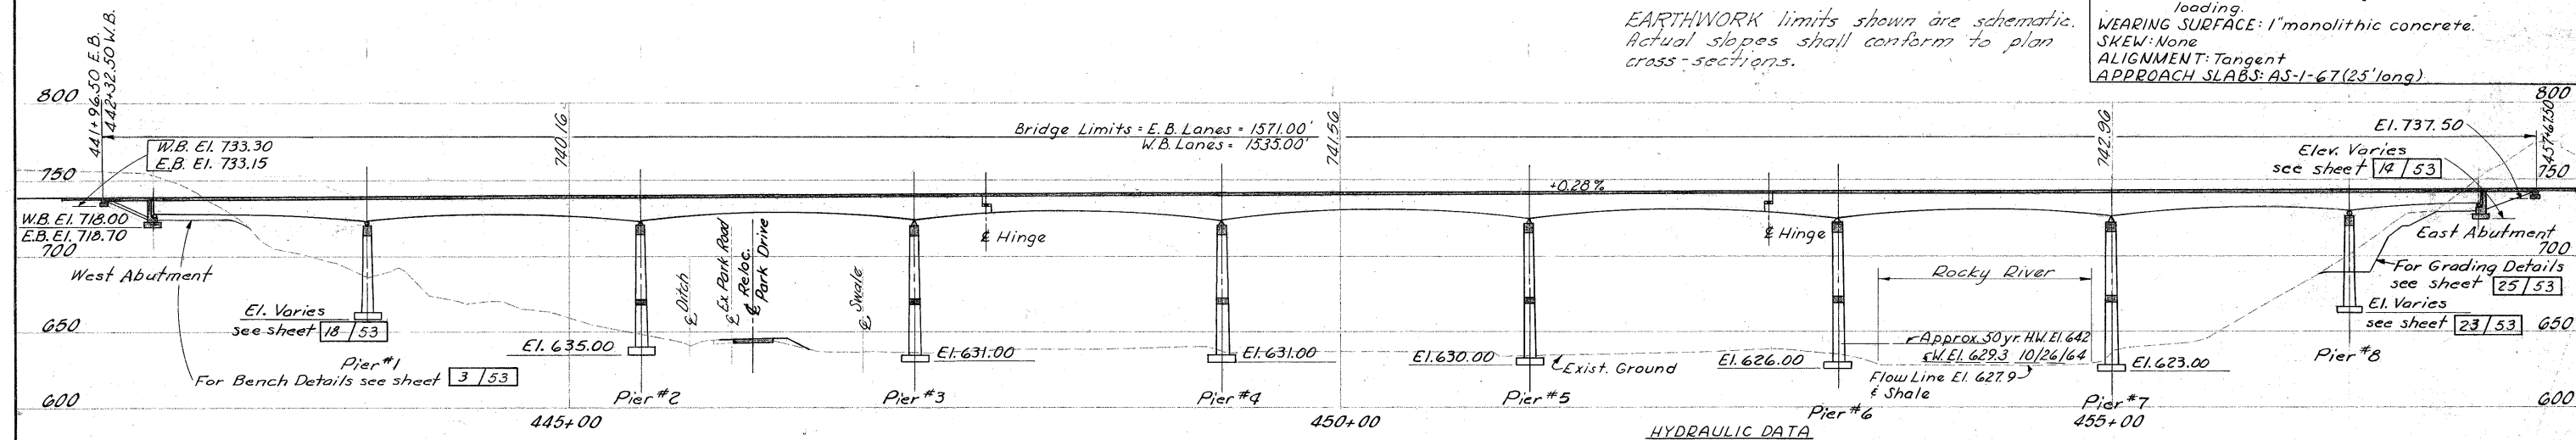
**HYDRAULIC DATA**  
 Drainage Area = 283 sq. mi.  
 $Q_{20} = 24,600$  c.f.s.  
 $V_{50} = 5.1$  ft/sec. (includes overbank)  
 $V_{50} = 10.4$  ft/sec. (Main channel)

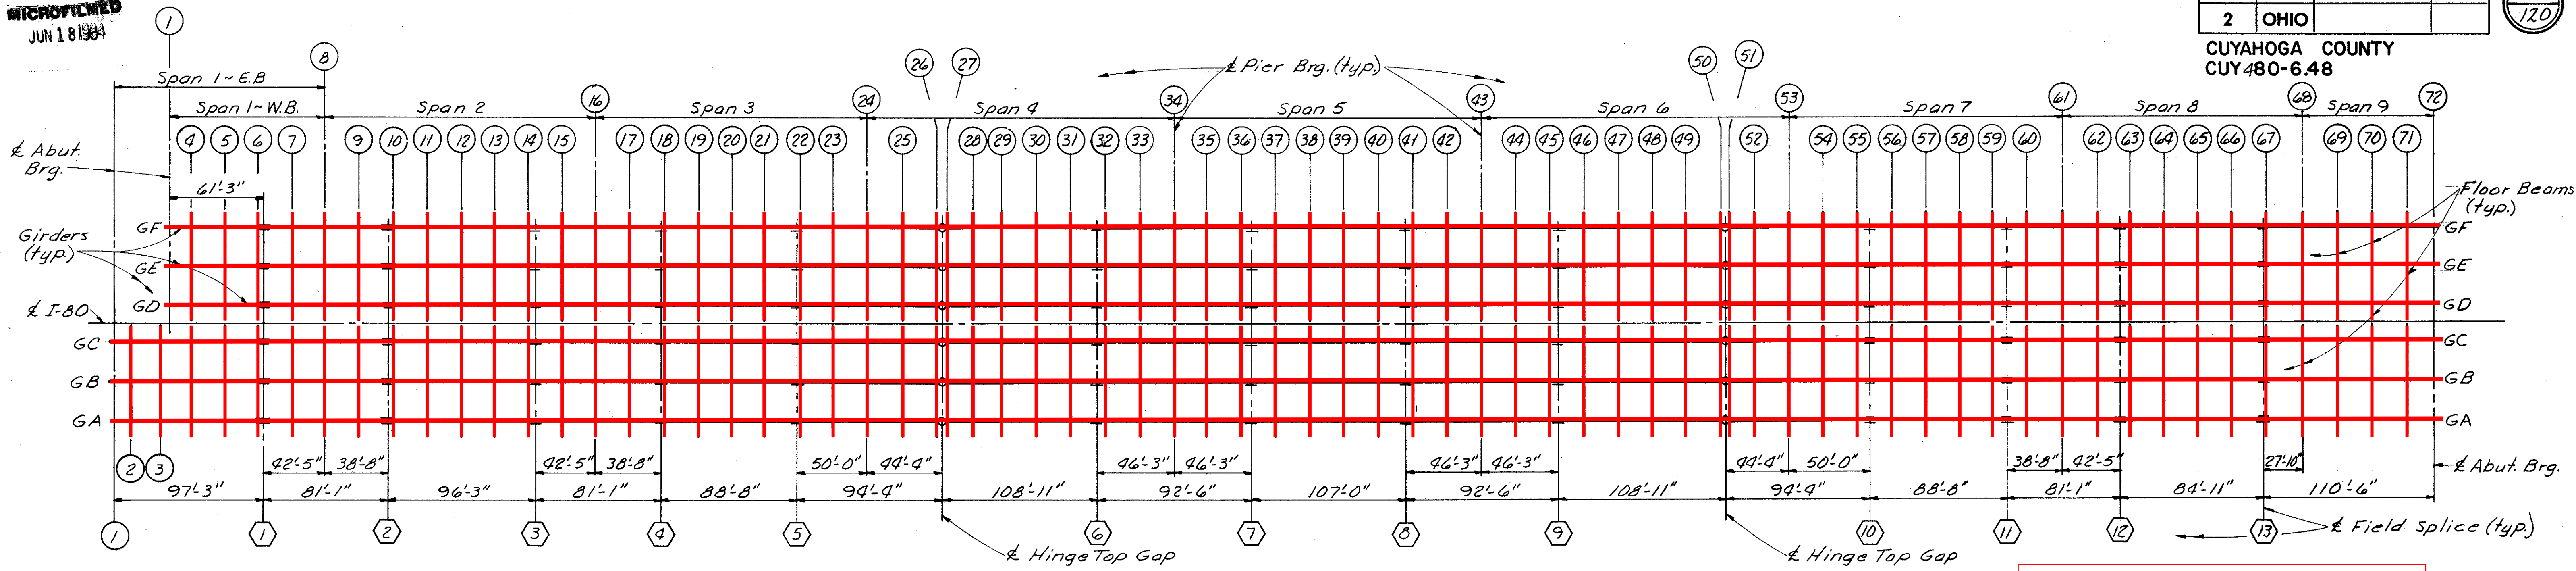
GENERAL FRAMING PLAN  
(Stringers & Lateral system not shown.)

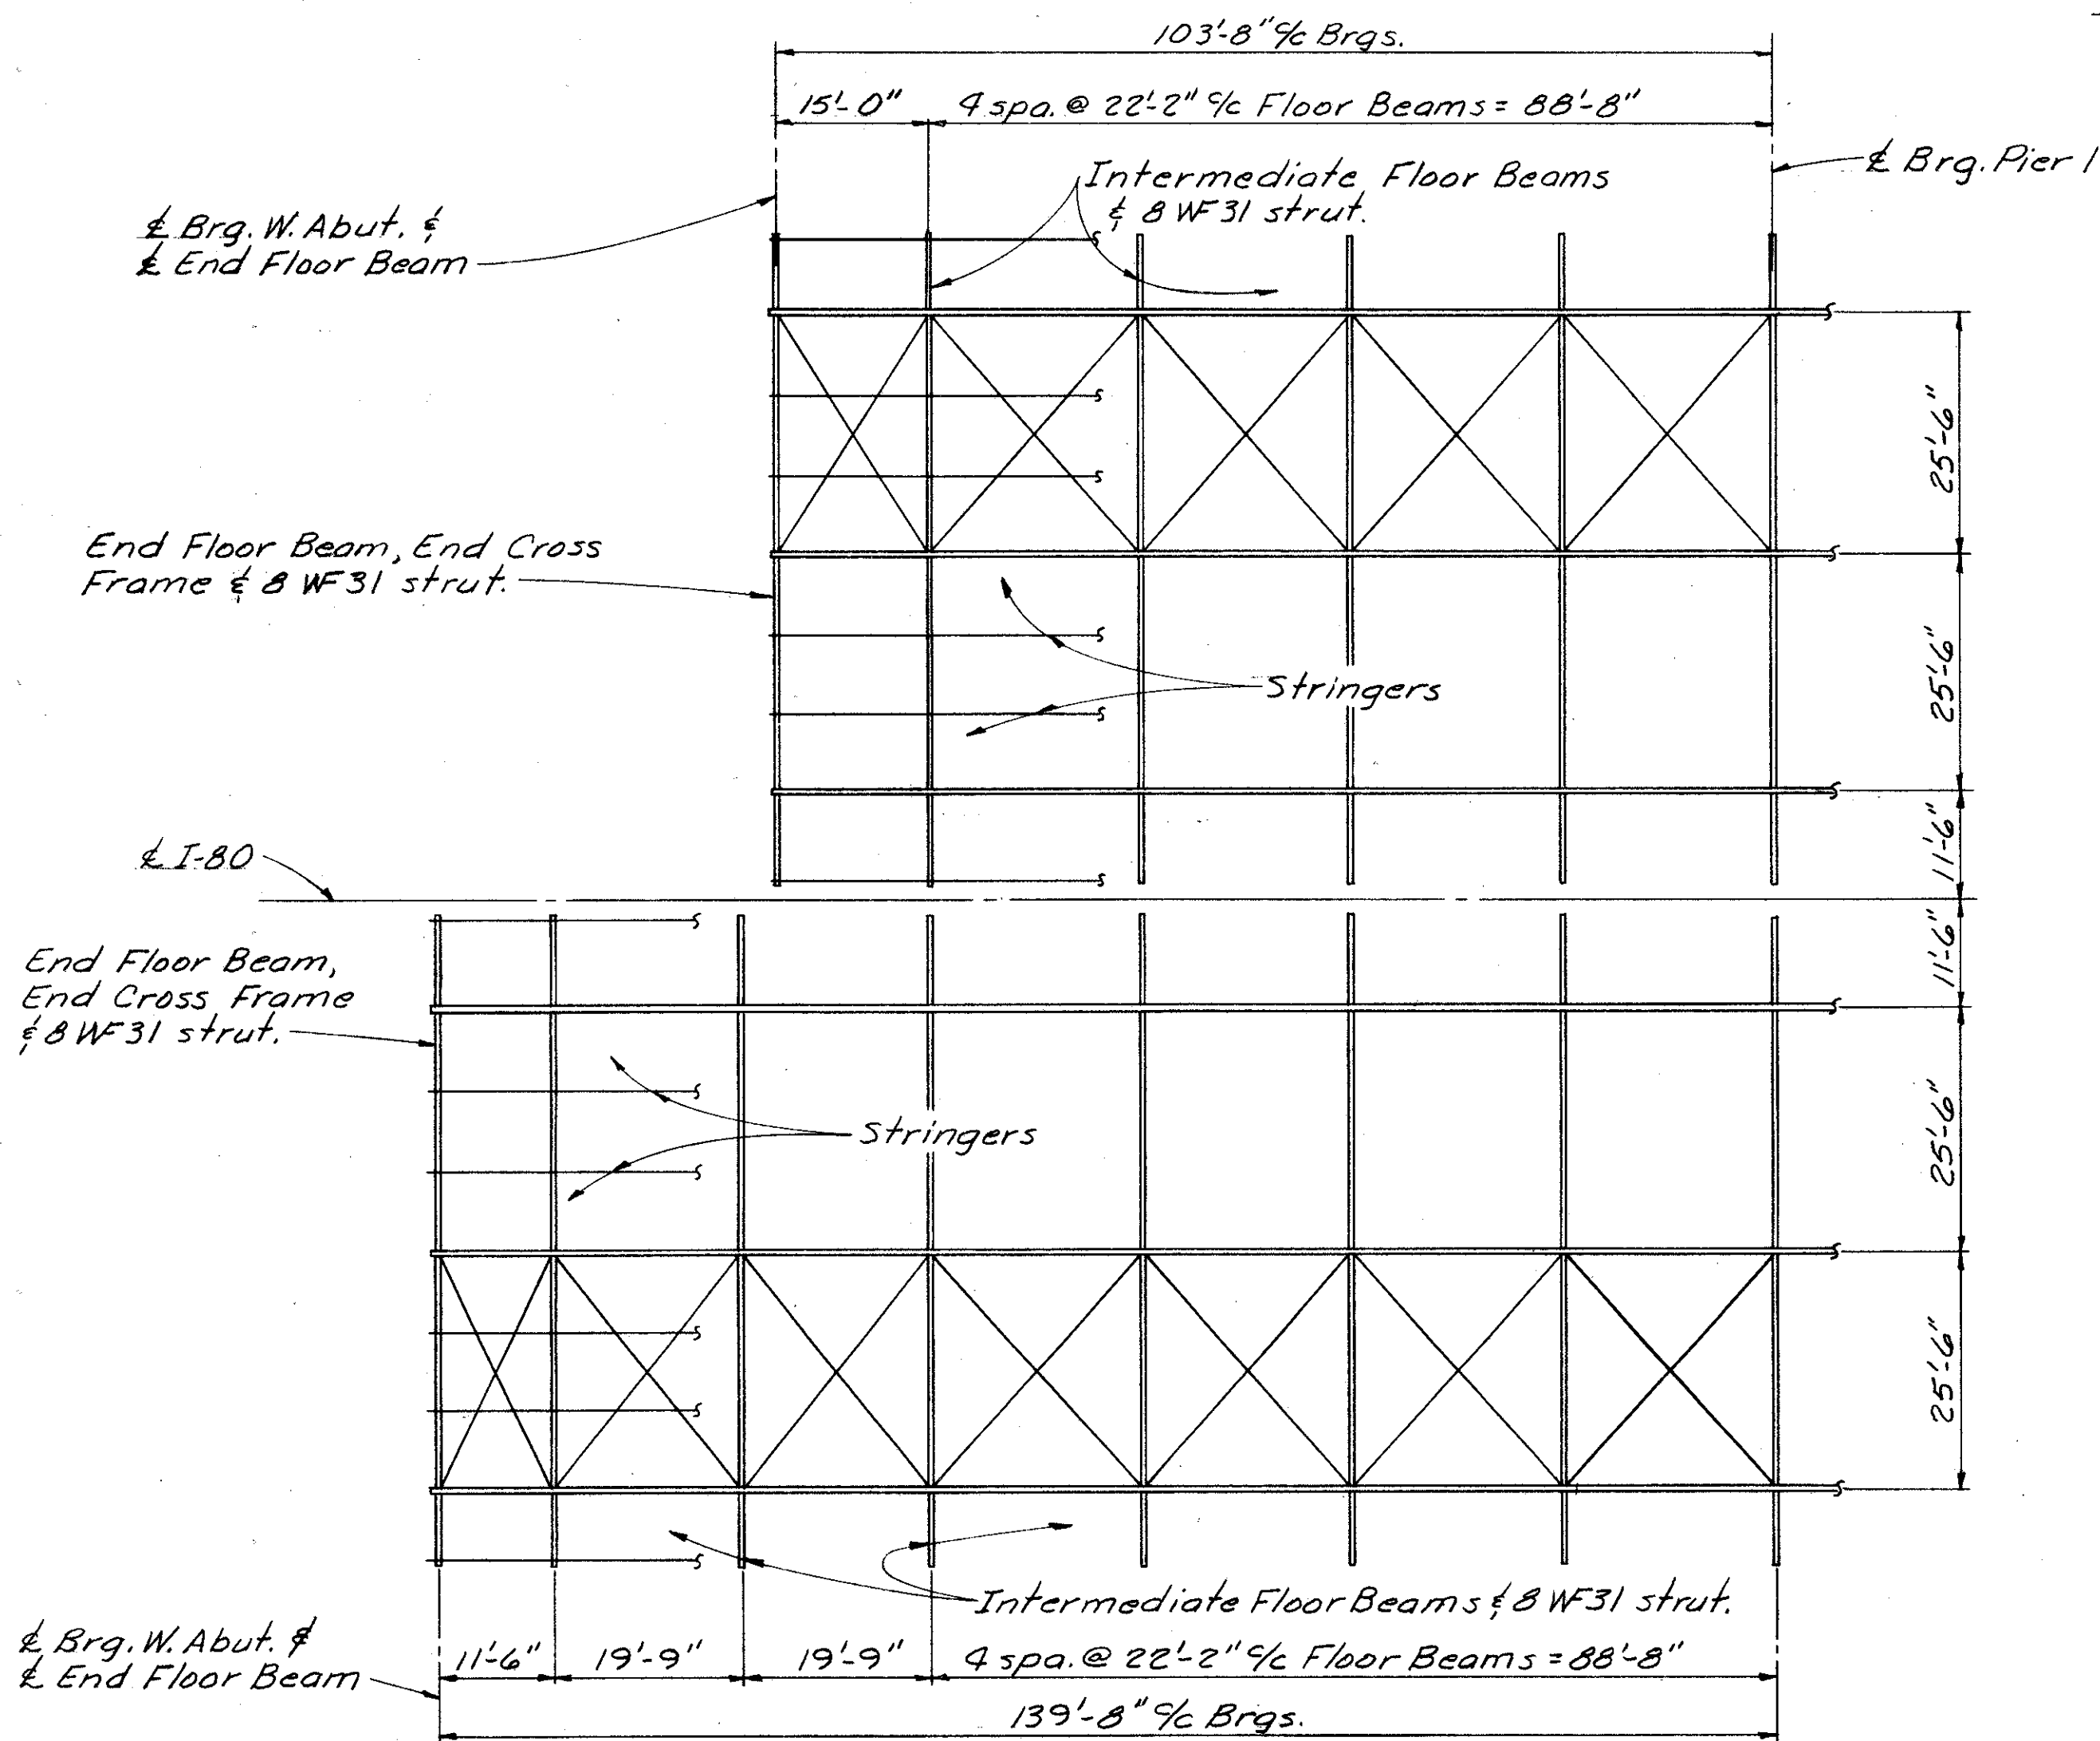
SPAN 1 FRAMING PLAN  
(Stringer intermediate crossframes not shown.)
