June 7, 2004  
June 28, 2004  
(Revised September 21, 2004)

Mr. Ben Kruse  
Consultant Contract Manager  
District 12  
Ohio Department of Transportation  
5500 Transportation Boulevard  
Garfield Heights, Ohio 44125-5396

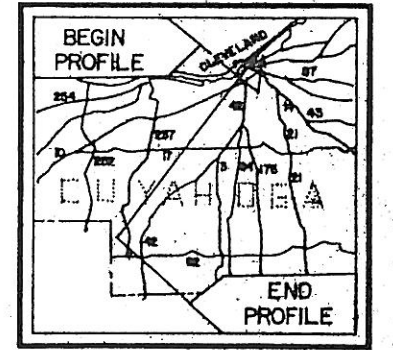
NOTE: THE INFORMATION SHOWN BY THIS SUBGRADE PROFILE WAS SECURED FOR THE USE OF THE STATE OF OHIO AND IS NOT TO BE CONSTRUED AS A PART OF THE PLANS GOVERNING THE CONSTRUCTION OF THE PROJECT.

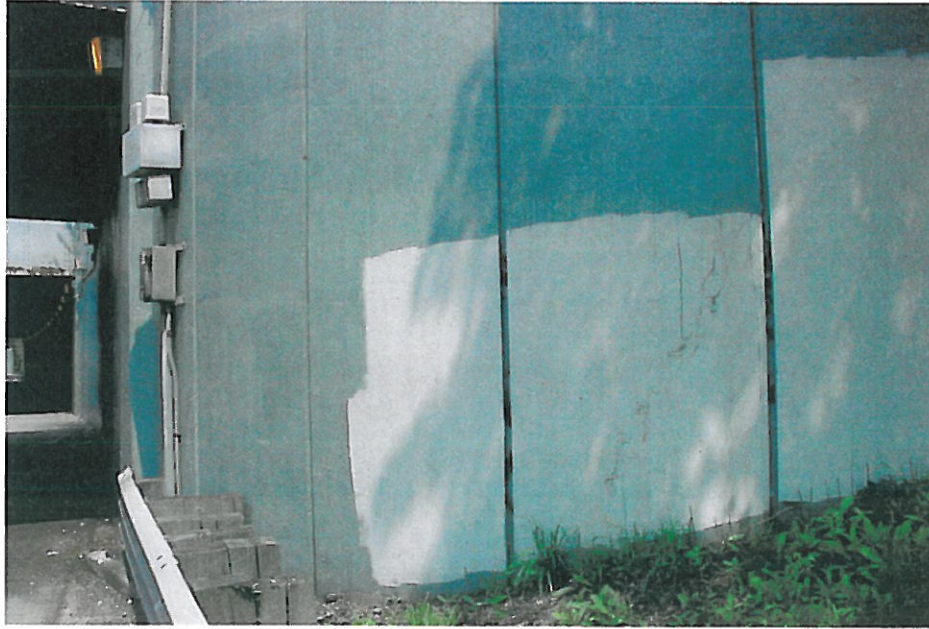
**Photograph Log**  
**Red Flag Study – CUY-IR-90**  
**Cleveland, Ohio**  
**Project # 142-45056**

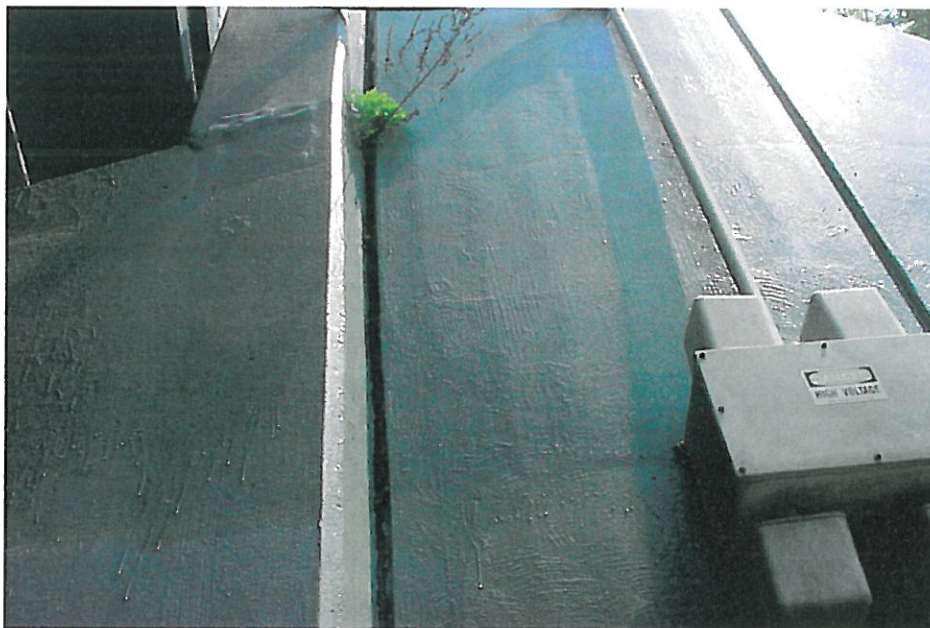
Hamilton Road bridge structure (Southeast wing wall) – Repair work and new distress

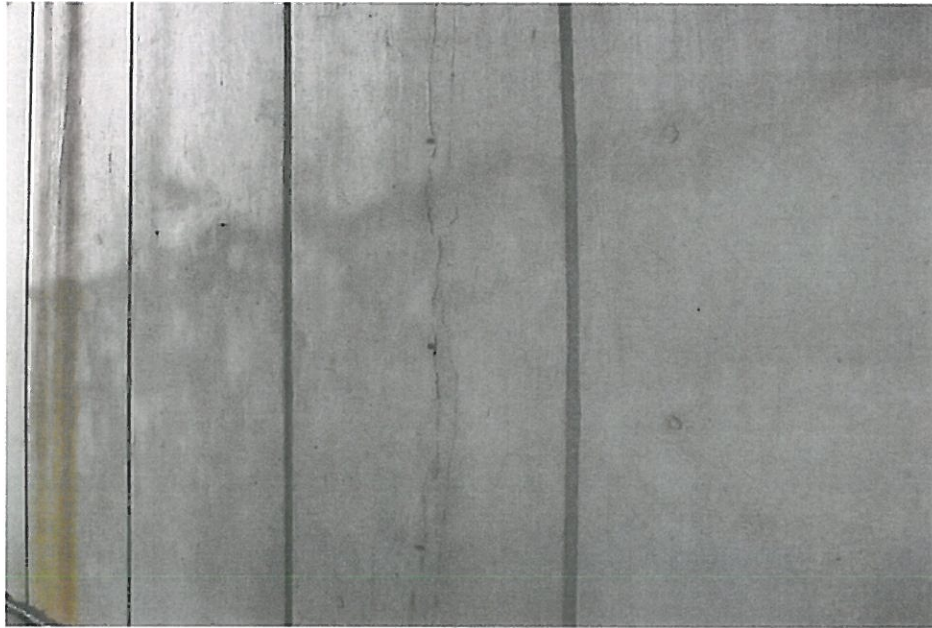
Photo #9  
Norfolk Southern Railroad (Westbound) – Cracks and rust stains

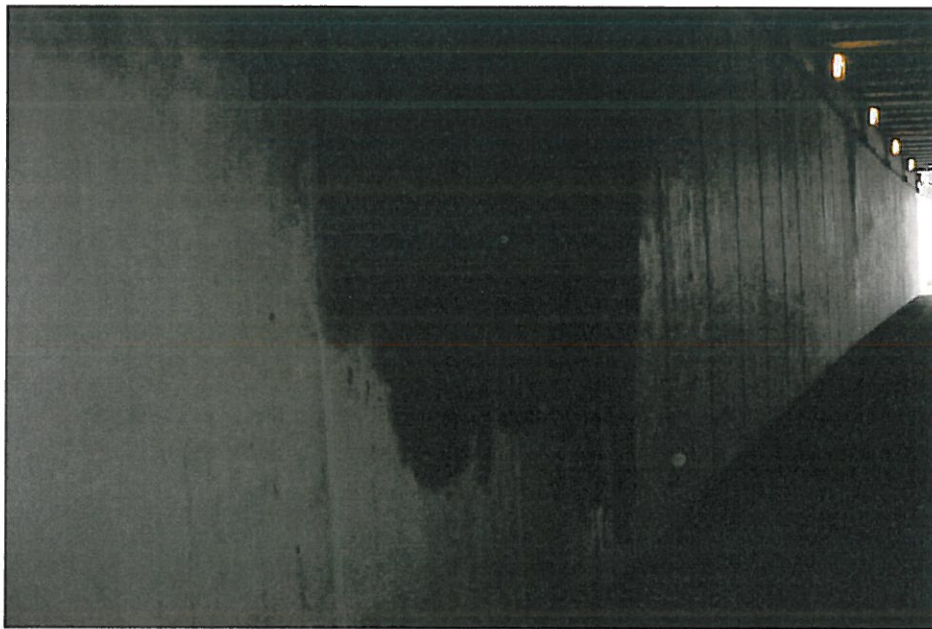
Photo #10  
Norfolk Southern Railroad (Eastbound) – Mildew

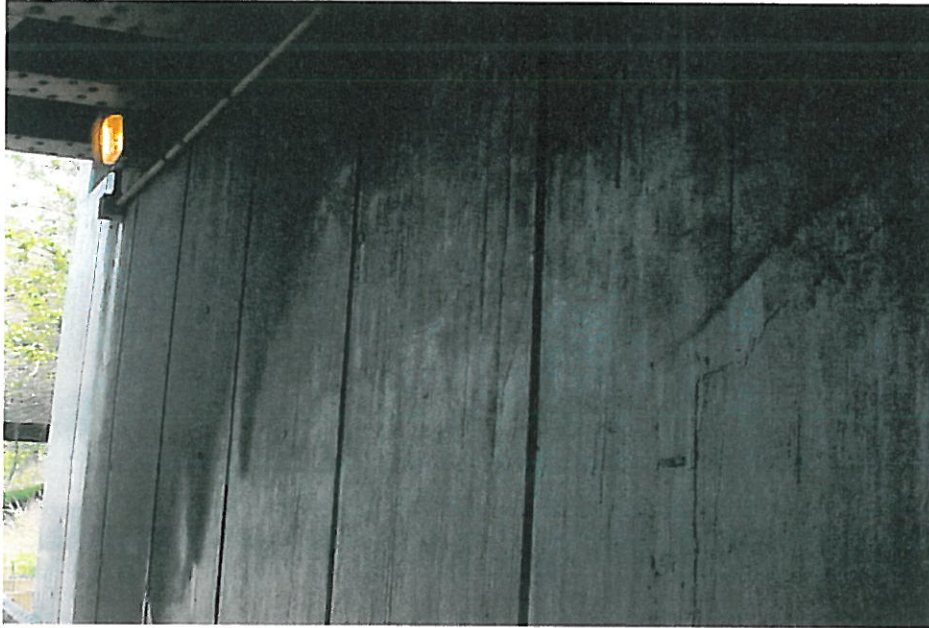
**Photo #11  
Norfolk Southern Railroad (Eastbound) – Mildew / Cracks**

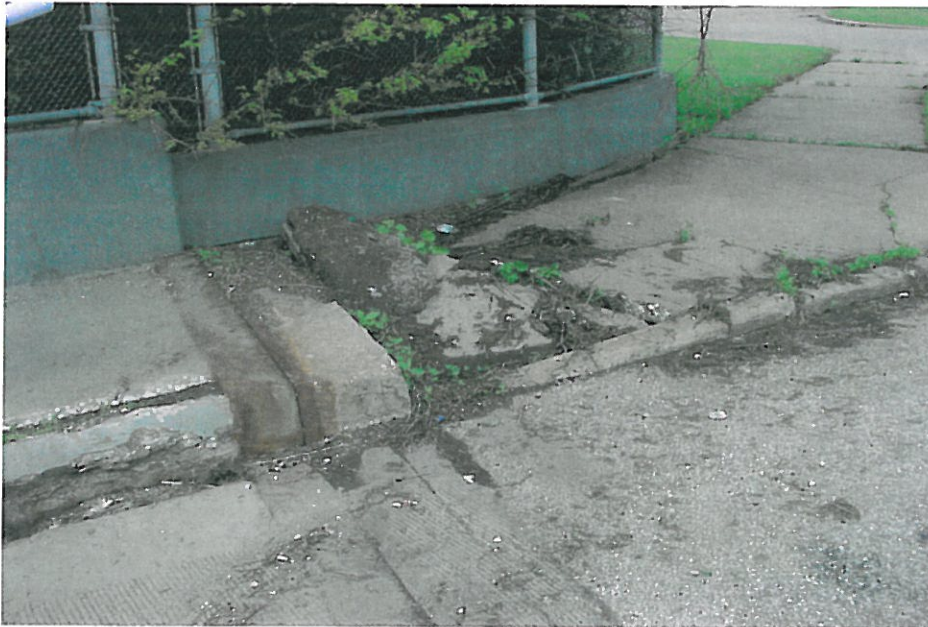
**Photo #12  
Lakeside Road bridge deck (Northeast section) – Undermined sidewalk**

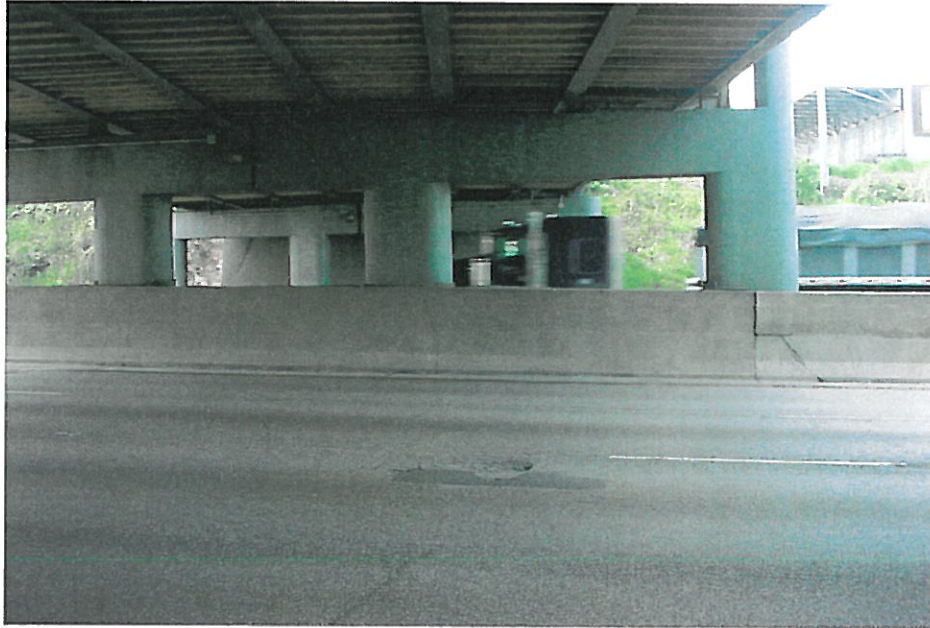
Photo #13  
Lakeside Road bridge structure – Cracks in barrier wall below all piers

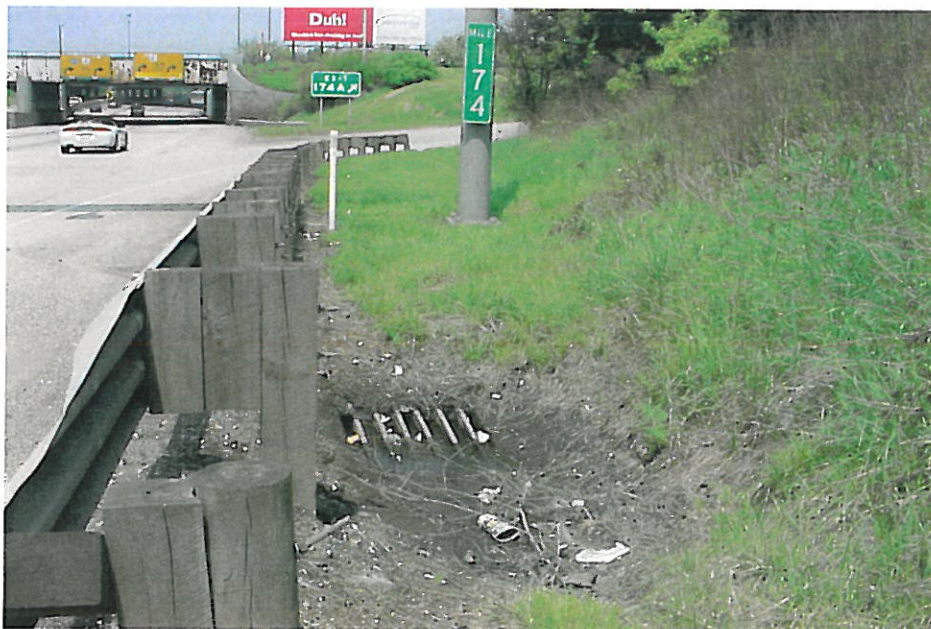
Photo # 14  
Eastbound IR-90 approaching Lakeside Road exit ramp – Backed up drain

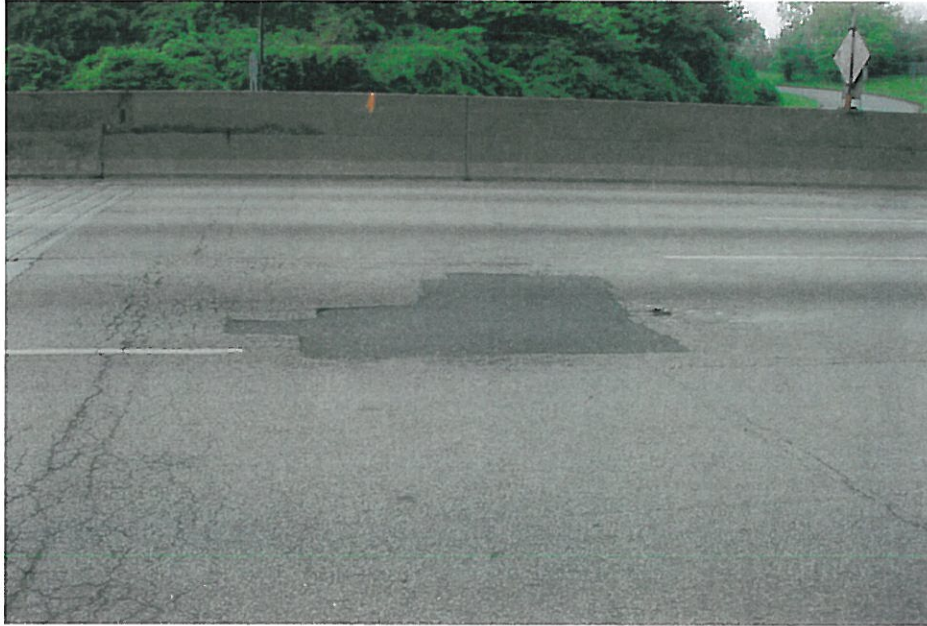
Photo #17  
Eastbound IR-90 at Lakeside Road exit ramp – Pavement distress and repair work

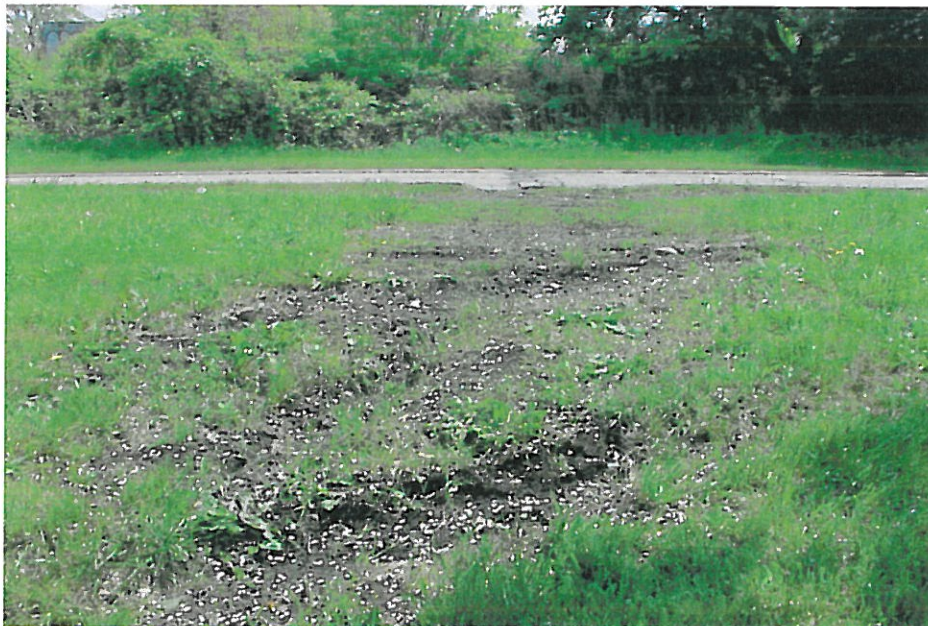
Photo #18  
South Marginal Road – Area of previous trench work

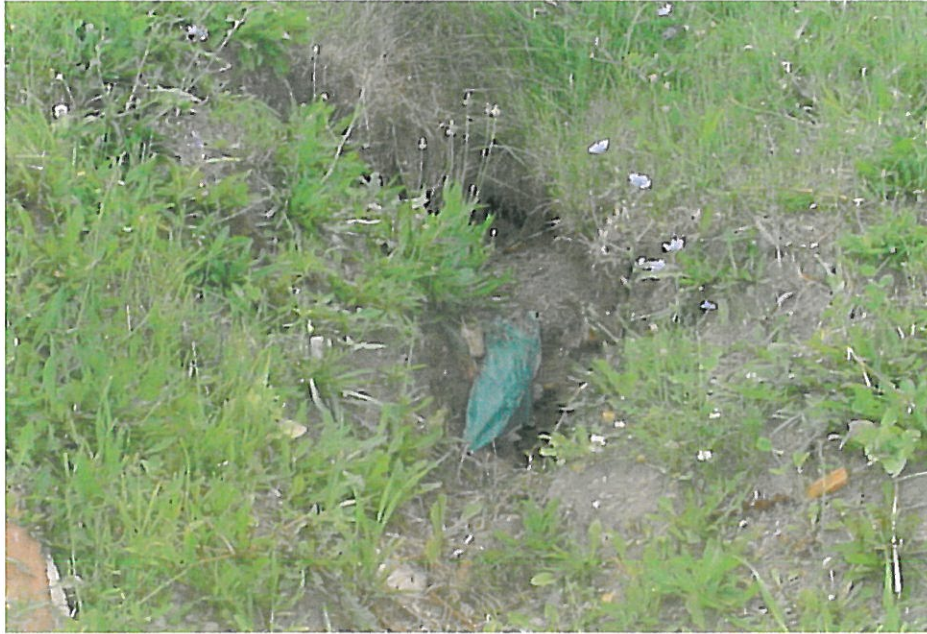
Photo #29  
South side of South Marginal Road – Channel erosion and minor slope failure

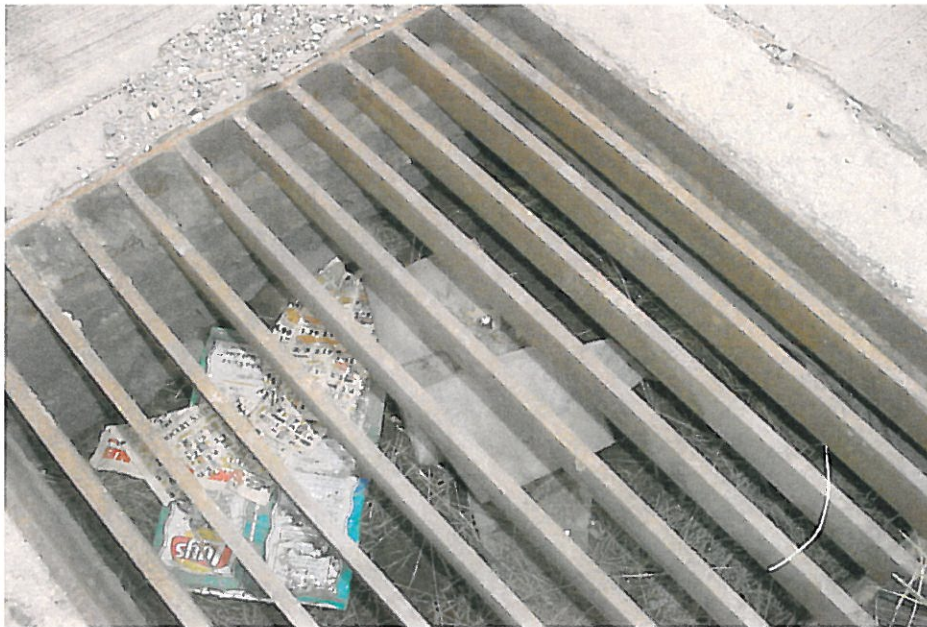
Photo #30  
Westbound I-90 (Near Quay 55) – Only top half of outlet and/or inlet pipes exposed

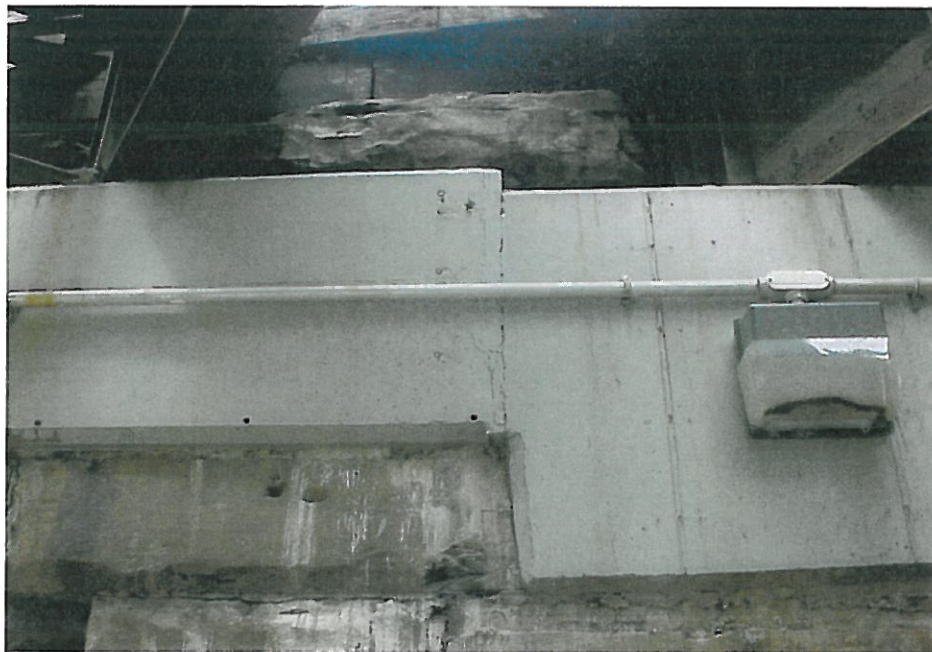
**Photo #36**  
West wall of CSX bridge structure – Hairline crack at joint

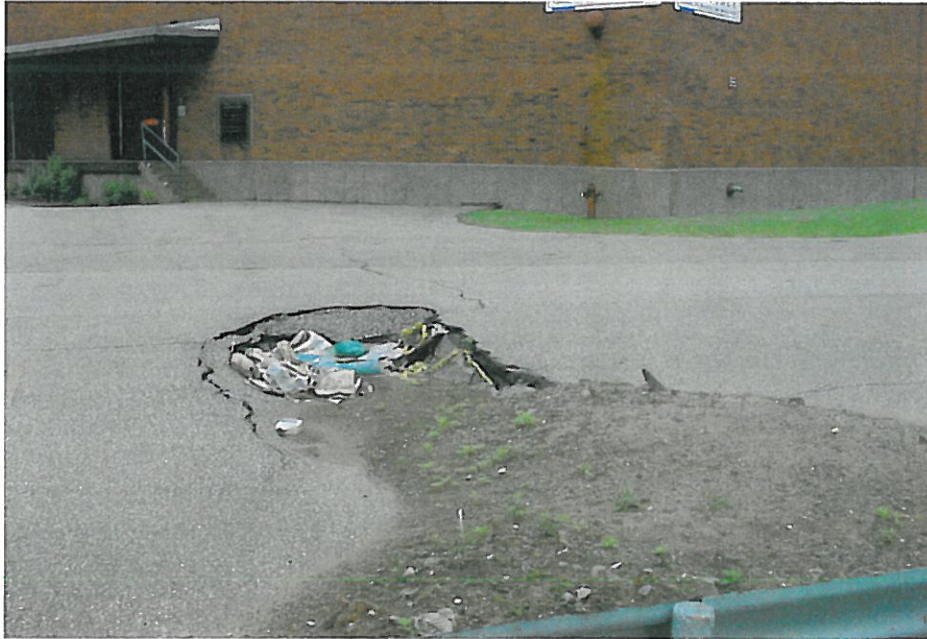
Photo #37  
Parking lot immediately north of Lake Court (East 55<sup>th</sup> Street) – Sinkhole

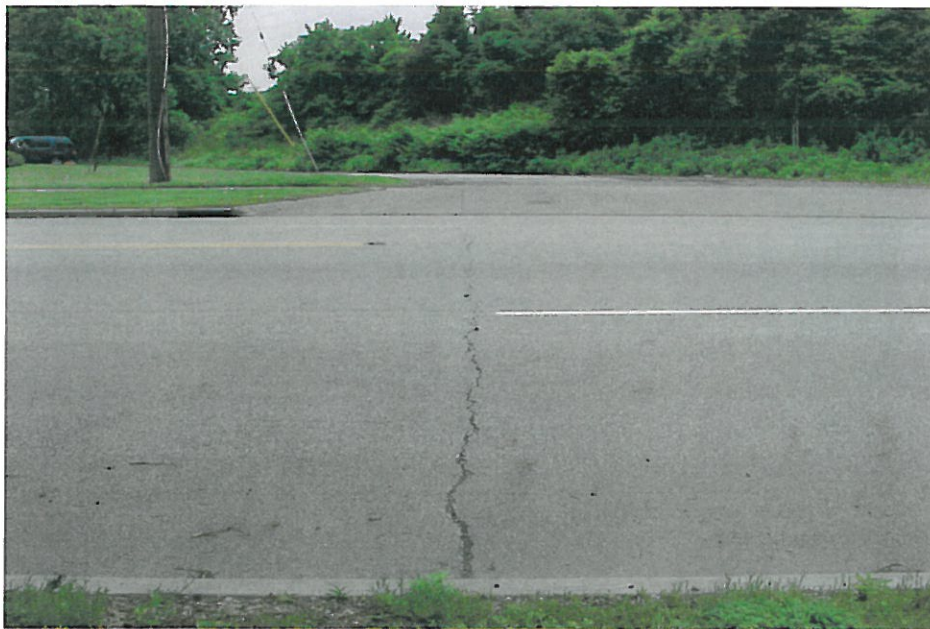
Photo #38  
East 55<sup>th</sup> Street – Longitudinal crack (Typical)

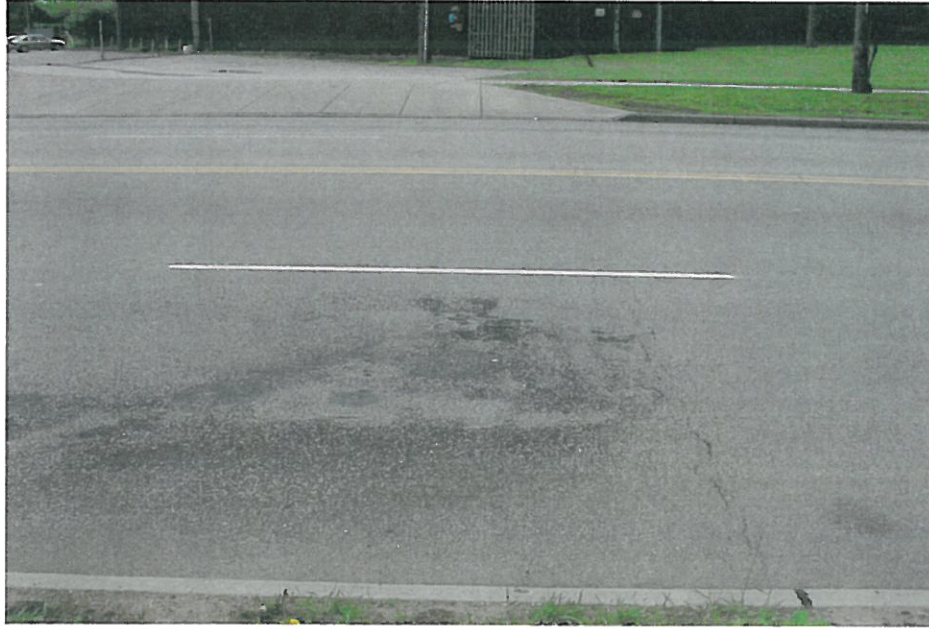
Photo #39  
East 55<sup>th</sup> Street – Longitudinal crack and surface wear

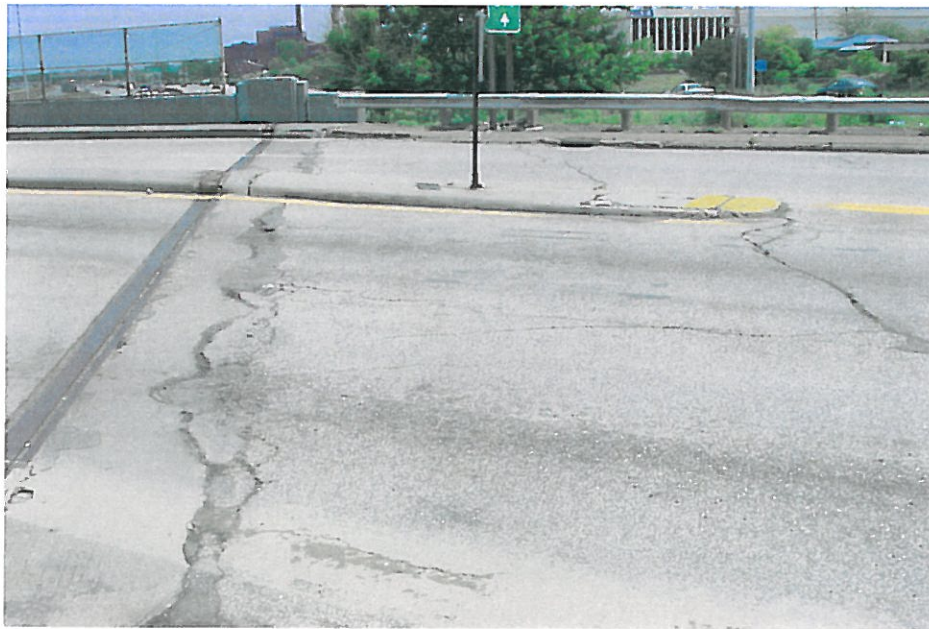
Photo #40  
Northbound East 55<sup>th</sup> Street approach to IR-90 overpass – Longitudinal cracks

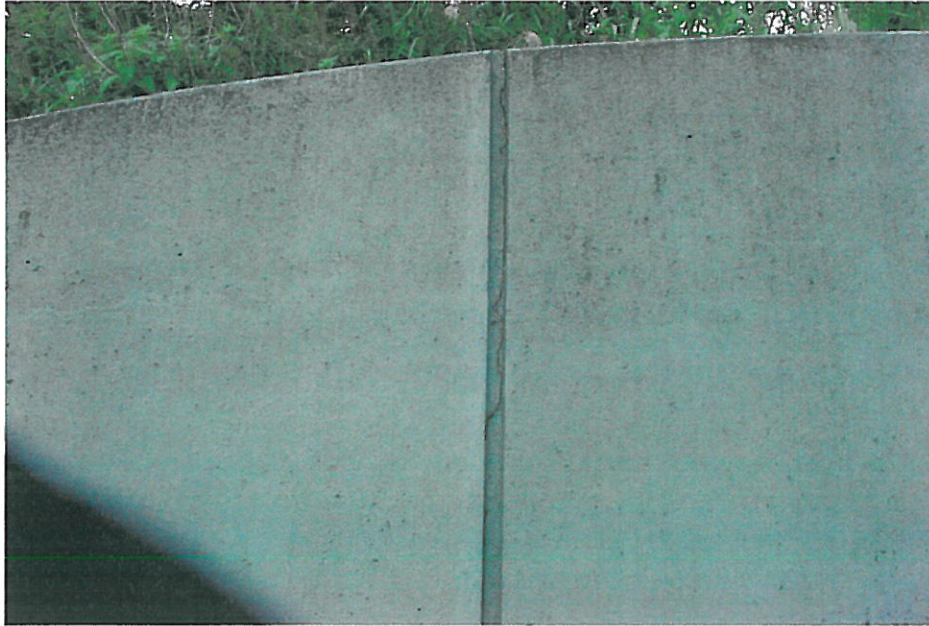
Photo #41  
East 55<sup>th</sup> Street bridge structure (Southeast wing wall) – Hairline crack

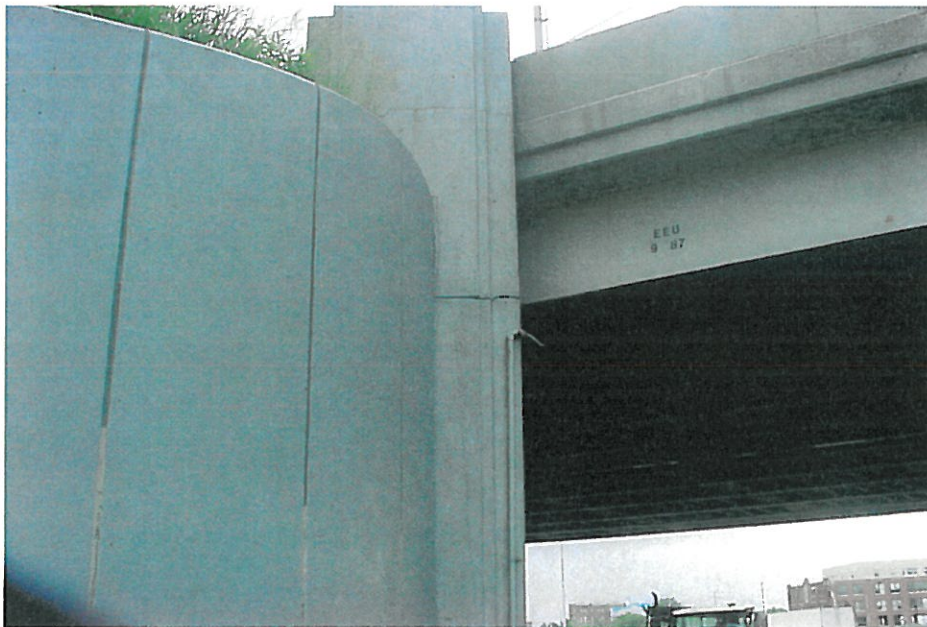
Photo #42  
East 55<sup>th</sup> Street bridge structure (SE abutment) – Vertical separation below bridge deck

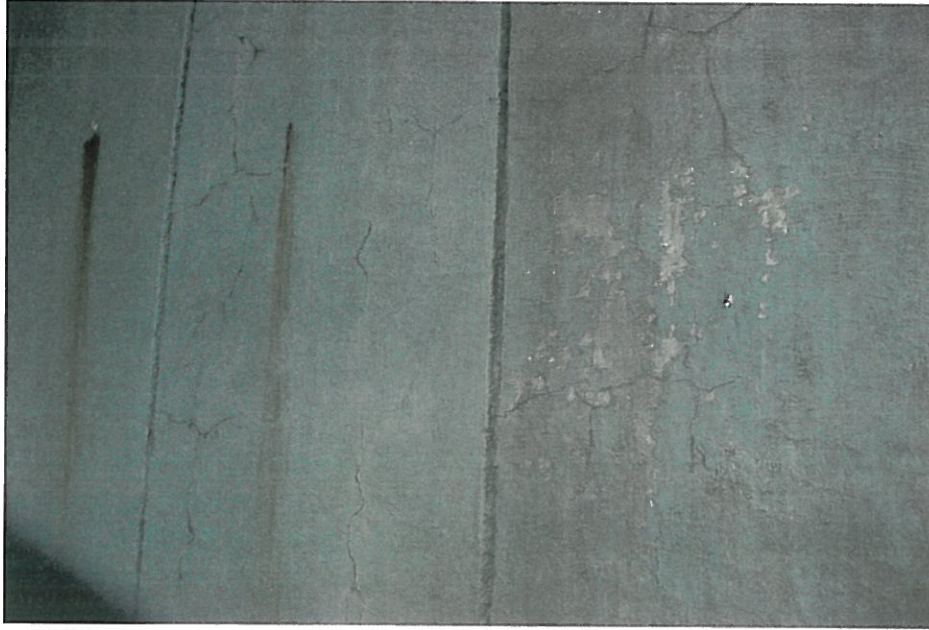
Photo #43  
East 55<sup>th</sup> Street bridge structure (South abutment) – Cracks and rust stains

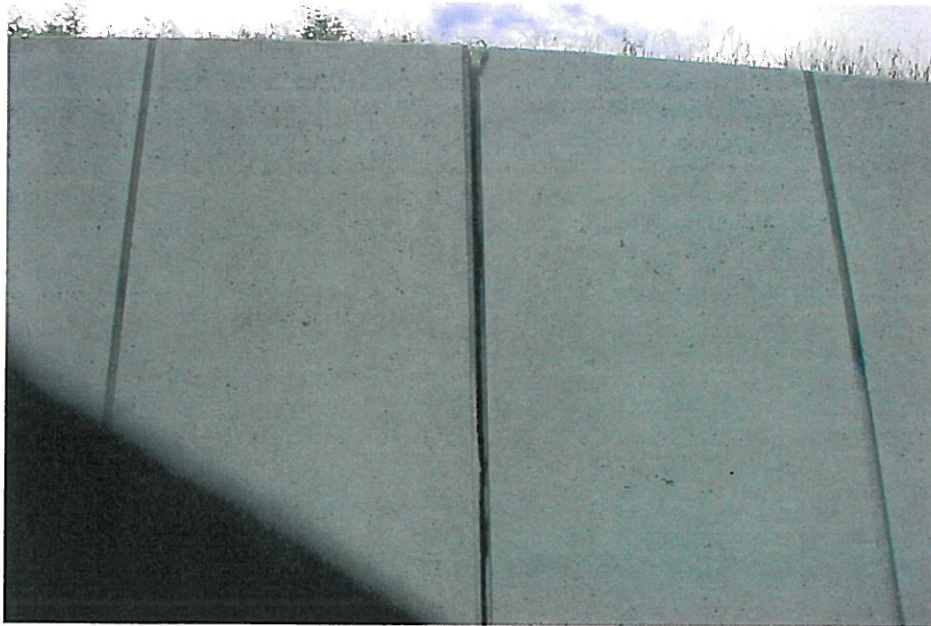
Photo #44  
East 55<sup>th</sup> Street bridge structure (Southwest wing wall) – Horizontal separation
