### Defect Listing

<b>Pipe Segment Refere...</b> CSO096A0040-CSO096A...	<b>City</b> CLEVELAND	<b>Street</b> E. 26TH ST	<b>Material</b> BRICK	<b>Location C...</b> LIGHT HIGH...	<b>Sewer Use</b> COMBINED
<b>Upstream MH</b> CSO096A0040	Total Length 5	Year Laid	<b>Shape</b> CIRCULAR	Location Details	
<b>DS Manhole</b> CSO096A0038	Length surveyed 5	Year Renewed	<b>Height</b> 18	<b>Width</b> 18	Pipe Joint...

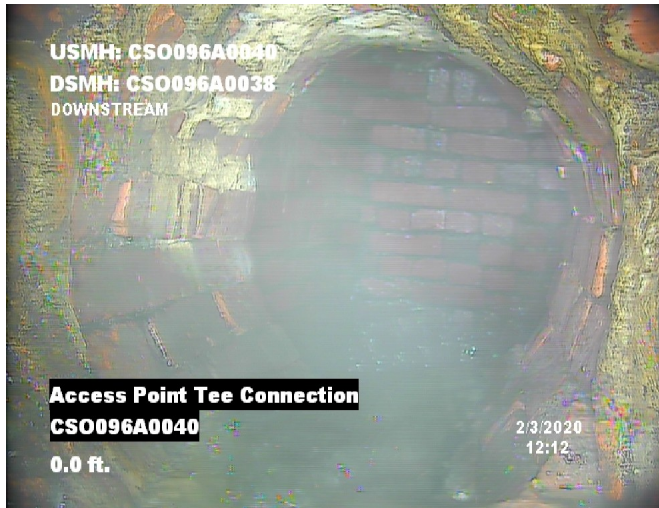
Distance: 0.0 ft.      Grade: 0  
 Condition: Access Point Tee Connection  
 Remarks: CSO096A0040

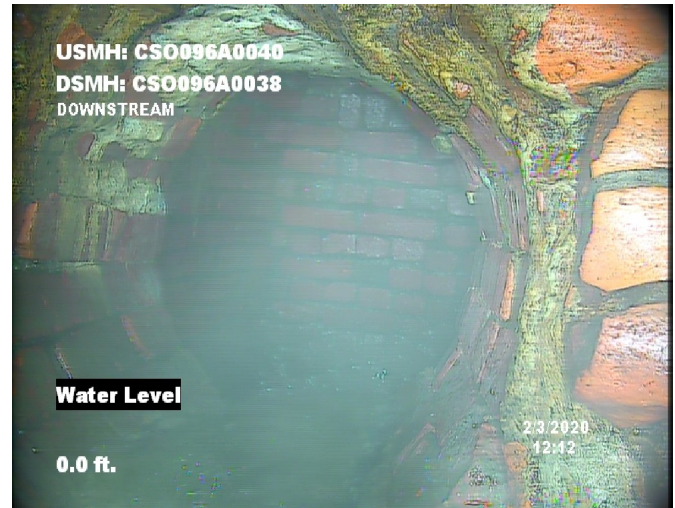
Distance: 0.0 ft.      Grade: 0  
 Condition: Water Level  
 Remarks: N/A

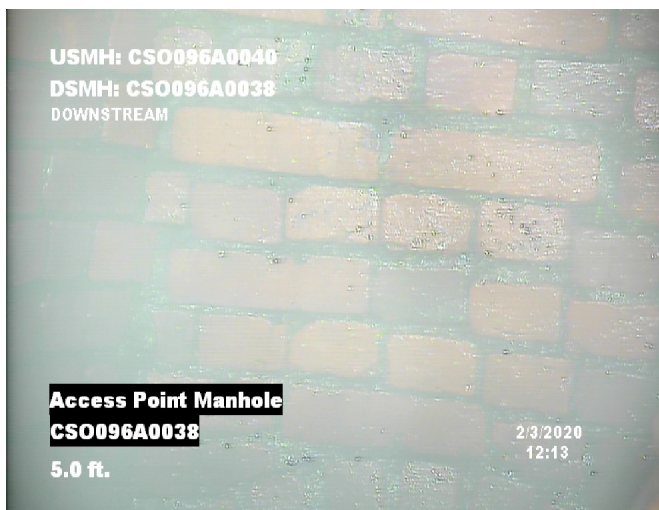
Distance: 5.0 ft.      Grade: 0  
 Condition: Access Point Manhole  
 Remarks: CSO096A0038
