### Defect Listing

<b>Pipe Segment Refere...</b> EAA6C10A08-CSO096A0...	<b>City</b> CLEVELAND	<b>Street</b> E. 26TH ST	<b>Material</b> BRICK	<b>Location C...</b> LIGHT HIGH...	<b>Sewer Use</b> COMBINED
<b>Upstream MH</b> EAA6C10A08	Total Length 120.2	Year Laid	<b>Shape</b> EGG SHAPED	Location Details	
<b>DS Manhole</b> CSO096A0040	Length surveyed 120.2	Year Renewed	<b>Height</b> 76	<b>Width</b> 60	Pipe Joint...

### Image Report 4/Page

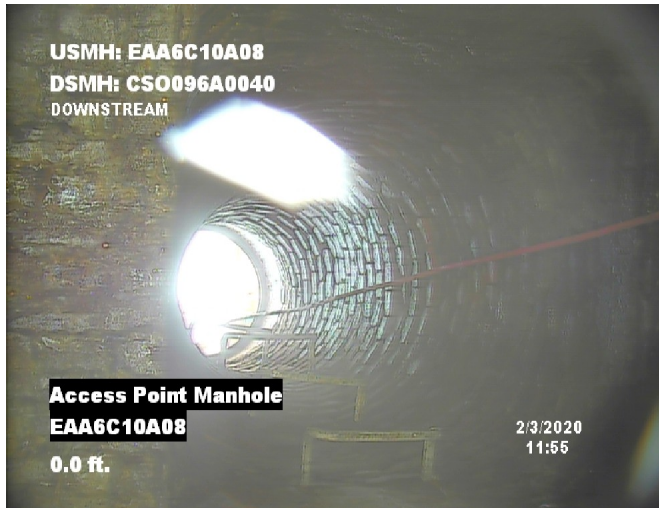
Distance: 0.0 ft.      Grade: 0  
 Condition: Access Point Manhole  
 Remarks: EAA6C10A08

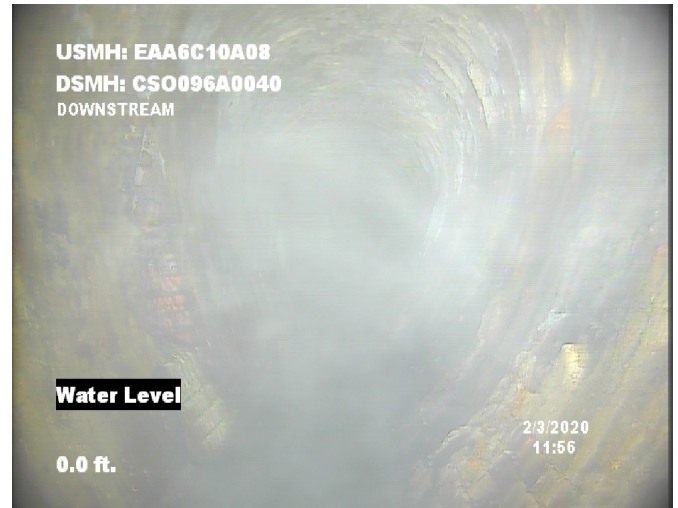
Distance: 0.0 ft.      Grade: 0  
 Condition: Water Level  
 Remarks: N/A

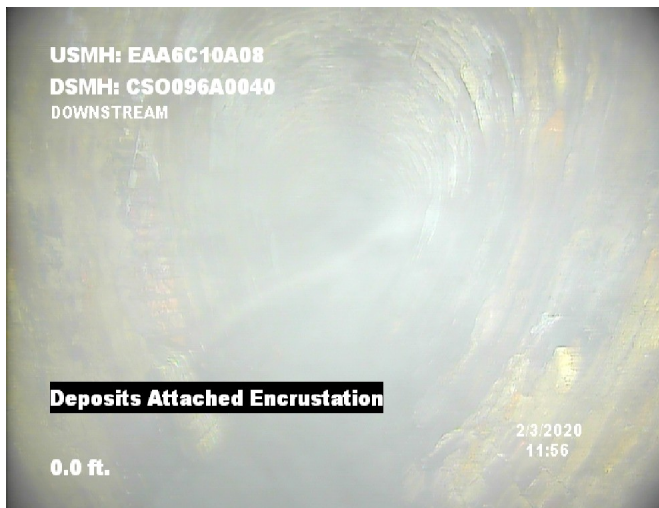
Distance: 0.0 ft.      Grade: 2  
 Condition: Deposits Attached Encrustation  
 Remarks: N/A

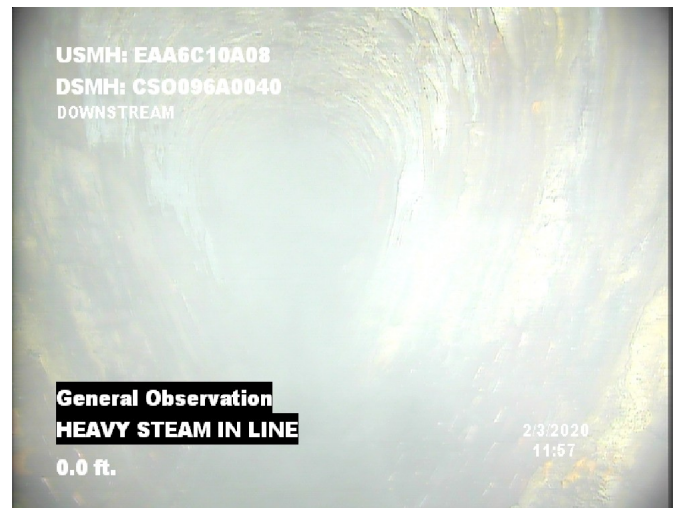
Distance: 0.0 ft.      Grade: 0  
 Condition: General Observation  
 Remarks: HEAVY STEAM IN LINE

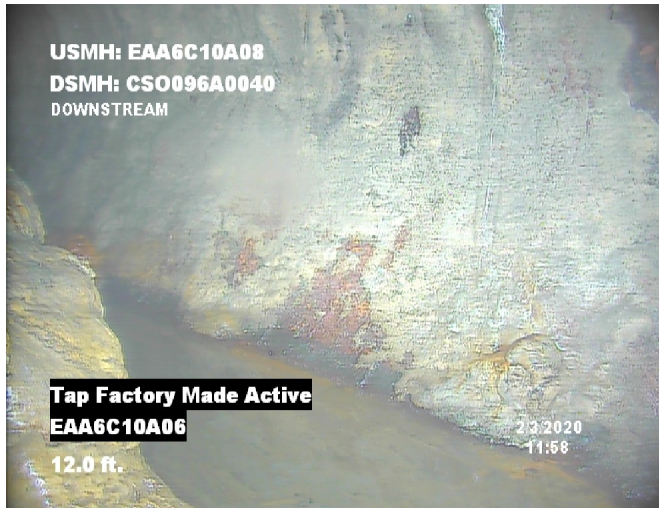
Distance: 12.0 ft.      Grade: 0  
 Condition: Tap Factory Made Active  
 Remarks: EAA6C10A06

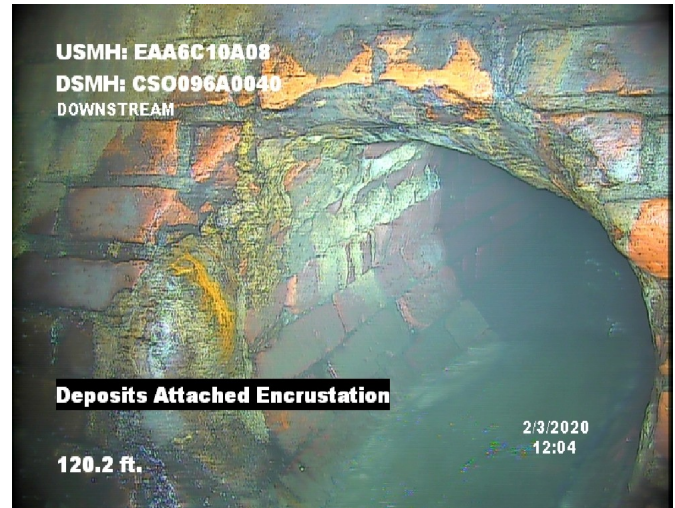
Distance: 120.2 ft.      Grade: 2  
 Condition: Deposits Attached Encrustation  
 Remarks: N/A

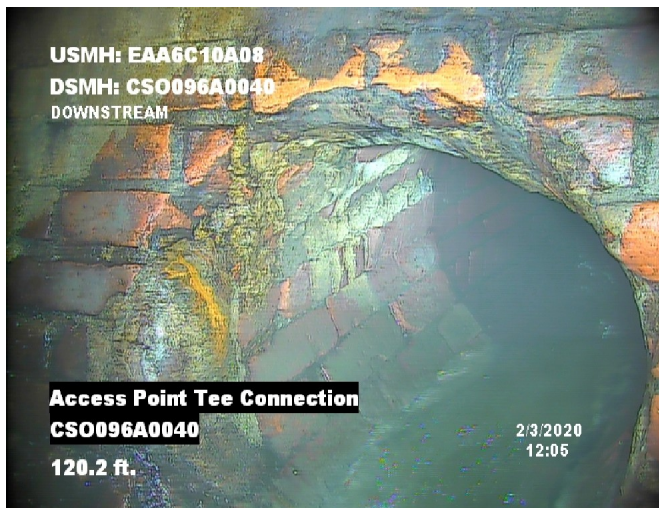
Distance: 120.2 ft.      Grade: 0  
 Condition: Access Point Tee Connection  
 Remarks: CSO096A0040
