Defect Listing

Pipe Segment Reference CSO099A0010-CSO099A0009	City CLEVELAND	Street E 38th st	Material Corrugated Metal Pipe		Location Code Easement/Right of Way	Sewer Use Combined Pipe
Upstream MH CSO099A0010	Total Length 205.3	Year Laid	Shape Circular		Location Details	
Downstream MH CSO099A0009	Length surveyed 205.3	Year Renewed	Height 48	Width	Pipe Joint Length

SPR	30	MPR	13	PO Number	Customer HDR
SPRI	3	MPRI	2.2	Work Order	Purpose Routine Assessment
QSR	3A00	QMR	3125		
OPR	43	Surveyed By Shawn_Dunnell	Direction Downstream	Date 11/21/2022	Media label
OPRI	2.7	Certificate Number 07001437	Pre-Cleaning No Pre-Cleaning	Time 09:56	Weather Snow
		Date Cleaned		End Time 10:08	Additional Info

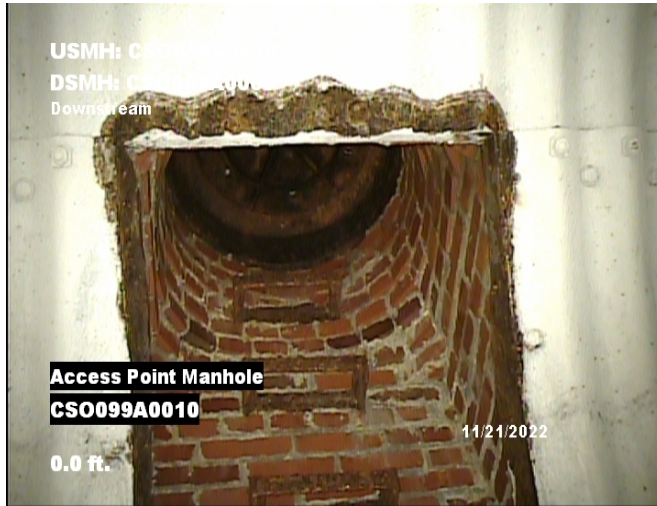
Distance: 0.0 ft. Grade: 0
 Condition: AMH-Access Point Manhole
 Remarks: CSO099A0010

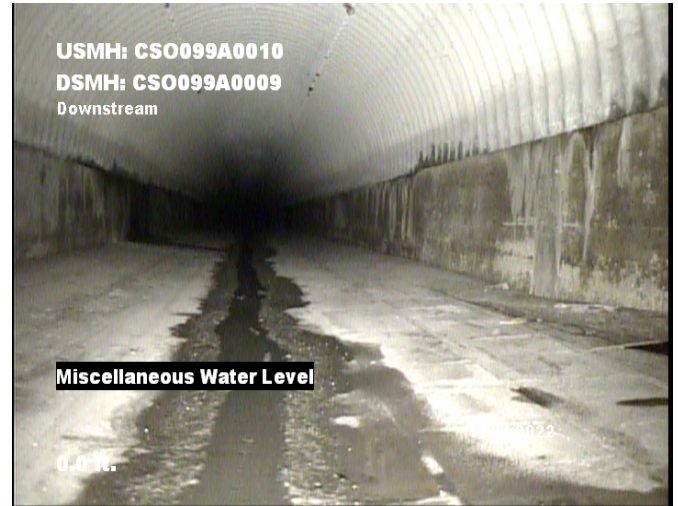
Distance: 0.0 ft. Grade: 0
 Condition: MWL-Miscellaneous Water Level
 Remarks: N/A

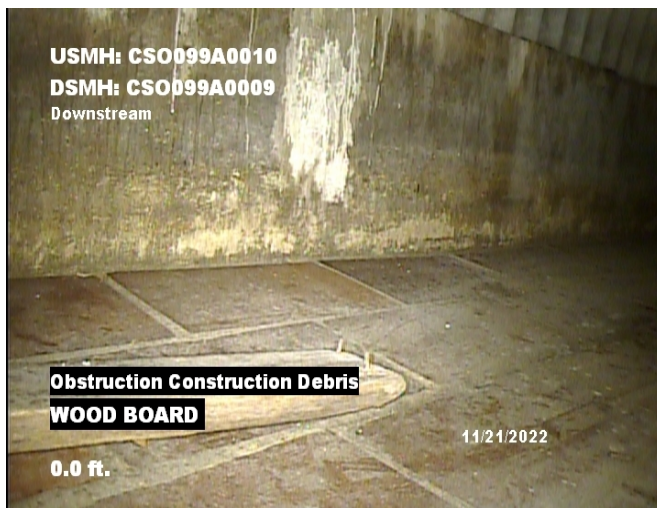
Distance	Condition	Cont. Dfct.	Values			Joint	Clock Position		Grade
			1st	2nd	%		At/From	To	
0	AMH-Access Point Manhole					<input type="checkbox"/>			
Remarks: CSO099A0010									
0	MWL-Miscellaneous Water Level				5	<input type="checkbox"/>			
0	OBN-Obstruction Construction Debris				5	<input type="checkbox"/>	6		2
Remarks: WOOD BOARD

Distance: 0.0 ft. Grade: 2
 Condition: OBN-Obstruction Construction Debris
 Remarks: WOOD BOARD

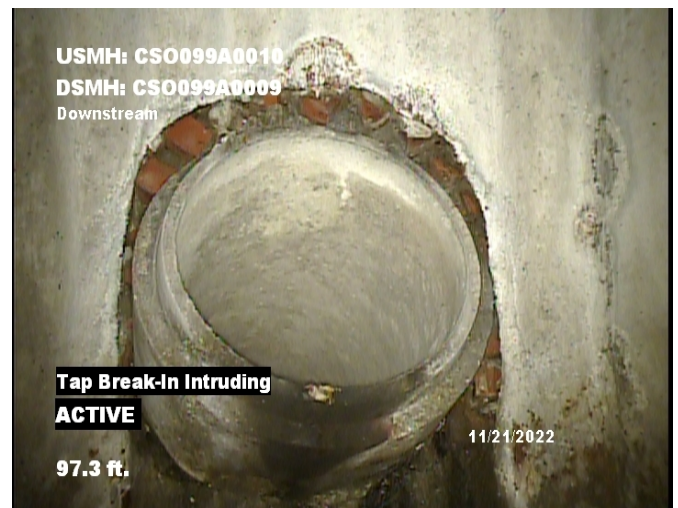
97.3	TBI-Tap Break-In Intruding		18	4		<input type="checkbox"/>	9		2
Remarks: ACTIVE									
123.7	SCP-Surface Damage Corrosion	S01				<input type="checkbox"/>	11	1	3
Remarks: VARYING POSITION (BOLTS)

Distance: 97.3 ft. Grade: 2
 Condition: TBI-Tap Break-In Intruding
 Remarks: ACTIVE

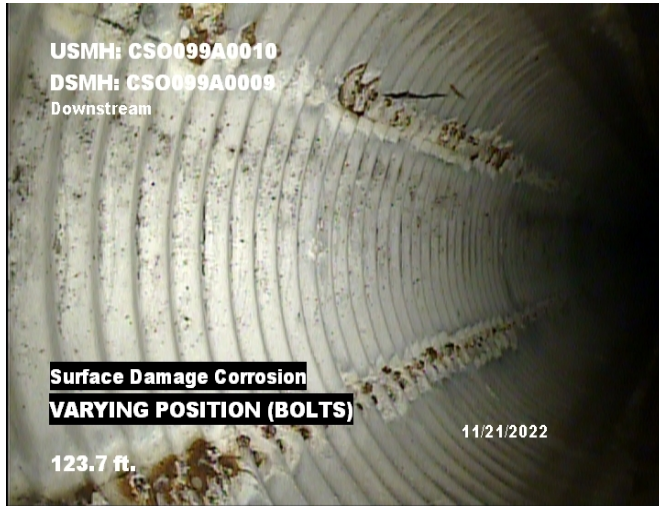
Distance: 123.7 ft. Grade: 3
 Condition: SCP-Surface Damage Corrosion
 Remarks: VARYING POSITION (BOLTS)

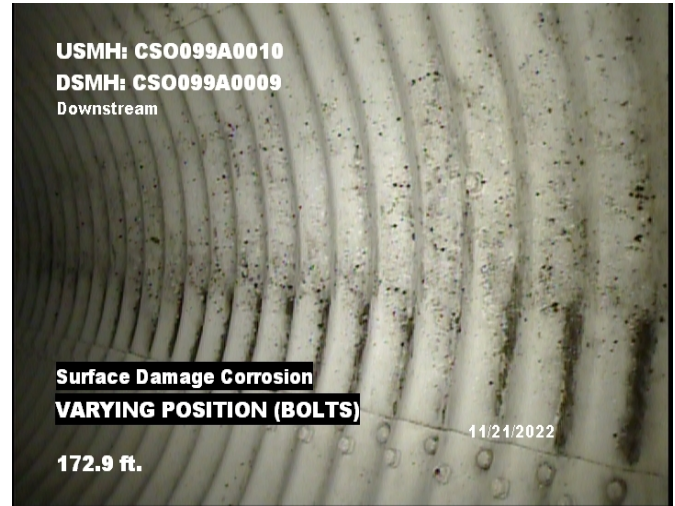
172.9	SCP-Surface Damage Corrosion	F01				<input type="checkbox"/>	11	1	3
Remarks: VARYING POSITION (BOLTS)									
184	OBR-Obstruction Rocks	S02			5	<input type="checkbox"/>	5	7	2

Distance: 172.9 ft. Grade: 3
 Condition: SCP-Surface Damage Corrosion
 Remarks: VARYING POSITION (BOLTS)

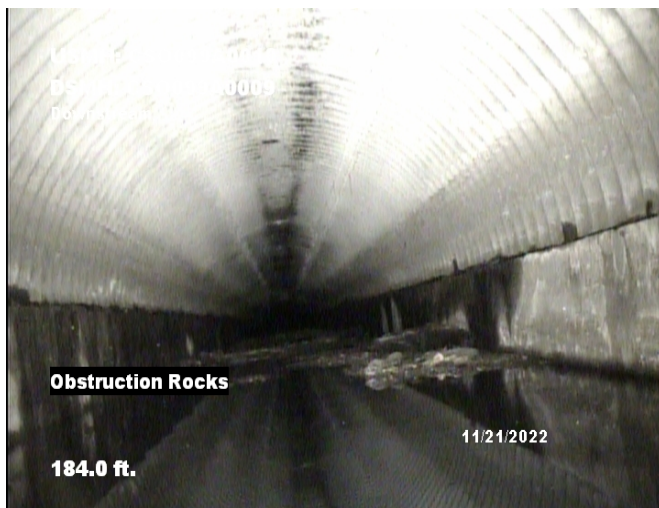
Distance: 184.0 ft. Grade: 2
 Condition: OBR-Obstruction Rocks
 Remarks: N/A

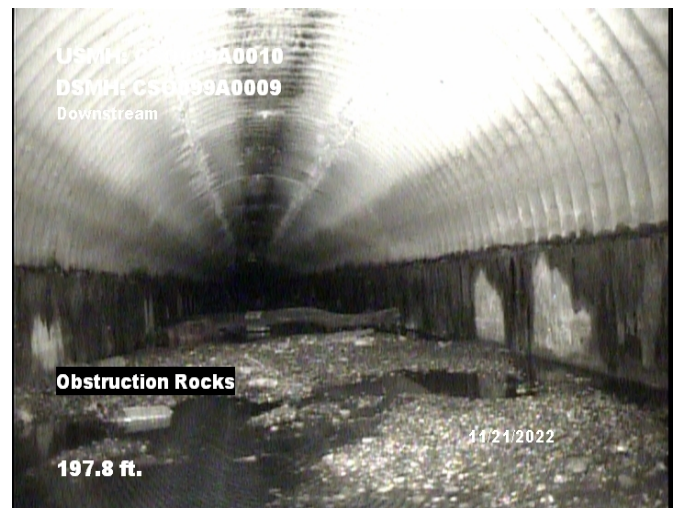
Distance: 197.8 ft. Grade: 2
 Condition: OBR-Obstruction Rocks
 Remarks: N/A

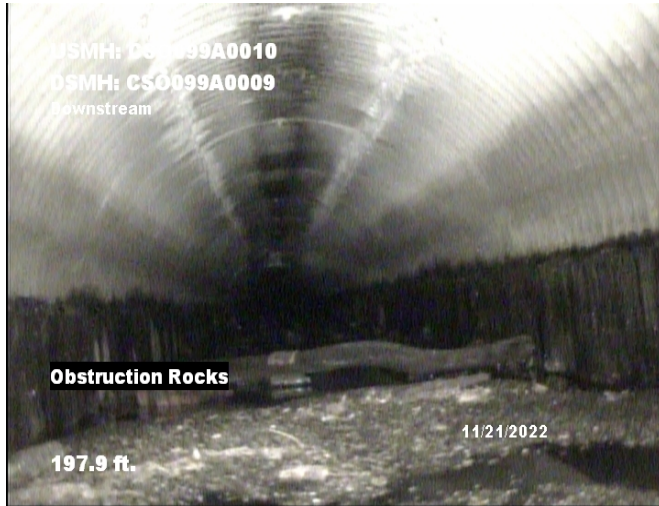
Distance: 197.9 ft. **Grade:** 3
Condition: OBR-Obstruction Rocks
Remarks: N/A

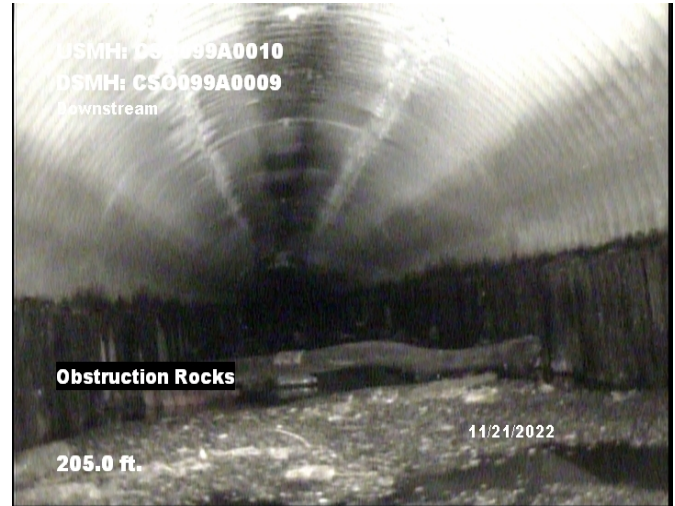
Distance: 205.0 ft. **Grade:** 3
Condition: OBR-Obstruction Rocks
Remarks: N/A

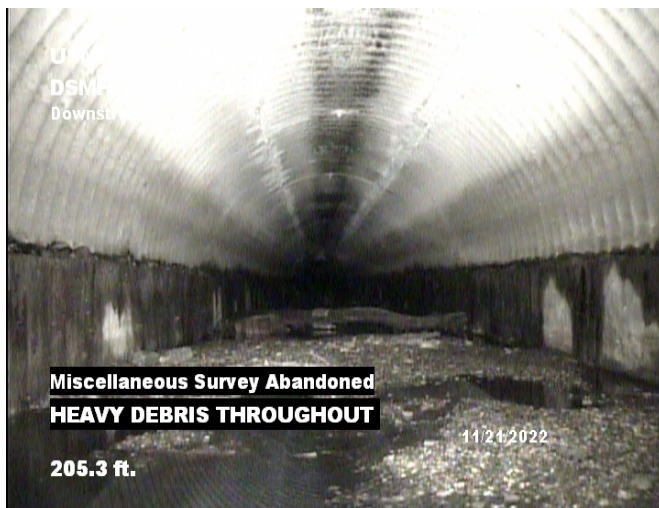
205.3	MSA-Miscellaneous Survey Abandoned					<input type="checkbox"/>			
Remarks: HEAVY DEBRIS THROUGHOUT

Distance: 205.3 ft. **Grade:** 0
Condition: MSA-Miscellaneous Survey Abandoned
Remarks: HEAVY DEBRIS THROUGHOUT
