## Defect Listing

<b>Pipe Segment Reference</b> CSO099A0010A-CSO099A0010	<b>City</b> CLEVELAND	<b>Street</b> E 38TH ST	<b>Material</b> Reinforced Concrete Pipe		<b>Location Code</b> <small>Local road streets with light traffic, town and city back.</small>	<b>Sewer Use</b> Combined Pipe
<b>Upstream MH</b> CSO099A0010A	Total Length 89.9	Year Laid	<b>Shape</b> Circular		Location Details E 38TH	
<b>Downstream MH</b> CSO099A0010	Length surveyed 89.9	Year Renewed	<b>Height</b> 36	<b>Width</b>	Pipe Joint Length

SPR	20	MPR	0	PO Number	<b>Customer</b> HDR
SPRI	2	MPRI	0	Work Order	<b>Purpose</b> Routine Assessment
QSR	2A00	QMR	0000		
OPR	20	<b>Surveyed By</b> Shawn_Dunnell	<b>Direction</b> Downstream	<b>Date</b> 11/01/2022	Media label
OPRI	2	<b>Certificate Number</b> 07001437	<b>Pre-Cleaning</b> Light Cleaning	<b>Time</b> 08:43	<b>Weather</b> Light Rain
		Date Cleaned		<b>End Time</b> 09:23	Additional Info

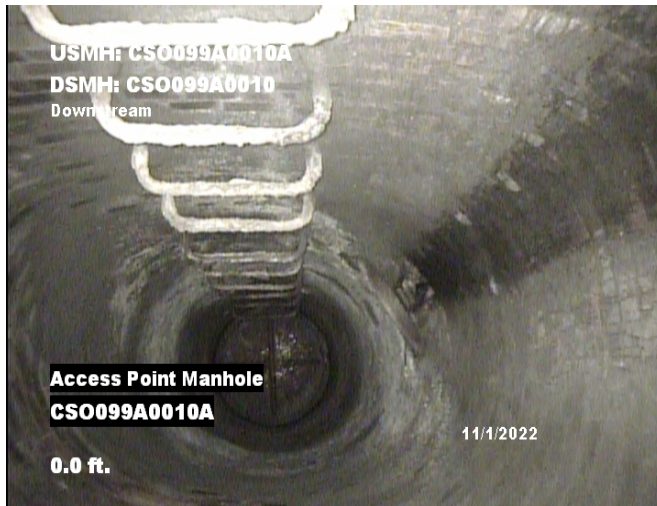
Distance: 0.0 ft.      Grade: 0  
 Condition: AMH-Access Point Manhole  
 Remarks: CSO099A0010A

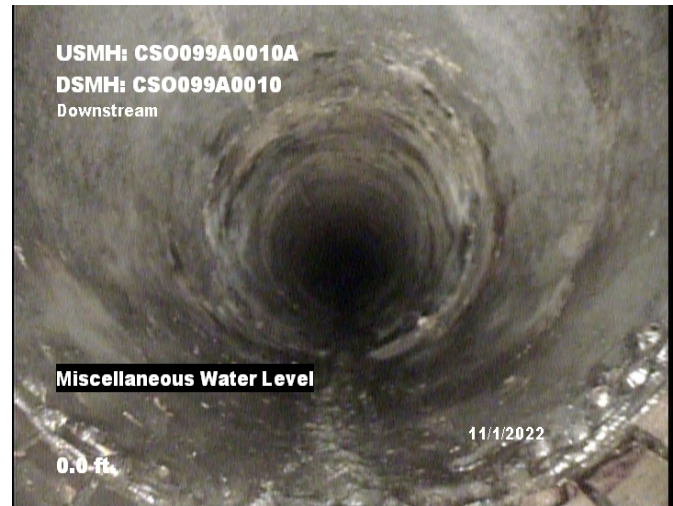
Distance: 0.0 ft.      Grade: 0  
 Condition: MWL-Miscellaneous Water Level  
 Remarks: N/A

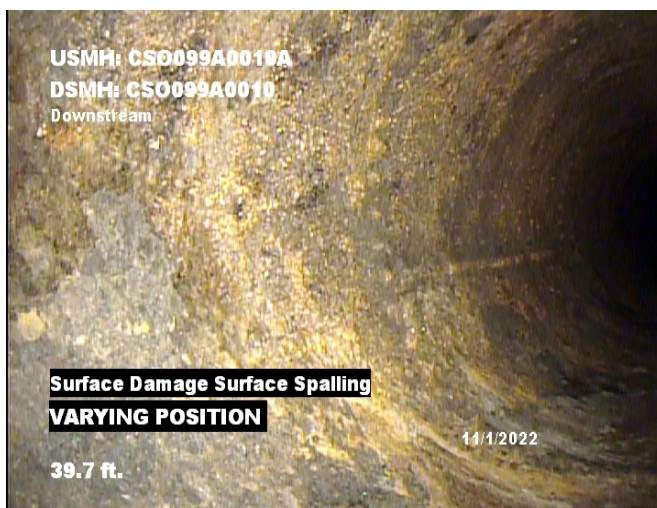
Distance: 39.7 ft.      Grade: 2  
 Condition: SSS-Surface Damage Surface Spalling  
 Remarks: VARYING POSITION

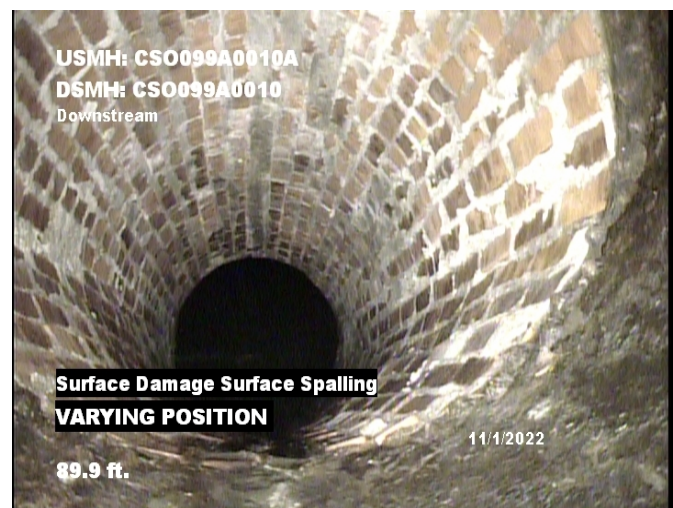
Distance: 89.9 ft.      Grade: 2  
 Condition: SSS-Surface Damage Surface Spalling  
 Remarks: VARYING POSITION

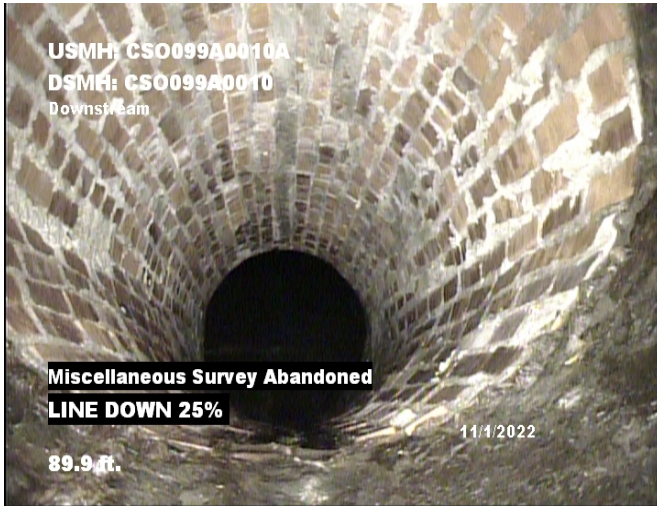
Distance:	89.9 ft.	Grade:	0
Condition:	MSA-Miscellaneous Survey Abandoned		
Remarks:	LINE DOWN 25%
