Defect Listing

Pipe Segment Reference CSO099A0010A-CSO099A0010	City CLEVELAND	Street E 38th st	Material Corrugated Metal Pipe		Location Code Easement/Right of Way	Sewer Use Combined Pipe
Upstream MH CSO099A0010A	Total Length 44.1	Year Laid	Shape Circular		Location Details E 38TH	
Downstream MH CSO099A0010	Length surveyed 44.1	Year Renewed	Height 48	Width	Pipe Joint Length

4 Image Report

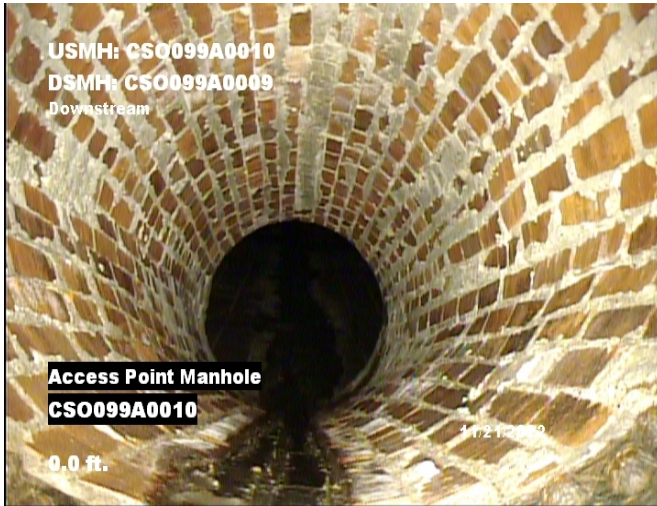
Distance: 0.0 ft. Grade: 0
 Condition: AMH-Access Point Manhole
 Remarks: CSO099A0010A

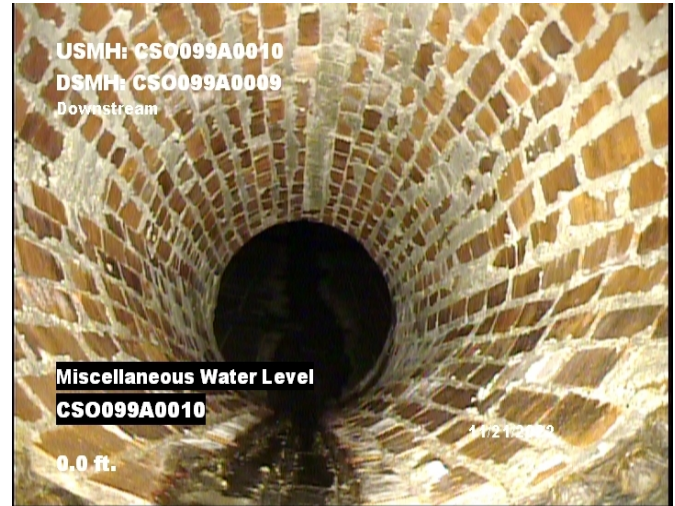
Distance: 0.0 ft. Grade: 0
 Condition: MWL-Miscellaneous Water Level
 Remarks: N/A

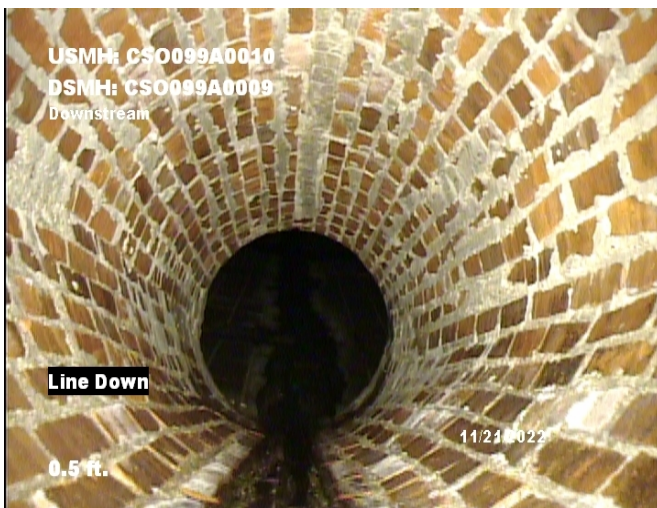
Distance: 0.5 ft. Grade: 2
 Condition: ID-Line Down
 Remarks: N/A

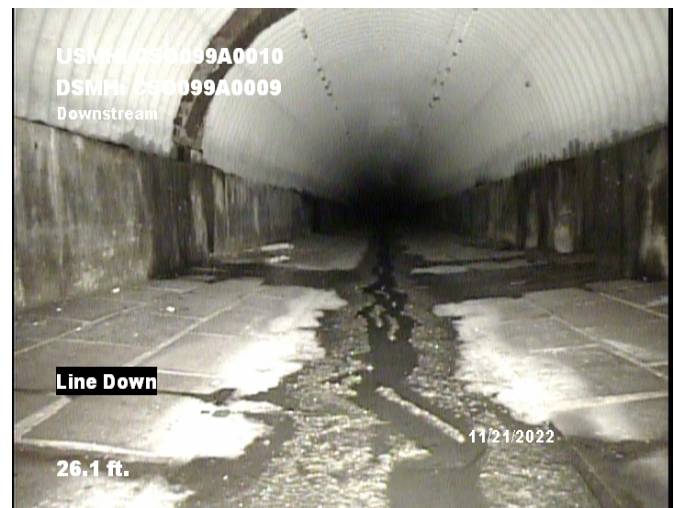
Distance: 18.0 ft. Grade: 2
 Condition: ID-Line Down
 Remarks: N/A

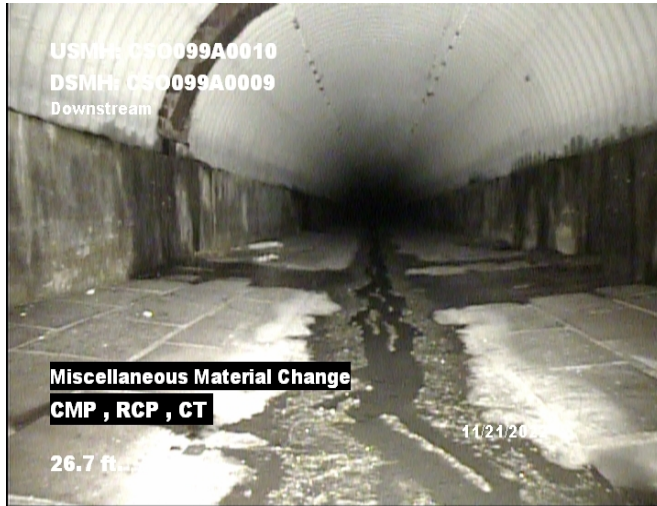
Distance: 26.7 ft. Grade: 0
 Condition: MMC-Miscellaneous Material Change
 Remarks: CMP - RCP - CT

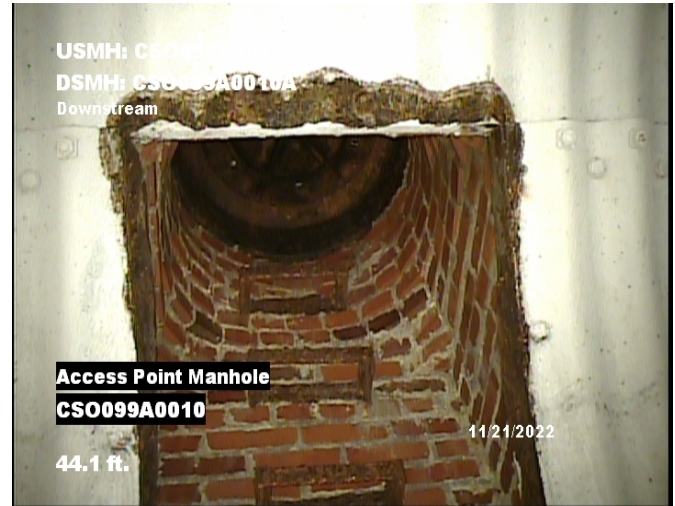
Distance: 44.1 ft. Grade: 0
 Condition: AMH-Access Point Manhole
 Remarks: CSO099A0010
