Defect Listing

Pipe Segment Reference CSO200A0003-CSO200A0000	City CLEVELAND	Street MARGINAL	Material Corrugated Metal Pipe		Location Code Airport	Sewer Use Combined Pipe
Upstream MH CSO200A0003	Total Length 230.3	Year Laid	Shape Arched		Location Details BURKE AIRPORT	
Downstream MH CSO200A0000	Length surveyed 230.3	Year Renewed	Height 93	Width 150	Pipe Joint Length

SPR 276	MPR 2	PO Number		Customer HDR	
SPRI 3	MPRI 2	Work Order		Purpose Routine Assessment	
QSR 3Q00	QMR 2100				
OPR 278	Surveyed By Shawn_Dunnell	Direction Downstream	Date 11/04/2022		Media label
OPRI 3	Certificate Number 07001437	Pre-Cleaning No Pre-Cleaning	Time 12:27		Weather Dry
Date Cleaned			End Time 12:40		Additional Info

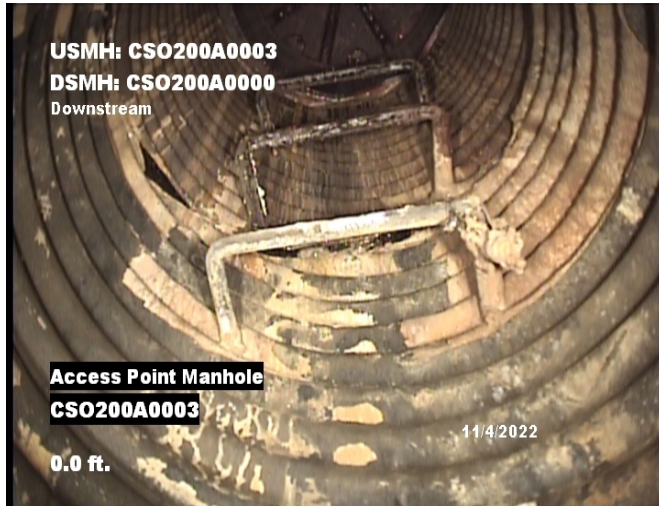
Distance: 0.0 ft. Grade: 0
 Condition: AMH-Access Point Manhole
 Remarks: CSO200A0003

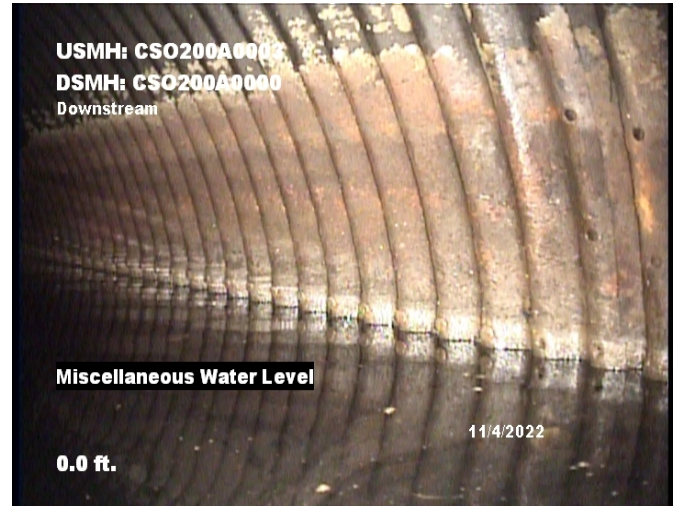
Distance: 0.0 ft. Grade: 0
 Condition: MWL-Miscellaneous Water Level
 Remarks: N/A

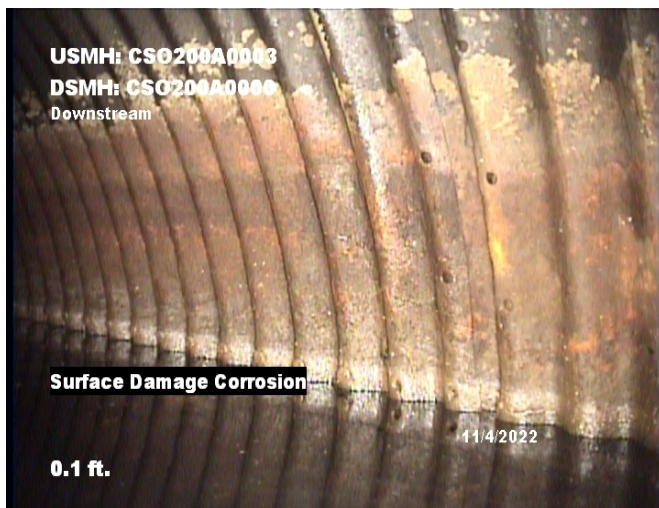
Distance: 0.1 ft. Grade: 3
 Condition: SCP-Surface Damage Corrosion
 Remarks: N/A

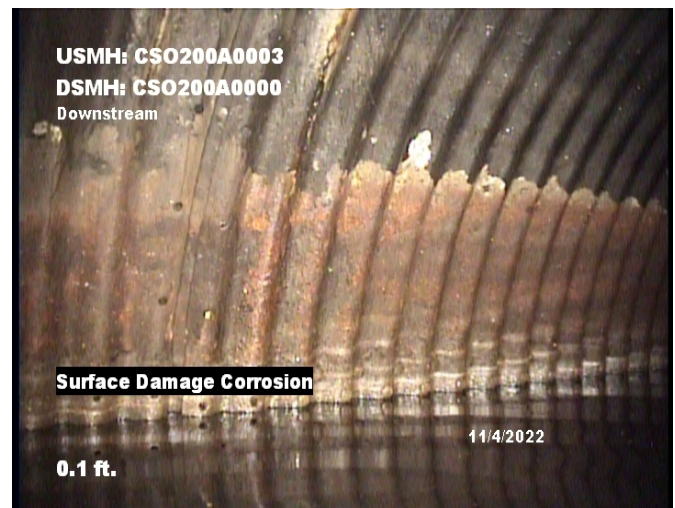
Distance: 0.1 ft. Grade: 3
 Condition: SCP-Surface Damage Corrosion
 Remarks: N/A

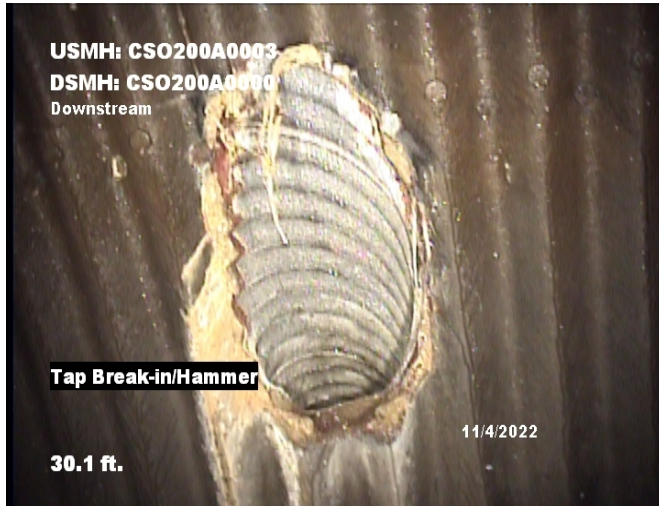
Distance: 30.1 ft. Grade: 0
Condition: TB-Tap Break-in/Hammer
Remarks: N/A

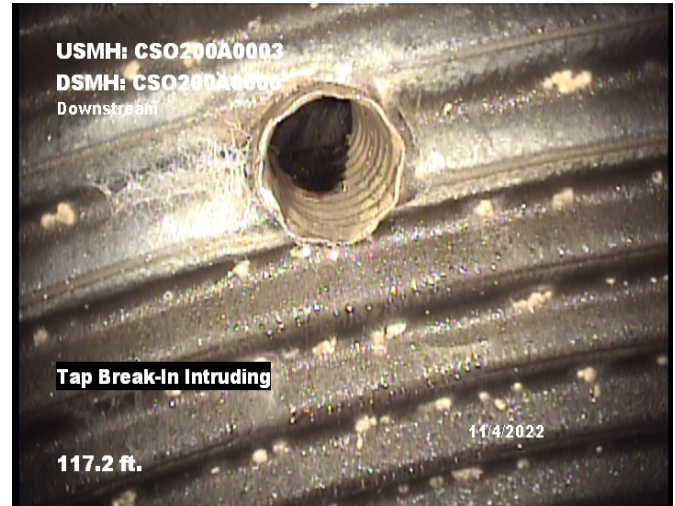
Distance: 117.1 ft. Grade: 2
Condition: TBI-Tap Break-In Intruding
Remarks: N/A

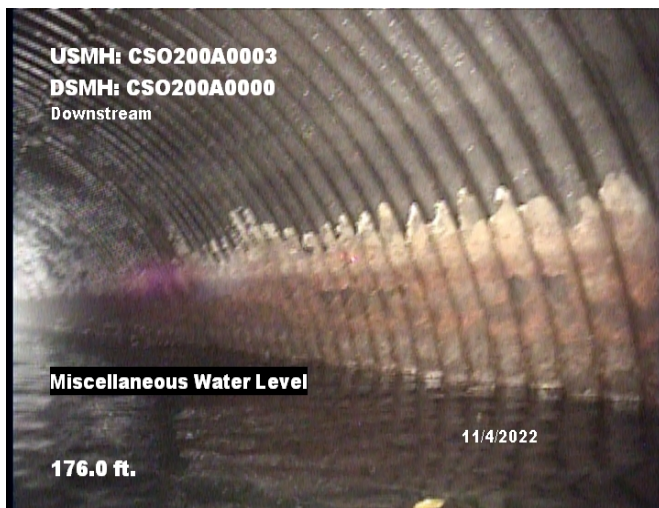
Distance: 175.9 ft. Grade: 0
Condition: MWL-Miscellaneous Water Level
Remarks: N/A

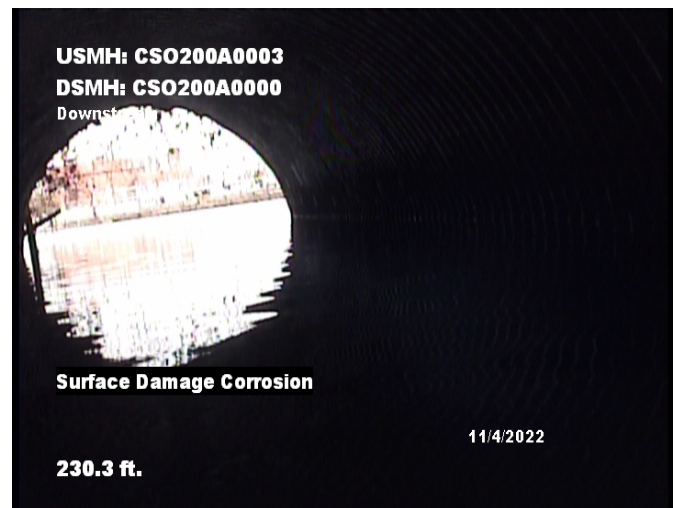
Distance: 230.3 ft. Grade: 3
Condition: SCP-Surface Damage Corrosion
Remarks: N/A

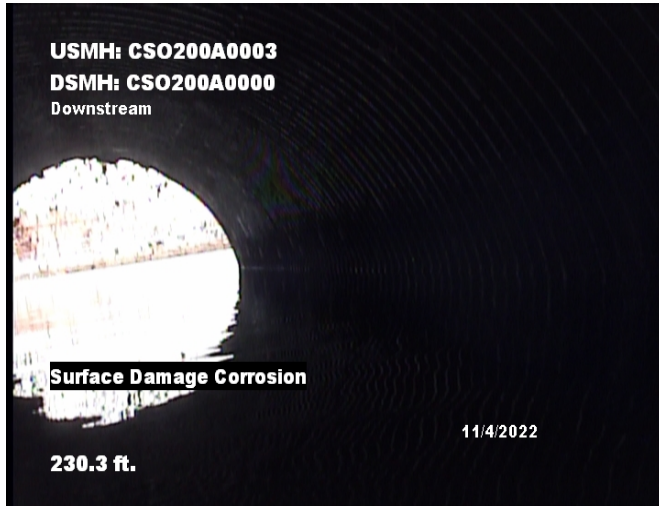
Distance: 230.3 ft. Grade: 3
 Condition: SCP-Surface Damage Corrosion
 Remarks: N/A

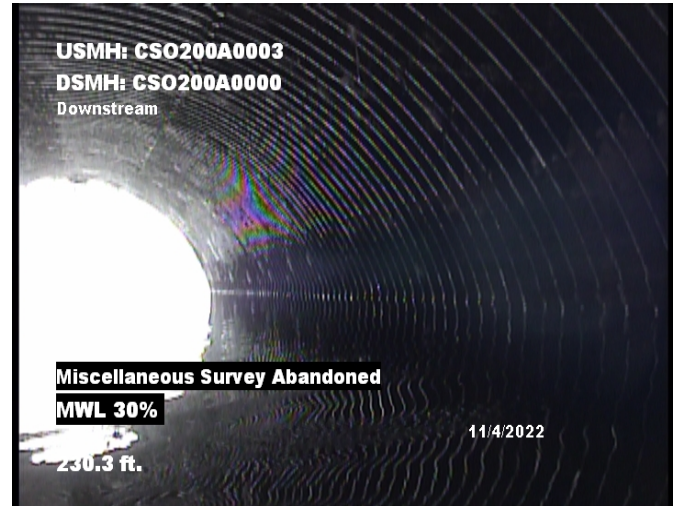
Distance: 230.3 ft. Grade: 0
 Condition: MSA-Miscellaneous Survey Abandoned
 Remarks: MWL 30%
