## Defect Listing

<b>Pipe Segment Reference</b> CSO200A0004-CSO200A0003	<b>City</b> CLEVELAND	<b>Street</b> MARGINAL	<b>Material</b> Corrugated Metal Pipe		<b>Location Code</b> Airport	<b>Sewer Use</b> Combined Pipe
<b>Upstream MH</b> CSO200A0004	Total Length 297.7	Year Laid	<b>Shape</b> Arched		Location Details BURKE AIRPORT	
<b>Downstream MH</b> CSO200A0003	Length surveyed 297.7	Year Renewed	<b>Height</b> 93	<b>Width</b> 150	Pipe Joint Length

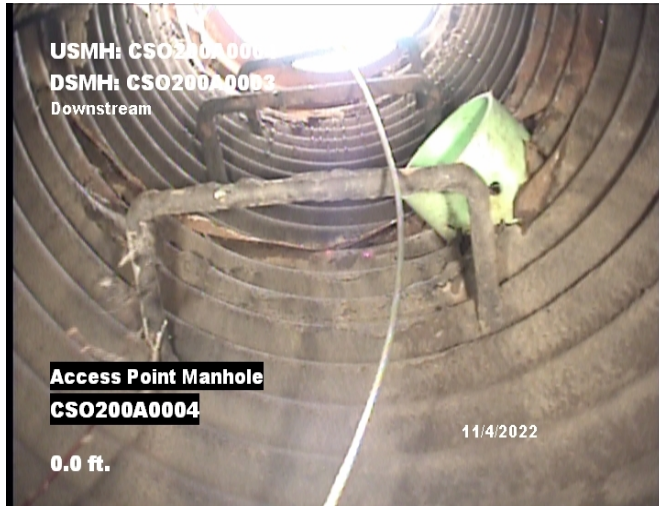
Distance: 0.0 ft.      Grade: 0  
 Condition: AMH-Access Point Manhole  
 Remarks: CSO200A0004

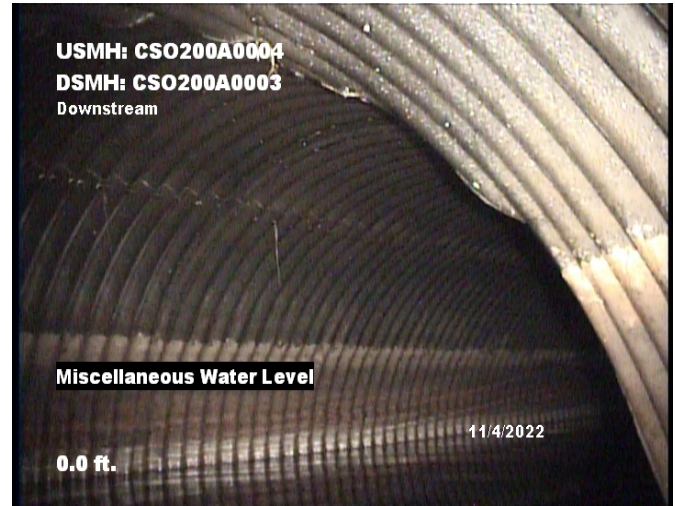
Distance: 0.0 ft.      Grade: 0  
 Condition: MWL-Miscellaneous Water Level  
 Remarks: N/A

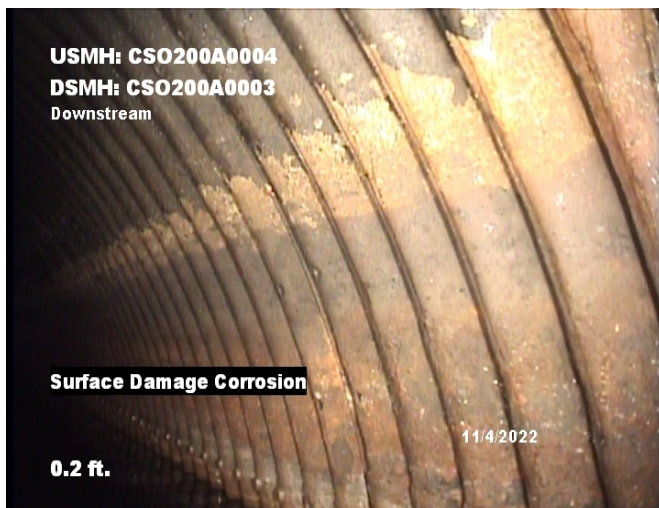
Distance: 0.2 ft.      Grade: 3  
 Condition: SCP-Surface Damage Corrosion  
 Remarks: N/A

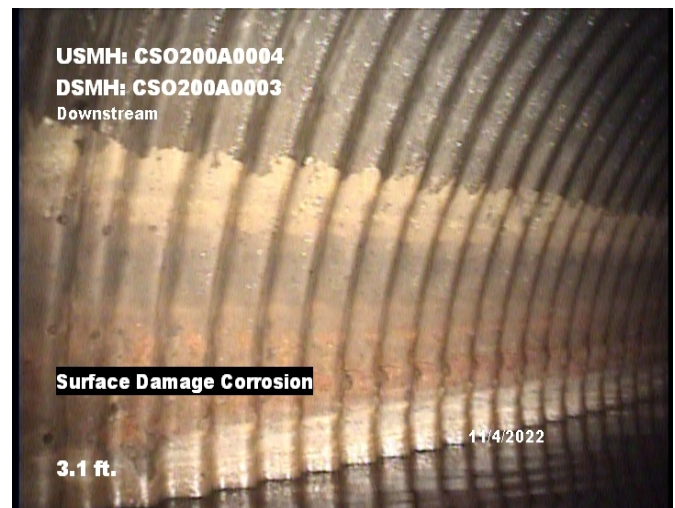
Distance: 3.1 ft.      Grade: 3  
 Condition: SCP-Surface Damage Corrosion  
 Remarks: N/A

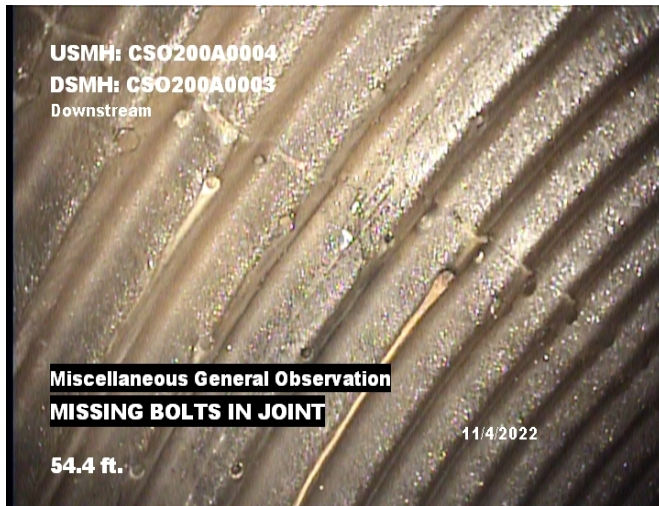
Distance: 54.4 ft.      Grade: 0  
Condition: MGO-Miscellaneous General Observation  
Remarks: MISSING BOLTS IN JOINT

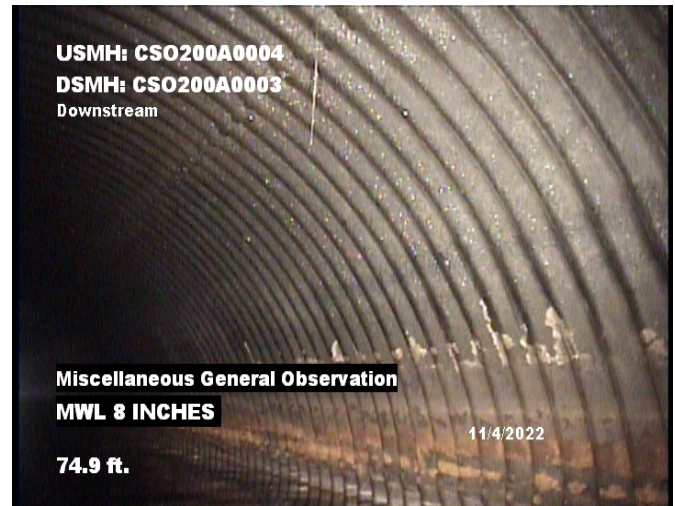
Distance: 74.9 ft.      Grade: 0  
Condition: MGO-Miscellaneous General Observation  
Remarks: MWL 8 INCHES

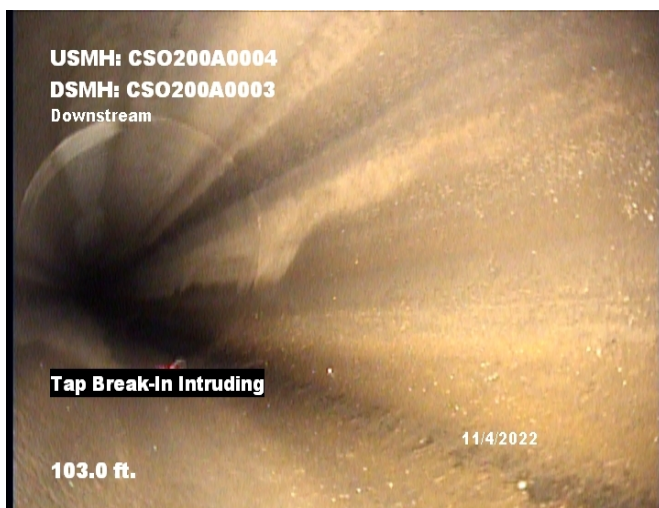
Distance: 103.0 ft.      Grade: 4  
Condition: TBI-Tap Break-In Intruding  
Remarks: N/A

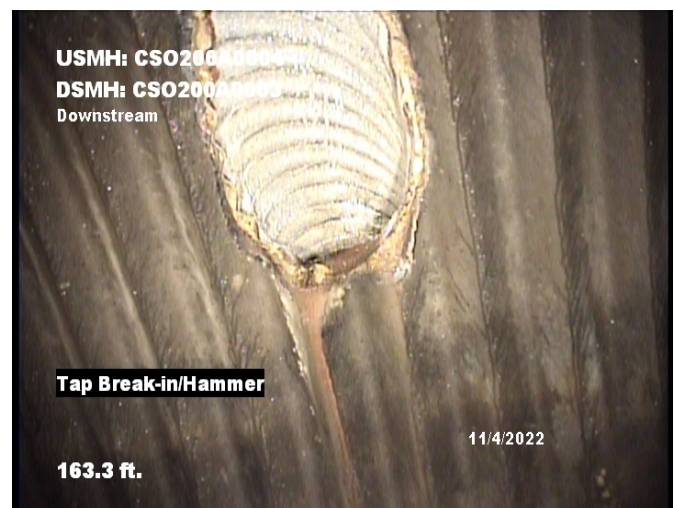
Distance: 163.3 ft.      Grade: 0  
Condition: TB-Tap Break-in/Hammer  
Remarks: N/A

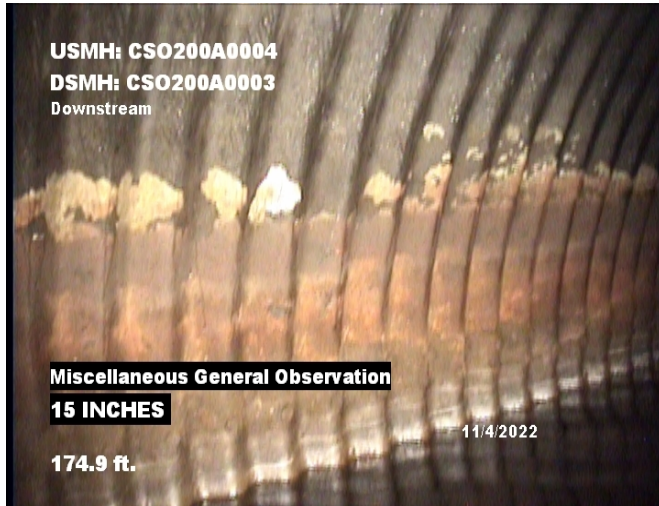
Distance: 174.9 ft.      Grade: 0  
 Condition: MGO-Miscellaneous General Observation  
 Remarks: 15 INCHES

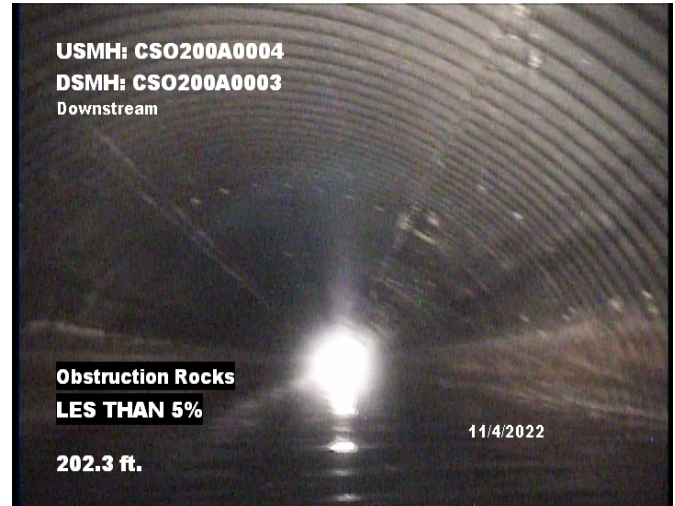
Distance: 202.3 ft.      Grade: 2  
 Condition: OBR-Obstruction Rocks  
 Remarks: LES THAN 5%

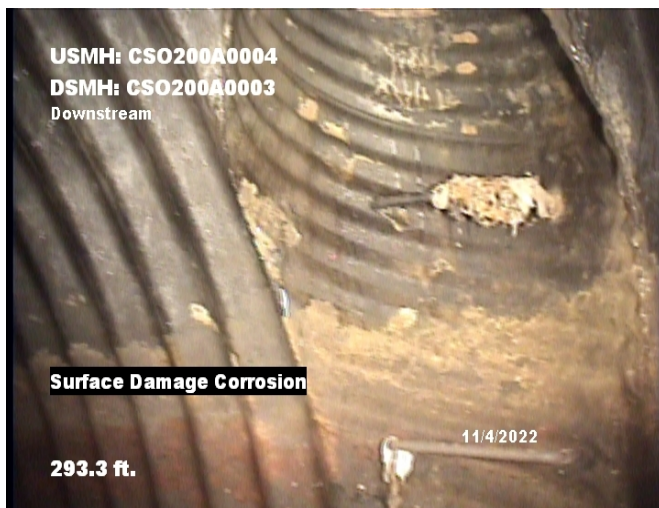
Distance: 293.3 ft.      Grade: 3  
 Condition: SCP-Surface Damage Corrosion  
 Remarks: N/A

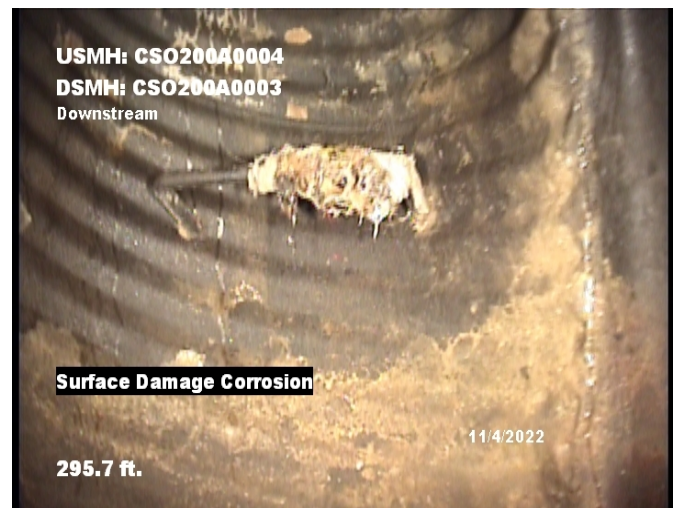
Distance: 295.7 ft.      Grade: 3  
 Condition: SCP-Surface Damage Corrosion  
 Remarks: N/A

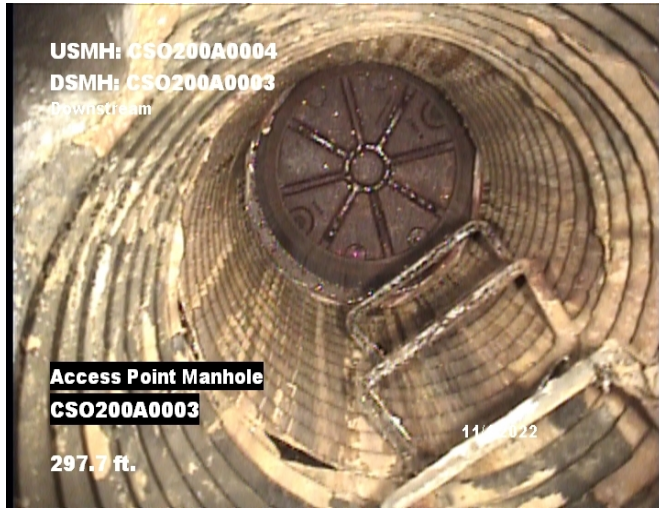
Distance: 297.7 ft.      Grade: 0  
 Condition: AMH-Access Point Manhole  
 Remarks: CSO200A0003
