Defect Listing

Pipe Segment Reference CSO200A0005-CSO200A0004	City CLEVELAND	Street MARGINAL	Material Corrugated Metal Pipe		Location Code Airport	Sewer Use Combined Pipe
Upstream MH CSO200A0005	Total Length 127.4	Year Laid	Shape Arched		Location Details BURKE AIRPORT	
Downstream MH CSO200A0004	Length surveyed 127.4	Year Renewed	Height 93	Width 150	Pipe Joint Length

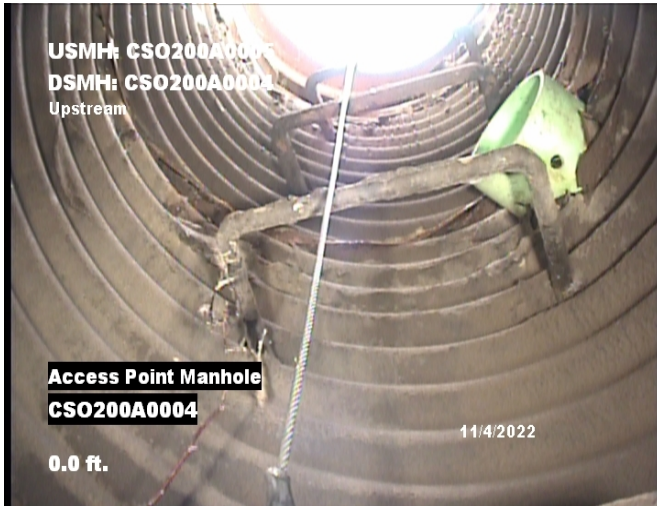
Distance: 0.0 ft. Grade: 0
 Condition: AMH-Access Point Manhole
 Remarks: CSO200A0004

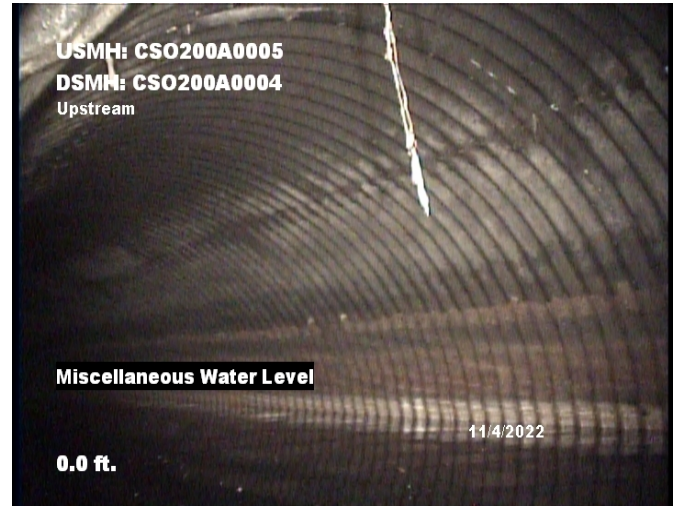
Distance: 0.0 ft. Grade: 0
 Condition: MWL-Miscellaneous Water Level
 Remarks: N/A

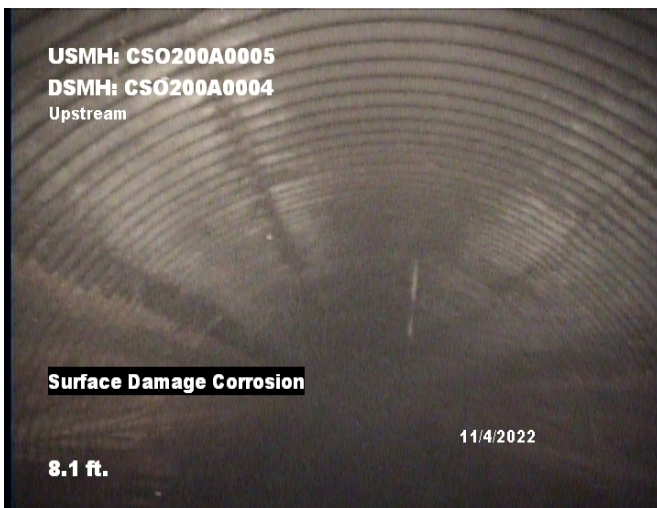
Distance: 8.1 ft. Grade: 3
 Condition: SCP-Surface Damage Corrosion
 Remarks: N/A

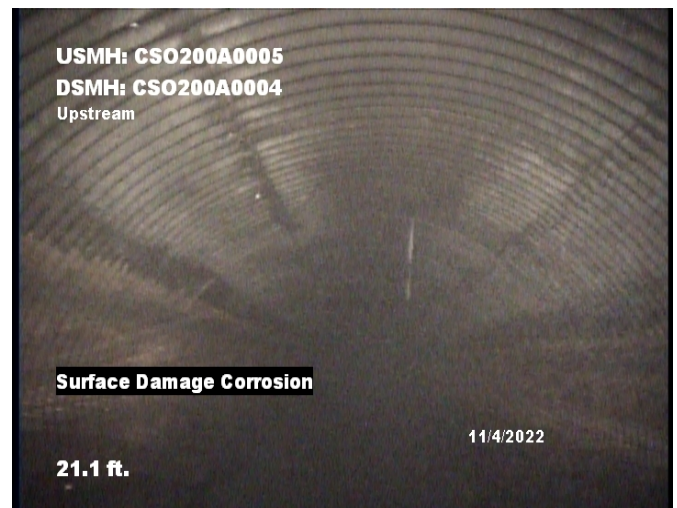
Distance: 21.1 ft. Grade: 3
 Condition: SCP-Surface Damage Corrosion
 Remarks: N/A

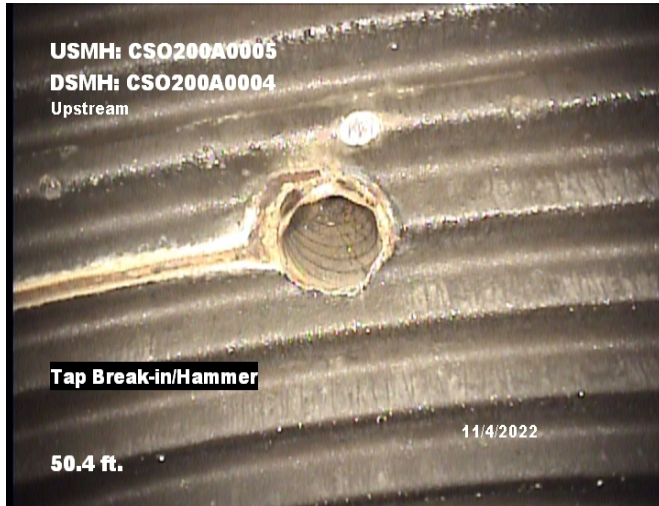
Distance: 50.4 ft. Grade: 0
Condition: TB-Tap Break-in/Hammer
Remarks: N/A

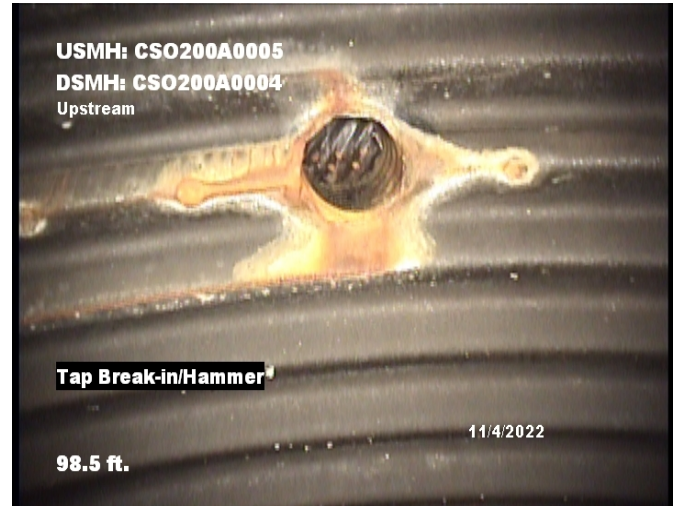
Distance: 98.5 ft. Grade: 0
Condition: TB-Tap Break-in/Hammer
Remarks: N/A

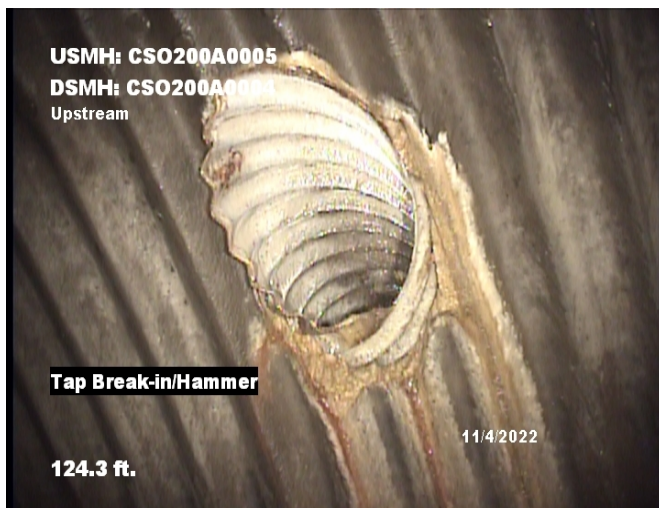
Distance: 124.3 ft. Grade: 0
Condition: TB-Tap Break-in/Hammer
Remarks: N/A

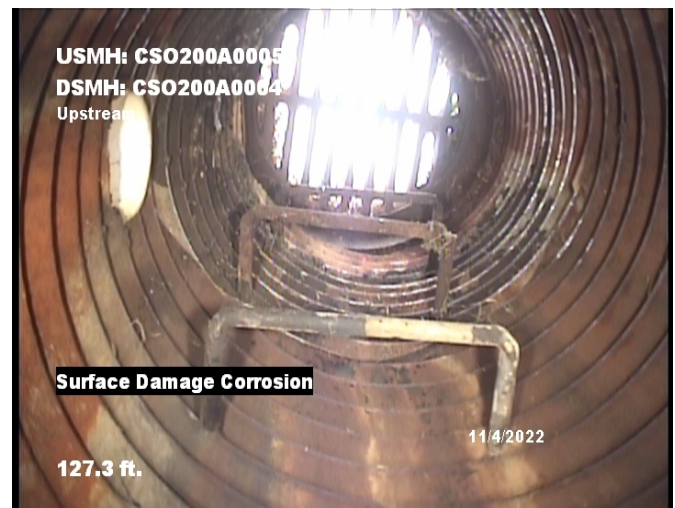
Distance: 127.3 ft. Grade: 3
Condition: SCP-Surface Damage Corrosion
Remarks: N/A

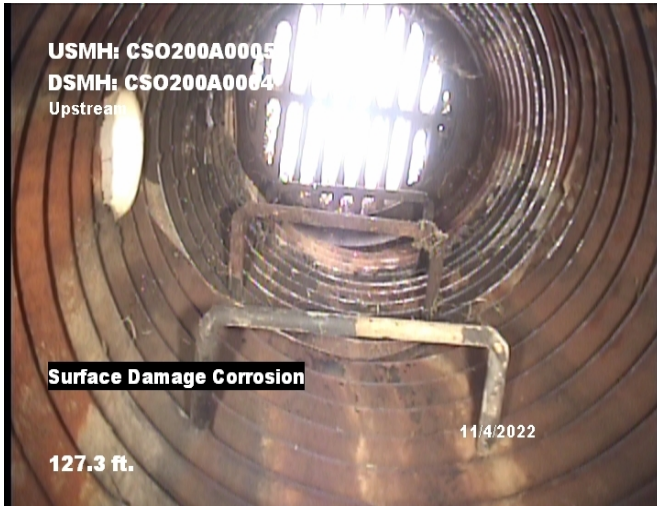
Distance: 127.3 ft. Grade: 3
 Condition: SCP-Surface Damage Corrosion
 Remarks: N/A

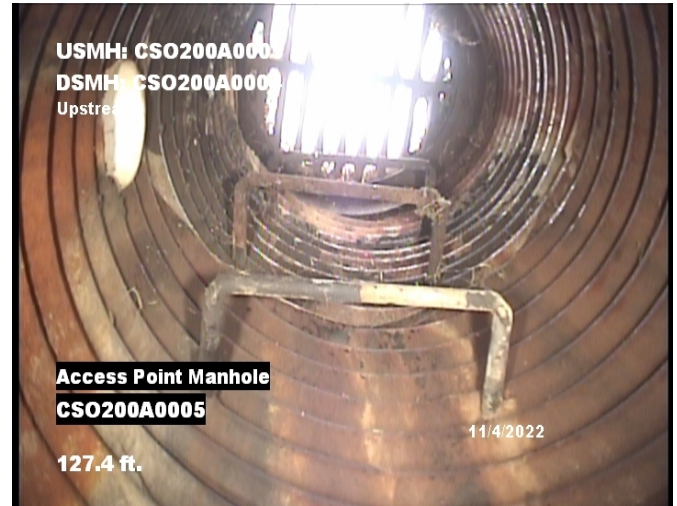
Distance: 127.4 ft. Grade: 0
 Condition: AMH-Access Point Manhole
 Remarks: CSO200A0005
