Defect Listing

Pipe Segment Refere... CSO200A0008B-CSO200...	City CLEVELAND	Street E 40TH ST	Material REINFORCED CONCRETE...		Location C... ASSESSMENT/R..	Sewer Use COMBINED
Upstream MH CSO200A0008B	Total Length 170	Year Laid	Shape SQUARE		Location Details	
DS Manhole CSO200A0007	Length surveyed 170	Year Renewed	Height 72	Width 72	Pipe Joint...

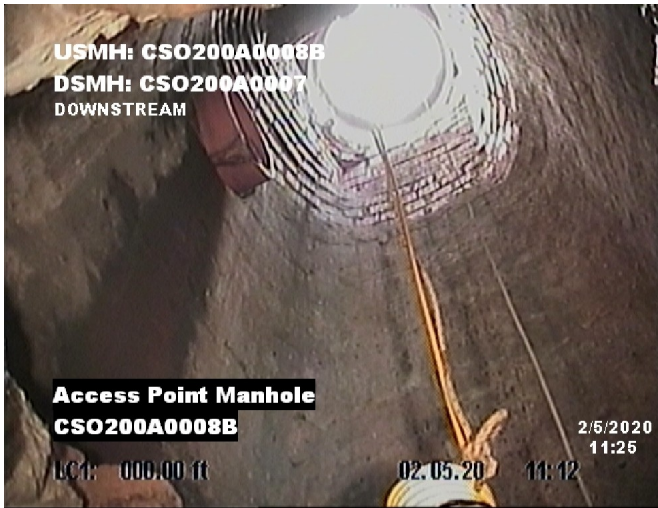
Distance: 0.0 ft. Grade: 0
 Condition: Access Point Manhole
 Remarks: CSO200A0008B

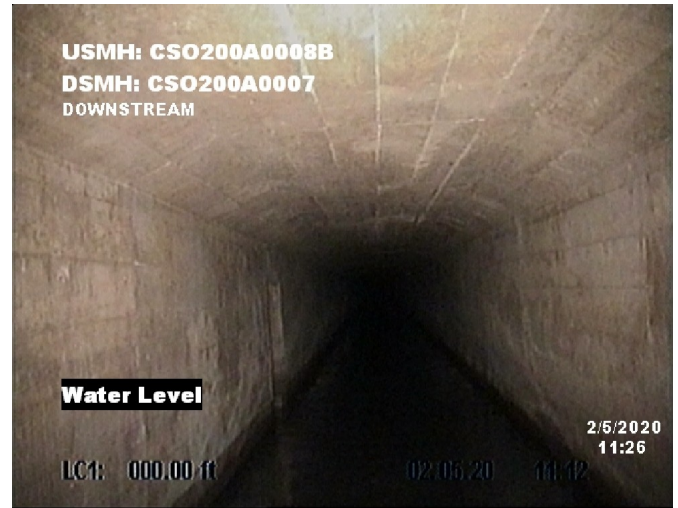
Distance: 0.0 ft. Grade: 0
 Condition: Water Level
 Remarks: N/A

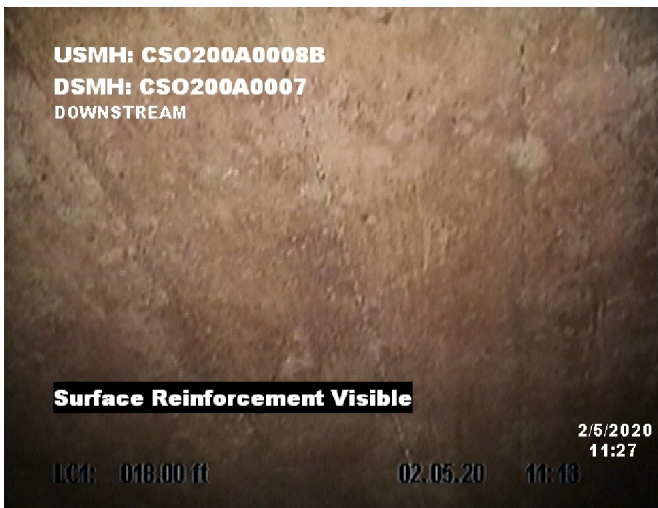
0.0 ft.	Water Level				15	<input type="checkbox"/>			
18.0 ft.	Surface Reinforcement Visible					<input type="checkbox"/>	11	1	5
18.0 ft.	General Observation					<input type="checkbox"/>			
Remarks: 53X30 OPENING TO 2ND BARRELL

Distance: 18.0 ft. Grade: 5
 Condition: Surface Reinforcement Visible
 Remarks: N/A

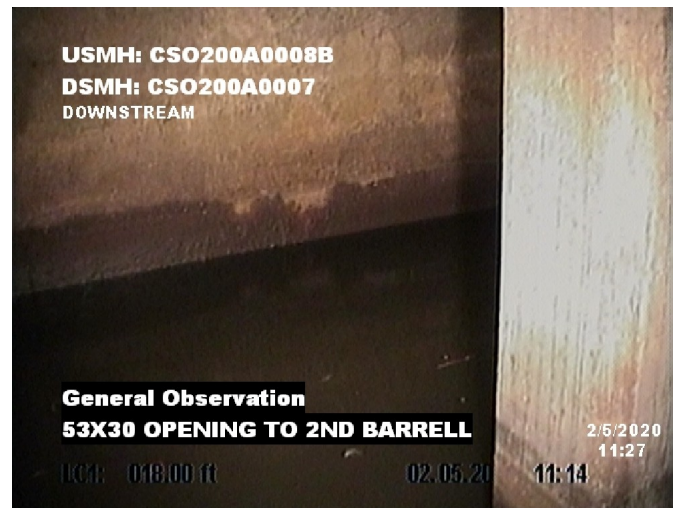
Distance: 18.0 ft. Grade: 0
 Condition: General Observation
 Remarks: 53X30 OPENING TO 2ND BARRELL

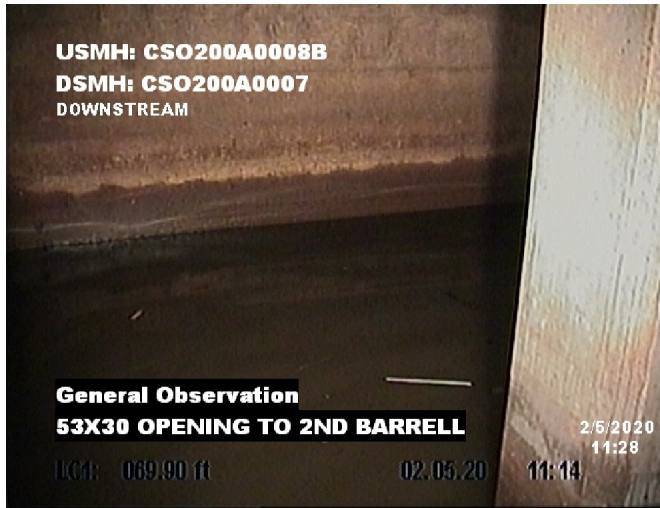
Distance: 69.9 ft. Grade: 0
 Condition: General Observation
 Remarks: 53X30 OPENING TO 2ND BARRELL

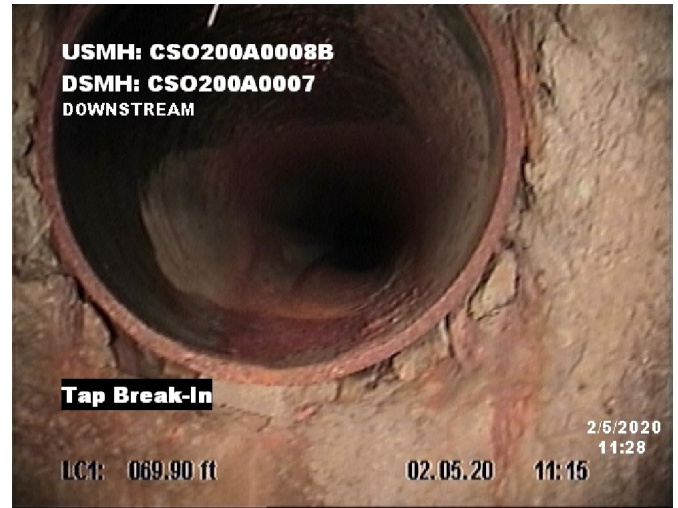
69.9 ft.	General Observation					<input type="checkbox"/>			
Remarks: 53X30 OPENING TO 2ND BARRELL									
69.9 ft.	Tap Break-In		18			<input type="checkbox"/>	3

Distance: 69.9 ft. Grade: 0
 Condition: Tap Break-In
 Remarks: N/A

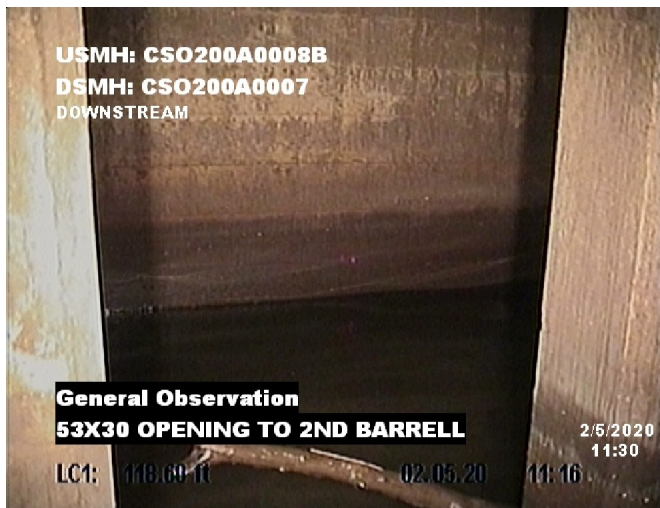
Distance: 118.6 ft. Grade: 0
 Condition: General Observation
 Remarks: 53X30 OPENING TO 2ND BARRELL

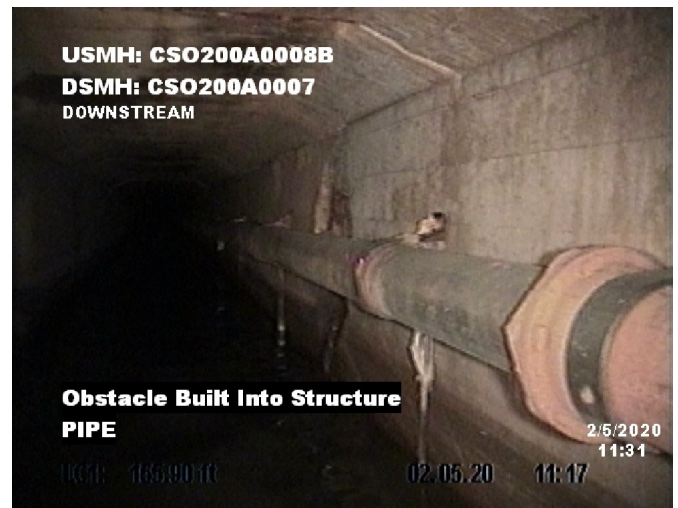
118.6 ft.	General Observation					<input type="checkbox"/>			
Remarks: 53X30 OPENING TO 2ND BARRELL									
165.9 ft.	Obstacle Built Into Structure	S01			10	<input type="checkbox"/>	3		2
Remarks: PIPE

Distance: 165.9 ft. Grade: 2
 Condition: Obstacle Built Into Structure
 Remarks: PIPE

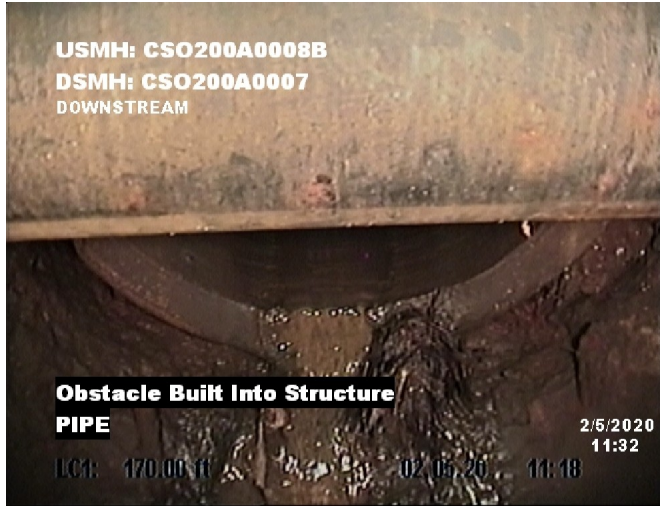
170.0 ft.	Obstacle Built Into Structure	F01			10	<input type="checkbox"/>	3		2
Remarks: PIPE									
170.0 ft.	Access Point Manhole					<input type="checkbox"/>			
Remarks: CSO200A0007

Distance: 170.0 ft. **Grade:** 2
Condition: Obstacle Built Into Structure
Remarks: PIPE

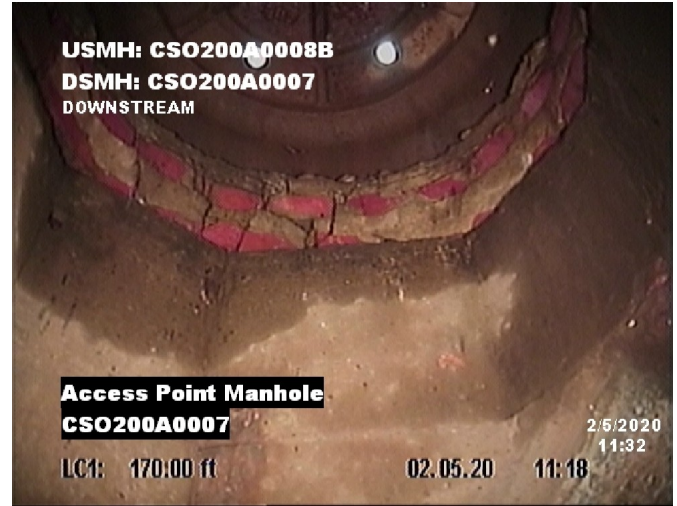
Distance: 170.0 ft. **Grade:** 0
Condition: Access Point Manhole
Remarks: CSO200A0007
