Defect Listing

Pipe Segment Refere... CSO200A0009-CSO200A...	City CLEVELAND	Street E 40TH ST	Material BRICK	Location C... EASEMENT/R..	Sewer Use COMBINED
Upstream MH CSO200A0009	Total Length 383.6	Year Laid	Shape CIRCULAR	Location Details	
DS Manhole CSO200A0008	Length surveyed 383.6	Year Renewed	Height 78	Width 78	Pipe Joint...

SPR 281	MPR 104	PO Number		Customer KS ASSOC	
SPRI 3.1	MPRI 2.4	Work Order G		Purpose ROUTINE ASSESSMENT	
QSR 543P	QMR 413B	Direction UPSTREAM	Date 20200205	Media label 001	
OPR 385	Surveyed By Dan_Zaffle	Pre-Cleaning NO PRE-CLEANING	Time 10:41	Weather DRY	
OPRI 2.9	Certificate Number U-804-1527	Date Cleaned	End Time 10:54	Additional Info

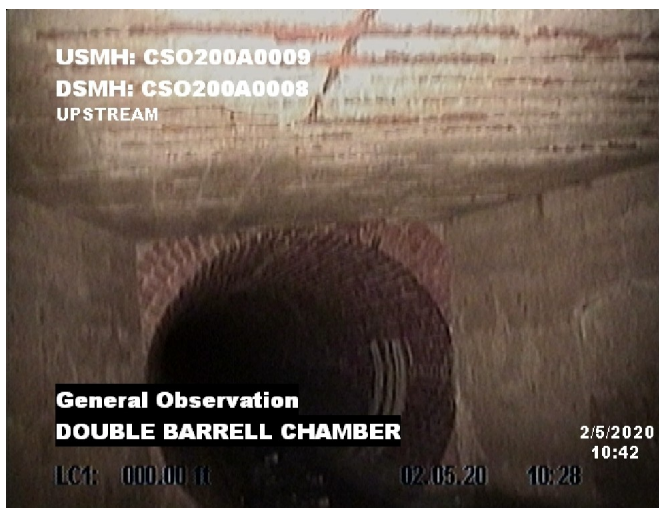
Distance: 0.0 ft. Grade: 0
 Condition: General Observation
 Remarks: DOUBLE BARRELL CHAMBER

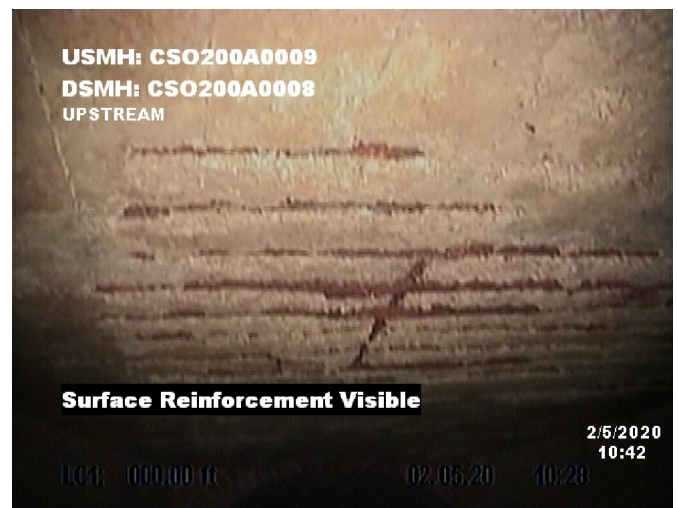
Distance: 0.0 ft. Grade: 5
 Condition: Surface Reinforcement Visible
 Remarks: N/A

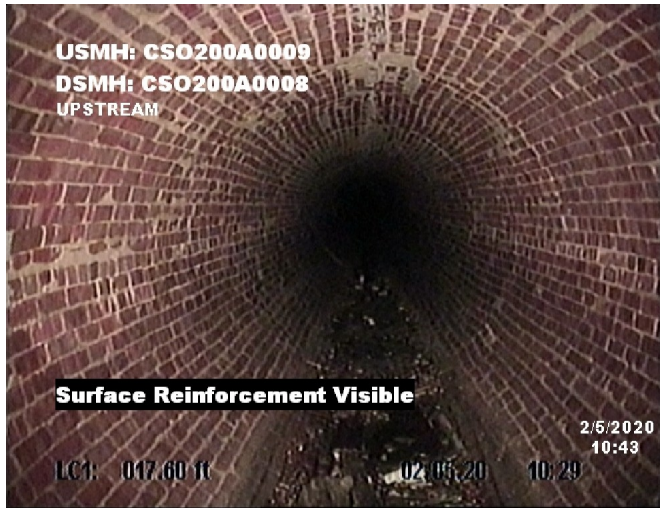
Distance: 17.6 ft. Grade: 5
 Condition: Surface Reinforcement Visible
 Remarks: N/A

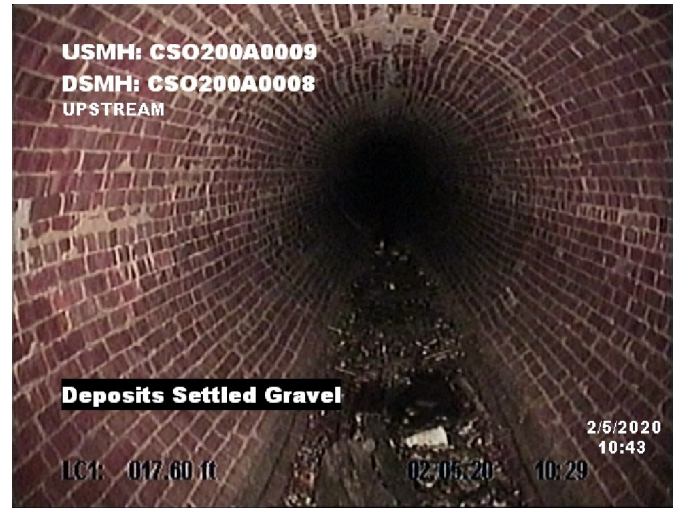
Distance: 17.6 ft. Grade: 2
 Condition: Deposits Settled Gravel
 Remarks: N/A

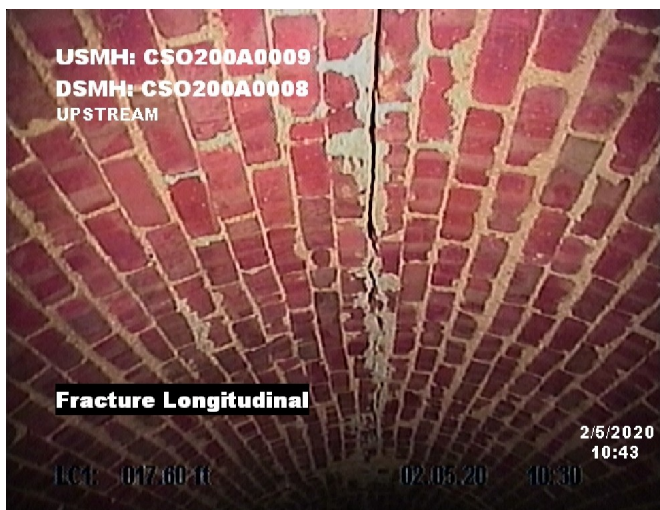
Distance: 17.6 ft. Grade: 3
 Condition: Fracture Longitudinal
 Remarks: N/A

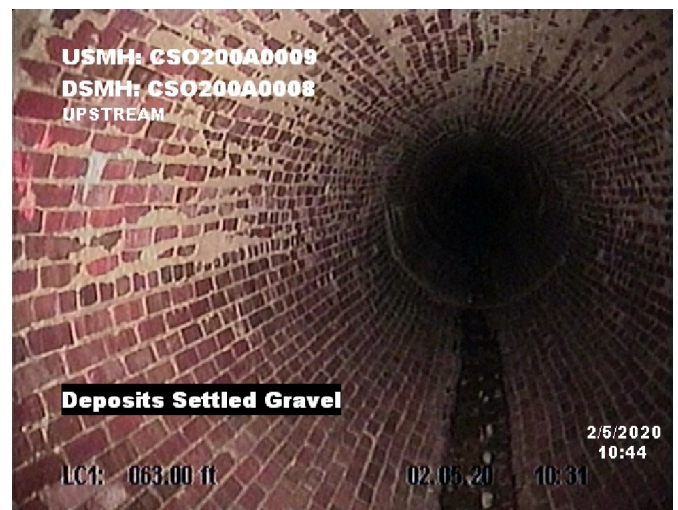
Distance: 63.0 ft. Grade: 2
 Condition: Deposits Settled Gravel
 Remarks: N/A

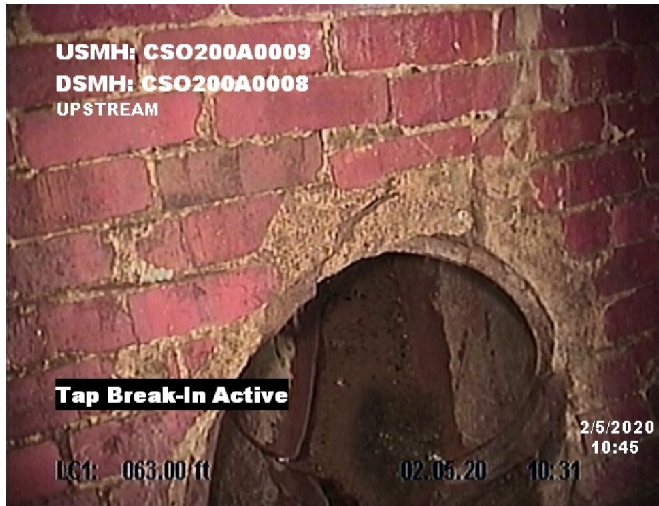
Distance: 63.0 ft. Grade: 0
 Condition: Tap Break-In Active
 Remarks: N/A

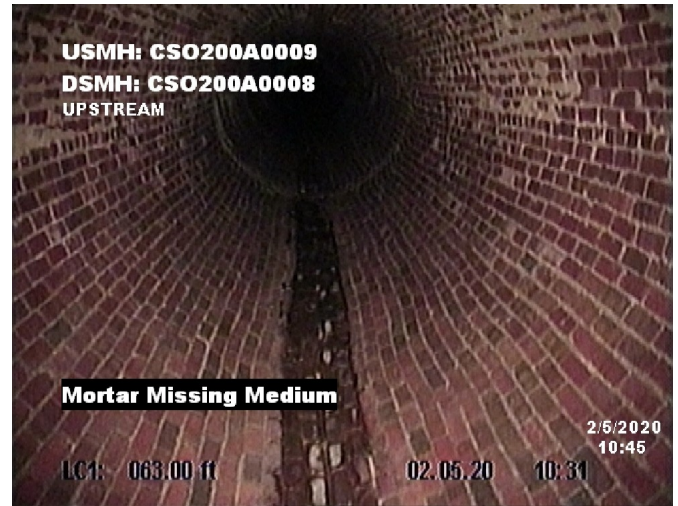
Distance: 63.0 ft. Grade: 3
 Condition: Mortar Missing Medium
 Remarks: N/A

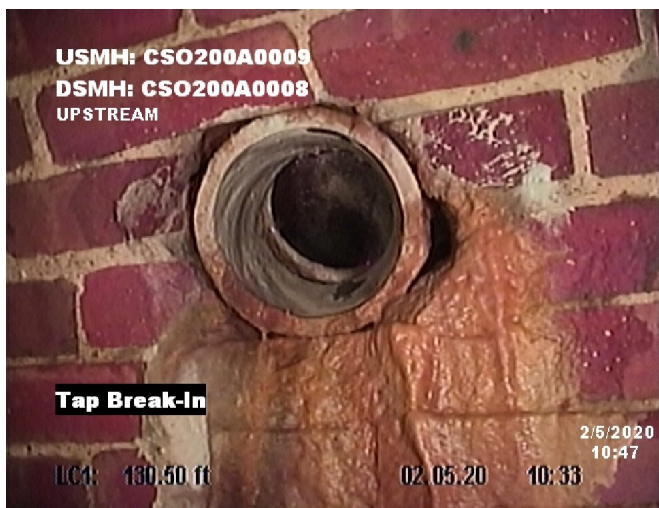
Distance: 130.5 ft. Grade: 0
 Condition: Tap Break-In
 Remarks: N/A

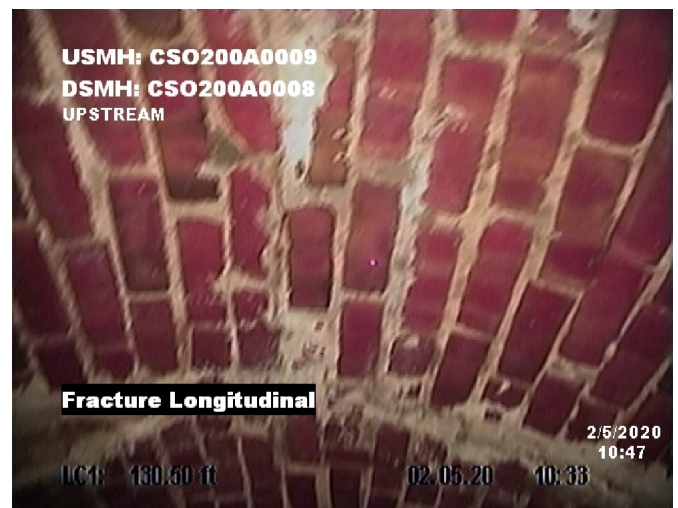
Distance: 130.5 ft. Grade: 3
 Condition: Fracture Longitudinal
 Remarks: N/A

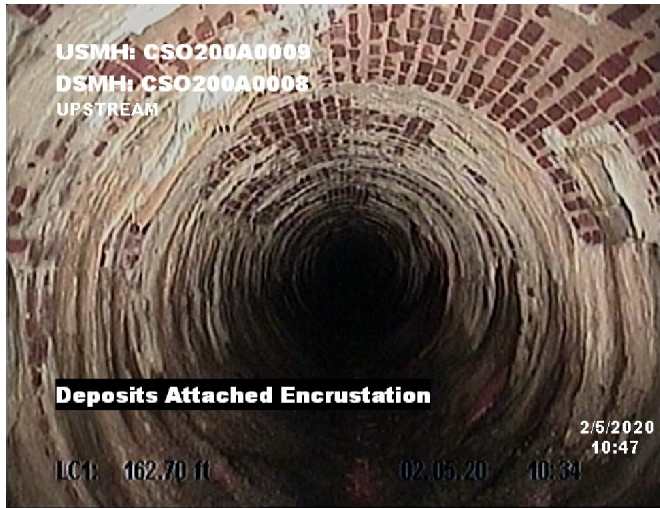
Distance: 162.7 ft. Grade: 2
 Condition: Deposits Attached Encrustation
 Remarks: N/A

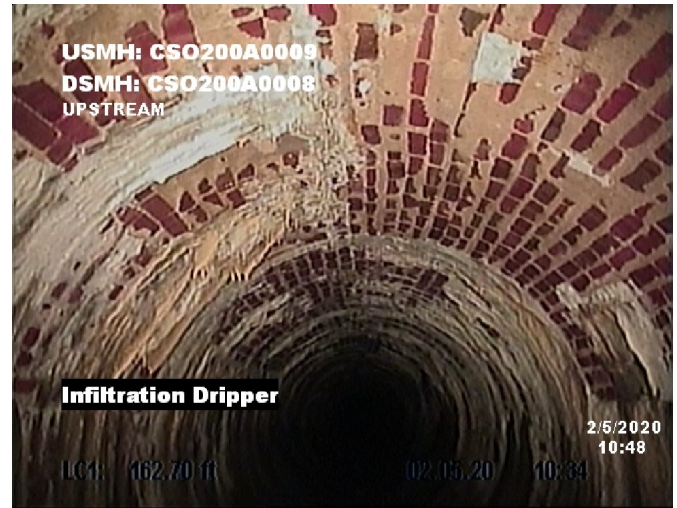
Distance: 162.7 ft. Grade: 3
 Condition: Infiltration Dripper
 Remarks: N/A

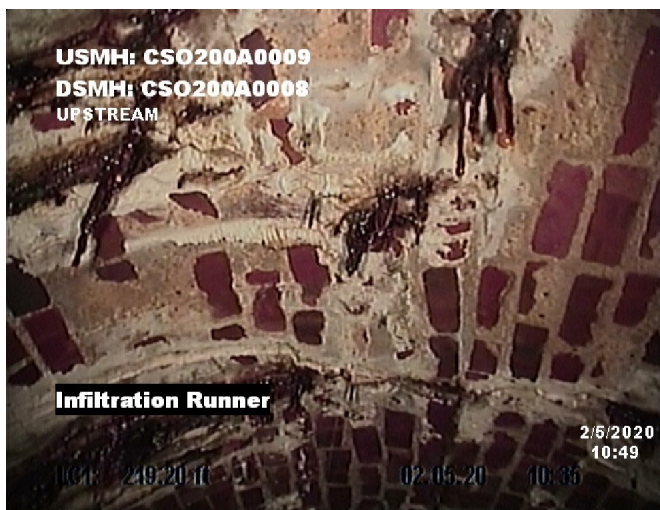
Distance: 219.2 ft. Grade: 4
 Condition: Infiltration Runner
 Remarks: N/A

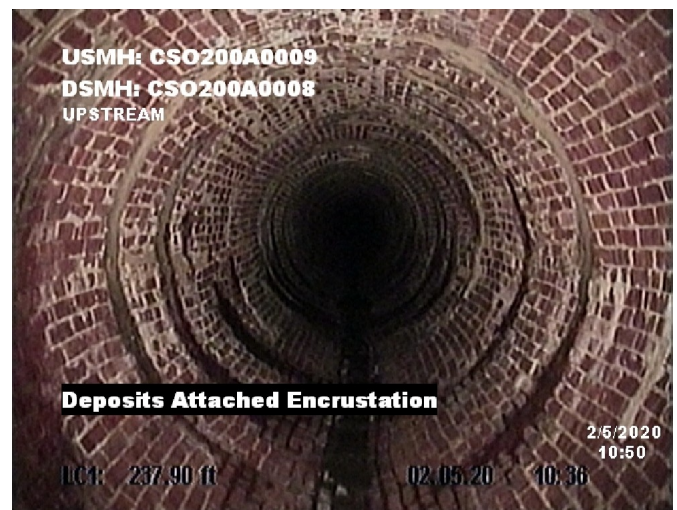
Distance: 237.9 ft. Grade: 2
 Condition: Deposits Attached Encrustation
 Remarks: N/A

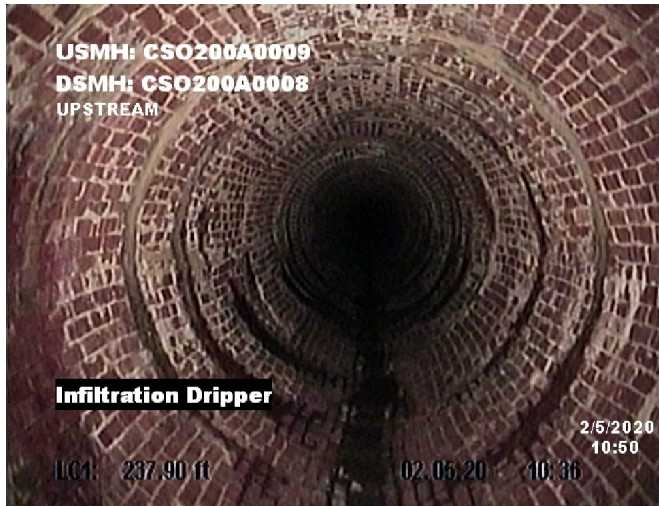
Distance: 237.9 ft. Grade: 3
 Condition: Infiltration Dripper
 Remarks: N/A

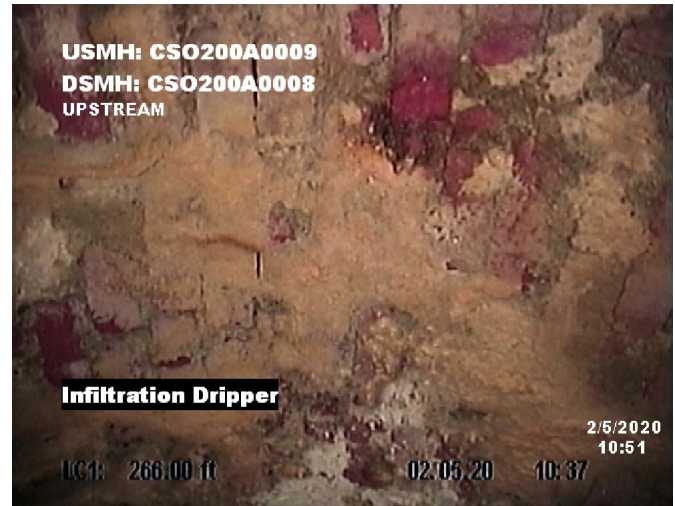
Distance: 266.0 ft. Grade: 3
 Condition: Infiltration Dripper
 Remarks: N/A

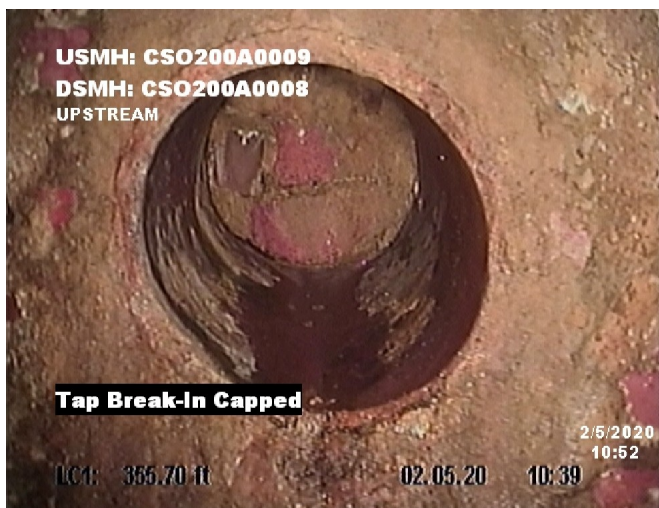
Distance: 355.7 ft. Grade: 2
 Condition: Tap Break-In Capped
 Remarks: N/A

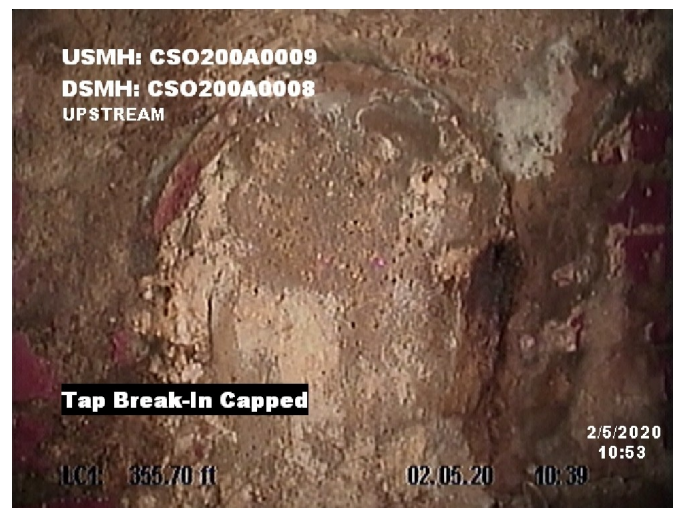
Distance: 355.7 ft. Grade: 2
 Condition: Tap Break-In Capped
 Remarks: N/A

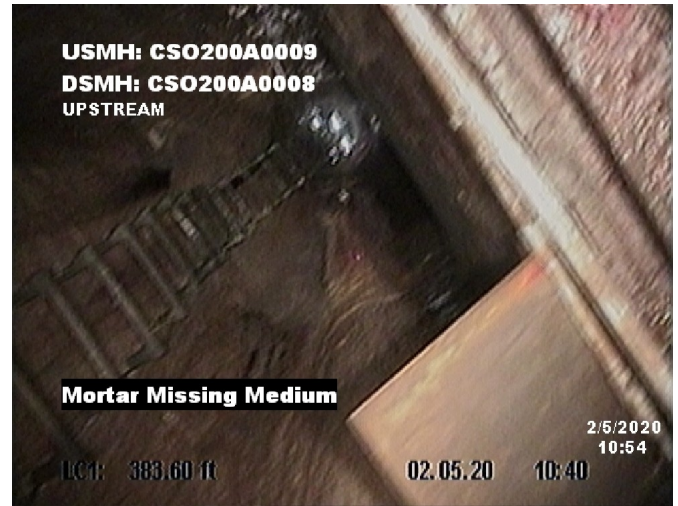
Distance: 383.6 ft. Grade: 3
 Condition: Mortar Missing Medium
 Remarks: N/A
