Defect Listing

Pipe Segment Refere... CSO200A0010-CSO200A...	City CLEVELAND	Street E 40TH ST	Material BRICK	Location C... MAIN HIGHW...	Sewer Use COMBINED
Upstream MH CSO200A0010	Total Length 62.9	Year Laid	Shape CIRCULAR	Location Details	
DS Manhole CSO200A0009	Length surveyed 62.9	Year Renewed	Height 60	Width 60	Pipe Joint...

SPR 0	MPR 48	PO Number		Customer KS ASSOC	
SPRI 0	MPRI 3	Work Order		Purpose ROUTINE ASSESSMENT	
QSR 0000	QMR 413A	G			
OPR 48	Surveyed By Dan_Zaffle	Direction DOWNSTREAM	Date 20200205	Media label 001	
OPRI 3	Certificate Number U-804-1527	Pre-Cleaning NO PRE-CLEANING	Time 12:37	Weather DRY	
Date Cleaned			End Time 12:51	Additional Info

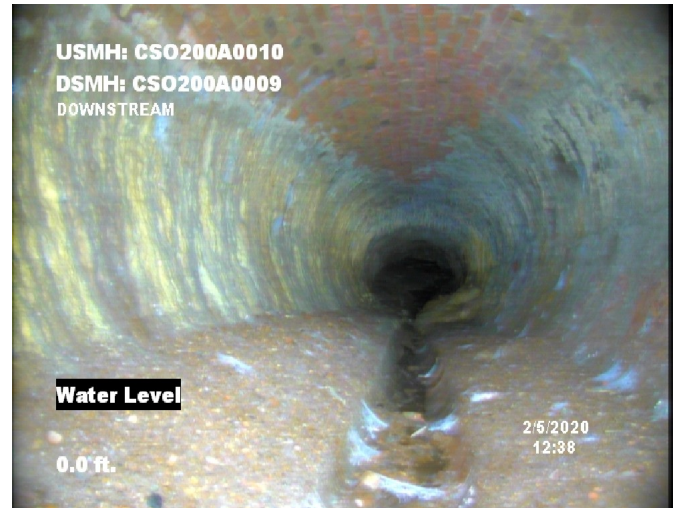
Distance: 0.0 ft. **Grade:** 0
Condition: Water Level
Remarks: N/A

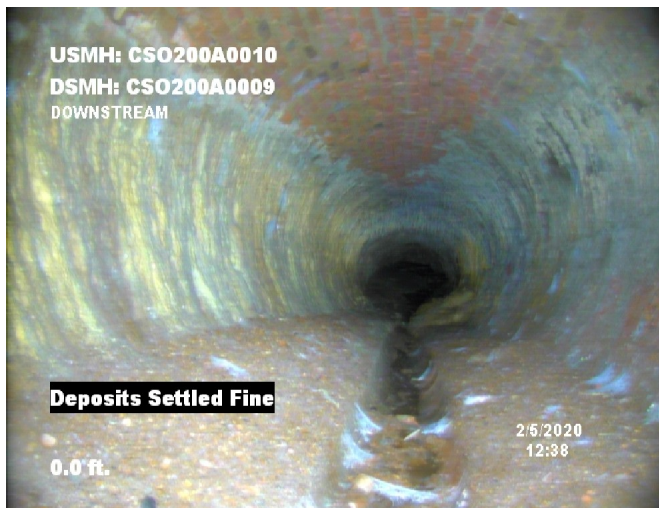
Distance: 0.0 ft. **Grade:** 3
Condition: Deposits Settled Fine
Remarks: N/A

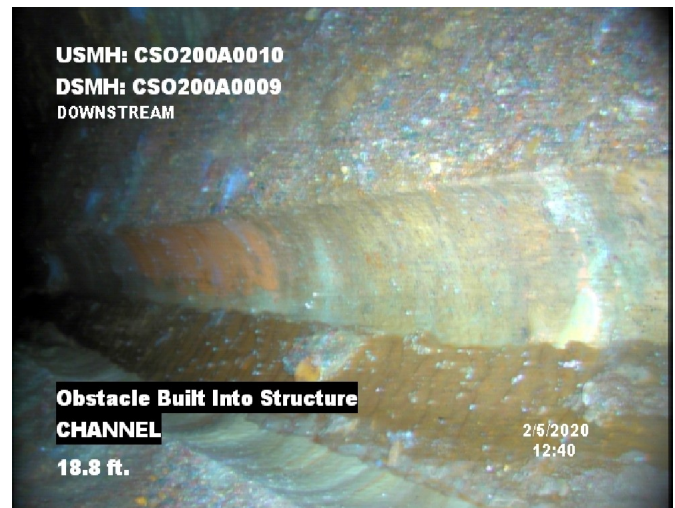
Distance: 18.8 ft. **Grade:** 2
Condition: Obstacle Built Into Structure
Remarks: CHANNEL

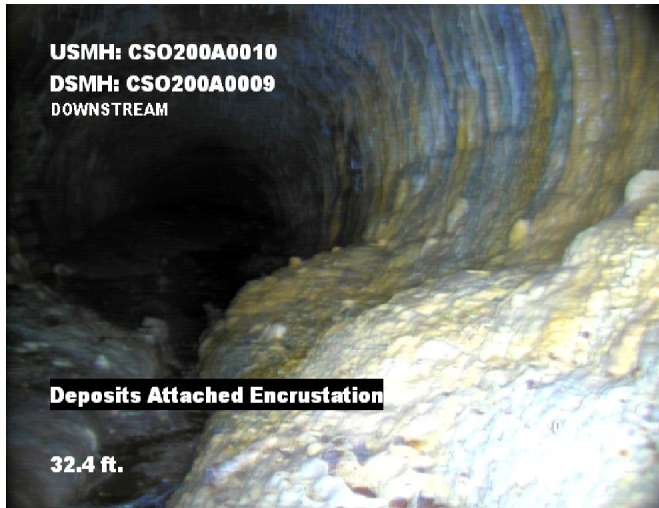
Distance: 32.4 ft. Grade: 3
 Condition: Deposits Attached Encrustation
 Remarks: N/A

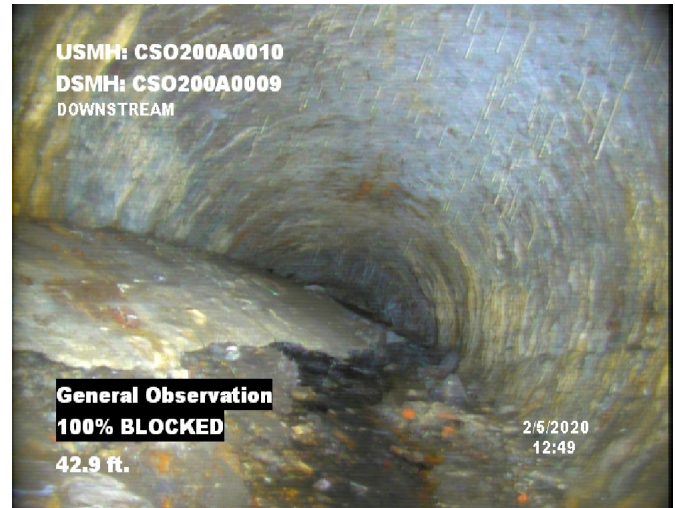
Distance: 42.9 ft. Grade: 0
 Condition: General Observation
 Remarks: 100% BLOCKED

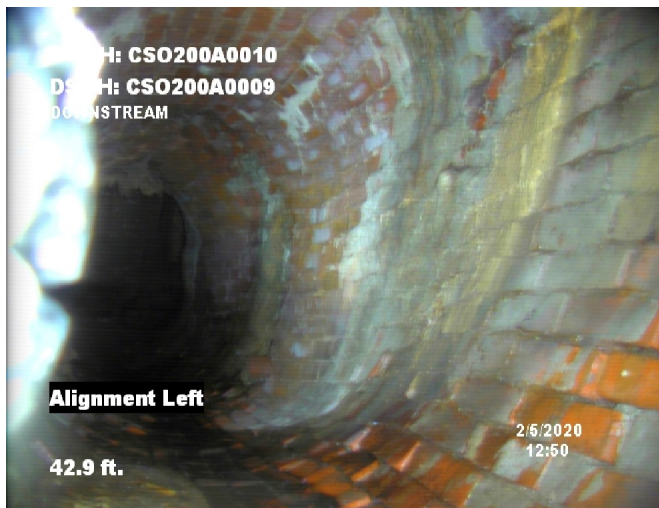
Distance: 42.9 ft. Grade: 4
 Condition: Alignment Left
 Remarks: N/A

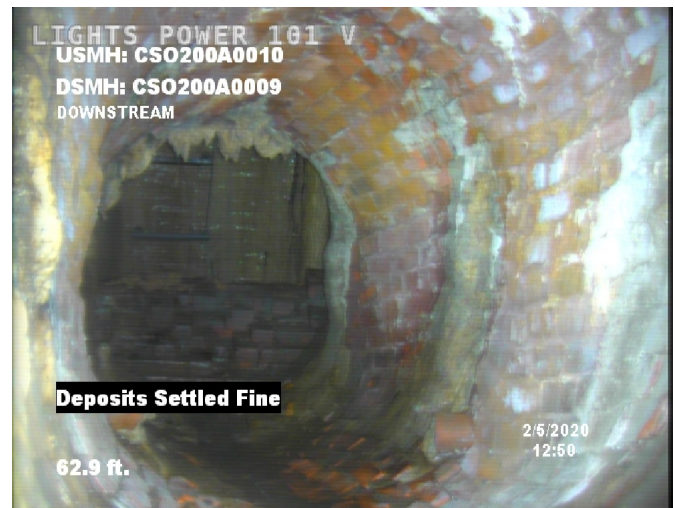
Distance: 62.9 ft. Grade: 3
 Condition: Deposits Settled Fine
 Remarks: N/A
