Structure Number: 1812505

Facility Carried: RMP BETWEEN SR 237

## Ohio Bridge Inspection Summary Report

**CUY-APTR-1005NS (1812505)**

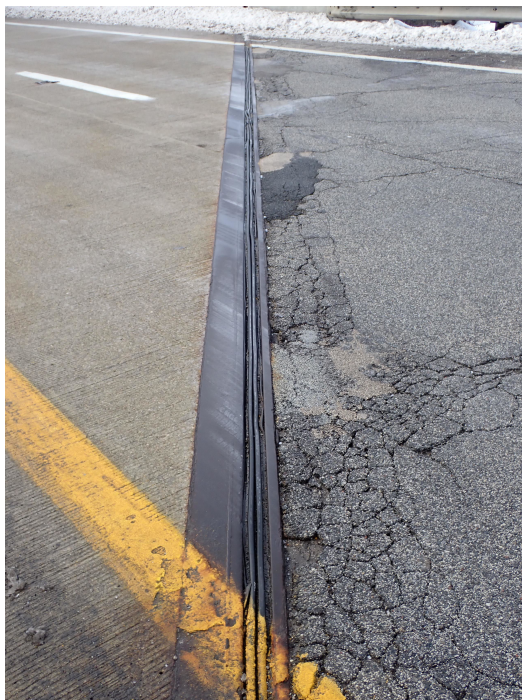
PHOTO 9 Condition

Description SB forward exjt.
