2018 UPDATE TO 2017 PHYSICAL CONDITION INSPECTION REPORT

Bridge CUY-490-0100

SFN 1811991

I-490 Bridge over the Cuyahoga River Valley

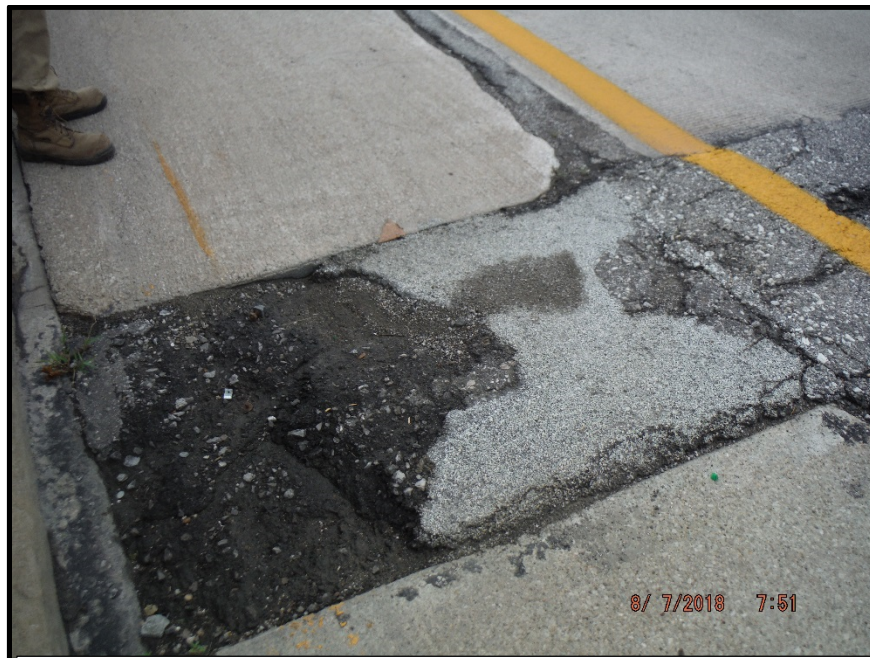
Photo 3 – The Westbound mainline forward relief joint which is deteriorating in the shoulder

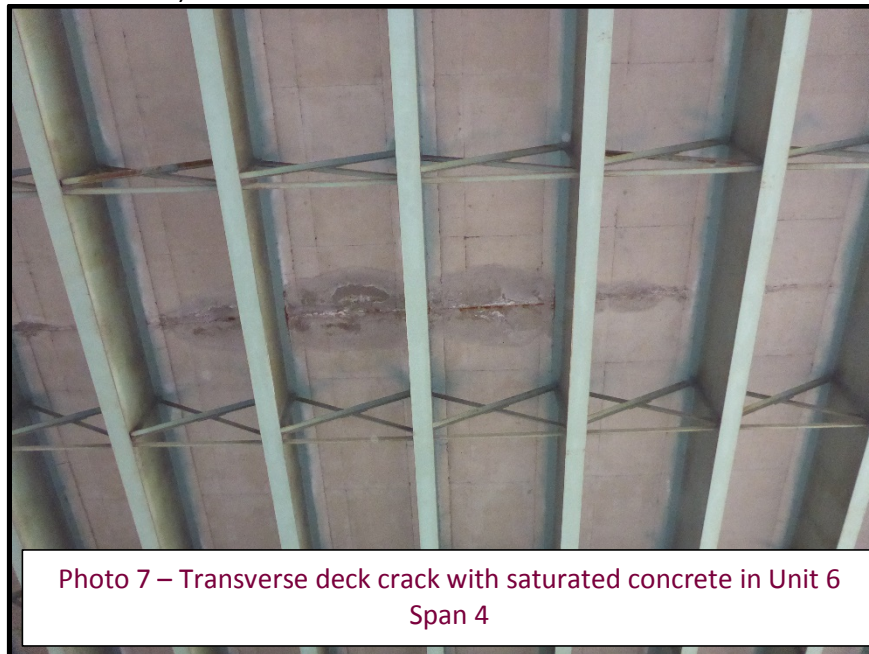
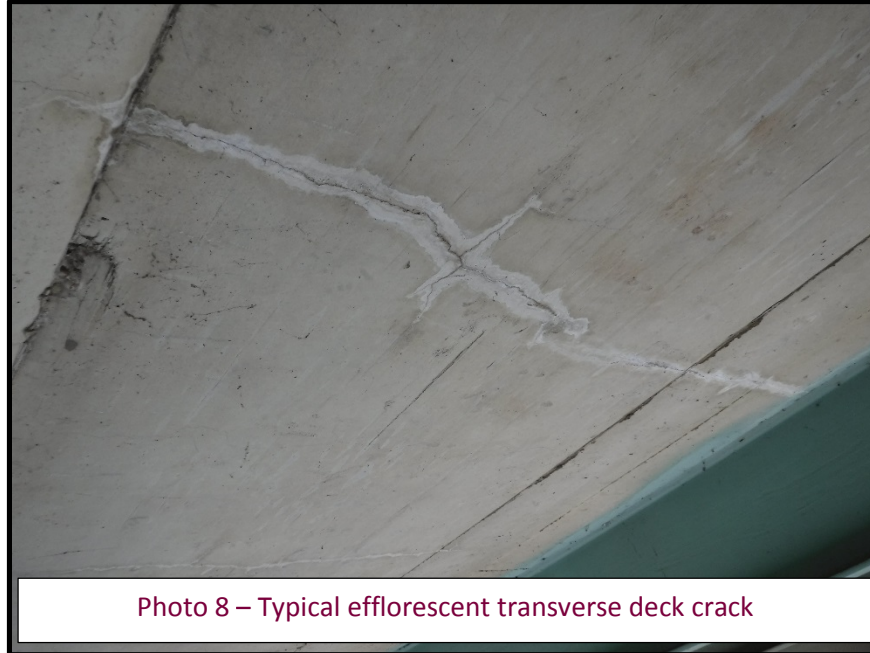
Cracking is most common in the middle of the bays between girders and stringers; some of these cracks exhibit minor rust staining and efflorescence. There are several locations near the middle of a few spans where a single transverse crack stretched all the way across the deck floor (see Photo 7). These areas often have smaller cracks and delaminations propagating from them. These large transverse cracks were most likely caused by deck pour construction joints. **There are also areas where the concrete around the cracks is saturated or efflorescent** (see Photos 7 and 8).

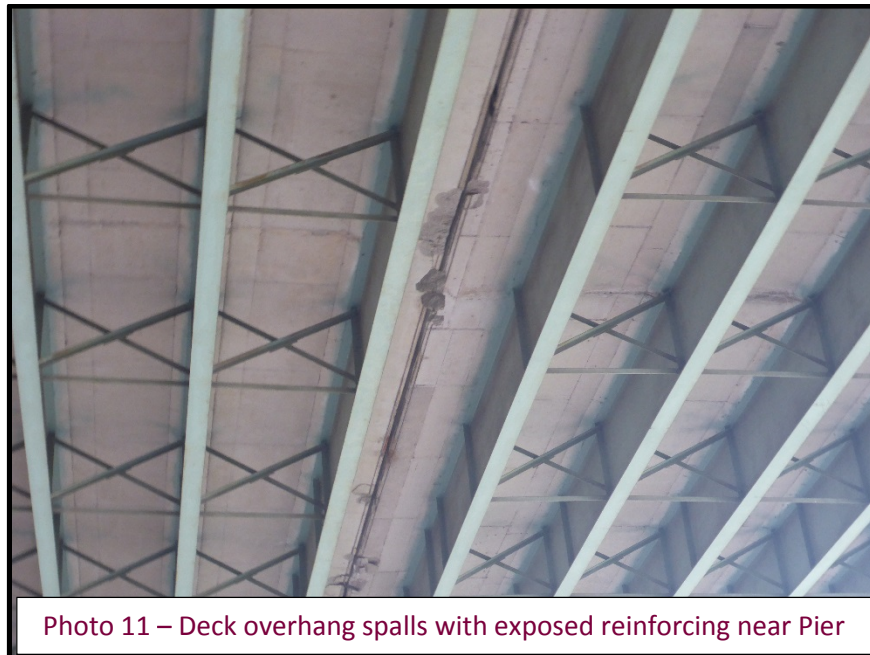
The Edge of Floor/Slab is in **good** condition. The edges of deck were inspected from a snooper. The transverse deck cracks which extend the width of the bridge at deck pour construction joints also extend through the edge of the deck. Throughout the bridge fascia there are minor vertical cracks; **these are located approximately every 5 to 10 feet and reflect cracking in the parapets.** There is also rust staining present on the edge of floor slab which appears to be leakage from the bridge railing. Larger cracks and spalling were noted near the expansion joints. Several spalls exist on the interior median joint in Unit 5 and Unit 6 (see Photo 11).

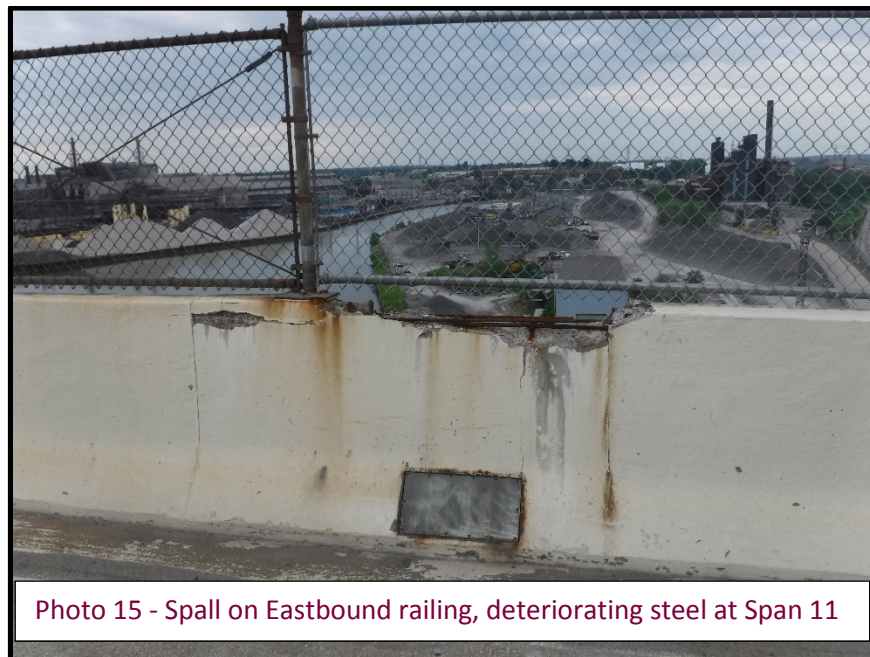
Photo 15 - Spall on Eastbound railing, deteriorating steel at Span 11

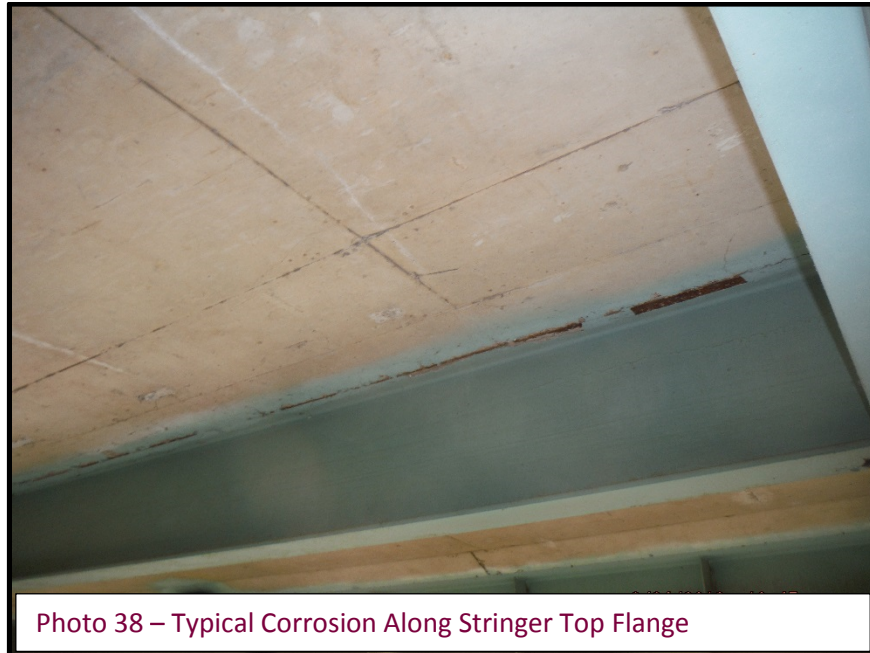
Photo 38 – Typical Corrosion Along Stringer Top Flange

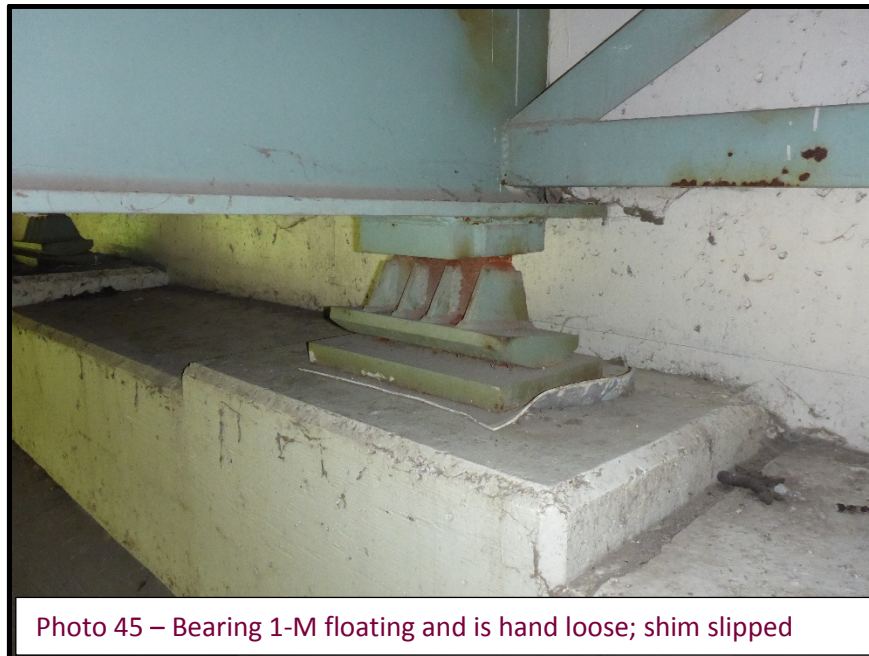
The Bearing Devices are in **fair** condition. **It was noted that rocker bearing 1-D, 1-M, 1-N of the Eastbound bridge is floating. The bearings are hand loose and appear to be carrying zero live load and zero dead load, the load is likely transferred through the deck to the adjacent bearings by way of the end diaphragms (see Photo 45). Many bearings at the Rear Abutment have the lead shim plate slipped out from the base plate of the rocker, which may indicate the periodic floating of other bearings as well.** The abutments typically have debris build-up around the bearings. Laminar corrosion present around bolts and base plates on the Forward Abutment bearings (see Photos 46). Many of the rockers at the abutments exhibit heavy rusting on both the rockers. Based on the cracking of the PCS around the abutment bearings and the observed rotations of the rockers, the debris and rust do not appear to be restricting movement and the bearings appear to be operating normally for the given temperature conditions observed during inspection.

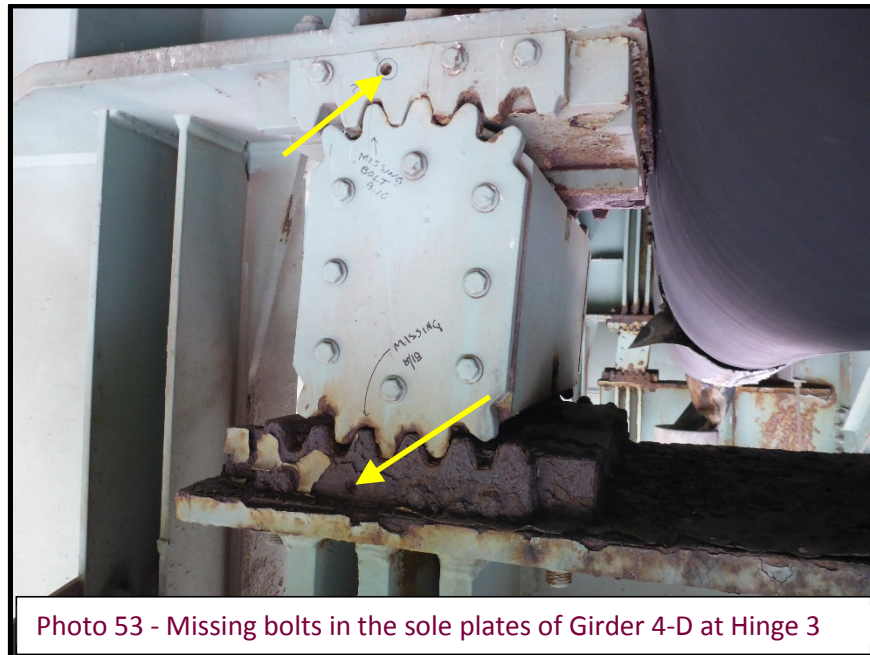
Photo 53 - Missing bolts in the sole plates of Girder 4-D at Hinge 3

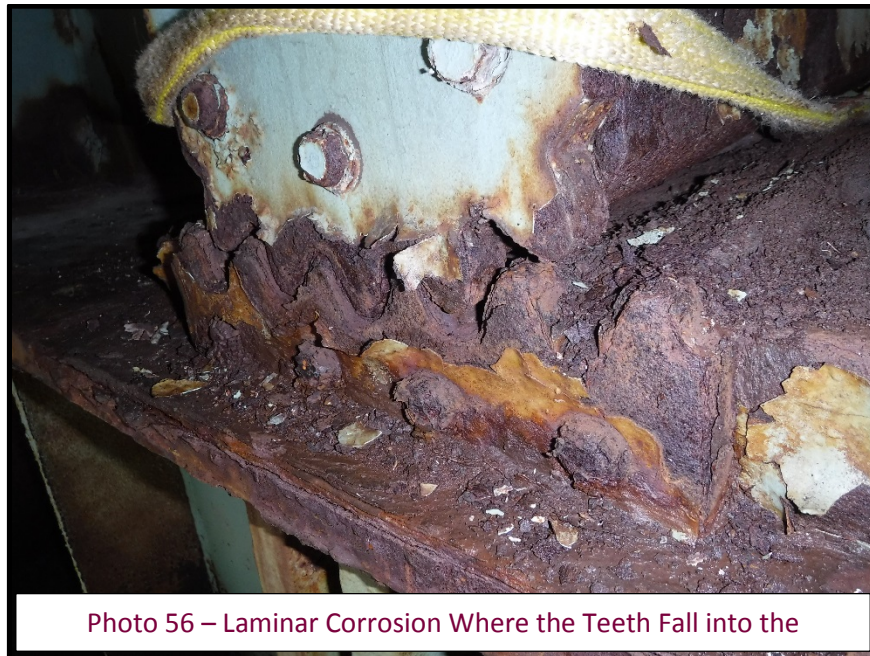
Photo 56 – Laminar Corrosion Where the Teeth Fall into the

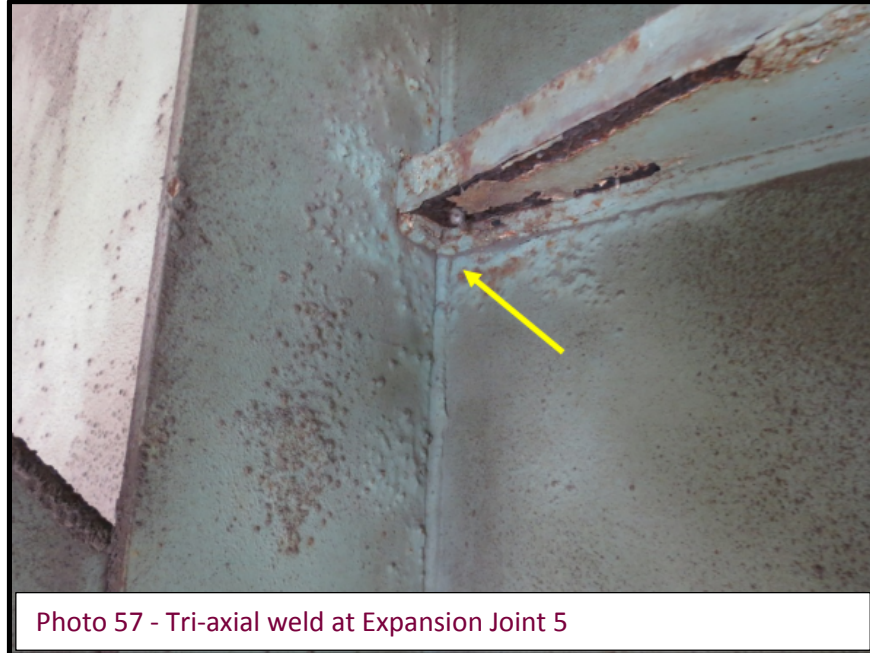
Photo 57 - Tri-axial weld at Expansion Joint 5

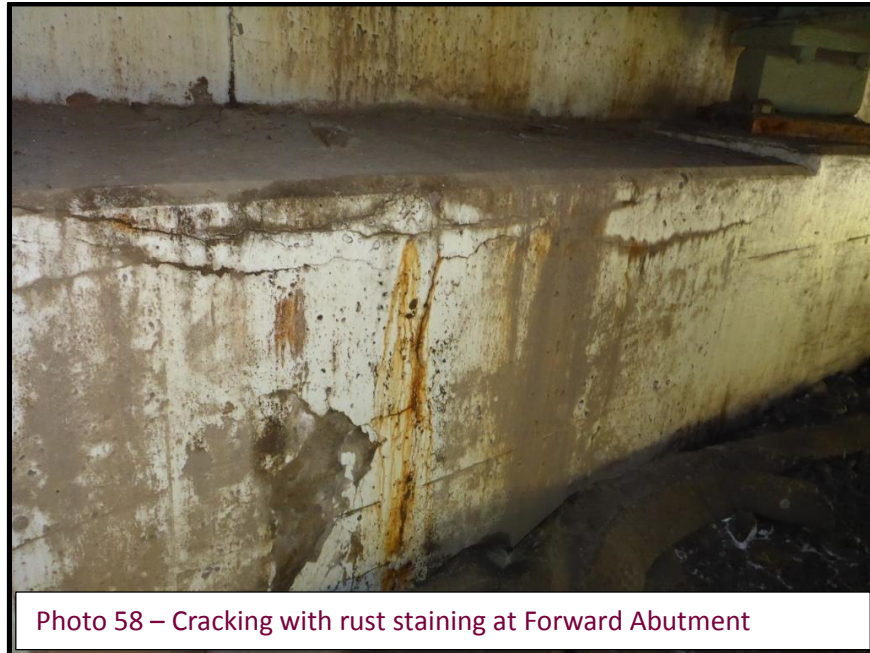
Photo 58 – Cracking with rust staining at Forward Abutment

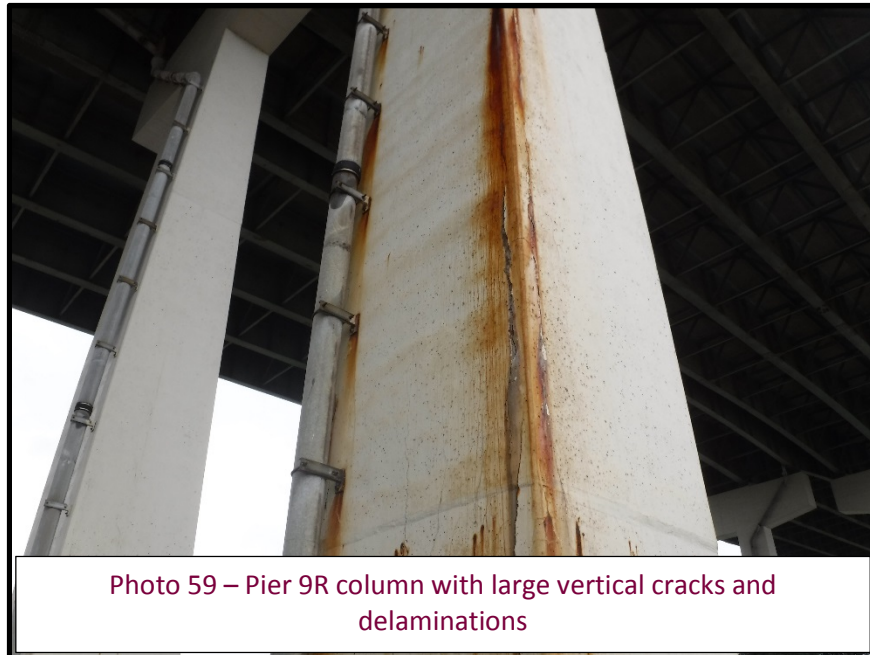
The pier caps and columns with drainage attached to them are generally in worse condition than the other piers. These deficiencies are likely caused by the leaking drainage systems or water leaking through the rusted manholes above the piers. Pier 9L and 9R are in worse condition than the other piers, with many vertical cracks, delaminations and rust stains closely spaced (see Photo 59).

Photo 59 – Pier 9R column with large vertical cracks and delaminations

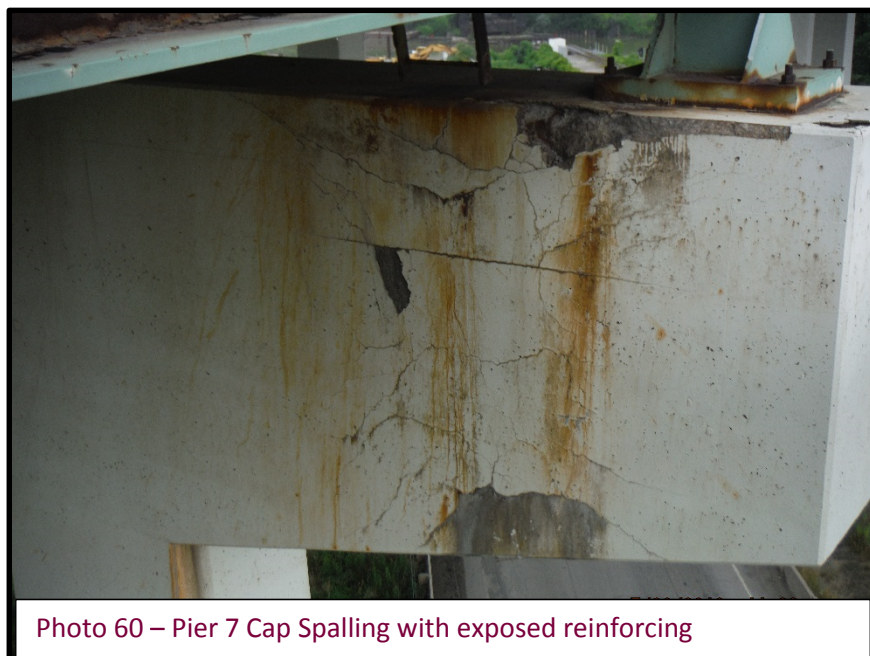
The South end of Pier 7R cap is in poor condition exhibiting a large spall with exposed and corroded reinforcing steel (see Photo 60).

Photo 60 – Pier 7 Cap Spalling with exposed reinforcing

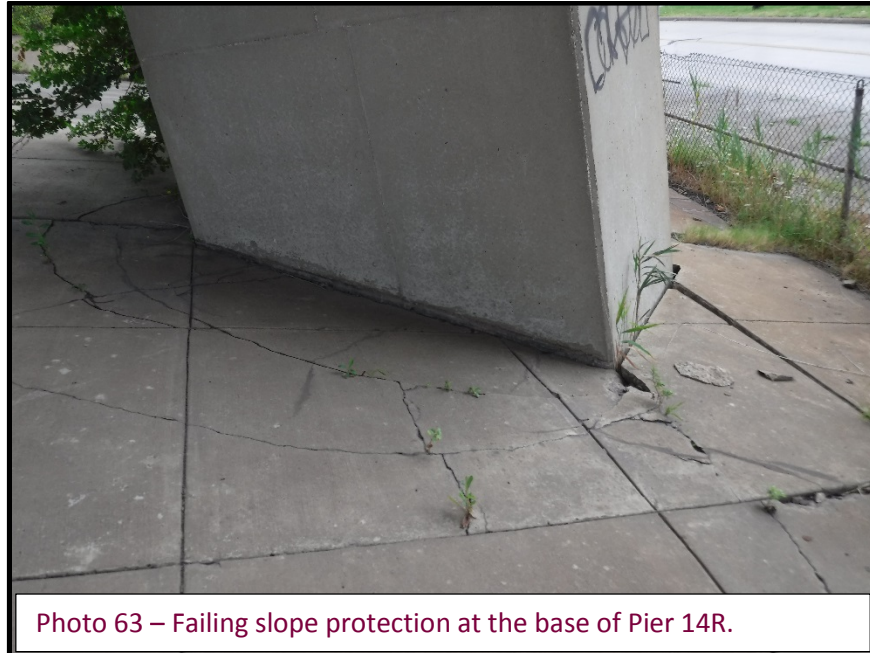
Slope protection is in **good** condition. Minor cracking exists at the bottom of the mainline Eastbound Rear Abutment. The slope protection is failing around the base of the South column of Pier 14R (see Photo 63).

Photo 63 – Failing slope protection at the base of Pier 14R.

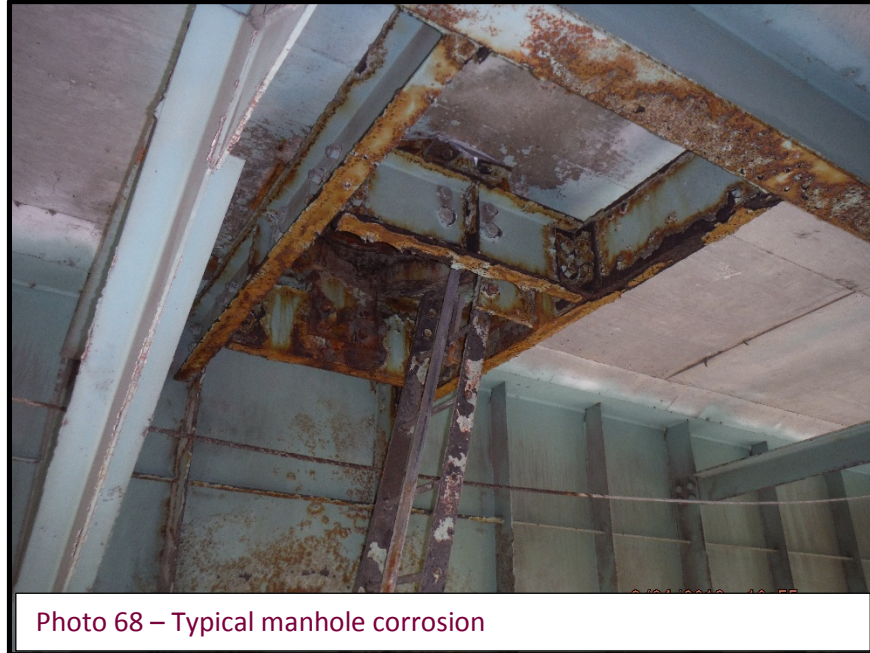
The manholes, located in the shoulders above Pier 4, Pier 9, Pier 12, Pier 15 and Pier 20, are in critical condition. The manhole and ladder systems are extremely corroded and cannot be used safely. Several manhole lids are corroded shut preventing access to the pier below. The manhole castings are also leaking water onto the steel below causing the heavy corrosion to the steel (see Photo 68).

Photo 68 – Typical manhole corrosion
