**OHIO DEPARTMENT OF TRANSPORTATION  
2015 PHYSICAL CONDITION REPORT**

**DETROIT-SUPERIOR BRIDGE OVER CUYAHOGA RIVER  
BRIDGE NO. CUY-6-1456**

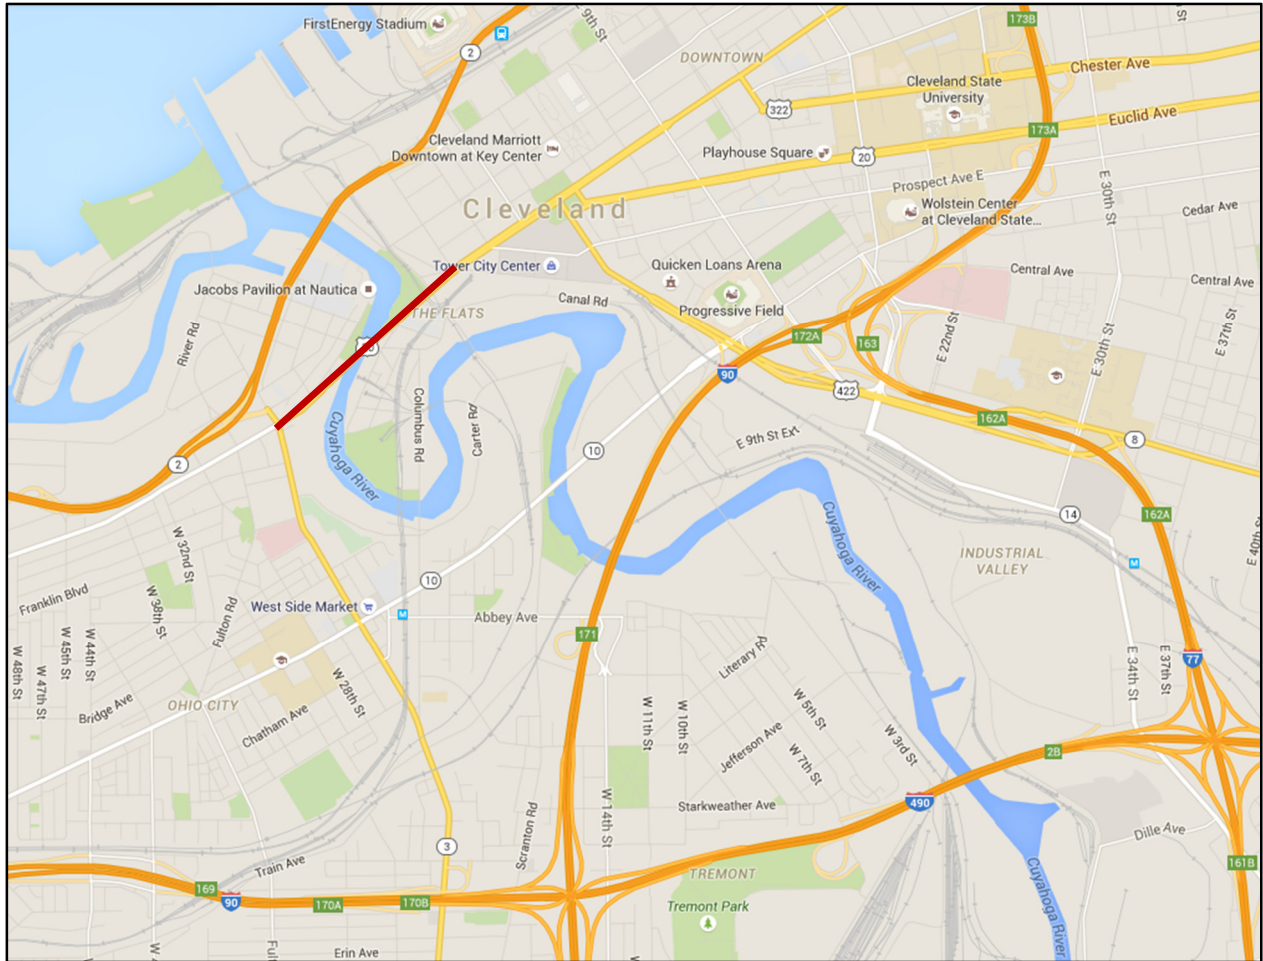
Figure 1 – CUY-6-1456 (Detroit-Superior Bridge) Location Map.

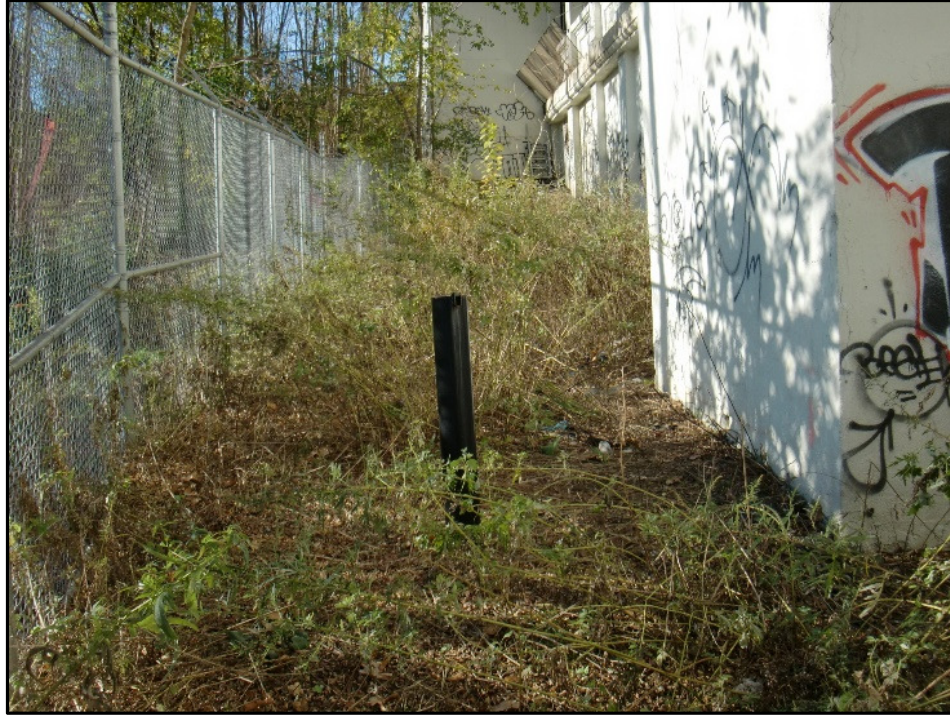
**Photo 3– Slope Inclinometer, Tower B South.**

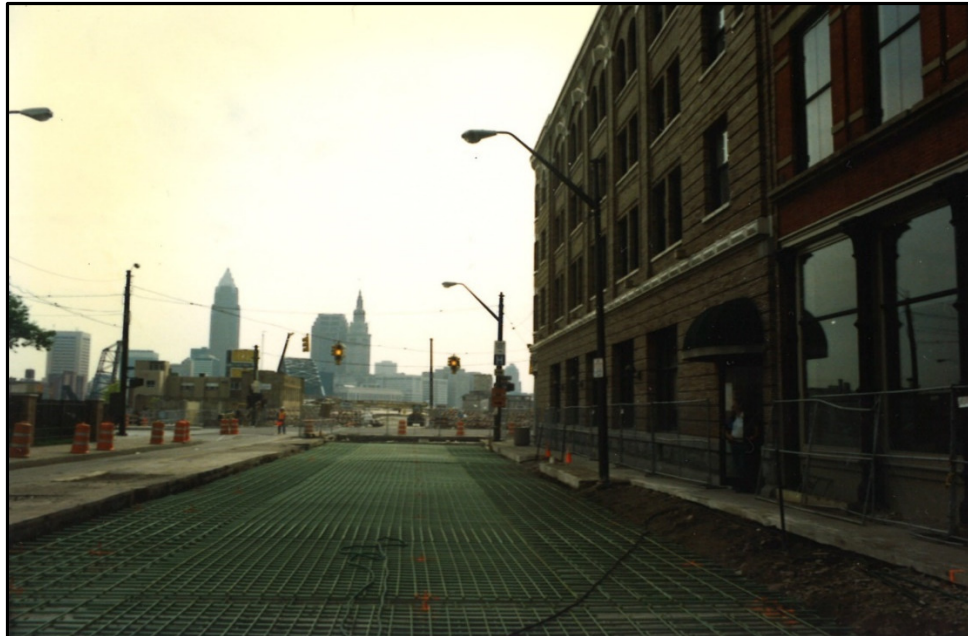
**Photo 4 - Construction of Detroit Avenue Tunnel Supplemental Roof Slab, Looking East, 1996.**

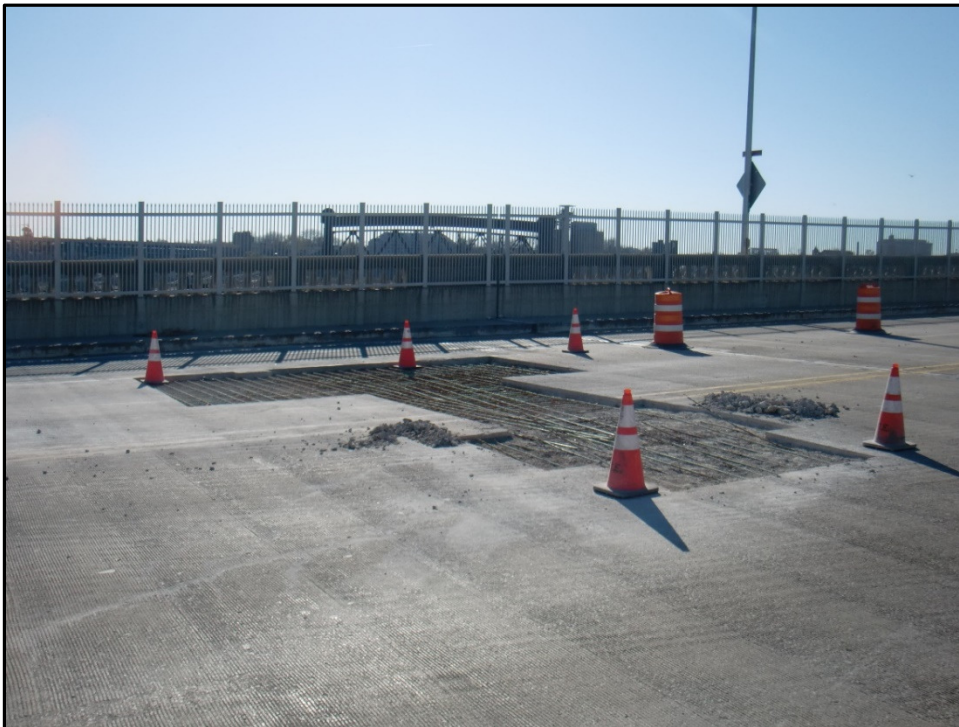
Photo 6 – Recent Wearing Surface Repair, Span 9 (November 2015).

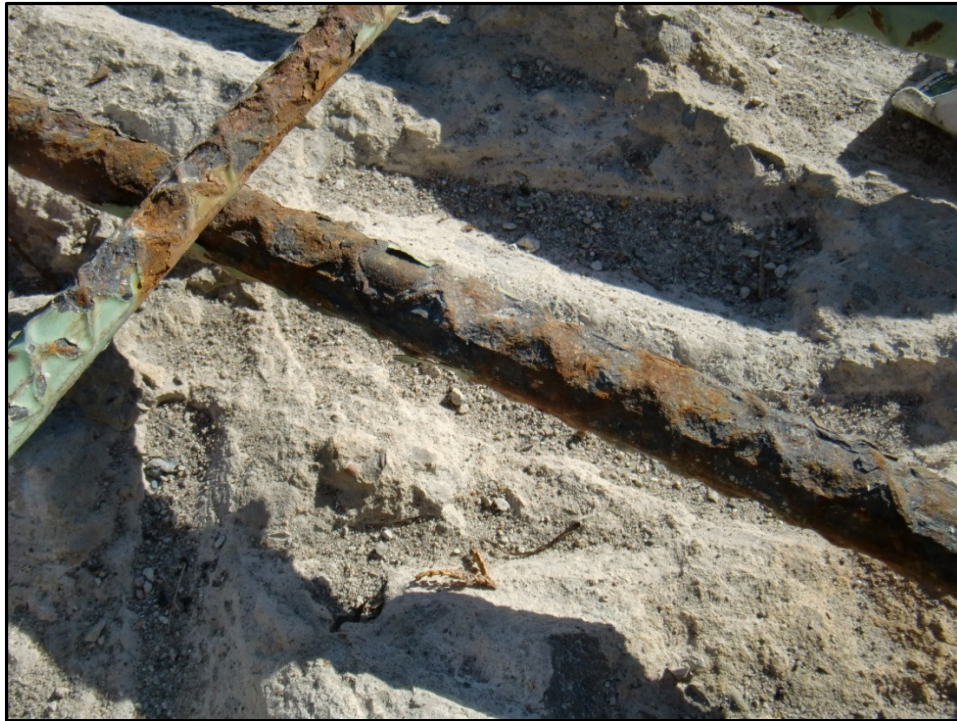
Photo 7 – 1/8-inch Section Loss of Epoxy Coated Rebar Following 18 years of Service.

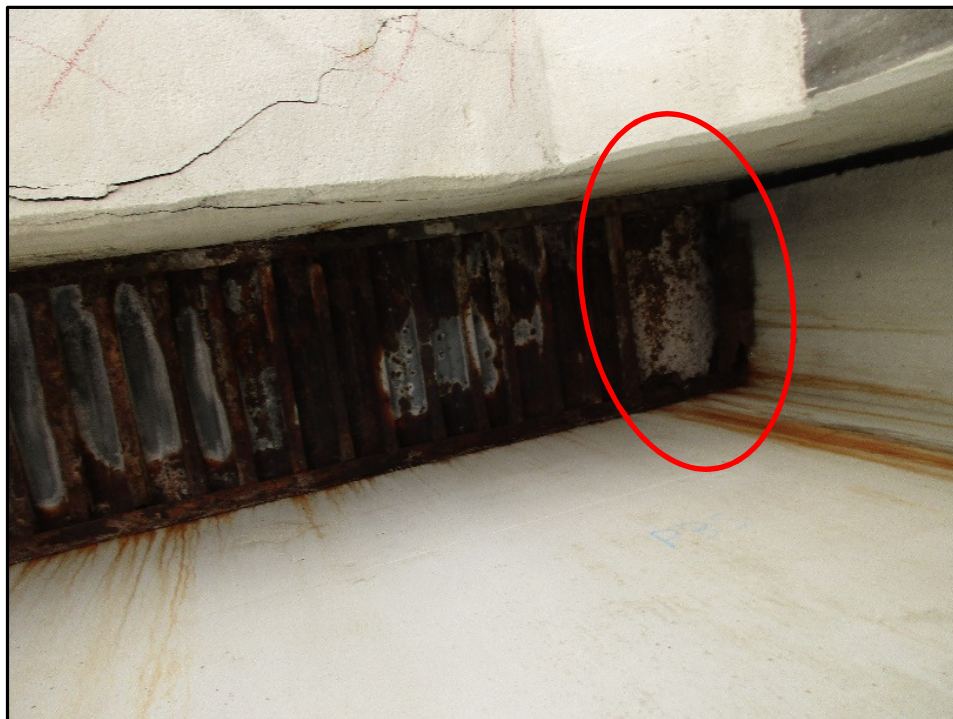
**Photo 9 - Corroded & Missing Stay-in-Place Form (Circled),  
Lower Deck Panel 15 Center, Span 2.**

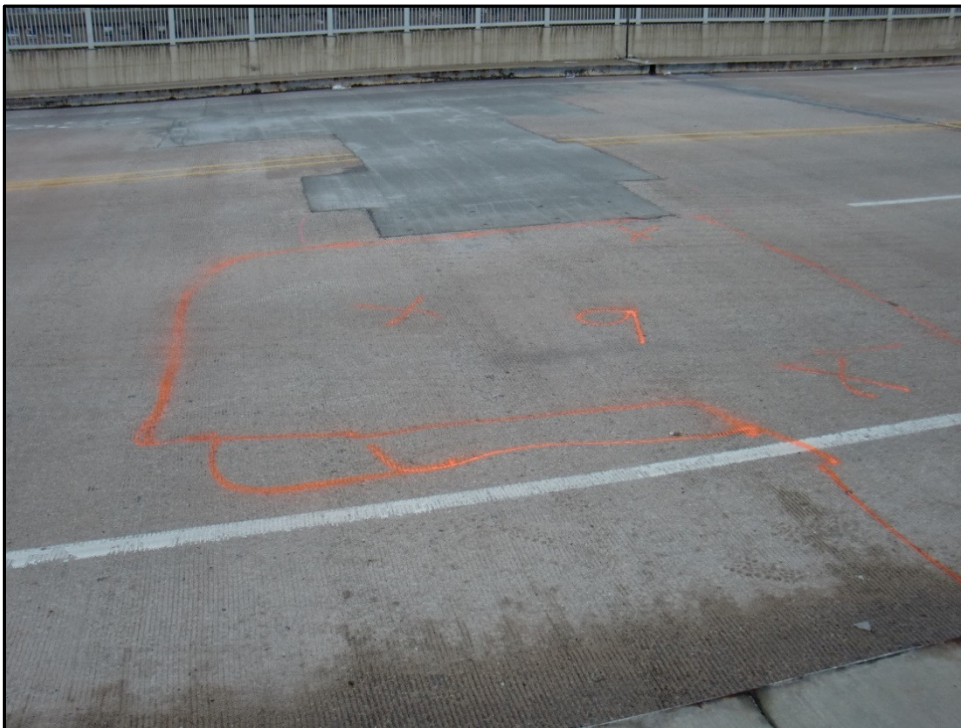
Photo 12 – Delaminated Wearing Surface Adjacent to November 2015 Repair, Span 9.

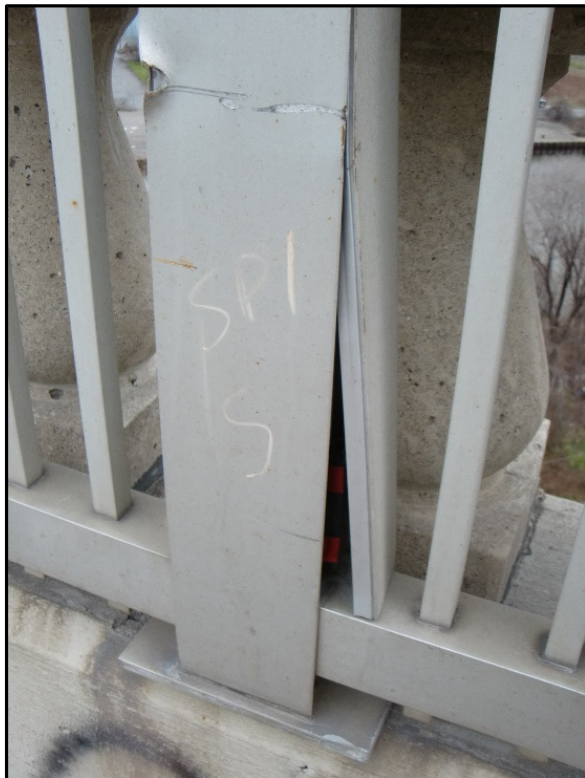
**Photo 14 – Vandalism & Attempted Theft of Aluminum Fence, South Rail.**

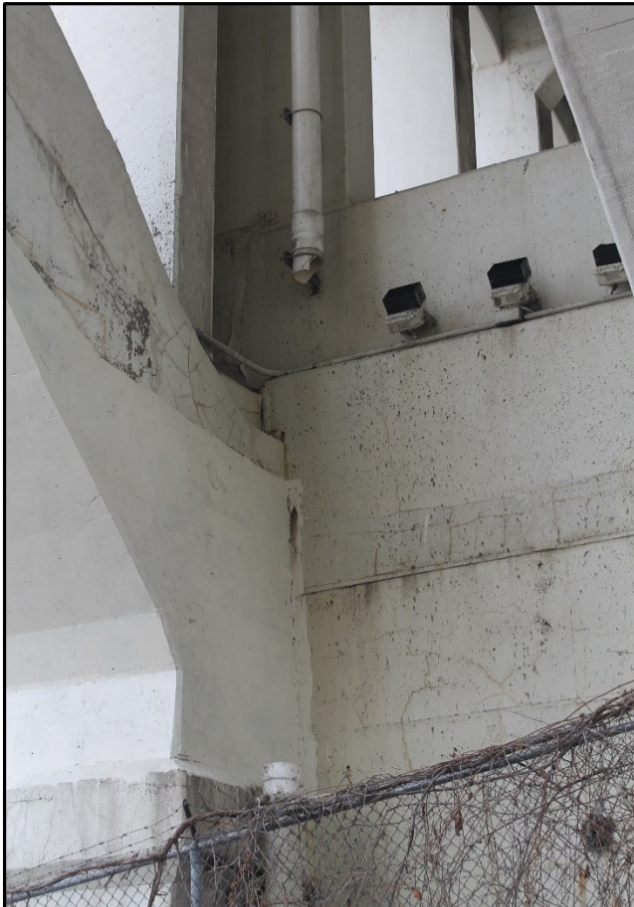
**Photo 17 – Broken PVC Drainpipe, Pier 1.**

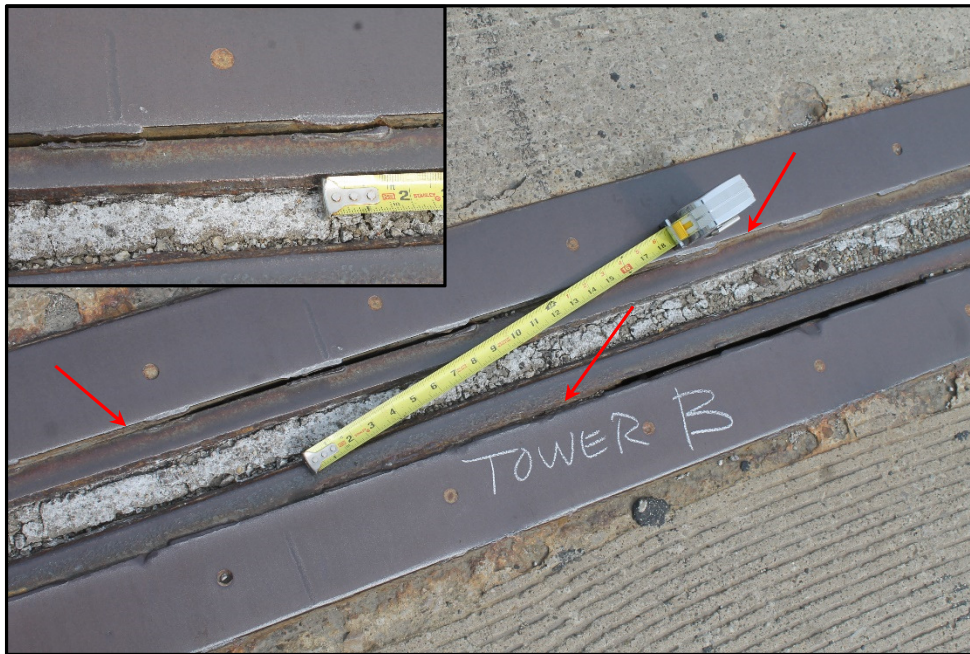
**Photo 18 – Pack Rust (at Arrows) & Broken Fillet Welds (Inset) with Infiltration Points, Tower B Expansion Joint.**

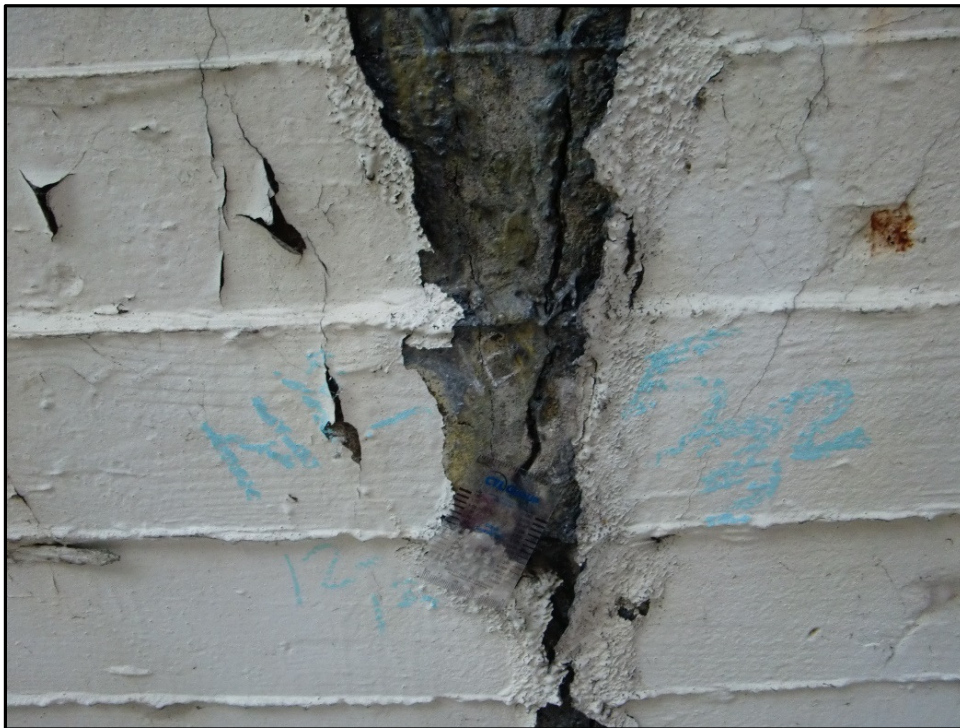
Photo 21 – Close-up of  $\frac{5}{32}$ " Open Epoxy-Injected Intrados Crack, Panel 13, NE Arch Rib, Span 5.

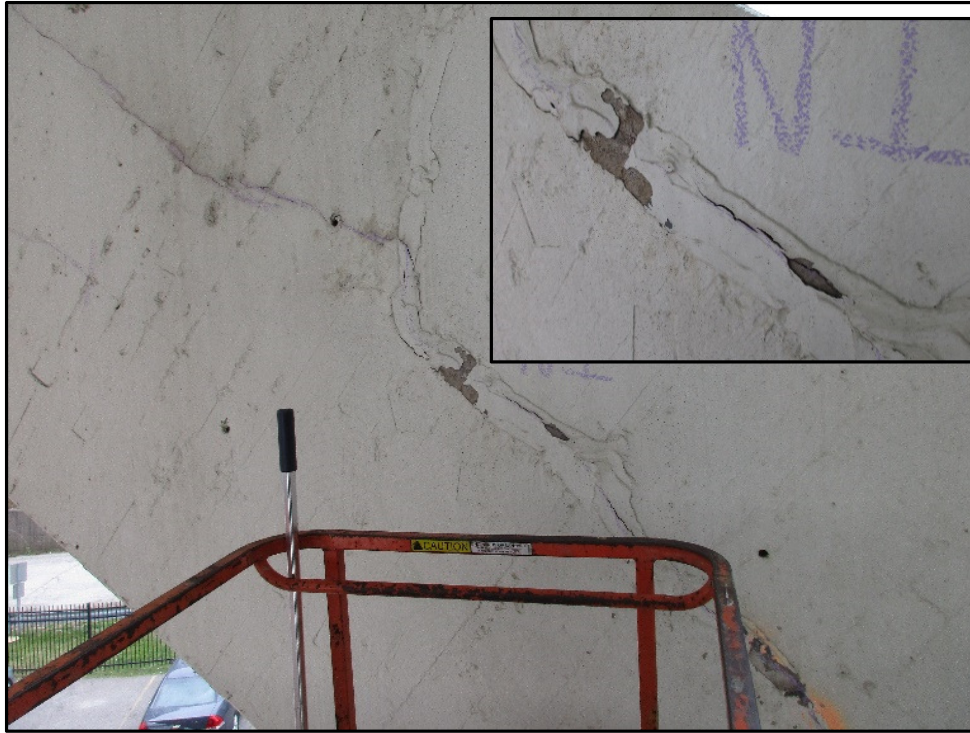
Photo 22 – New Crack at Previous Epoxy Injection Repair, NI Arch Rib, Span 3.

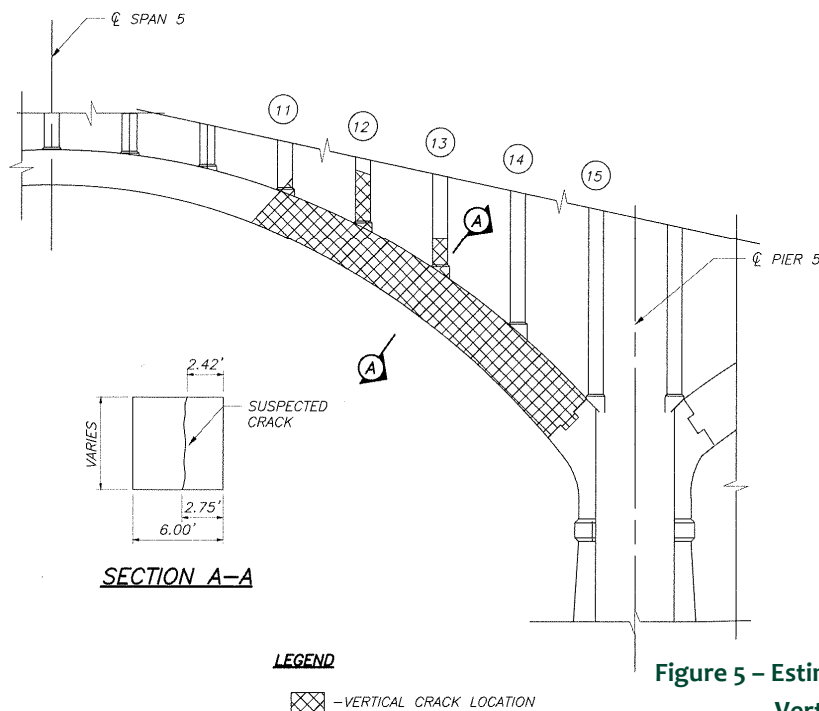
**Figure 5 – Estimated Alignment of Vertical Crack, Span 5 NE Arch & Spandrel Columns.**

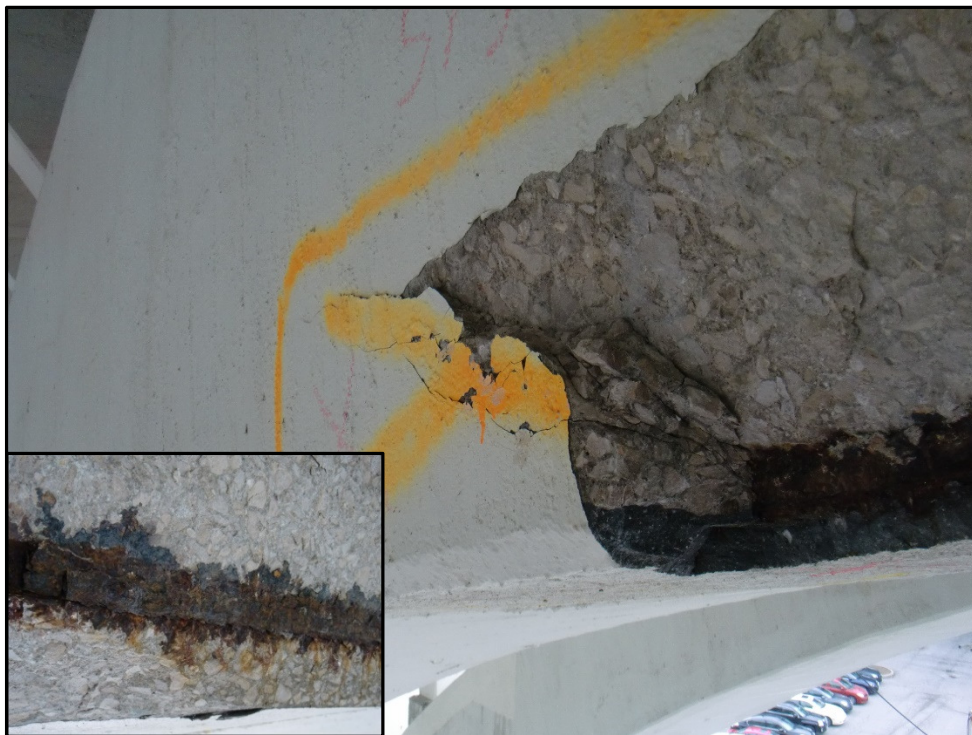
**Photo 23 – Sound 1996 Shotcrete Patch & Fractured Original Concrete, SI Arch Rib, Span 7.**

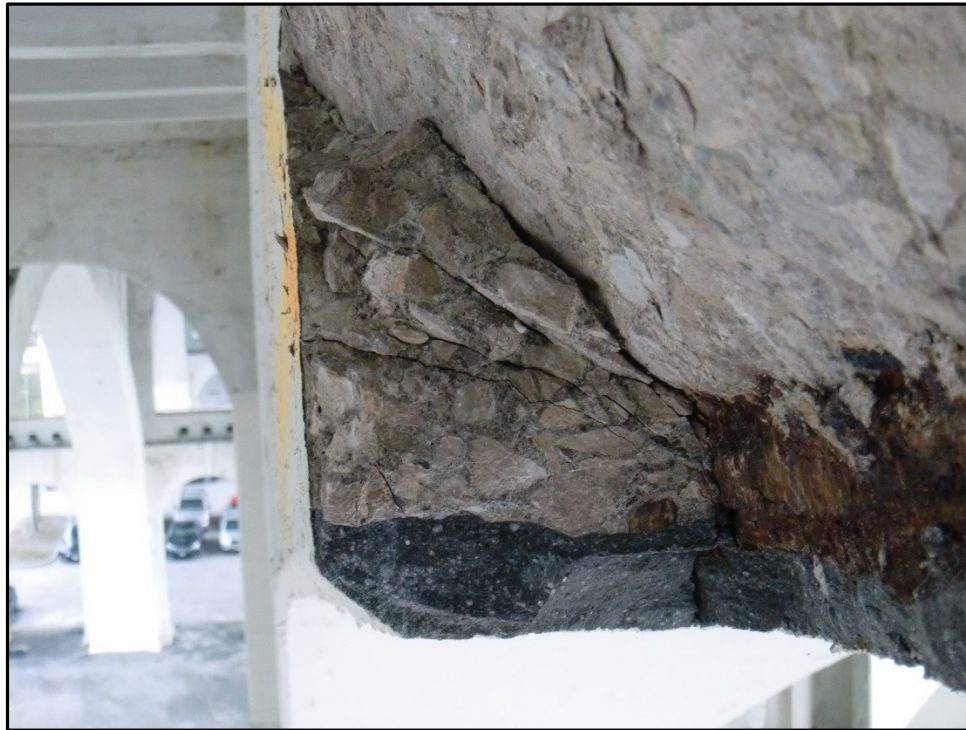
Photo 24 – Sound 1996 Shotcrete Patch & Fractured Original Concrete, SI Arch Rib, Span 7.

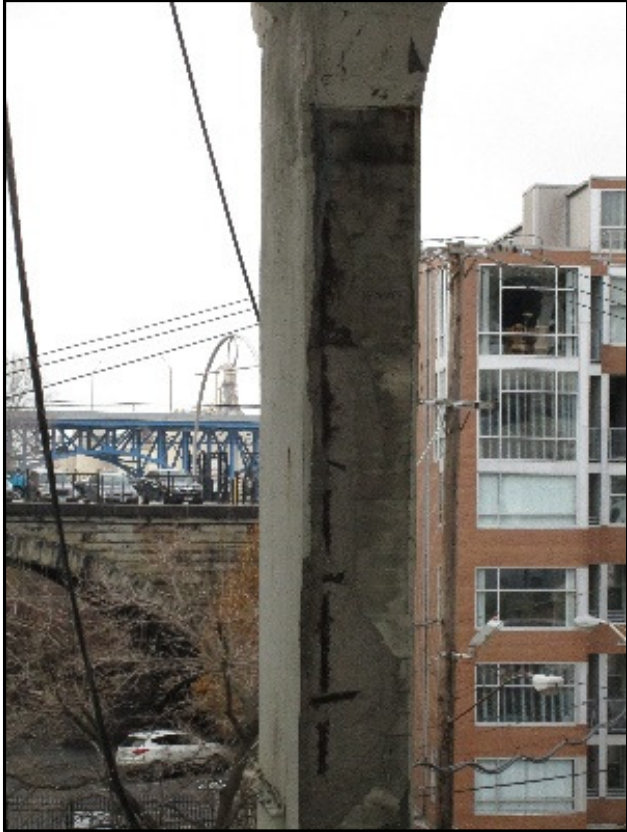
**Photo 25 – Cracked & Spalled Lower Deck Column NE 2, Span 3.**

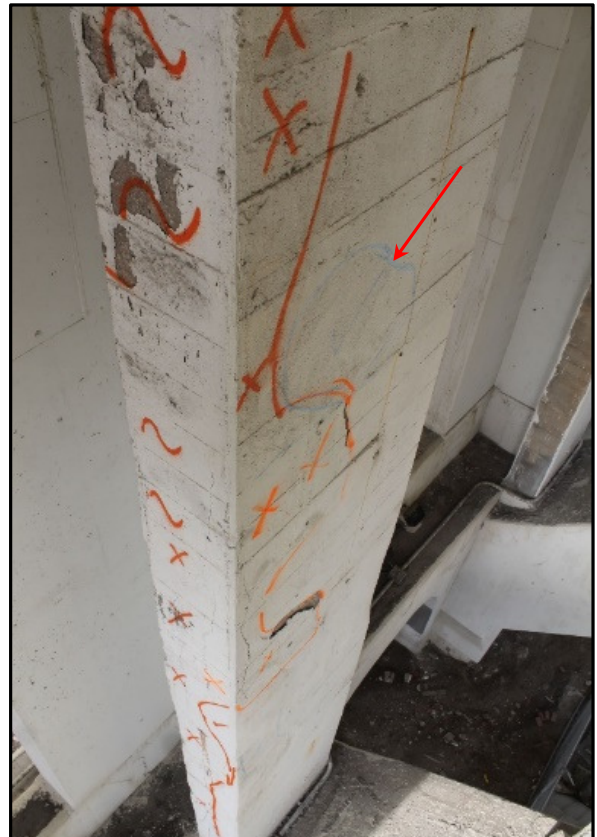
**Photo 26 – Delaminated Surfaces Surrounding 1995 Patch Area (at Arrow), Lower Deck Column SE 1, Span 3.**

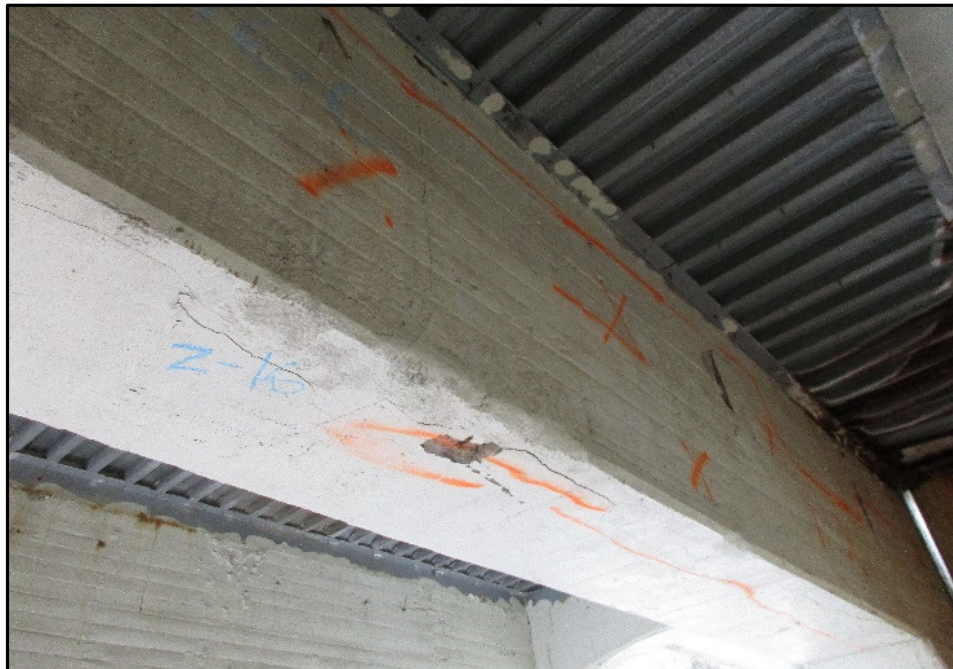
Photo 27 – Delaminated Surfaces of Lower Deck Floorbeam 16, Center Bay, Span 2.

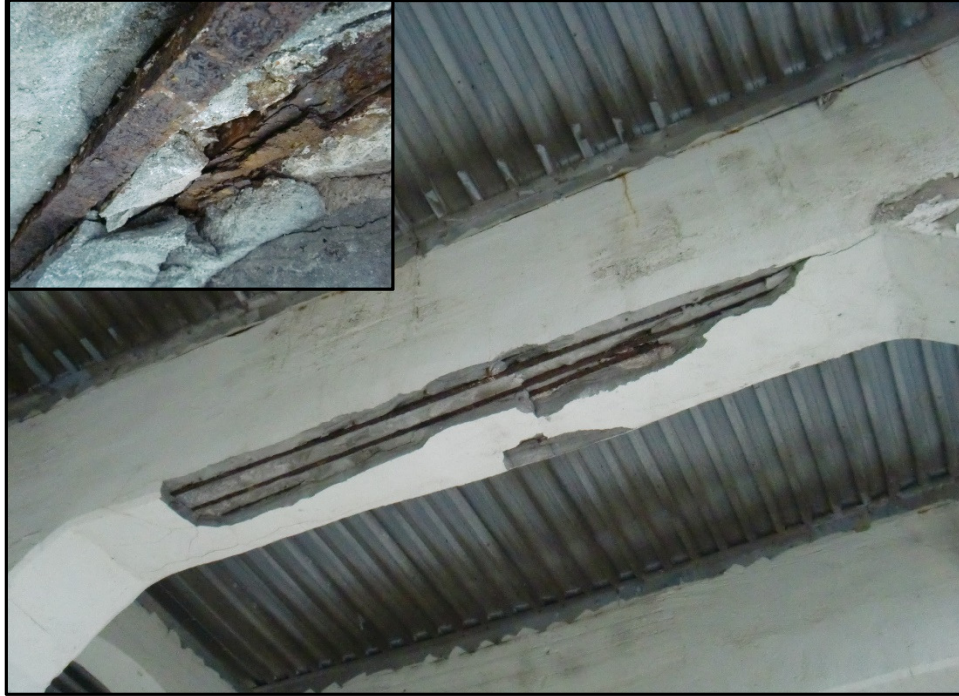
Photo 28 – Spalled 1996 Shotcrete Patch, Lower Deck Floor Beam 14, South Bay, Span 6. (Inset: Continued reinforcement corrosion at shotcrete patch-original concrete interface.)

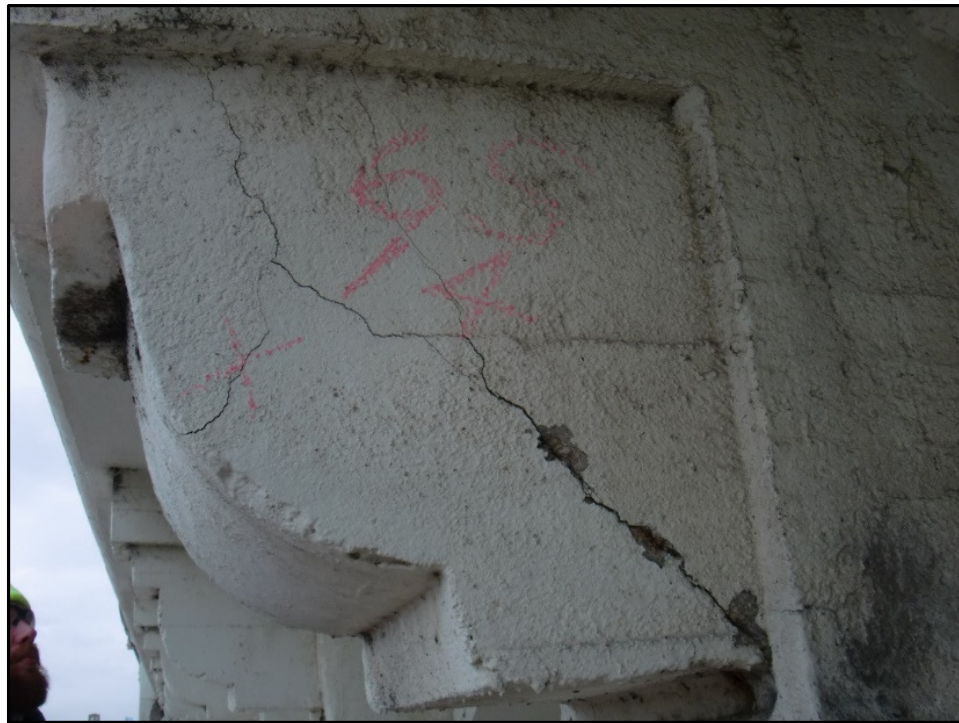
Photo 29 – Common Crack in Line of Primary Reinforcement, Lower Deck Corbel.

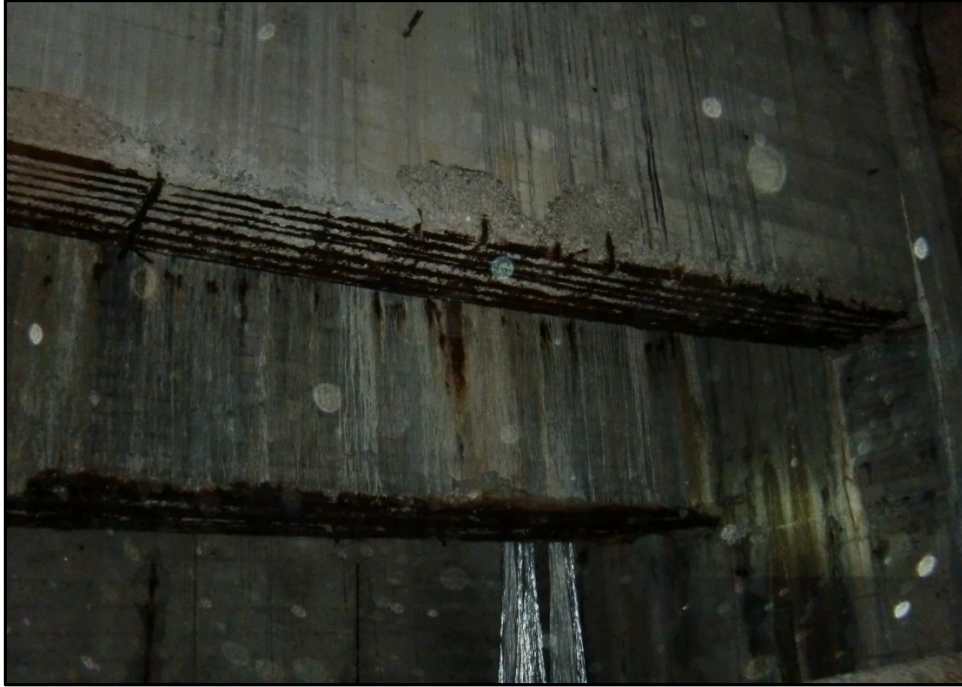
**Photo 30 – Exposed Bottom Reinforcement Mat, Lower Deck Floorbeams 1 & 2, East Station.**

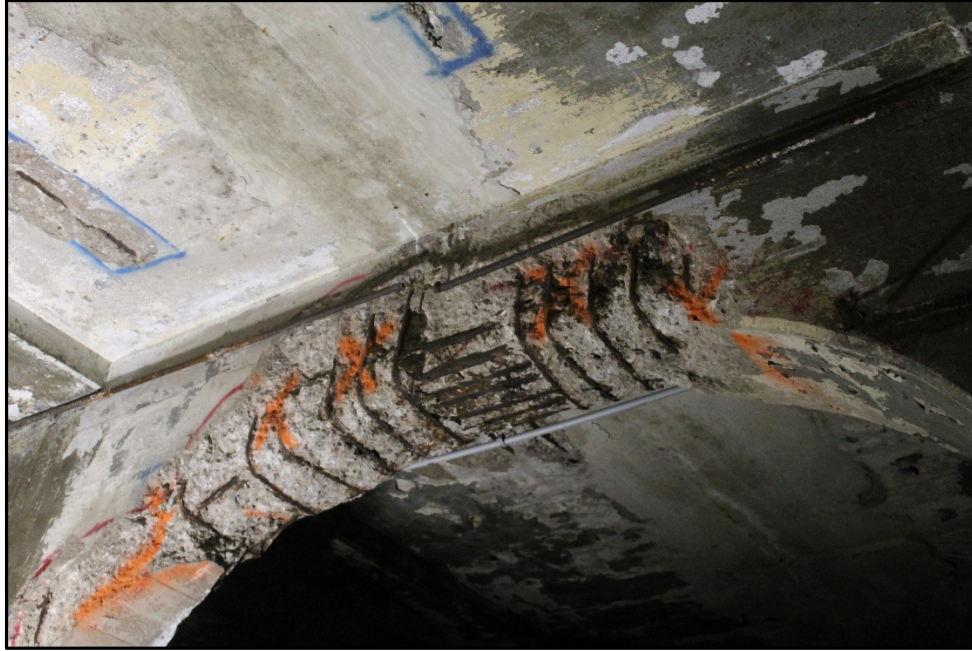
Photo 31 – Spalled Beam D22, West Station.

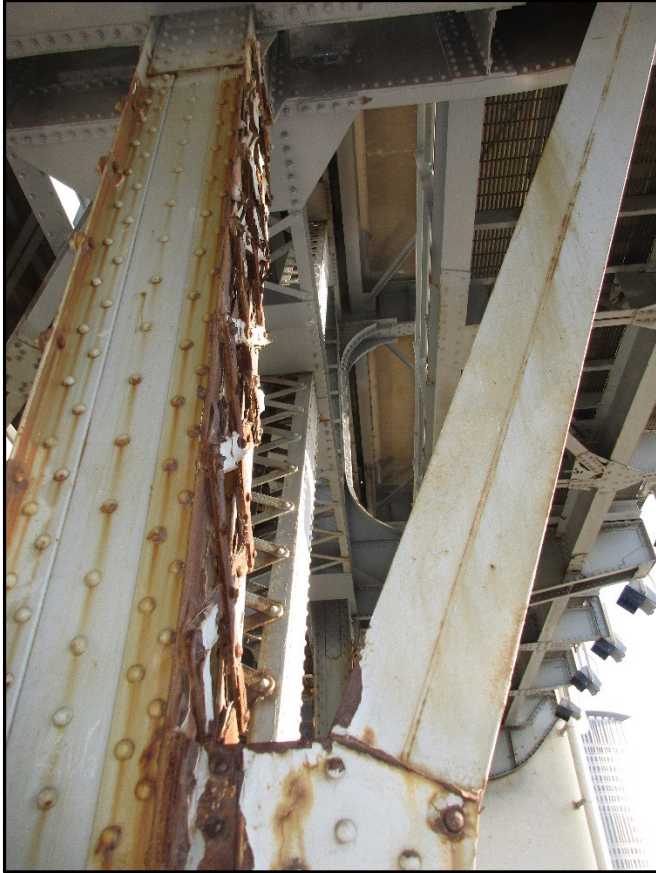
Photo 32 – Typical Minor Corrosion of Vertical Below Lower Deck.

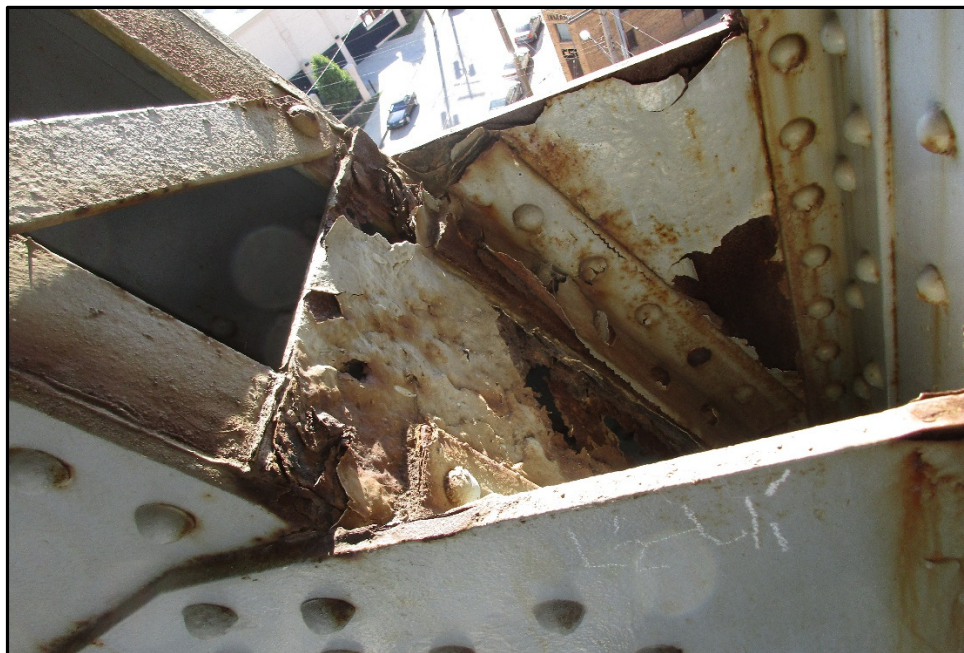
Photo 33 – Minor Pitting Top Stay Plate, U1'-L2' South.

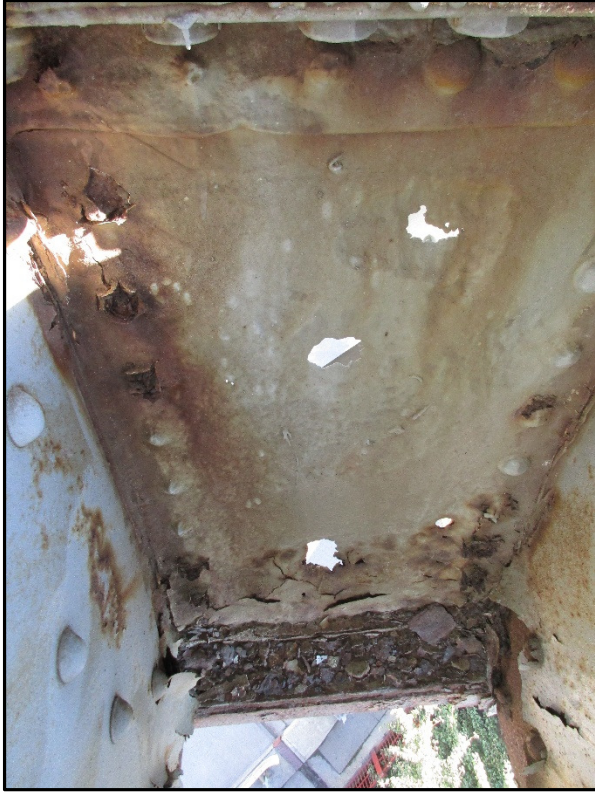
Photo 34 – Common Perforations of Lower Chord Diaphragm.

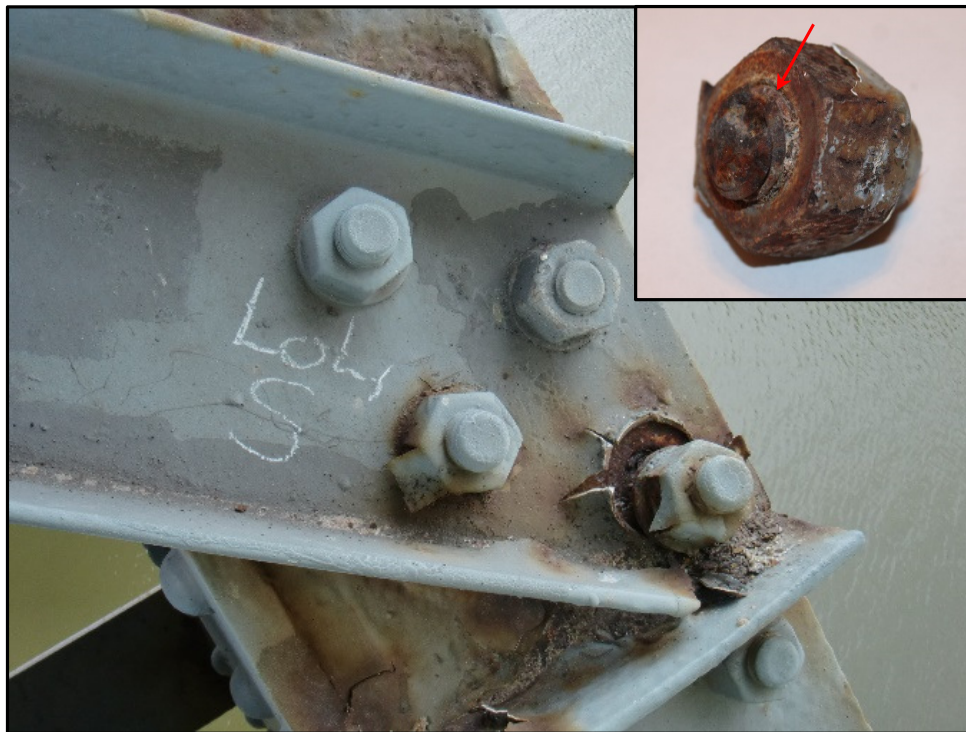
Photo 37 – Fractured Bolt, South LoL1.  
(Inset: Fracture Origin at Arrow.)

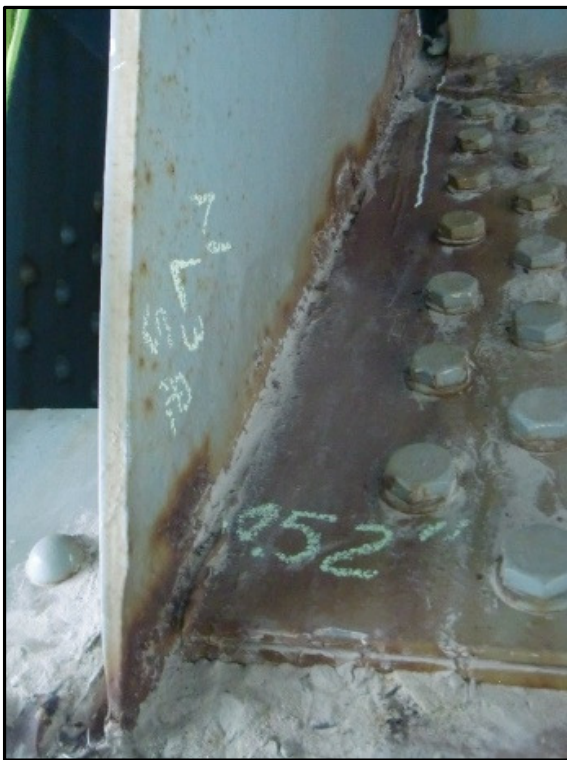
**Photo 38 – 0.23" Deep Section Loss x 6" Long at Edge of Gusset Plate, North L<sub>3</sub>.**

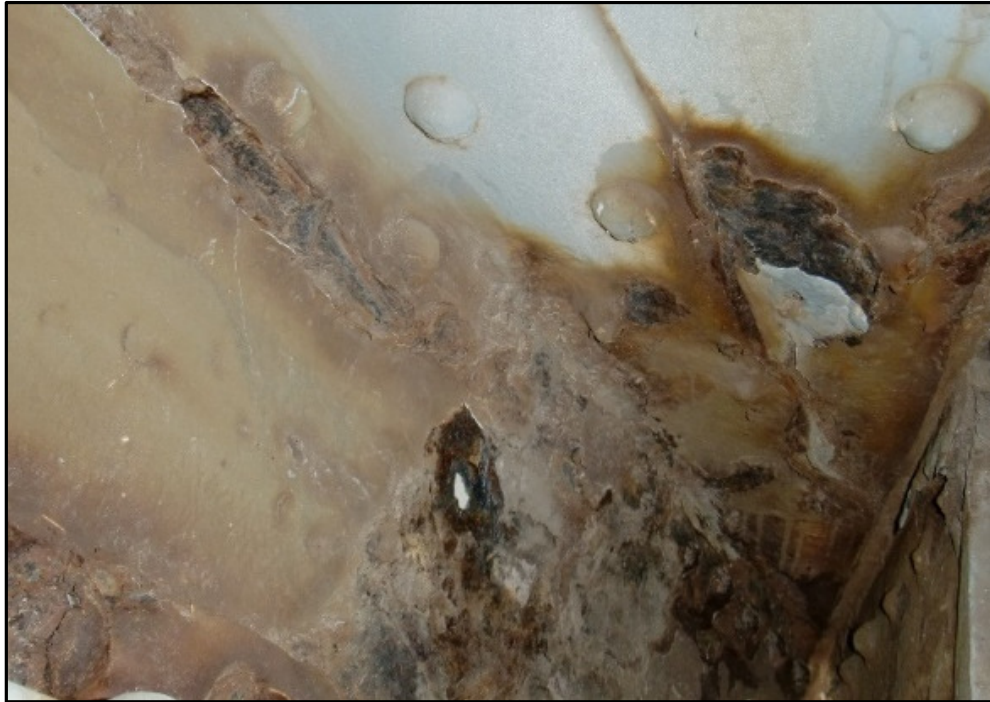
Photo 39 – Typical Rust Nodule (at Arrow) on Interior Gusset Plate Surface.

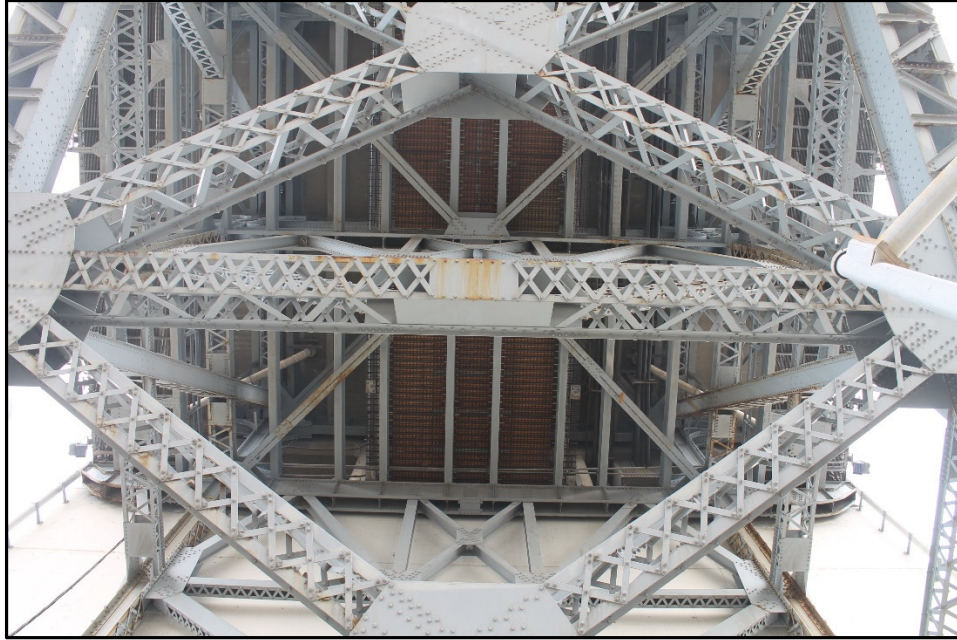
Photo 40 – Light Corrosion Satin, Lower Lateral Bracing.

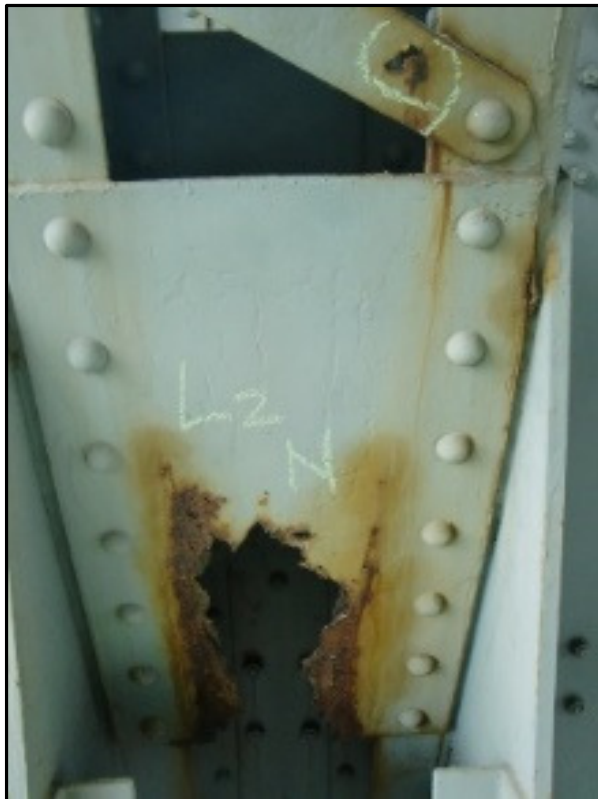
Photo 41 – Perforation of Sway Brace Stay Plate & Lacing Bar, North L<sub>2</sub>.

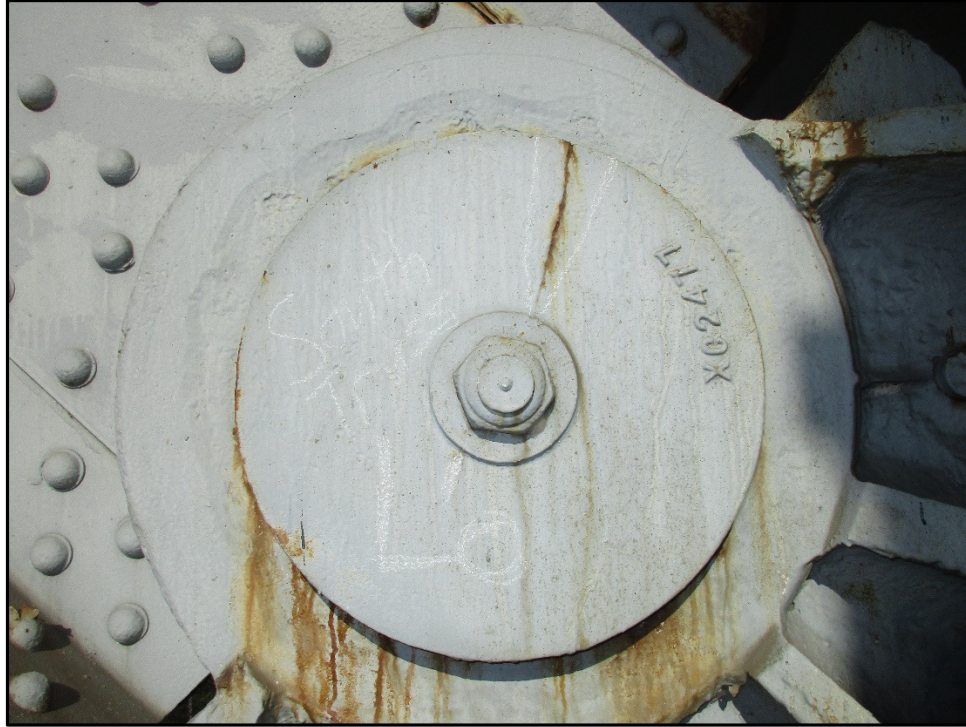
Photo 42 – Typical Bearing Pin Cover Plate Crack.

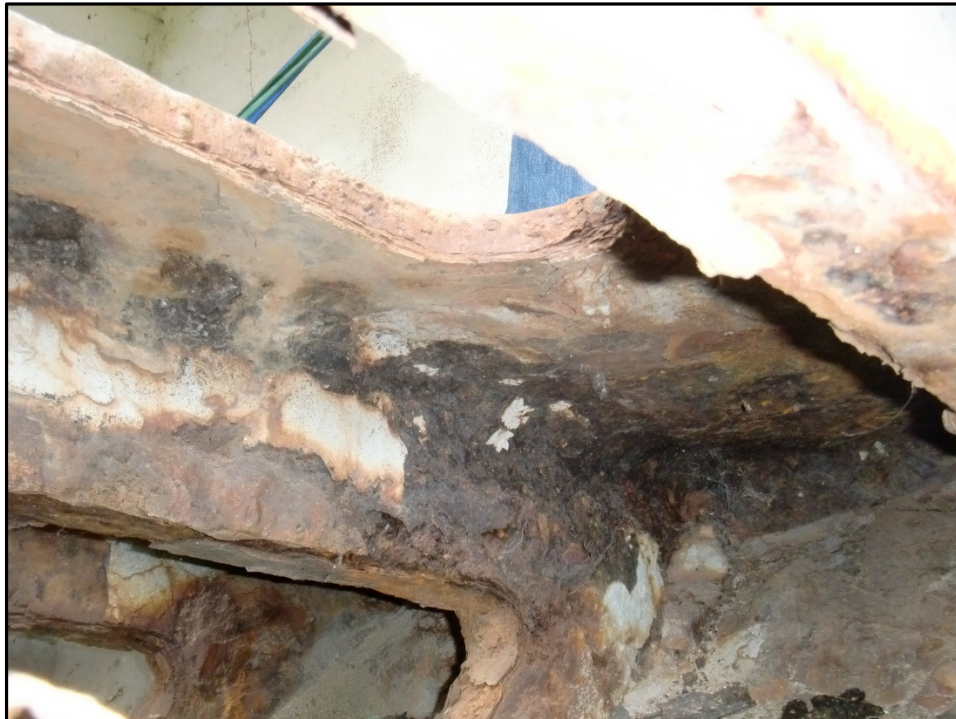
Photo 43 – Typical Corrosion Interior Surface of Bearing Casting.

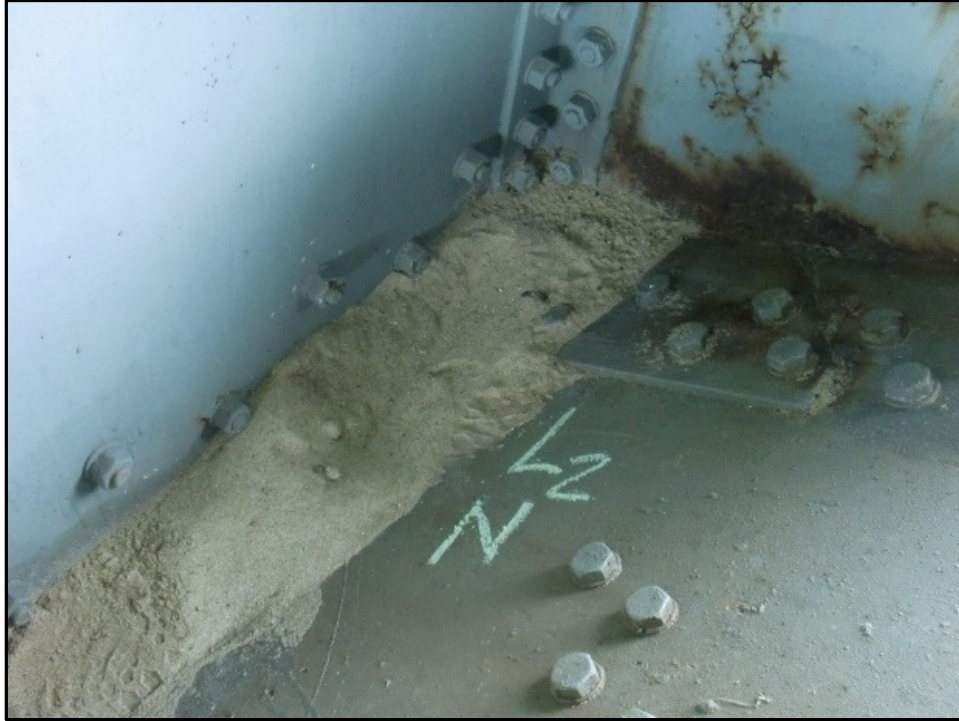
Photo 44 – Blast Material Accumulation, Top of Lower Lateral Bracing Gusset Plate, Panel Point North L2.

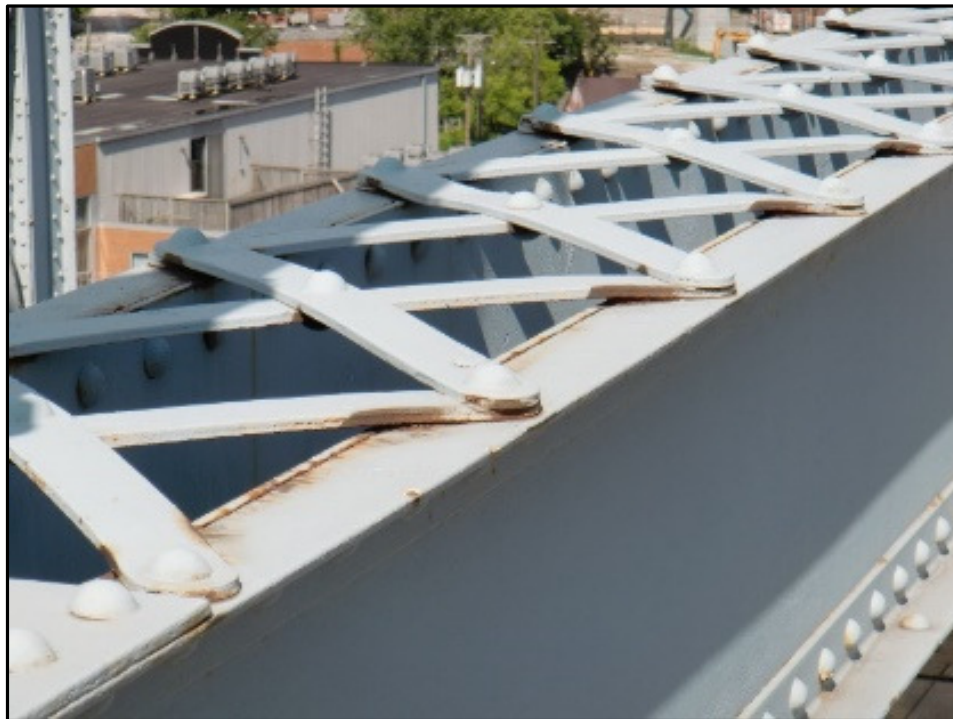
Photo 45 – Oxidized Top Coat & Light Rust Staining Above Upper Deck.
