**OHIO DEPARTMENT OF TRANSPORTATION  
2015 PHYSICAL CONDITION REPORT**

**DETROIT-SUPERIOR BRIDGE OVER CUYAHOGA RIVER  
BRIDGE NO. CUY-6-1456**

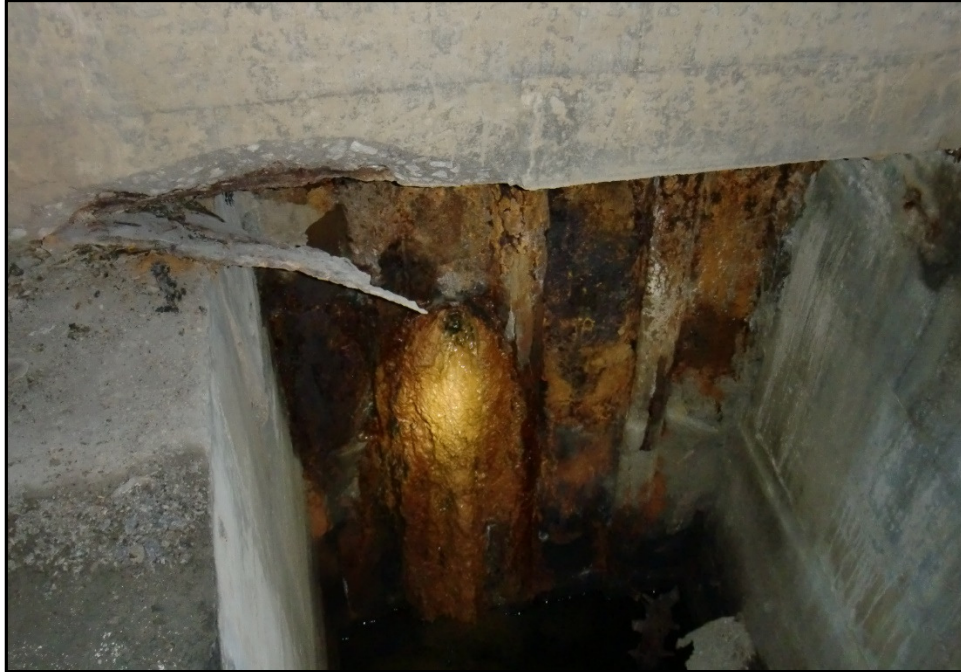
**Photo 45 – Possible Deposit Clogged Pedestrian Tunnel Drain Outlet, East Abutment Cellular Construction.**

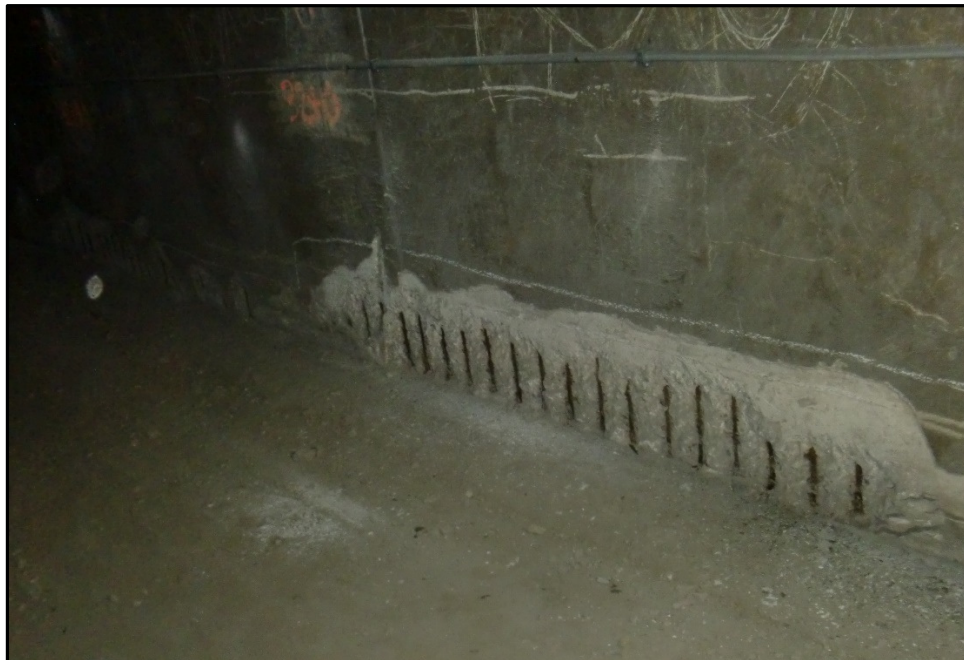
**Photo 46 – Typical Wall Base Spalls, Detroit Ave. & West 25<sup>th</sup> St. Tunnel.**

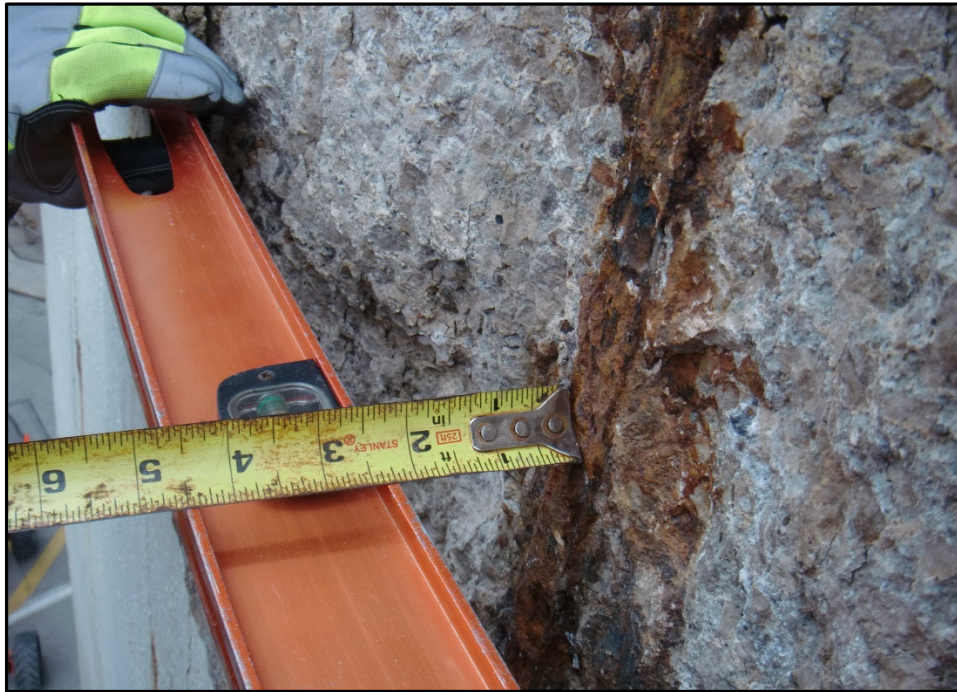
**Photo 48 – Scaled Concrete & Rebar Corrosion, SE Lower Deck Shaft.**

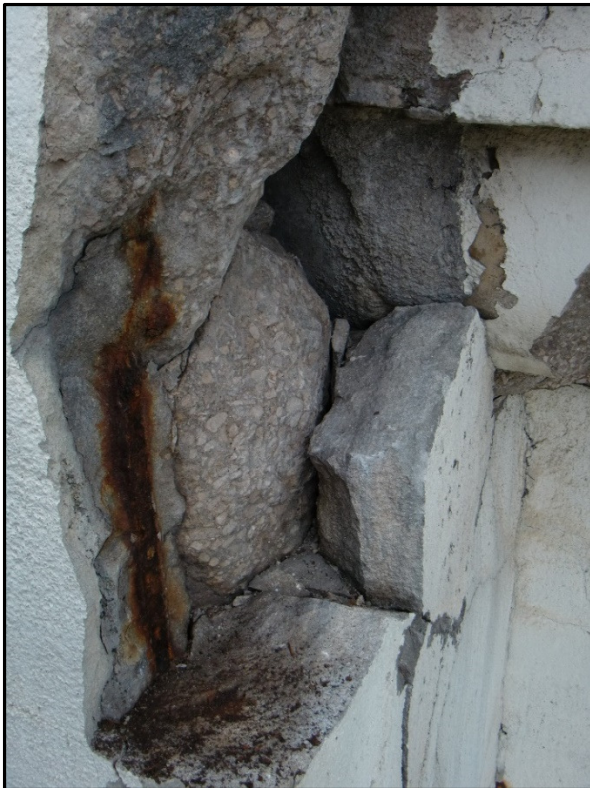
**Photo 49 – Deeply Cracked East Face of South Exterior Lower Deck Shaft, Pier 5 at Lower Deck Corbel.**

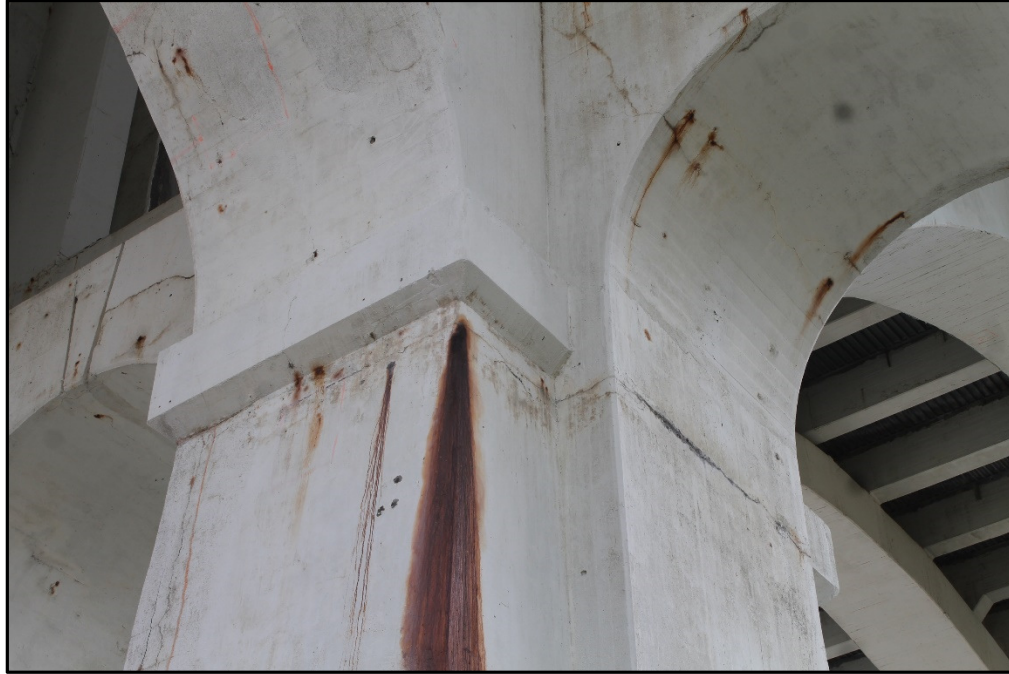
**Photo 50 – Rust Stains Indicating Active Corrosion of Pier Reinforcement.**

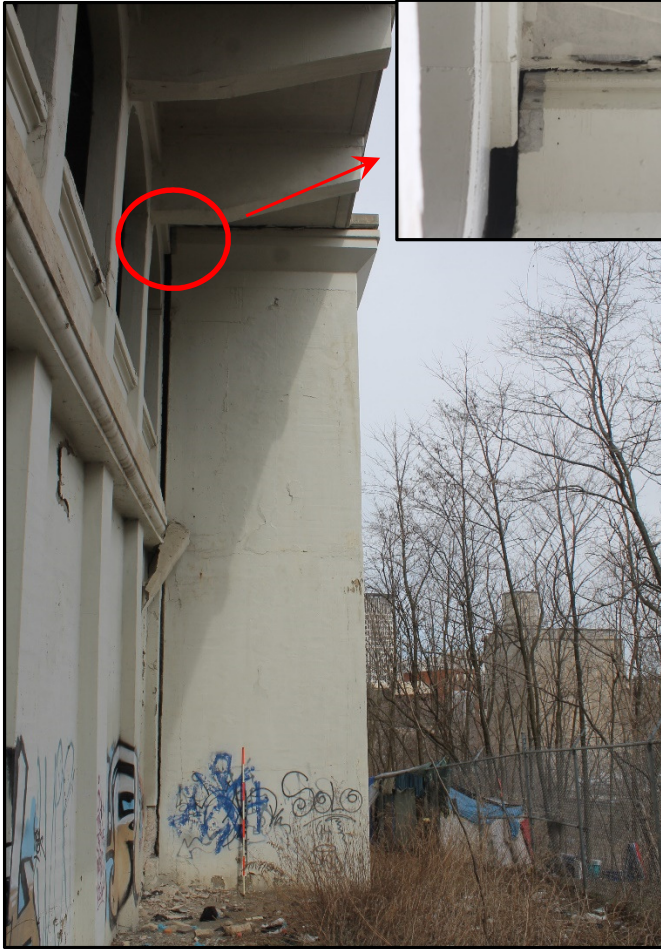
**Photo 52 – Rotation of Tower B South  
(Inset: Rotation at top NW corner.)**

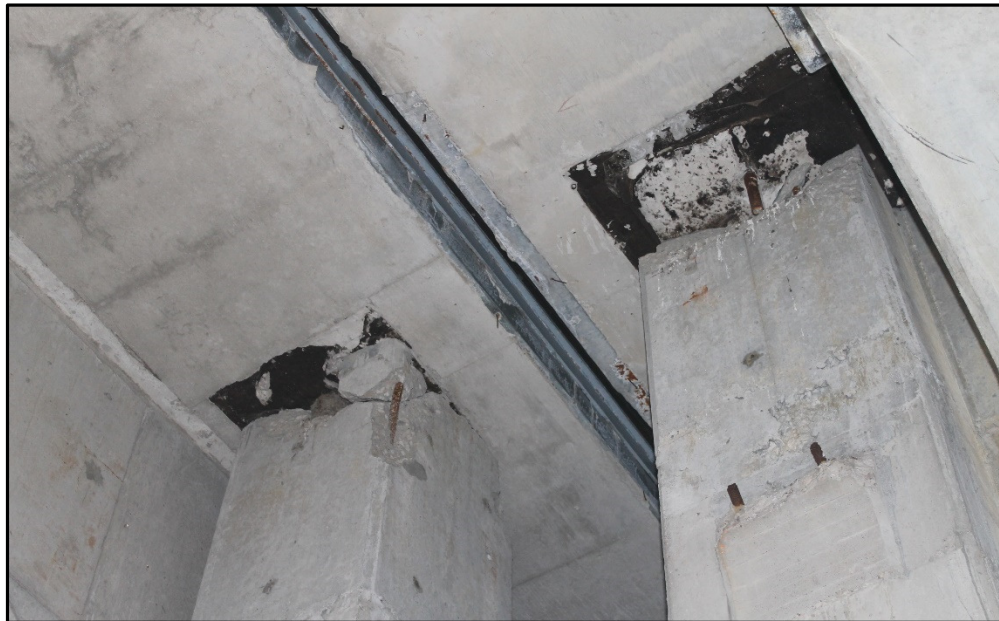
**Photo 53 – Fracture of Top Interior Section Against Upper Deck Slab, Tower B South.**

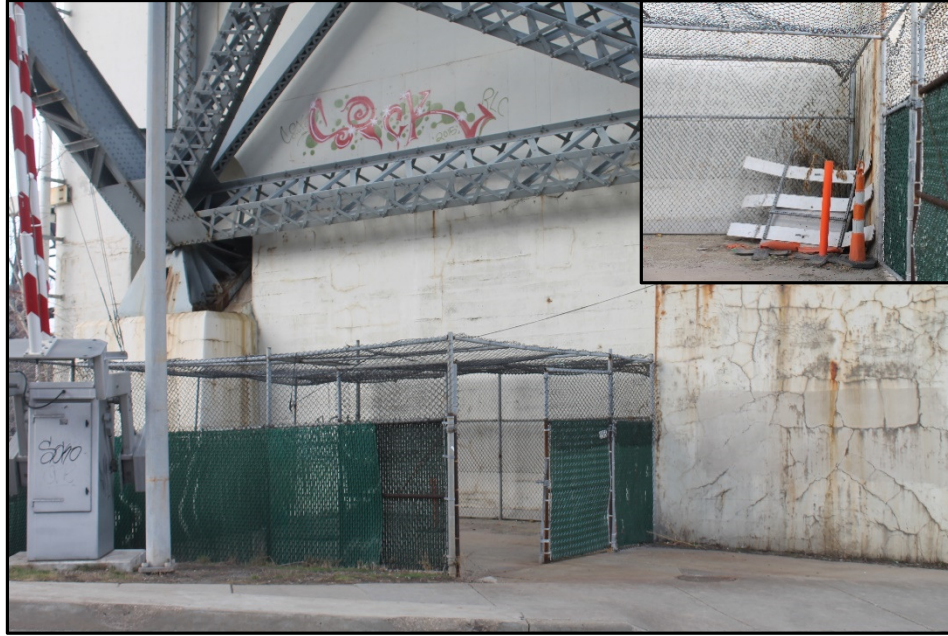
**Photo 57 – Illegal Access onto Steel Superstructure Through Vehicle Enclosure & Graffiti on Pier 4. (Inset: Barricade propped up for access through broken chain-link cover.)**

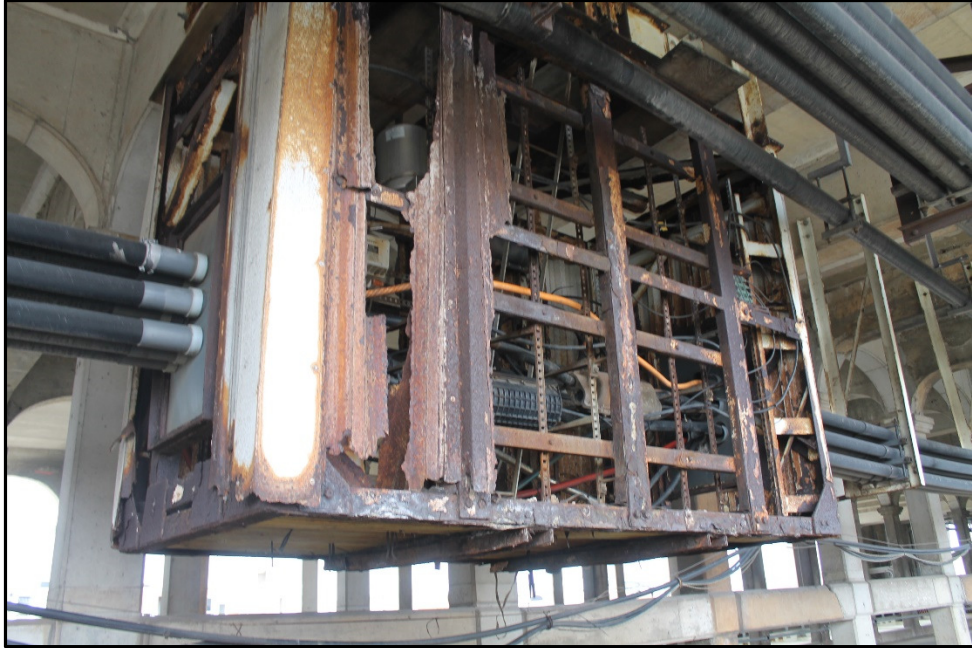
Photo 59 – Corroded & Unsecure Telephone Junction Chamber, Span 2 Lower Deck.

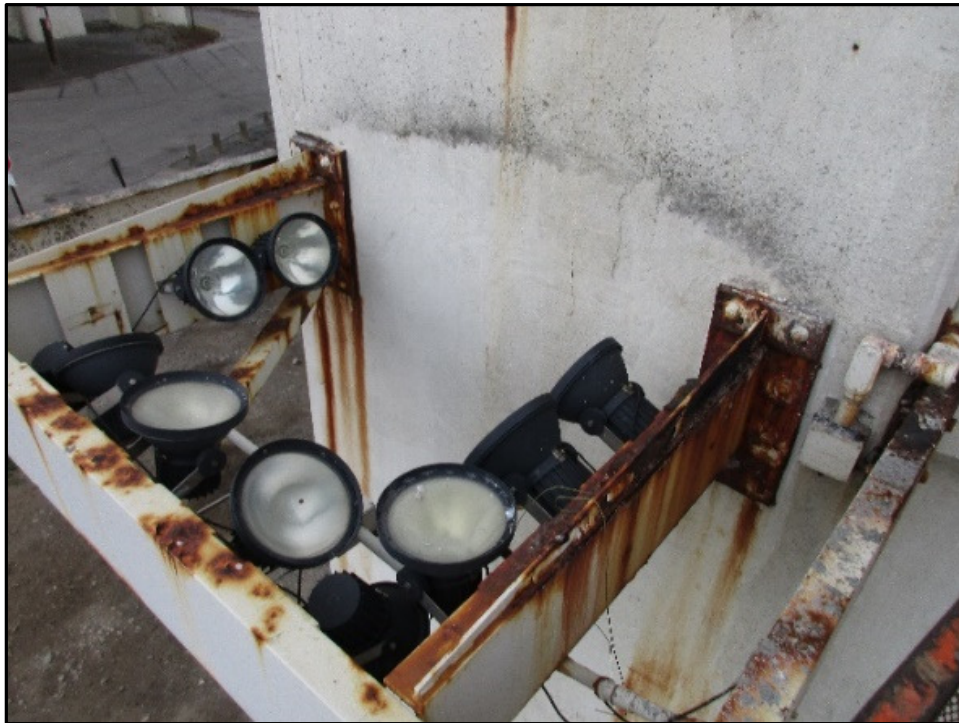
Photo 60 – Typical Paint Failure & Corrosion, Exterior Pier Shaft Lighting Brackets.
