# Ohio Department of Transportation

## Fracture Critical Member and Fatigue Prone Connection Identification Plan

District: 12  
County-Route-SLM: CUY-010-1613  
Structural File Number: 1801503

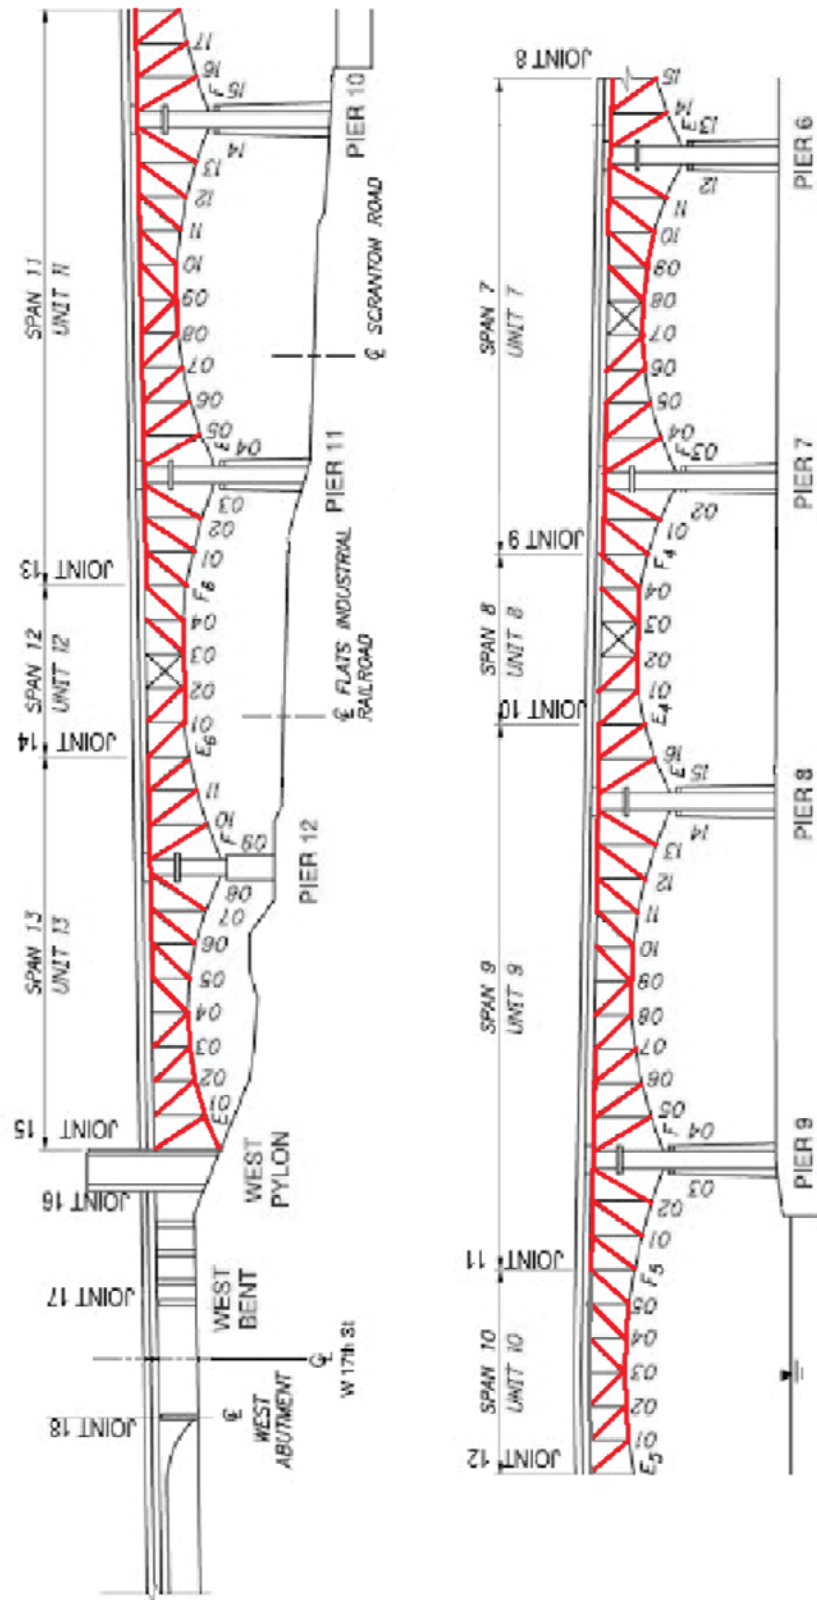
**Figure 3a:** Fracture Critical Member Locations (Highlighted Red)

Fracture critical members include select truss chords, diagonals, pins, gusset plates, and upper deck floorbeams (see *Figures 3 & 4*).

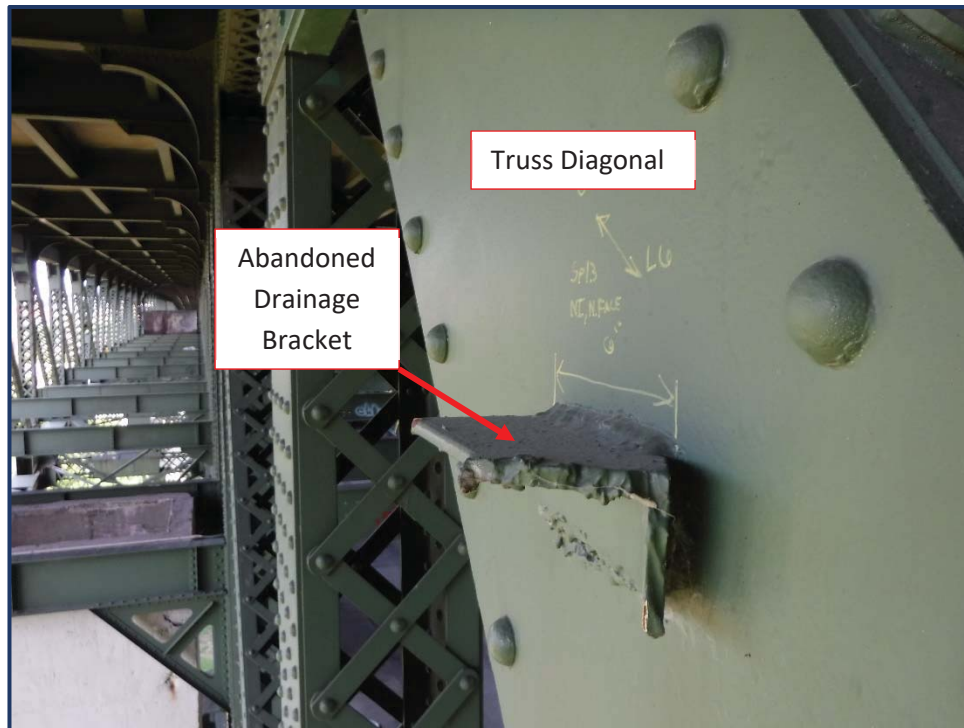
<b>Known Structural Risk Factors &amp; Fatigue Prone Details</b> <i>Category reference: AASHTO LRFD Bridge Design Specs, 9<sup>th</sup> Ed. Table 6.6.1.2.3-1</i>			
Photo Reference	Label / Fatigue Category	Where?	Description
1	Abandoned Drainage Brackets, <b>Fatigue Category E</b>	Span 13 Truss Diagonals	Fillet welds connecting abandoned drainage brackets to truss diagonals (NI L6-U7, SI L6-U7, SE L6-U7)
2	Abandoned Utility Brackets, <b>Fatigue Category E</b>	South Exterior Truss Upper Chords	Fillet welds connecting abandoned utility brackets to truss upper chords (S5 U10-U11, S7 U4-U5, S9 U0-U1, S9 U12-U13, S11 U11-U12, S13 U6-U7). Crack present in vertical fillet weld at S9 U0-U1.
3	Cracks in Flange Angles	Lower Chords	Cracks in fillet of lower flange angles at gusset plates (S6 SI L1-L2, S12 NI L1-L2, S12 NI L2-L3, S12 NI L2-L4, S12 SI L0-L1, S12 SI L2-L3, S12 SI L3-L4, S12 SE L3-L4). Some locations have been arrested with drilled holes.

*Photo 1 – Abandoned Drainage Bracket on Truss Diagonal*

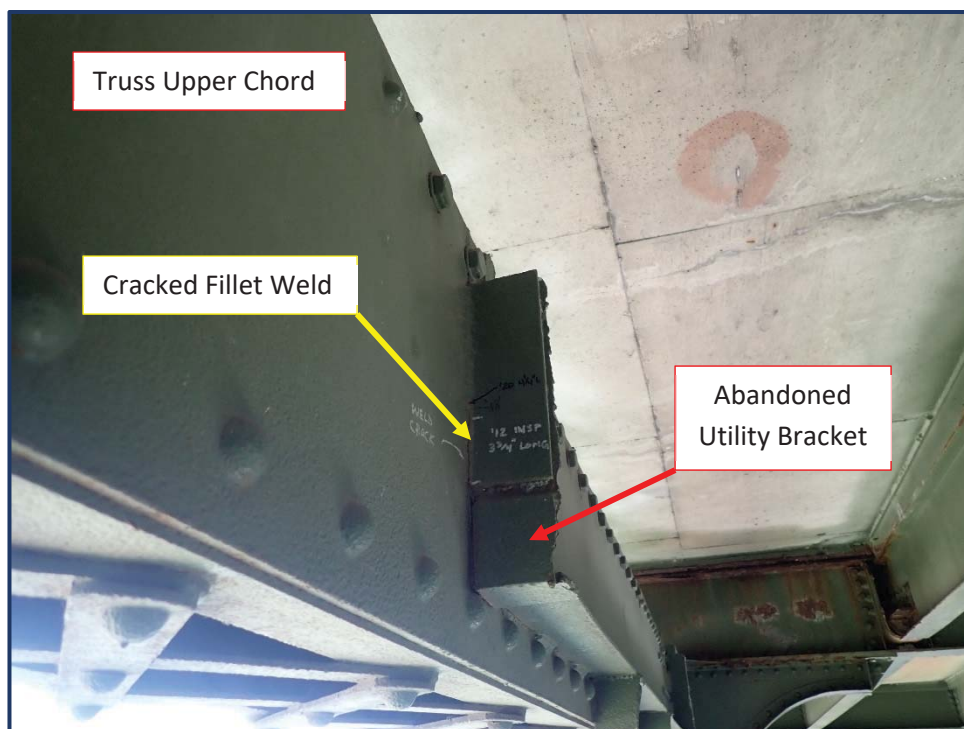
*Photo 2 – Abandoned Utility Bracket on Truss Upper Chord*

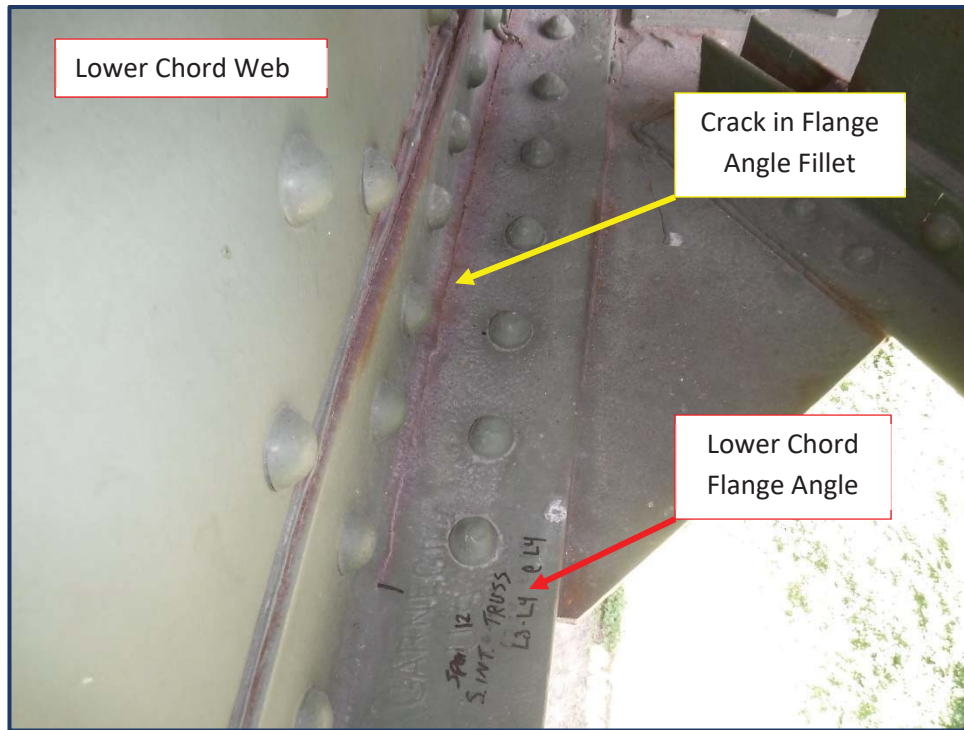
*Photo 3 – Cracks in Fillet of Lower Chord Flange Angles*

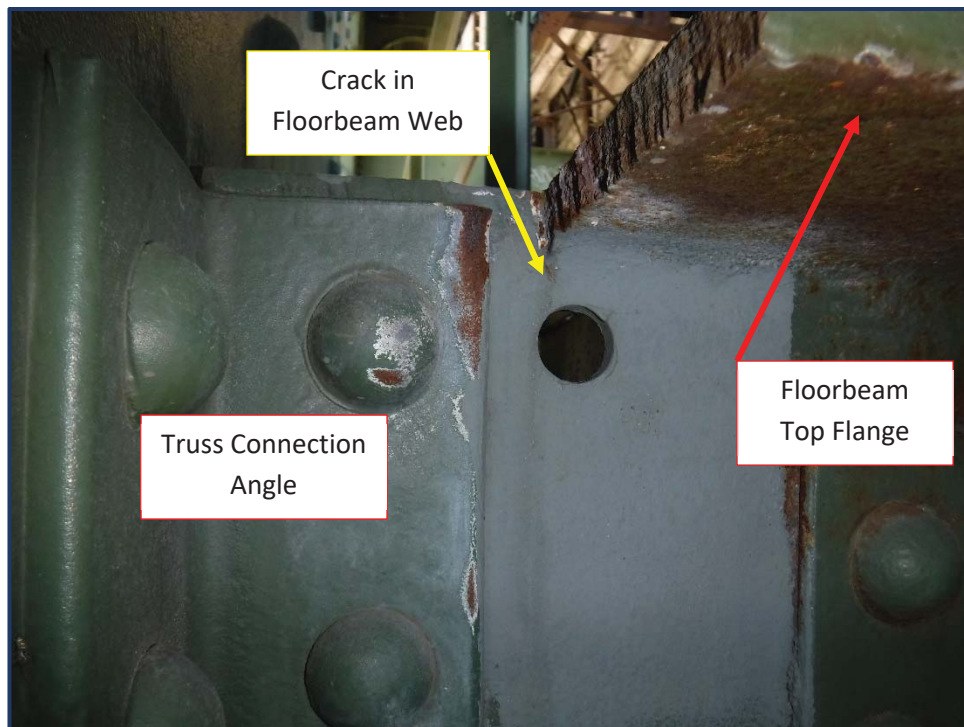
4	Cracks in Floorbeam Connections	Maintenance Deck Floorbeams	Cracks in floorbeam webs at connection to truss. Some locations have been arrested with drilled holes.

*Photo 4 – Cracks in Maintenance Deck Floorbeam Web at Truss Connection*
