PHASE I ENVIRONMENTAL SITE ASSESSMENT

PORTSMOUTH BYPASS PROJECT
SCI-823, PID No. 19415

OHIO DEPARTMENT OF TRANSPORTATION

AUGUST 1, 2003

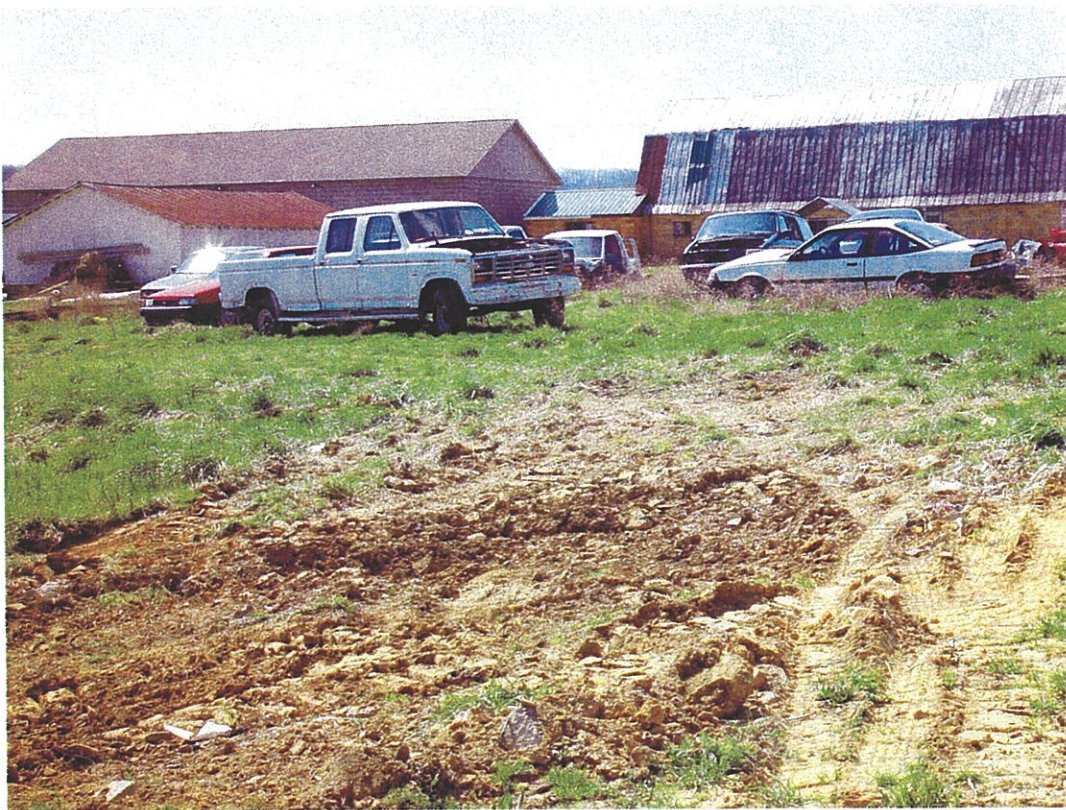
Photo 13. View looking south at the rear of the buildings and junk automobiles located on the Turner property.

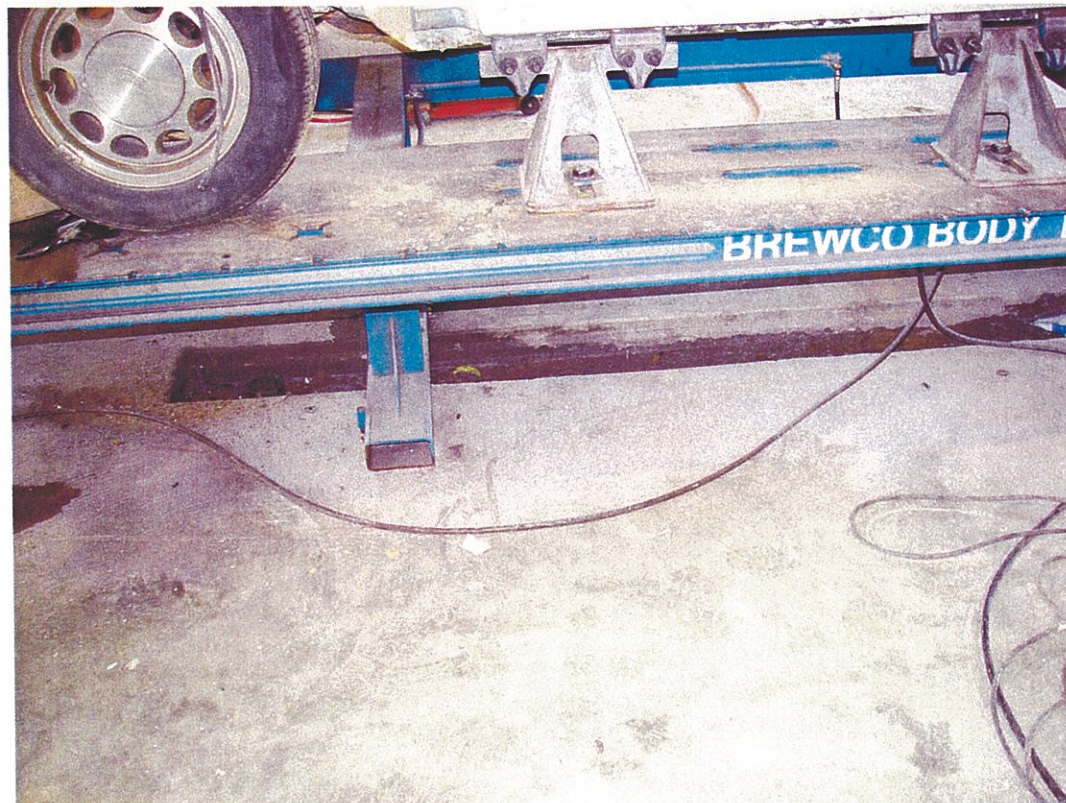
Wastes are transported off-site by Safety Kleen, which has picked up waste twice since 2001. Thompson's Oil picks up the used oil for recycling. Four (4) open trenches located under the garage bays drain to the ground surface north of the building, between the concrete block building and the storage shed. Staining at these outlets was observed and is believed to be dry paint overspray drained when the trenches are cleaned with water. Acetylene, oxygen and carbon dioxide tanks, lubricants, paint cans, clear coat, thinner and antifreeze are located on the floor and on storage racks along the interior north wall of the concrete block building. No evidence of staining was observed within the gravel parking lot or on other portions of the parcel. This parcel is located approximately 50 feet north of the proposed "Valley" ROW.

Photo 14. View looking at the trench drains located in the auto repair building on the Turner property.

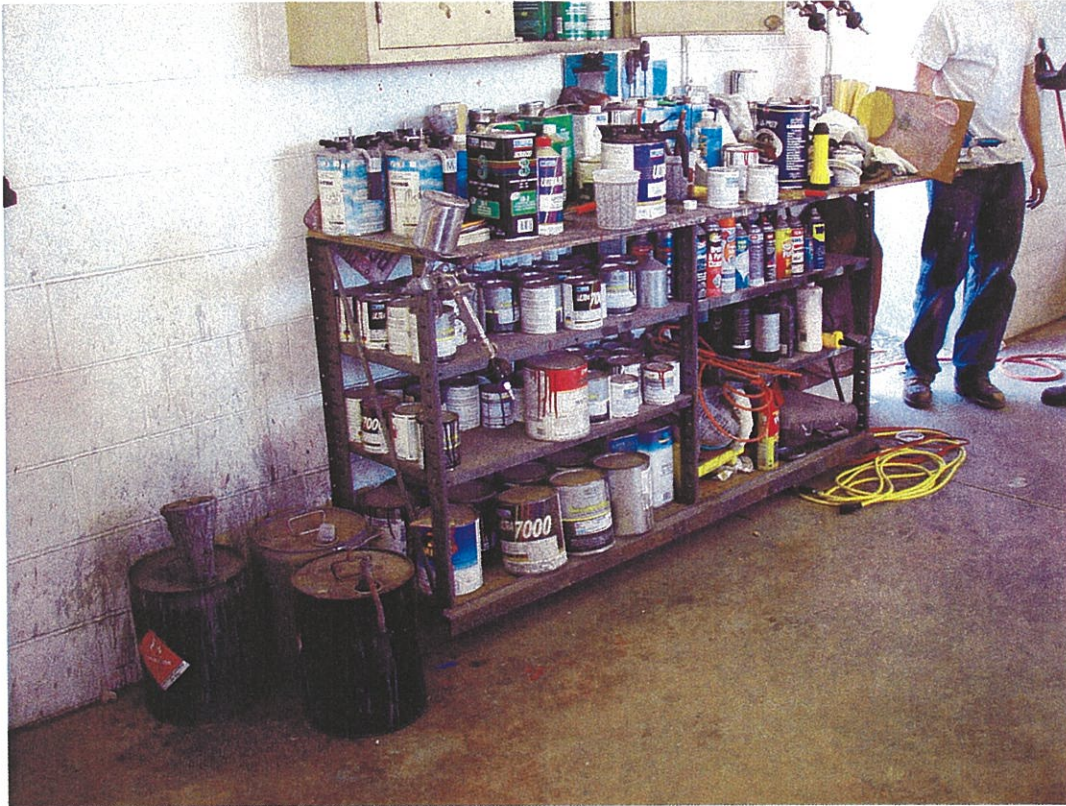
Photo 15. View of paints, solvents, waste solvents and lubricants located in the auto repair building.

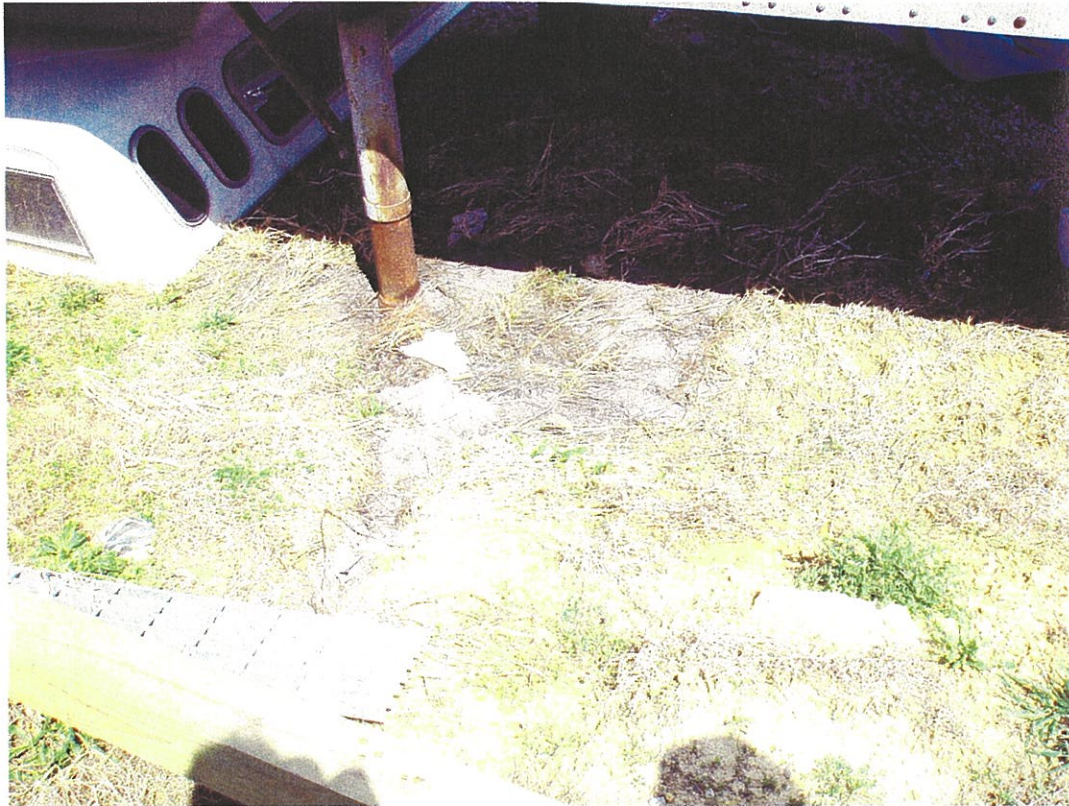
Photo 17. View looking at the area that the trench drains discharge onto the ground surface.

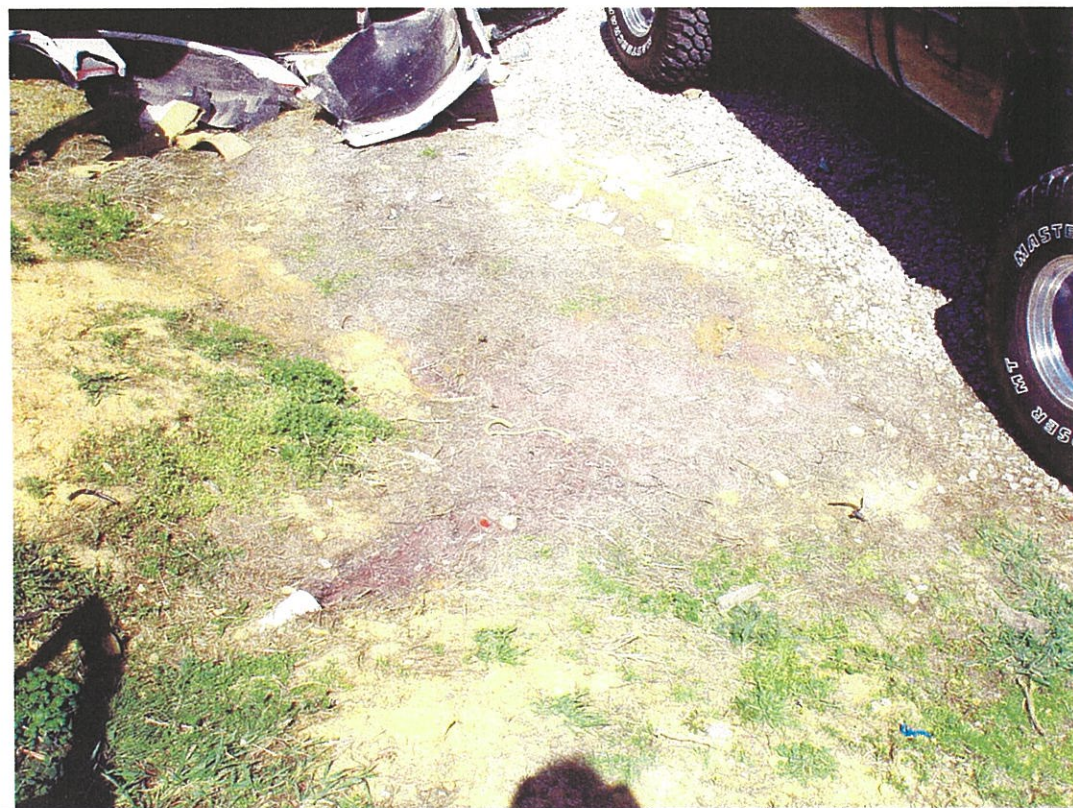
Photo 18. View looking at the area that the trench drains discharge onto the ground surface.

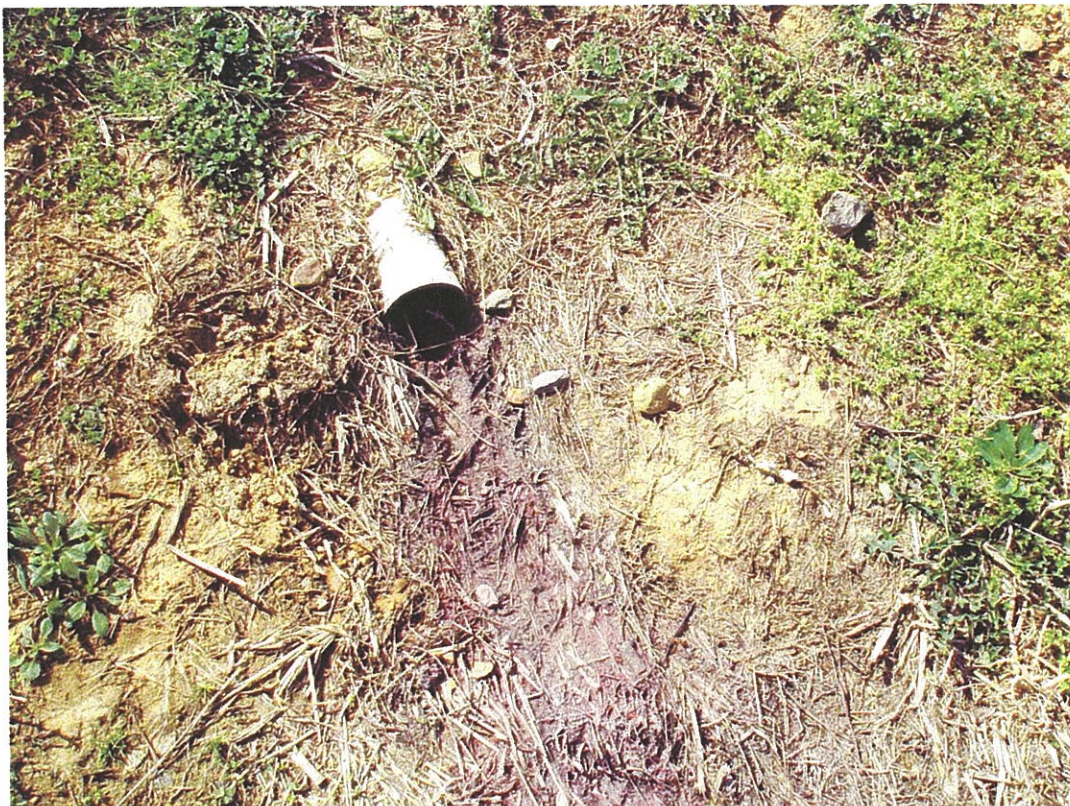
Photo 19. View looking at the area that the trench drains discharge onto the ground surface.

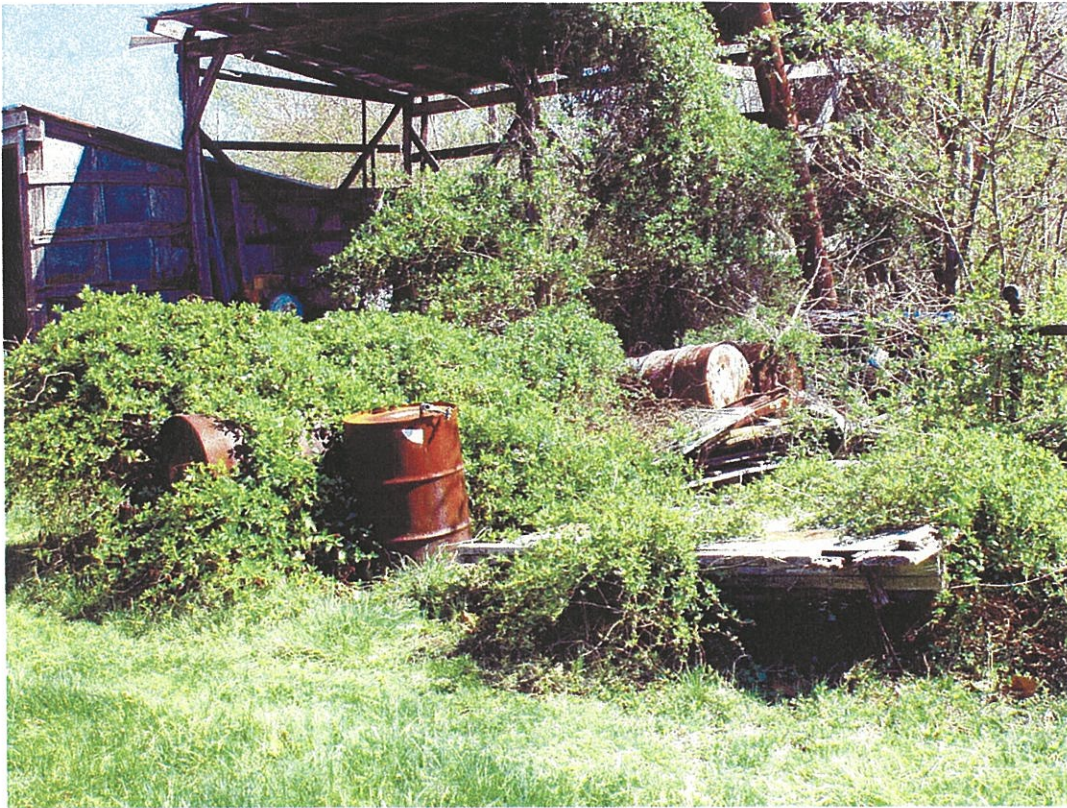
From approximately 1984 through 1986, Mr. McGuire operated a creosote dipping tank for logs that were then sold to the highway department as guardrail posts. The process consisted of dipping logs in an aboveground dipping tank that held approximately 1,000-1,500 gallons of creosote. The logs were then allowed to 'drip-dry' overnight above the tank. Mr. McGuire indicated that there were no leaks or spills from the tank while it was in operation. Mr. McGuire sold the tank and related equipment approximately 10 years ago. The creosote tank was located in the shed adjacent to (west of) the sawmill operations, approximately 220 feet from the "Hill" ROW. Therefore, Phase II ESA is not recommended to address potential contamination from this operation.

Photo 23. View looking at the barn storage area (former creosote dipping pit area) located on the southern portion of the McGuire property.

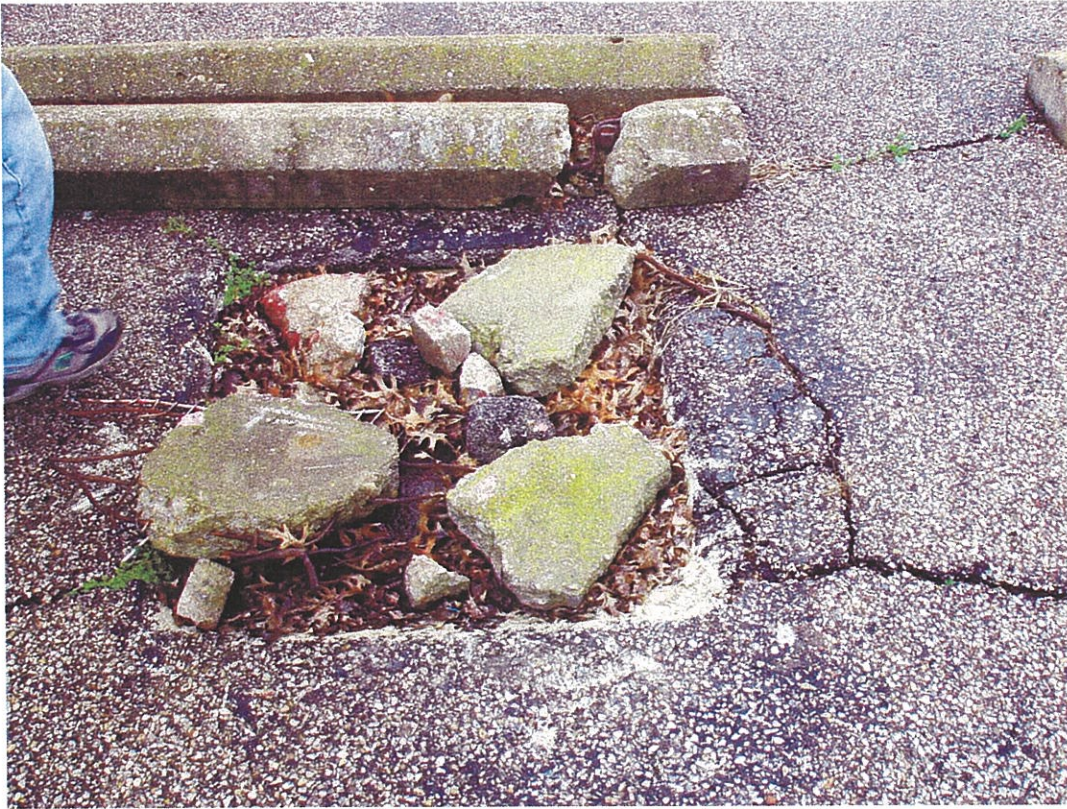
Photo 37. View of a former drain located on the eastern portion of the Harwood's gasoline station property.

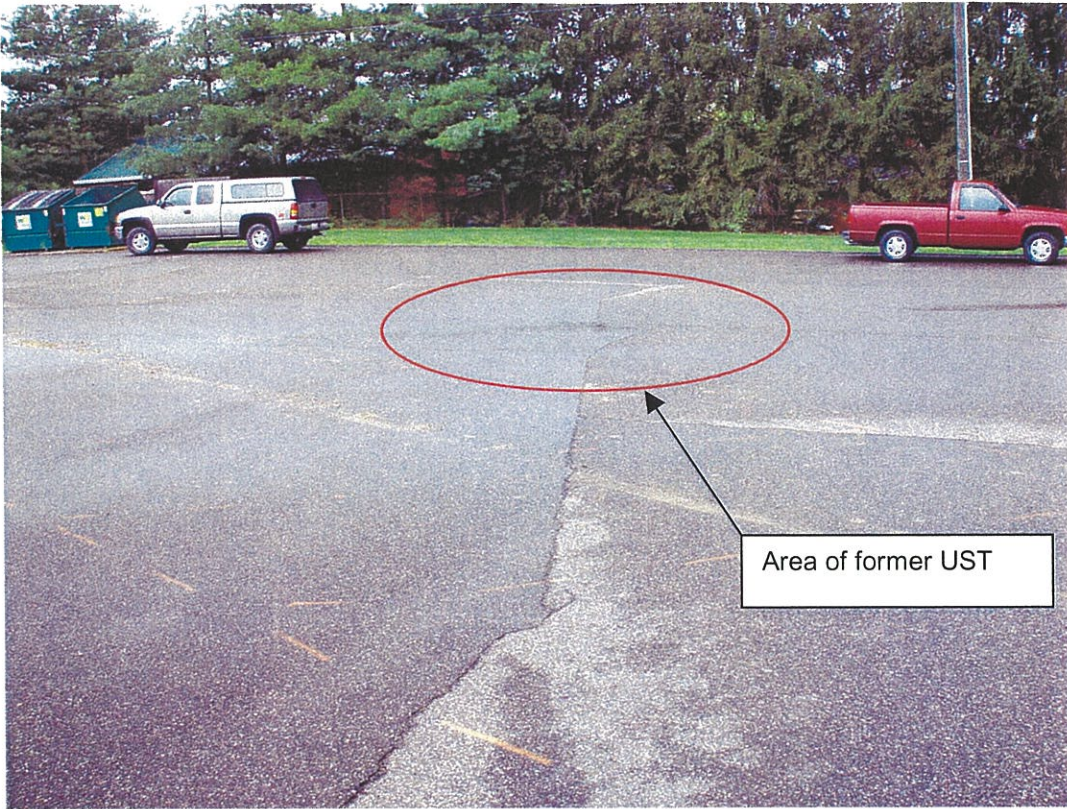
3. **Lucasville Junior High School (PIDs 241601000, 241603000).** The UST, lines and fuel dispenser were removed on June 24, 1996. Soil samples collected from the excavation, under the dispenser, and from the stockpiled soils were below Category 1 Action Levels, and the site was recommended for No Further Action status. BUSTR concurred in their letter dated May 21, 1997. ROW is not required from this site, and proposed "Valley" ROW is located 236 feet south of the former UST system. As such, no further investigation is recommended.

Photo 43. View of the Valley Middle School LUST property looking at the area that the former UST area.

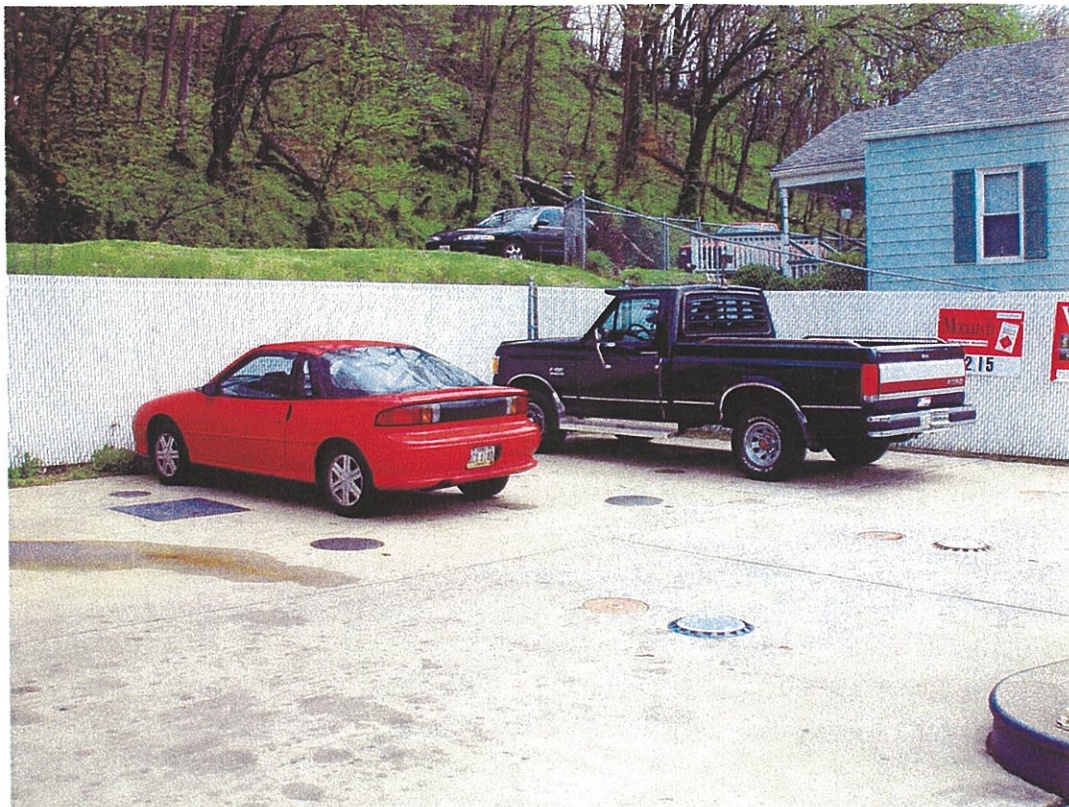
5. **Buster's Bi-Lo Gas Station (PIDs 161471000, 161064000, 161063000, 161065000).** The gasoline station currently operates 3, 8,000-gallon, cathodically-protected gasoline USTs that were originally installed on October 1, 1970. The total UST system was upgraded in October 1994 with electronic line leak detection and automatic tank gauging in accordance with BUSTR, and now operates under Permit Number 73000075. No contamination was found by the inspector during the upgrades. ROW is not required from this site; a retaining wall will be constructed on the south side of Gallia Pike for the proposed "Hill" and "Valley" ROWs. As such, no further investigation is recommended.

Photo 47. View of the Buster's Bi-Lo property UST system location.

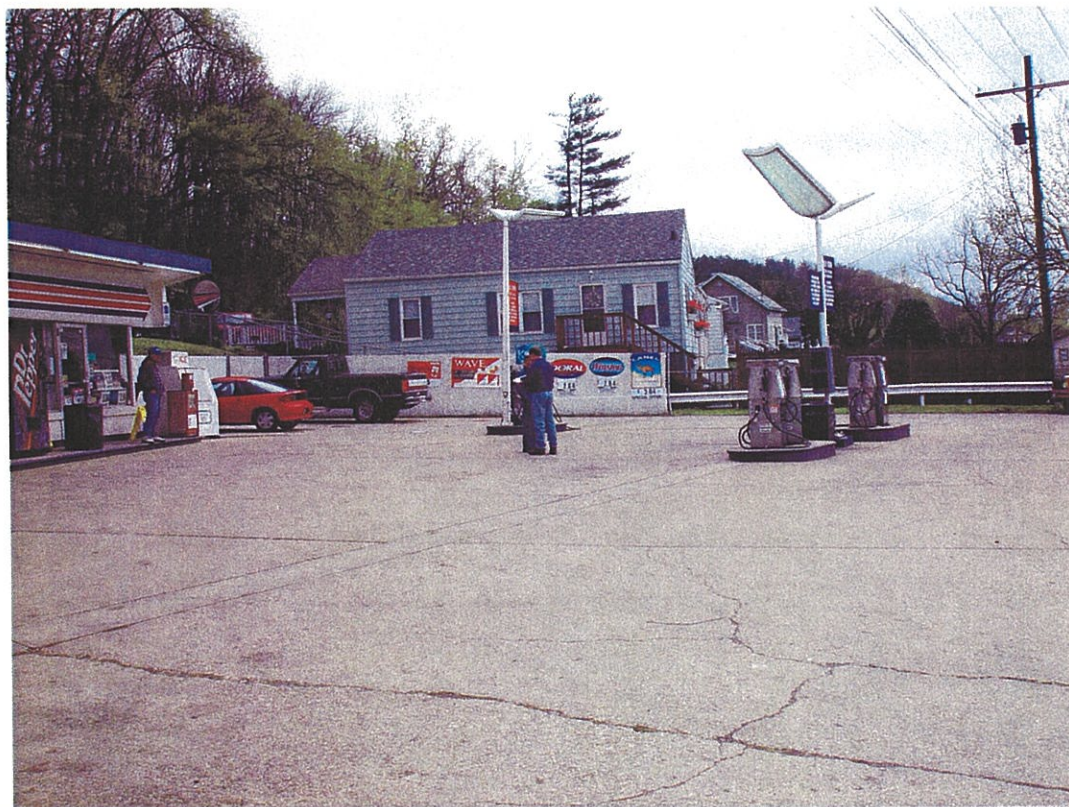
Photo 48. View looking east at the Buster's Bi-Lo property UST system and fuel island location.

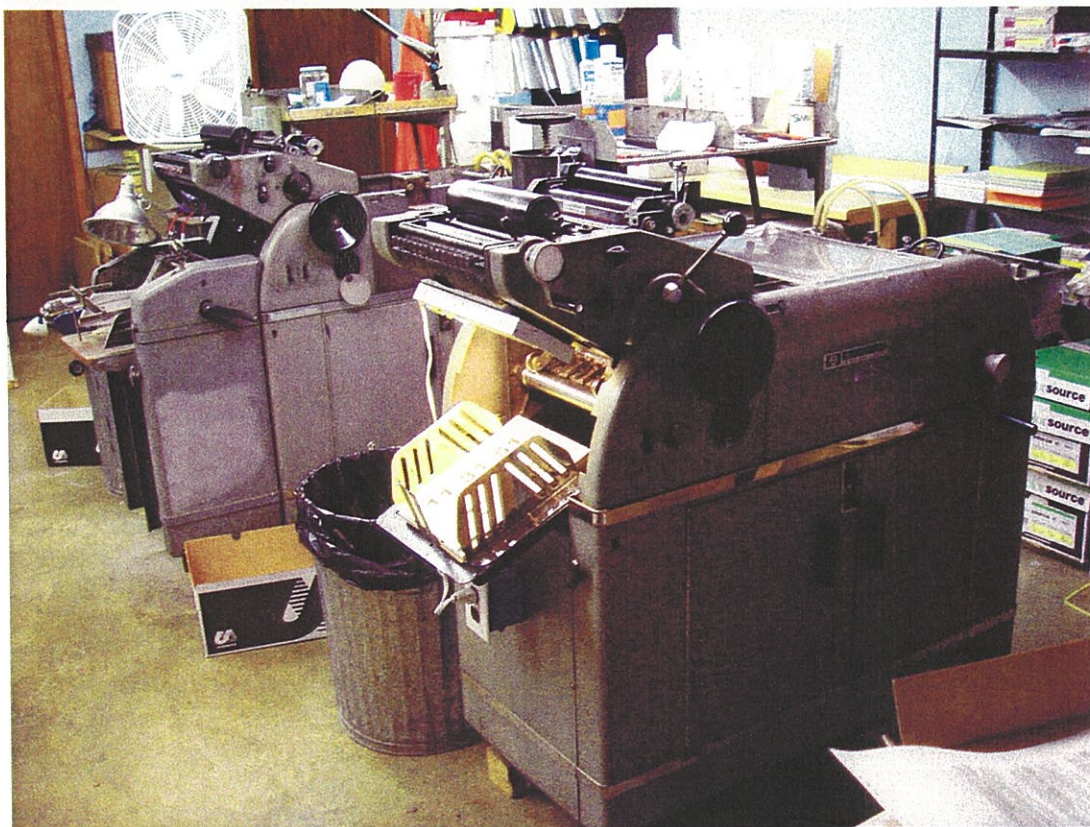
Photo 56. View looking at the printing equipment located in the print shop.

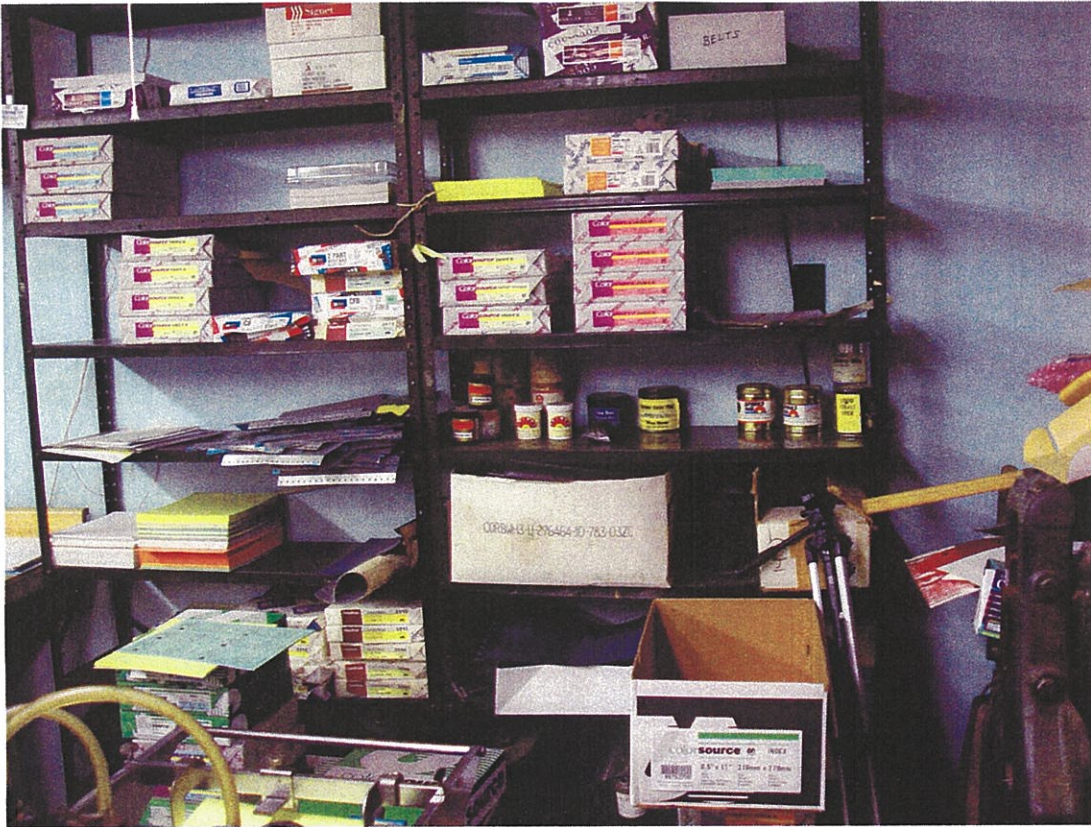
Photo 57. View looking at the printing supplies located in the print shop.

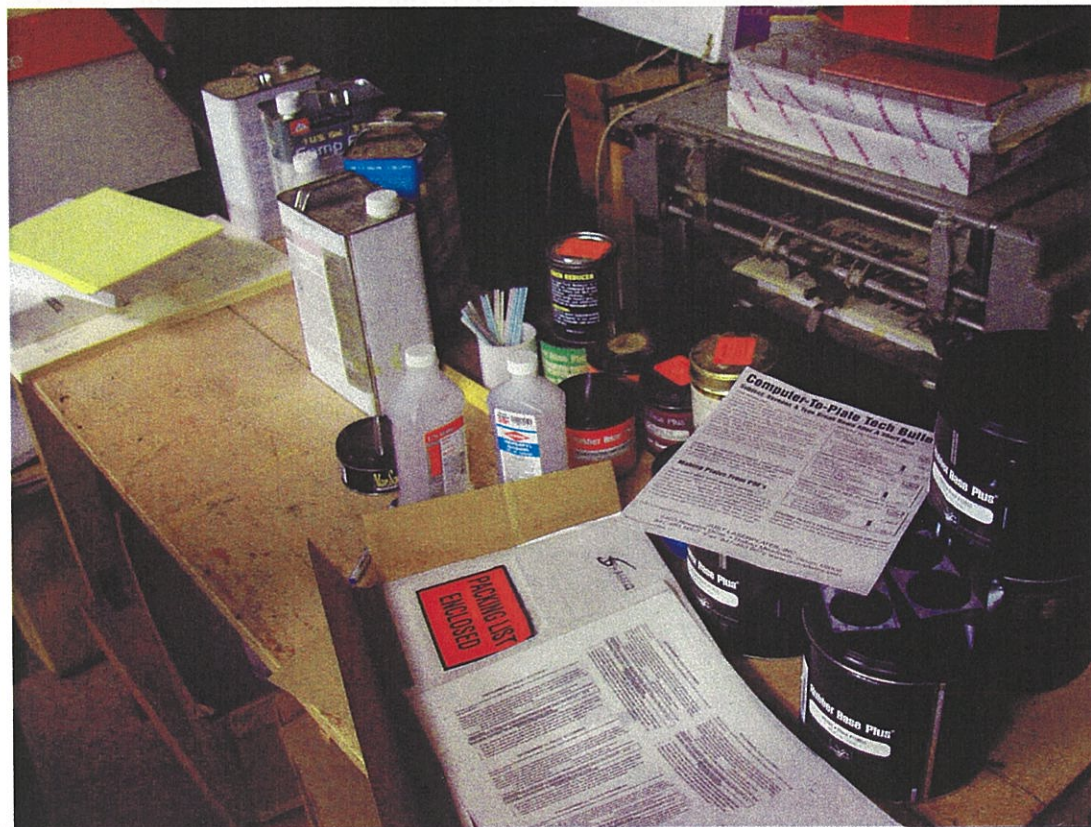
Photo 58. View looking at the printing supplies located in the print shop.
