Geology and Field Reconnaissance  
Portsmouth Bypass  
Project SCI-823-0.00  
Phase 3 – Stage I  
Scioto County, Ohio

**REPORT OF  
GEOLOGY AND FIELD RECONNAISSANCE  
FOR  
PROJECT SCI-823-0.00  
PHASE 3 – STAGE I  
SCIOTO COUNTY, OHIO**

DLZ Job. No. 0121-3070.03  
PID No. 77366  
Document No. 0089

November 16, 2007

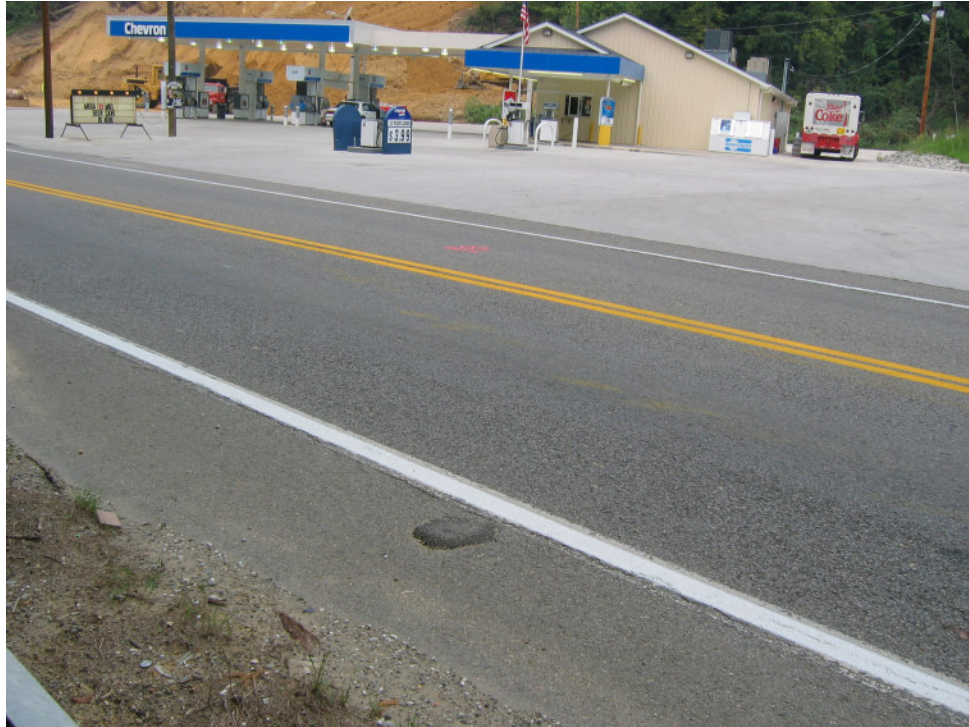
The existing pavement for SR 140 is in relatively good condition. Pershing and Slocum Roads are very badly deteriorated. There is also cracking in the asphalt of SR 335 along the Little Scioto River. The chip seal pavement utilized on Stout Hollow Road and Blake Hollow Road is in good condition. Photos illustrating the pavement conditions of all of these roads can be found in Appendix B.

**Photo 1.** SR 140 pavement.

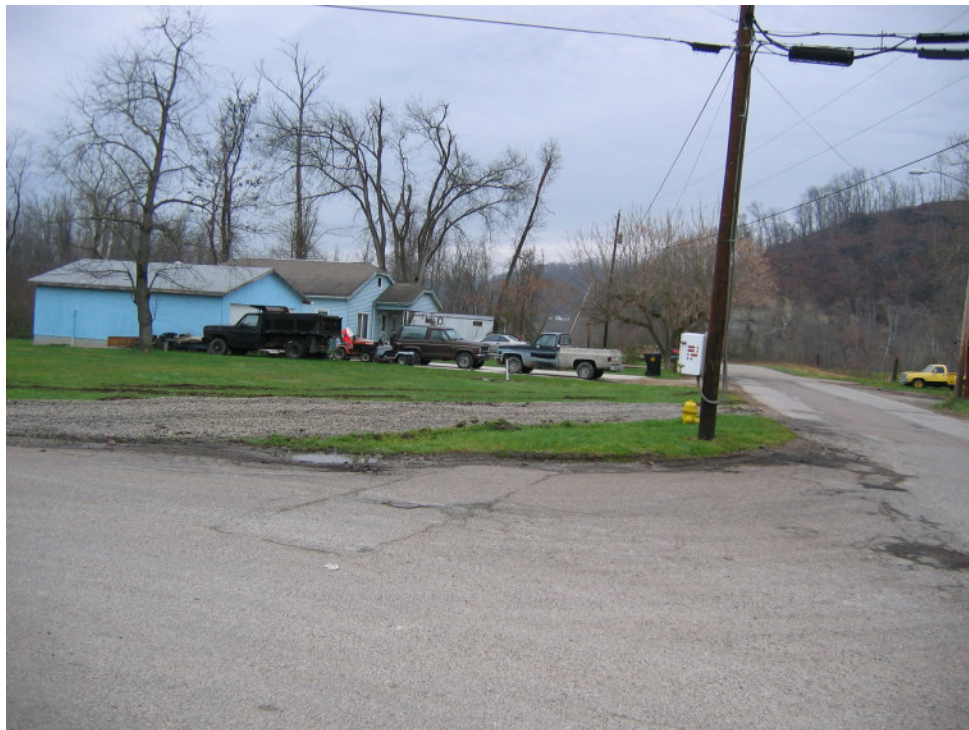
**Photo 2.** Pershing Avenue. and Slocum Avenue asphalt pavement

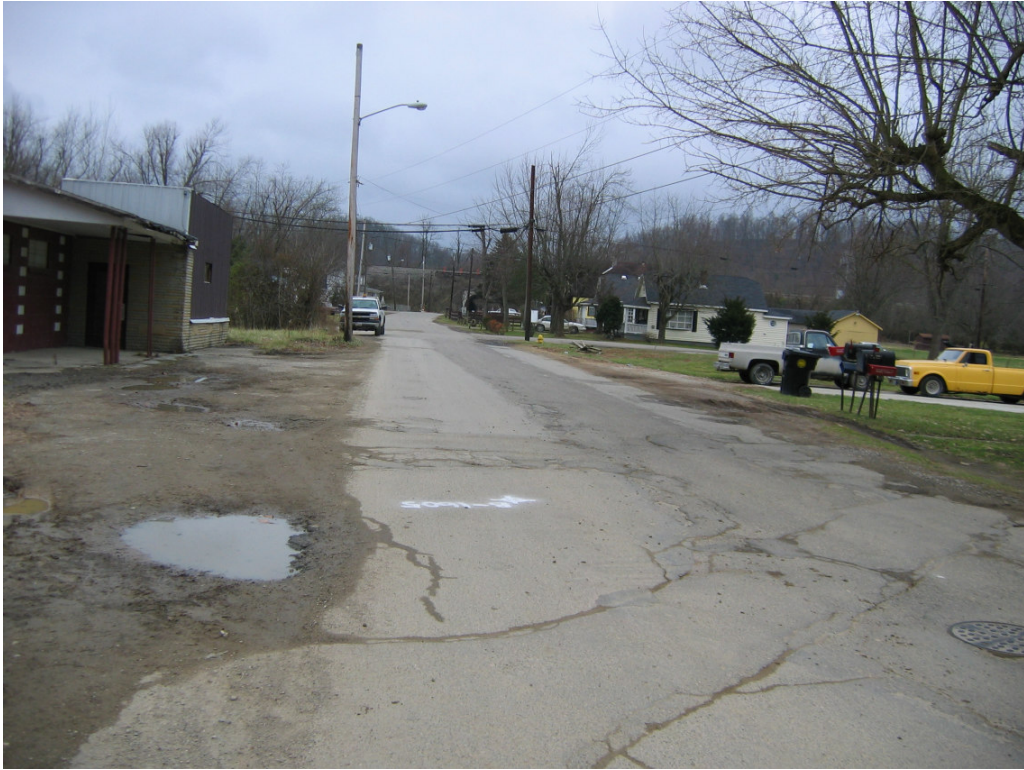
**Photo 3.** Slocum Avenue asphalt pavement.

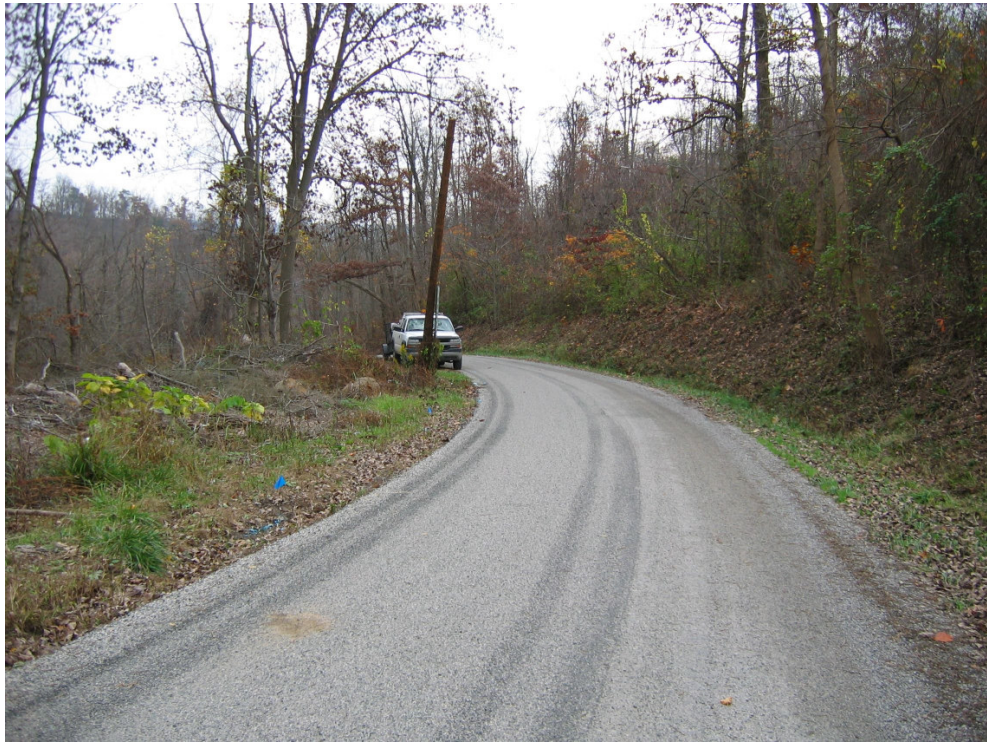
**Photo 4.** Stout Hollow Road chip seal pavement.

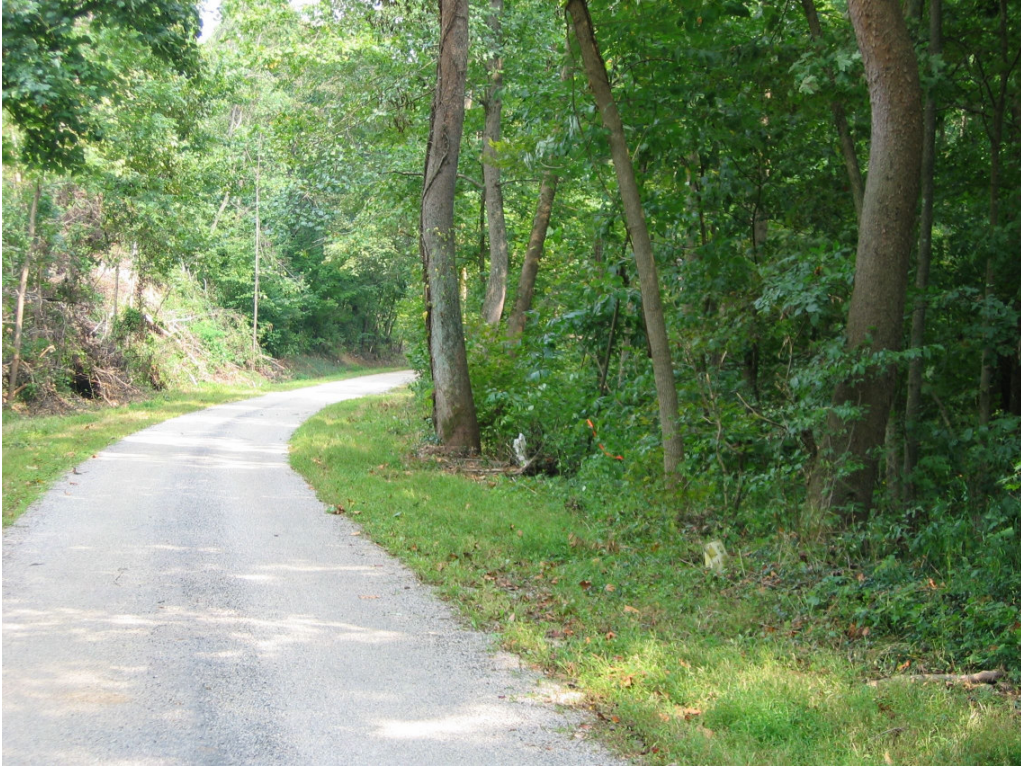
**Photo 5.** Blake Hollow Road chip seal pavement.

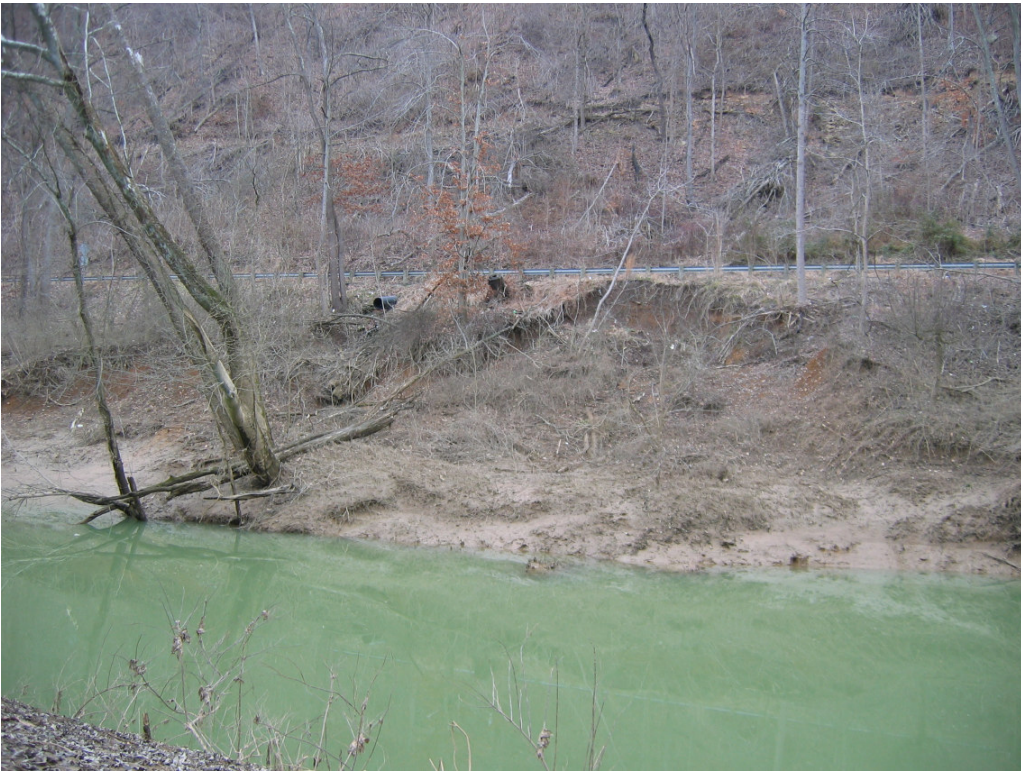
This area includes the northern shore of the Little Scioto River to the edge of SR 335. Cracking along the shoulder of SR 335 and displaced trees provided evidence of recent movement during the investigation. Slope movement in this area is likely due to saturation and rapid drawdown during flood events. Photos of this landslide can be seen in Appendix I.

**Photo 6.** Landslide along SR 335.

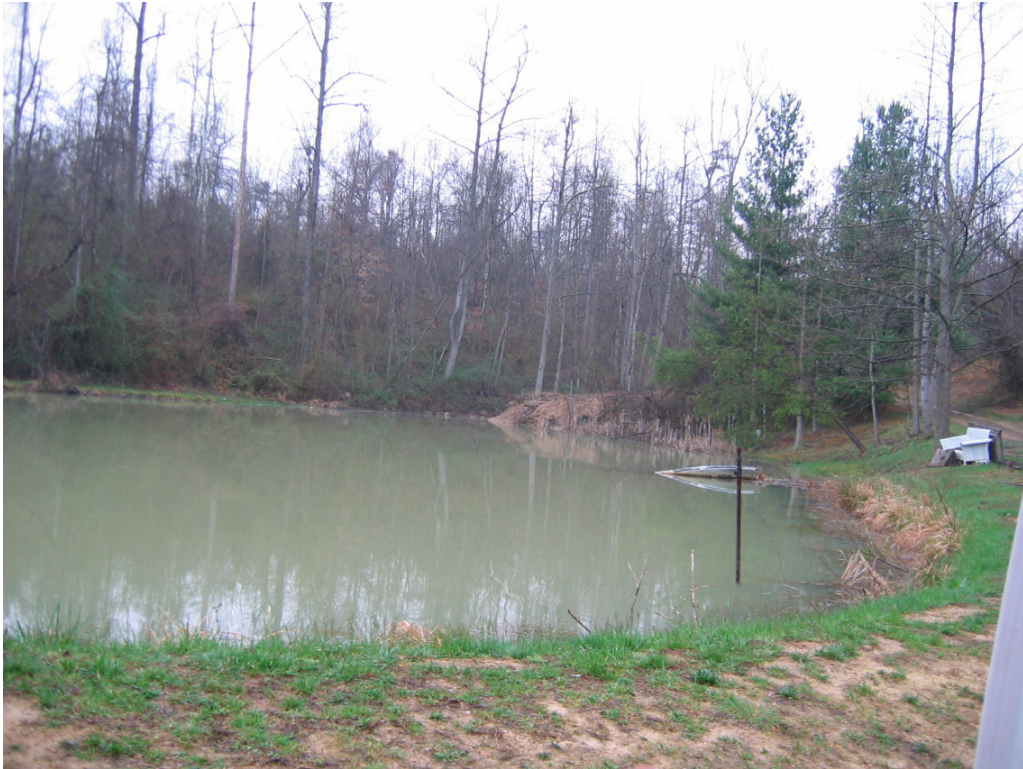
**Photo 7.** Excavated embankment pond at Station 73+50.

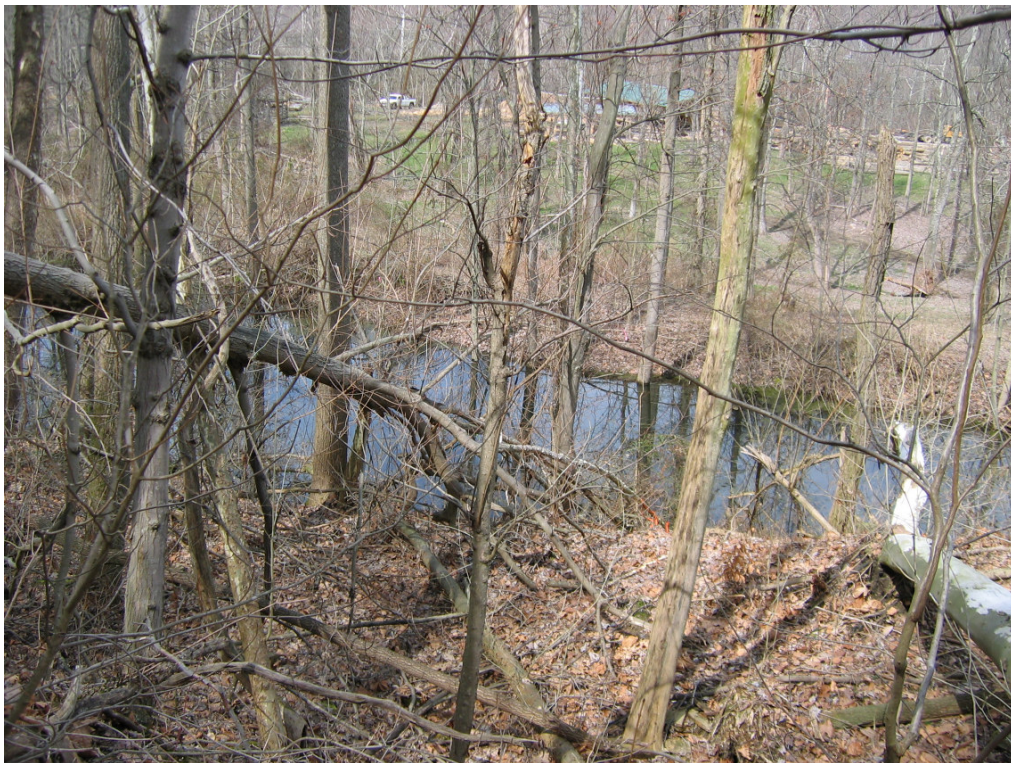
**Photo 8.** Excavated embankment pond at Station 107+50.

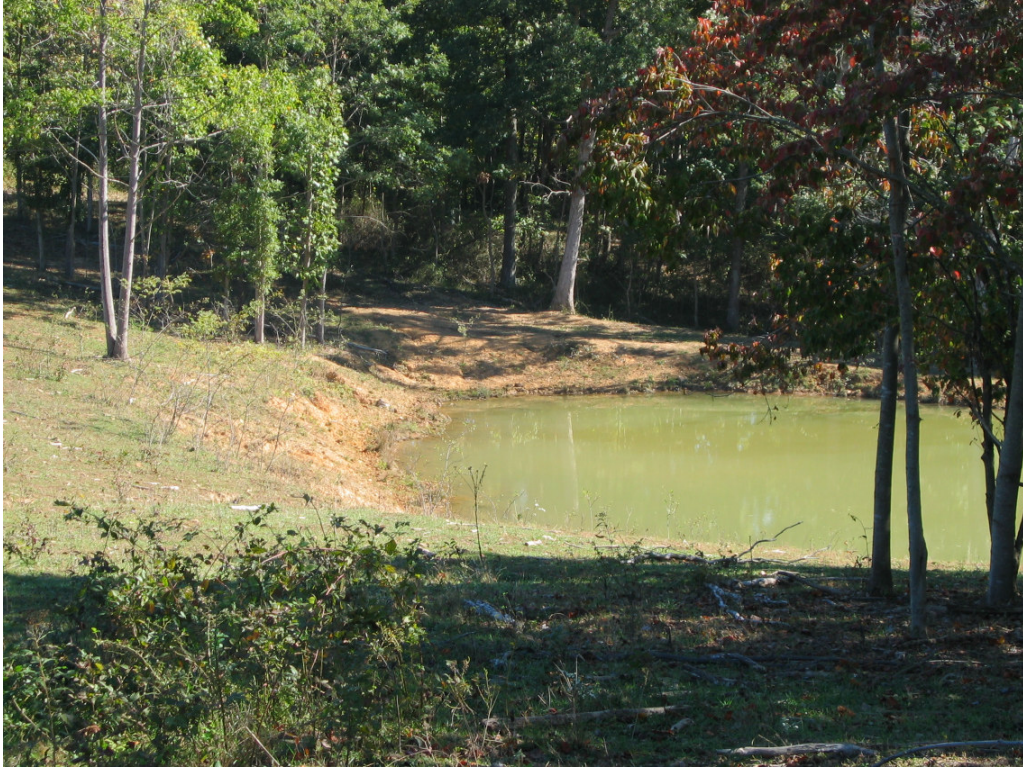
**Photo 9.** Excavated embankment pond at Station 265+00.

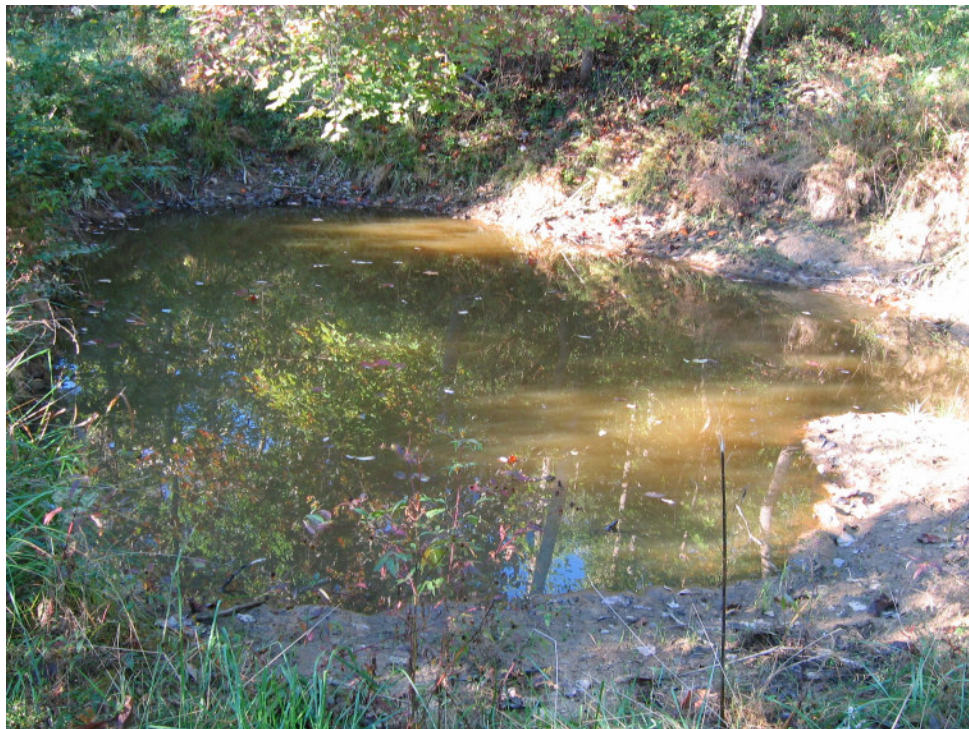
**Photo 10.** Spring-fed pond at Station 269+90.

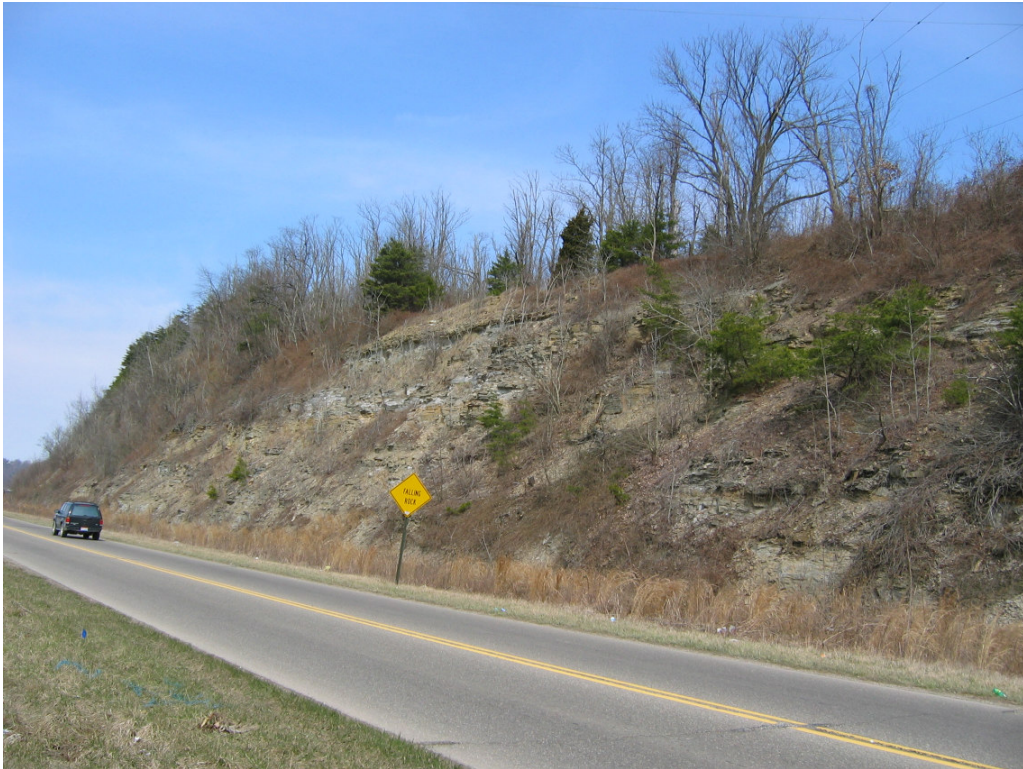
**Photo 11.** Rock cut at station 44+00.

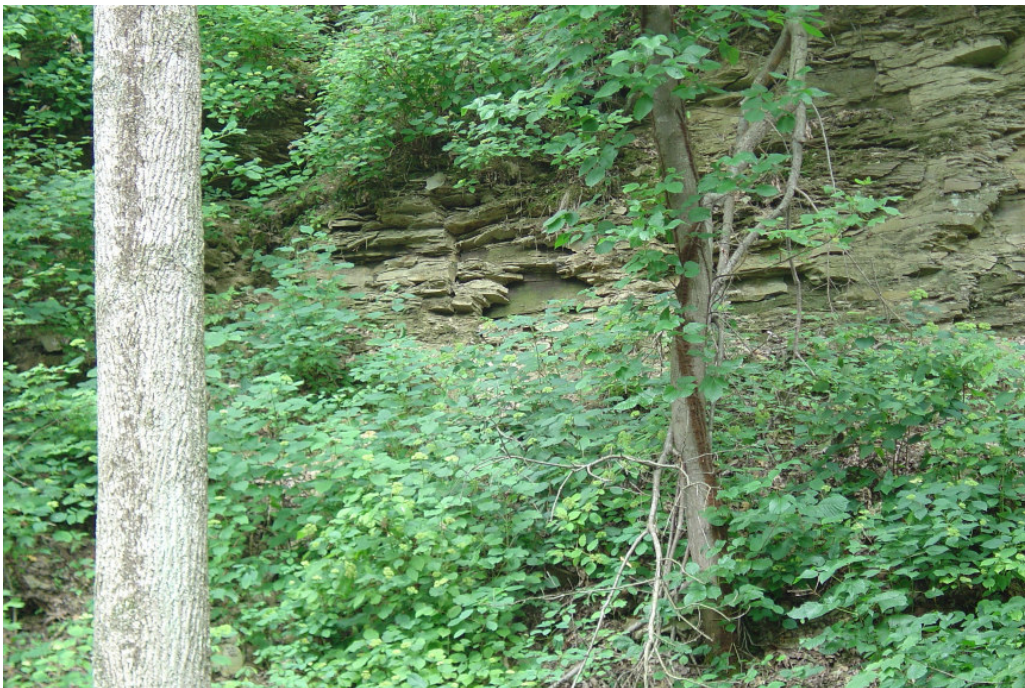
**Photo 12.** Bedrock exposure left of station 106+50.

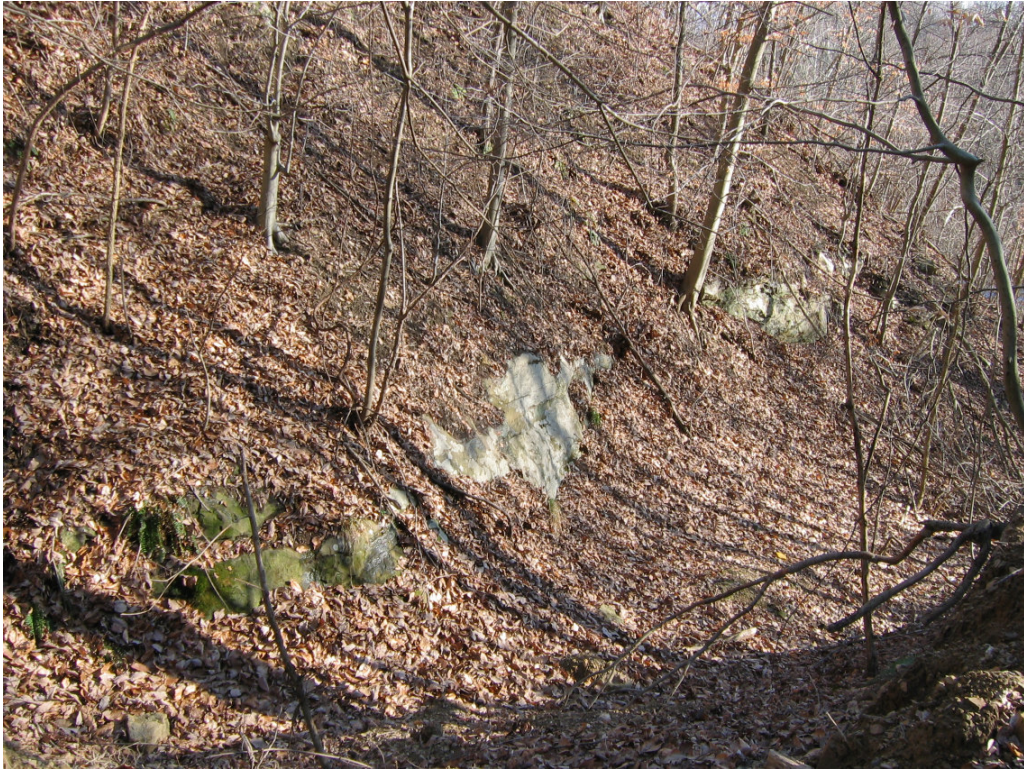
**Photo 13.** Bedrock exposure right of station 143+00.

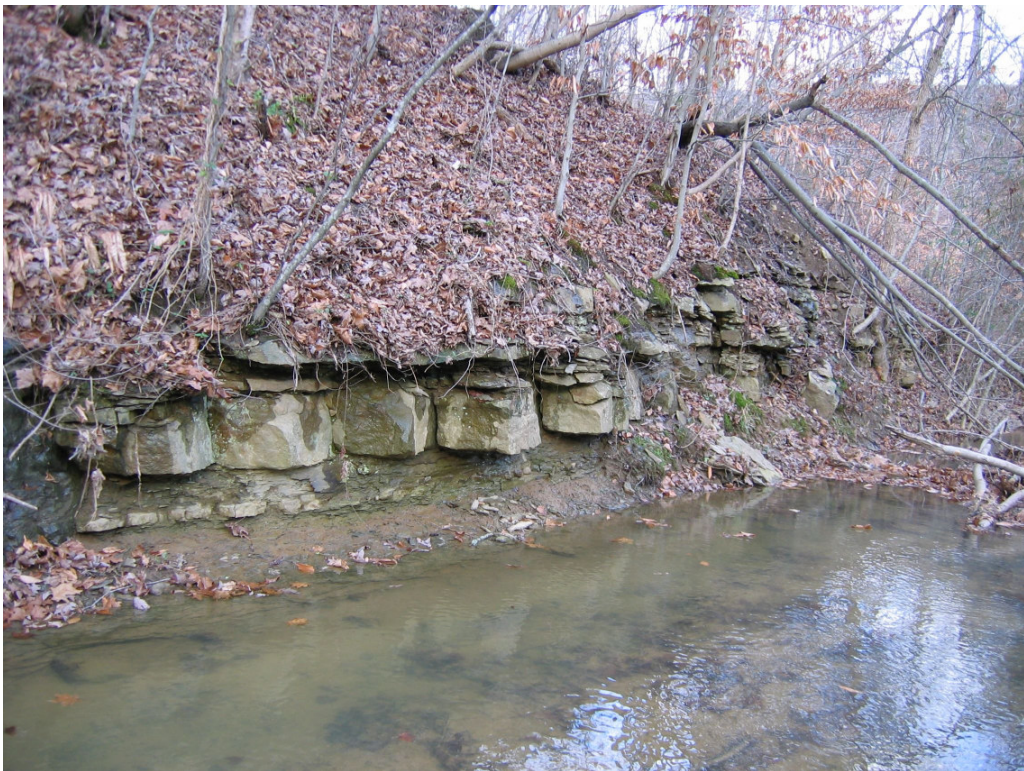
**Photo 14.** Bedrock exposure right of station 302+00.

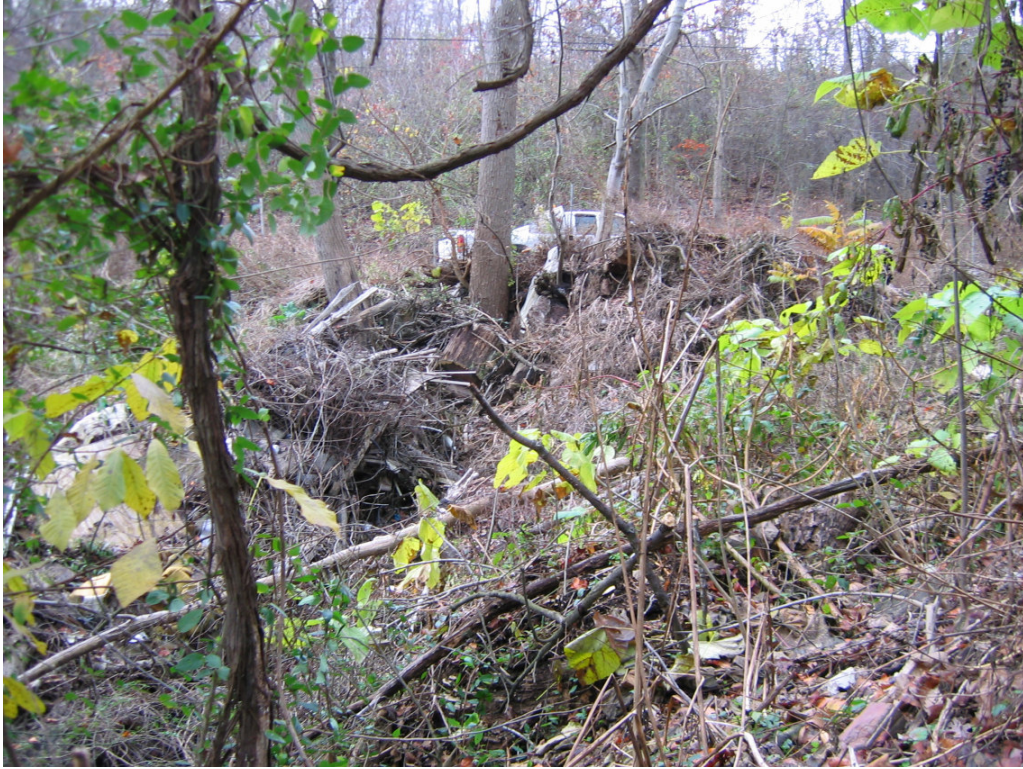
Many small dumps, miscellaneous junk, and other debris can be found along the alignment within the limits of construction. The dumps are generally small and are indicated on the land use and reconnaissance notes in Appendix A. A representative photo of a dump can be found in Appendix B. There was one area of debris that was unusually large along Stout Hollow Road, to the left of where it is crossed by the alignment. This area of debris is outlined on the land use and reconnaissance notes in Appendix A.

**Photo 15.** Debris pile north of Stout Hollow Road left of station 166+00.

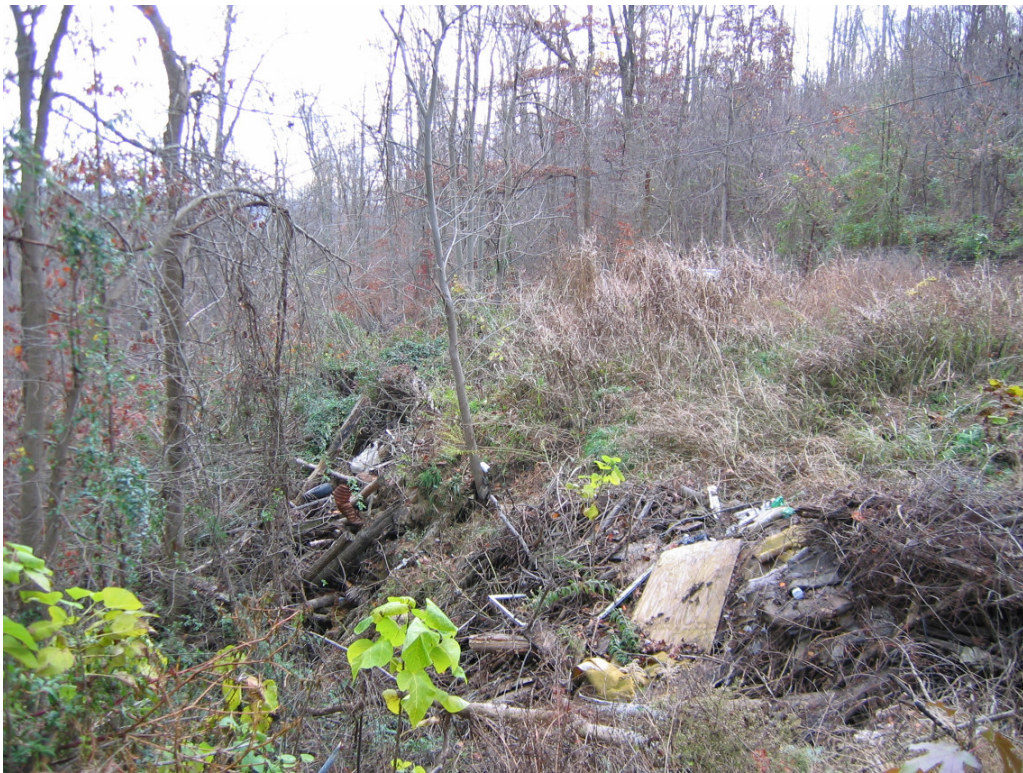
**Photo 16.** Debris pile north of Stout Hollow Road, left of station 166+00.

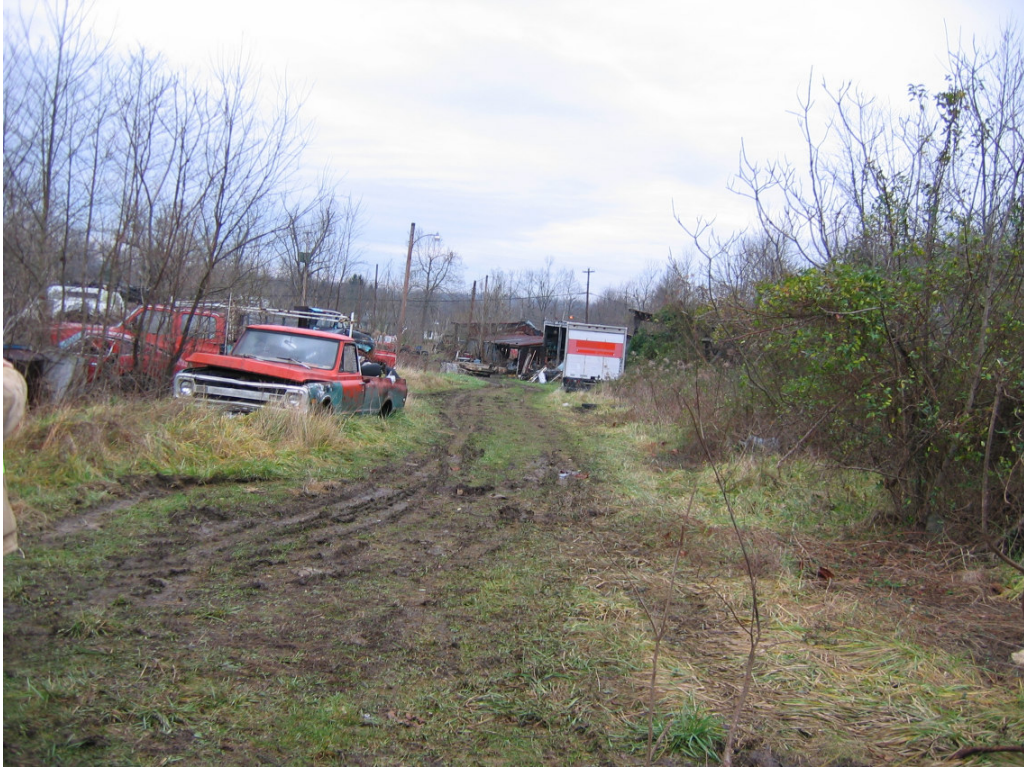
This area is used as a junkyard. A large amount of debris and deteriorating cars can be found to the right and left of the proposed alignment.

**Photo 16.** Junkyard to the right of station 118+00.
