August 22, 2019

Eric Evanoo, E.I.
Ohio Department of Natural Resources
2045 Morse Road, Bldg. E-3
Columbus, OH 43229

RE: Evaluation Timber Sidewalk and Railing
On Bridge ASD-20SP-00.85
At Mohican State Park
(Structural File Number 0326437)

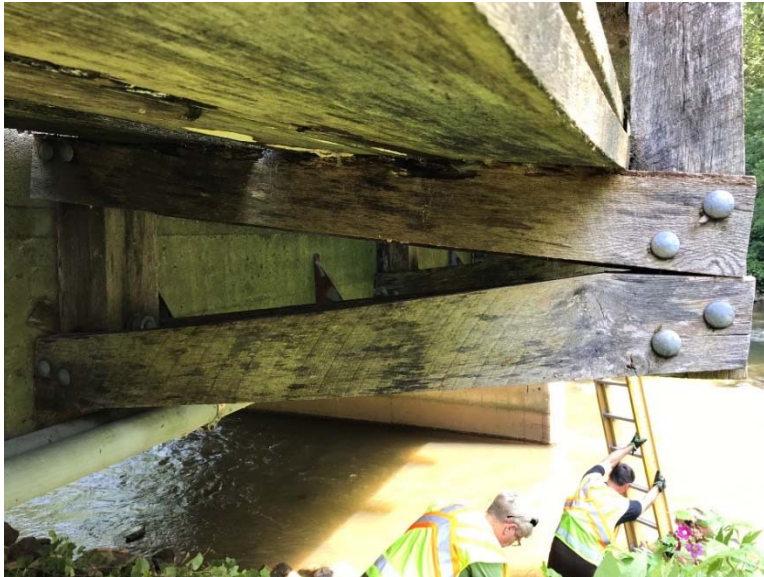
Picture # 1 - Typical downstream sidewalk cantilever support.

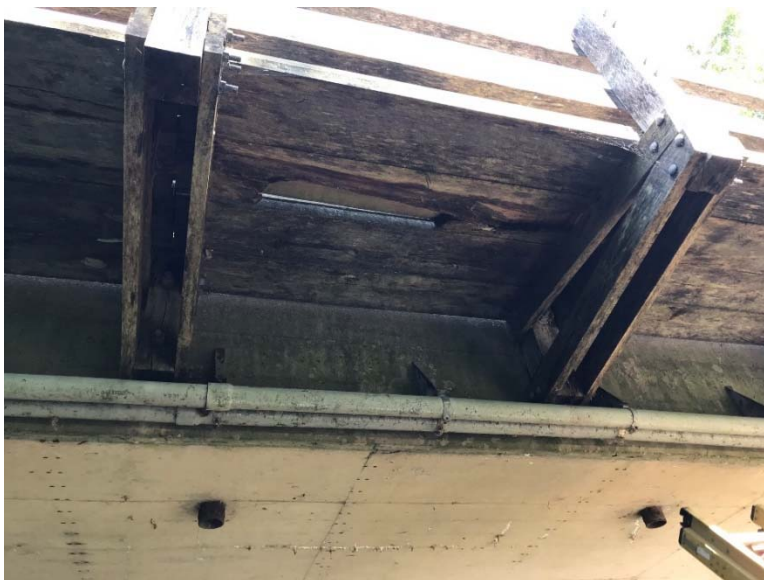
The sidewalk planking installed in 2005 is deteriorated throughout, with several holes where planks have completely rotted through. The planks installed over the 2005 planks are successfully carrying the pedestrian loads to the adjacent cantilevered supports. (See Picture # 2).

Picture # 2 - Hole in sidewalk plank in bay 4.

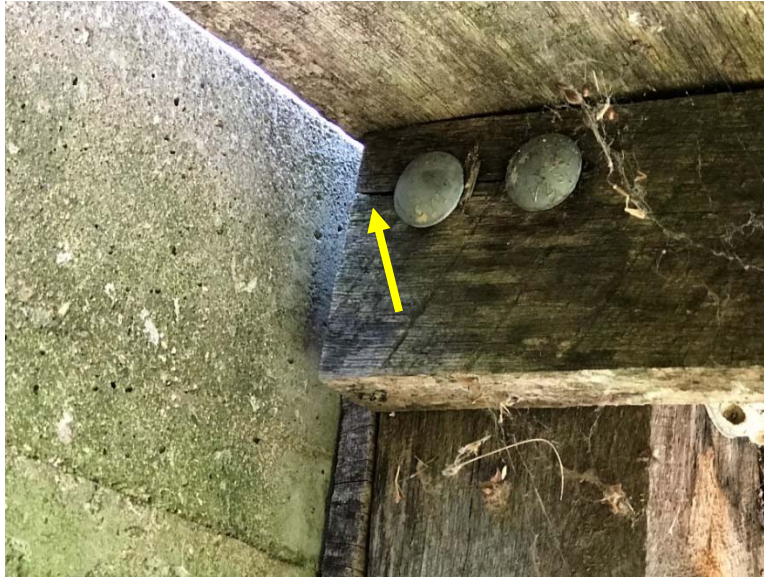
The cantilevered support members display varying levels of deterioration. Many of the members have splits emanating from the connection bolts, or rot. (See Picture # 3 and Picture # 4).

Picture # 3 - Split at connection bolts at cantilever 7.

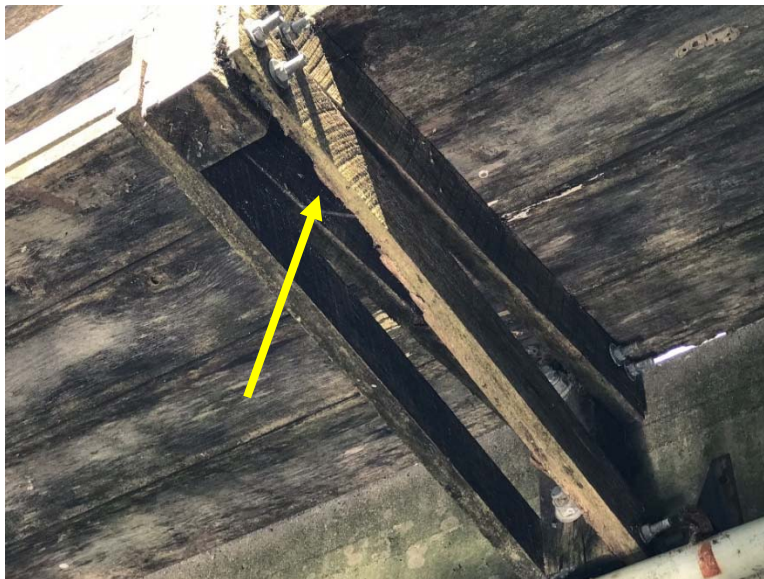
Picture # 4 - Heavy deterioration on north diagonal on cantilever 13.

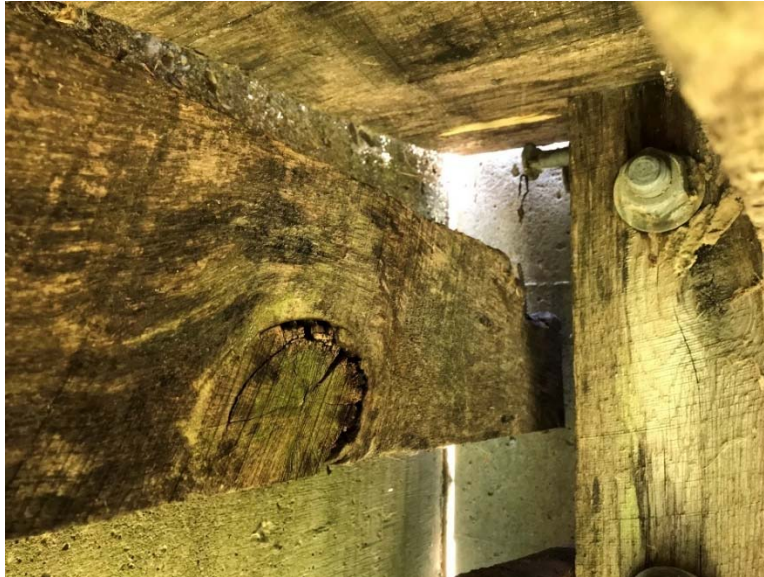
Two horizontal 2x6 boards on the cantilevers have broken away from the connection to the vertical 6x6. These are the south board at cantilever 1 (See Picture # 5) and the north board at cantilever 13 (See Picture # 6).

Picture # 5 - Failed south horizontal sidewalk support board at cantilever 1.

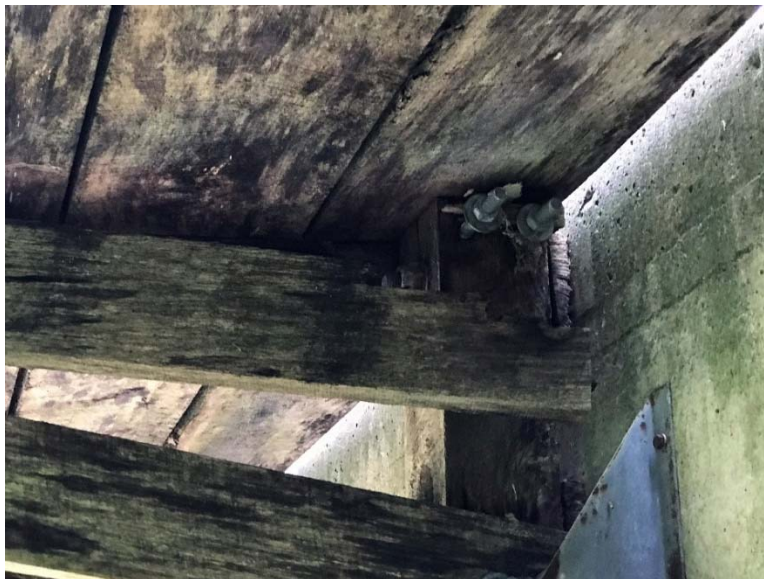
Picture # 6 - Failed north horizontal sidewalk support board at cantilever 13.

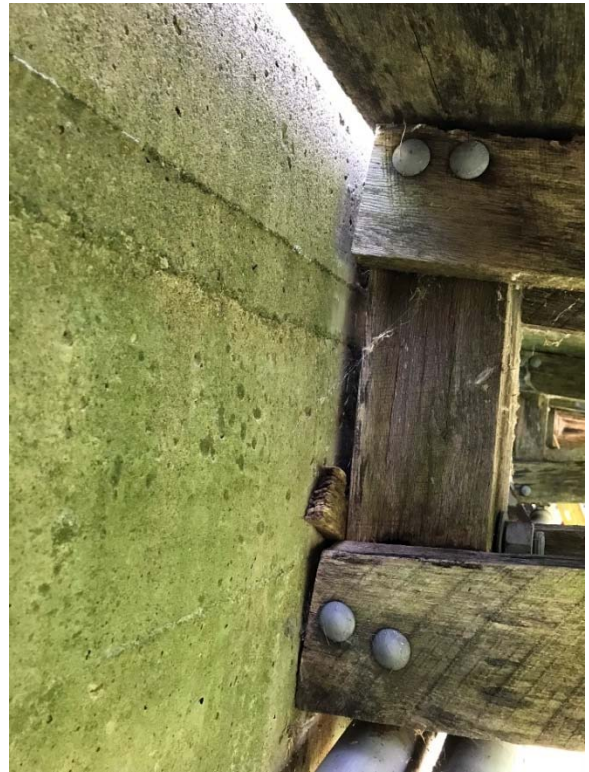
One of the primary concerns with the downstream railing and sidewalk was the noticeable sag away from the concrete slab. The fall of the 4'-0" wide sidewalk was estimated to be 6 3/8". Over time, the natural relaxation of the wood and minute enlargement of the connection bolt holes under repetitive load would contribute to some of this sag. The primary cause of the sag is that 3/4"x10" steel filler plates shown in the plans to fill the gap between the wood cantilevers and the vertical face of the concrete slab are missing at all cantilever locations. With this gap, the cantilever is free to rotate away from the slab until the bottom of the cantilever makes contact with the slab. (See Picture # 7.) The photograph shows an ineffective wood

shim. Shims may have been used during construction, but most are now gone and those remaining do little to level the sidewalk.

Picture # 7 - Gap between sidewalk cantilever support and downstream side of concrete slab. (Cantilever 2 shown.)

Two 3 ½" diameter conduits hang directly below the sidewalk cantilever brackets. They can be seen in Picture # 7. They do not interfere with the brackets.

The new railing and sidewalk need to have some type permanent material included to fill the ¾" gaps between the wood and the concrete slab. The plans specify galvanized steel plates and spacers. Another option may be to use ¾" elastomeric rubber pads to fill the gap. These are typically used as bearings to support bridge beams on the concrete abutments. We do not recommend using wood shims. This appears to have been tried before on the bridge. The relatively thin wood deteriorates faster than the remaining wood components and most of these have fallen out, leading to the sag in the sidewalk.

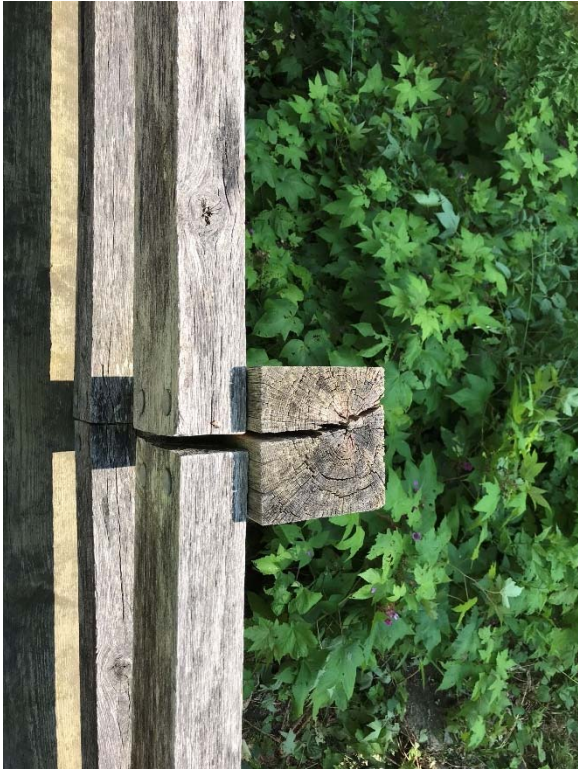
The downstream railing posts exhibit consistent deterioration. Most have large splits, some extending the full length of the vertical member. (See

Picture # 8 - Split in top of post 2.

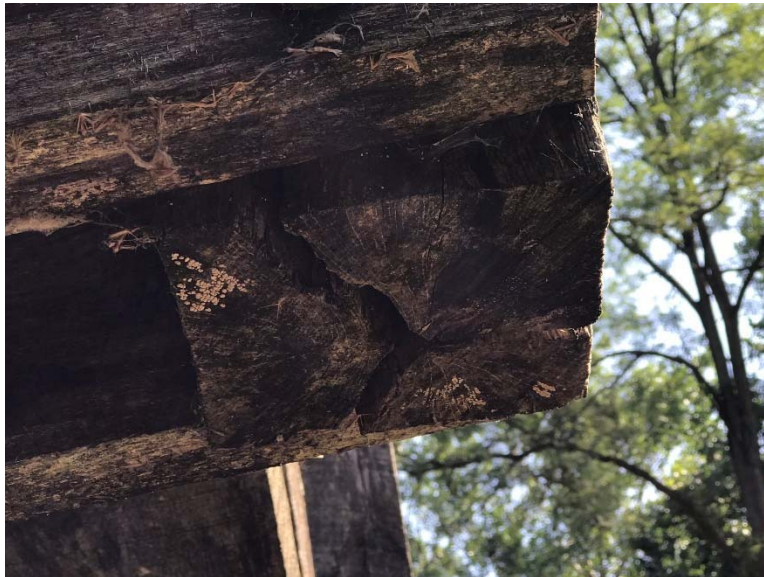
Picture # 9 - Large splits in bottom of post 7.

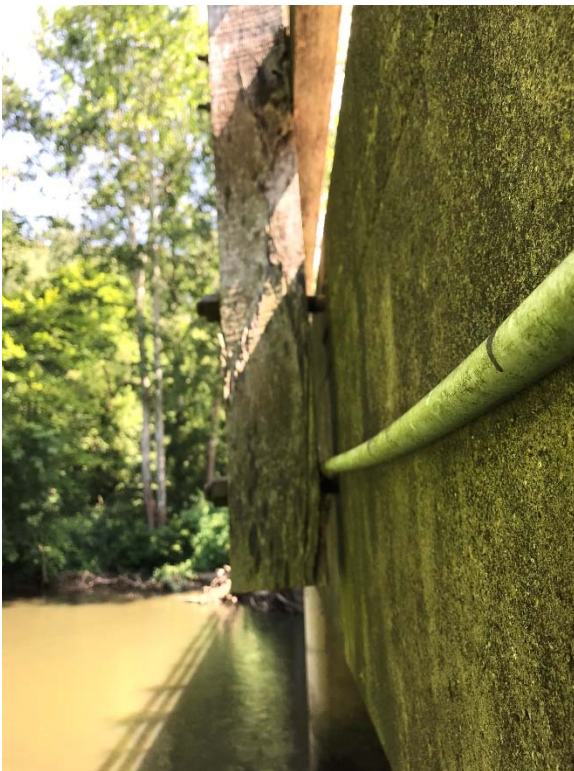
All of the post are not tight against the slab and can be rocked back and forth. The posts were detailed with a gap of $\frac{3}{4}$ " similar to the downstream sidewalk cantilevers. The gaps were to be filled by two 4"x4" steel spacers, one placed at each anchor rod protruding from the concrete. These spacers are not present, allowing the posts to rock. A defunct 1/2" conduit runs between the anchor rods, providing a minimal amount of support to post. (See Picture # 10.) The conduit is severed at the rear abutment. The purpose and time of installation of this conduit is not known.

Picture # 10 - Typical gap between upstream railing post and slab. Note defunct conduit.

The defunct conduit on the upstream side of the bridge must be removed or relocated to accommodate proper shimming of the railing posts to the side of the concrete slab.

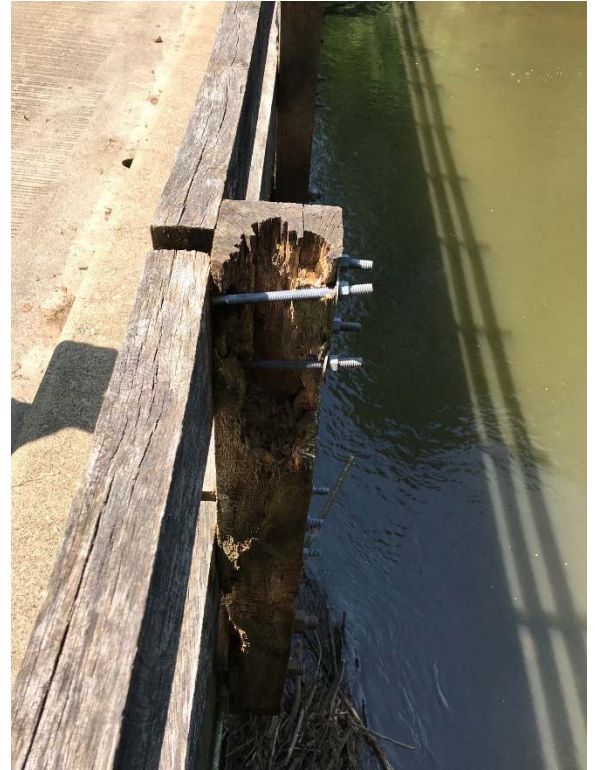
The tops of posts 12, 13, 15, 16, 19 and 22 from the south end of the bridge display rot. Post 16 has the worst deterioration. (See Picture # 11.)

Picture # 11 - Heavily rotted downstream post 16.

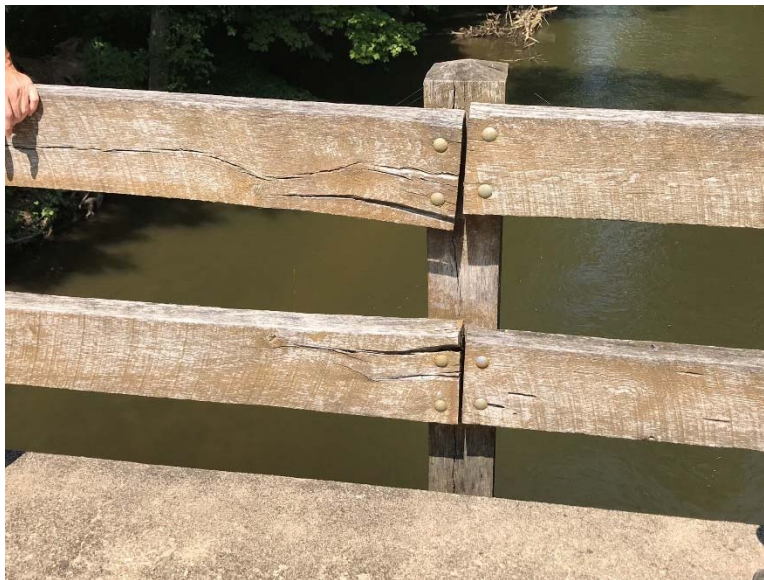
About half of the top and bottom railing panels display noticeable cracking. (See Picture # 12.)

Picture # 12 - Typical cracked panels on upstream railing.
