PROJECT: BEL-147-25.87		DRILLING FIRM / OPERATOR: TERRACON / FAY		DRILL RIG: MOBILE B-57		STATION / OFFSET: 1366+24, 5' LT.		EXPLORATION ID												
TYPE: LANDSLIDE		SAMPLING FIRM / LOGGER: TERRACON / SWYCK		HAMMER: CME AUTOMATIC		ALIGNMENT: BEL - 147		B-001-0-23												
PID: 118147 SFN: N/A		DRILLING METHOD: 3.25" HSA / NQ2		CALIBRATION DATE: 1/26/23		ELEVATION: 1290.7 (MSL) EOB: 25.0 ft.		PAGE												
START: 5/4/23 END: 5/4/23		SAMPLING METHOD: SPT / NQ2		ENERGY RATIO (%): 90		LAT / LONG: 39.975584, -80.880162		1 OF 1												
MATERIAL DESCRIPTION AND NOTES		ELEV.	DEPTHS	SPT/ RQD	N <sub>60</sub>	REC (%)	SAMPLE ID	HP (tsf)	GRADATION (%)					ATTERBERG				ODOT CLASS (GI)	SO4 ppm	HOLE SEALED
		1290.7							GR	CS	FS	SI	CL	LL	PL	PI	WC			
ASPHALT (24")			1																	
		1288.7	2	14 9 6	23	89	SS-1A	-	-	-	-	-	-	-	-	-	-		-	
HARD, BROWN, <b>CLAY</b> , TRACE SAND, TRACE GRAVEL, DAMP			3				SS-1B	4.50	-	-	-	-	-	-	-	-	11	A-7-6 (V)	-

PROJECT TYPE LANDSLIDE

**N4225522 BEL-147-25.87 PID 118147 – Slide Repair**

800 Morrison Road Columbus, Ohio 43230 PH. (614) 863-3113 FAX. (614) 863-0475	<b>ROCK CORE PHOTO OF BORING B-001-0-23 (Box 1 of 1)</b>  BEL-147-25.87 PID 118147 - Slid

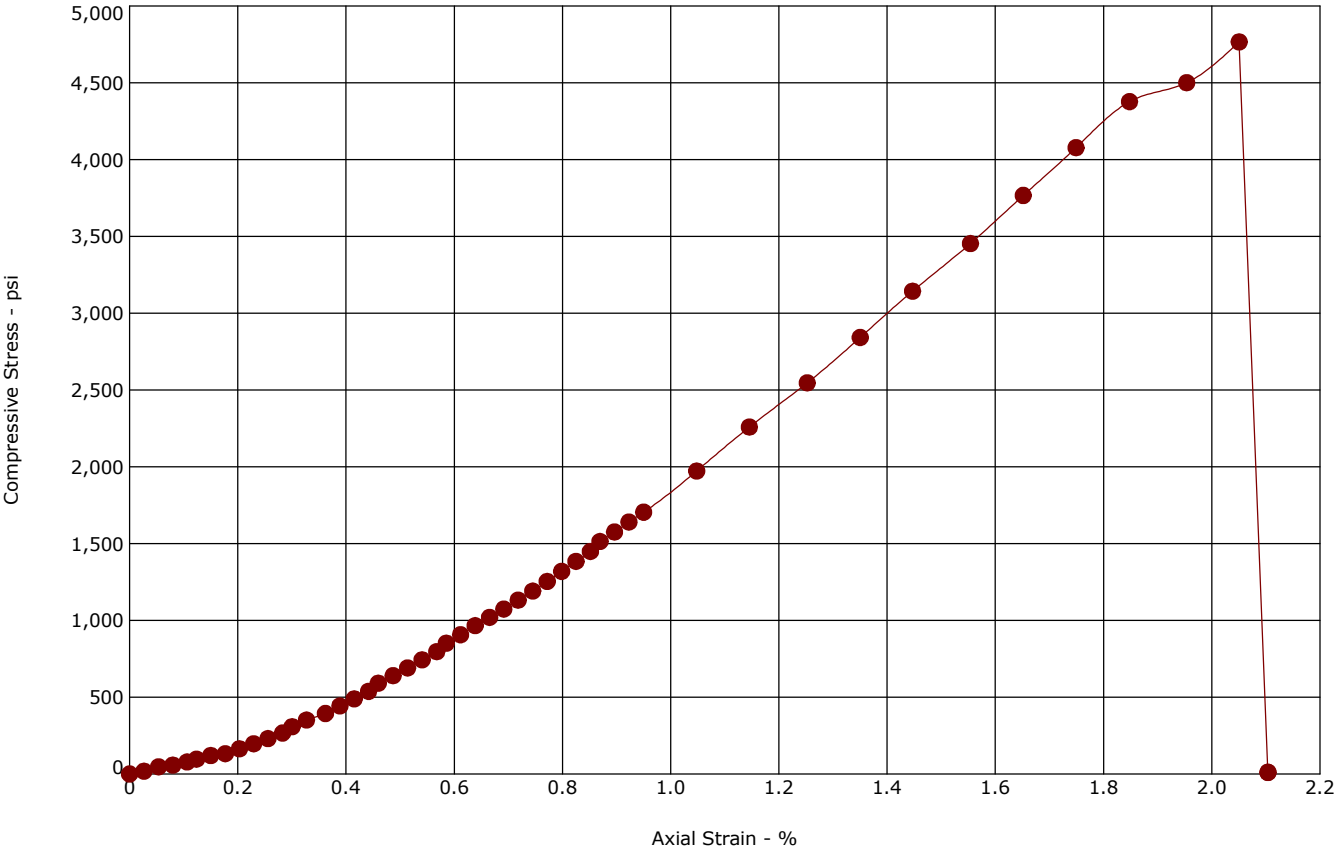
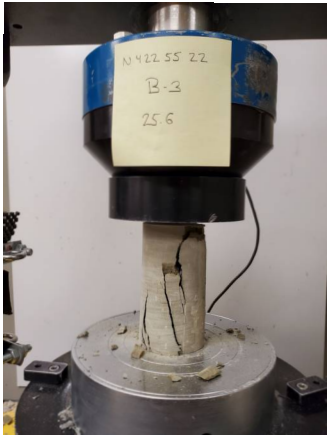
# Unconfined Compression Test

Boring ID	Depth (Ft)	Sample type	LL	PL	PI	Fines (%)	Description
B-003-0-23	25.6 - 26	NQ2					SANDSTONE

<table><tr><td>Moisture Content (%):</td><td>2.6</td></tr><tr><td>Failure Strain (%):</td><td>2.05</td></tr><tr><td>Unconfined Compressive Strength (psi):</td><td>4766</td></tr><tr><td>Undrained Shear Strength (psi):</td><td>2383</td></tr></table>
