# INTEROFFICE COMMUNICATION

**TO:** Cody Notz, P.E., District Geotechnical Engineer, District 11  
**COPY:** Brian Logston, P.E., Office of Geotechnical Engineering  
**FROM:** Andrew Jalbrzikowski, Office of Geotechnical Engineering  
Paul Painter, Office of Geotechnical Engineering  
**DATE:** February 15, 2024  
**SUBJECT:** BEL-250-8.15 PID 113235 Geophysical Exploration Summary

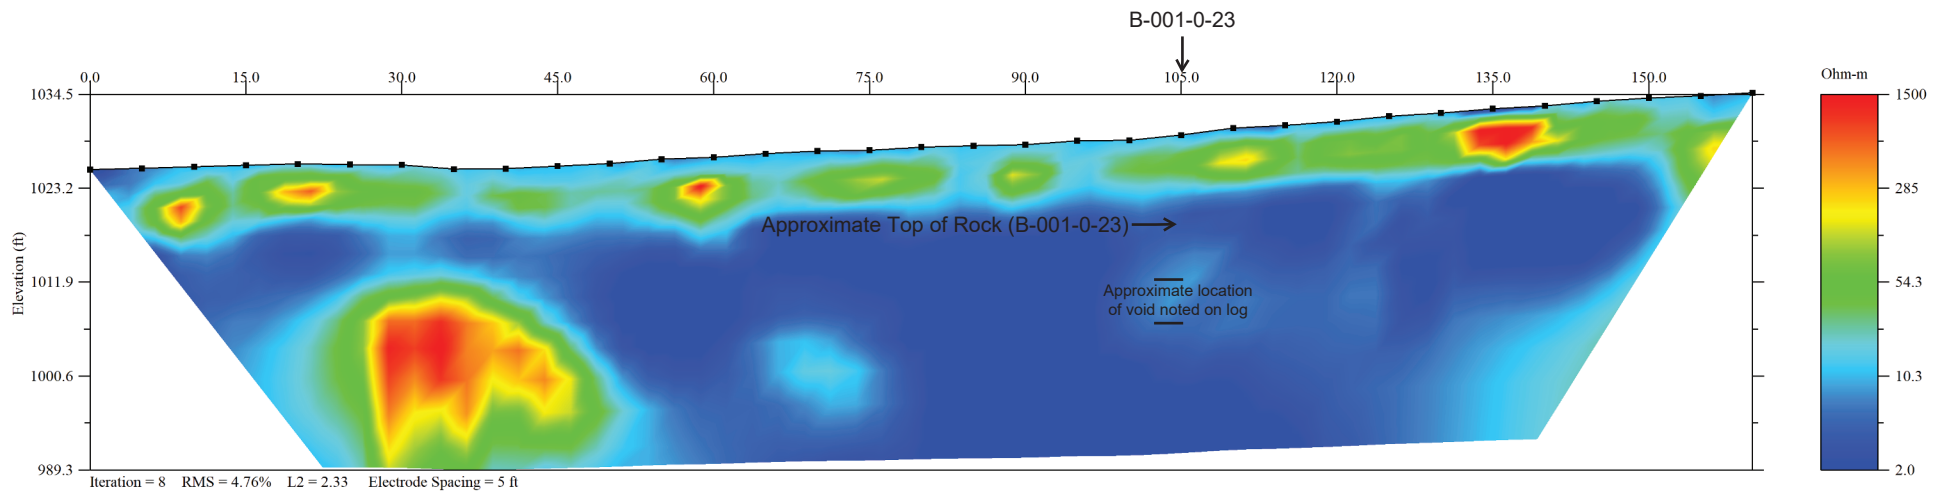
## BEL-250-8.15 ER Survey Line Inverted Resistivity Section

The ER section shows a contrast slightly above the top of rock as encountered in B-001-0-23. A high resistivity zone is indicated to the south of B-001-0-23, but it is in the normal range of earth materials and not considered to be an anomaly. This is confirmed by positive chargeability values in the same area of the IP section. A faint localized resistivity contrast is present in the area noted as a void on

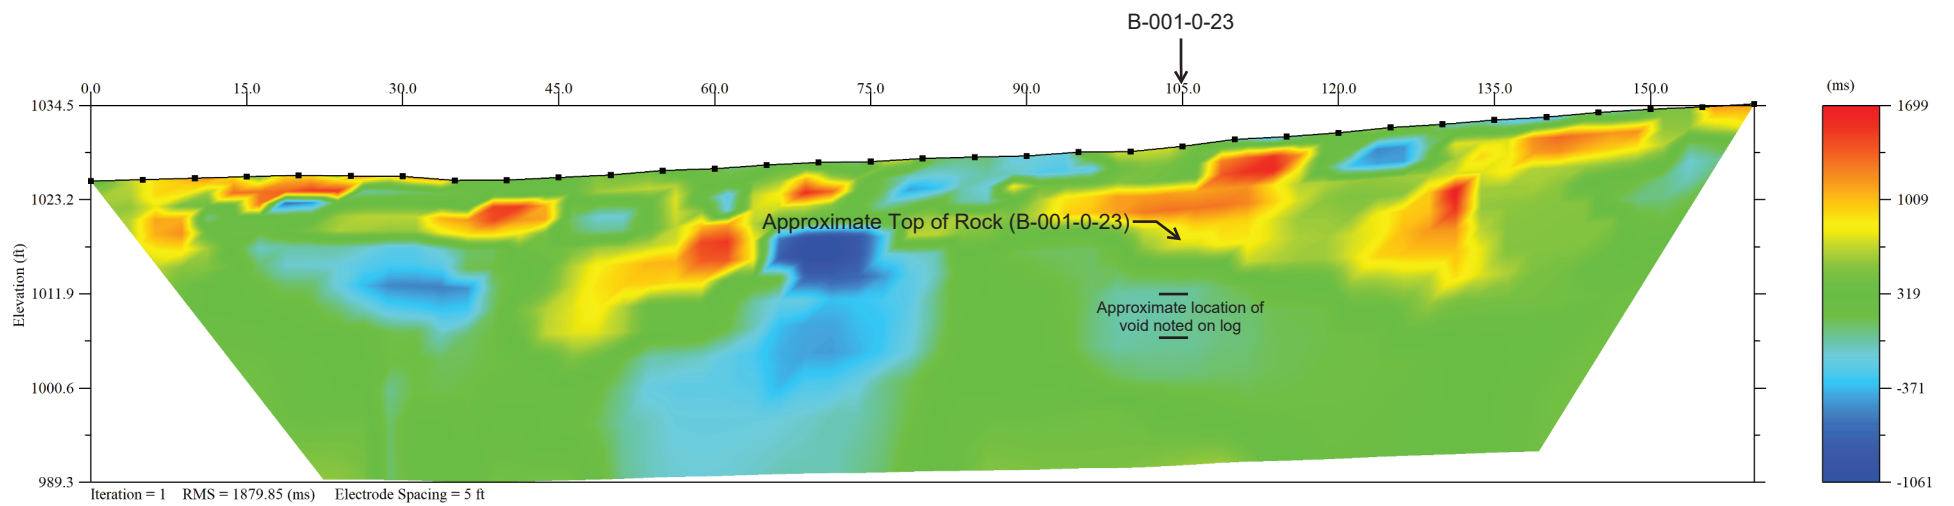
## BEL-250-8.15 Induced Polarization Section

the boring log. The IP section shows a faint negative chargeability zone in the same contrast area. This could indicate the presence of clay minerals, but it is unlikely an indication of an air-filled void.

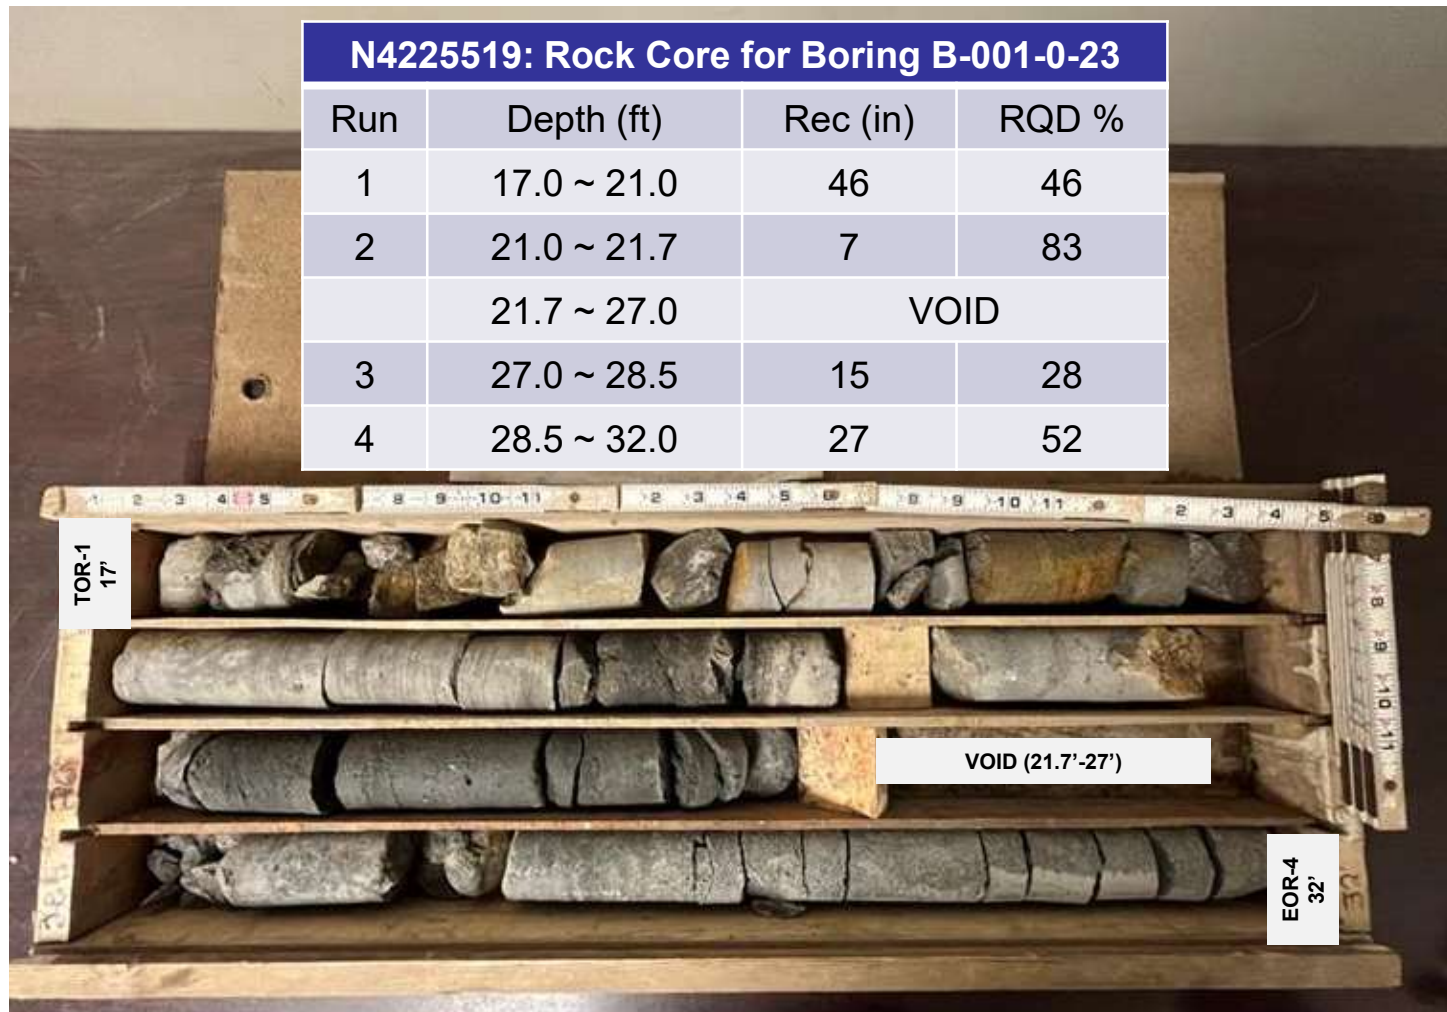
**PHOTO 1: ROCK CORE OF BORING B-001-0-23, BOX 1 of 1**

On May 3, 2023, a retaining wall boring was completed by Terracon. Overburden soil consisting of gravel and stone fragments with sand (A-1-b) was encountered to the top of rock. Sandstone bedrock underlain by shale was encountered at elevation 1017.6. The sandstone was described as severely weathered and weak. The shale was described as weak to slightly strong. From elevation 1010.9 to 1005.6, a "void" was encountered but no notes of tool drop were shown on the boring log. The void is near the elevation coal was encountered at historic boring B-001-0-16, completed approximately 210 feet south. Historic boring B-001-0-16 completed 75 feet north did not encounter coal, but it was only extended to a depth of 16.9 feet or an approximate elevation of 1018.9. Elevations of the historic borings were determined using the provided coordinates and digital elevation models from the Ohio Statewide Imagery Program (OSIP) and the USGS 3DEP map service. An exploration plan and the boring logs are attached.

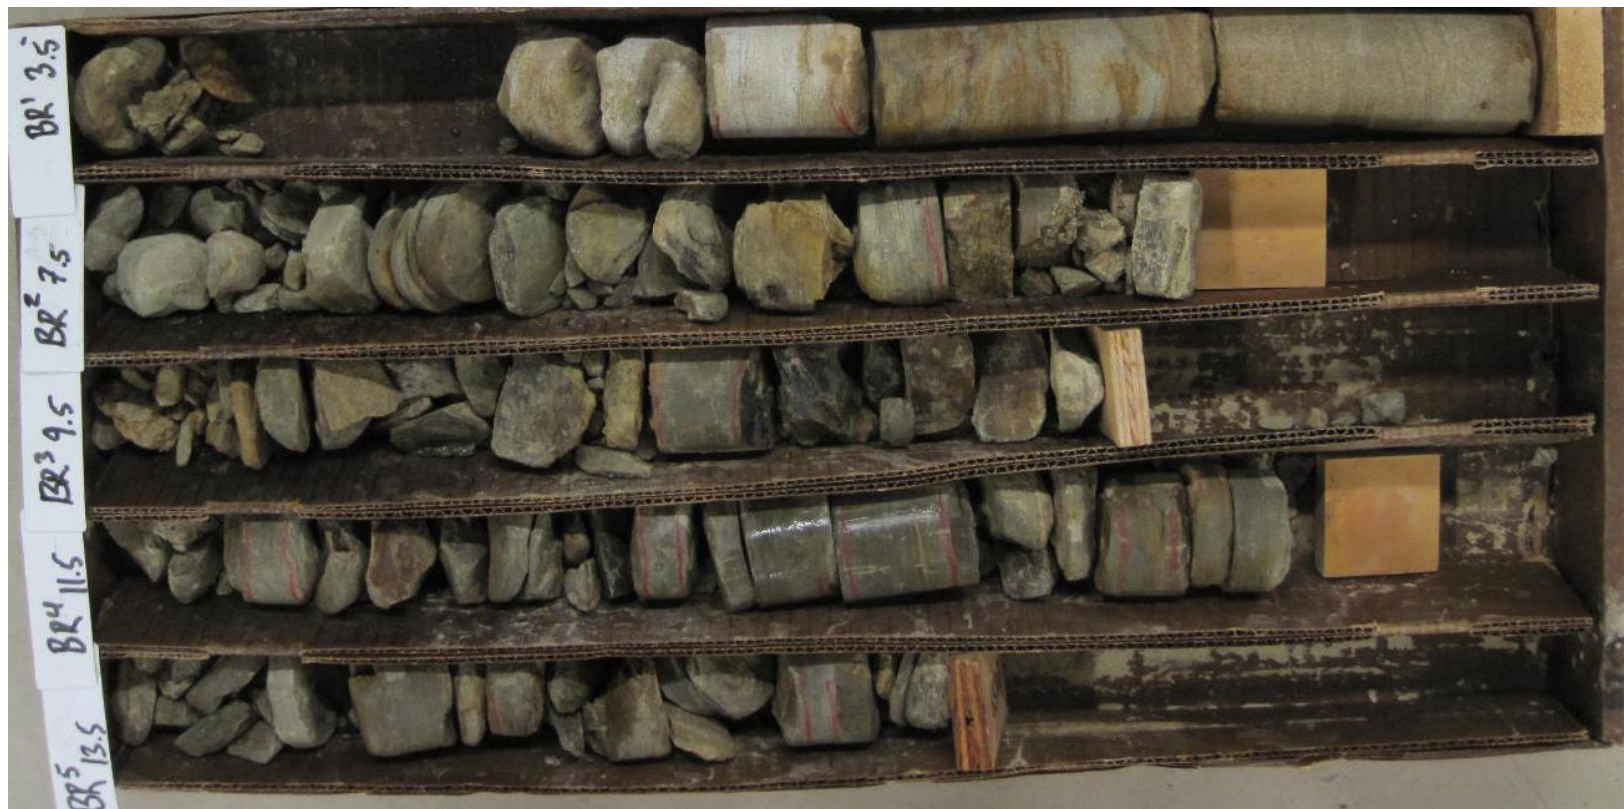
B-001-0-24

| Run #: | Depth | | Recovery | | RQD | |
|---|---|---|---|---|---|---|
| NQ2-1 | 3.5' | 5.5' | 18/24 | 75% | 10/24 | 42% |
| NQ2-2 | 5.5' | 7.5' | 18/24 | 75% | 0/24 | 0% |
| NQ2-3 | 7.5' | 9.5' | 17/24 | 71% | 0/24 | 0% |
| NQ2-4 | 9.5' | 11.5' | 20/24 | 83% | 0/24 | 0% |
| NQ2-5 | 11.5' | 13.5' | 14/24 | 58% | 0/24 | 0% |

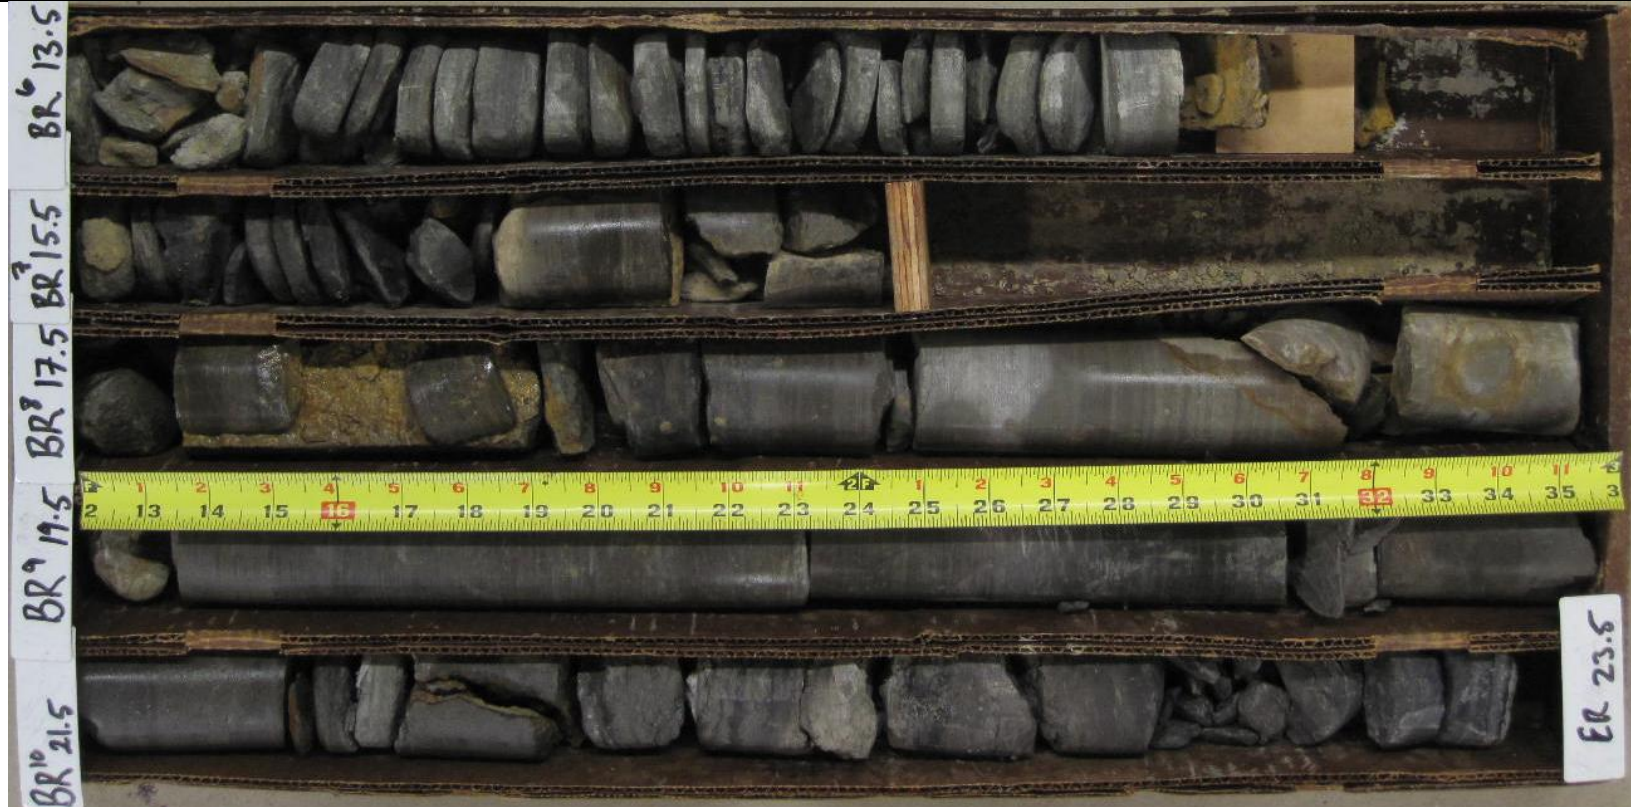
B-001-0-24

| Run #: | Depth | | Recovery | | RQD | |
|---|---|---|---|---|---|---|
| NQ2-6 | 13.5' | 15.5' | 18/24 | 75% | 0/24 | 0% |
| NQ2-7 | 15.5' | 17.5' | 13/24 | 54% | 0/24 | 0% |
| NQ2-8 | 17.5' | 19.5' | 24/24 | 100% | 12/24 | 50% |
| NQ2-9 | 19.5' | 21.5' | 24/24 | 100% | 20/24 | 83% |
| NQ2-10 | 21.5' | 23.5' | 22/24 | 92% | 3/24 | 13% |

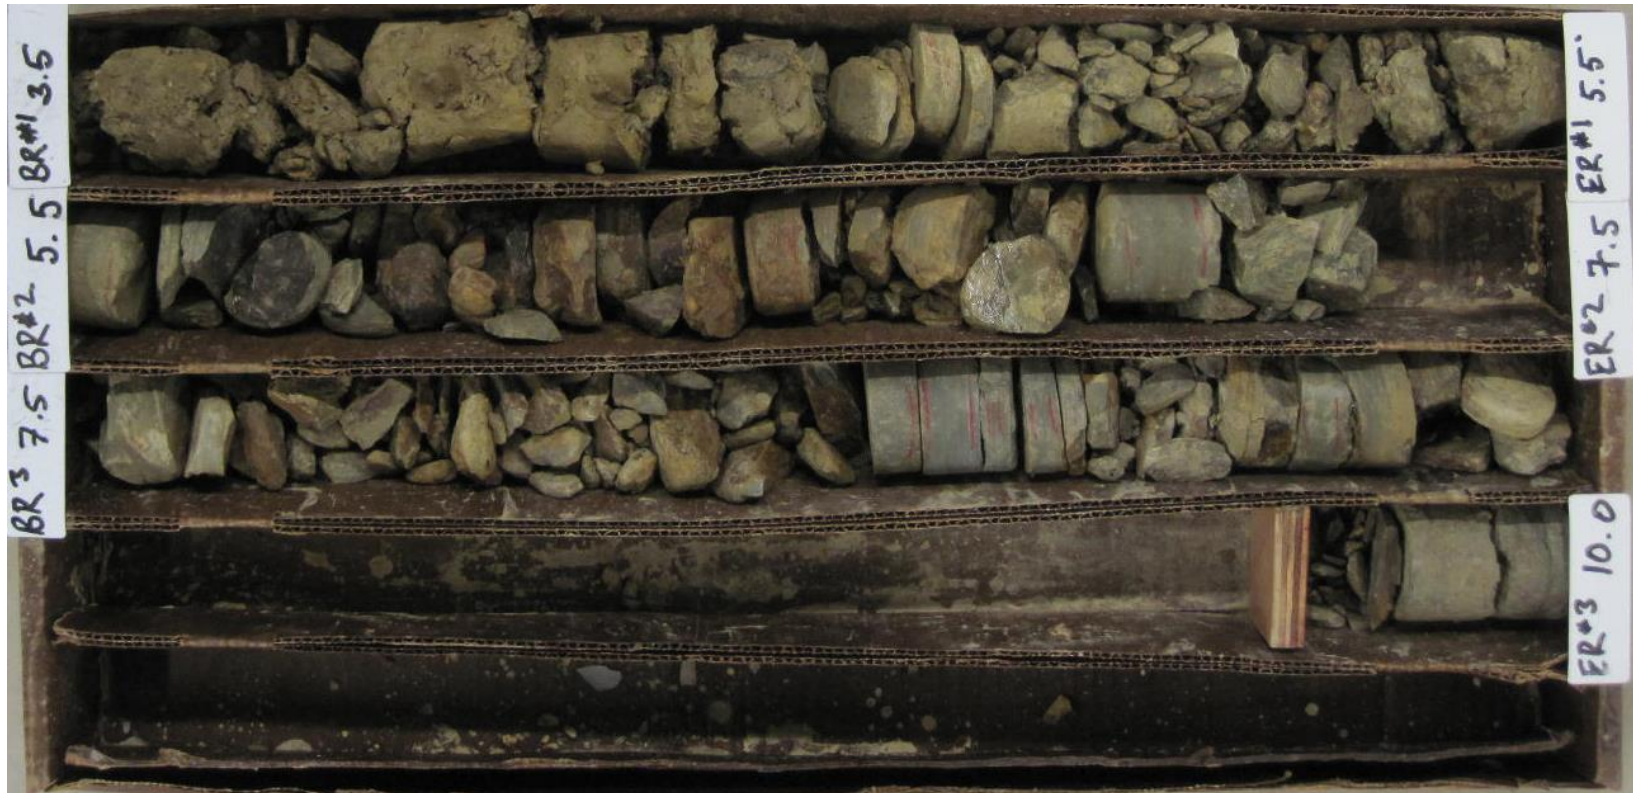
B-002-0-24

| Run #: | Depth | | Recovery | | RQD | |
|---|---|---|---|---|---|---|
| NQ2-1 | 3.5' | 5.5' | 24/24 | 100% | 0/24 | 0% |
| NQ2-2 | 5.5' | 7.5' | 21/24 | 88% | 0/24 | 0% |
| NQ2-3 | 7.5' | 10.0' | 28/30 | 93% | 0/30 | 0% |

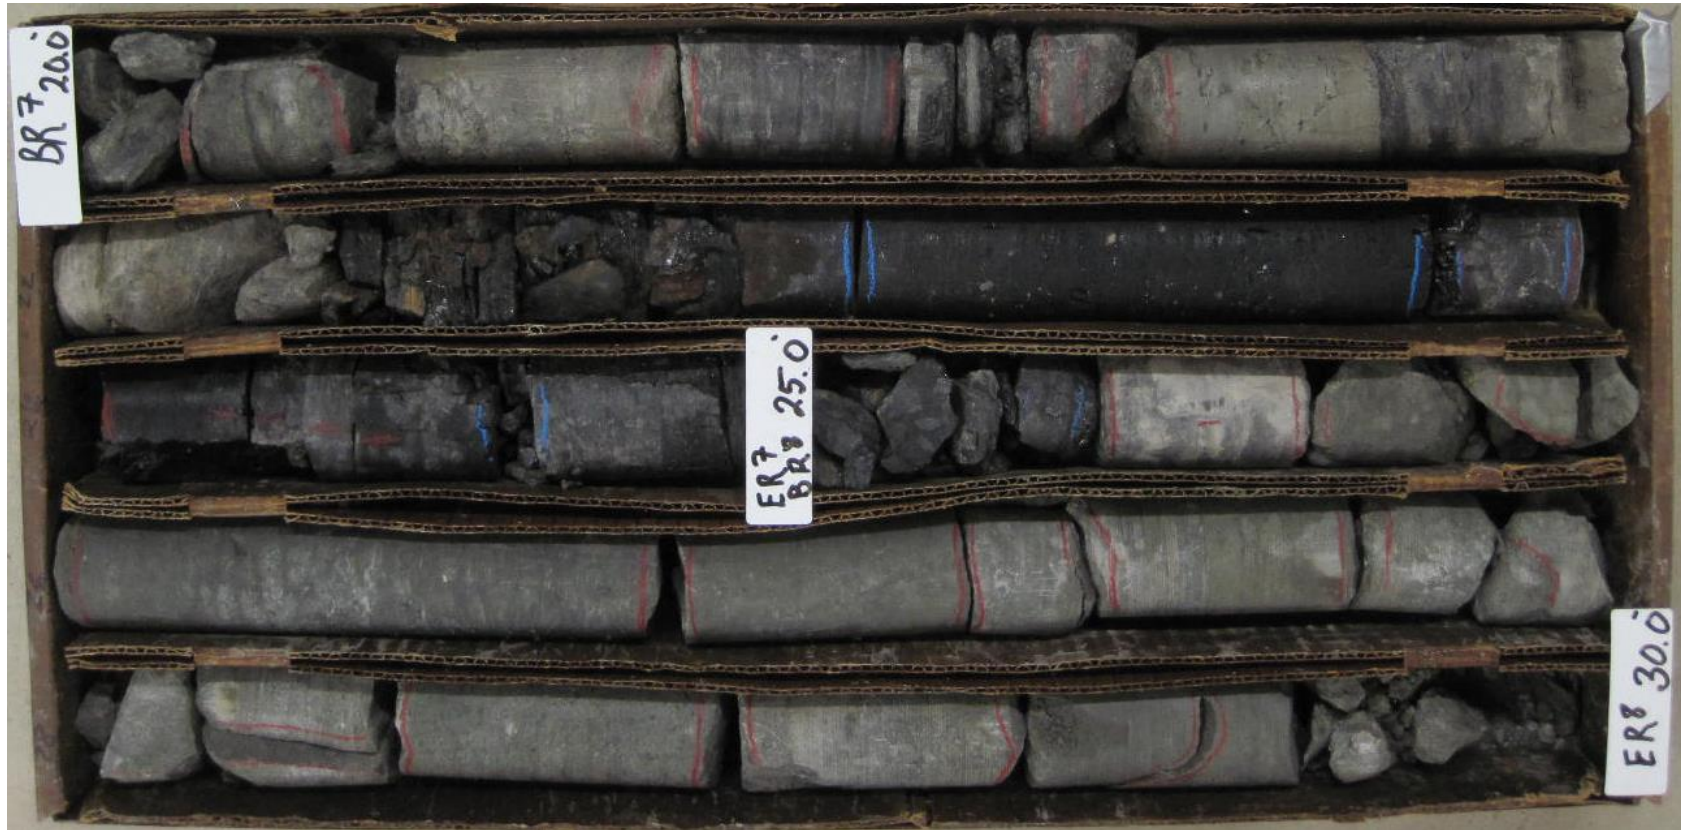
B-002-0-24

| Run #: | Depth | | Recovery | | RQD | |
|---|---|---|---|---|---|---|
| NQ2-7 | 20.0' | 25.0' | 60/60 | 100% | 15/60 | 25% |
| NQ2-8 | 25.0' | 30.0' | 57/60 | 95% | 27/60 | 45% |
