Re: CUY-BH-FY2023 Misc (PID 105909) Asbestos Survey

CUY-271-15.410, Highland Road over I-271

SFN 1811851

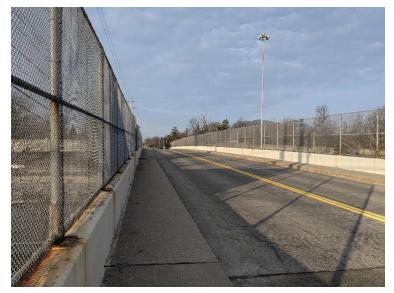
PHOTO 1 Looking west at CUY-271-15.410 bridge

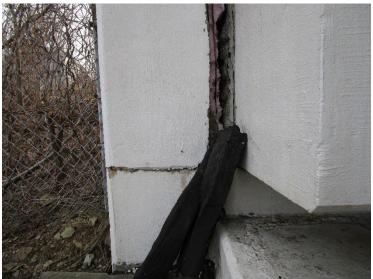
PHOTO 2 Looking at the north end east abutment 4"x4" mastic sealant. Sample collected here.

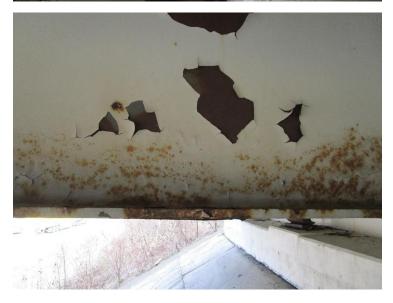
PHOTO 3 Underside of bridge. Paint samples collected.

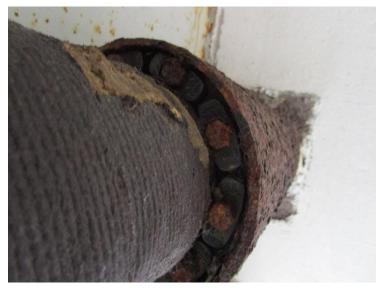
PHOTO 4 Internal mastic packing in coupler. Sample taken here.

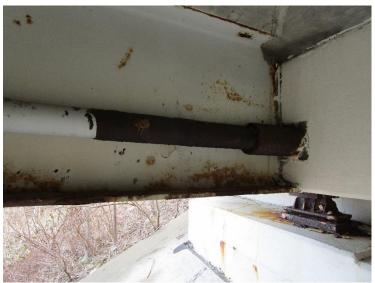
PHOTO 5 External pipe wrap around 4" PVC conduit at north beam. Sample taken here.

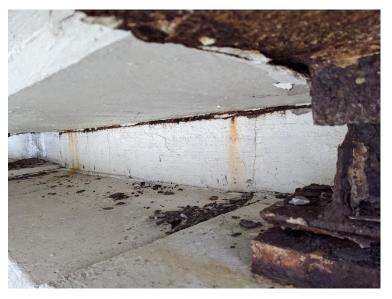
PHOTO 6 Expansion joint on east back wall. Sample taken here.

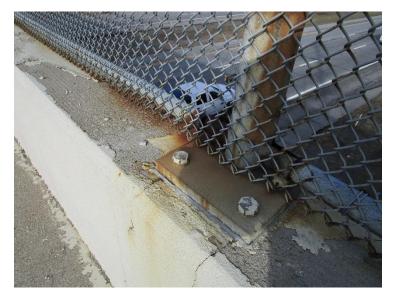
PHOTO 7 Vandal fence mounting flange. Caulking samples taken here.

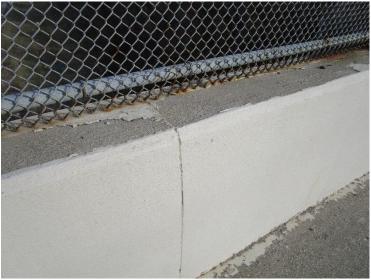
PHOTO 8 Parapet railing on the deck. Sample taken of joint compound.

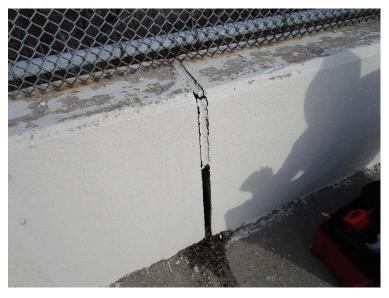
PHOTO 9
Parapet railing on the deck.
Sample taken of expansion joint.
